# **INDOOR AIR QUALITY ASSESSMENT**

**Winthrop Middle School  
151 Pauline Street  
Winthrop, Massachusetts**

Prepared by:  
Massachusetts Department of Public Health  
Bureau of Environmental Health  
Indoor Air Quality Program  
January 2013

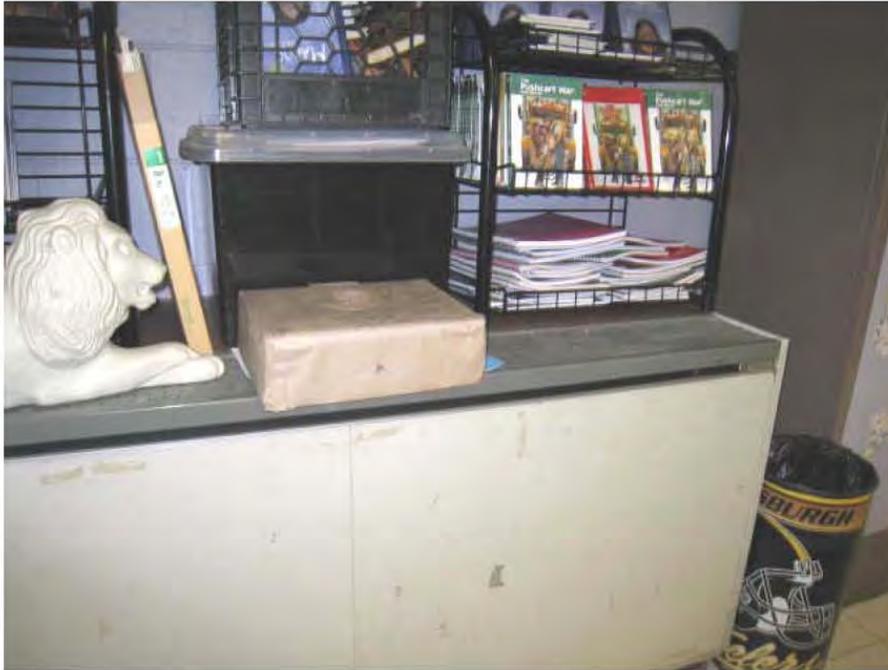
**Picture 1**

**Typical univent, note items on top**

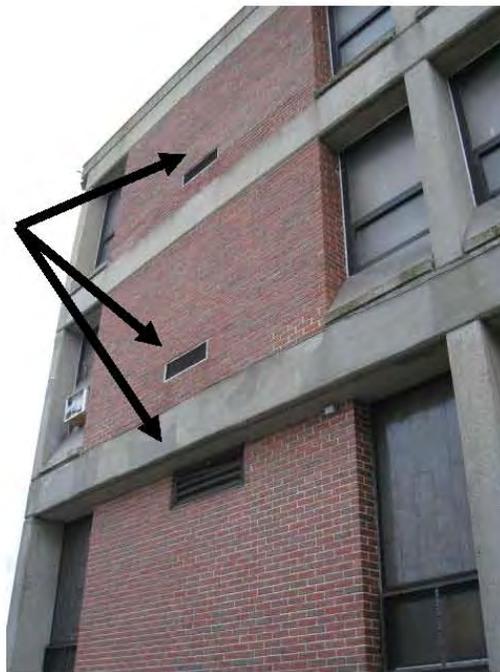
**Picture 2**

**Univent fresh air intakes (arrows)**

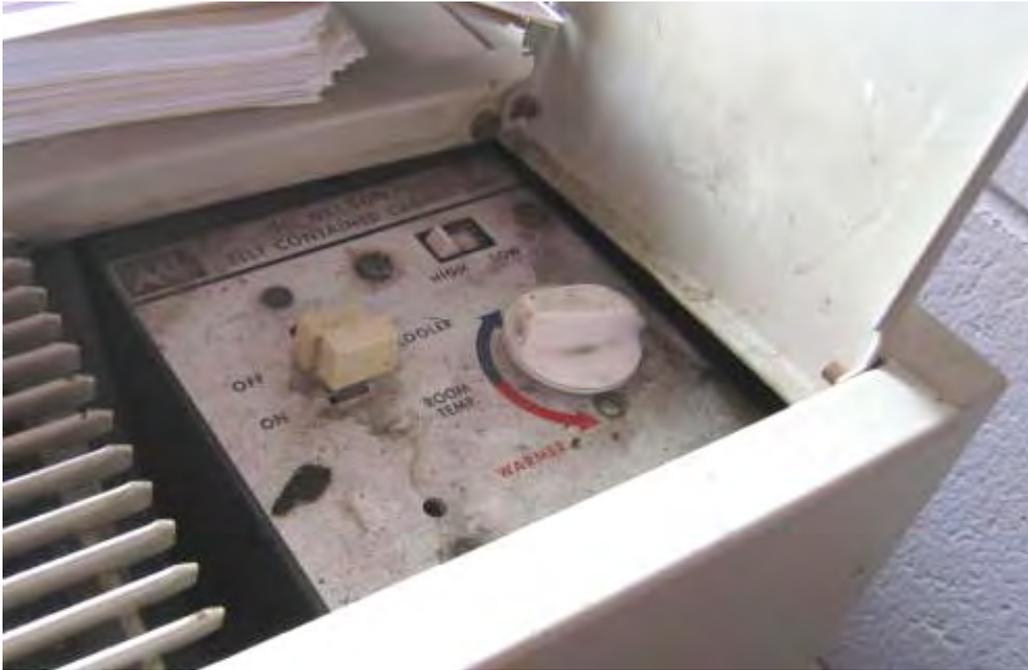
**Picture 3**

classrooms through an air diffuser located in the top of the unit. As mentioned, the majority of univents were found deactivated at the time of assessment (Picture 3; Table 1). In addition, some univents were found obstructed by furniture and other items on top of air diffusers and/or in front of return vents along the bottom of the units (Picture 1). Some univent covers were ajar (Picture 4), compromising filtration. In order for univents to provide fresh air as designed, they must remain “on” and operating while rooms are occupied and remain free of obstructions.

**Univent controls, showing unit is shut off**

1. Operate all ventilation systems throughout the building including univents and interior classroom HVAC systems continuously during periods of occupancy to maximize air exchange. This is of critical importance given the high levels of carbon dioxide documented in numerous areas of the school.
2. Consult with an HVAC engineering firm regarding the feasibility of repair vs. replacement of ventilation system components given their age. In the interim, work with

an HVAC engineering firm to adjust/repair univents and exhaust vents to improve air exchange in classrooms.

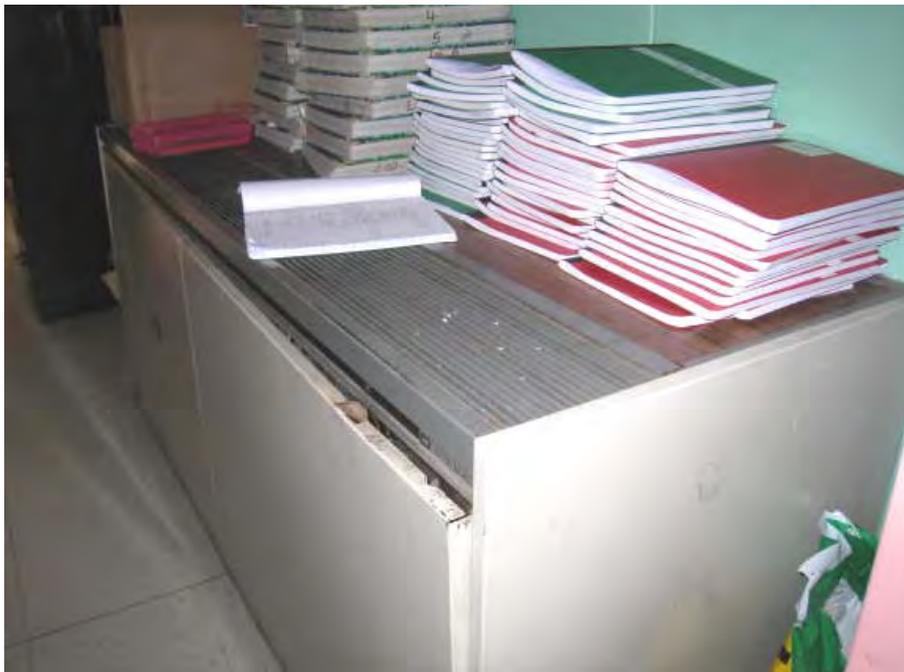
**Picture 4**

**Univent with cover ajar**

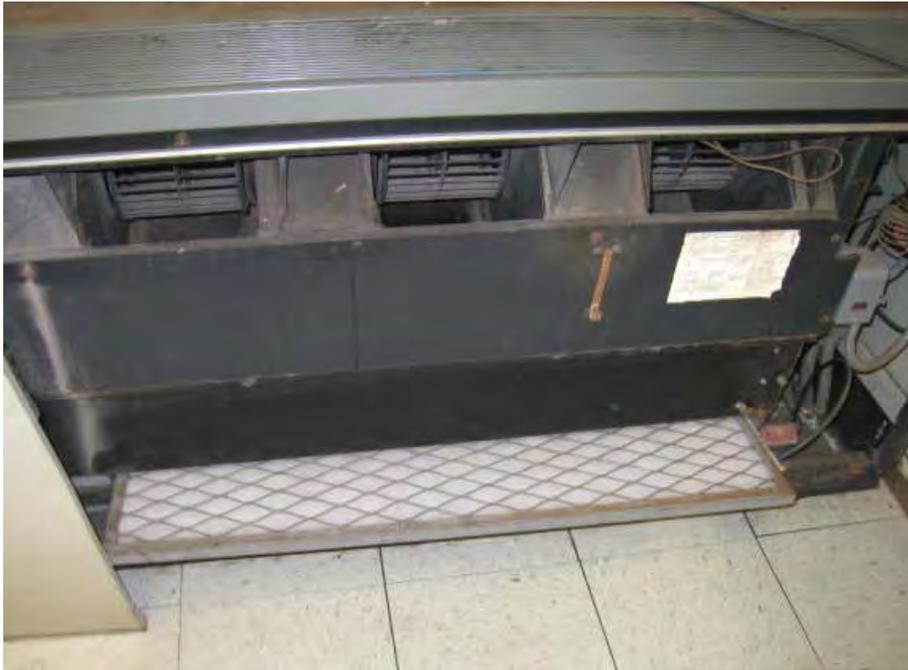
**Picture 5**

**Open univent showing filter material in lattice "cage"**

4. Consider replacing metal filter racks with proper fitting disposable filters with an equal or greater dust-spot efficiency to eliminate the time needed to replace filters from bulk material rolls. Prior to any increase of filtration, each piece of air handling equipment should be evaluated by a ventilation engineer as to whether it can maintain function with more efficient filters. The time saved through this measure may allow an increased frequency of filter changes; changing filters at least twice a year is recommended.

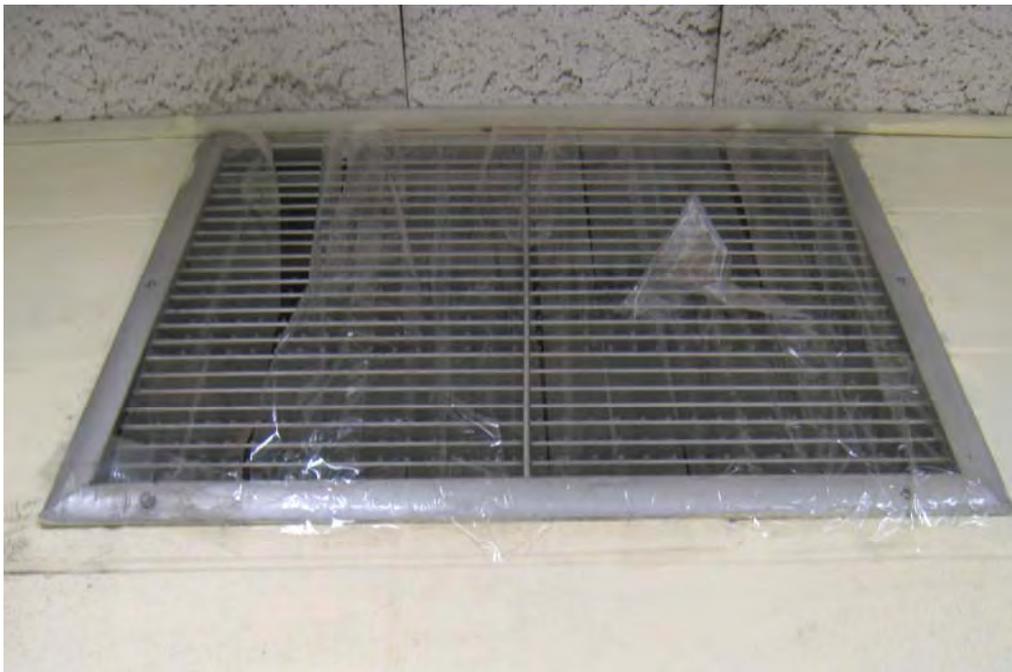
**Picture 6**

**Vent sealed with plastic tape**

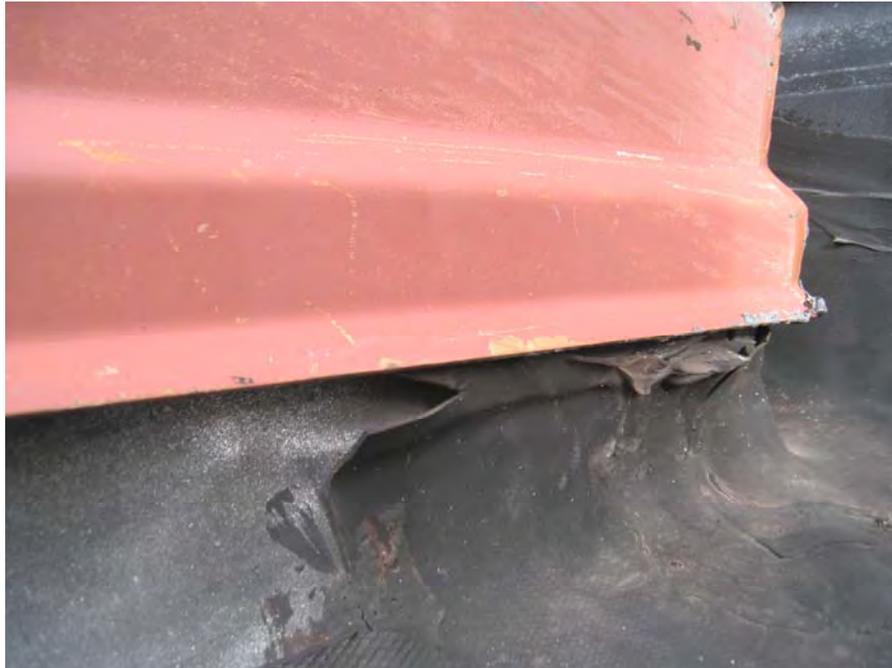
**Picture 7**

Water leaks from the roof were reported in hallways and some classrooms. Additional leaks from plumbing were also reported in lower level classrooms, including room 6A. BEH/IAQ staff noted damage to the flashing/sealing material around the rooftop access hatch and other junction areas on the roof (Picture 7). Repairs to these areas should prevent further

**Damaged sealing material around rooftop access hatch**

water infiltration. Consideration should also be given to replacing the current roof, which was installed over 15 years ago and is nearing its end of useful service life.

8. Ensure roof flashing/junctions and plumbing leaks are repaired and replace any remaining water-damaged ceiling tiles and wall materials. Examine the area above these tiles for mold growth. Disinfect areas of water leaks with an appropriate antimicrobial, as needed.

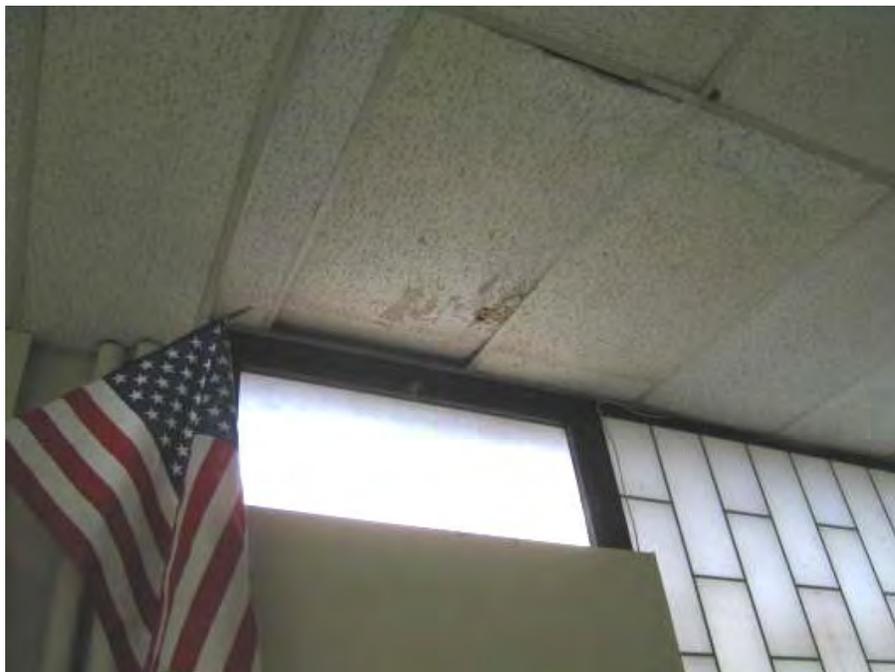
**Picture 8**

Water-stained and missing ceiling tiles were observed in some classrooms (Picture 8). In some areas, water-damaged tiles were the interlocking mineral variety, which can be difficult to replace. These interlocking mineral tiles may also contain asbestos mastic (Picture 9). A determination should be made concerning whether these tiles contain asbestos. If they do, the tiles should be left in place until they can be removed by a licensed asbestos remediation contractor.

**Water-damaged ceiling tiles in room 6A**

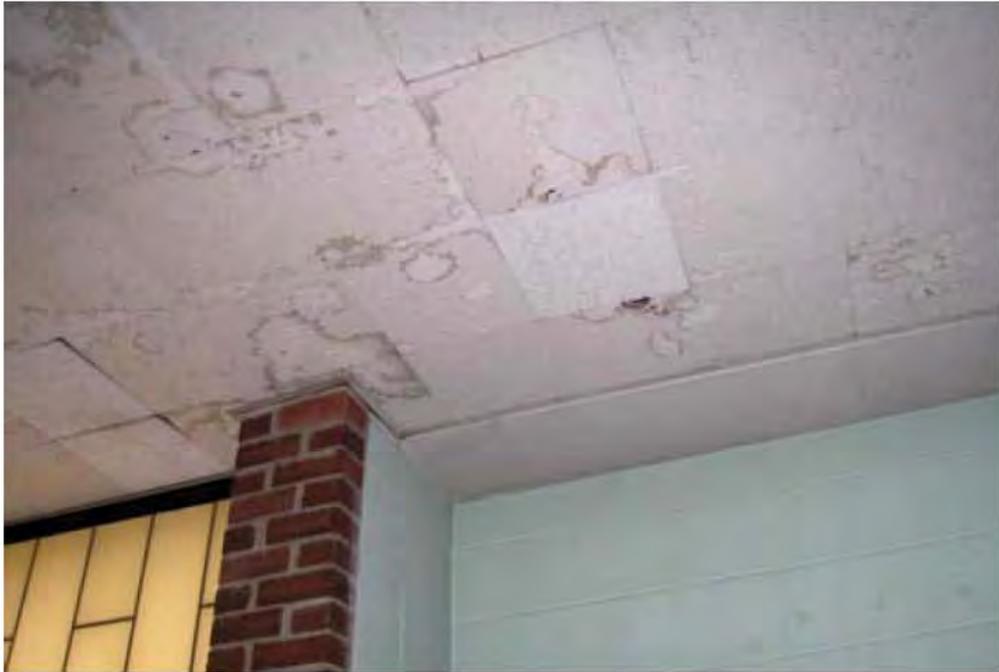
**Picture 9**

**Water-damaged interlocking ceiling tiles**

9. Determine whether interlocking ceiling tiles contain asbestos. If so, remediate damaged tiles in conformance with Massachusetts asbestos remediation and hazardous waste disposal laws.

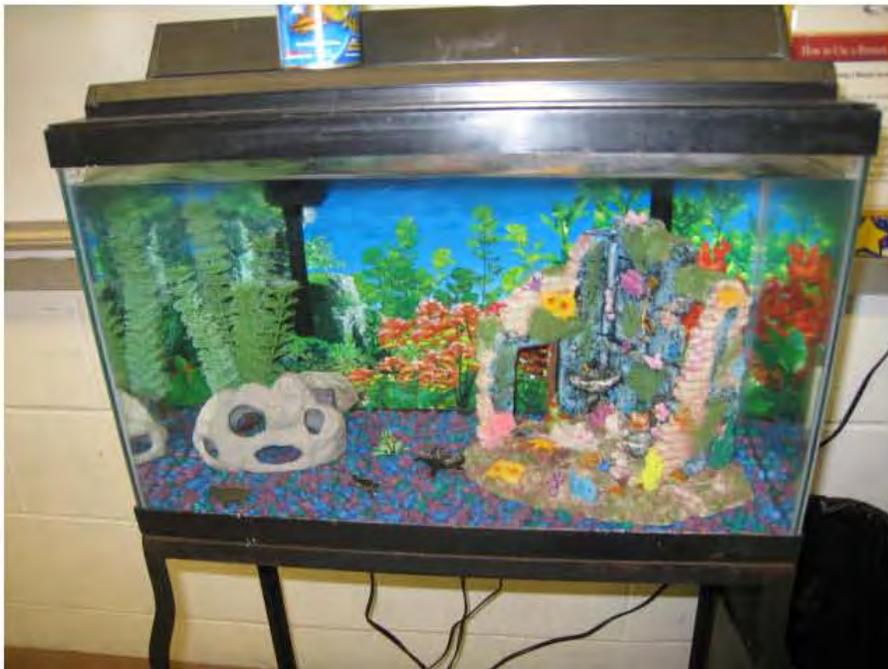
**Picture 10**

**Classroom aquarium**

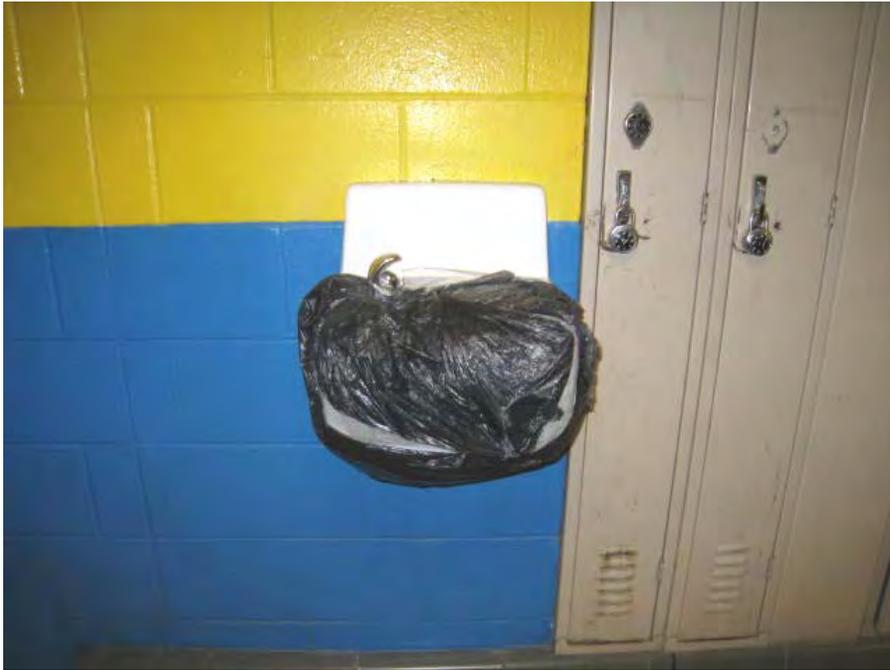
**Picture 11**

Drinking fountains in the main hallways and a toilet in the staff lounge were found to be out of order and covered with plastic (Picture 11). In addition, lab sinks in a science classroom were covered (Picture 12) and the cabinets beneath them were locked. It is not known if the water service to these disused fixtures had been shut off. To prevent both water leaks and the infiltration of sewer gases through unused drains, it is recommended that these fixtures be repaired, if desired, or properly abandoned.

**Out of service water fountain**

12. Repair broken/unused plumbing fixtures or decommission them completely.
13. Ensure plants, trees and shrubs are located at least five feet away from exterior walls/foundation of the building.

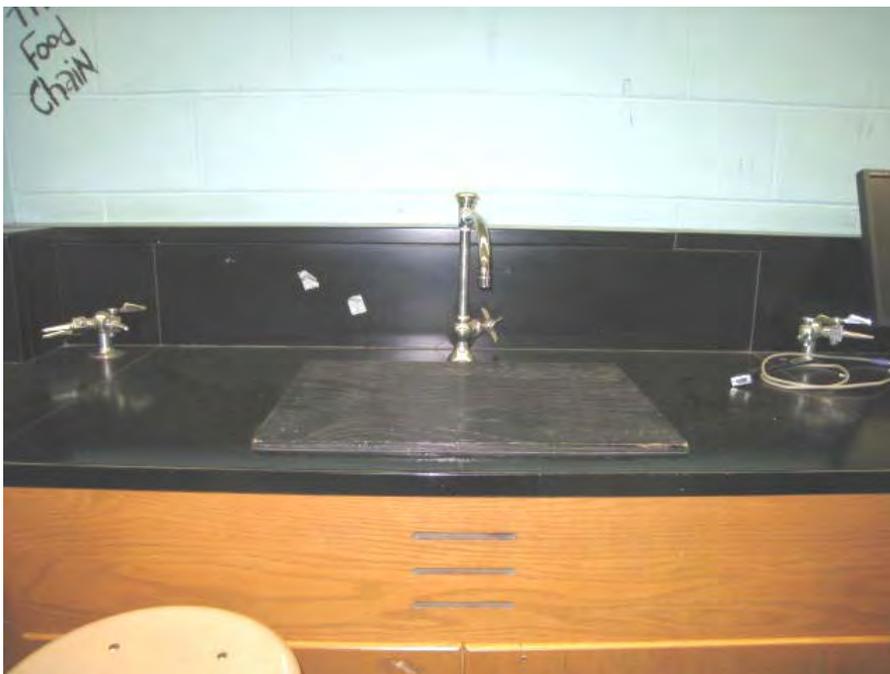
**Picture 12**

**Covered/sealed science lab sink**

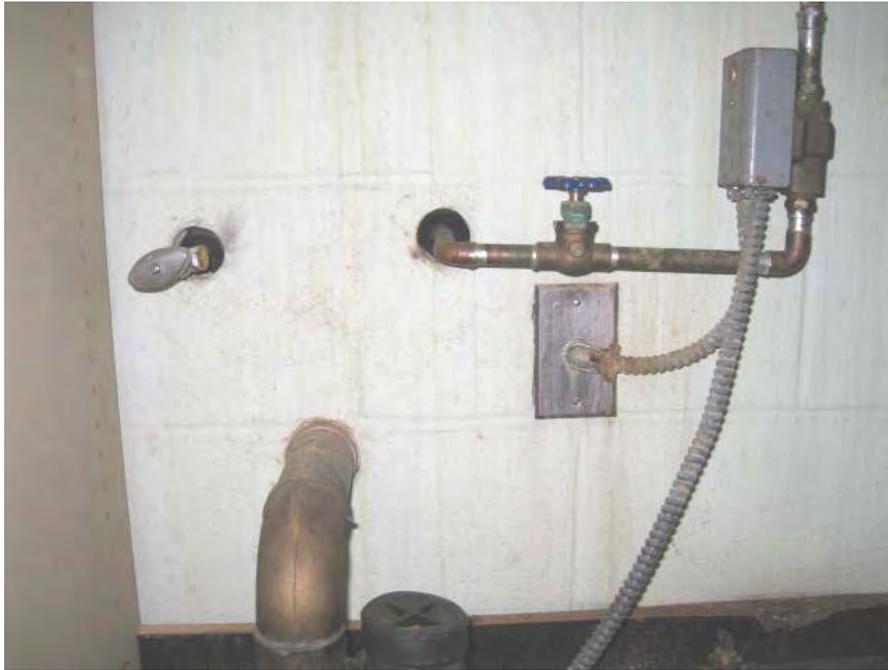
**Picture 13**

but there were several water-damaged ceiling tiles in this room. In addition, there were breaches noted between the areas under sinks and cabinets that open into an unfinished subfloor and wall cavity (Picture 13). These breaches can allow moisture and odors into the occupied space and should be sealed with an appropriate sealant.

**Breaches under sink in room 6A**

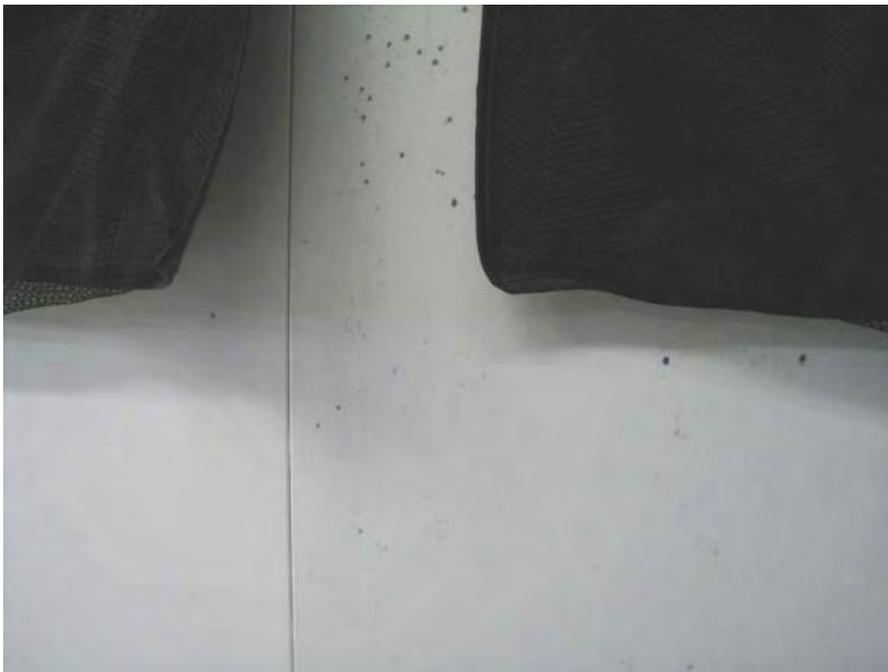
**Picture 14**

There were concerns regarding mold on an interior partition wall between rooms 107 and 109. BEH/IAQ staff examined the area of concern and noted dots of black staining on the wall underneath a large fabric wall hanging (Picture 14). It was reported that the spots kept reappearing following cleaning and painting. The presence of the wall hanging is likely preventing this area from drying following hot, humid weather, and may be contributing to mold growth. It is recommended that the affected area be thoroughly cleaned with an antimicrobial agent and allowed to dry completely; layers of paint may also need to be scraped off to get at the wall substrate layer. Unlike most of the school, which is composed of cement block and similar materials, these partition walls are composed of organic materials that may support mold colonization if they become and stay moist.

**Black staining/possible mold growth on partition wall**

10. Clean partition wall between rooms 107 and 109 with an antimicrobial agent and allow it to dry completely; layers of paint may also need to be scraped off to get at the wall substrate layer. Consider moving the black fabric wall hanging from this location to prevent this area from accumulating moisture.

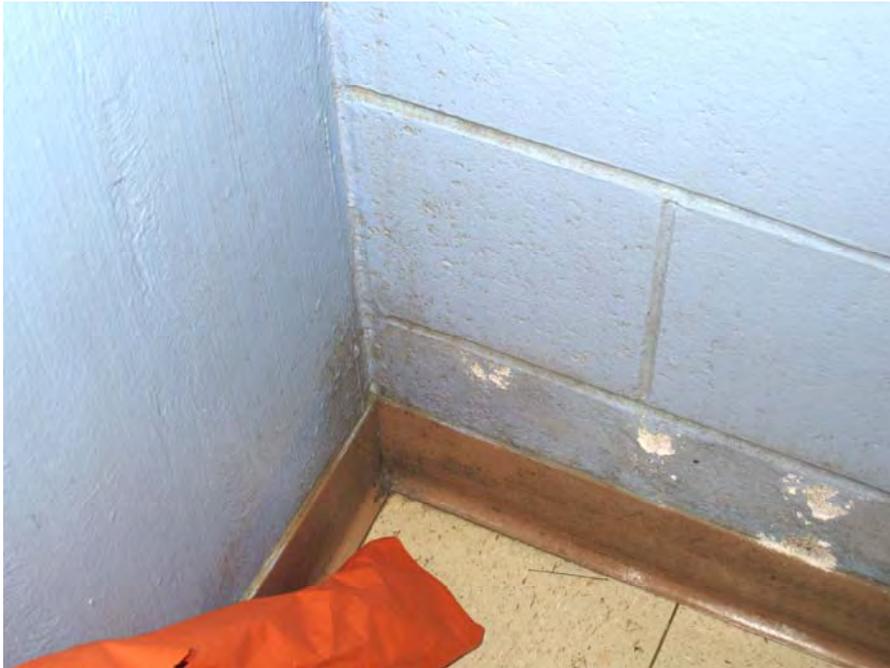
**Picture 15**

Additional concerns were reported regarding the presence of mold in the teachers' room closet. BEH/IAQ staff observed conditions in this closet. A number of items were stored directly on the floor; however, no items appeared to be moist or water-damaged. Dark staining/debris was observed on the cement walls, particularly at the corners where the walls and floor meet (Picture 15). Cement is a semi-porous material that is not a source of mold growth,

and no signs of water damage (e.g. efflorescence) were noted on these walls. The paint applied to the walls also does not support mold growth. Given the location and concentration of the dark material, it is likely that the debris collected in the uneven surface of the cement walls stems from dirt suspended on a mop. Measures should be taken to clean the walls thoroughly to remove the material. Floors should be cleaned with well-rinsed mops to prevent future build up.

**Staining/dirt on wall in teachers' room closet**

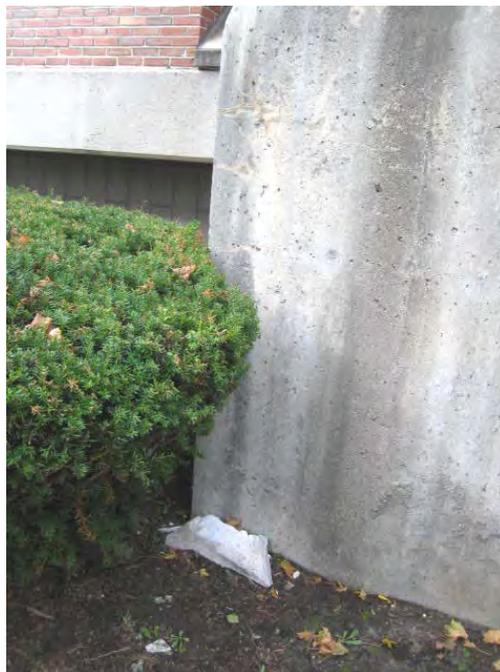
**Picture 16**

During an examination of the exterior of the building, BEH/IAQ staff observed trees and shrubs in close proximity to the building (Picture 16). Shrubs/trees in close proximity to the building hold moisture against the building exterior and prevent drying. The growth of roots against exterior walls can bring moisture in contact with the foundation. Plant roots can eventually penetrate the wall, leading to cracks and/or fissures in the sublevel foundation. Over time, these conditions can undermine the integrity of the building envelope and provide a means of water entry into the building via capillary action through exterior walls, foundation concrete and masonry (Lstiburek & Brennan, 2001). The freezing and thawing action of water during the winter months can create cracks and fissures in the foundation that can result in additional penetration points for both water and pests. Trees and shrubs can also be a source of pollen, debris and mold into univents and windows. Consideration should be given to removing landscaping in close proximity to the building so as to maintain a space of 5 feet between shrubbery and the building.

**Shrub next to foundation**

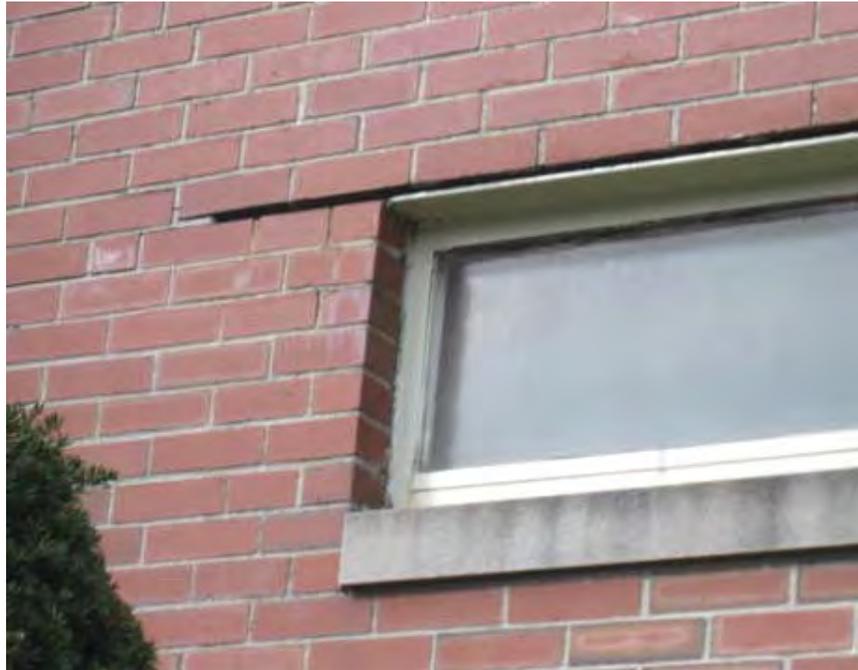
**Picture 17**

There were also cracks/missing mortar observed above windowsills and air intake vents (Picture 17). These cracks may lead to water infiltration during times of wind-driven rain and need to be repaired.

**Missing mortar above window**

14. Repoint cracks and missing mortar on the outside of the building to prevent water infiltration.
15. Ensure indoor plants are equipped with drip pans. Examine drip pans periodically for mold growth and disinfect with an appropriate antimicrobial, as needed. Move plants away from the air stream of mechanical ventilation equipment.

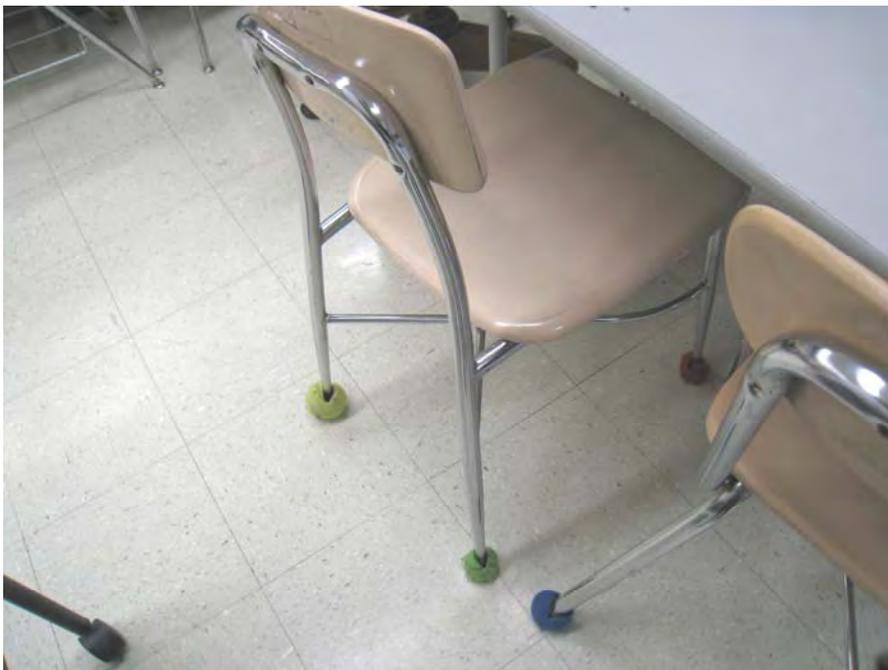
**Picture 18**

In an effort to reduce noise, tennis balls had been sliced open and placed on the base of desk/chair legs in some classrooms (Picture 18). Tennis balls are made of a number of materials that are a source of respiratory irritants. Constant wearing of tennis balls can produce fibers and cause VOCs to off-gas. Tennis balls are made with a natural rubber latex bladder, which becomes abraded when used as a chair leg pad. Use of tennis balls in this manner may introduce latex dust into the school environment. Some individuals are highly allergic to latex (e.g., spina bifida patients) (SBAA, 2001). It is recommended that the use of materials containing latex be limited in buildings to reduce the likelihood of symptoms in sensitive individuals (NIOSH, 1997).

**Tennis balls used as chair glides**

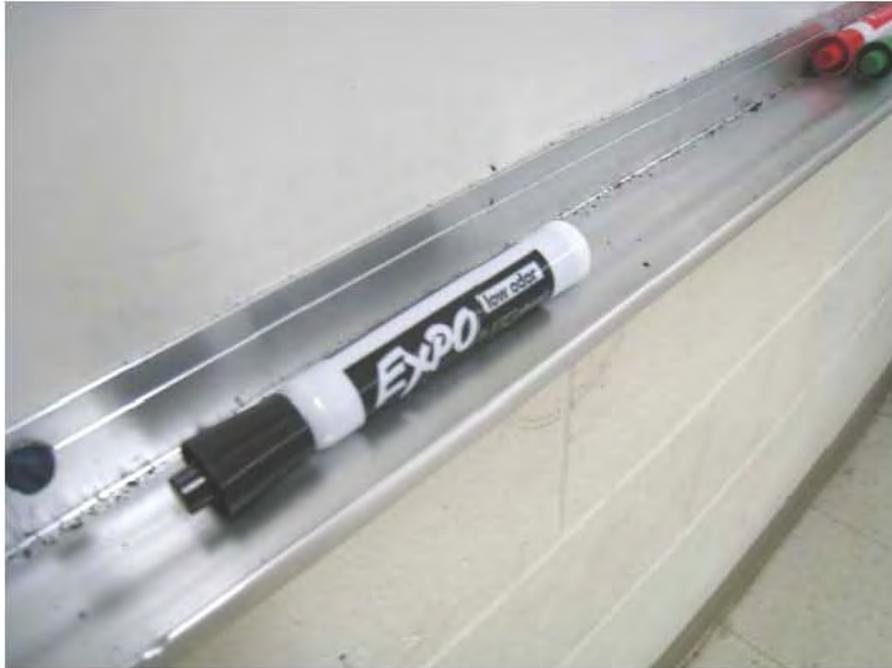
**Picture 19**

**Whiteboard marker debris**

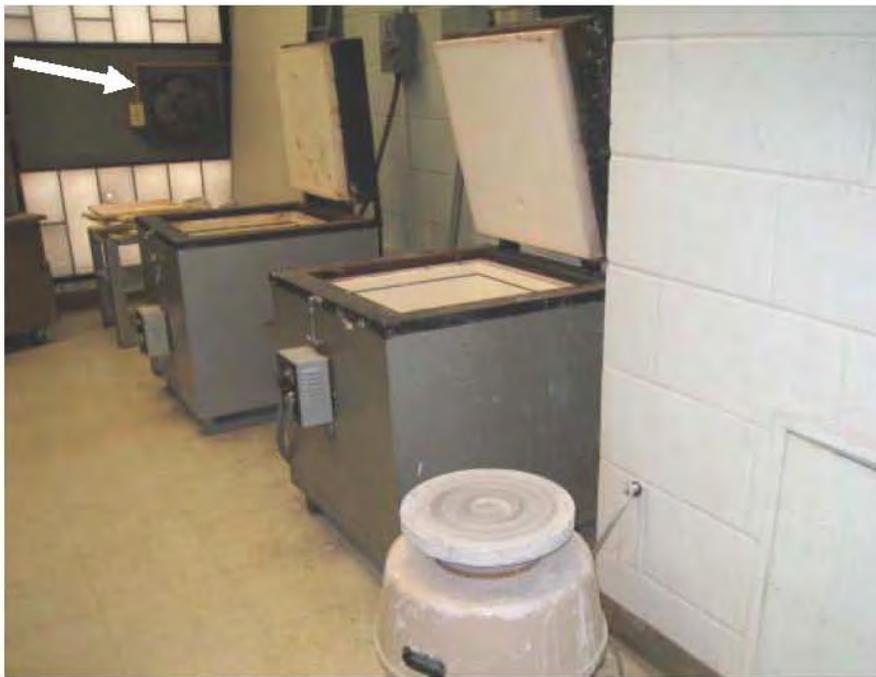
**Picture 20**

Other conditions that can affect indoor air quality were observed during the assessment. In a storeroom adjacent to the art area were two pottery kilns (Picture 20). Pottery kilns can be a significant source of water vapor, particulate and other related pollutants when operating. In addition, a pottery kiln is a source of waste heat that can present a safety/fire hazard. The kilns appeared to be electrically operated, and there was a switch-operated exhaust fan in the wall near but not directly adjacent to the kilns (Picture 21). The kilns were not outfitted with a dedicated exhaust hood, which removes heat and pollutants outside building. In addition, the switch for the exhaust may be difficult to reach when the kilns are in operation, since the switches are located

**Pottery kilns, note wall-mounted switch-activated exhaust fan several feet away (arrow)**

next to the fan on the wall. Kilns should be vented directly outdoors and kept away from students. Bottles of pottery glazing materials were examined and they were labeled as “lead free”, which is appropriate and recommended to protect the safety and health of staff and students.

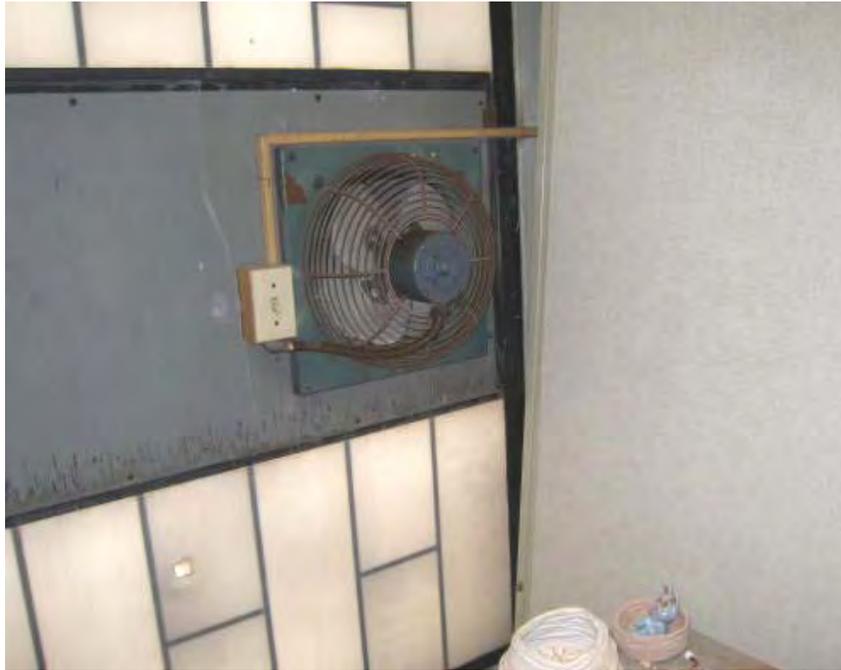
**Picture 21**

**Kiln room exhaust fan with switch**

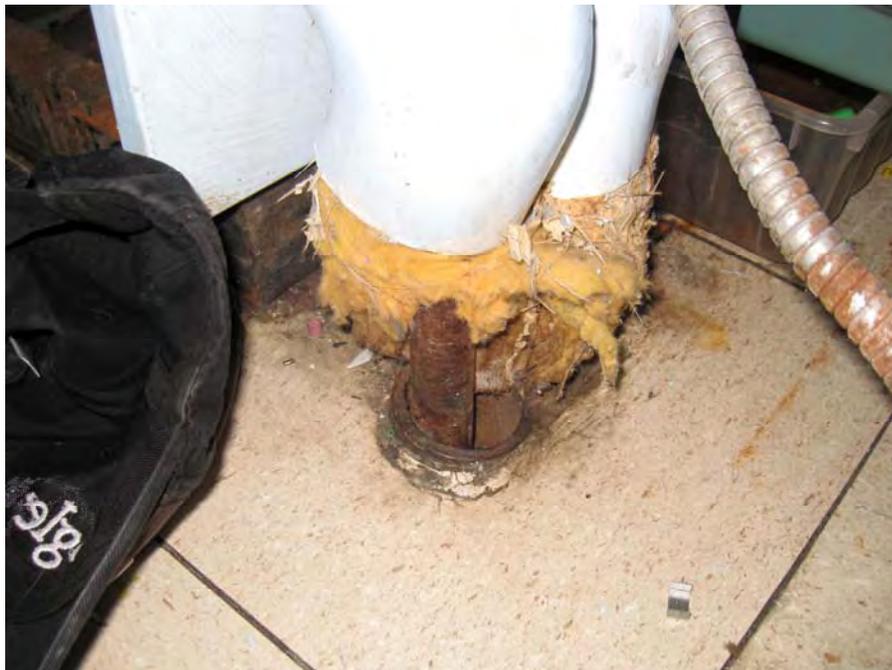
**Picture 22**

Exposed fiberglass insulation was observed around pipes leading into univent cabinets (Picture 22). Fiberglass particles are a source of irritation to the eyes and respiratory system. Pipe wrapping should be examined, and exposed insulation should be re-wrapped to prevent aerosolization of fiberglass materials.

**Exposed fiberglass pipe insulation**

24. Investigate function of marked-out device on ceiling of teachers' lounge and repair or replace as needed.
25. Encapsulate exposed fiberglass insulation around univent pipes in classrooms.

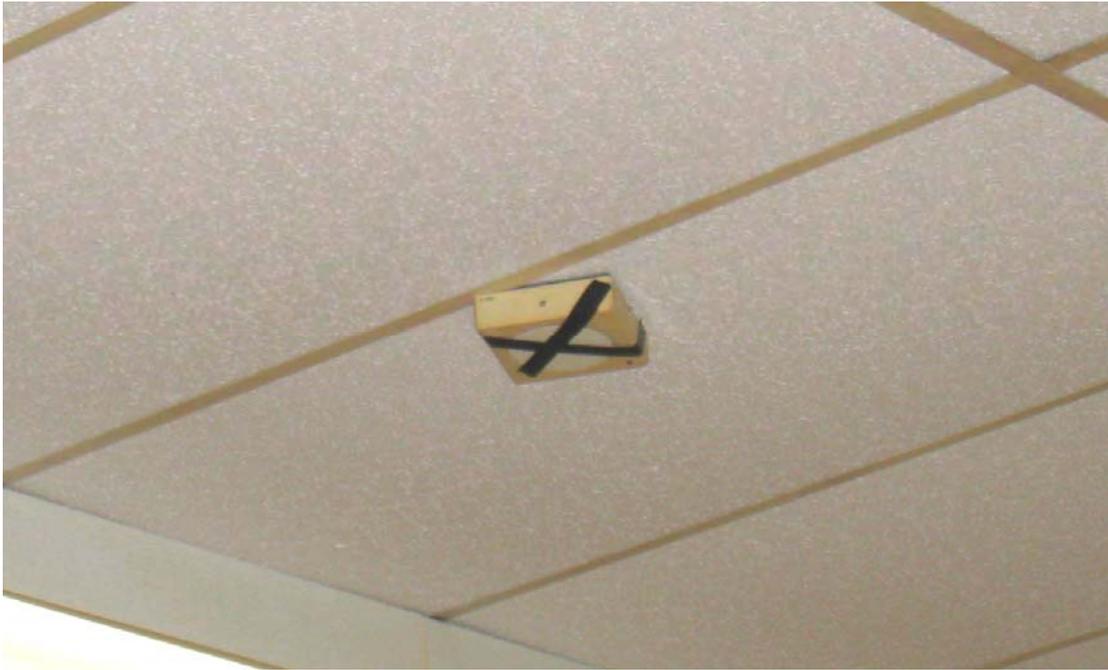
**Picture 23**

Black tape was observed on a device that is likely a fire detector in the teachers' lounge (Picture 23). Measures should be taken to determine whether this unit is operable. If not, this fire detector should be replaced.

**Black tape markings on device on teachers' lounge ceiling**
