# **INDOOR AIR QUALITY ASSESSMENT**

**Barnstable Intermediate School  
895 Falmouth Road  
Hyannis, MA**

Prepared by:  
Massachusetts Department of Public Health  
Bureau of Environmental Health  
Indoor Air Quality Program  
February 2014

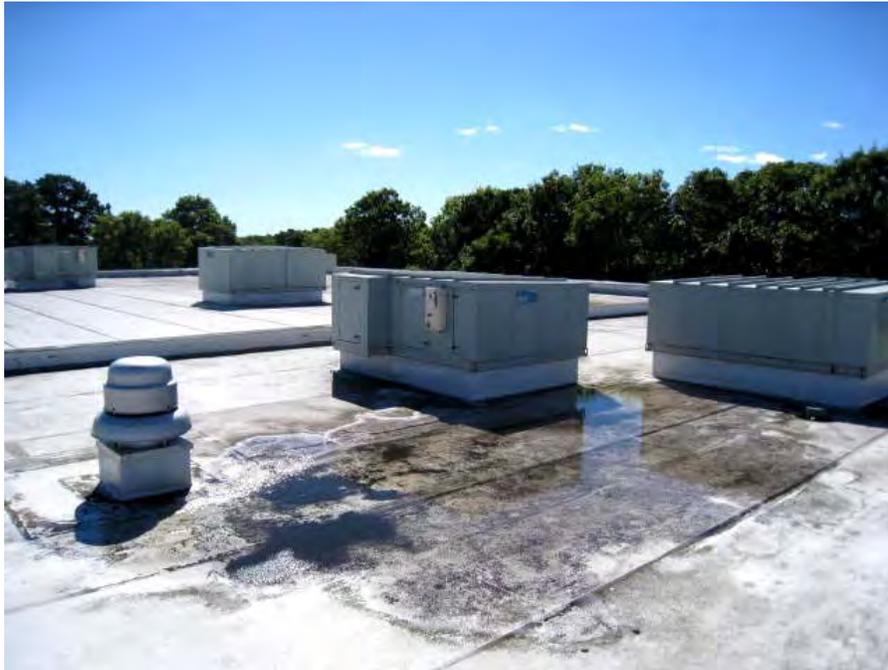
**Picture 1**

Fresh air in classrooms is supplied by air handling units (AHUs) located on the roof (Picture 1) and ducted to fresh air supply diffusers located in classrooms (Picture 2). Exhaust ventilation in classrooms is provided by ceiling-mounted vents (Picture 3) ducted to rooftop motors.

it is recommended that classroom doors remain shut while exhaust vents are operating to function as designed. Exhaust vents must be activated and remain free of obstructions. It was observed that several of the exhaust fans on the roof were not operating at the time of assessment.

**Air-handling units on the roof; note exhaust vent fan and pooling water**

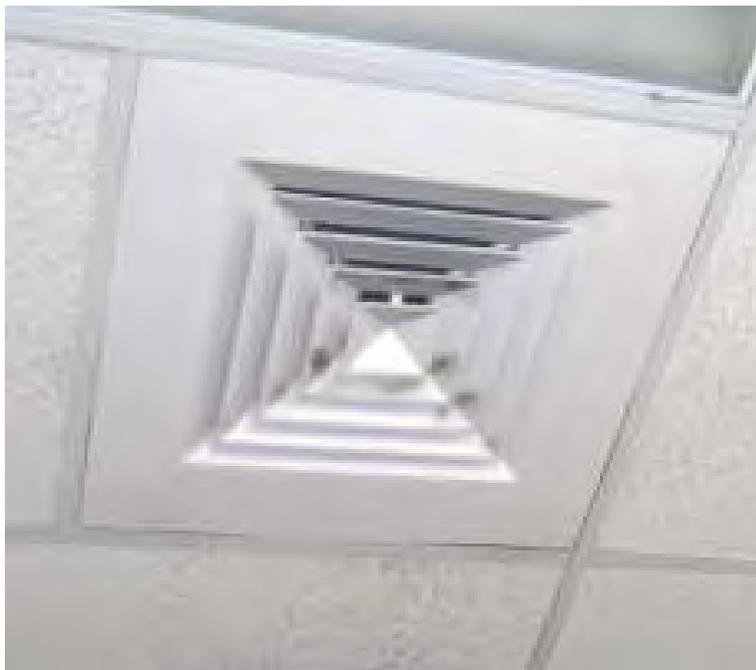
**Picture 2**

**Typical supply vent in classroom, note dust/debris accumulation on louvers**

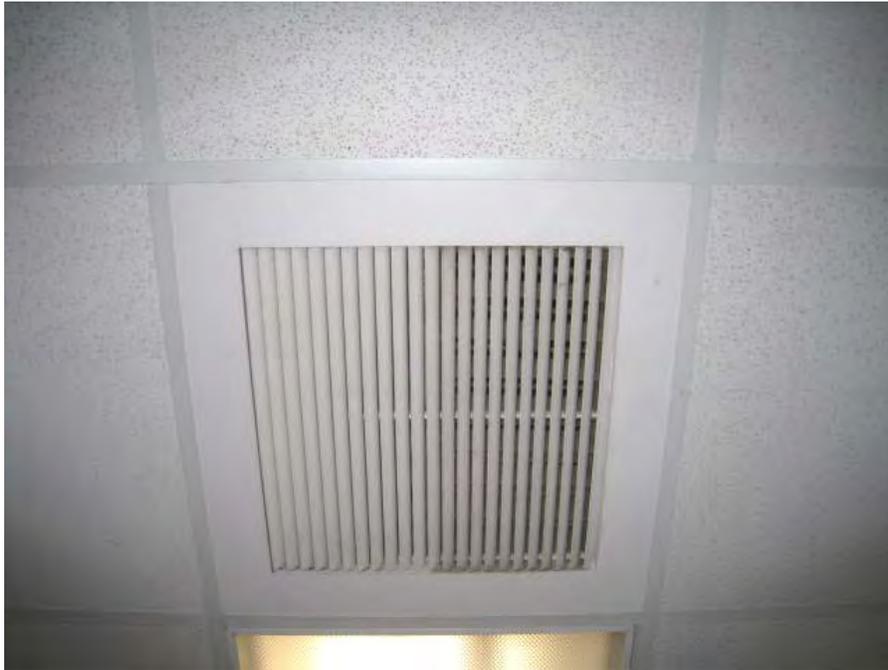
**Picture 3**

**Typical classroom return vent**

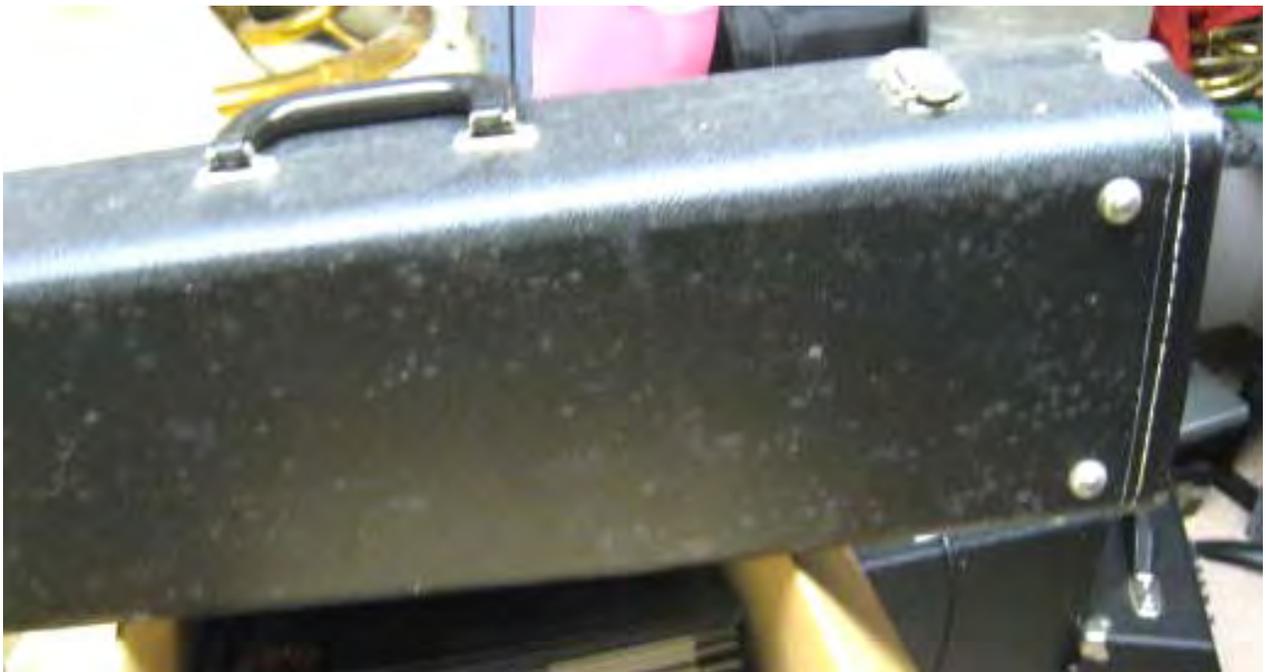
**Picture 4**

**Mold-colonized instrument case**

15. The storage areas in the band and chorus rooms should be examined and thoroughly cleaned out to remove mold-contaminated and water-damaged items. Discard mold-contaminated items including leather, paper, cloth and instrument cases. If materials are of significant value, a professional restoration contractor should be consulted about potential for cleaning.

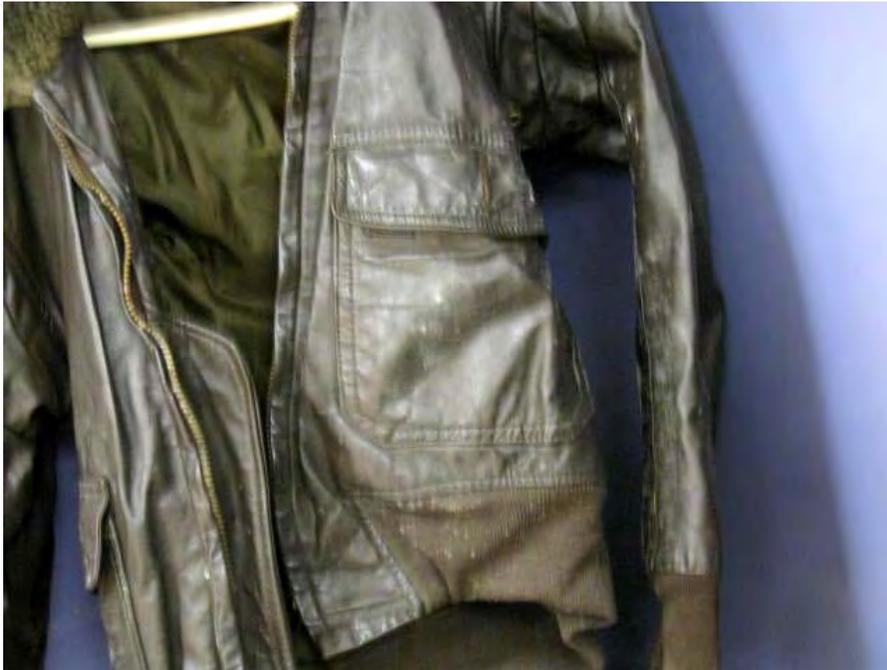
**Picture 5**

**Mold-colonized leather jacket**

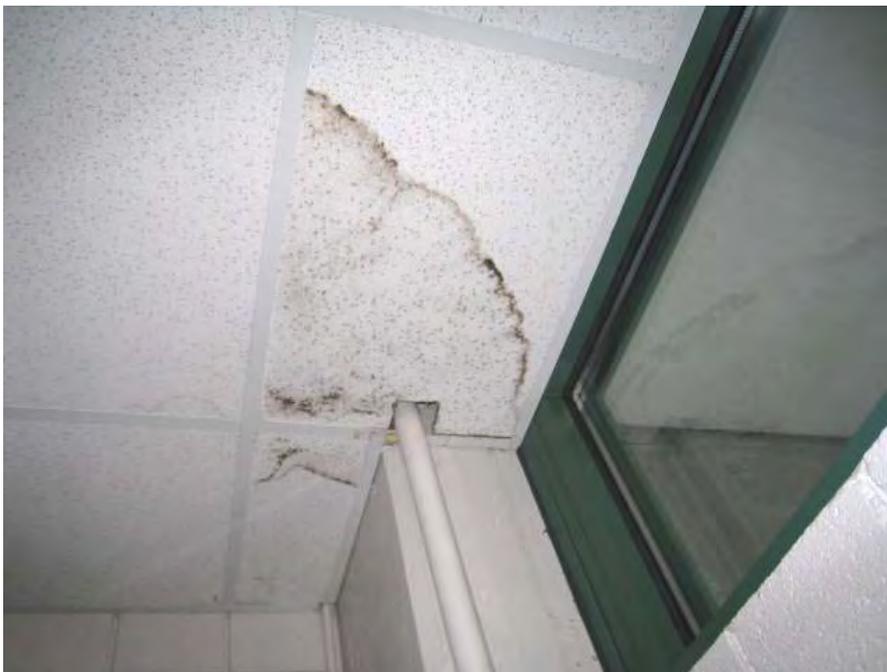
**Picture 6**

Other concerns regarding water damage and mold have been expressed in the building. Water-damaged, bowed/missing ceiling tiles and damaged paint were observed in many classrooms, particularly in the new wing (Pictures 6 through 10). Water infiltration was also reported to come from ceilings/windows and flow under cabinets located along exterior walls in some classrooms. Musty odors from some of these cabinets were reported. In one classroom, a section of molding on top of the cabinets could be peeled back from the wall, which was found colonized with mold (Picture 9). This suggests that mold may also be colonizing both wood and gypsum wallboard behind these and any other cabinets that have been affected by similar conditions. In order to remove water-damaged and moldy materials from these areas, the cabinets will need to be removed, inspected and discarded/repared if portions are mold-colonized. Sections of affected gypsum wallboard will also need replacement.

**Water-damaged ceiling tiles, possibly mold-contaminated (dark staining)**

14. Ensure roof/plumbing leaks are repaired and replace any remaining water-damaged ceiling tiles. Disinfect areas of water leaks with an appropriate antimicrobial, as needed.

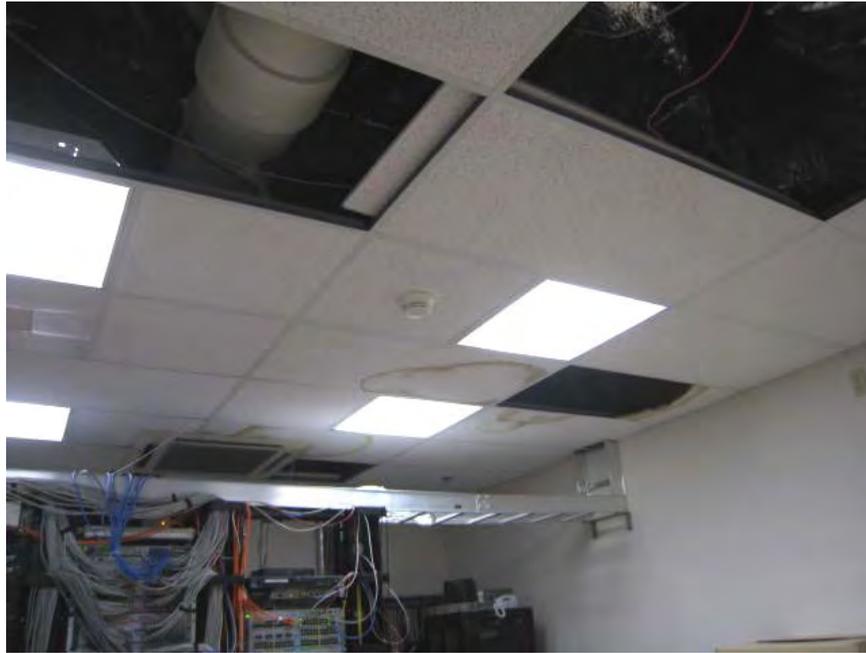
**Picture 7**

**Water-damaged and missing ceiling tiles in server room**

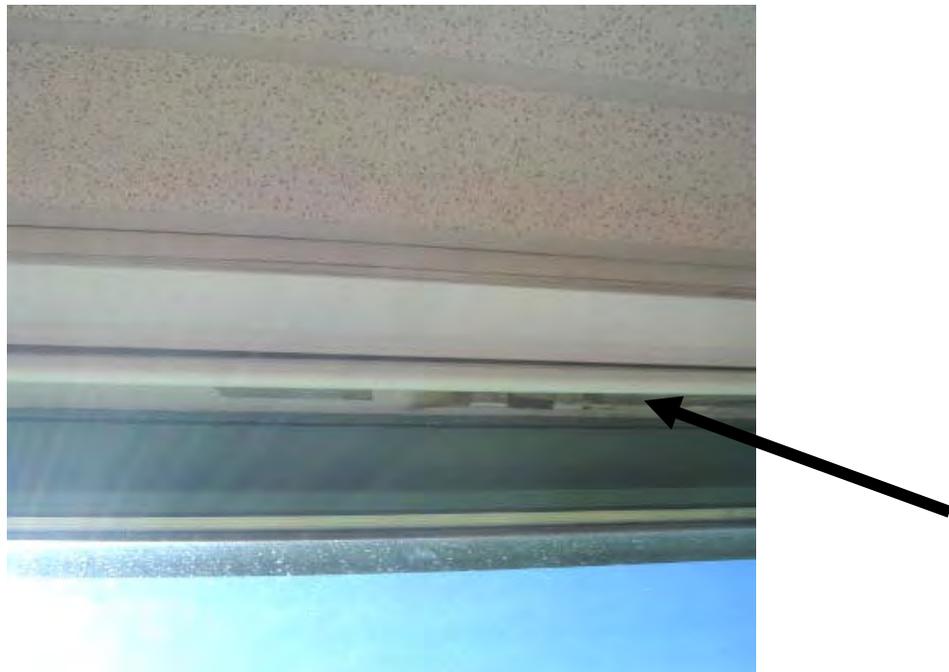
**Picture 8**

There appears to be two conditions that are contributing to the infiltration of water into the building in these areas. The first is that the windows in the building do not appear to be weather-tight in some areas. Weather on Cape Cod, in particular, can be very wet, with periods of both heavy rain and high humidity. When windows are not closed or do not seal, rainwater during heavy or wind-driven events can infiltrate the building and moisten materials, which, if

**Water-damaged paint (arrow) at top edge of window**

8. Have a professional building envelope contractor examine the exterior for damaged caulking, missing flashing and other gaps/breaches around windows and cement floor joist beams.

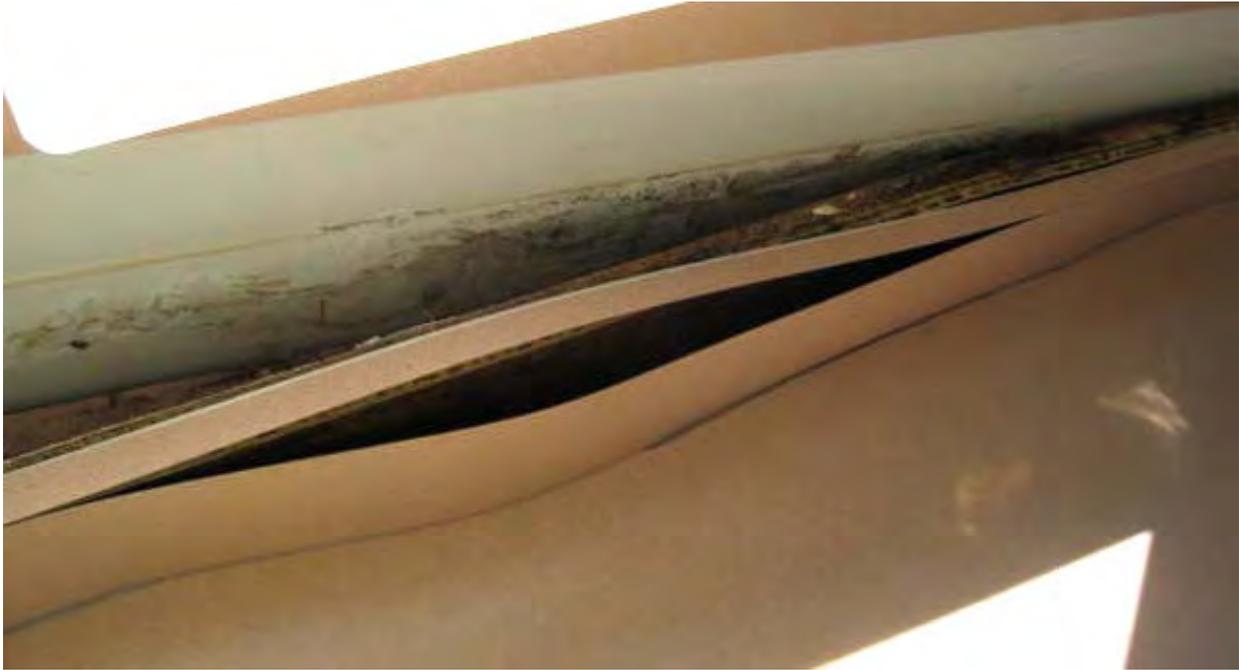
**Picture 9**

**Water-damaged/mold-colonized wood and plaster behind cabinet molding**

11. Deconstruct and examine cabinets adjacent to windows suspected of moisture intrusion to examine drywall behind it. Remove and replace any mold-contaminated wood, drywall or other building materials.

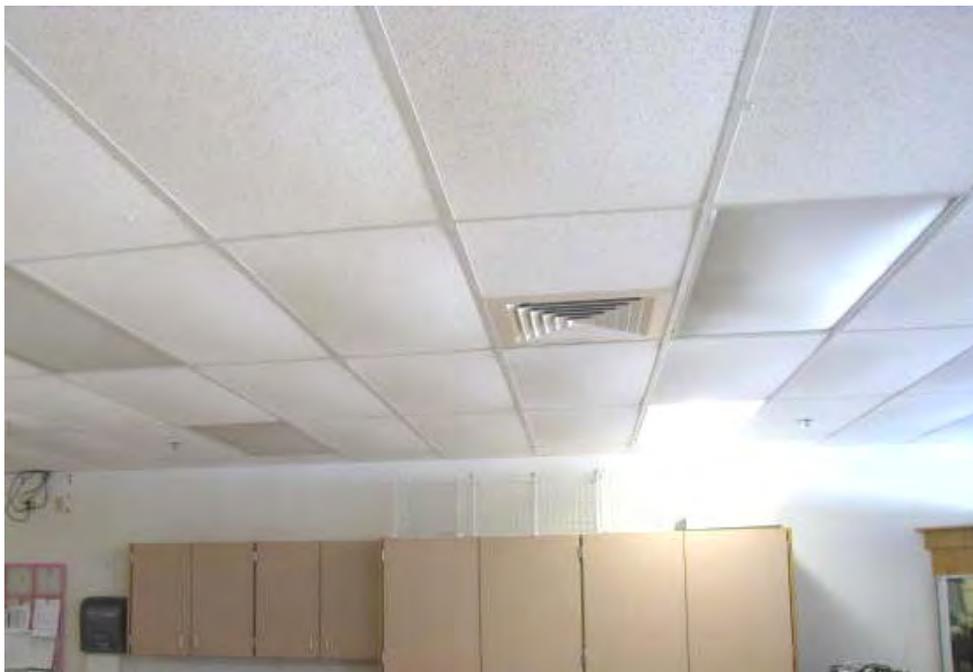
**Picture 10**

In some classrooms ceiling tiles were observed to be bowed (Picture 10). This suggests that the tiles are becoming moistened over a long period of time and sagging. It may also indicate that there may be pressurization of the plenum above ceiling tiles. Given that the fresh air and exhaust system are both reportedly ducted, this may indicate that outside air is infiltrating/pressurizing the plenum through gaps/breaches in the exterior cladding.

**Bowed ceiling tiles in classroom**

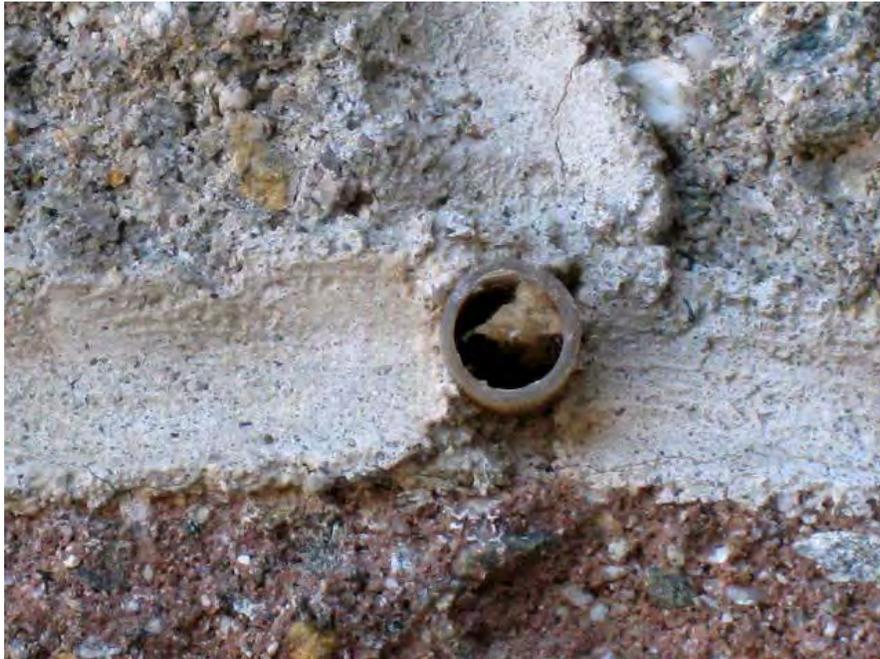
**Picture 11**

**Weep hole in exterior wall**

9. Examine weep holes around perimeter of building and open/clear if found blocked. Unearth and clear buried weep holes.
10. Repair damaged EIFS.

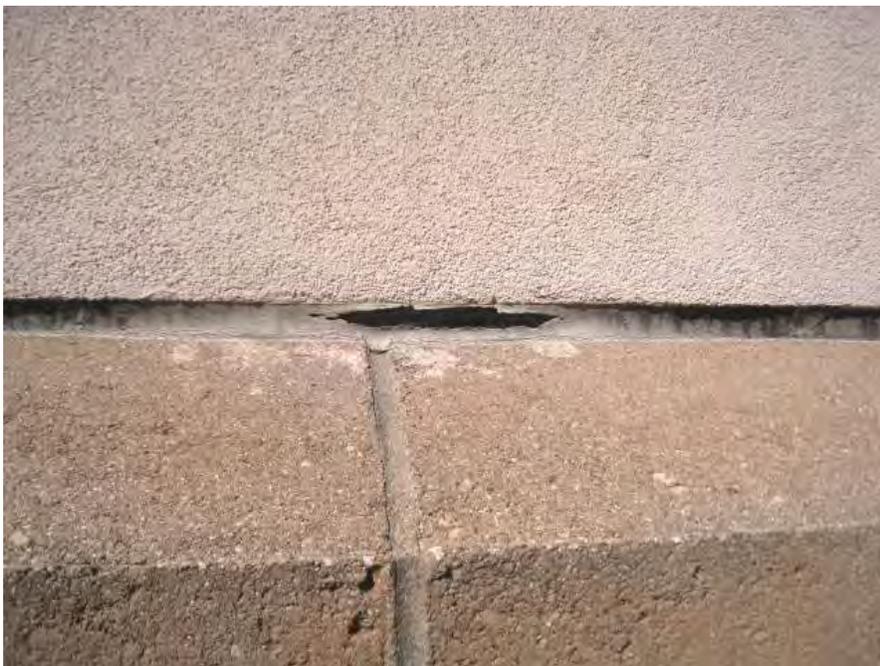
**Picture 12**

- Failure to install or properly install sealant joints around windows, doors, pipes, conduits, and other penetrations of the field of the EIFS (Picture 12);
- Failure to flash window and door openings in the field of the EIFS to divert leakage through the window or door to the exterior;
- Failure to properly back wrap edges at terminations and penetrations in the field of the EIFS; and
- Water erosion damage that has not been repaired (Picture 13).

**Missing caulking**

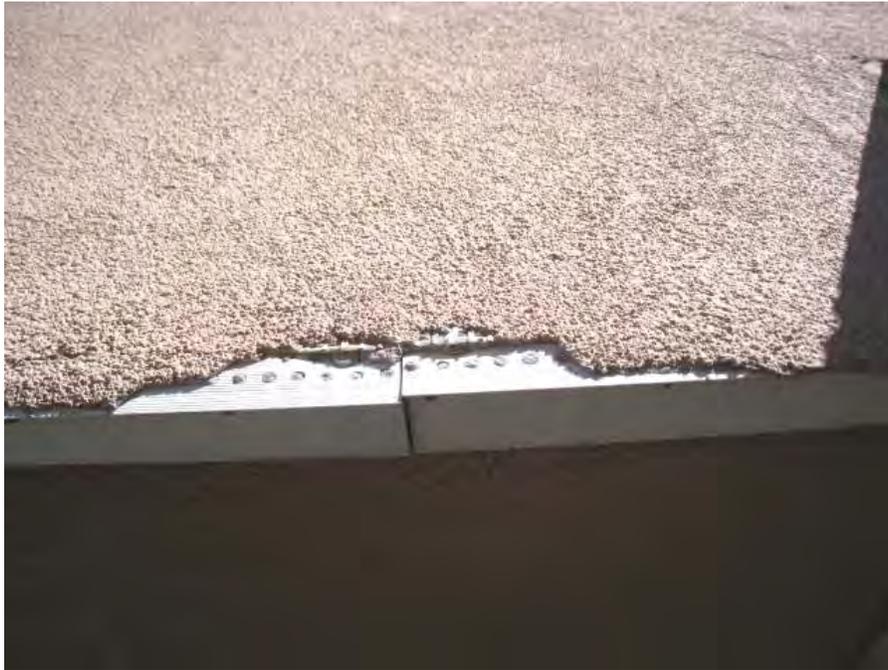
**Picture 13**

**Water erosion damage that has not been repaired**

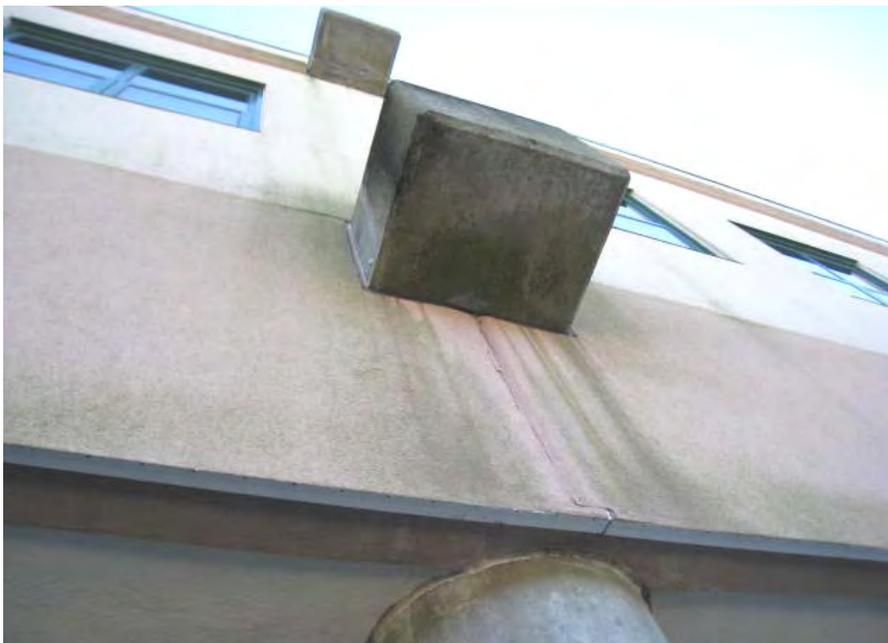
**Picture 14**

Another likely water penetration source is an architectural feature that exists in the exterior wall. It appears the cement joist beams that support floors have ends that protrude through the EIFS (Picture 14). These beams should have a continuous seal around each junction with the EIFS to prevent water penetration. If not continuous, rainwater can penetrate into the building under certain wind/weather conditions, particularly along the flat surface on the top of each beam.

**End of support floors beams that protrude through EFIS, note water staining beneath beam**

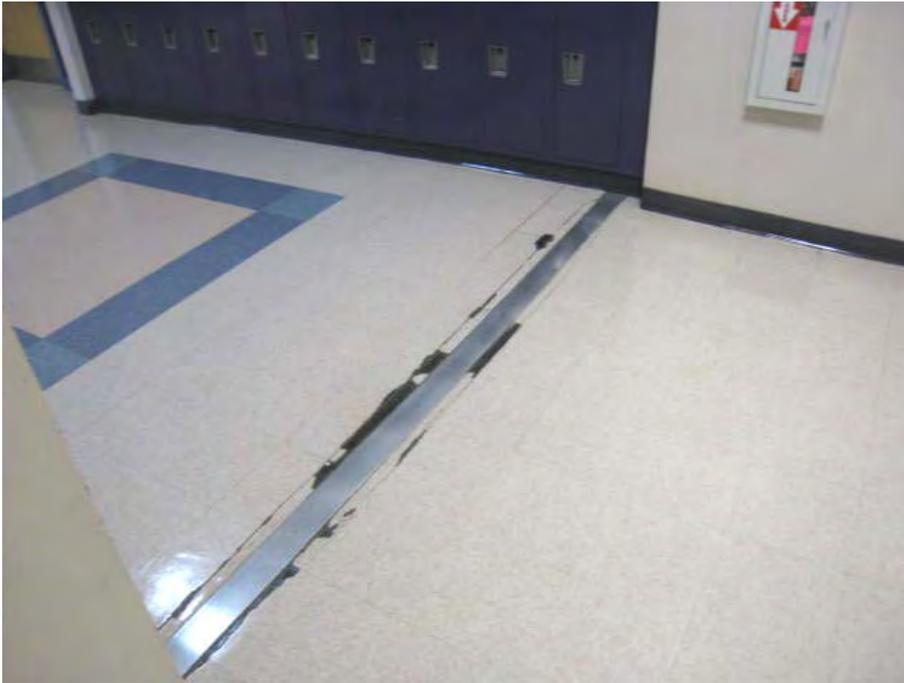
**Picture 15**

Additional water penetration issues were noted relative to the 1999-era wing. An expansion joint was observed on the second floor (Picture 15), where the new wing was added. Often, where two portions of a building are joined, there is the potential for infiltration of air and water because building materials do not line up completely and differences in materials can create gaps. The outside of the new wing, not only had issues with the water-tightness of the EIFS, but an indentation or trench was observed at the edge along the foundation. Poor grading in this area can cause water to pool against the base of the building, which can lead to infiltration. Issues were also observed relative to gutters and downspouts on the short slanted roofs along the back of the building. Lack of proper drainage from the roof and away from the building can contribute to water infiltration.

**Expansion joint in floor**

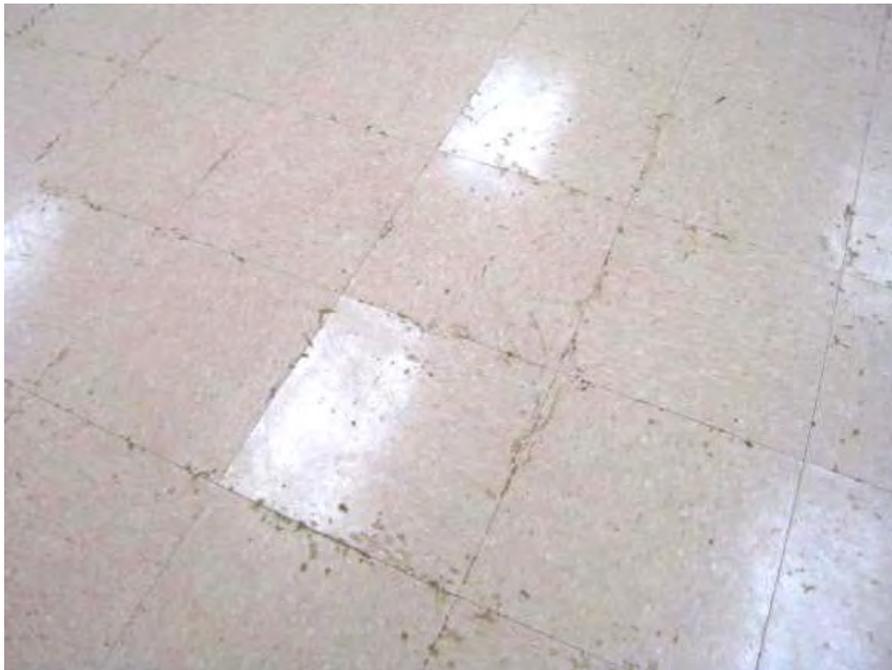
**Picture 16**

**Stained floor tiles/moistened mastic in first floor room**

12. Clean/strip accumulated tile mastic/wax. If continued moisture accumulation/damage to floor tiles in the building occurs, consideration should be given to having a building engineer examine other potential remediation/prevention strategies.

13. Consider contacting a reputable flooring contractor to remove/replace old tiles and mastic. Slab should be completely cleaned, prepped and sealed using a proper sealant.

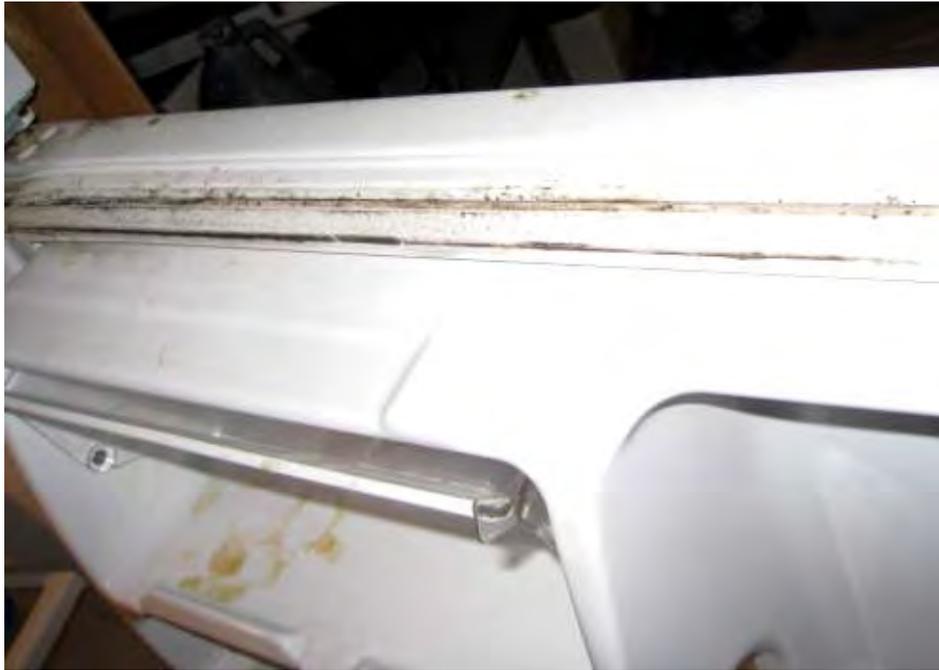
**Picture 17**

A refrigerator in the 236A storage room had visible mold growth and staining on the gasket (Picture 17). The gasket should be cleaned with an antimicrobial solution. Frequent/excessive mold staining on gaskets is an indication that the refrigerator does not seal properly and needs to be repaired/replaced.

**Mold on refrigerator gasket**

17. Clean and disinfect interior of refrigerators and freezers with mild detergent or antimicrobial agent. If they cannot be adequately cleaned, replace mold-contaminated gaskets. Clean spilled food promptly, and clean out the refrigerator of expired items on a regular schedule.

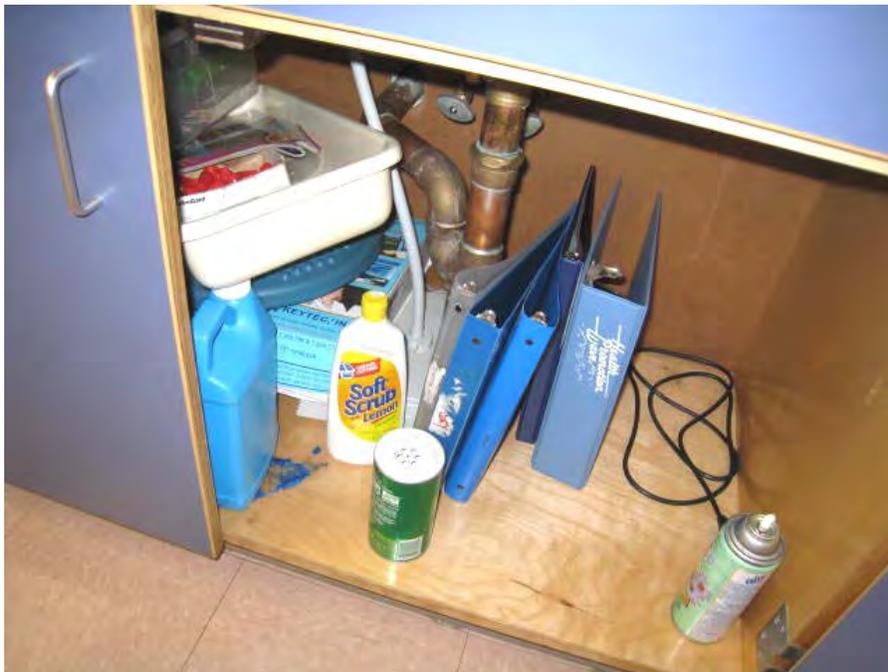
**Picture 18**

Some classroom sinks had cabinets beneath them containing large amounts of stored materials, including porous items (Picture 18). The area underneath sinks is a moist environment and should not be used to store items that can become colonized with mold. Large amounts of items stored under sinks can also make detecting leaks difficult. One of the sink cabinets had water-damaged wood, possibly from a historic plumbing leak. Some of the sinks are laboratory type that are reportedly shut off when they are in use. This can lead to dry drain traps if water isn't occasionally poured into the traps. Dry traps can allow moisture and odorous gases into occupied spaces.

**Items and cleaning products under sink**

19. Seal areas between sink countertops and backsplashes to prevent water damage to the interior of cabinets and adjacent materials.
20. Do not store porous or significant amounts of items under sinks.

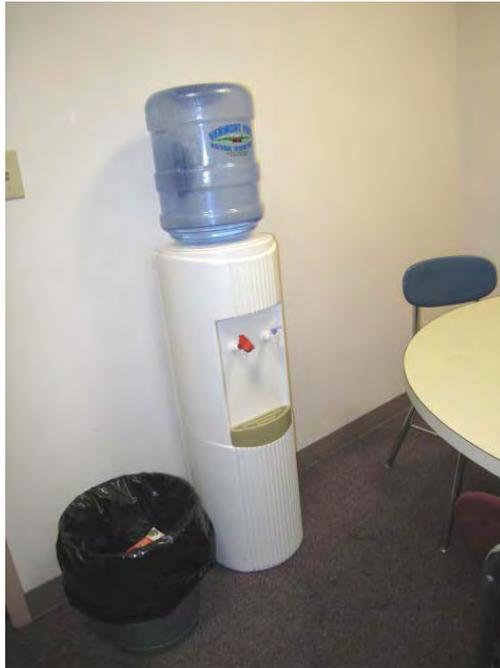
**Picture 19**

A water dispenser was observed to be located in a carpeted area (Picture 19). Water can spill or leak from these appliances and moisten carpet. Water dispensing equipment should be located on non-porous surfaces such as floor tile or a waterproof mat.

**Water dispenser on carpet**

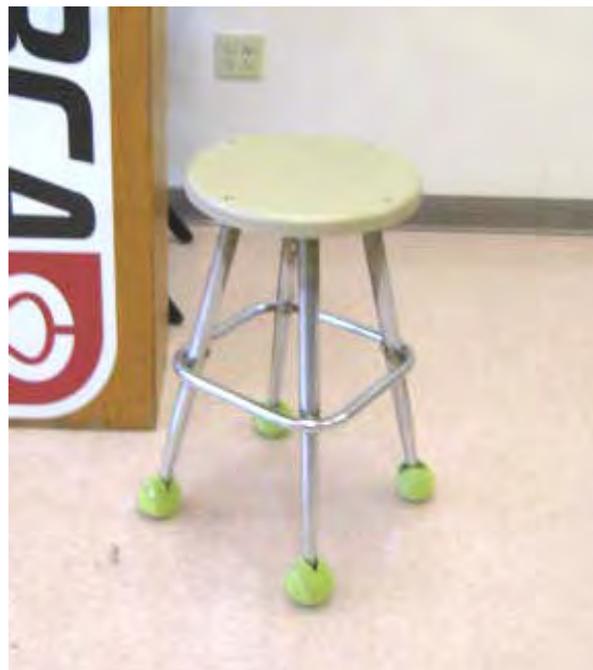
**Picture 20**

Sliced-open tennis balls were observed on the legs of a stool (Picture 20). Tennis balls are made of a number of materials that are a source of respiratory irritants. Constant wearing of tennis balls can produce fibers and cause VOCs to off-gas. Tennis balls are made with a natural rubber latex bladder, which becomes abraded when used as a chair leg pad. Use of tennis balls

in this manner may introduce latex dust into the school environment. Some individuals are highly allergic to latex (e.g., spina bifida patients) (SBAA, 2001). It is recommended that the use of materials containing latex be limited in buildings to reduce the likelihood of symptoms in sensitive individuals (NIOSH, 1997).

**Tennis balls used as stool glides**

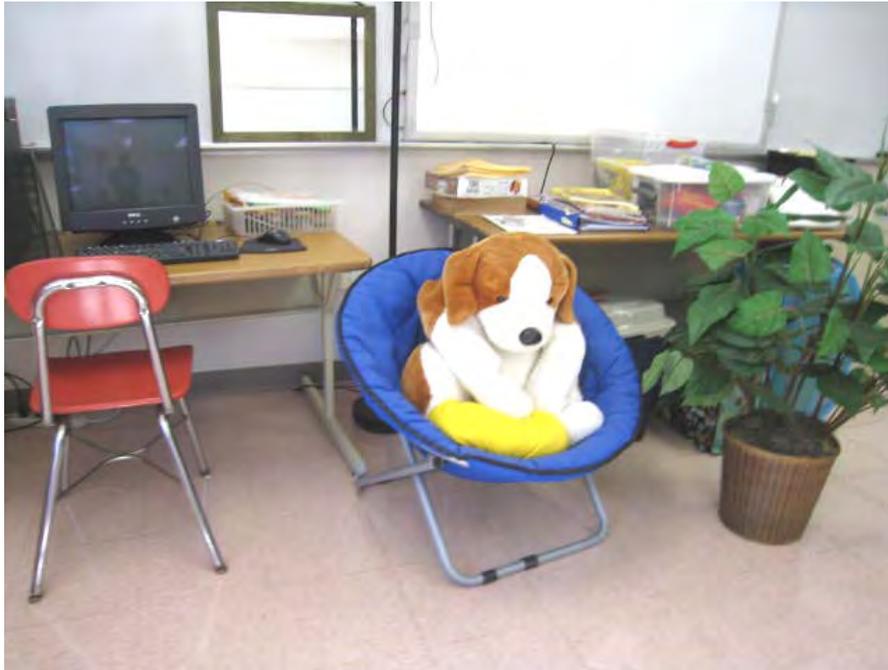
**Picture 21**

Upholstered furniture and plush toys were observed in some locations (Picture 21, Table 1). Upholstery and plush toys are covered with fabrics that may be exposed to human skin. This type of contact can leave oils, perspiration, hair and skin cells. Dust mites feed upon human skin cells and excrete waste products that contain allergens. In addition, if relative humidity levels increase above 60 percent, dust mites tend to proliferate (US EPA, 1992). In order to remove dust mites and other pollutants, frequent vacuuming of upholstered furniture is recommended (Berry, 1994). It is also recommended that upholstered furniture (if present in schools), be professionally cleaned on an annual basis. If an excessively dusty environment exists due to

**Upholstered furniture and plush toys**

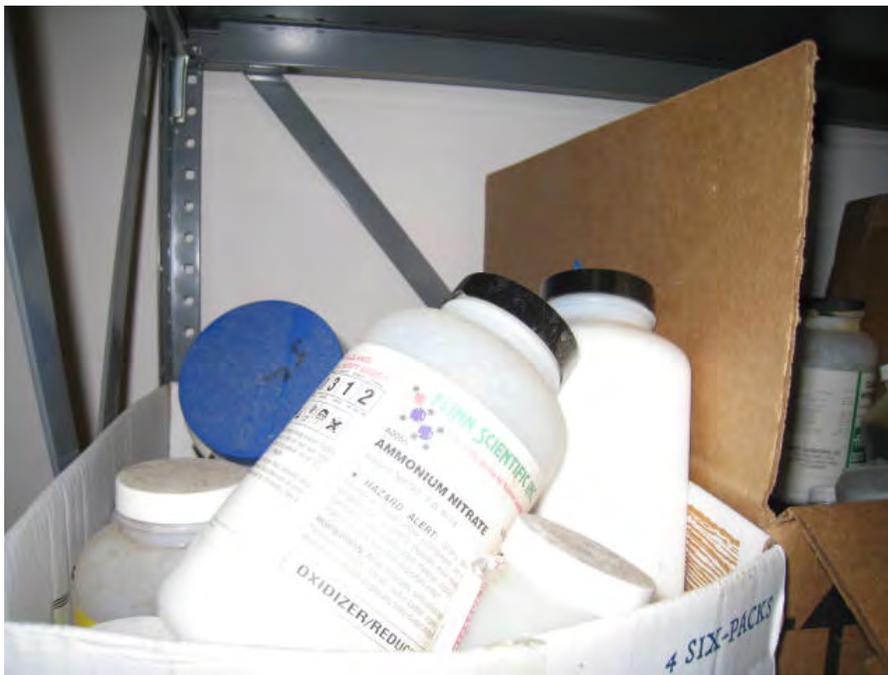
**Picture 22**

**Storage of chemicals in a disorganized manner inside cardboard boxes**

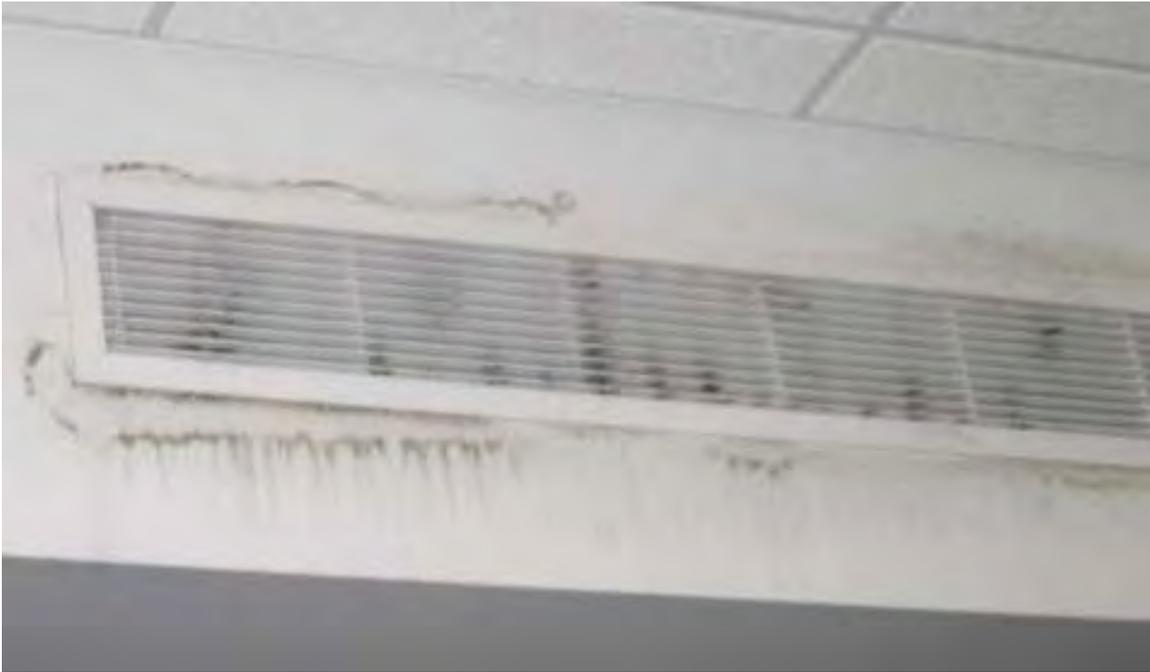
**Picture 23**

A number of air diffusers, exhaust/return vents and personal fans were found to have accumulated dust/debris, particularly the supply vents in the library (Picture 23; Table 1). Re-activated supply vents and fans can aerosolize dust accumulated on vents/fan blades. If exhaust vents are not functioning, backdrafting can occur, which can re-aerosolize accumulated dust particles.

**Accumulated dust/debris on supply vents in the library**
