# **INDOOR AIR QUALITY ASSESSMENT**

**Boxford Town Library  
10 Elm Street  
Boxford, Massachusetts**

Prepared by:  
Massachusetts Department of Public Health  
Bureau of Environmental Health  
Indoor Air Quality Program  
September 2014

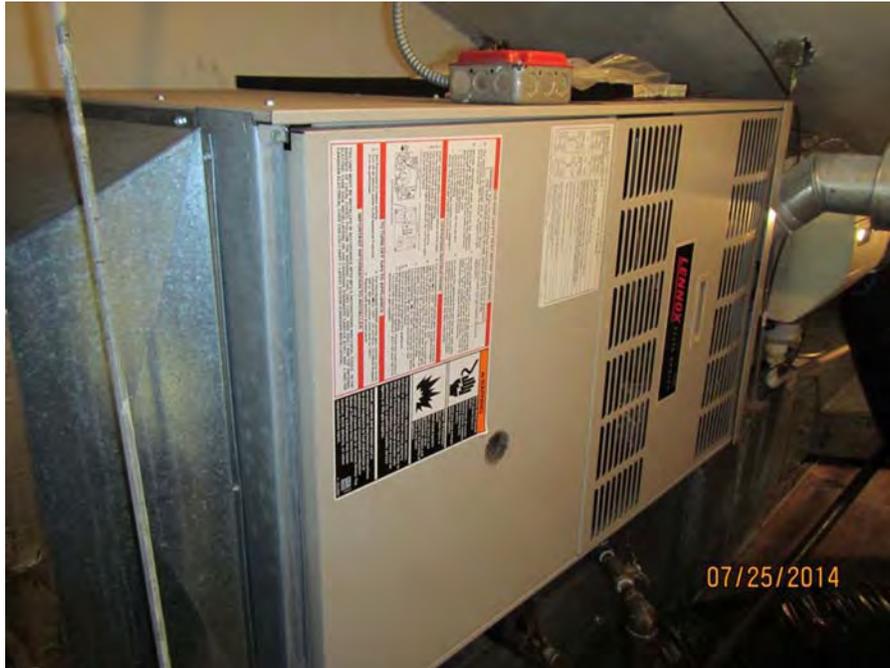
**Picture 1**

**Forced Hot Air (FHA) furnace unit in attic**

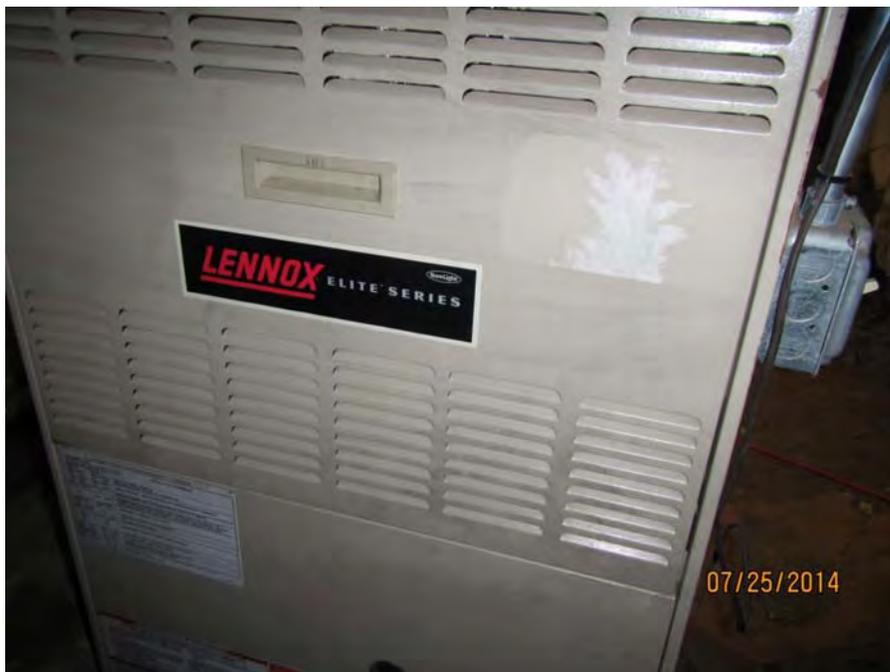
**Picture 2**

**FHA furnace unit in basement of original 1843 building**

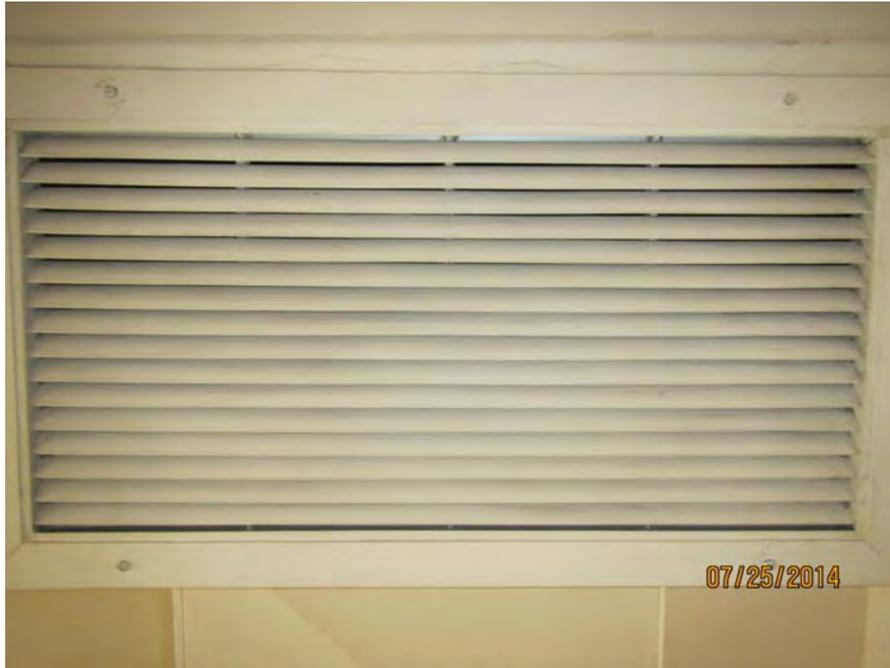
**Picture 3**

**Return air grate**

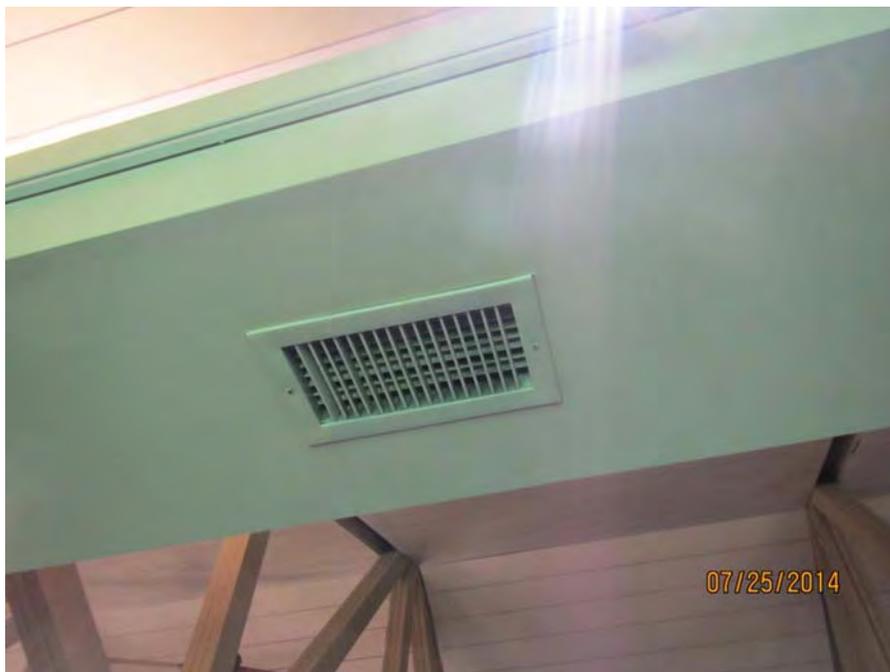
**Picture 4**

**Supply air diffuser**

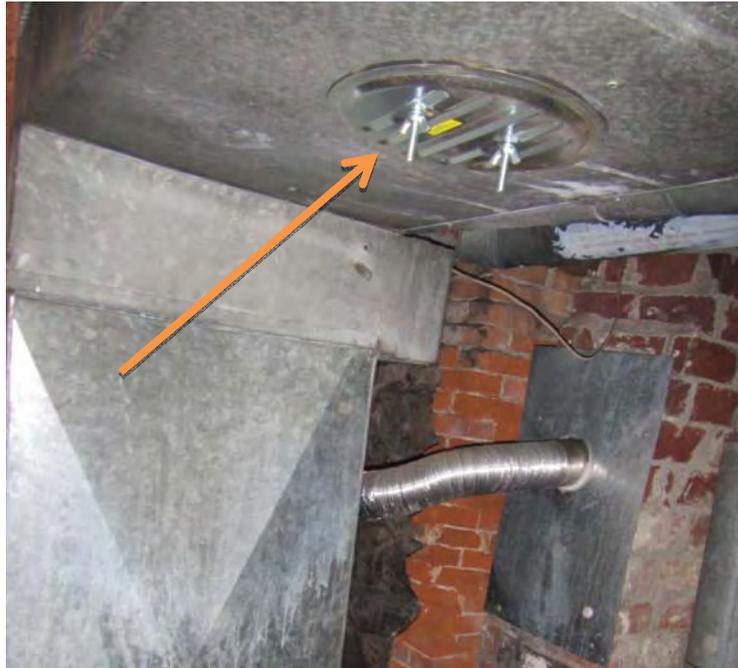
**Picture 5**

The areas were then freshly painted. In addition, air ducts for the FHA units were cleaned due to reported mold within the ducts (Picture 5). It should be noted that the areas remediated for water damage/mold were not confined to a single area. First and second floor areas in both the original building and the 1979 addition were reported to have experienced water damage/mold growth. It is important to note that although it appears that the water damage/mold remediation was completed properly, little has been done to address the sources of water penetration. If the source of water exposure has not been not addressed, water damage and microbial growth will persist.

**Access hole with cover used for mold remediation in ducts**

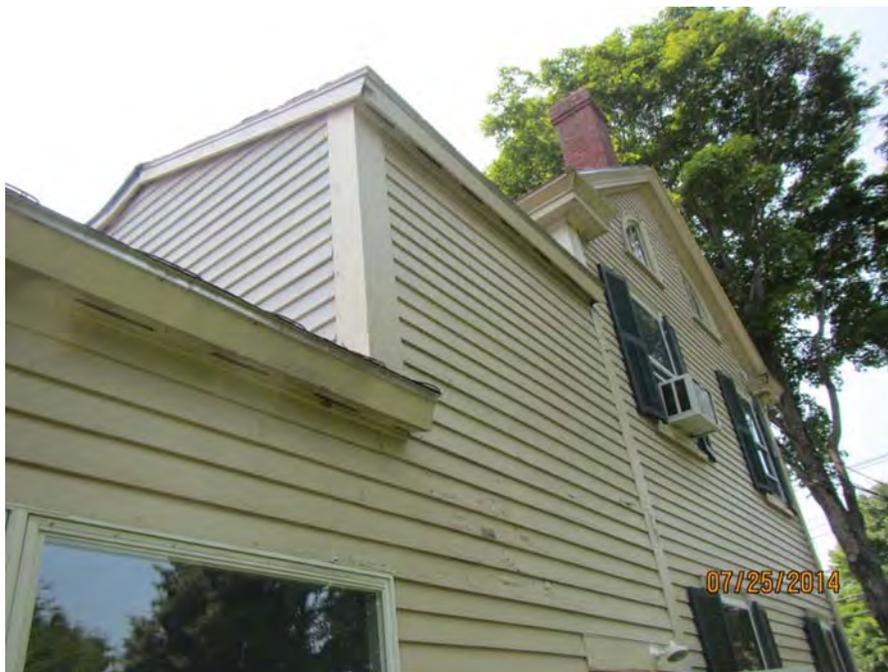
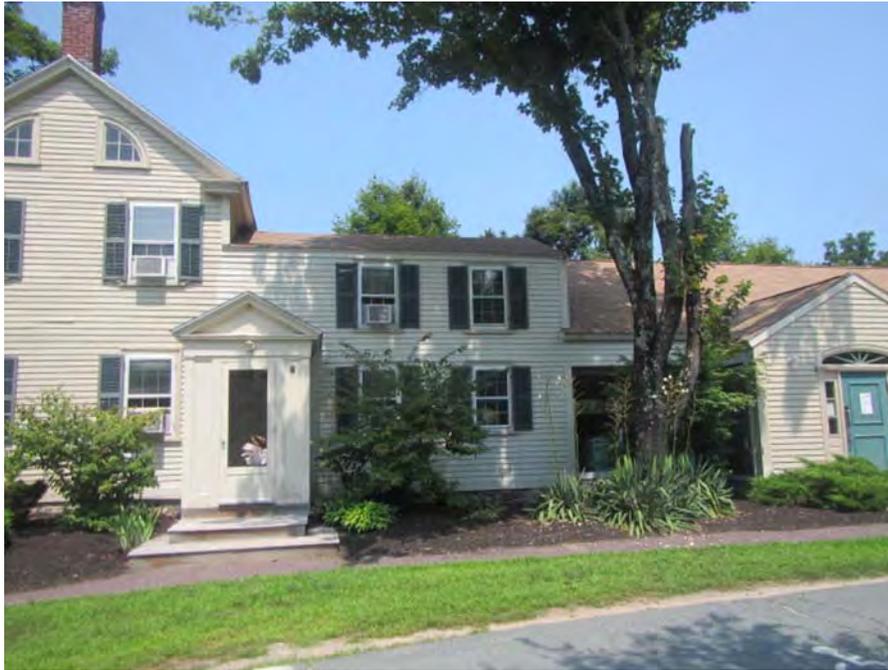
- **Lack of roof drainage:** The BTL lacks a gutter system for its roof (Pictures 6 and 7). A gutter system is necessary to collect and shed water *away* from the building. Signs of water pooling and chronic moisture were noted in close proximity to the foundation (Pictures 8 and 9).

**Boxford library (north side); note lack of gutter system**

**Boxford library (south side); note lack of gutter system**

3. Install a gutter and downspout system to capture water and direct it away from the foundation.
4. Repair/replace damaged siding, flashing, trim, and window/door frames.

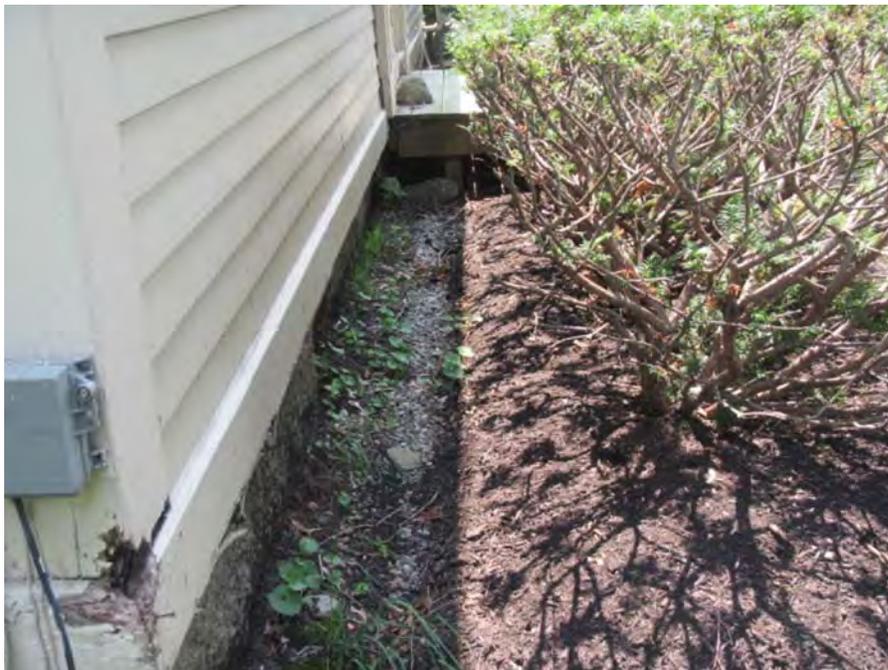
**Picture 8**

**Evidence of water pooling in close proximity to foundation**

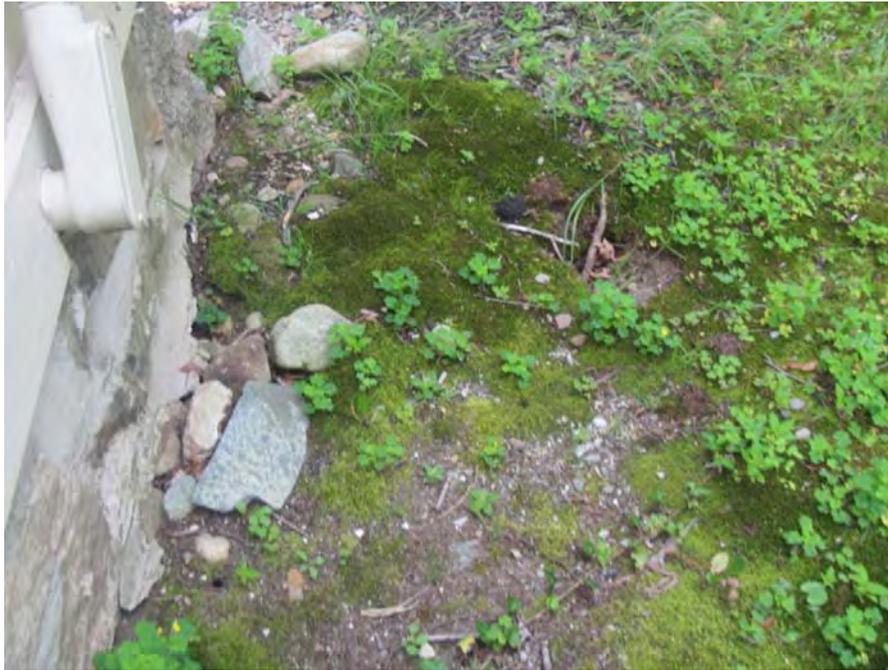
**Picture 9**

**Signs of chronic moisture near foundation**

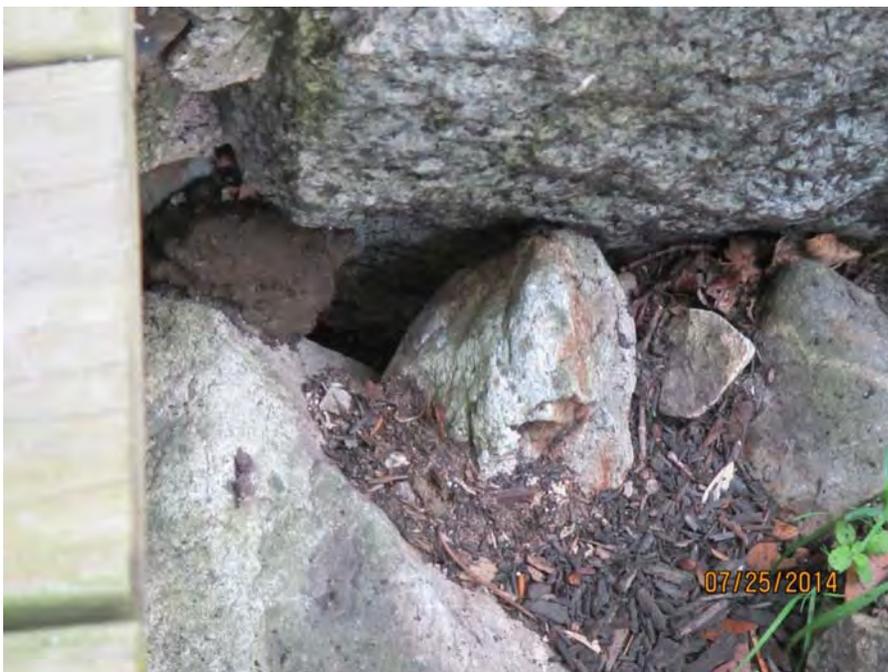
**Picture 10**

- **Breaches in foundation:** Rainwater can infiltrate the foundations through the existing holes/breaches (Picture 10) or by capillary action. The water may then cause microbial growth and odors in basement areas.

**Holes/gaps in original foundation**

- a. sealing gaps in foundations;
  - b. installing perimeter drains;
  - c. providing vapor barriers;
  - d. installing a sloped, water impermeable surface barrier (clay cap);

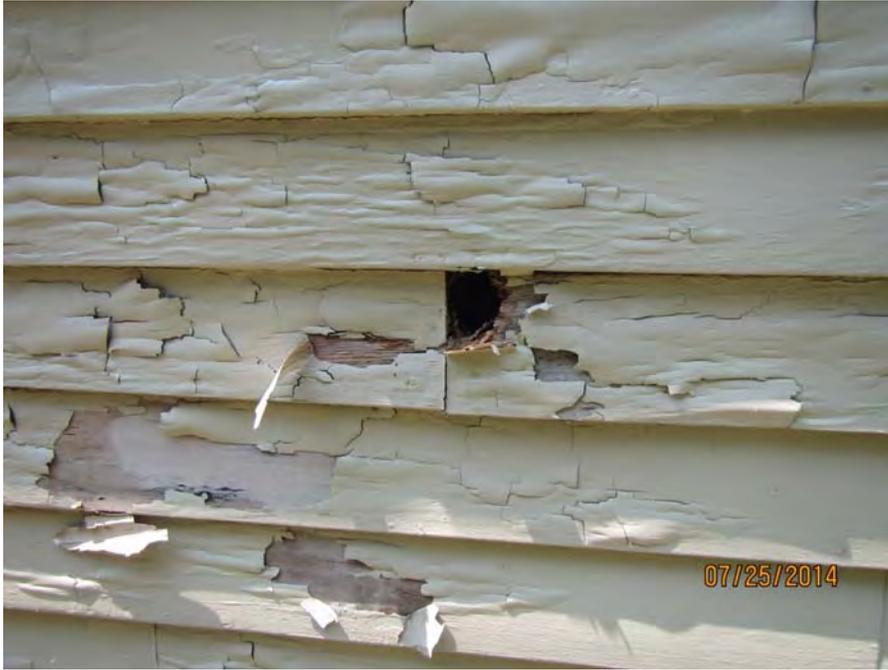
**Picture 11**

- **Breaches to the building envelope:** BEH/IAQ staff observed rotted, damaged, or missing wood siding and trim at the BTL (Pictures 11 through 14). During a driving rainstorm, water can roll down exterior walls and enter through holes/breaches in the siding. This allows water to get behind the siding and enter the wall cavity, where it can be absorbed by insulation and GW. Damage to building materials and microbial growth

**Water-damaged wood siding; note large hole**

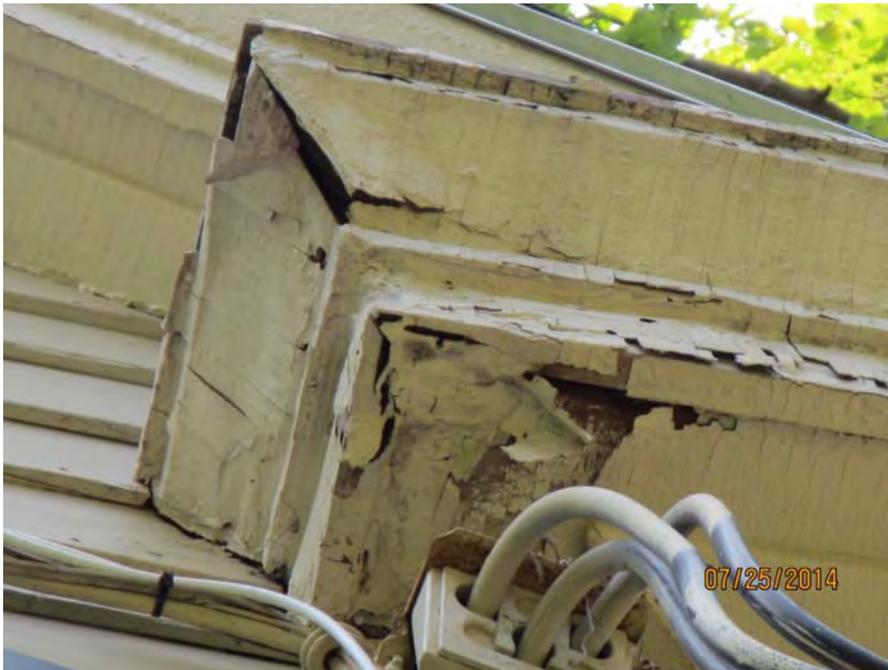
**Picture 12**

**Water-damaged trim**

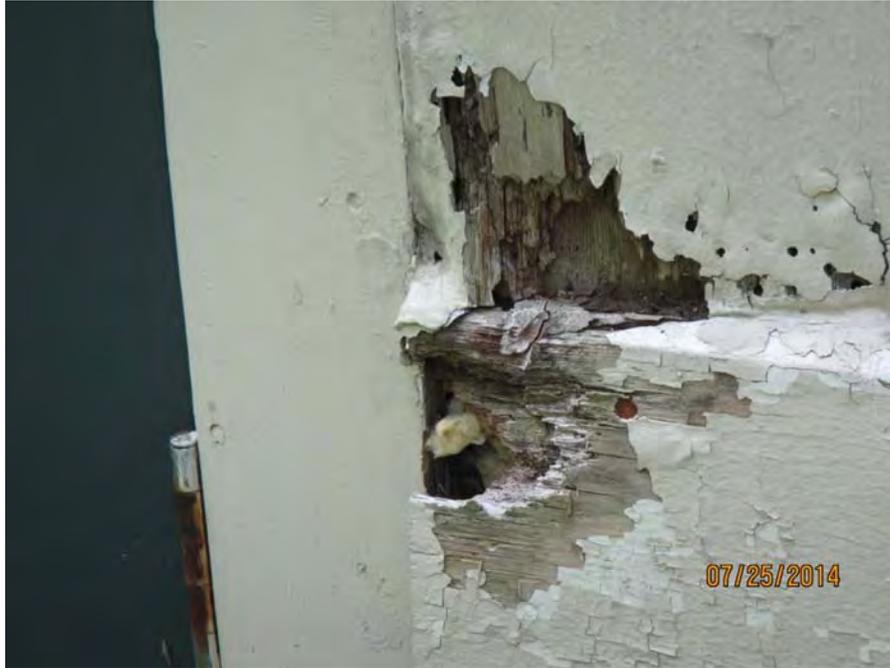
**Picture 13**

**Water-damaged siding & trim**

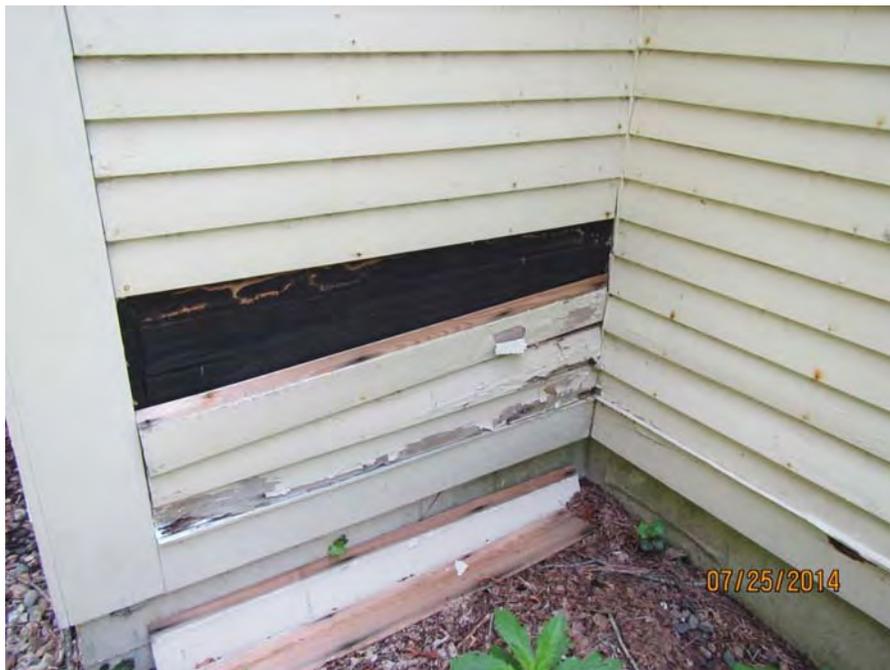
**Picture 14**

**Missing siding**

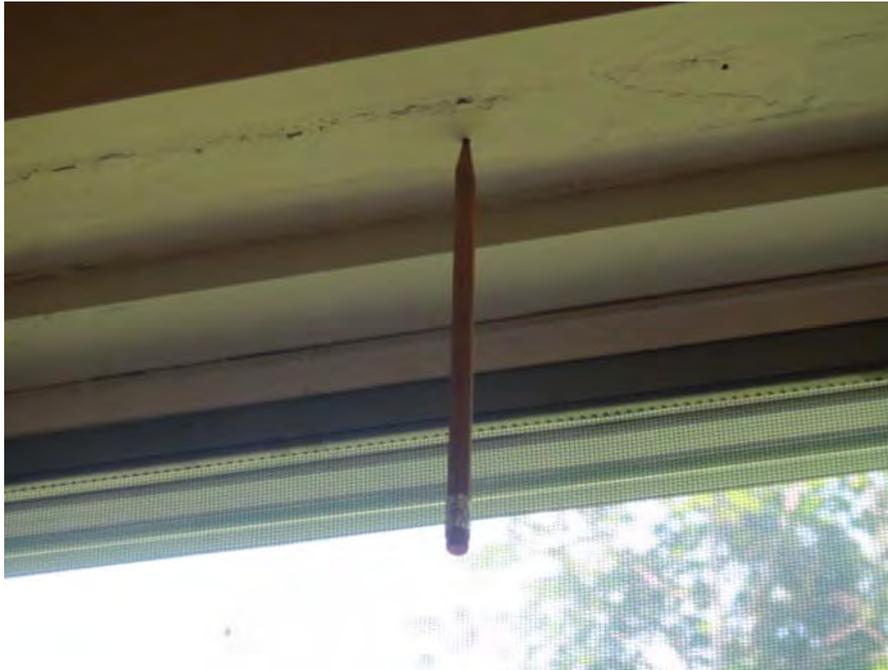
**Picture 15**

can occur when moisture persists. Several windows and door frames were also found to be water-damaged due to improperly flashed/sealed windows and rotted trim (Picture 15).

**Water-damaged window frame, note pencil inserted by BEH/IAQ staff**

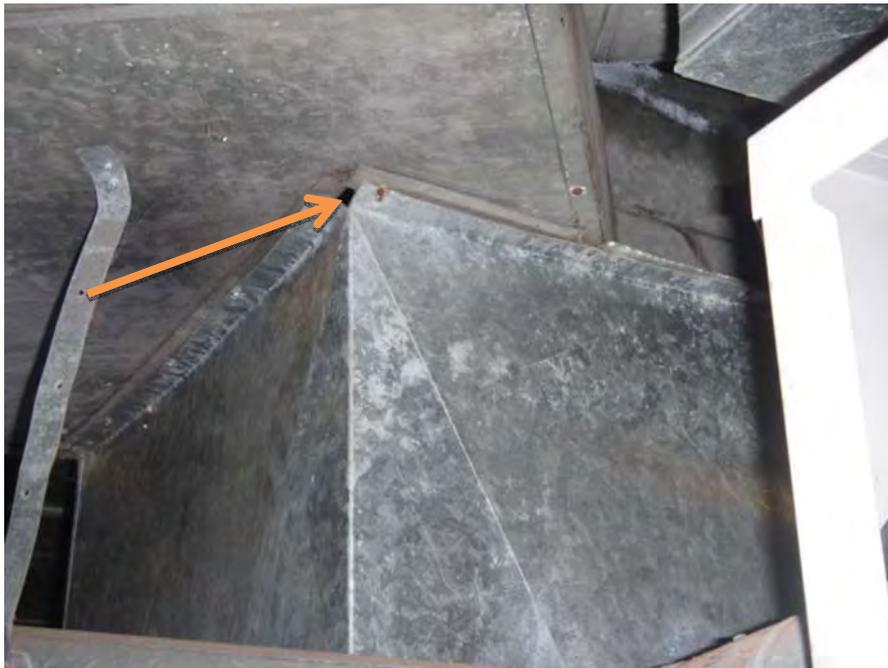
**Picture 16**

**Return ductwork showing unsealed joints/gaps (arrow)**

11. Consider providing a back-up power source for the sump pump to avoid continued flooding events during severe storms/power loss.
12. Seal the joints of the return ductwork in the original basement to avoid entrainment of basement moisture, odors, and pollutants.

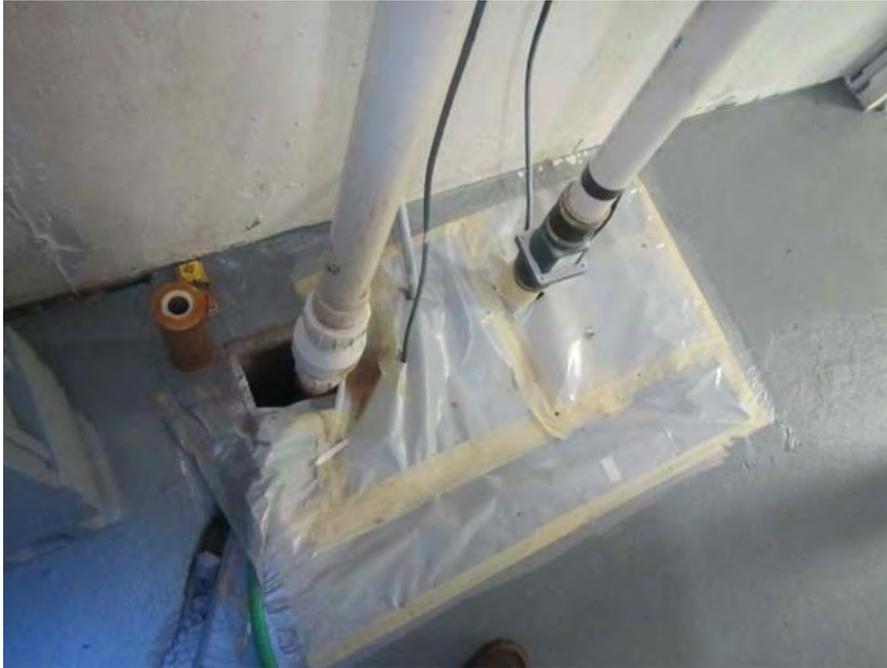
**Picture 17**

- **Groundwater:** The BTL appears to have a high groundwater level as evidenced by the sump pump in the basement of the 1979 addition (Picture 17). Groundwater levels fluctuate seasonally, with highest levels in early spring (Fletcher, 2014). BEH/IAQ staff observed the sump pump in activation at the time of the assessment (late July). It is likely that the 1979 addition basement extends well below the seasonal high groundwater table for the area. This results in a constant exposure to moisture, odors, and elevated humidity. It was also reported to BEH/IAQ staff that during severe storm events, the building has periodically lost power. This results in the deactivation of the sump pump motors. Several floods have occurred as a result of power loss. Town officials have reported that at times over 4 feet of water has accumulated in the basement due to the lack of an operating sump pump. Building materials and stored items were damaged as a result. Due to the repeated flooding of the basement, it is not recommended that porous materials be stored in basement areas. Consideration should be given to providing a back-up power source and a properly sealed cover for the basement sump pump.

**Sump pump in flood remediated 1979 addition basement; note makeshift cover**

- e. sealing the cover for sump pump; and
  - f. sealing gaps/crevices in basement ceilings.
7. Examine the building envelope for proper insulation and ventilation, and remedy conditions leading to condensation, ice dams, water damage, and microbial growth.

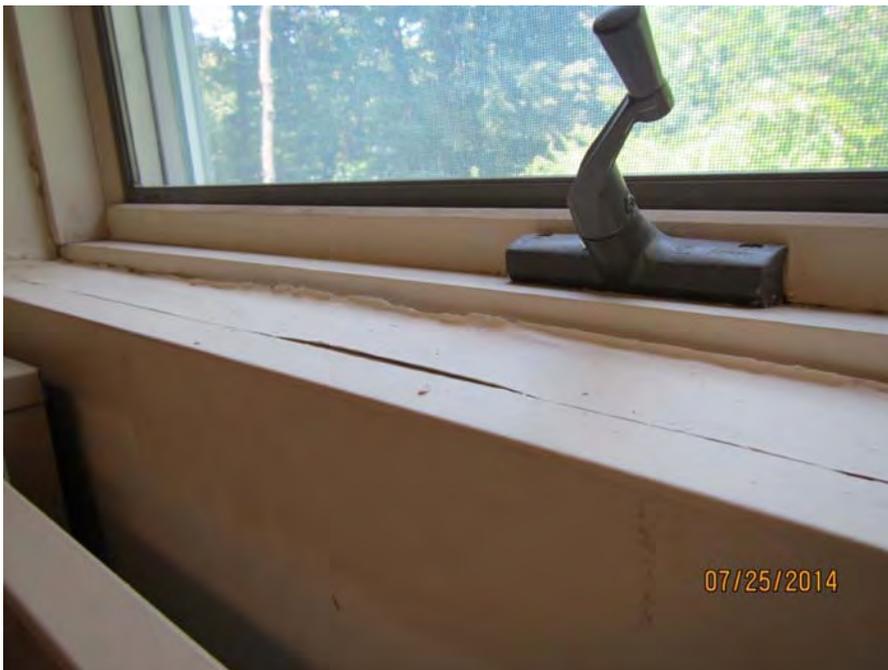
**Picture 18**

- **Condensation:** Condensation is another source of moisture at the BTL. Older single-paned windows are a source for condensation due to the temperature differences on the surface of the glass and interior spaces in relation to the dew point. The condensation collects on windowsills causing further water damage (Picture 18). Also, opening

**Water-damaged window sill**

5. Consider replacing older, single pane windows with newer insulating models.
6. Consult with a basement water intrusion contractor to take necessary actions to prevent storm water, groundwater, and associated moisture from entering basements. This may include:

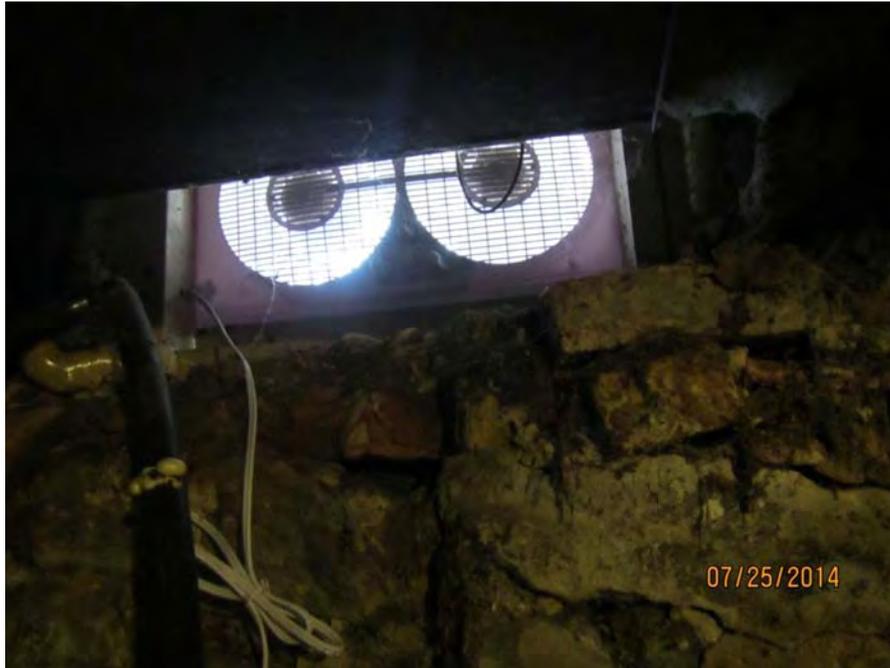
**Picture 19**

**Window fan used as exhaust ventilation for original dirt floor basement**

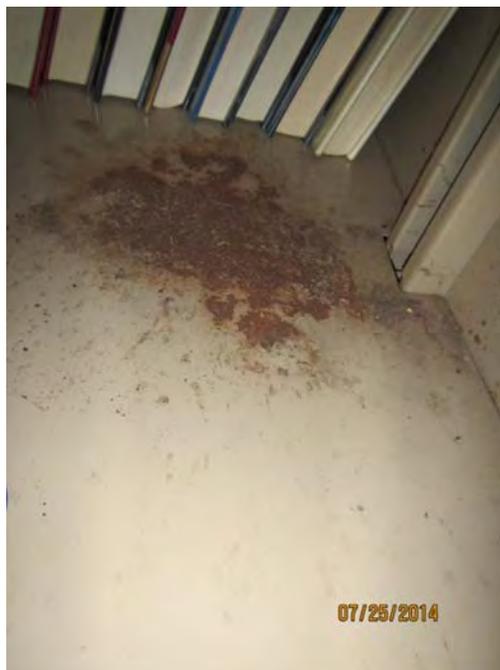
**Picture 20**

**Metal shelving showing rust due to condensation**

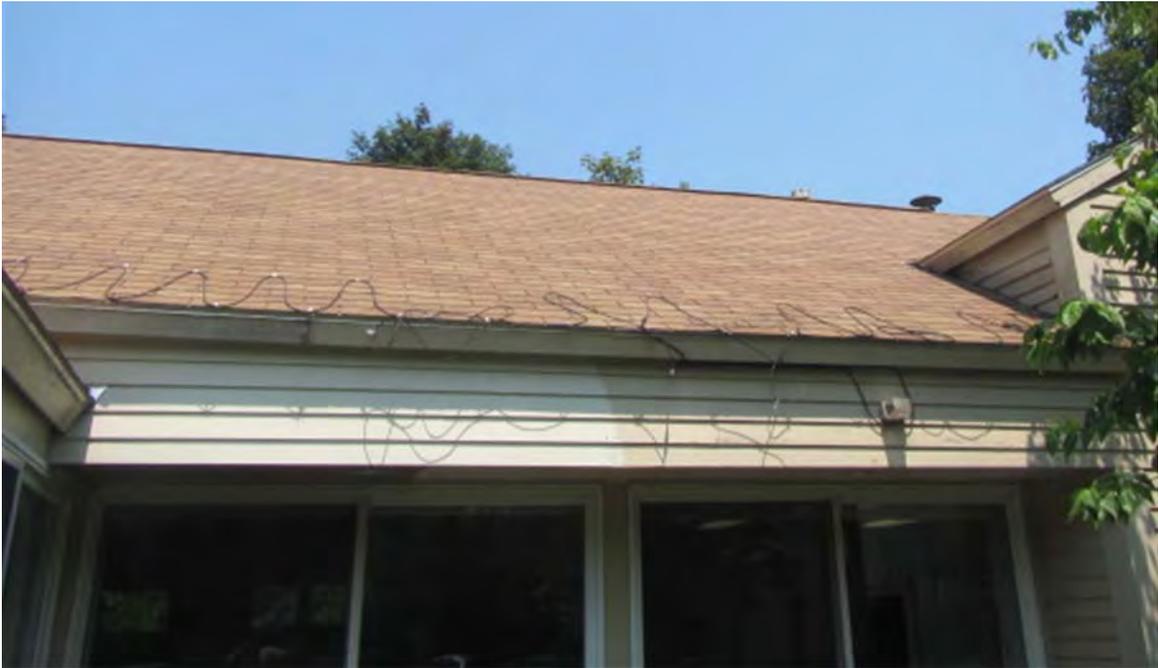
**Picture 21**

**Electric heat coils to prevent further ice dams**

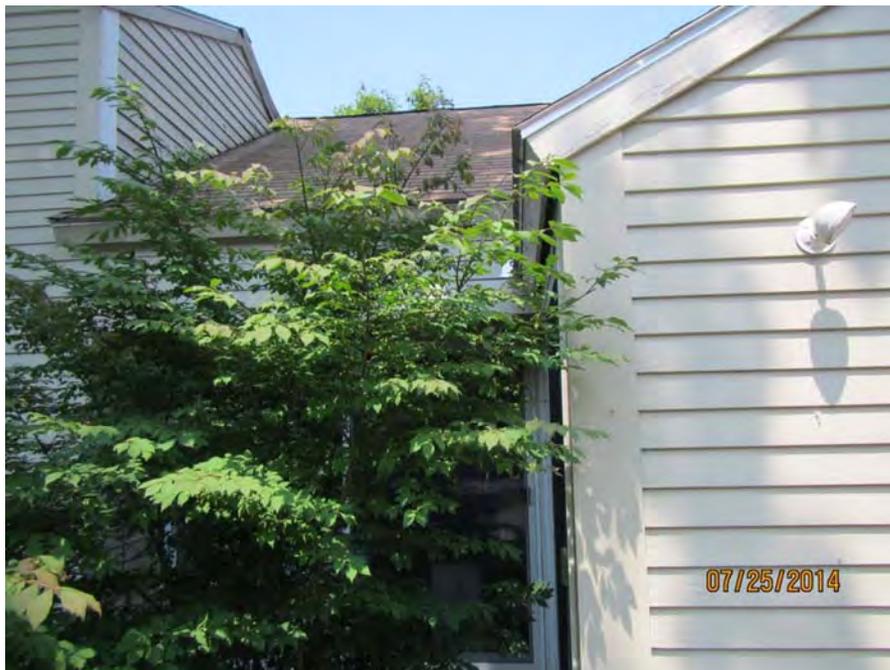
**Picture 22**

Trees, shrubs, plant growth, and mulch were visible in close proximity to the building and foundation (Picture 22). It is important to keep vegetation away from the building, since it may allow moisture, pests, and pollen to enter the building. Bark mulch also absorbs and holds moisture against the foundation. Moisture can penetrate through the foundation into the building through capillary action. Numerous trees have reportedly been cut down prior to this assessment; however, any remaining vegetation within five feet of the building should be trimmed/removed. Consideration should also be given to grading the slope of the surface perimeter down and away from the foundation and installing a water impermeable barrier (clay cap) around the building perimeter (Lstiburek and Brennan, 2001). This should help to reduce soil saturation and storm water infiltration into the basements. Weed blocking fabric and crushed stone can minimize the amount of maintenance required to keep vegetation clear of the perimeter.

**Shrubbery in close proximity to building**

9. Remove vegetation within 5-feet of the building, and consider using weed blocking fabric and crushed stone over proposed clay perimeter barrier to avoid excess maintenance involved with keeping vegetation away from foundation.

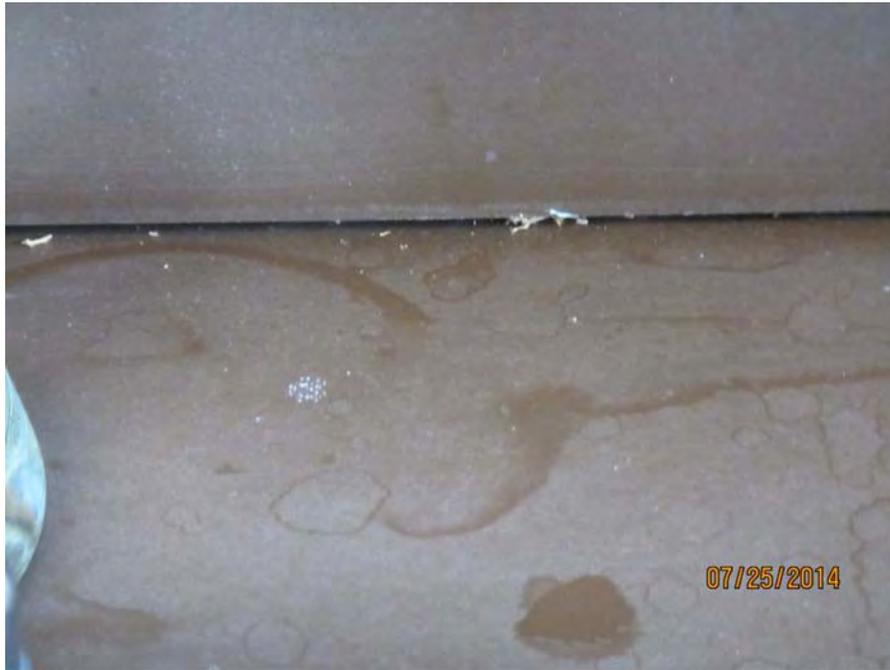
**Picture 23**

The area between the sink counter and the backsplash in the upstairs break room was not properly sealed with caulking (Picture 23). Water can penetrate through backsplash seams if they are not watertight. Water penetration and chronic exposure of porous and wood-based materials can cause these materials to swell and show signs of water damage. Porous materials were found stored under the sink.

**Gap between sink counter and backsplash**

19. Seal the space between the break room/kitchen sink and backsplash with waterproof, mildew resistant caulking and repair any leaks in the plumbing to avoid further water damage. Also, refrain from storing porous materials under the kitchen sink.

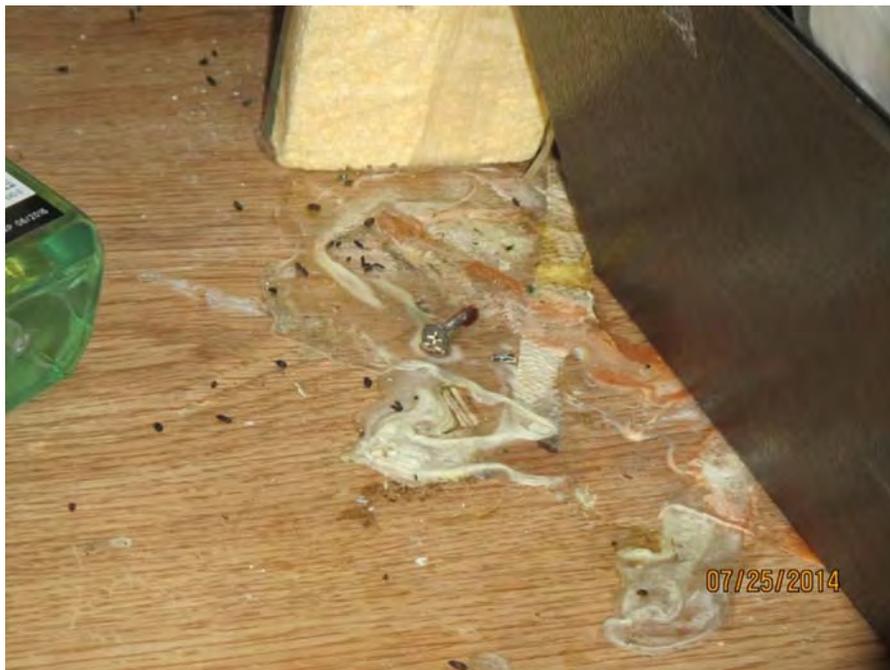
**Picture 24**

The plumbing under the sink also appears to be leaking, since BEH/IAQ staff observed water damage and moist conditions directly below the sink drain (Picture 24). Materials stored under sinks may make leaks harder to detect and repeated moistening of porous materials can result in mold growth. As discussed, moistened materials that are not dried within 24 to 48 hours can become potential sources for mold growth.

Signs of rodent infestation were observed throughout the BTL. Mouse droppings were visible under the sink in the second floor break room and traps and bait boxes were noted in basement areas (Pictures 24 and 31). There were many rodent holes observed along the perimeter of the foundation as well as holes/gaps around doors and in between fieldstone, which allow for easy access for rodents to enter the building. It was reported to BEH/IAQ staff that a pest control company makes a visit once per month. MDPH typically recommends adopting a more comprehensive integrated pest management plan (IPM) to more effectively control rodents and other pests.

**Water-damaged sink cabinet; note mouse droppings**

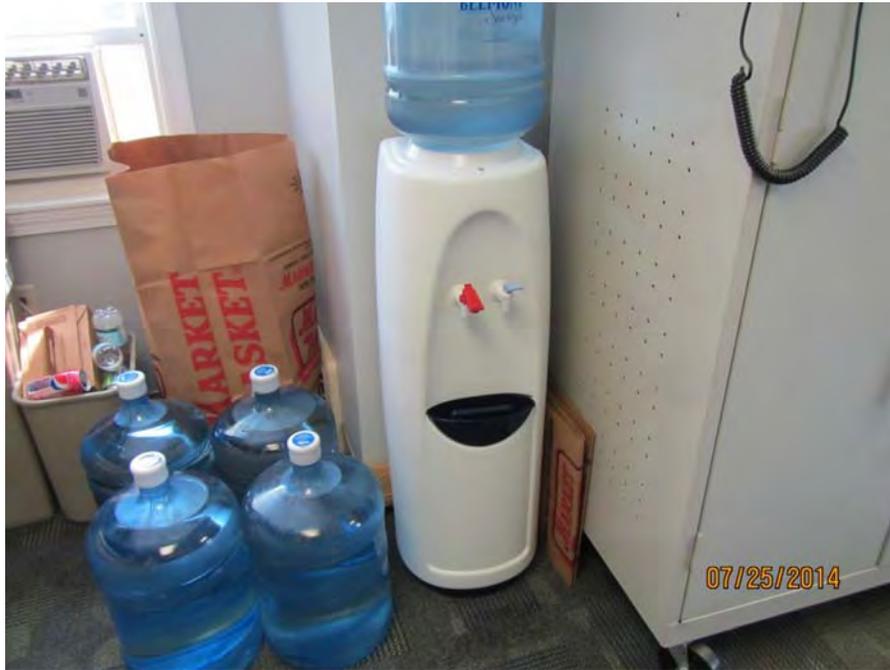
**Picture 25**

A water cooler and water bottles were observed in carpeted areas (Picture 25). Spills or leaks from this equipment can moisten carpet and lead to microbial growth and degradation of the carpet. MDPH recommends placing rubber or plastic trays beneath this equipment to protect the carpet from any leaks.

**Water cooler on carpeted surface**

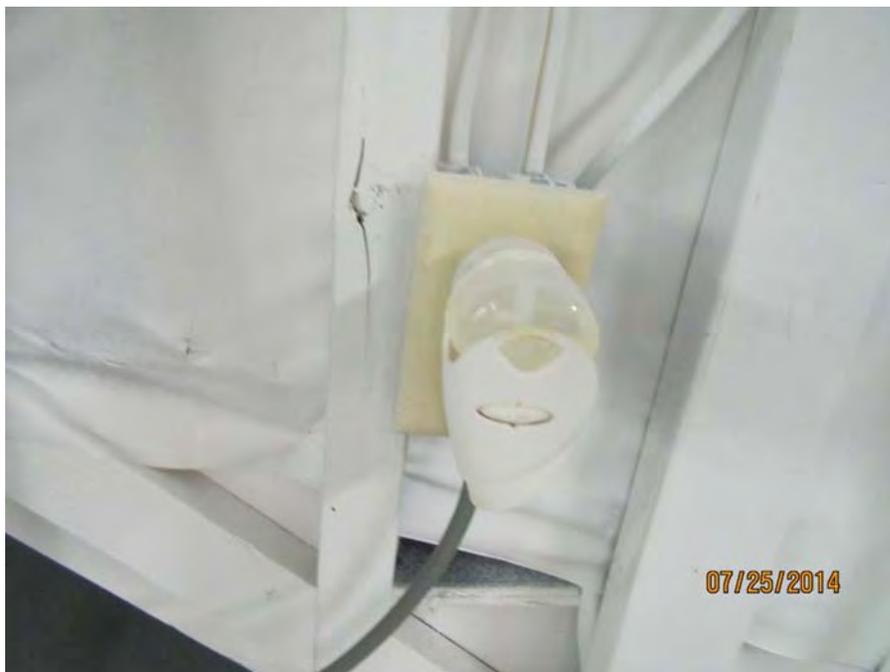
**Picture 26**

Air deodorizers and cleaning products were observed in several areas (Picture 26). Air deodorizers contain chemicals that can be irritating to the eyes, nose and throat of sensitive individuals. Many air fresheners contain 1,4-dichlorobenzene, a VOC which may cause reductions in lung function (NIH, 2006). Furthermore, deodorizing agents do not remove materials causing odors, but rather mask odors that may be present in the area. Cleaning products contain chemicals that can be irritating to the eyes, nose and throat of sensitive individuals. These products should be properly labeled. Consideration should be given to working with building management to provide staff with cleaning products and supplies to prevent any potential for adverse chemical interactions.

**Plug-in air deodorizer**

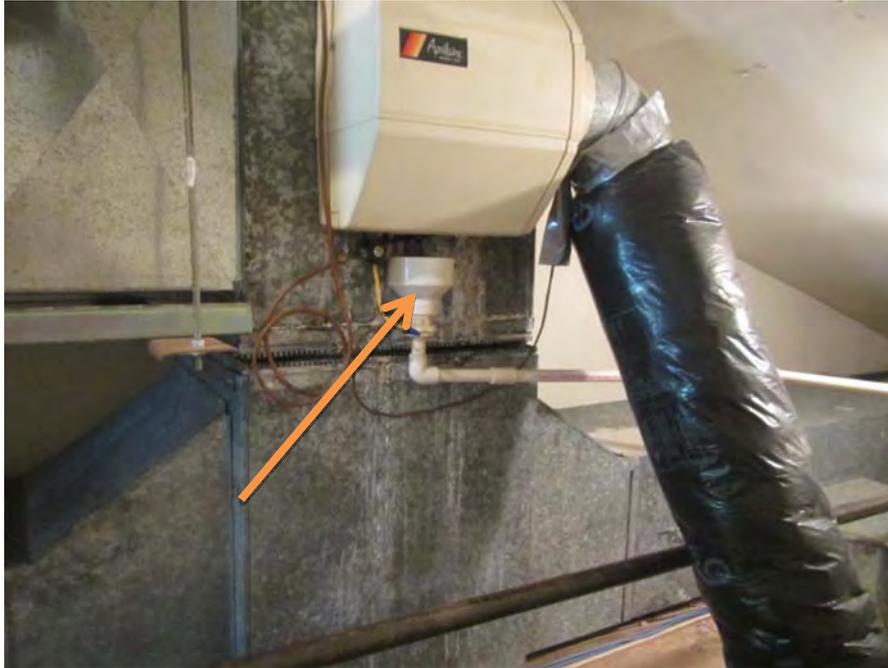
**Picture 27**

The FHA unit in the attic space above the main library has a humidifier ducted to the return vent. Beneath the attached humidifier unit is a condensate drain that catches any water generated when the humidifier is in use (Picture 27). This drain line leads to a water trap that is attached to a sewer drain/vent stack (Picture 28). It was reported to BEH/IAQ staff that the humidifier is no longer in use. Water traps are designed to be filled with water to create a seal to prevent sewer gases from entering occupied areas. Since this humidifier is no longer in use, no water is present in the trap to prevent sewer gases and odors from being drawn into the FHA unit. Odors entrained in the heating unit can be dispersed throughout occupied areas. This unit should be disconnected and the drain line and trap properly capped and sealed.

**Attached FHA humidifier; note condensate catch/drain line apparatus**

2. Disconnect the abandoned humidifier attached to the FHA unit in the attic space from the drain line. Properly cap and seal the drain line to prevent entrainment of sewer gases into occupied spaces.

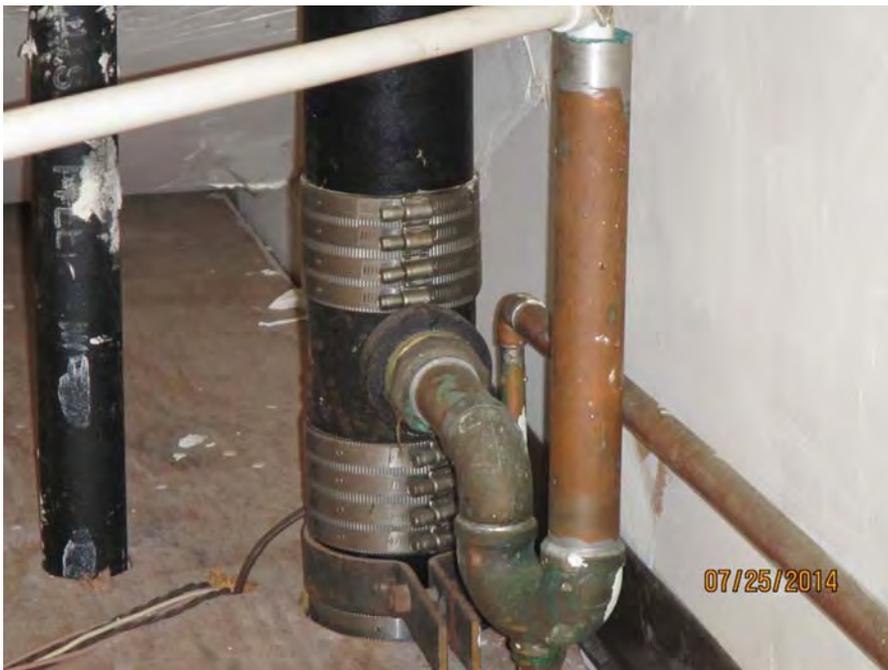
**Picture 28**

**Humidifier drain line entering water trap attached to sewer drain/vent line**

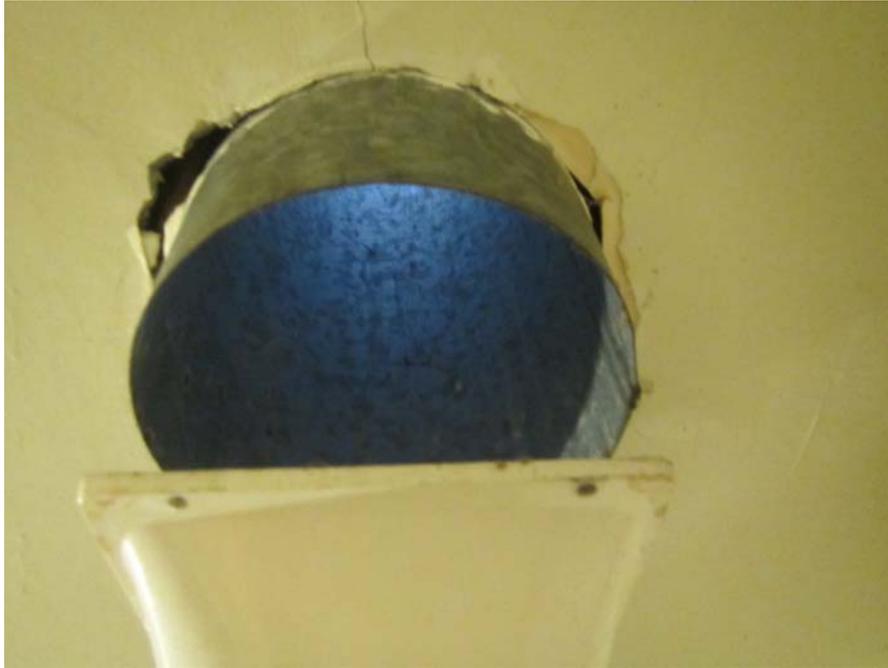
**Picture 29**

rodents/squirrels from accessing the attic. A plastic container was modified and placed under the duct to catch rainwater (Picture 29). BEH/IAQ staff observed water staining as well as bird waste and gnawed walnut shells on the plywood floor below the duct/plastic container, confirming the presence of pests.

**Make-up air duct for FHA unit; note container used to catch storm water**

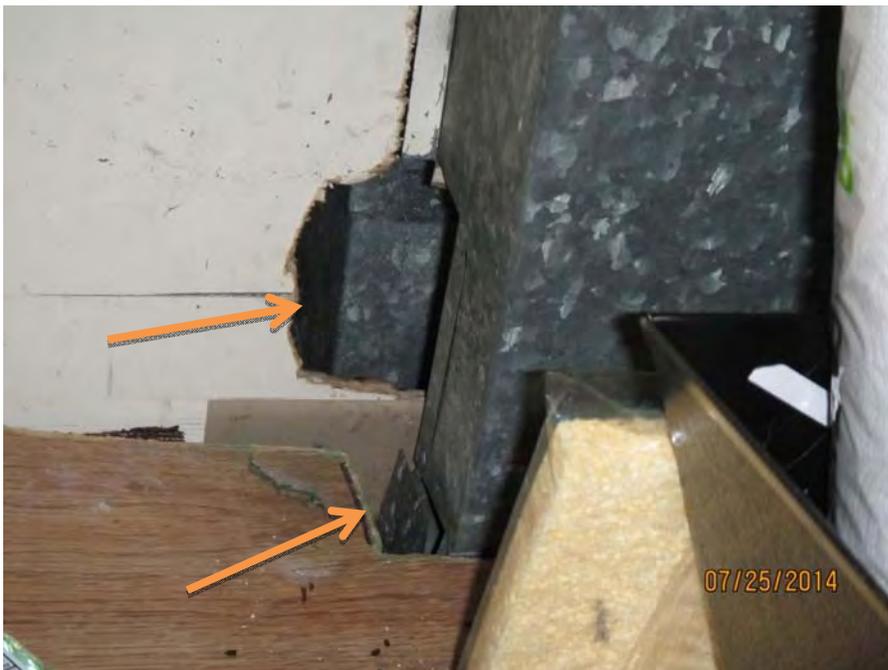
**Picture 30**

BEH/IAQ staff observed holes/breaches in the wall and around ductwork under a sink cabinet in the second floor break room (Picture 30). Odors, pollutants, moisture, and pests can

**Holes/breaches in wall and around ductwork under sink cabinet**

20. Seal holes/breaches in wall under sink cabinet in break room to prevent entry of pests, moisture and odors into occupied areas.
21. Refrain from storing porous materials (e.g. books, papers) in the basement area due to the continued moisture concerns such as groundwater, high humidity, and flooding.

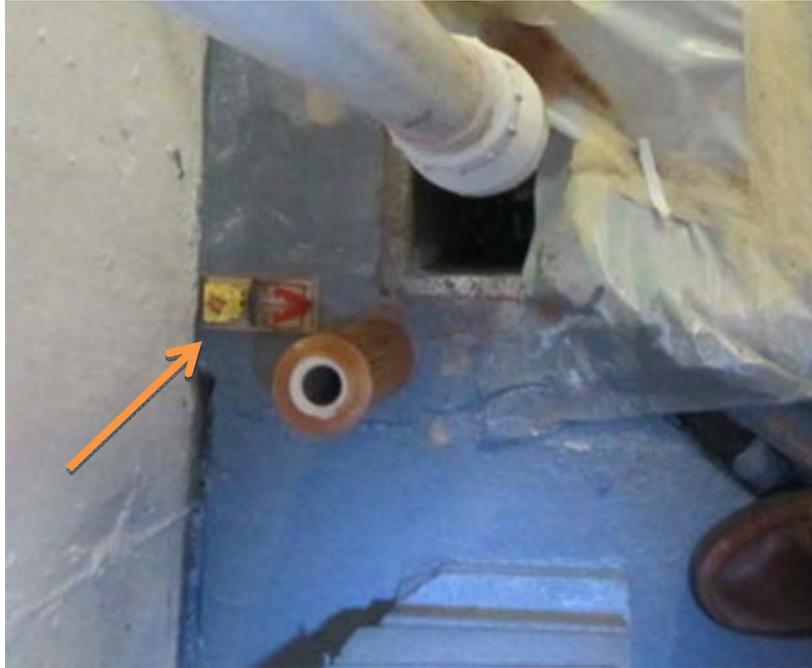
**Picture 31**

**Mouse trap in basement of 1979 addition**

- a. Keep list/inventory of location of all rodent bait/sticky traps, monitor on a regular basis and replace as needed to prevent odors from rodent die off. Do not place rodent traps in the airstream of ventilation equipment;

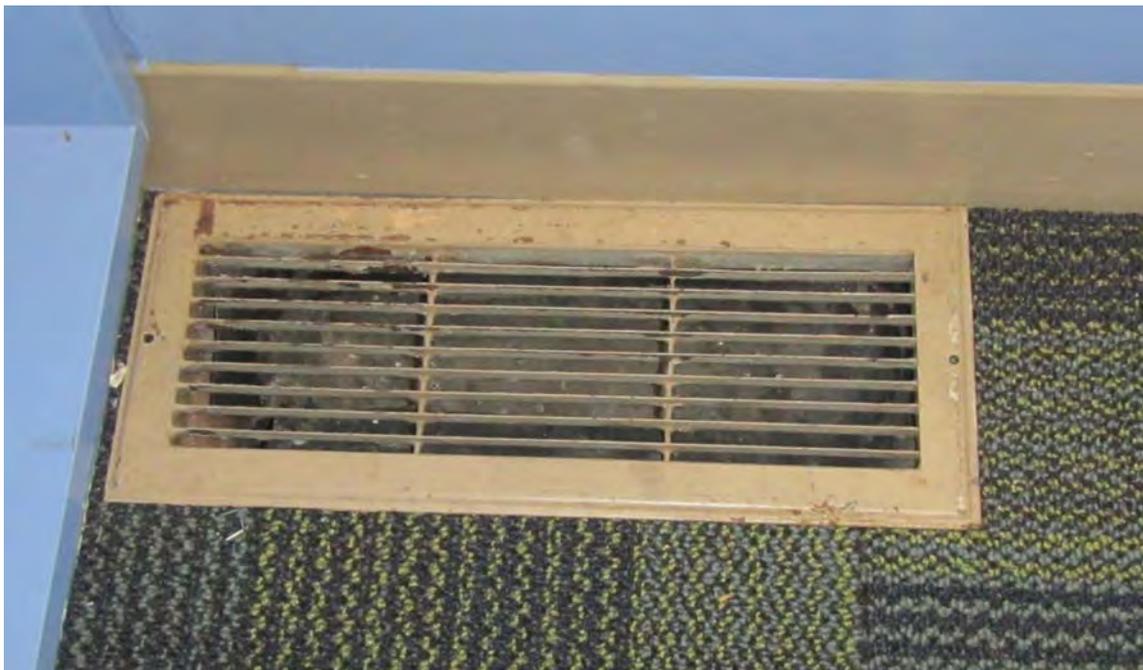
**Picture 32**

**Supply diffuser showing rusting and dust particles**
