# **INDOOR AIR QUALITY ASSESSMENT**

**Boxford Town Library  
10 Elm Street  
Boxford, Massachusetts**

Prepared by:  
Massachusetts Department of Public Health  
Bureau of Environmental Health  
Indoor Air Quality Program  
September 2014

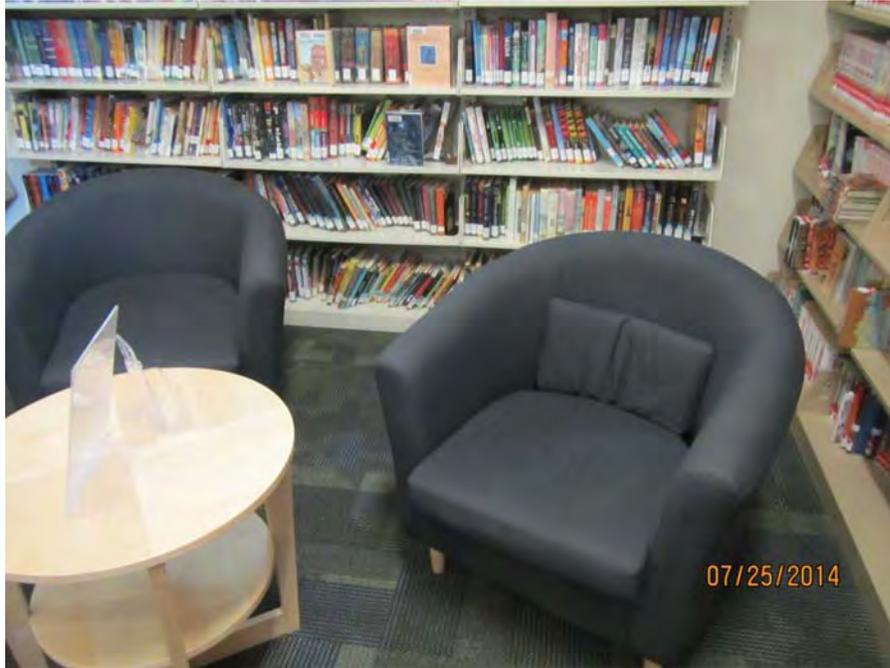
**Picture 33**

Upholstered furniture and plush toys were observed in several areas (Picture 33; Table 1). These items are covered with fabrics that may be exposed to human skin. This type of contact can leave oils, perspiration, hair and skin cells. Dust mites feed upon human skin cells and excrete waste products that contain allergens. In addition, if relative humidity levels increase above 60 percent, dust mites tend to proliferate (US EPA, 1992). In order to remove dust mites and other pollutants, frequent vacuuming of upholstered furniture and plush toys is

**Upholstered furniture**

recommended (Berry, 1994). It is also recommended that upholstered furniture be professionally cleaned on an annual basis. Where an excessively dusty environment exists due to outdoor conditions or indoor activities (e.g., renovations), cleaning frequency should be increased (every six months) (IICRC, 2000).

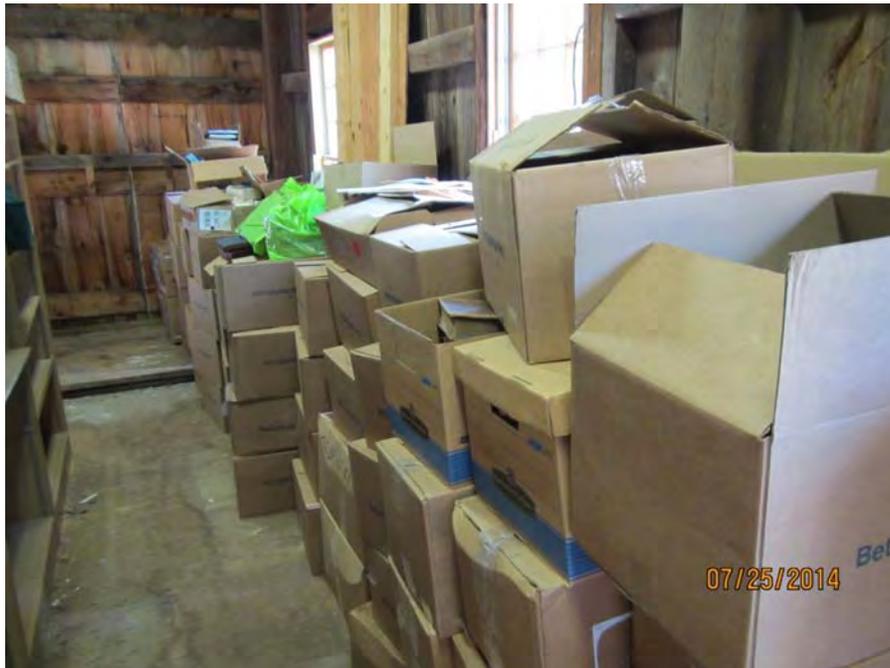
**Picture 34**

The BTL has an outbuilding on the premise that is currently being used to store books and other porous materials. Storing porous materials in unconditioned areas can result in damage to the materials due to moisture, microbial growth, and rodents (Pictures 34 and 35).

**Storage of books and other porous materials in outbuilding**

22. Refrain from leaving windows and doors open during operation of AC units.
23. Storage of porous materials (e.g., books) in the unconditioned outbuilding is not recommended. These materials are subject to moisture, microbial growth, and rodent damage. Due to site limitations, off-site storage of these materials may be preferred.

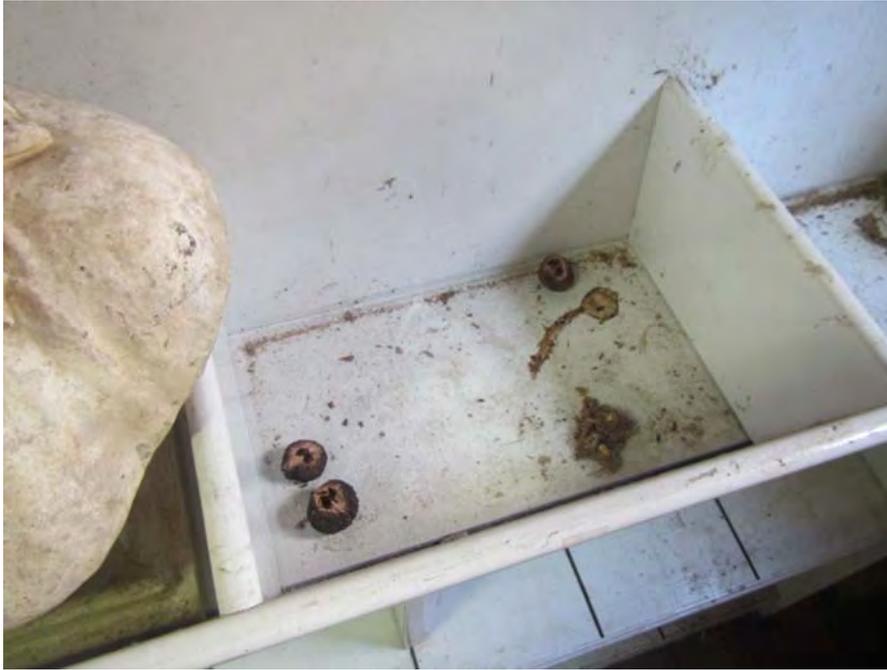
**Picture 35**

**Evidence of rodent activity in outbuilding with stored books**
