INDOOR AIR QUALITY ASSESSMENT MOLD INVESTIGATION

**George H. Mitchell Elementary School
500 South Street
Bridgewater, Massachusetts**

Prepared by:
Massachusetts Department of Public Health
Bureau of Environmental Health
Indoor Air Quality Program
November 2014

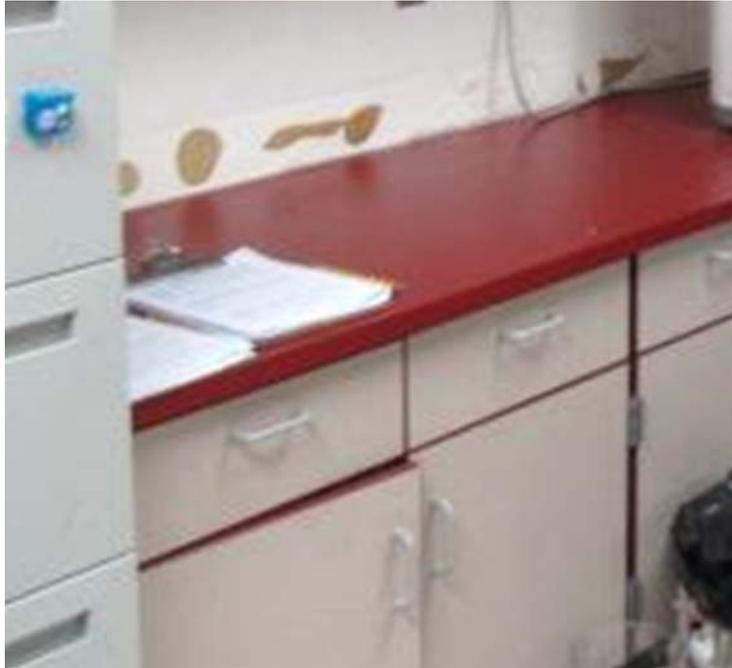
Picture 1

surface mold off of GW behind the backsplash (Picture 1). BEH/IAQ staff recommended removal of the countertop in order to observe conditions behind it. The countertop was removed and BEH/IAQ staff returned to the MES on November 4, 2014 and observed a small area that appeared to be surface mold on the wall (Picture 2). At that time, a verbal recommendation to remove the material and then clean and disinfect the area with an antimicrobial solution was made. Mr. Baroncelli also reported that damaged backsplashes were removed in a number of other classrooms for repair/replacement.

Damaged backsplash removed from classroom 123

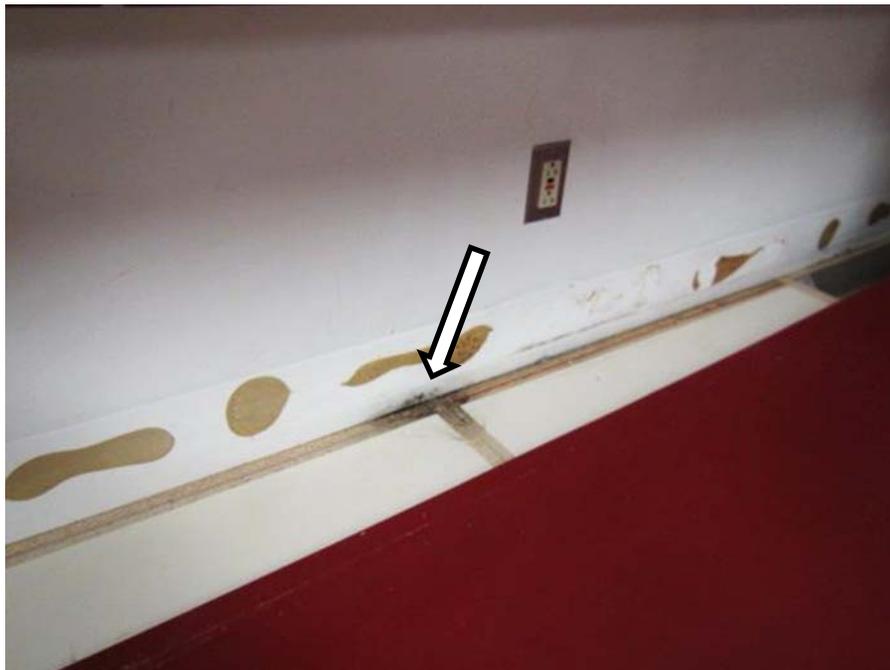
Picture 2

Small area of mold growth (arrow) behind countertop

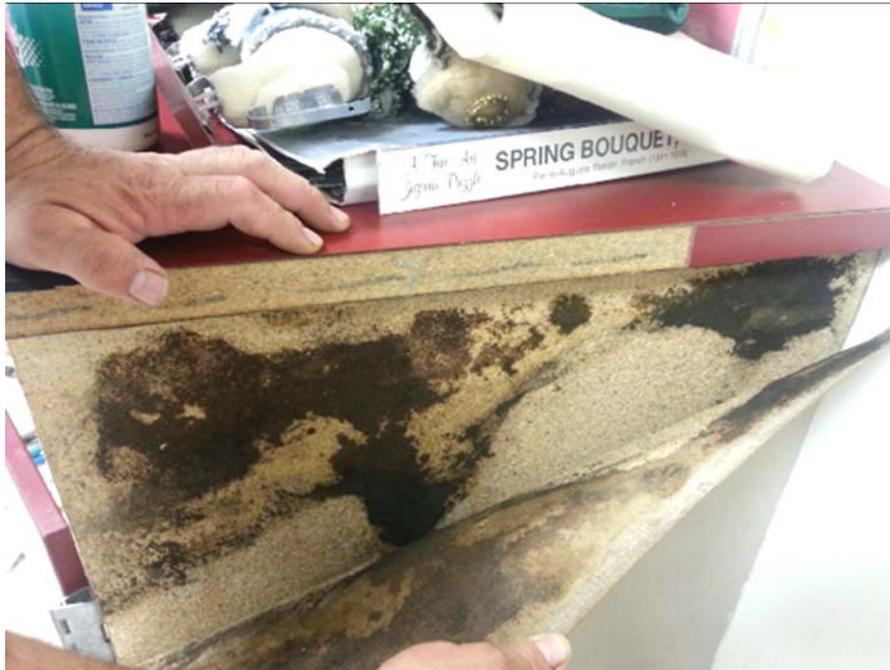
Picture 3

BEH/IAQ staff were asked to examine a sink cabinet in classroom 128. In this case it appeared that moisture had been trapped between failing laminate covering on the cabinet, creating mold growth conditions on the particle board substrate (Picture 3). At the time of the assessment the failing laminate was sealed with tape until the cabinet could be removed later that day (Picture 4). In subsequent correspondence with BRPS maintenance staff the cabinet was removed from the classroom and discarded.

Likely mold growth behind failing laminate on counter in classroom 128

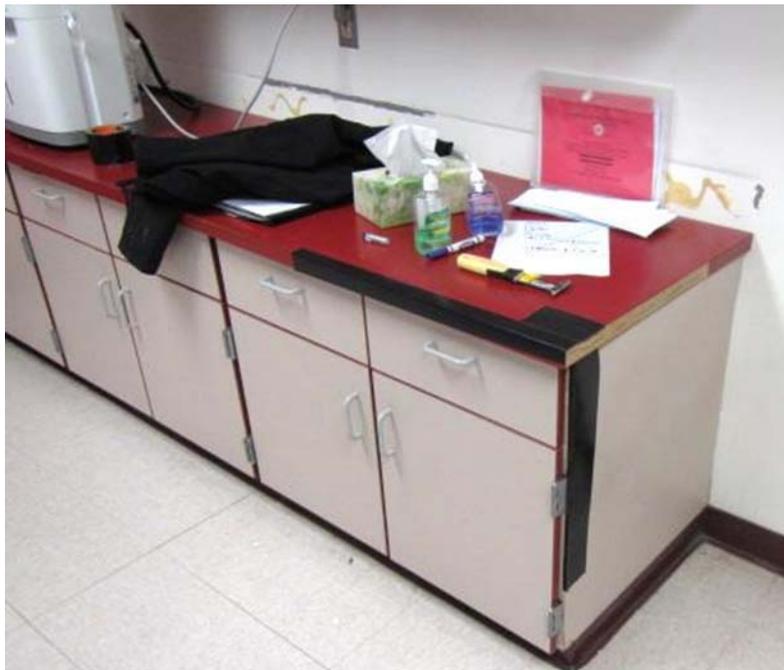
Picture 4

Edges of failing laminate in classroom 128 temporarily sealed with tape prior to removal
