# **INDOOR AIR QUALITY ASSESSMENT**

**Burlington Public Library  
22 Sears Street  
Burlington, Massachusetts**

Prepared by:  
Massachusetts Department of Public Health  
Bureau of Environmental Health  
Indoor Air Quality Program  
February 2014

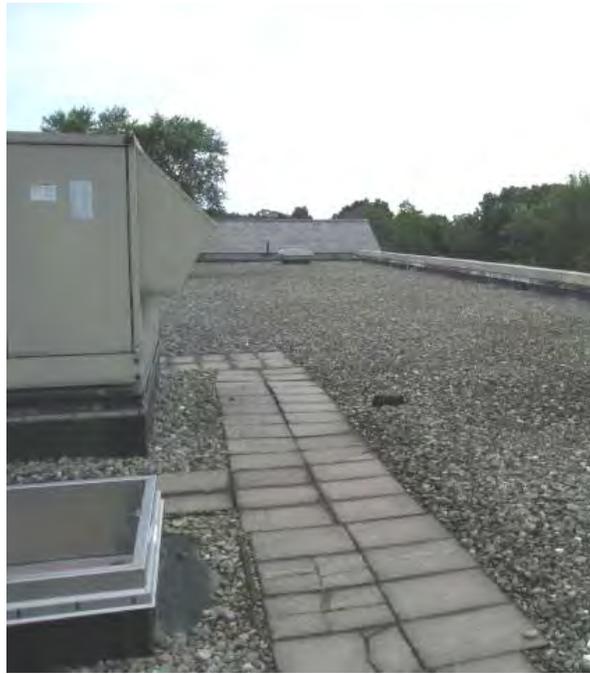
**Picture 1**

Mechanical ventilation is provided by two rooftop air handling units (AHUs) (Picture 1). Fresh air is drawn into the AHUs, filtered and heated/cooled and then ducted to numerous variable air volume (VAV) units located in the ceilings for additional tempering. Conditioned air is delivered into rooms through ceiling-mounted air diffusers (Picture 2). Curtain-style air diffusers are also located along perimeter walls of the building (Picture 3). Return air is reportedly drawn into the ceiling plenum through perforated metal ceiling tiles.

**Air handling unit (AHU)**

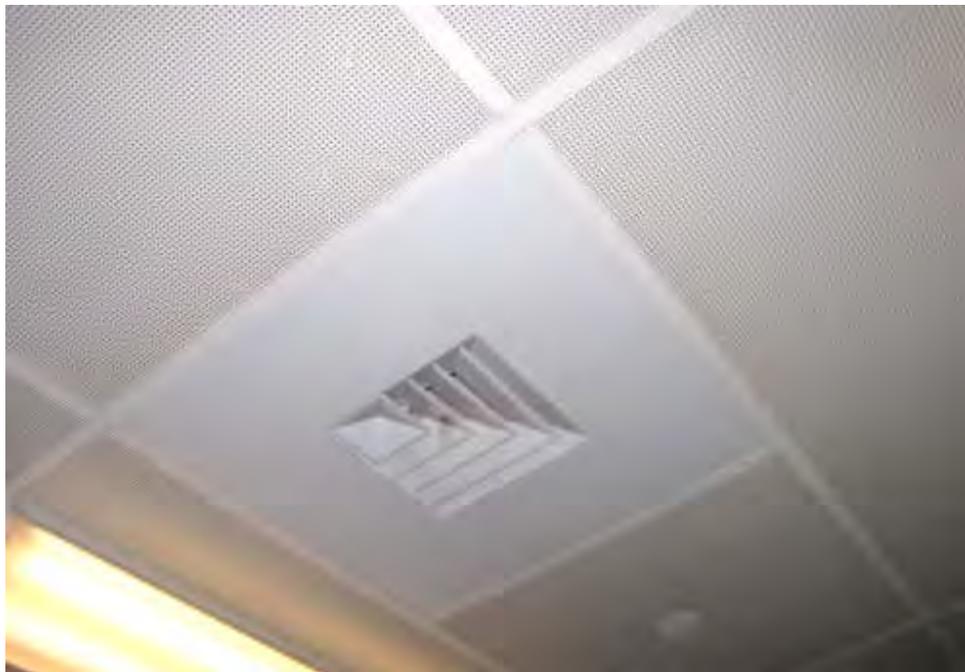
**Picture 2**

**Ceiling-mounted fresh air diffuser**

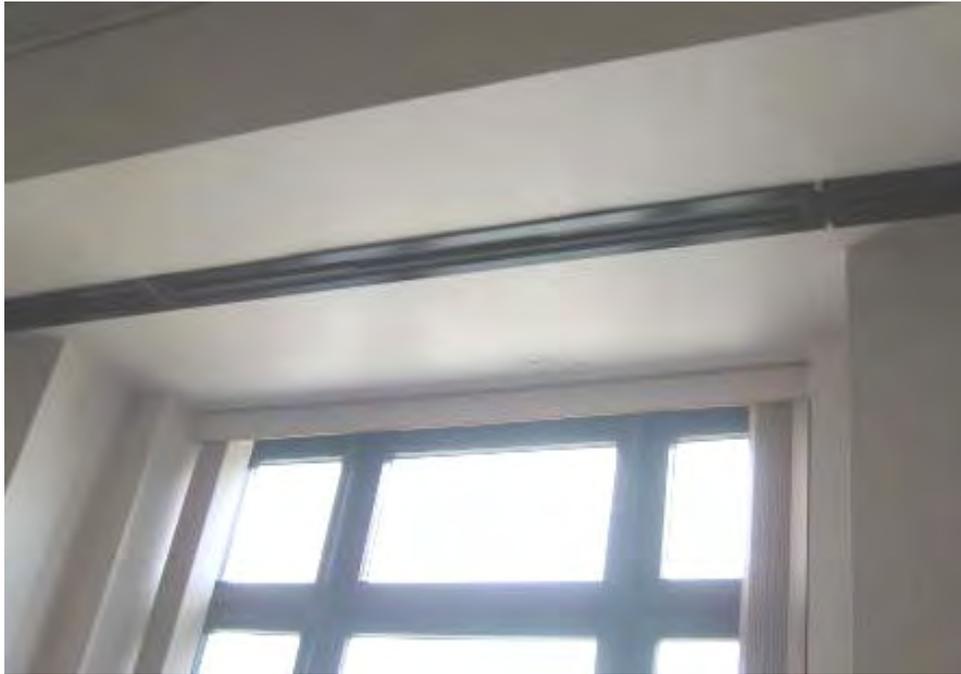
**Picture 3**

**Curtain-style fresh-air diffuser in front of window**

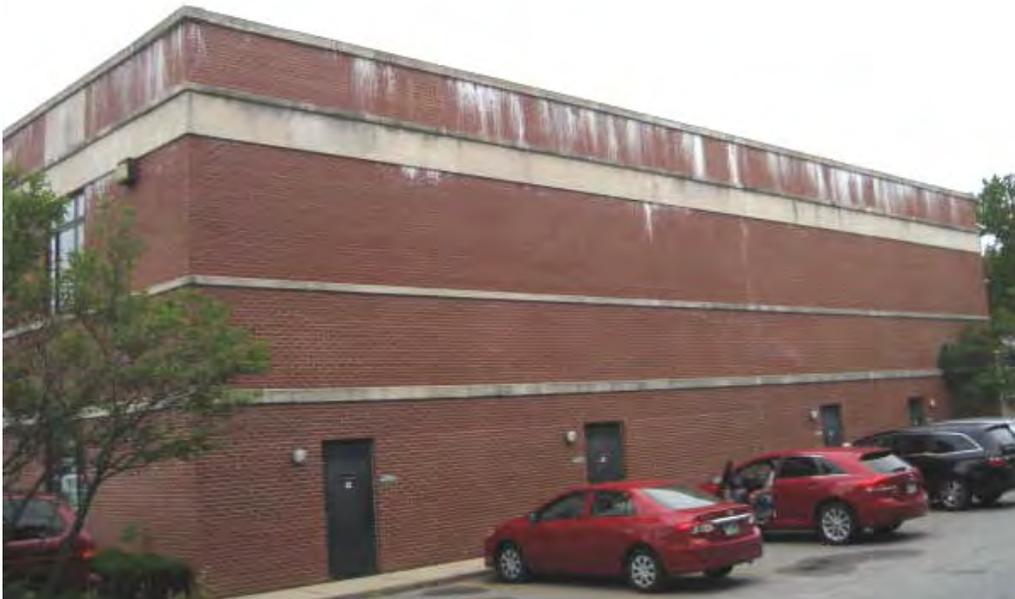
**Picture 4**

Several sources of moisture issues were reported/found during both the August 8, 2013 and the October 29, 2013 visits. The exterior walls exhibited a significant coating of white material along the edge of the roof (Picture 4). This material is efflorescence./ Please note, efflorescence is not mold; it is a sign of water exposure in brick and mortar. As moisture penetrates and works its way through mortar, brick or plaster, water-soluble compounds dissolve, creating a solution. As the solution moves to the surface of the material, the water evaporates, leaving behind white, powdery mineral deposits. The roof in this area is flat with a raised parapet. The parapet itself was cracked (Picture 5) and had efflorescence above the roof membrane (Picture 6). Signs of chronic moisture issues (staining) were also visible along the front of the building below the slate roof/metal flashing (Picture 7).

**Side of building showing efflorescence (white deposits near the top edge of the building)**

1. Have a professional building envelope specialist/building engineer examine the roof and upper walls of the BPL for sources of water infiltration that are leading to efflorescence and intrusion into the building. This should include an investigation of the rooftop and internal drainage systems to assess the likelihood of continued issues with leaks/flooding and alternative methods for providing drainage for the building.

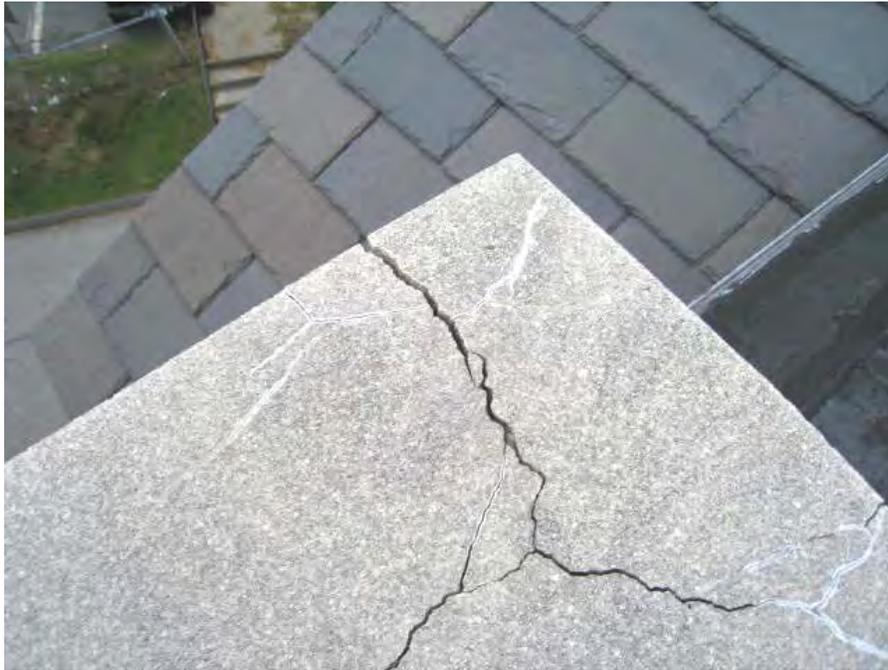
**Picture 5**

**Cracks in top of parapet**

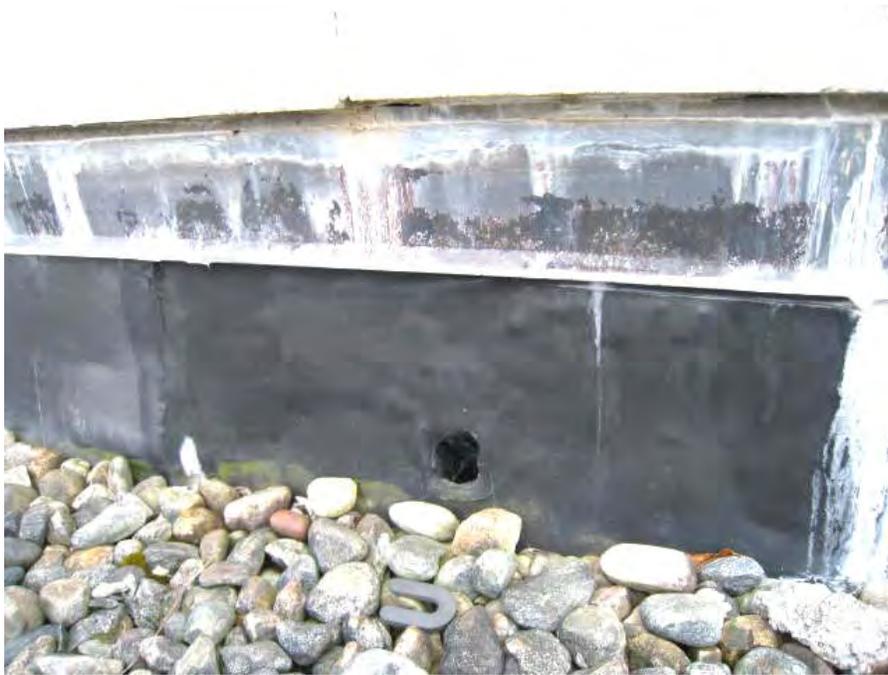
**Picture 6**

**Efflorescence on roof parapet, note drain hole**

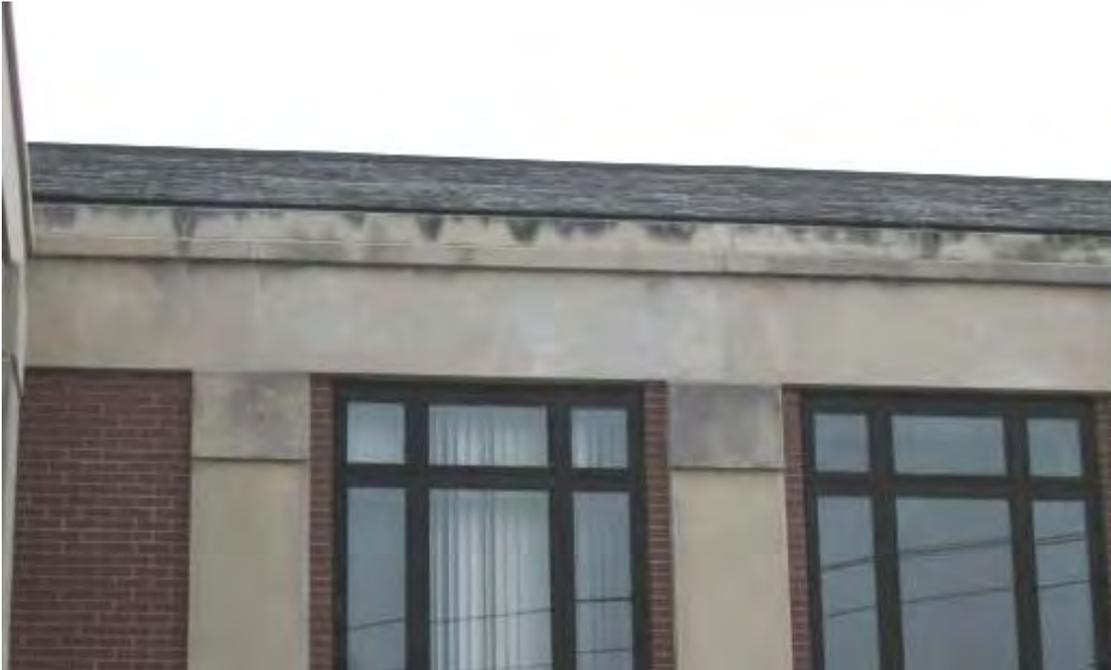
**Picture 7**

**Signs of water infiltration (staining) on the front edge of the building where the roof is slate**

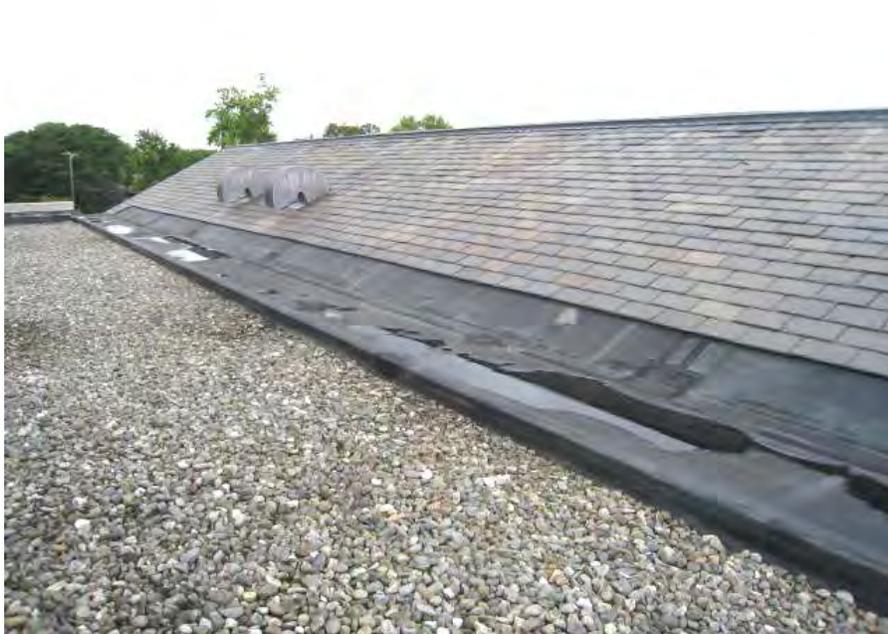
**Picture 8**

These stains indicate damage is occurring to the parapet, roof and façade of the building and suggest that even if no leaks from the roof have been detected inside the building, this condition may be contributing to increased humidity inside. Water was also observed pooling on the joint between the flat rubber membrane and peaked slate roofs (Picture 8).

**Water pooling on joint between flat rubber and peaked slate roof areas**

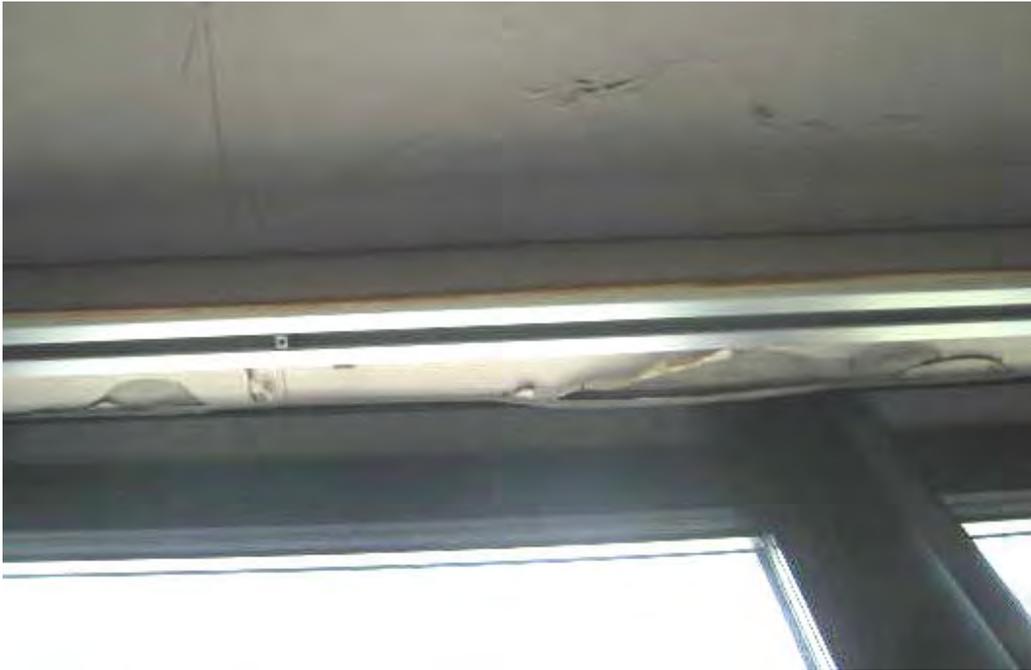
**Picture 9**

the internal conduits, which led to a significant flow of water into the building from locations above and adjacent to the windows in many rooms (Pictures 9 and 10). This situation resulted in extensive water damage to wallboard, carpeting and items that were located in these areas. A flooding restoration contractor was reportedly hired to dry/clean items and carpeting but no wallboard materials were removed and carpeting that was dried was put back in place. Internal drainage pipes were reportedly cleaned and repaired and a regular schedule of maintenance for the system has been implemented. The internal drainage design does not appear to be appropriate or well-designed for this building and will need frequent monitoring and maintenance to prevent another flooding incident. It is also possible that moisture has remained in wall cavities long enough to establish microbial growth. For that room, an examination of wall interiors/cavities in areas with extensive water damage should be conducted.

**Peeling paint showing water damage above second-floor window**

4. Continue to monitor and maintain the internal drainage system and roof drains to prevent additional leaks/floods.
5. Consider opening wall cavities impacted by recent water intrusion events to determine if hidden water damage and mold growth or continued dampness exists. Remove and replace building materials found to be mold-colonized or significantly deteriorated. Small test holes may be used and then patched or covered by a blank switch/outlet plate if materials do not need to be remediated.

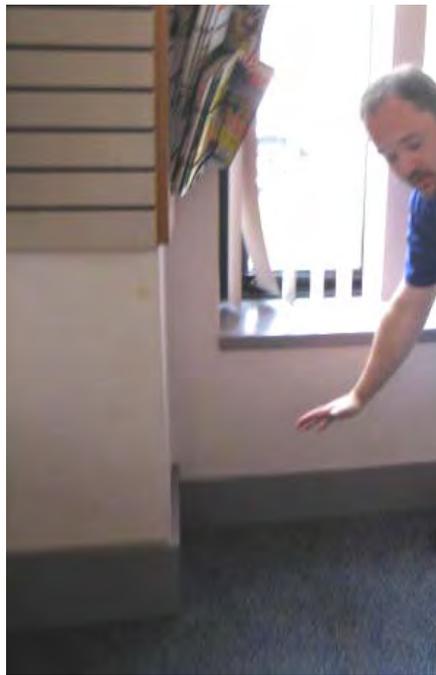
**Picture 10**

**Demonstration of location on first floor where severe water infiltration occurred**

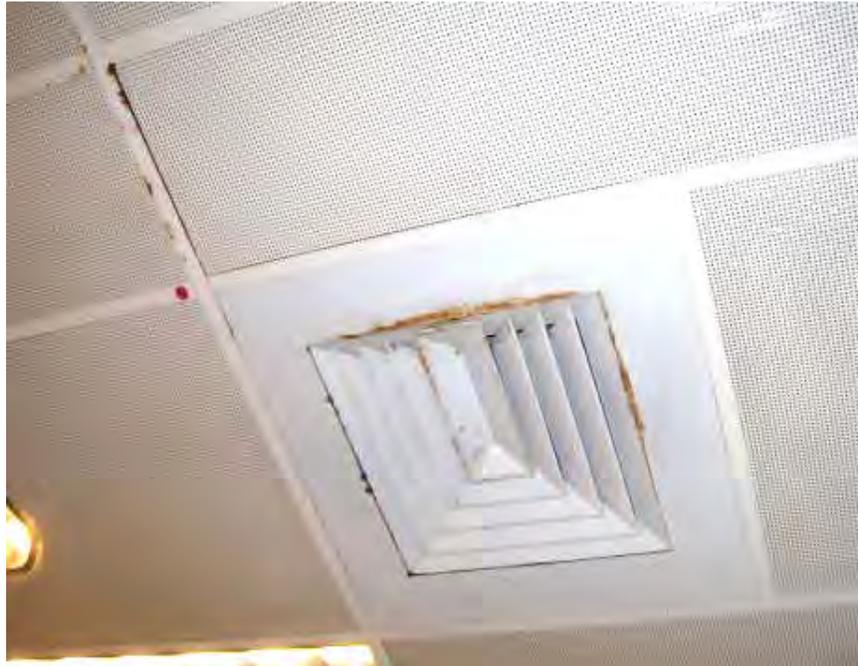
**Picture 11**

BPL staff also report that some of the VAV boxes have been subject to significant leaks, including condensate and, potentially, heating/cooling fluid. Several supply vents and some of the metal ceiling tiles show evidence of rust from these incidents (Picture 11). HVAC systems should be maintained regularly to prevent leaks from occurring. If condensation is occurring, the system may need additional/replacement insulation or reconfiguration to include a condensate drip pan piped to adequate drainage.

**Rust (dark staining) on supply vent and metal ceiling tiles**

7. Work with an HVAC engineering firm to examine all VAV boxes and associated piping and ductwork to find/repair water damage, leaks and sources of condensation. Ensure insulation is intact and continuous over surfaces where needed.

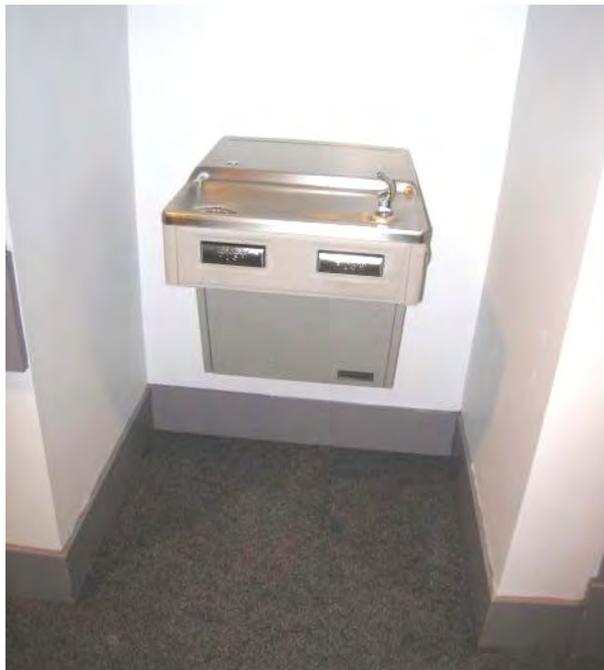
**Picture 12**

- Windows in some areas are not watertight.
- Water fountains were observed in carpeted areas (Picture 12), which can be a source of leaks/spills.
- Plants and shrubs were noted to be growing in close proximity to the outside of the building (Picture 13), which can hold moisture against the building's exterior. The

**Water fountain in carpeted area**

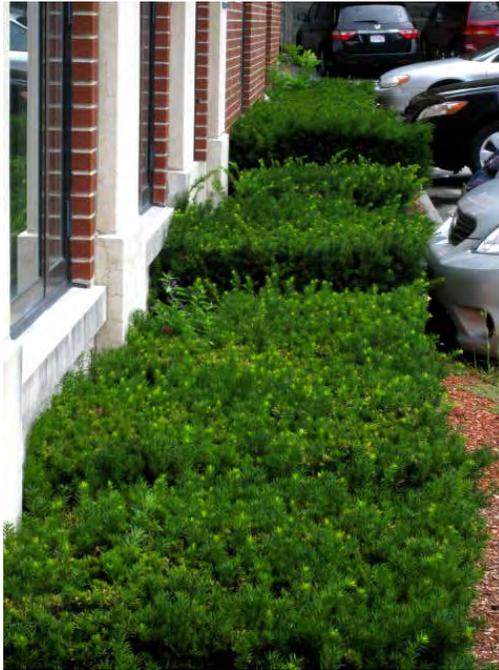
**Picture 13**

growth of roots against exterior walls can bring moisture in contact with the foundation.

Plant roots can eventually penetrate the wall, leading to cracks and/or fissures in the foundation. Over time, these conditions can undermine the integrity of the building envelope and provide a means of water entry into the building via capillary action through exterior walls, foundation concrete, and masonry (Lstiburek & Brennan, 2001).

**Shrubs in contact with building foundation/external wall**

15. Remove plants from direct contact with the exterior of the building. Consider trimming shrubbery to five feet away from the building foundation.
16. Ensure exterior doors remain watertight. Look for light penetration/drafts around doors, replace/install weather stripping as needed.

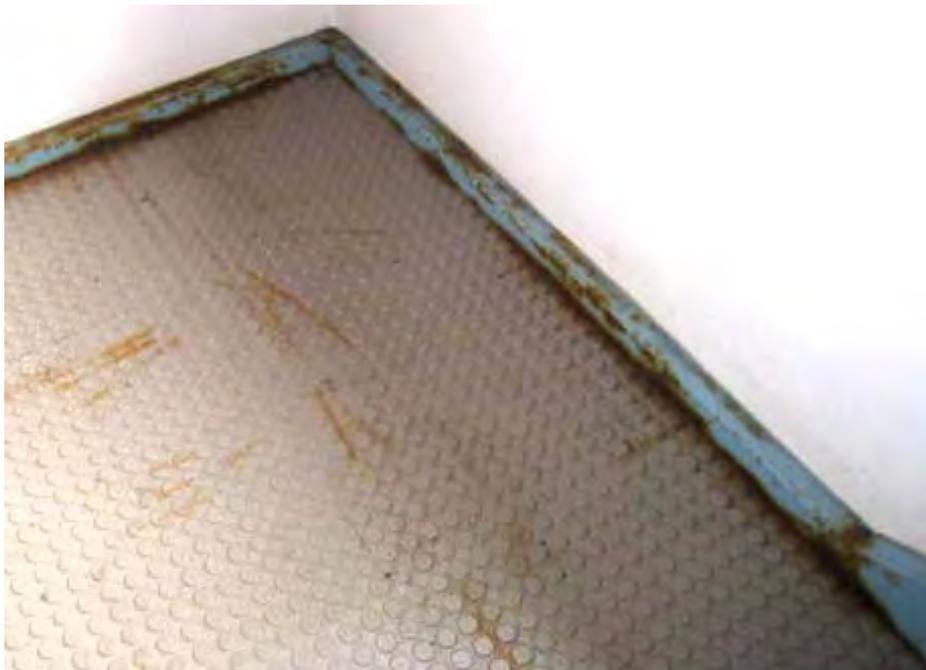
**Picture 14**

- Basement areas are subject to chronic water intrusion and condensation. The stairwell to the basement was observed to be damp, which is reportedly a typical condition (Picture 14). There were also signs of chronic dampness in the boiler room, including floor stains and corrosion on equipment.
- Basement hallway walls showed signs of historic water damage, which reportedly stems from high groundwater infiltration. Since the interior basement stairs directly communicate with the rest of the library, moisture issues in this area are likely contributing to overall humidity issues in the building.
- Stairs from the basement to the outside are covered in moss and show other signs of chronic dampness (Picture 15). If the doors to the outside do not remain watertight, source will also add moisture into the building.

**Rust stains and damp flooring in bottom of basement stairwell**

2. Seek professional opinion regarding issues of chronic dampness in the basement, correction of which may require additional drainage work outside the building foundation to direct groundwater away. If chronic dampness in the basement cannot be corrected, consider methods to isolate basement areas from occupied areas (e.g., doors) to prevent moisture/odor intrusion.

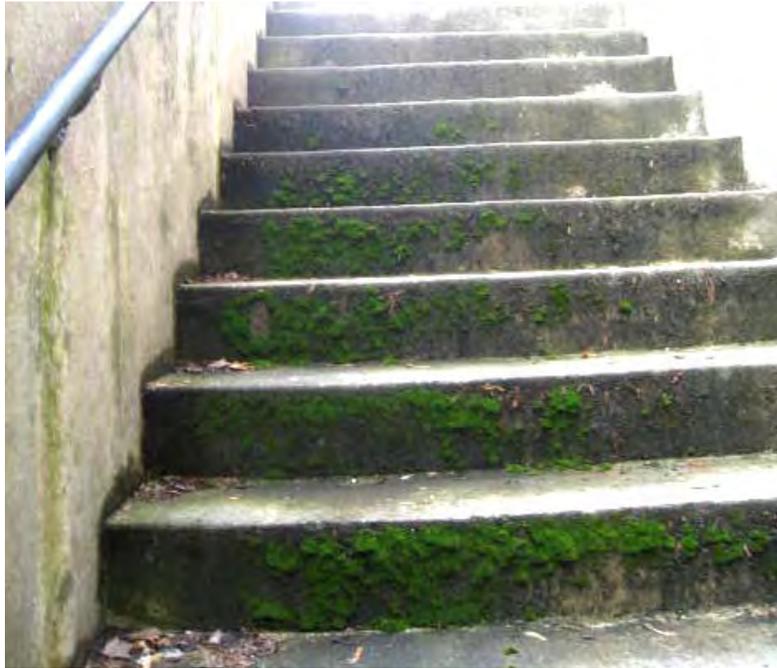
**Picture 15**

**Stairs from basement to outside, note moss and other evidence of chronic dampness**

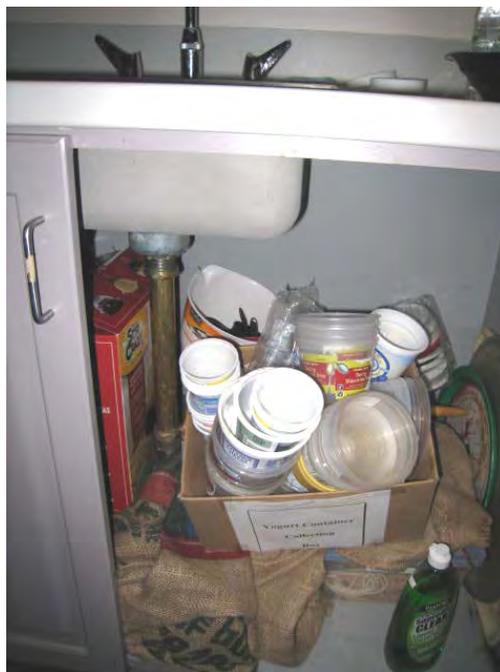
**Picture 16**

Areas under sinks were examined and some were found to contain porous materials such as paper products (Picture 16). The area underneath sinks is a moist environment and items stored there may be subject to chronic dampness due to leaks and condensation, which may lead to microbial growth. In addition, accumulated items under sinks may make it harder to detect leaks.

**Items, including cardboard and paper, under sink**

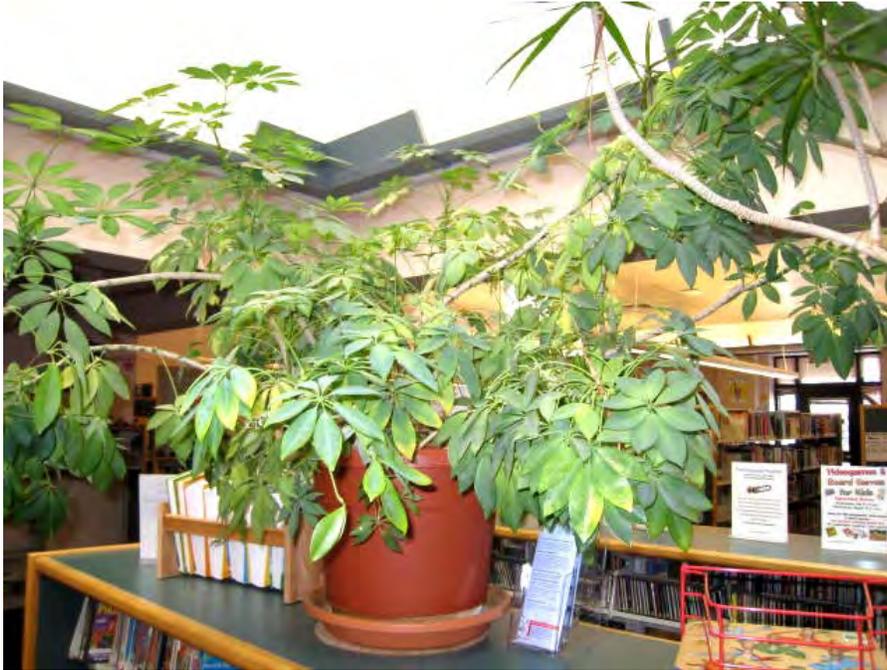
**Picture 17**

Plants were observed in some areas (Picture 17). Plants can be a source of pollen and mold, which can serve as respiratory irritants for some sensitive individuals. Plants should be properly maintained and equipped with drip pans to prevent water damage to porous building materials and be located away from ventilation sources to prevent the aerosolization of dirt, pollen or mold.

**Plants in children's area**

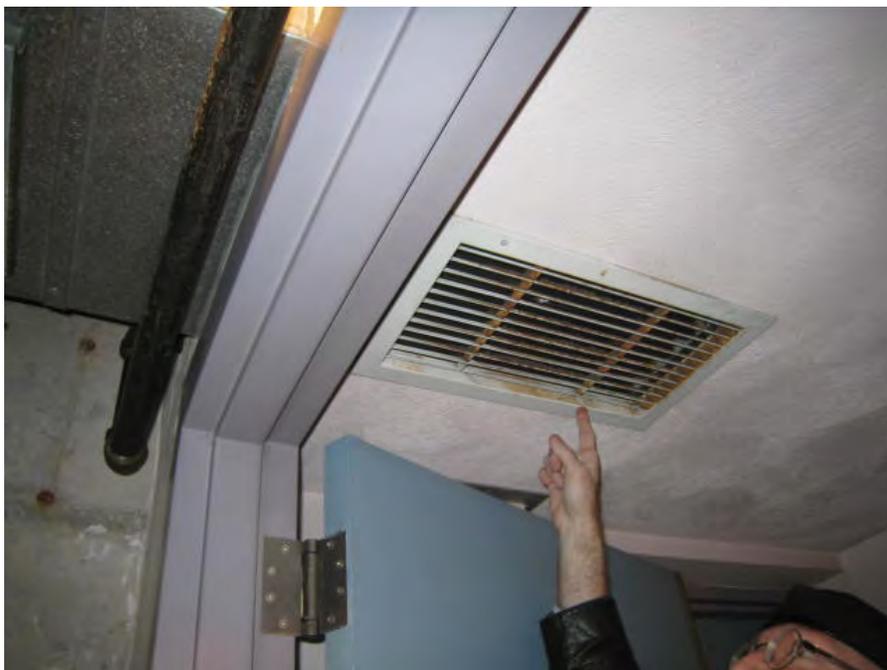
**Picture 18**

Finally, other conditions that can affect indoor air quality were observed during the assessment. Of note is the existence of an unidentified, ducted vent in the basement hallway (Picture 18). BEH/IAQ staff traced this ductwork to a fixture that appears to be the combustion air intake for the building's heating system (Picture 19), which has an opening in a subterranean pit. It is possible that this vent is meant to serve as the pressure equalization vent for the building's elevator. An inspection door was opened in this ductwork and the interior was found coated with dirt and other debris (Picture 20). In addition, the vent vanes were corroded, indicating exposure to moisture. These conditions likely indicate the draw of unconditioned/unfiltered outdoor air from the below grade air intake. In this configuration, hot, moist air can enter the building through this vent to create odors and condensation in the basement area during hot, humid weather.

**Unidentified vent in basement, note rust on vent vanes**

14. Identify the purpose of the vent in Picture 18. Clean the interior of this duct of dirt and debris. Have a building engineer determine whether this vent and ductwork are necessary for the operation of the elevator. If not necessary, consideration should be given to permanently sealing this vent since it is a source of unconditioned outdoor air that would be a moisture/odor source.

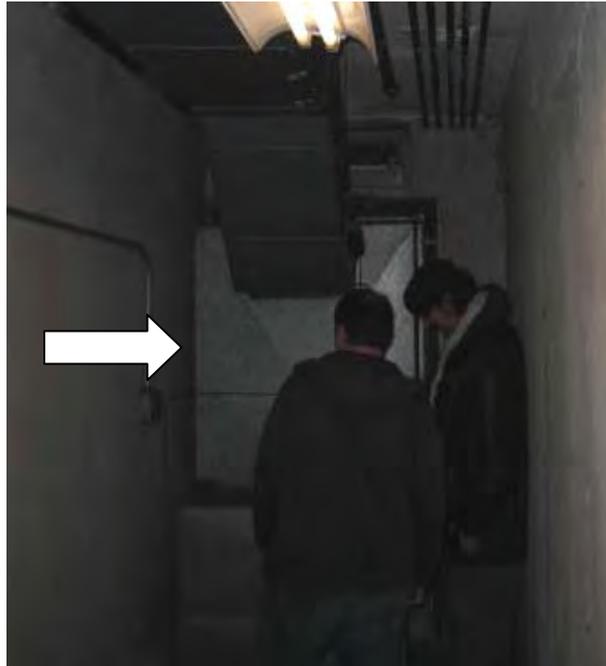
**Picture 19**

**Fixture that appears to be the combustion air intake for the building's heating system**

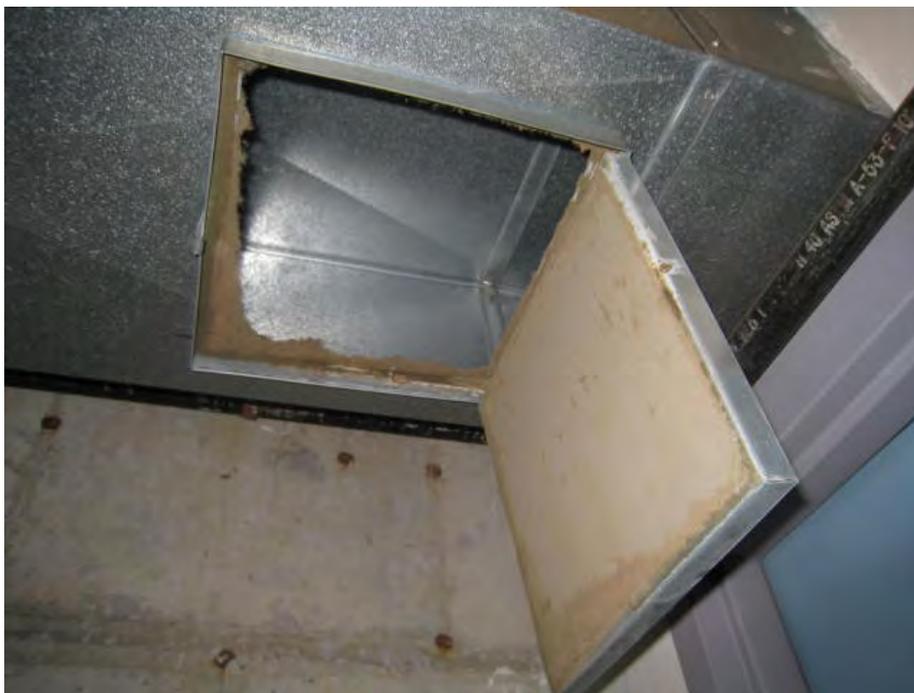
**Picture 20**

**Dirt and debris accumulation inside the duct shown in Picture 18**

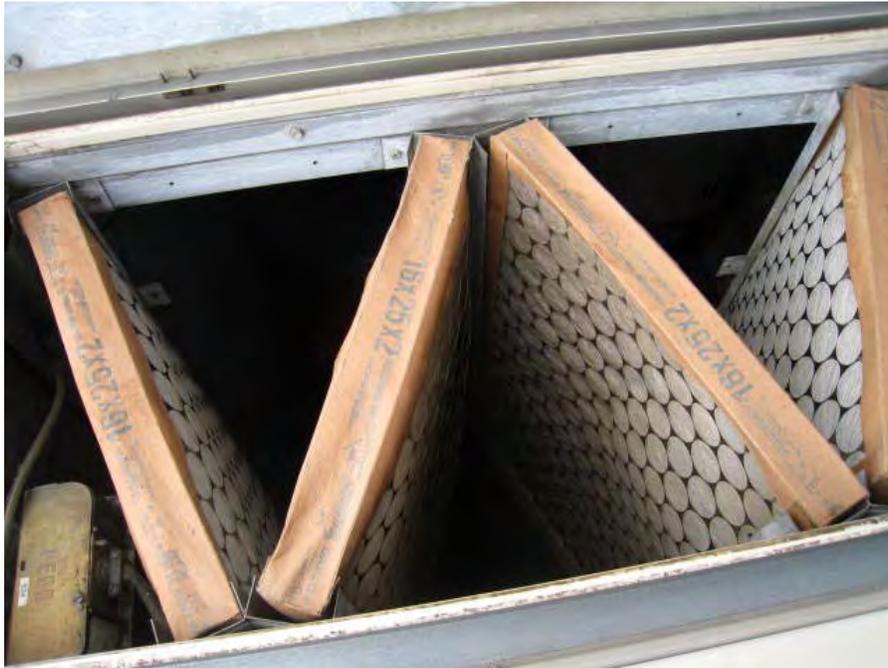
**Picture 21**

**Filters in AHU**

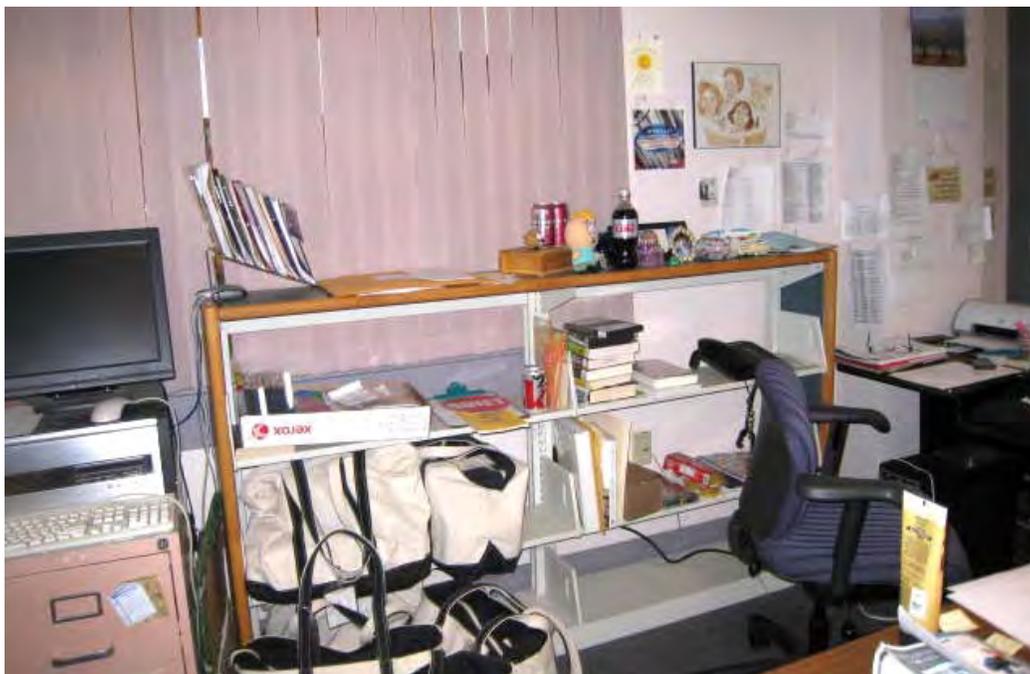
**Picture 22**

In some areas, large numbers of items were found stored on desks, tables and counters (Pictures 22 and 23). Large numbers of items provide a source for dusts to accumulate. These items make it difficult for custodial staff to clean. Items should be relocated and/or cleaned periodically to avoid excessive dust build up.

**Various items in office**

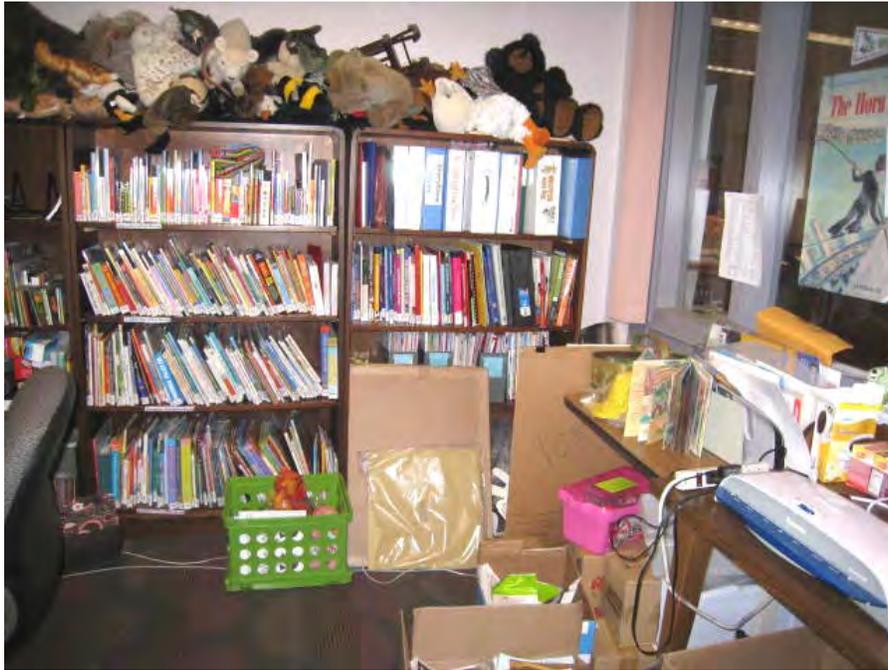
**Picture 23**

Upholstered furniture and plush toys were observed in several areas (Picture 23; Table 1). These items are covered with fabrics that may be exposed to human skin. This type of contact can leave oils, perspiration, hair and skin cells. Dust mites feed upon human skin cells and excrete waste products that contain allergens. In addition, if relative humidity levels increase above 60 percent, dust mites tend to proliferate (US EPA, 1992). In order to remove dust mites and other pollutants, frequent vacuuming of upholstered furniture and plush toys is recommended (Berry, 1994). It is also recommended that upholstered furniture (if present in public buildings), be professionally cleaned on an annual basis. Where an excessively dusty environment exists due to outdoor conditions or indoor activities (e.g., renovations), cleaning frequency should be increased (every six months) (IICRC, 2000).

**Items, including plush toys**

21. Clean plush toys and upholstered furniture regularly with a HEPA-equipped vacuum to remove dust and dust mites.
22. Clean carpeting annually or semi-annually in soiled high traffic areas as per the recommendations of the Institute of Inspection, Cleaning and Restoration Certification (IICRC). Copies of the IICRC fact sheet can be downloaded at: [http://1.cleancareseminars.net/?page\\_id=185](http://1.cleancareseminars.net/?page_id=185) (IICRC, 2005).

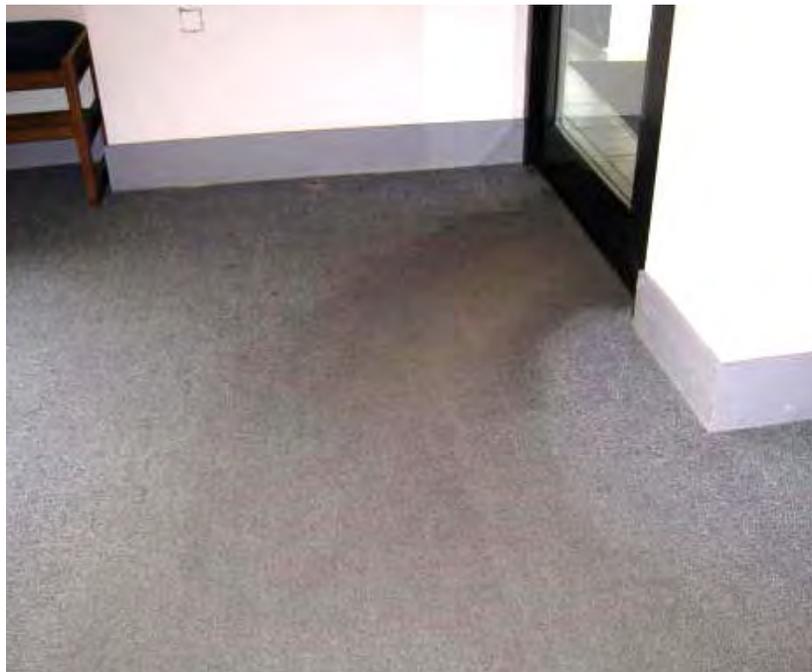
**Picture 24**

The BPL is carpeted; the Institute of Inspection, Cleaning and Restoration Certification (IICRC), recommends that carpeting be cleaned annually (or semi-annually in soiled high traffic areas) (IICRC, 2005). While new carpeting has been installed in many areas, some of the carpeting in other areas is old and worn (Picture 24) and can provide a source of particulates from carpet fibers and aerosolizable organic materials.

**Worn carpeting in front entrance area**

23. Continue with plans to replace worn carpeting and consider the use of carpet squares in these areas.
24. Ensure photocopiers and laminations machines are located in well-ventilated areas.
