# **INDOOR AIR QUALITY ASSESSMENT**

**Burlington Town Hall Annex  
25 Center Street  
Burlington, Massachusetts**

Prepared by:  
Massachusetts Department of Public Health  
Bureau of Environmental Health  
Indoor Air Quality Program  
April 2014

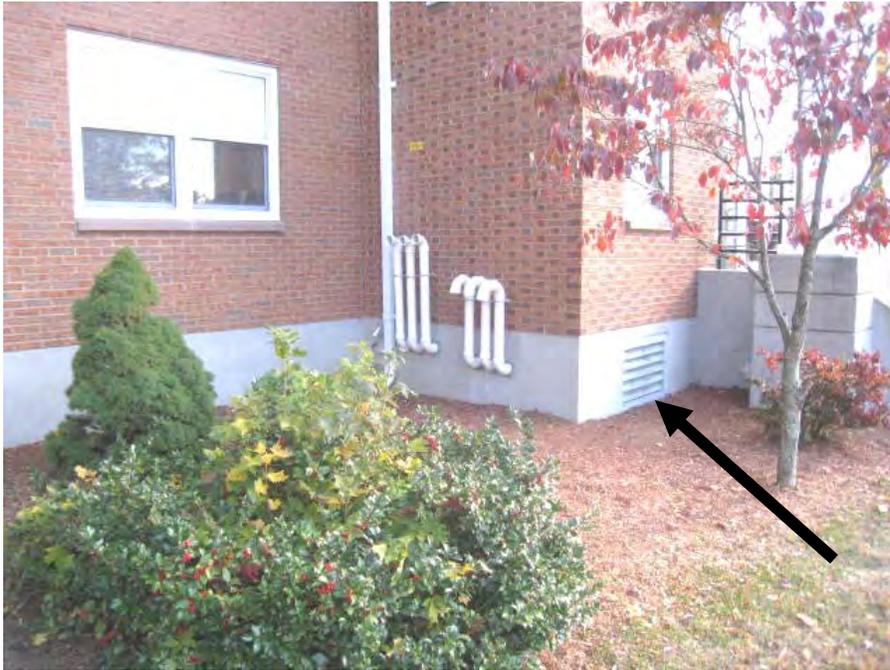
**Picture 1**

**Fresh air vent for basement HVAC units (arrow). Note HVAC exhaust vents (white pipes) to the left**

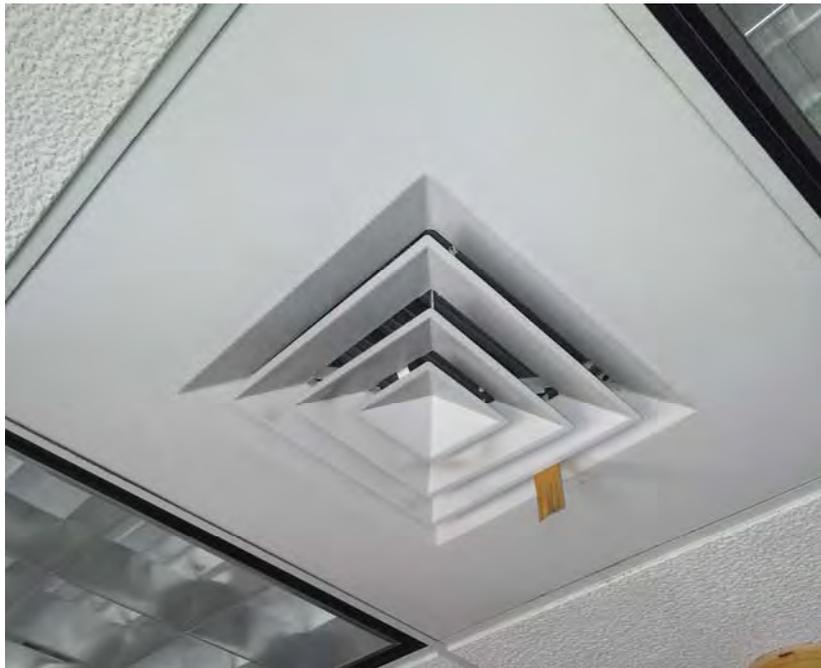
**Picture 2**

**Fresh air diffuser**

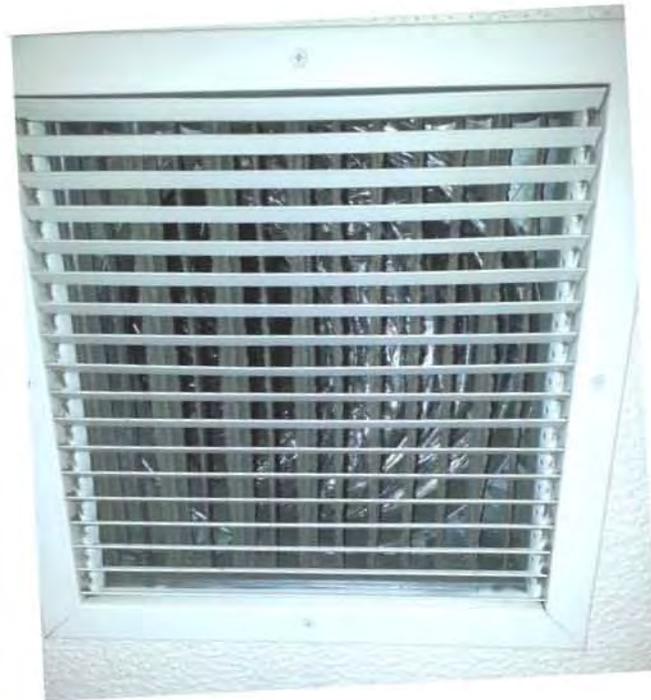
**Picture 3**

The filters for the ducted HVAC system appear designed to be installed on return vents inside the grill. Although a few of them were observed with filters installed (Picture 21), most of these grilles did not have filters (Picture 3). Without the designed filtration, dusts and debris from inside the BTA are collected and redistributed throughout the building.

**Exhaust vent, note open channel to exhaust ducting**

20. Store opened cans of paint and other VOC sources away from occupied areas.
  21. Avoid the use of air fresheners and scented products.
  22. Replace all filters on exhaust/return vents. Ensure they are changed at least twice a year or as per the manufacture's instructions.

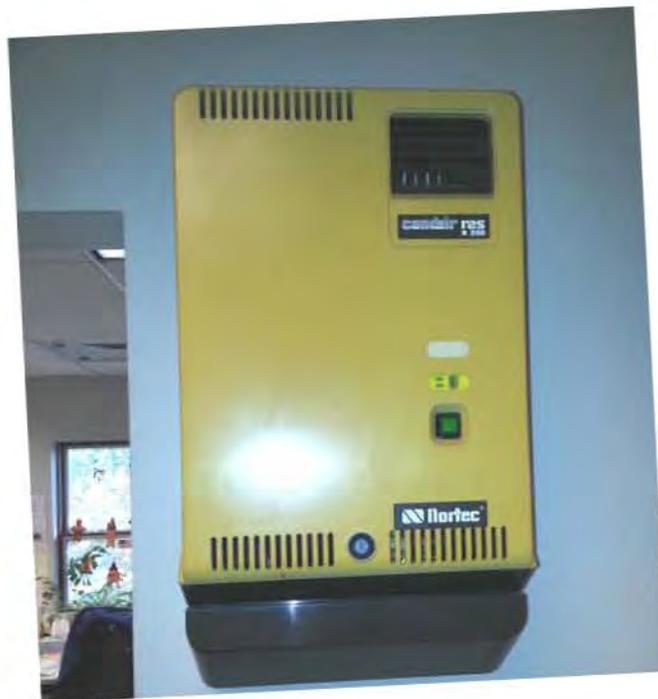
**Picture 4**

It was noted that the building had humidifier units located on walls of several offices and common areas (Pictures 4 and 5). It was reported that these units were installed in the 1990s, but had been deactivated with the water service to each unit shut off. The reasons for installing these units were reportedly to improve the functioning of copy machines, which had been known to experience paper jams during periods of low relative humidity, as well as to improve occupant comfort. The humidifying machines had reportedly been deactivated because of the expenses associated with maintenance and repair; in addition, newer copy machines are more tolerant of dry conditions. MDPH/BEH does not recommend the use of humidifying devices in office spaces.

**Humidifying unit**

12. Ensure that all water service to the disused humidifier units is cut and capped to prevent leaks. Consider having these units properly removed.
  13. Repair/reconfigure basement window wells so that water drains away from windows rather than accumulating.

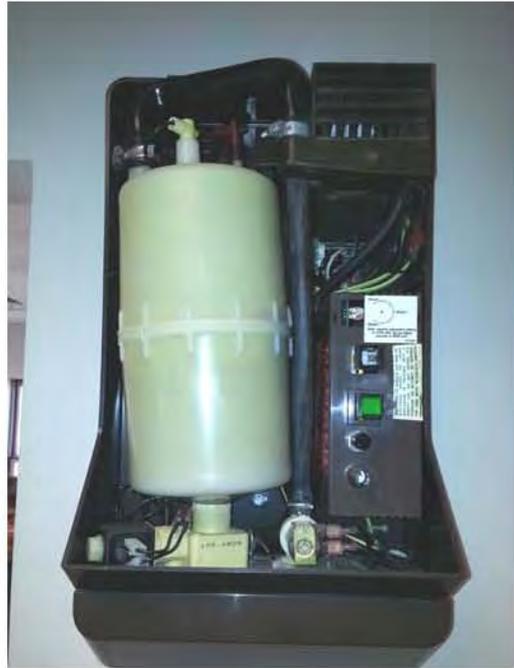
**Picture 5**

**Inside view of humidifying unit**

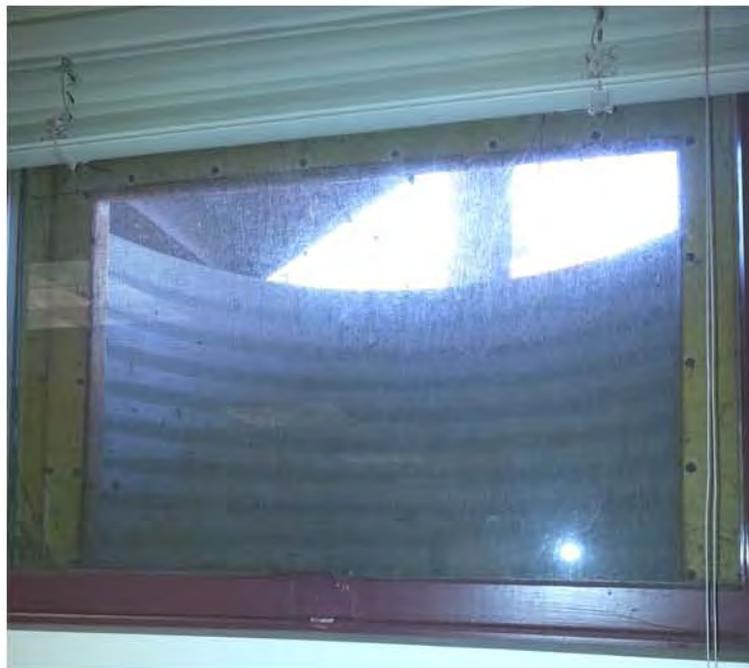
**Picture 6**

**Window well from inside the basement, note corrugated metal basin that is reported to fill with water, and water-damaged sill**

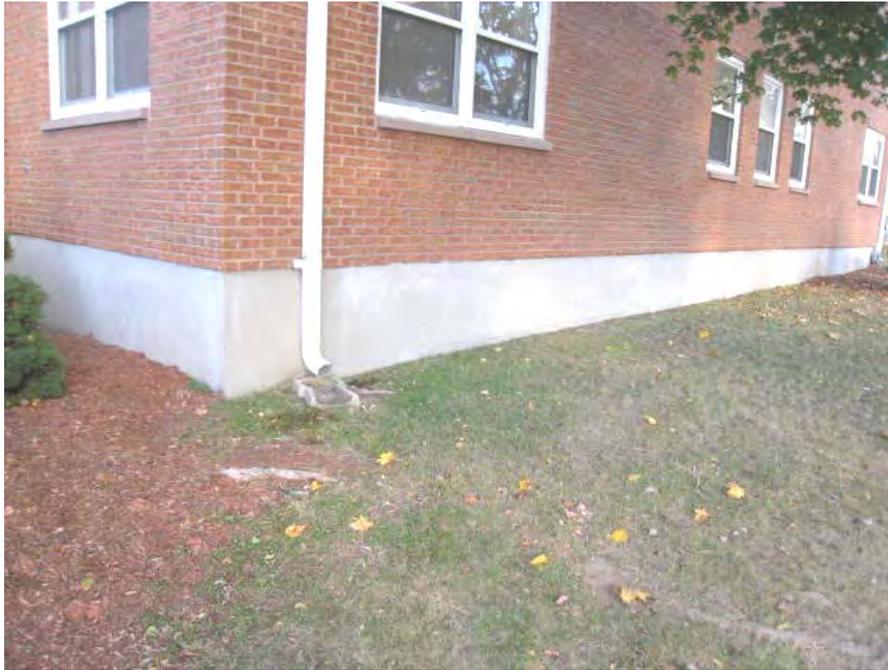
**Picture 7**

**Gutter downspout emptying close to the building**

15. Consider use of non-porous flooring in basement areas.
  16. Ensure downspouts drain at least five feet away from the outside of the building.
  17. Trim/remove shrubbery and other plants from the perimeter of the building.

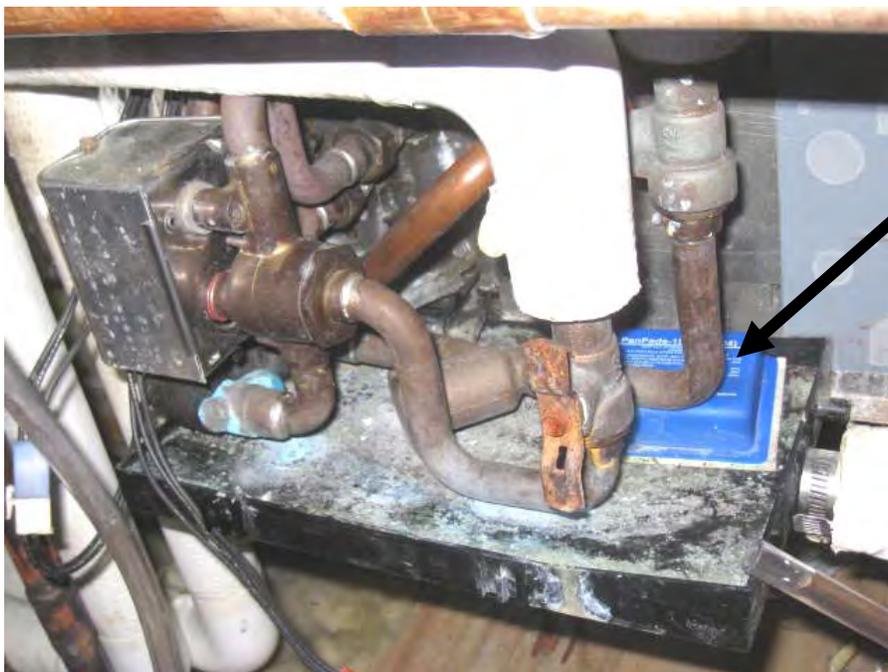
**Picture 8**

During an examination of the attic area, one of the VAV boxes was inspected. VAV boxes at the BTA are equipped with a drip pan that is designed to collect condensate from the HVAC system when in cooling mode. It was reported that VAV box drip pans use sponges to absorb water; this is not an optimal method of moisture control. Drip pans should be designed to collect and *drain* moisture to a properly-designed condensate drainage system. The drip pan examined had accumulated mineral deposits (Picture 8), suggesting that a significant amount of water builds up inside during the cooling season. Collected condensate can be a source of leaks, microbial contamination and odors. It appeared that in an attempt to prevent microbial contamination, treatment tablets containing ammonium chloride are used in the drip pan (Pictures 8 and 9). These tablets can release ammonia, which can be a respiratory irritant and should not be used in this manner; properly draining drip pans prevent the need for any condensate treatment.

**Interior of VAV box showing drain pan with mineral deposits and treatment tablet (arrow)**

9. Examine VAV boxes throughout the building for proper drainage from condensate drain pans and overflow tubing. Repair/reconfigure as necessary to provide drainage. Do not use water treatment chemicals in condensate drain pans, but have the pans cleaned periodically to prevent build-up of minerals and other materials.

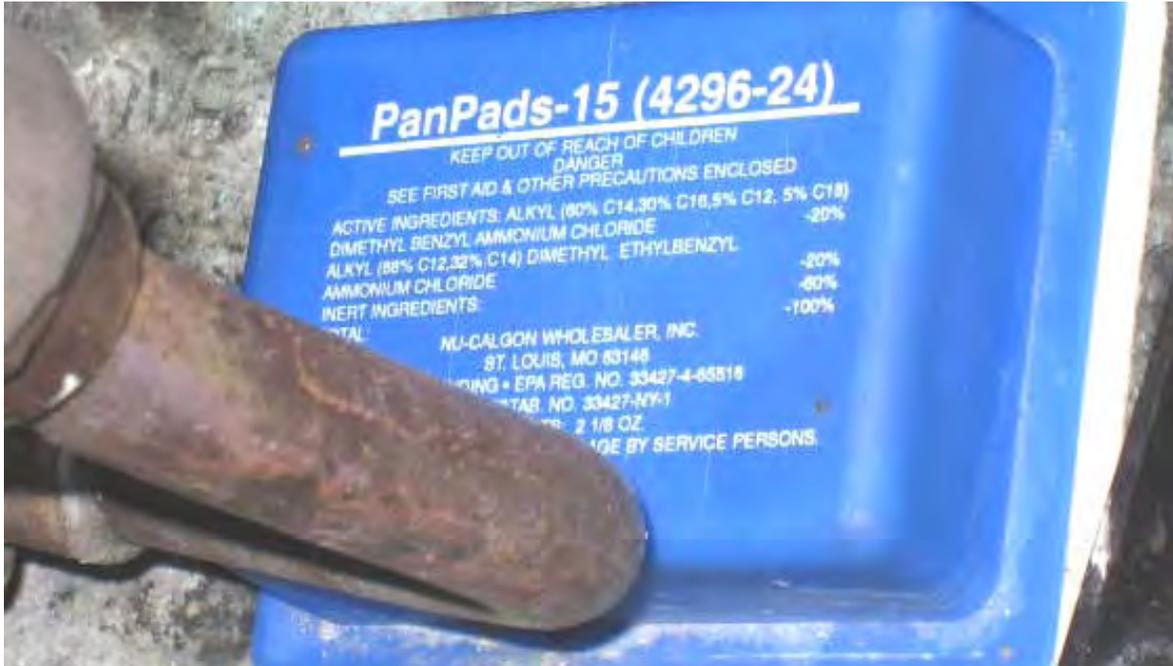
**Picture 9**

**Close-up of drain pan treatment tablet showing list of ingredients**

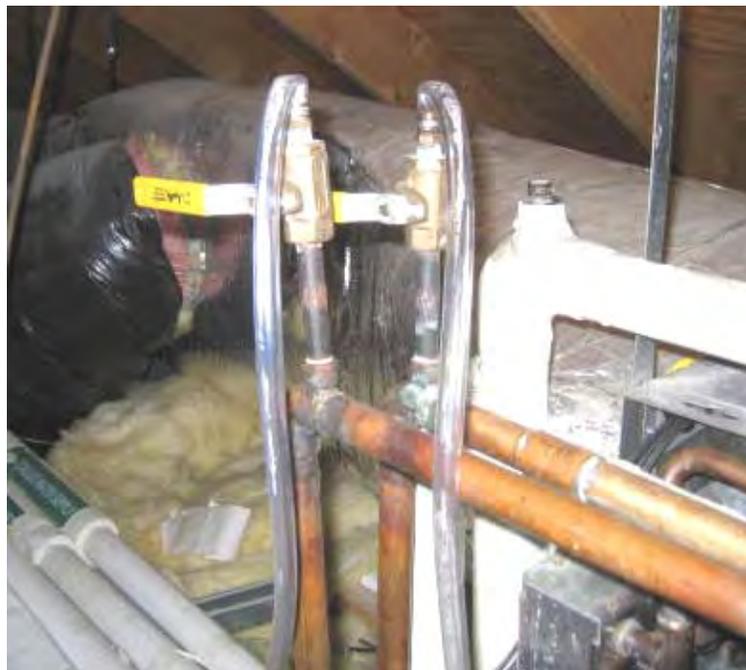
**Picture 10**

Additionally, the VAV box examined had two plastic tubes coming off what appeared to be the coolant line (Picture 10). The ends of these tubes were found to contain water (Picture

**Plastic blow-off hoses from coolant system in VAV box**

11). The tubes are likely designed to relieve excess pressure in coolant lines; however they should also be directed to a proper condensate/coolant drain rather than being allowed to drain onto the floor. If other VAV boxes are similar to the one observed, they may be significant sources of moisture/leaks to the interior of the building.

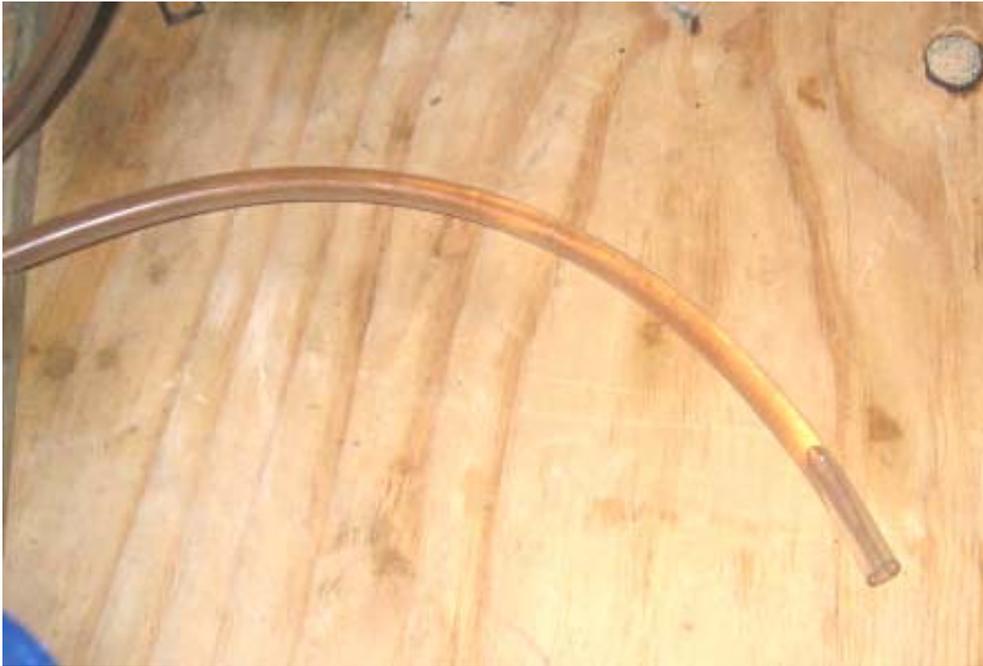
**Picture 11**

**Liquid in end of blow-off hose**

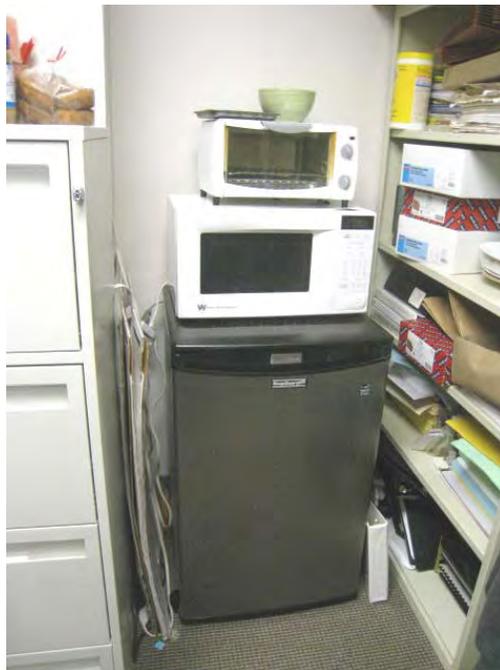
**Picture 12**

Water dispensers and refrigerators were observed to be located in carpeted areas (Picture 12). Spills or leaks from these appliances can moisten carpeting. Water-dispensing and other appliances should be located in an area with non-porous flooring or on a waterproof mat.

**Refrigerator on carpet**

18. Prevent water damage by using drip pans for plants and cleaning them regularly.
  19. Consider outfitting water dispensers and refrigerators with a rubber/plastic mat to prevent water damage to carpeting.

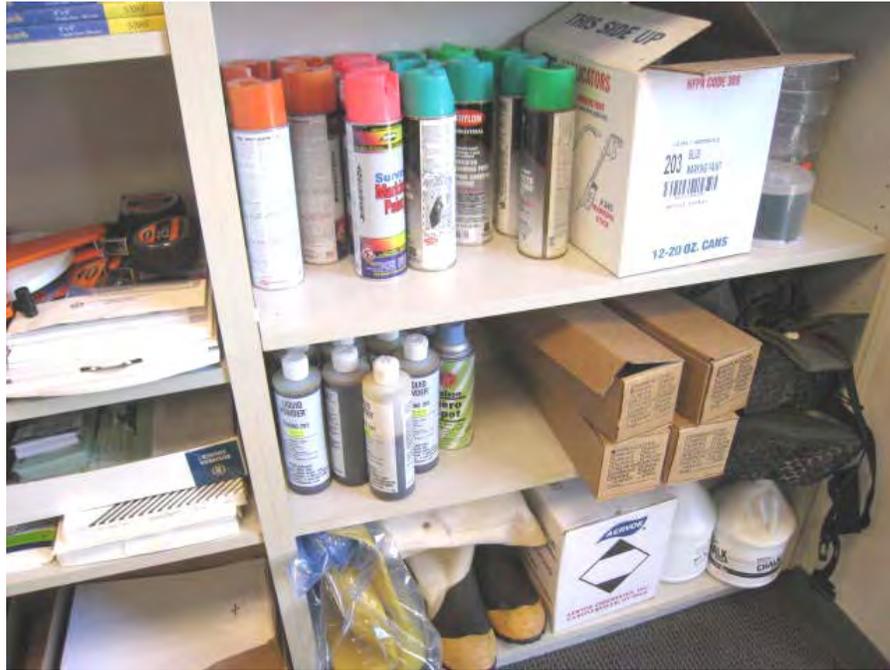
**Picture 13**

Paints were stored in the Engineering area (Table 1, Picture 13). Opened cans of paint may evaporate during storage; partially used cans should be stored away from occupied areas.

**Paint storage**

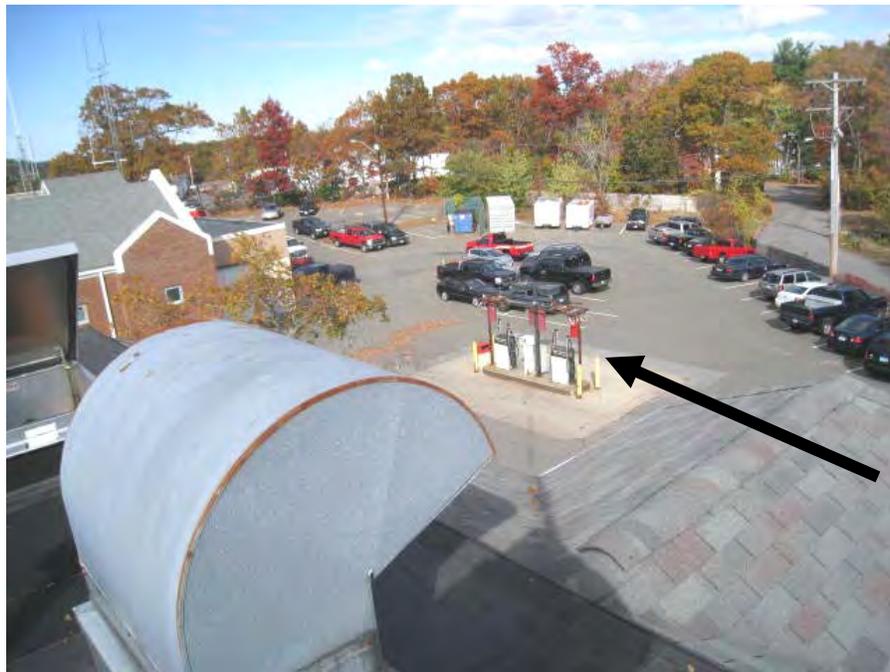
**Picture 14**

Other conditions that can affect IAQ were observed during the assessment. Gasoline-like odors were reported to occur at times on the second floor of the BTA corresponding to filling and maintenance at gasoline pumps/tanks located to the northwest of the building (Picture 14). The roof has a large candy-cane style vent (Picture 14) that serves as a pressurization relief vent for the elevator shaft, which may be drawing in vapors from the tanks when they are in use or being filled, particularly under northwesterly wind conditions. Vapors and odors can then be distributed throughout the building by the piston-like action of the elevator. It is recommended that the elevator vent be rotated 180° to have its opening facing away from the gas pumps to minimize gasoline vapor entrainment.

**Gasoline pumps (arrow) and large “candy cane” vent (foreground, left)**

4. Consult with an elevator/ventilation engineer relative to reducing the size of the elevator make-up air vent (“candy-cane style” vent) and changing the direction of the open end to reduce the chance for entraining odors/vapors from the fueling area located outside. This may additionally make more space for accessing the HVAC system in the attic.

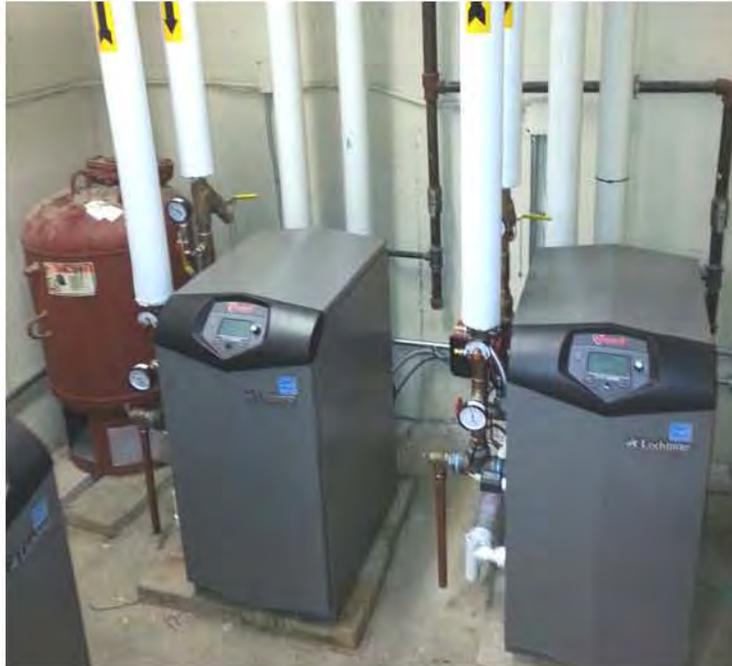
**Picture 15**

The building appears to have two furnaces. One furnace is located in the basement along with a gas-fired water heater (Picture 15). The exhaust vents for these units are located along the foundation in the southwest corner of the building (Pictures 1 and 16). These vents are directly adjacent to the fresh air intake for the building (Picture 1) and directly below a vent/wall penetration of unknown function (Picture 16). Because of the location of these vents and the fact that windows in this building are not completely airtight, exhaust from the furnaces may be able to penetrate into the second floor of building during the heating season.

**Heating units in basement (note exhaust piping)**

1. Ensure that the exhaust vent for the attic furnace is free of holes to vent products of combustion completely outdoors.
2. Render the windows above the basement furnace vents airtight.

3. Extend the basement furnace exhaust vents to a sufficient height above the roof-line and HVAC/elevator intakes. Determine the use of the vent shown in Picture 16 and seal if not needed.

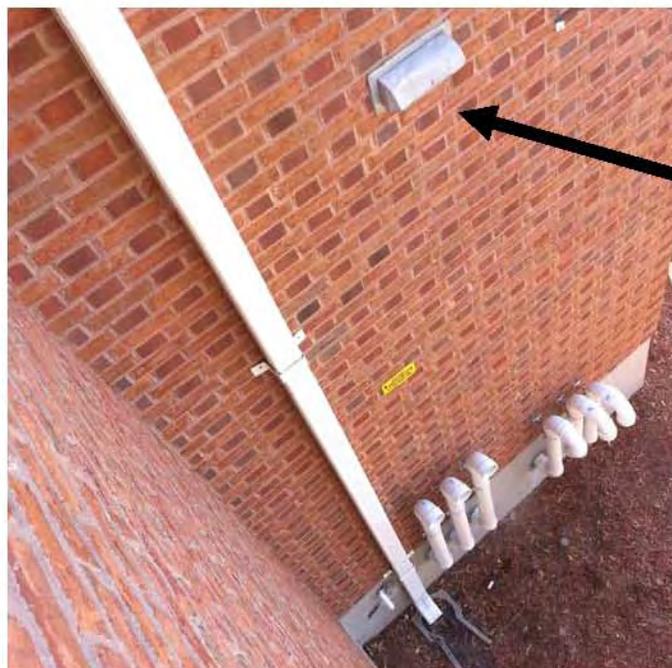
**Picture 16**

**Exhaust from heating units in basement directly up against wall, note unknown vent partway up wall (arrow)**

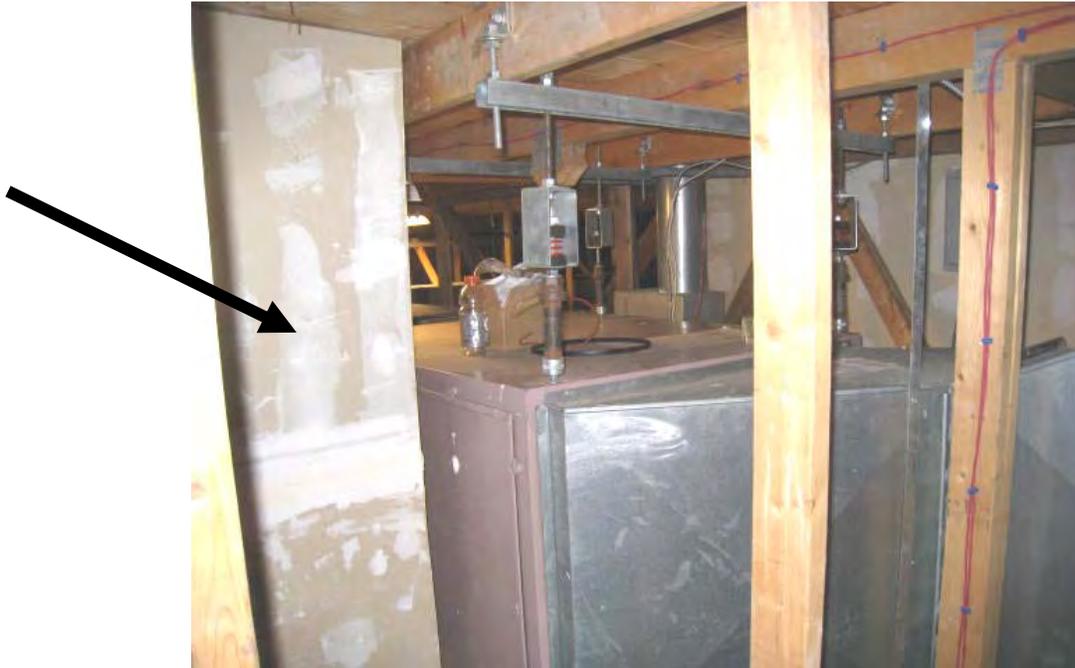
**Picture 17**

The second furnace, located in the attic area, was examined (Pictures 17 and 18). During the course of the assessment, BEH/IAQ staff detected natural gas and combustion odors in the attic space, which did not appear to impact office space. However, the conditions noted in the attic pose a number of potential issues:

**Side view of HVAC equipment in attic; note elevator shaft vent on left side of picture (arrow)**

5. Accessibility to the attic furnace needs to be improved. Reducing the diameter of the elevator shaft air vent will allow more space around the HVAC unit for accessibility.

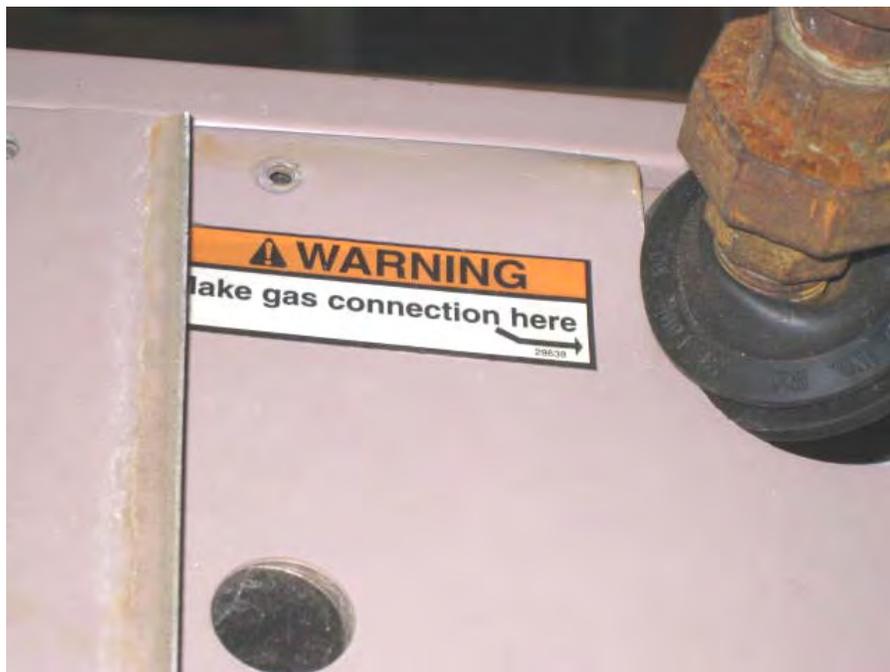
**Picture 18**

**Gas connection notice on HVAC equipment found in attic**

6. Determine if the furnace in the attic is required. If it is, have the unit thoroughly serviced and regularly maintained, including changing of filters at least twice a year.

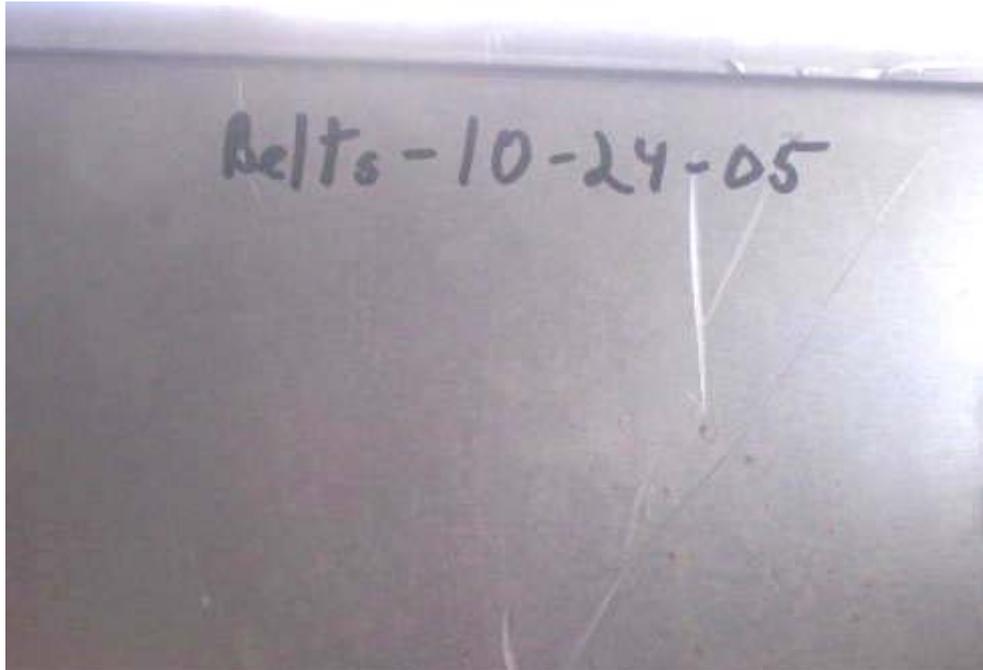
**Picture 19**

- The notation “belts 10/24/05” was hand-written on the cabinet suggesting that 2005 was the most recent time the belts were changed (Picture 19). This suggests that regular maintenance on this equipment is not occurring.

**Notice on HVAC duct in attic which may indicate last time belts were changed/other service performed (10/24/05)**

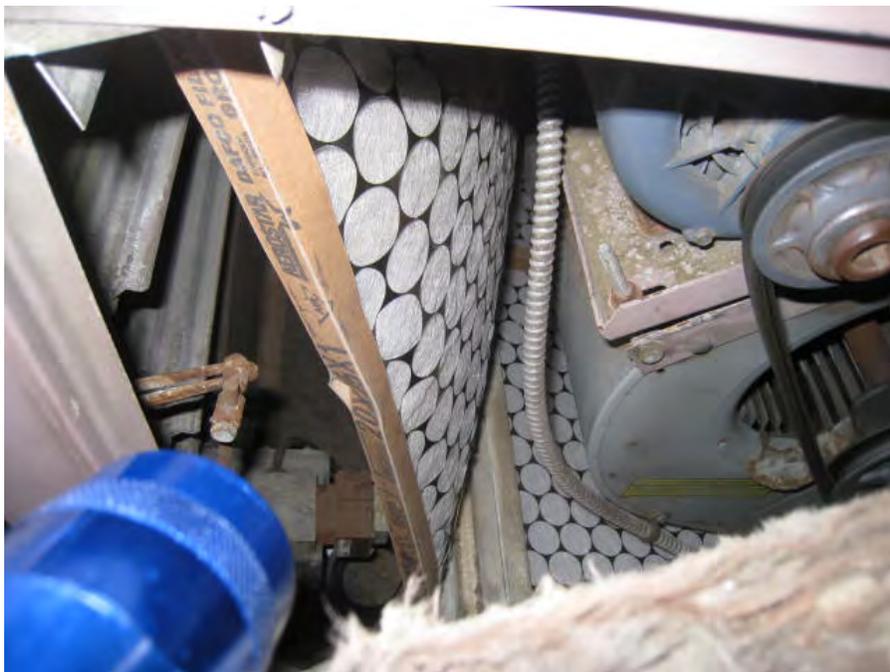
**Picture 20**

- Because of the inaccessibility of the air filters, gaps were observed around where the filters should be installed (Picture 20). This will allow air from the attic to be drawn into the unit, unfiltered, which may include dust and debris, which is then distributed to portions of the building served by this HVAC equipment.

**Filters improperly installed in attic HVAC unit**

The attic furnace/HVAC equipment needs to be thoroughly evaluated as to function, connection, and service history. If this unit is needed, modifications are required to ensure that it can function safely and effectively, including installation of effective sprinklers overhead. In addition, rearrangement of items in the attic should be conducted such that the filters, belts and other areas are accessible for regular maintenance.

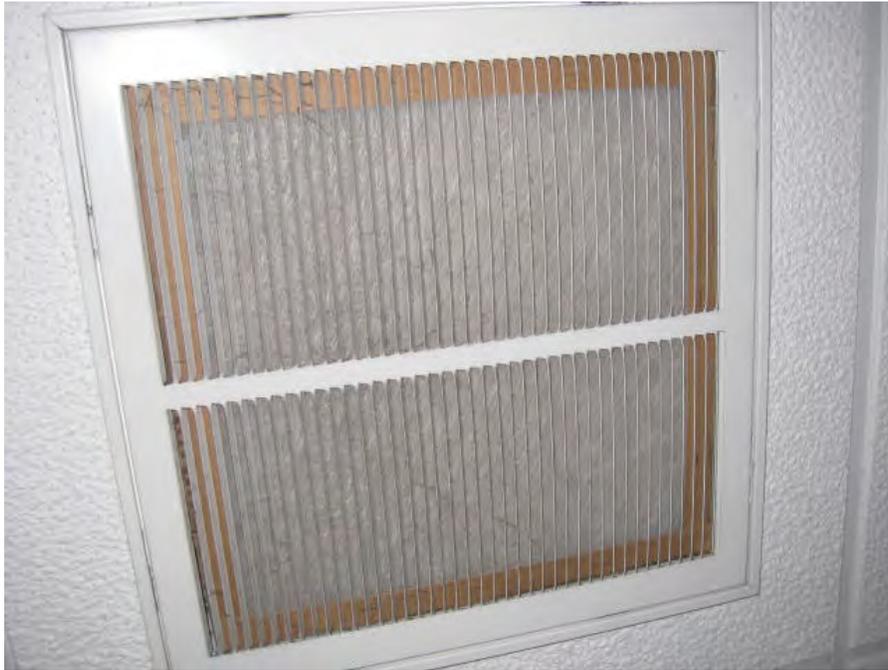
**Picture 21**

**Exhaust grill with filter installed (compare with Picture 3, a similar grill without filter)**
