INDOOR AIR QUALITY ASSESSMENT

**Gardner Public Schools' Administration Building
70 Waterford Street
Gardner, Massachusetts**

Prepared by:
Massachusetts Department of Public Health
Bureau of Environmental Health
Indoor Air Quality Program
January 2014

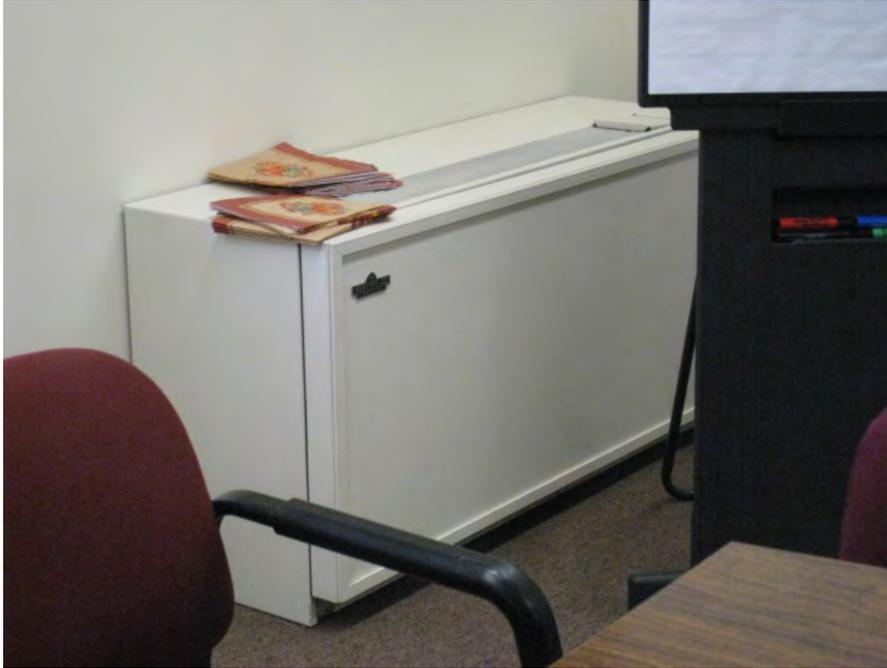
Picture 1

Mechanical ventilation in the original building was provided by unit ventilators (univents) (Picture 1). A univent draws fresh air from a vent on the exterior of the building and returns air through an air intake at the base of the unit. Fresh and return air are mixed, filtered, heated and provided to rooms through an air diffuser located in the top of the unit. It was reported that the univent system had been deactivated during the 2004 renovations and the exterior vents were sealed (Picture 2). Therefore, no mechanical ventilation currently exists in the building. The sole means of introducing fresh air into the building is through open windows. Window and wall-mounted air conditioners provide cooling in these areas during warm weather.

Example of deactivated univent in GSA

2. Consider consulting with a heating, ventilation and cooling (HVAC) engineer concerning the feasibility of installing a mechanical ventilation system in the building such as replacing or recommissioning univents.

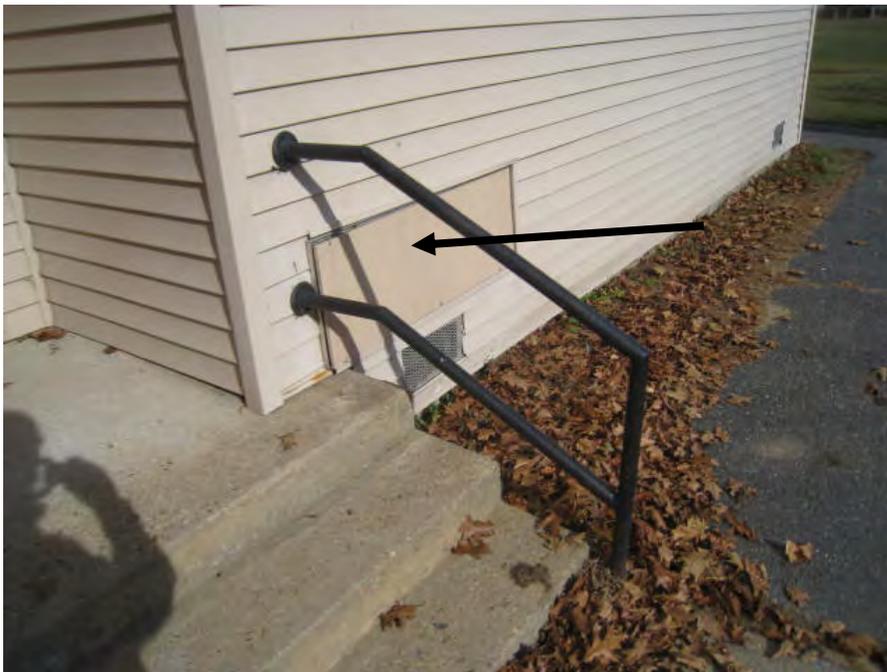
Picture 2

Sealed univent fresh air intake (arrow)

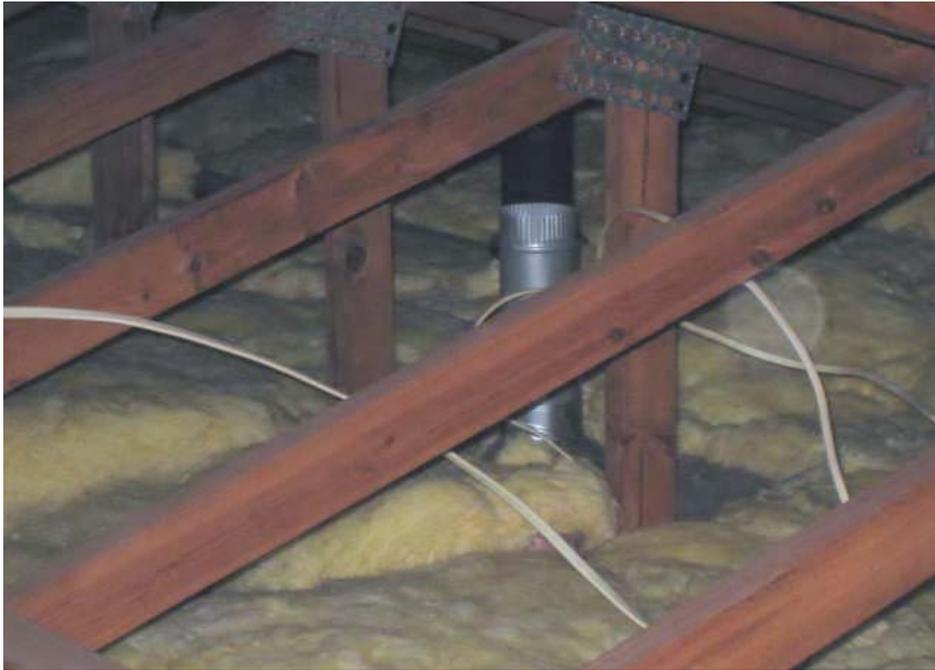
Picture 3

As mentioned, restroom vents were found to be open into the attic space. Restroom vents should be vented directly to the outdoors to remove restroom odors and water vapor from the GSA.

Restroom exhaust vent terminating in attic space

14. Vent restroom exhaust directly to the outdoors.
 15. Ensure plants have drip pans and avoid over-watering. Examine drip pans periodically for mold growth. Disinfect with an appropriate antimicrobial where necessary.

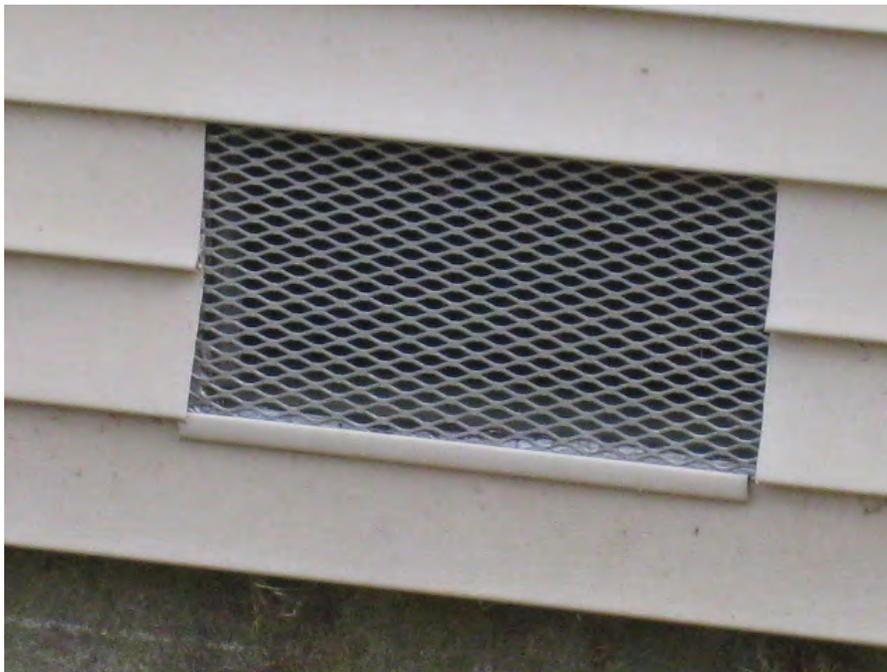
Picture 4

Passive vents were observed in the exterior walls of the crawlspace (Picture 4). These vents are typically designed to allow water vapor and odors to be removed or diluted and are installed in a manner to create cross-ventilation in the crawlspace. Some vents were observed to be obstructed with dislodged insulation (Picture 5) and one had a utility pipe extending from it (Picture 6). Due to the current configuration of passive vents, the crawlspace is likely to become pressurized under typical wind conditions, resulting in air-flow into occupied areas of the building. The pressurization could be reduced/eliminated by sealing the crawlspace vents on the windward side of the building and installing a mechanical exhaust fan in the leeward side. This would result in air/odors from the crawlspace being vented outside the building rather than the migration of odors into the occupied floor above.

Crawlspace vent

1. Seal all crawlspace vents in the windward side of the building and install a mechanical exhaust fan in a vent on the leeward side of the building to facilitate the movement of air from the crawlspace to the outdoors.

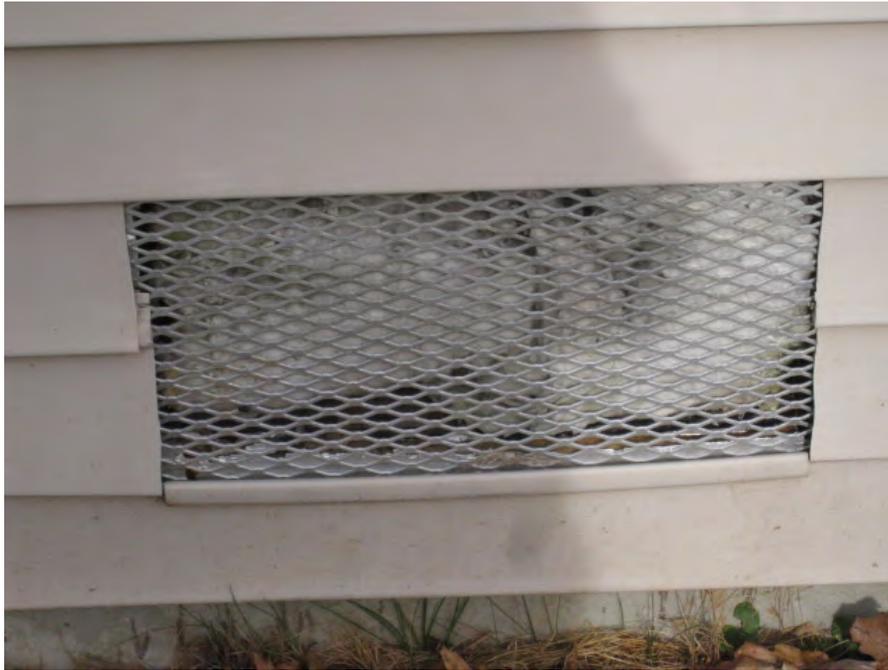
Picture 5

Crawlspace vent obstructed with insulation

6. Ensure that crawlspace and attic insulation are positioned so as not to obstruct crawlspace and exhaust vents.
 7. Continue inspection of the building envelope and repair/replace missing or damaged caulking and seal all cracks and holes in walls to prevent water penetration.

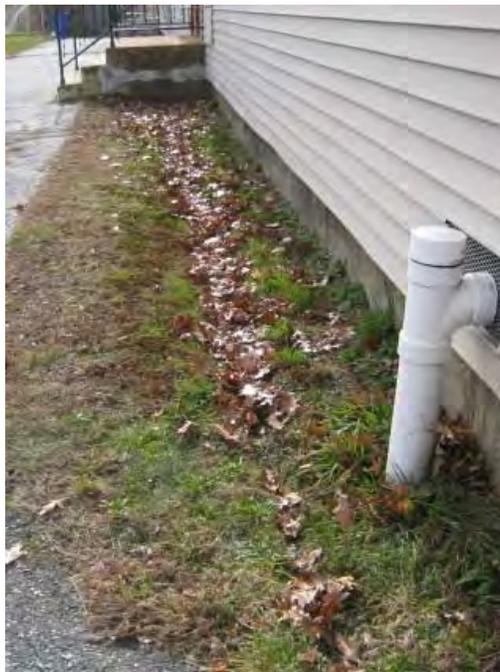
Picture 6

- The building foundation is surrounded by grass, plant growth and debris (Pictures 6 and 7), which can result in the accumulation of rainwater and subsequent water penetration into the crawlspace. In addition, the growth of grass and roots against exterior walls can bring moisture in contact with the foundation, eventually leading to cracks and/or fissures.

Crawlspace vent with utility pipe (note: grass and leaves against the foundation)

8. Remove grass, plants and debris away from the exterior wall/foundation of the building to prevent water penetration into basement and crawlspace.
 9. Install gutters and downspouts on the roof to direct rainwater at least 5 feet away from the foundation.

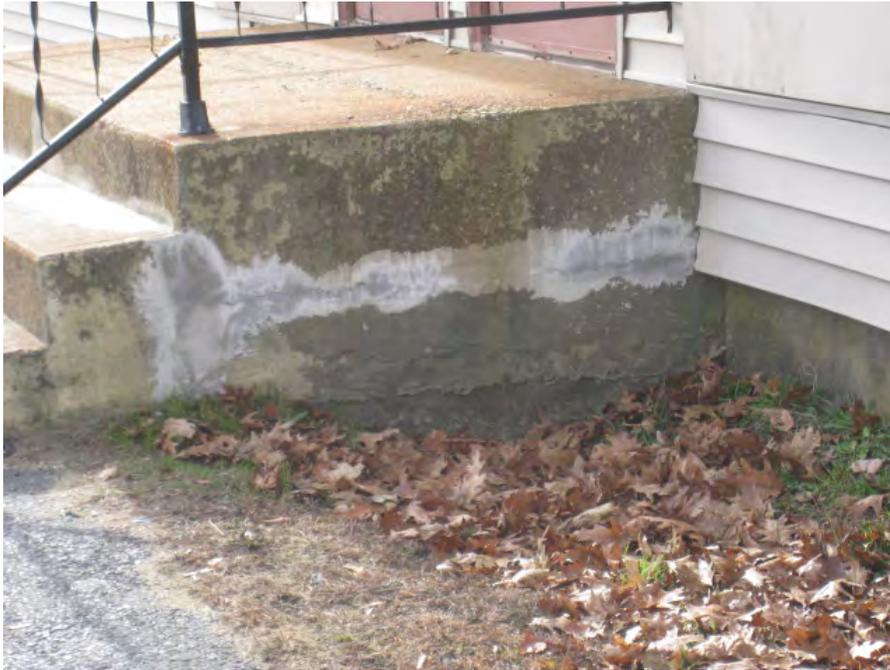
Picture 7

Cracks and erosion of concrete stairs (note: grass, accumulation of leaves, and debris along the foundation)

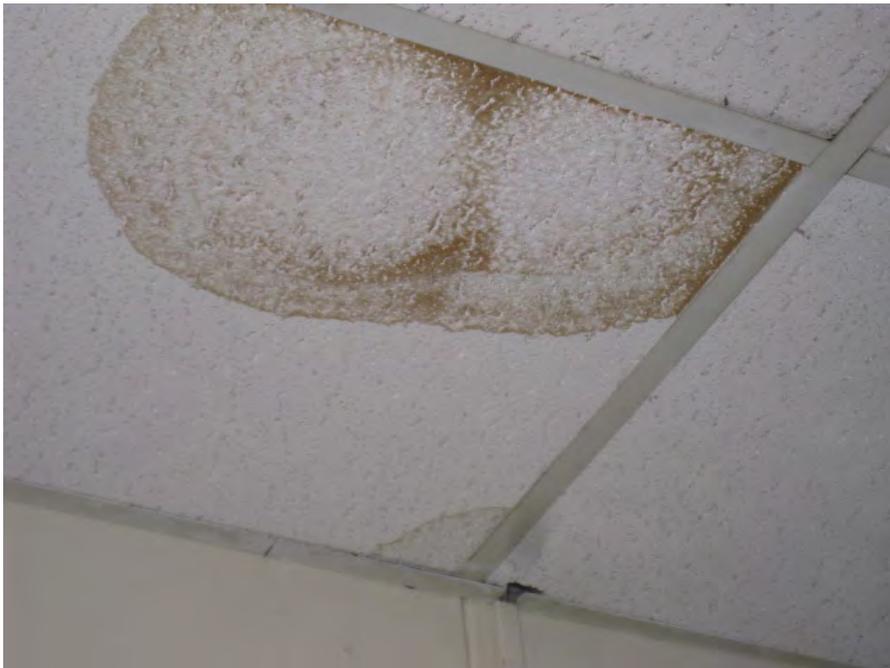
Picture 8

Water-damaged ceiling tiles were observed in the GSA, primarily where the suspended ceiling meets the exterior walls of the office space (Tables 1, Picture 8) which may be indicative of a roof or exterior wall leak or plumbing problems. If repeatedly moistened, ceiling tiles can

be a medium on which mold can grow. Water-damaged tiles should be replaced after a water leak is discovered and repaired.

Water-damaged ceiling tiles

10. Replace all water-damaged ceiling tiles and monitor for future leaks.
 11. Remove all water-damaged porous materials and discard. Water-damaged insulation should be removed and replaced.

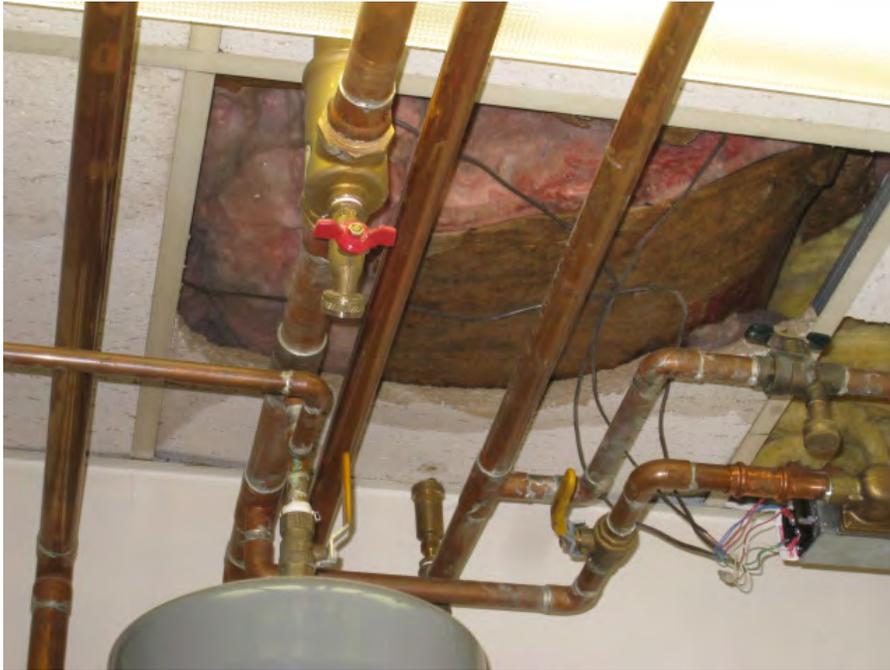
Picture 9

In the mechanical room, a water-damaged ceiling tile above the furnace had been removed, and water damage was observed on the insulation and wood flooring of the attic space (Picture 9). Water-damaged insulation should be removed and the area should be cleaned and disinfected thoroughly.

Water-damaged ceiling tile and insulation in the mechanical room

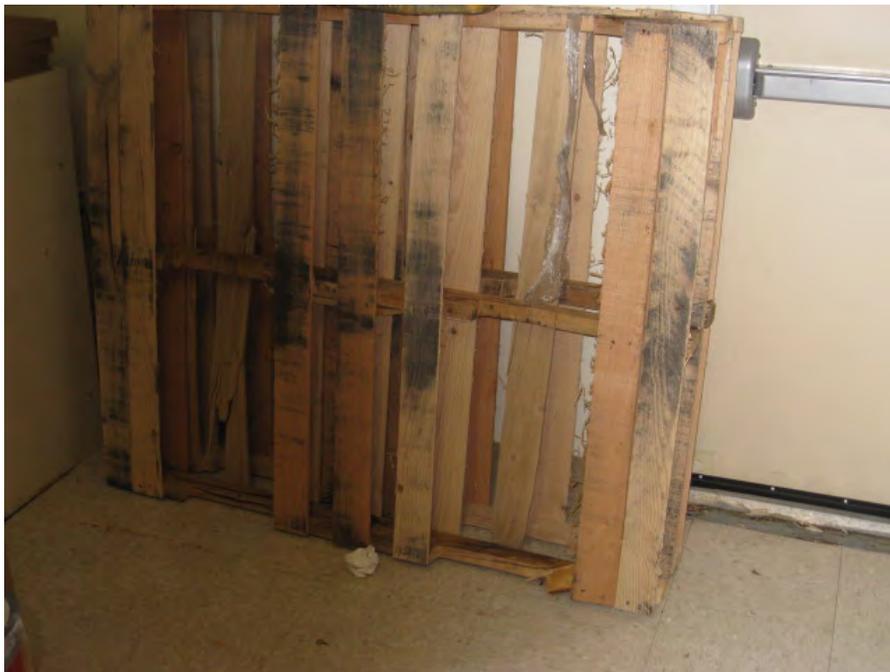
Picture 10

A water-damaged wood pallet was observed in a hallway (Picture 10). All water-damaged items should be removed/discarded. BEH/IAQ staff also observed water in a mop pail in the mechanical room (Picture 11). Stagnant water can be a source of odors; mop buckets should be emptied and dried after every use.

Water-damaged pallet

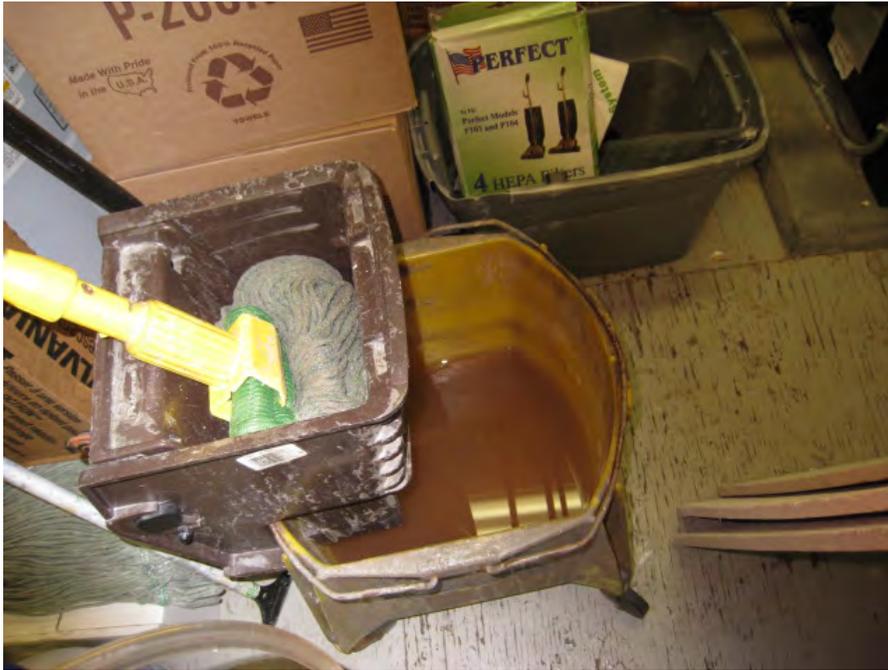
Picture 11

Stagnant water in mop pail

12. Empty and dry janitorial mop pail after each use. Do not allow stagnant water to accumulate in pail.
 13. Open soffit vents on roof to allow air-flow to prevent ice dam formation and resulting water damage in the attic space. Insulate around the attic access door.

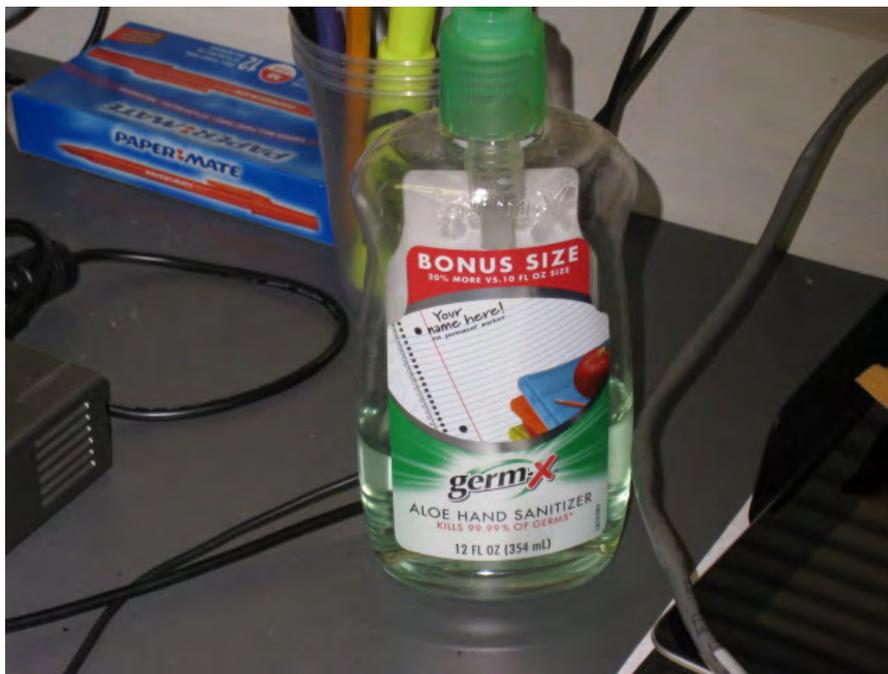
Picture 12

Hand sanitizer was observed in some areas (Picture 12). Hand sanitizer products may contain ethyl alcohol and/or isopropyl alcohol which are highly volatile and may be irritating to the eyes and nose, and may also contain fragrances to which some people may be sensitive.

Hand-sanitizer

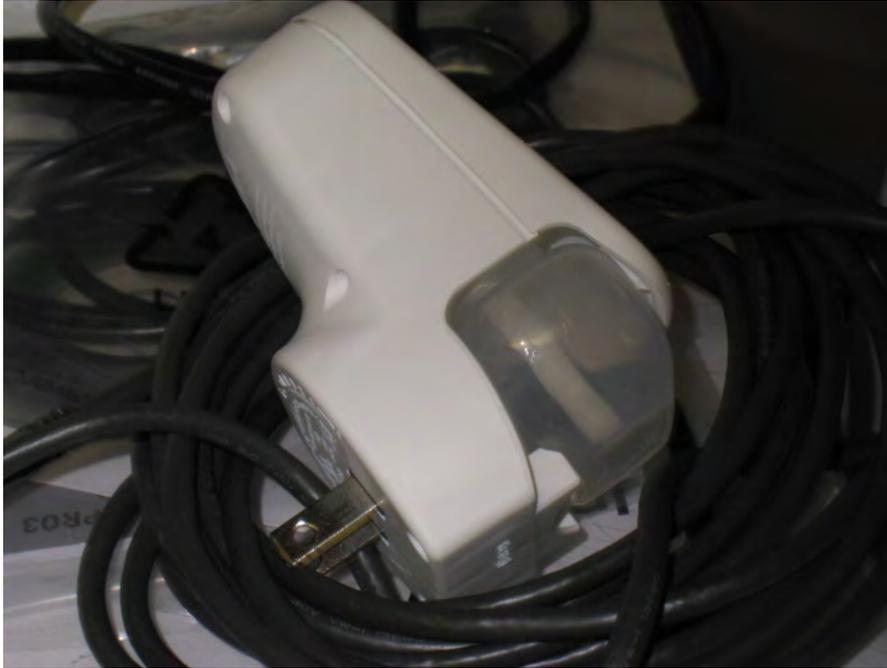
Picture 13

A plug-in air freshener was found (unplugged but with a strong odor) and other deodorizing materials were observed in a few areas as (Table1; Picture 13). Air deodorizers contain chemicals that can be irritating to the eyes, nose and throat of sensitive individuals. Many air fresheners contain 1,4-dichlorobenzene, a VOC which may cause reductions in lung function (NIH, 2006). Furthermore, deodorizing agents do not remove materials causing odors, but rather mask odors that may be present in the area.

Plug-in air deodorizer found unplugged in IT office

16. Refrain from use of air deodorizers/fresheners.
17. Relocate or consider the amount of stored materials to allow for more thorough cleaning.
18. Consider cleaning carpeting annually (or semi-annually in soiled high traffic areas).
19. Vacuum upholstered furniture/pillows/cushions frequently and clean annually. If not feasible, consider removal.
20. Refer to resource manuals and other related indoor air quality documents for further building-wide evaluations and advice on maintaining public buildings. Copies of these materials are located on the MDPH's website: <http://mass.gov/dph/iaq>.

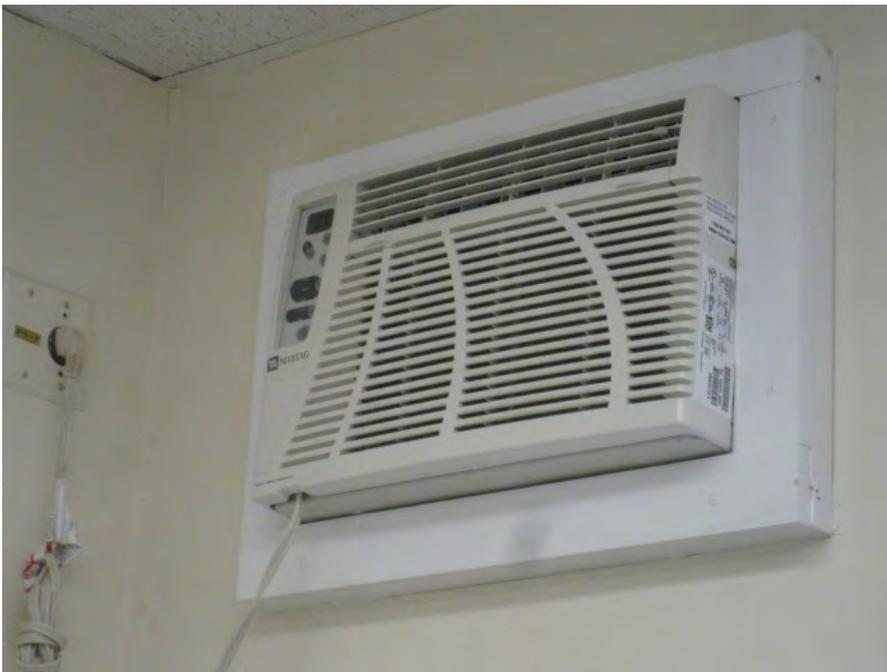
Picture 14

As mentioned, wall-mounted air conditioners (ACs) were observed in several areas (Table 1, Picture 14). These units are normally equipped with filters, which should be cleaned or changed as per manufacturer's instructions.

Wall-mounted air-conditioner

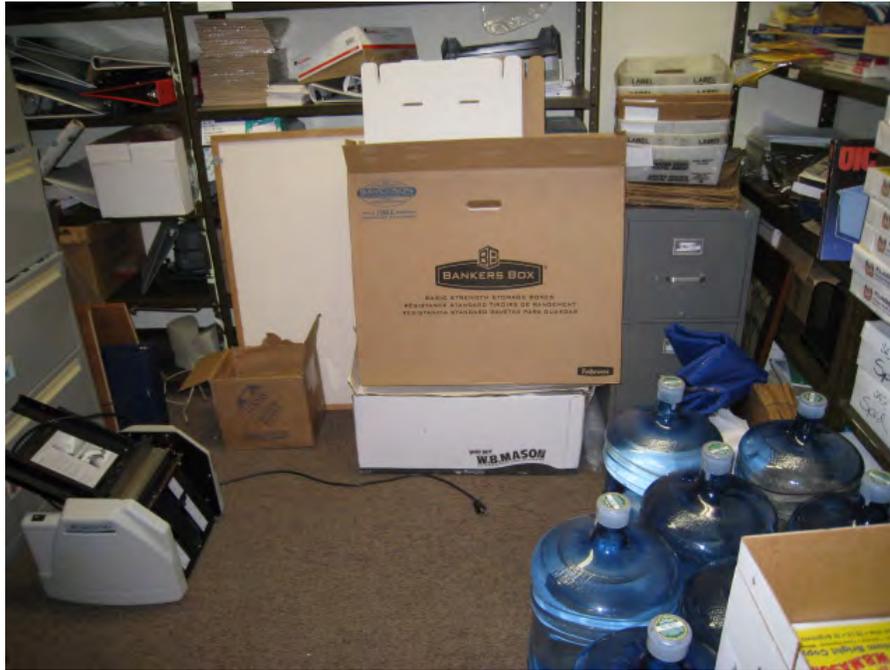
Picture 15

In several rooms, items were observed on the floors, windowsills, tabletops, counters, bookcases and desks (Table 1; Picture 15). Large number of items stored in occupied areas provides a source for dusts to accumulate. These items (e.g., papers, folders, boxes) make it difficult for custodial staff to clean. Items should be relocated and/or be cleaned periodically to avoid excessive dust build up. In addition, these materials can accumulate on flat surfaces (e.g., desktops, shelving and carpets) in occupied areas and subsequently be re-aerosolized causing further irritation.

Boxes and clutter on floor

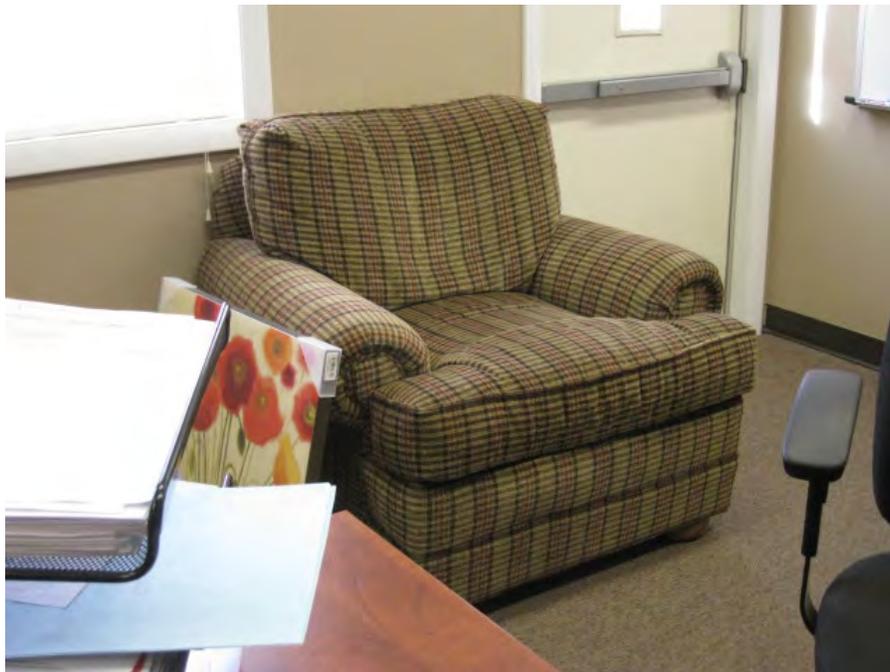
Picture 16

An upholstered chair was observed in one room (Picture 16). Upholstered furniture is covered with fabrics that are exposed to human skin. This type of contact can leave oils, perspiration, hair and skin cells. Dust mites feed upon human skin cells and excrete waste products that contain allergens. In addition, if relative humidity levels increase above 60 percent, dust mites tend to proliferate (US EPA, 1992). In order to remove dust mites and other pollutants, frequent vacuuming of upholstered furniture is recommended (Berry, 1994). It is also recommended that upholstered furniture be professionally cleaned on an annual basis. If an excessively dusty environment exists due to outdoor conditions or indoor activities (e.g., renovations), cleaning frequency should be increased (every six months) (IICRC, 2000).

Upholstered chair in office
