INDOOR AIR QUALITY ASSESSMENT

**Hardwick Municipal Office Building
307 Main Street
Gilbertville, Massachusetts**

Prepared by:
Massachusetts Department of Public Health
Bureau of Environmental Health
Indoor Air Quality Program
April 2014

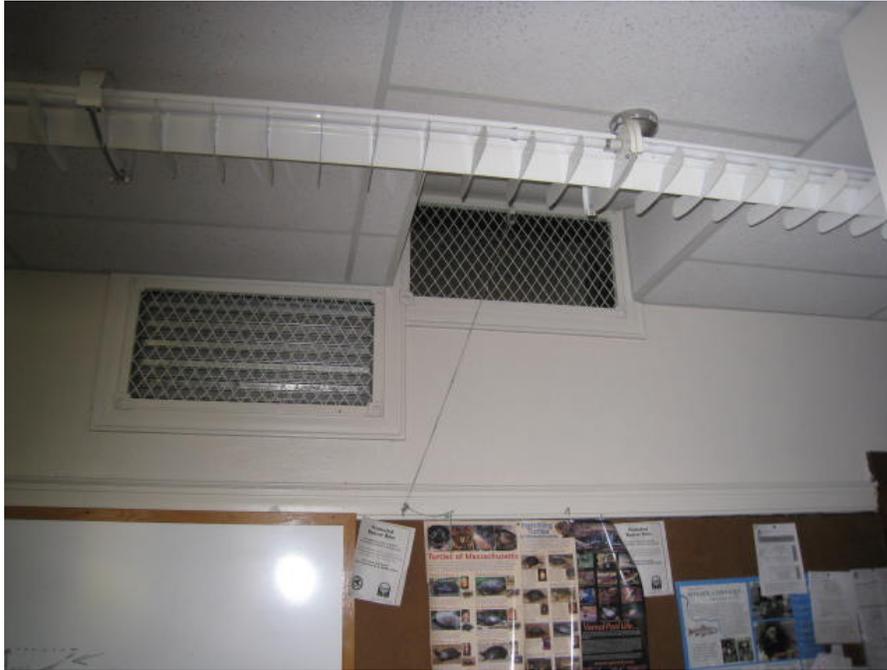
Picture 1

Ventilation was originally provided by grated, louvered, wall vents (Pictures 1 and 2). The wall vents are connected by a ventilation shaft to vault-like "air-mixing" rooms in the basement. The draw of air into these vents is controlled by a draw chain pulley system. The chains of the pulley system were designed to set the flue in the ventilation shaft at a desired angle to adjust fresh air intake. Air movement in such a system is provided by the stack effect. Heating elements located in the base of the ventilation shaft warm the air, which rises up the ventilation shaft. As heated air rises, negative pressure is created, drawing cold air from the enclosed air-mixing rooms in the basement into the heating elements/ventilation shaft. This

Former fresh air supply

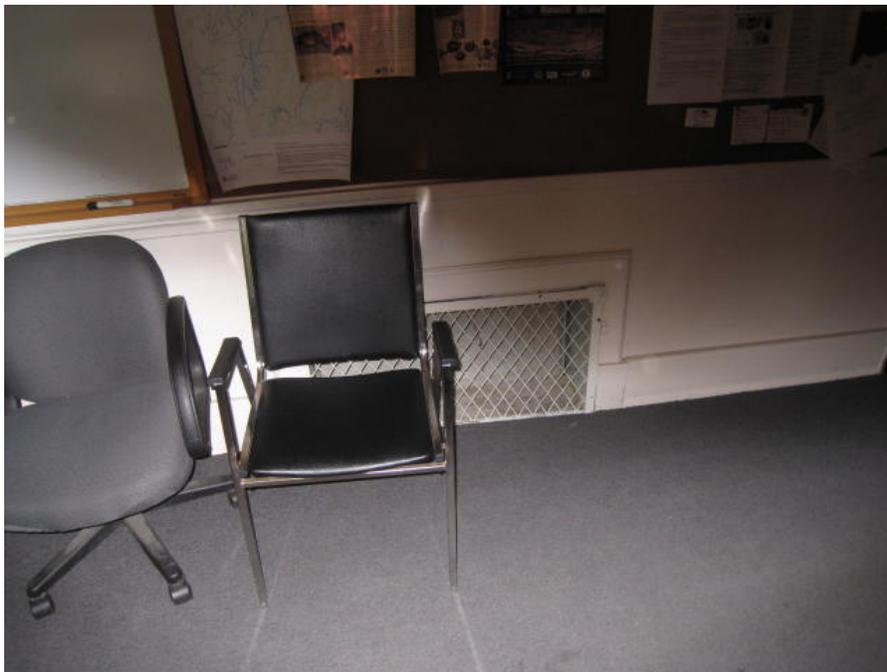
Picture 2

Former exhaust

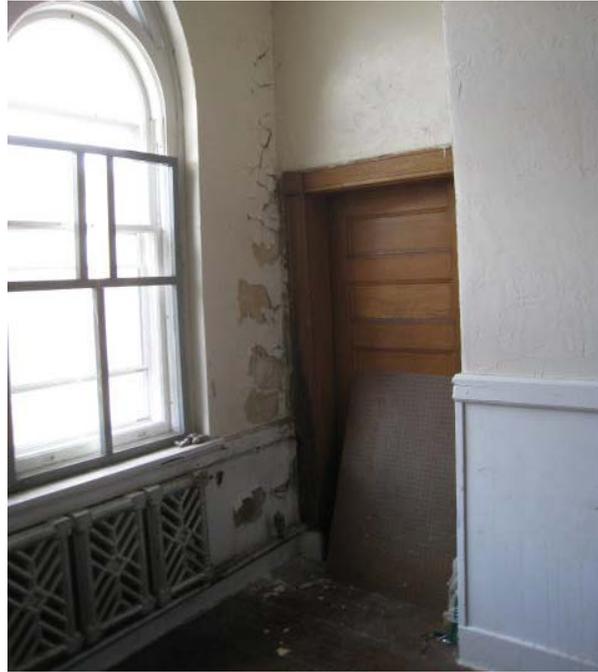
Picture 3

Water-damaged wall plaster, peeling paint, ceiling tiles and other moisture indicators were observed in a number of areas throughout the building (Table 1). In the uppermost level/former gymnasium, the observed damage to plaster is likely associated with steam leakage from a radiator valve (Picture 3). While plaster is not likely to grow mold, repeated moistening can lead to its deterioration. Water damage to ceiling tiles and plaster in other areas is likely due to periodic water leaks from plumbing or the roof.

Leaking radiator valve, note damage to plaster

1. Repair the radiator valve in the former gymnasium. Repair plaster as needed.
2. Install weather-stripping underneath boiler room/hallway doors to prevent the migration of odors and particulates.
3. Seal the pipe in Pictures 4 and 5.
4. Keep the door to the stairwell with the ceiling-mounted radiator (shown in Picture 6) closed.

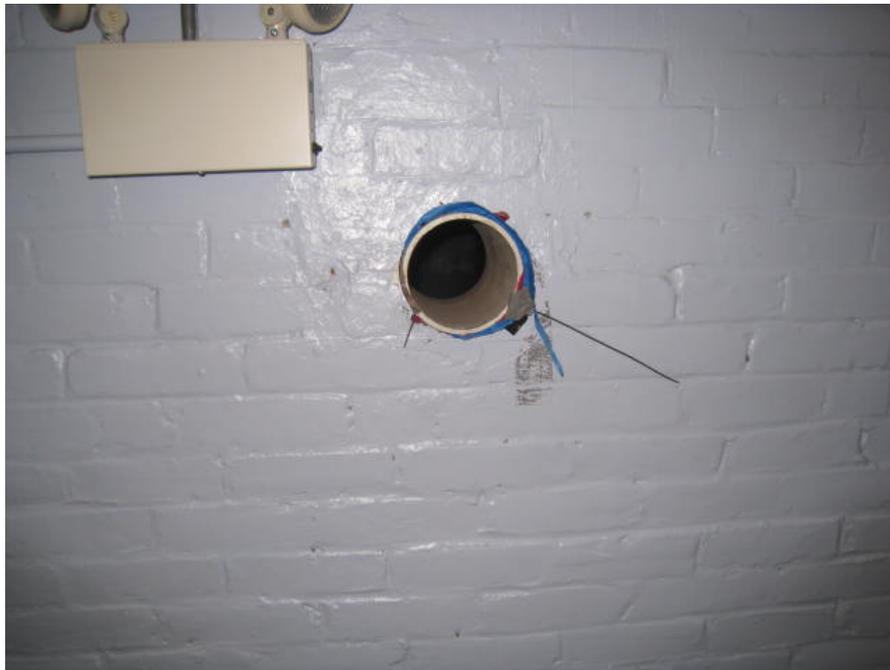
Picture 4

- An access door to the furnace area opens into HPD offices. Air and pollutants may pass through spaces in and around the door frame.
- An abandoned pipe in the furnace room opens into the former cafeteria (Pictures 4 and 5).
- A door to the furnace room was left open at the base of the stairs on the opposite side of the building from the HPD. A ceiling mounted radiator (Picture 6) that provides heat for the hallway exists outside the open basement door, which can

Hole in wall on occupied side of former cafeteria

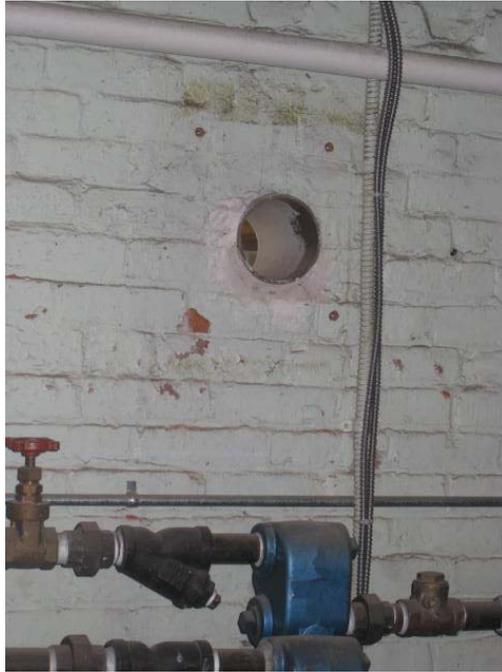
Picture 5

Hole in wall on furnace room side of wall from Picture 4

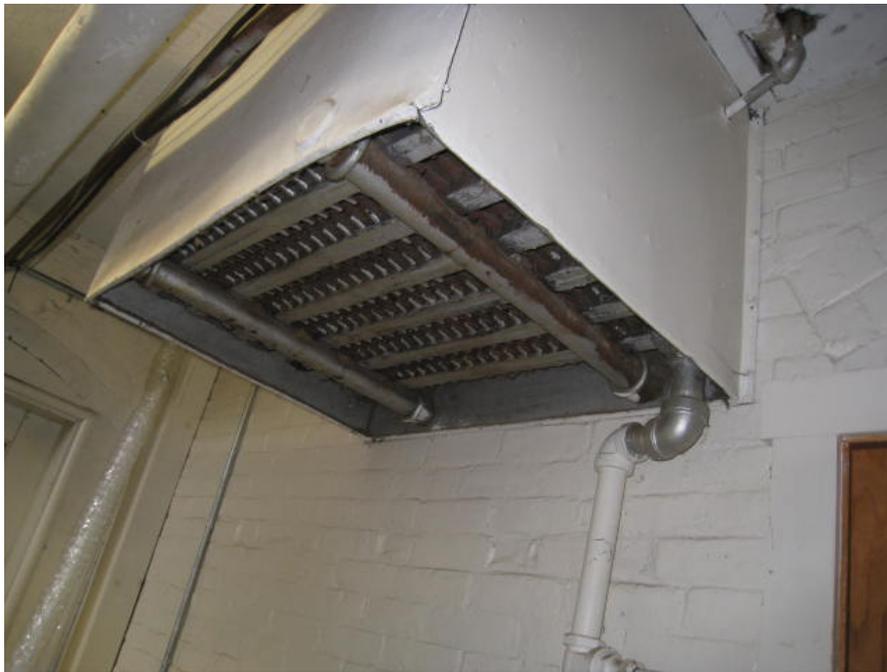
Picture 6

Radiator on ceiling outside furnace room door

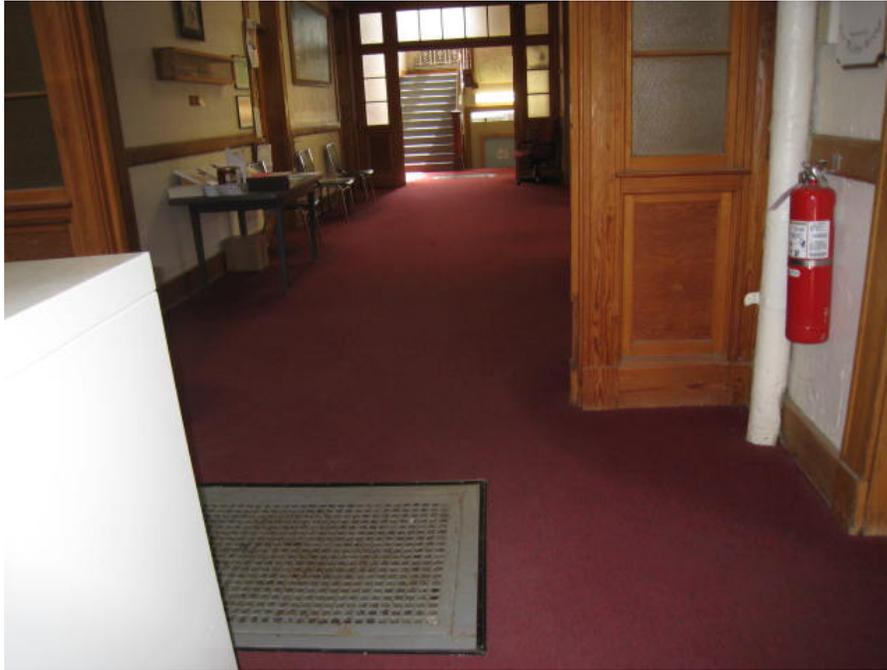
Picture 7

allow furnace room odors to enter the main hallway through a floor heating vent (Picture 7).

Floor heating vent above radiator in Picture 6
