# **INDOOR AIR QUALITY ASSESSMENT**

**Massachusetts Registry of Motor Vehicles  
73 Winthrop Avenue  
Lawrence, Massachusetts**

Prepared by:  
Massachusetts Department of Public Health  
Bureau of Environmental Health  
Indoor Air Quality Program  
September 2014

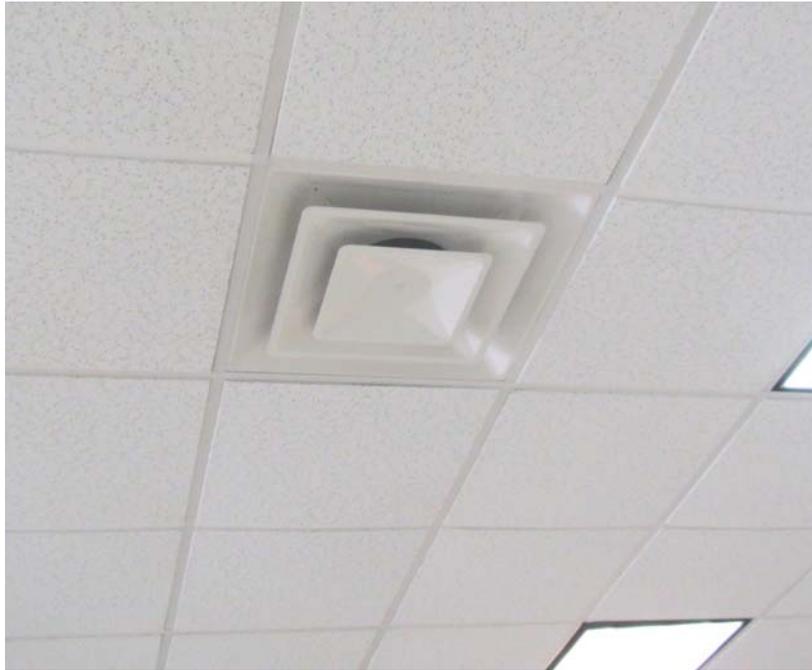
**Picture 1**

Fresh air for the RMV is supplied by air handling units (AHUs) located on the roof. The AHUs draw in air, heat or cool it and deliver it to spaces via supply vents (Picture 1). Ceiling-mounted exhaust vents remove stale air and return it via a plenum to the AHUs. The system is controlled by wall-mounted digital thermostats. According to Mr. Northrup, some of these thermostats had been found to be non-functional and had been replaced prior to the assessment; others had reportedly been set to the “automatic” setting but had been changed to the “on” setting prior to the assessment. The automatic setting on the thermostat activates the HVAC system at a

**Supply vent**

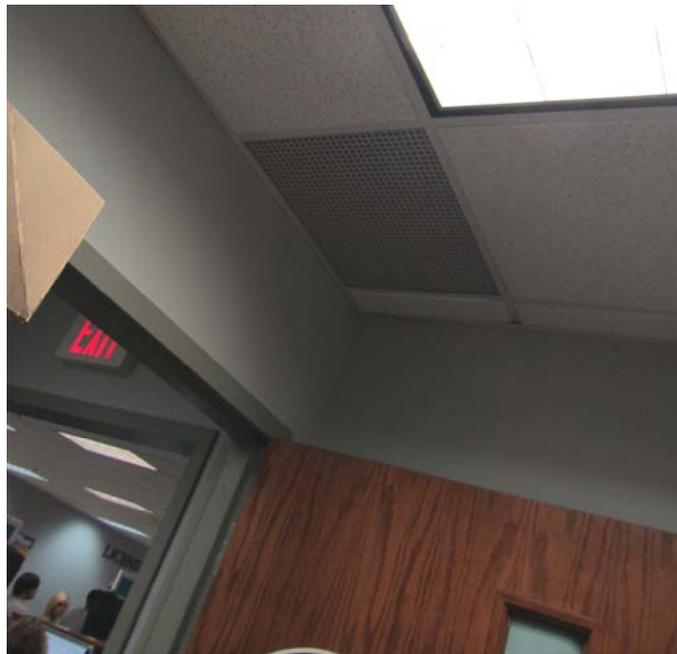
**Picture 2**

As noted above, most of the carbon dioxide readings that were above 800 ppm were in or adjacent to the waiting area. This area has a large number of people continually cycling through it. Additional fresh air may need to be supplied to this area, and similarly additional exhaust ventilation. It was observed that the exhaust vents for the waiting/clerks areas were mostly located over the clerk area, which would tend to draw stale air through the breathing zone of employee work stations. Installing additional exhaust ventilation in the waiting area may facilitate the removal of stale air and help reduce carbon dioxide levels. Some offices had similar issues; in some cases the exhaust vent was located directly next to doors, which are often left open (Picture 2). This would tend to draw air from the hallway into the exhaust vent rather than exhausting air from the office.

**Exhaust vent in an office, note proximity to the door**

1. Operate HVAC systems/AHUs throughout the building continuously during occupied periods.
2. Consider adding and/or modifying the location of exhaust vents in the waiting area and offices to allow for more thorough removal of stale air from these spaces.

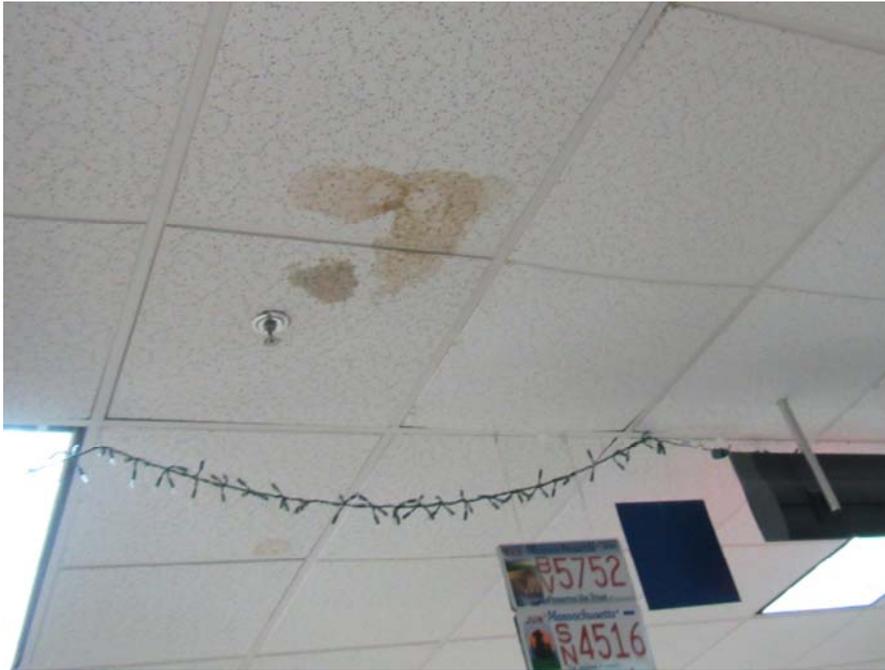
**Picture 3**

A number of areas had water-damaged ceiling tiles (Table 1; Picture 3). Water-damaged ceiling tiles can indicate leaks from the roof or plumbing system and provide a source for mold growth. Water-damaged ceiling tiles should be replaced after a water leak is discovered and repaired. There were reports of past roof leaks, particularly in the kitchen/break room; reportedly, the roof has been repaired recently.

**Water-damaged ceiling tile**

6. Ensure leaks are repaired and replace water-damaged ceiling tiles. Examine the area above and around these areas for mold growth. Disinfect areas of water leaks with an appropriate antimicrobial as needed.

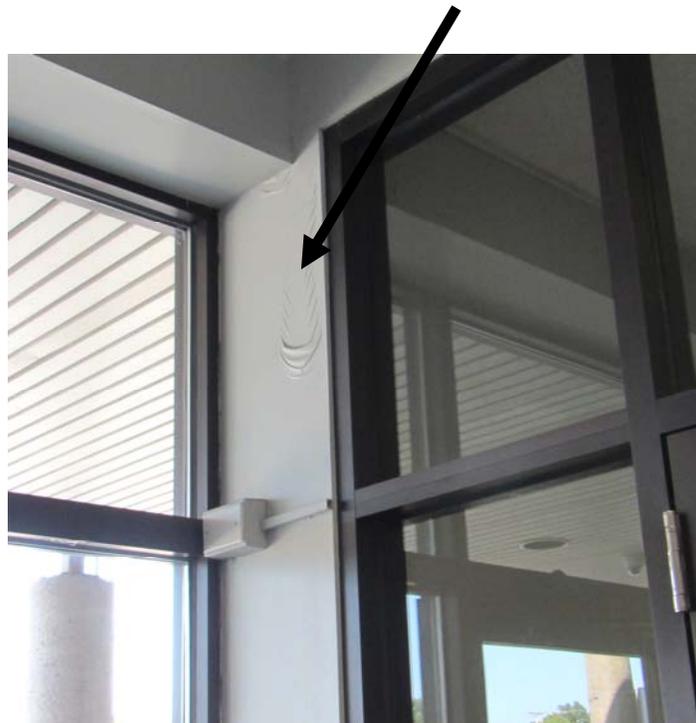
**Picture 4**

Water-damaged paint was observed in the vestibule (Picture 4) and water-damaged carpeting was observed in several areas, including outside the men's restroom (Picture 5). There was also evidence of historic water infiltration in the data room where tile mastic could be seen around the edges of the floor tiles (Picture 6). Reportedly, there has not been water infiltration in the data room during the current tenancy by the RMV.

**Water-damaged paint in vestibule (arrow)**

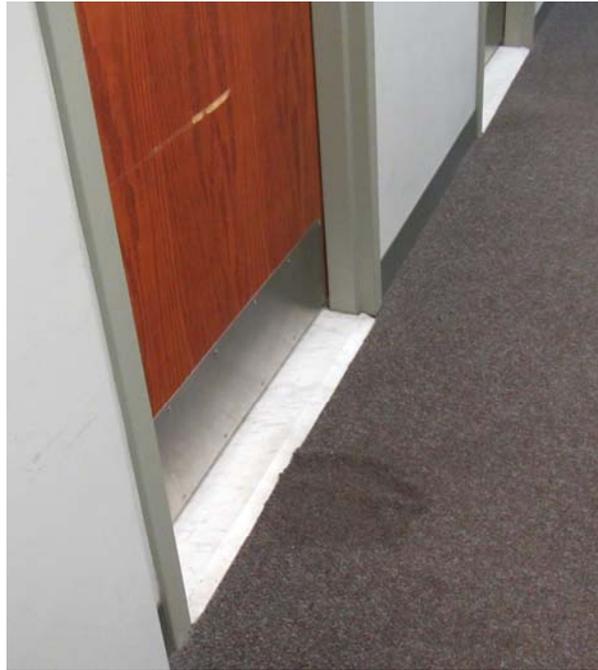
**Picture 5**

**Water-damaged carpeting outside men's room**

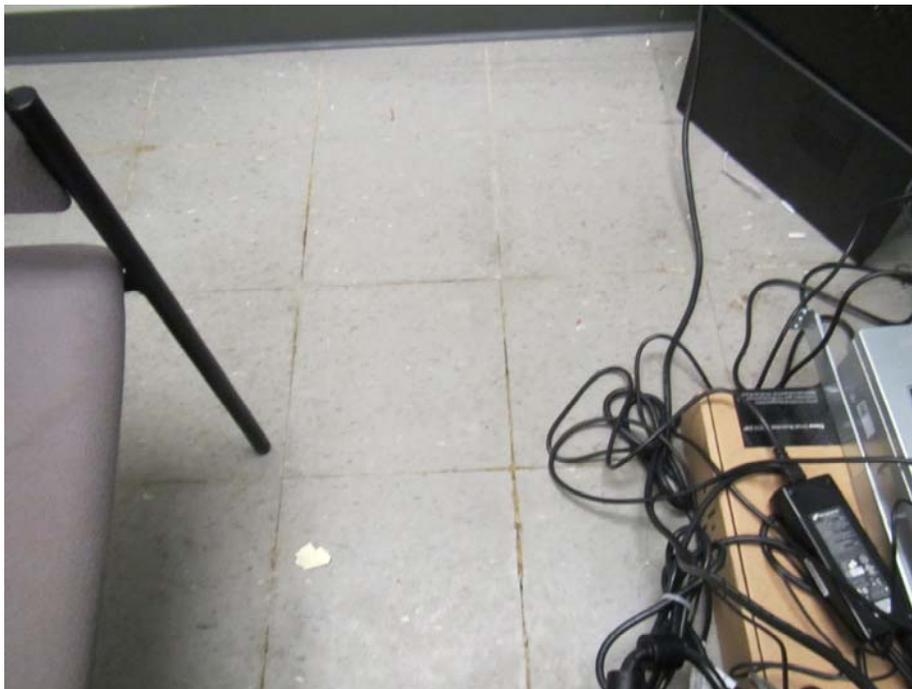
**Picture 6**

**Mastic coming up between tiles, a sign of historic water infiltration**

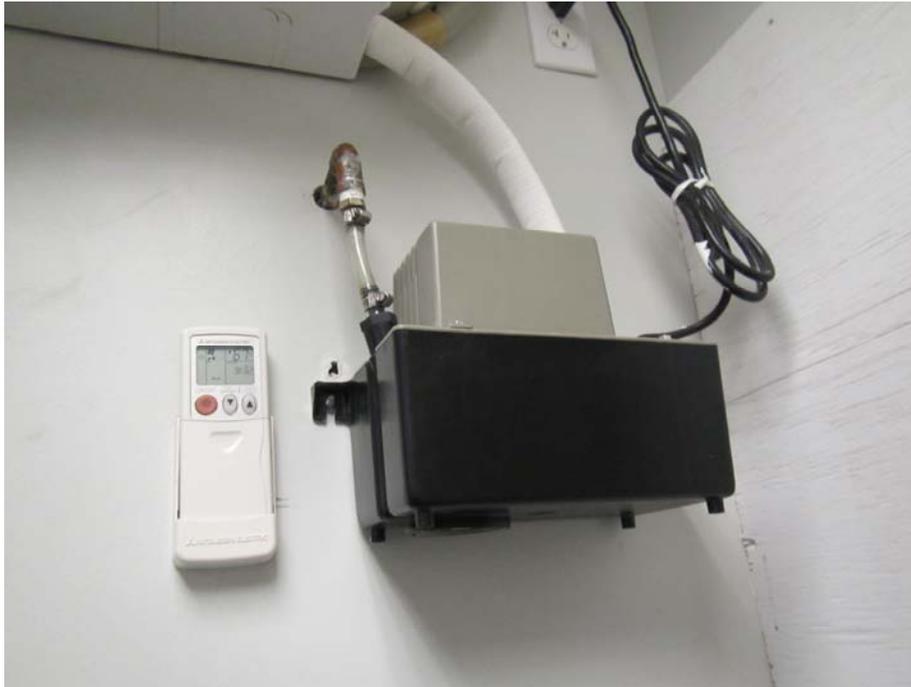
**Picture 7**

A ductless air conditioning unit was observed in the data room. This unit is equipped with a condensate drain which is pumped to the outside (Picture 7), reportedly to the roof. The drain piping and pump on this unit should be examined periodically to ensure that they are functioning correctly and not leaking.

**Condensate piping and pump for ductless air conditioner**

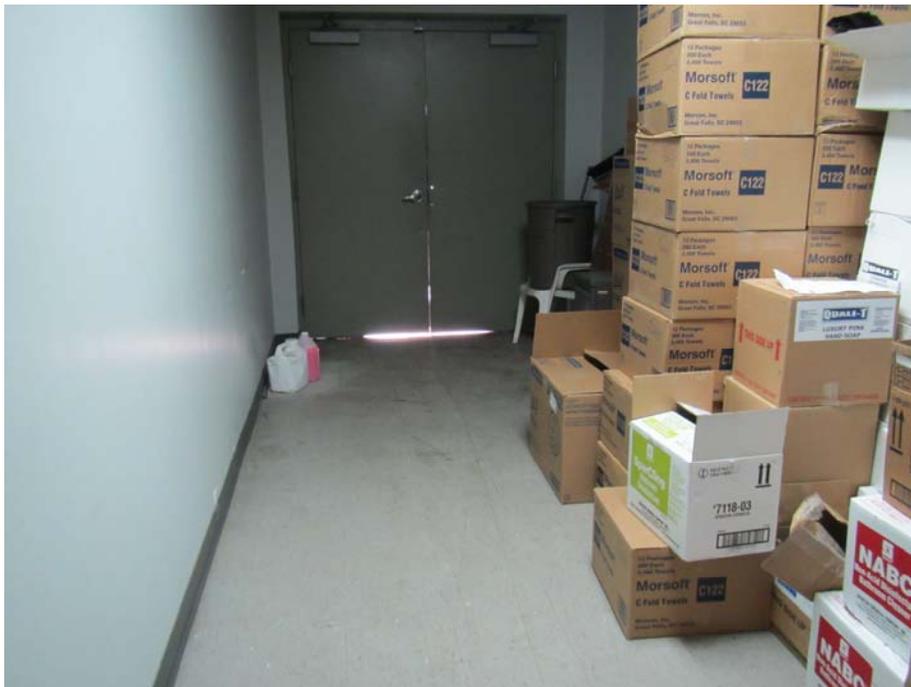
**Picture 8**

Light was observed penetrating through spaces around/underneath the exterior door in the loading dock area (Picture 8), which can serve as a pathway for moisture, insects, rodents and other pests into the building. In some areas, boxes and paper were observed on the floor (Table 1; Picture 8). During humid weather, floors may be subject to condensation, which can moisten items stored on the floor and lead to damage and microbial growth. This is particularly true in areas with a connection to the outside, such as the loading dock shown in Picture 8. Porous items should be stored on shelving or in cabinets to protect them from condensation.

**Light visible under/around door to outside; note also boxes stored on the floor**

7. Install weather stripping around exterior doors to prevent drafts, water penetration and pest entry. Check for tightness by monitoring for light and/or drafts around doors.

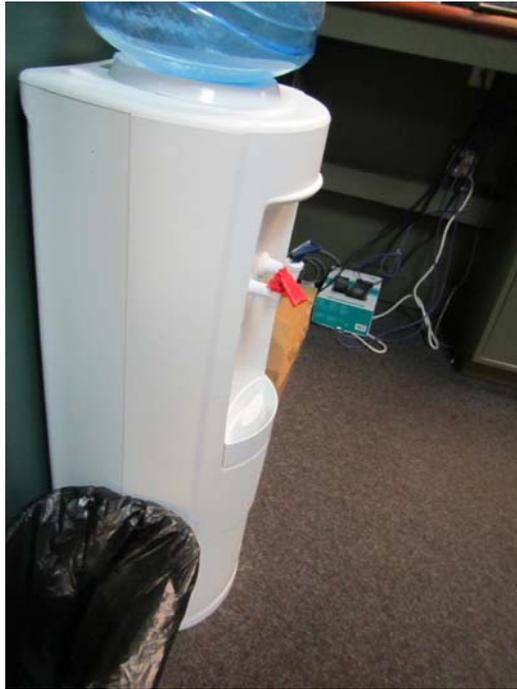
**Picture 9**

Water coolers and mini refrigerators were observed to be located in carpeted areas, where they can spill or leak and cause water damage to the carpet (Picture 9). These appliances should be located on non-porous flooring or on a waterproof mat.

**Water cooler on carpet**

8. Consider moving water dispensers and refrigerators to non-carpeted areas or supplying each unit with a waterproof mat.
9. Store boxes and other porous materials off the floor. Consider removing or relocating papers/boxes//stored items to allow for more thorough cleaning.

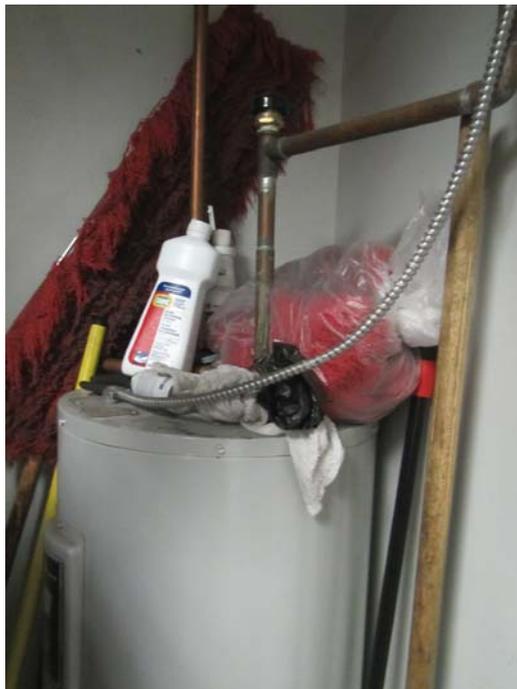
**Picture 10**

In the custodial closet, items, including plastic and cleaners, were observed on top of the water heater (Picture 10). This appliance becomes hot in use and may volatilize plastics from items placed on top, leading to odors and potentially fire. Also note that there was no exhaust vent in this closet, which can allow odors from cleaners, mop buckets, and other items to migrate to occupied areas.

**Items on top of water heater in custodial closet**

13. Clean air diffusers, and return/exhaust vents and personal fans periodically of accumulated dust/debris.
14. Avoid storing anything on top of water heater in custodial closet. Keep items in closet clean and dry to avoid odors.

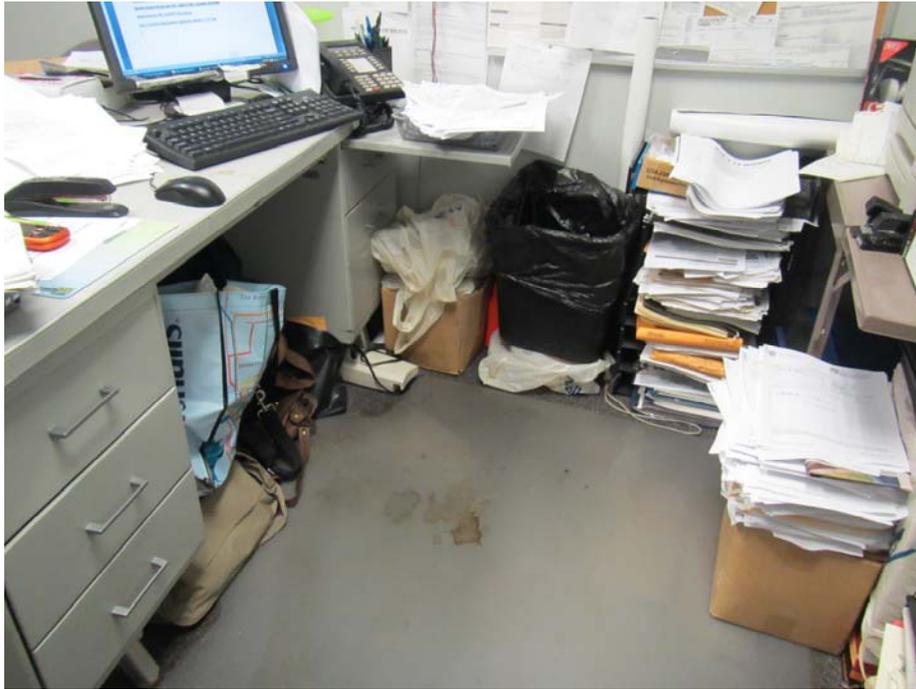
**Picture 11**

In some areas, accumulation of items, including papers, boxes and personal items were found stored on desks, tables and counters (Picture 11). Large numbers of items provide a source for dusts to accumulate. These items make it difficult for custodial staff to clean. Items should be relocated and/or cleaned periodically to avoid excessive dust build up.

**Items/papers in an office and stained floor mat**

12. Ensure that the space is thoroughly cleaned on a regular basis. Occupants can assist with cleaning by properly storing/reducing accumulated papers, boxes and other items.

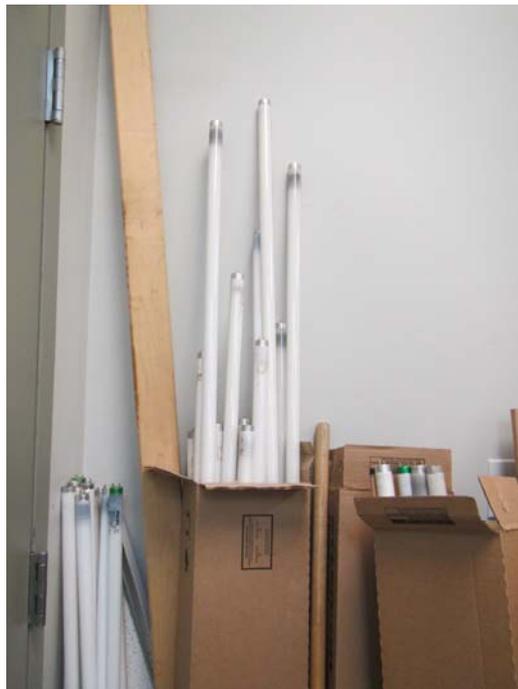
**Picture 12**

In the loading dock area, a collection of spent fluorescent light bulbs was observed, many of which were not properly contained (Picture 12). These bulbs contain mercury, and must be properly handled and stored in order to prevent breaks and mercury release.

**Improperly stored fluorescent bulb**

17. Photocopiers should be kept in well-ventilated rooms, and should be located near windows or exhaust vents.
18. Properly store and dispose of fluorescent light bulbs.
19. Refer to resource manuals and other related indoor air quality documents for further building-wide evaluations and advice on maintaining public buildings. Copies of these materials are located on the MDPH's website: <http://mass.gov/dph/iaq>.
