# **INDOOR AIR QUALITY ASSESSMENT**

**Monson Town Offices  
29 Thompson Street  
Monson, Massachusetts**

Prepared by:  
Massachusetts Department of Public Health  
Bureau of Environmental Health  
Indoor Air Quality Program  
March 2014

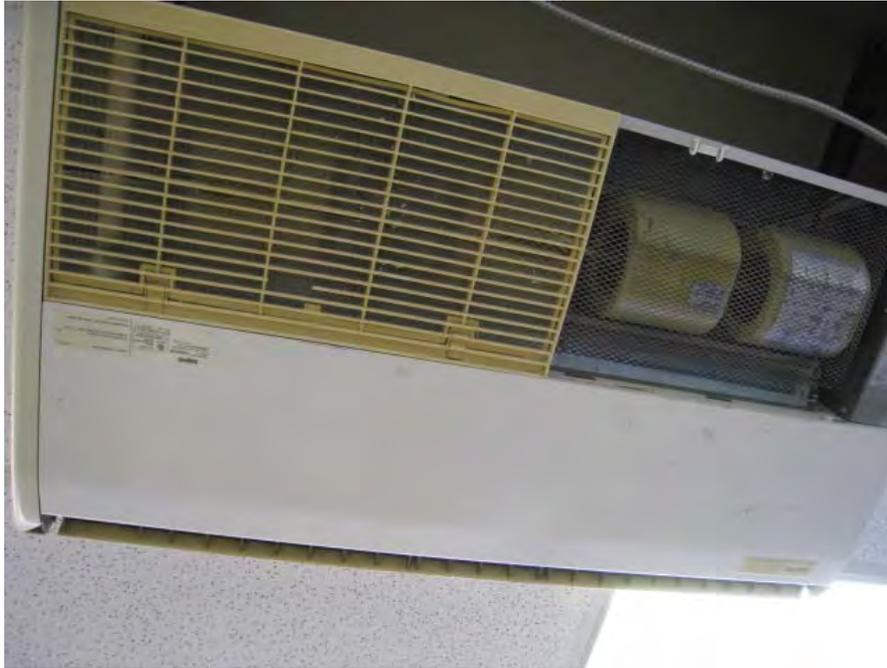
**Picture 1**

Fresh air to the MTO is supplied by a unit ventilator (univent) system (Picture 1). A univent draws air from the outdoors through a fresh air intake located on the exterior wall of the building (Picture 2). Return air from the room is drawn through an air intake located at the base of the unit (Figure 1). Fresh and return air are mixed, filtered, heated or cooled and provided to offices through an air diffuser located in the top of the unit. Univents were found deactivated/non-functional; therefore, the ventilation system is not able to draw fresh air from outdoors. The sole means for introducing fresh air into the building is through openenable windows. In order for univents to provide fresh air as designed, they must remain “on” and operating while rooms are occupied.

Of note, univents in the MTO were installed when the school building was constructed, over 50 years ago. The age of the equipment makes service and repairs of these units difficult. According to the American Society of Heating, Refrigeration and Air-Conditioning Engineers (ASHRAE), the service life<sup>1</sup> for a unit heater using hot water or steam is 20 years, assuming routine maintenance of the equipment (ASHRAE, 1991). Despite attempts to maintain the univents, the operational lifespan of the equipment has been exceeded. Maintaining the balance of fresh air to exhaust air will become more difficult as the equipment ages and as replacement parts become increasingly difficult to obtain.

**Example of uninvent in MTO**

3. Given the age of the univent system, and questions as to whether this system has the capacity to operate, it is suggested that the univent fans be disconnected so the system can provide heat as a radiant heat system only if the building is used as town offices. If this is done, disconnect the building from the energy control system that is used by the school system and control heat manually within the building.

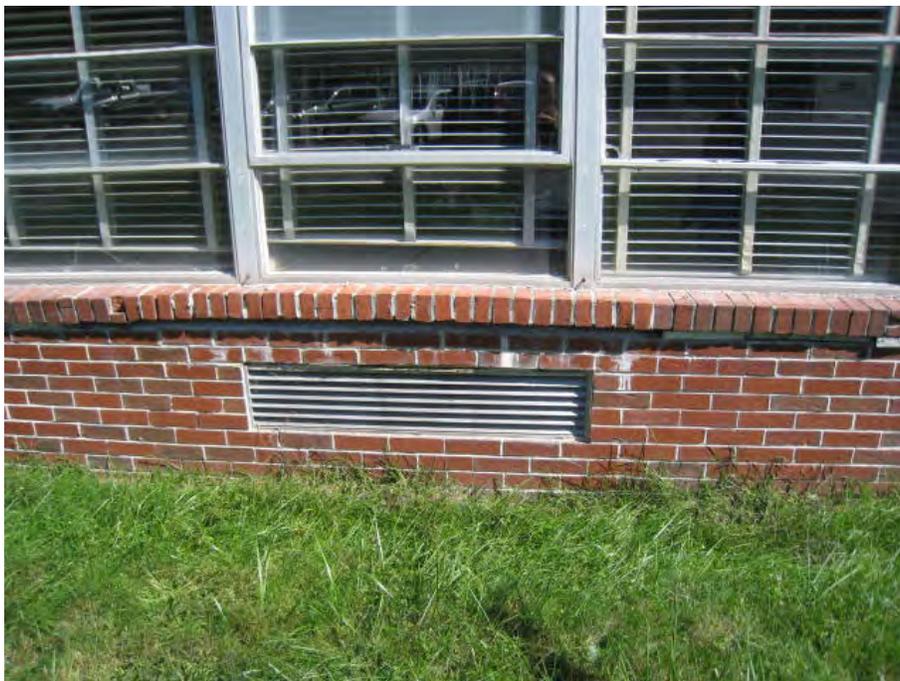
**Picture 2**

**Univent air intake on exterior wall**

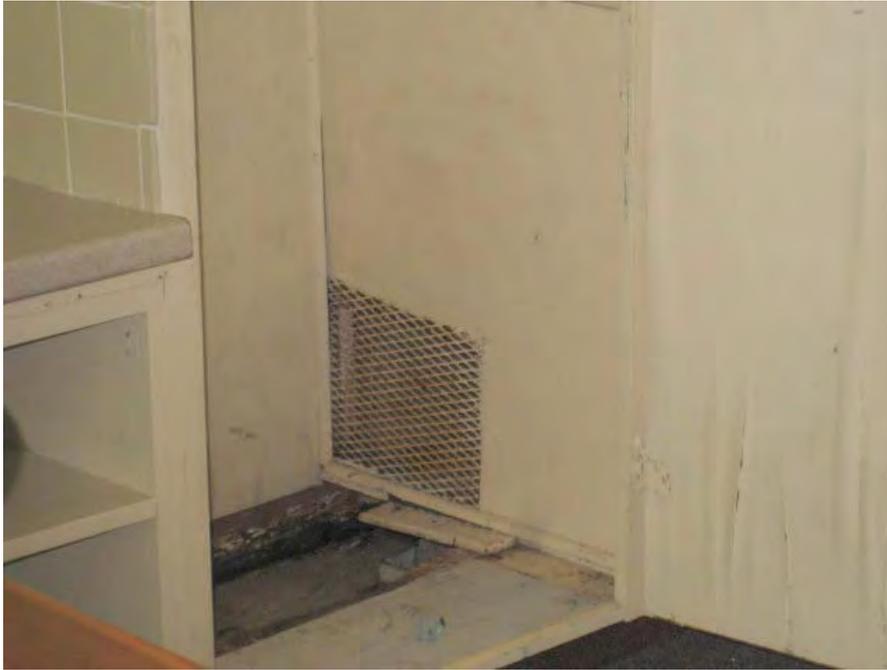
**Picture 3**

Exhaust ventilation is provided by ducted, grated wall vents (Picture 3) located in storage closets powered by roof-top motors (Picture 4). At the time of assessment, BEH/IAQ staff

could not detect any draw of air by the mechanical exhaust systems. It was reported that the exhaust motors had not been operable since the MTO has occupied the space. As with supply ventilation, in order to function properly, exhaust vents must be activated and allowed to operate while rooms are occupied. Without adequate supply and exhaust ventilation, excess heat and environmental pollutants can accumulate, leading to indoor air/comfort complaints.

**Exhaust vent located in storage closet**

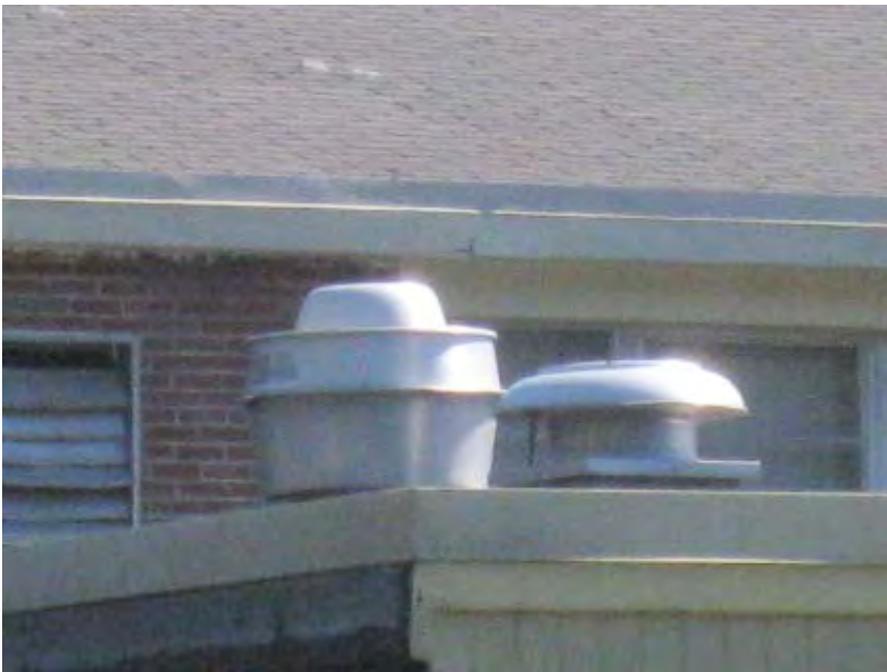
**Picture 4**

**Roof-top exhaust vent**

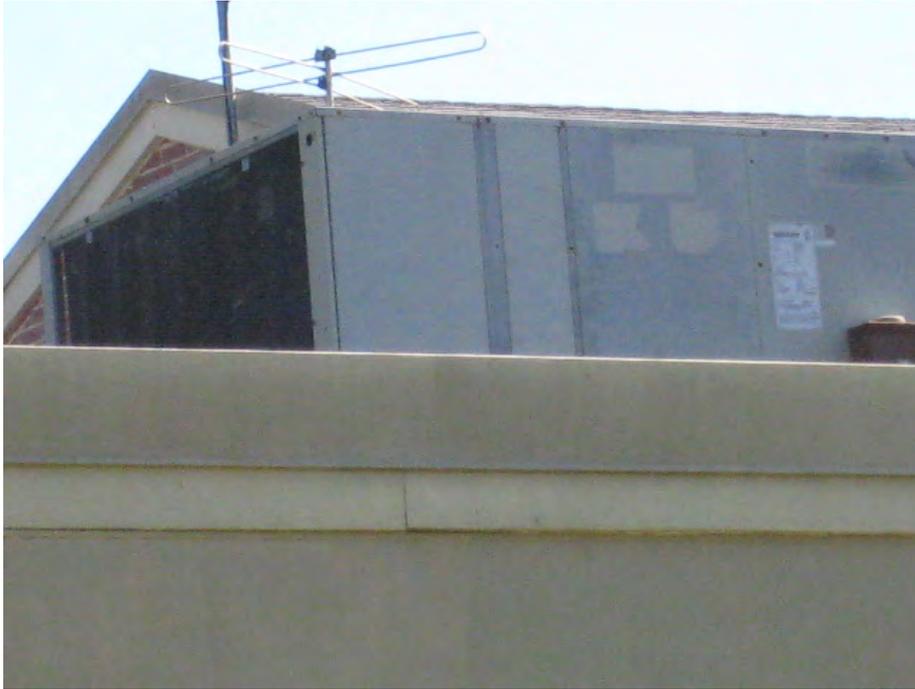
**Picture 5**

The heating, ventilation and cooling (HVAC) system in some areas (i.e. former cafeteria, gymnasium) is provided by a roof-top air handling unit (AHU) (Picture 5). The AHU is designed to draw in fresh, outdoor air through air intakes; filter, heat and/or cool the air; then distribute it to occupied areas via ceiling-mounted air diffusers (Picture 6); air would be returned via ducted exhaust vents. As BEH/IAQ staff did not access the roof, it was not known if this system was functioning at the time of the assessment.

**Roof-top AHU**

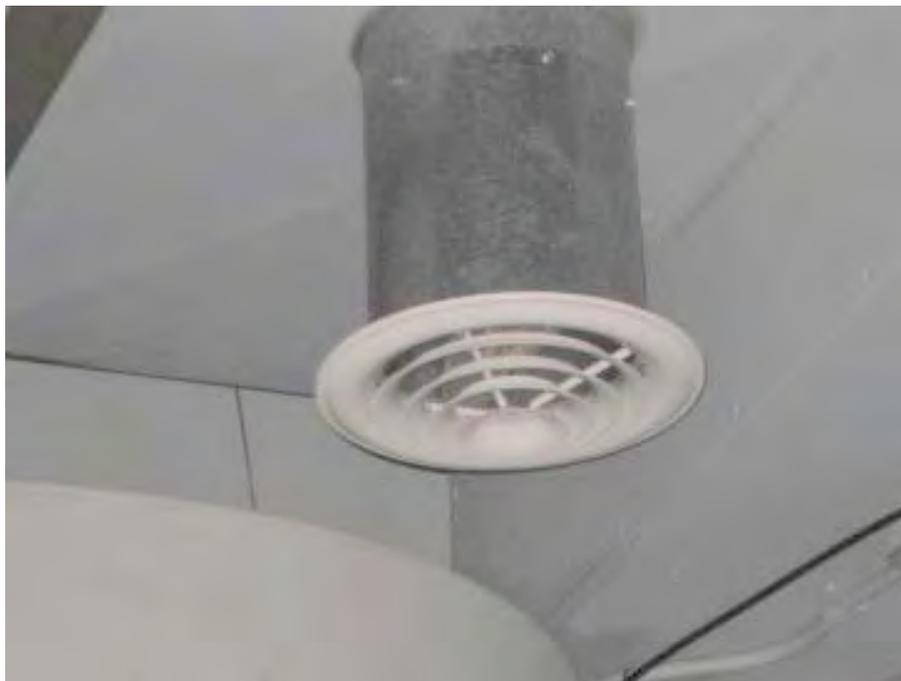
**Picture 6**

**Supply diffuser in gymnasium/stage area**

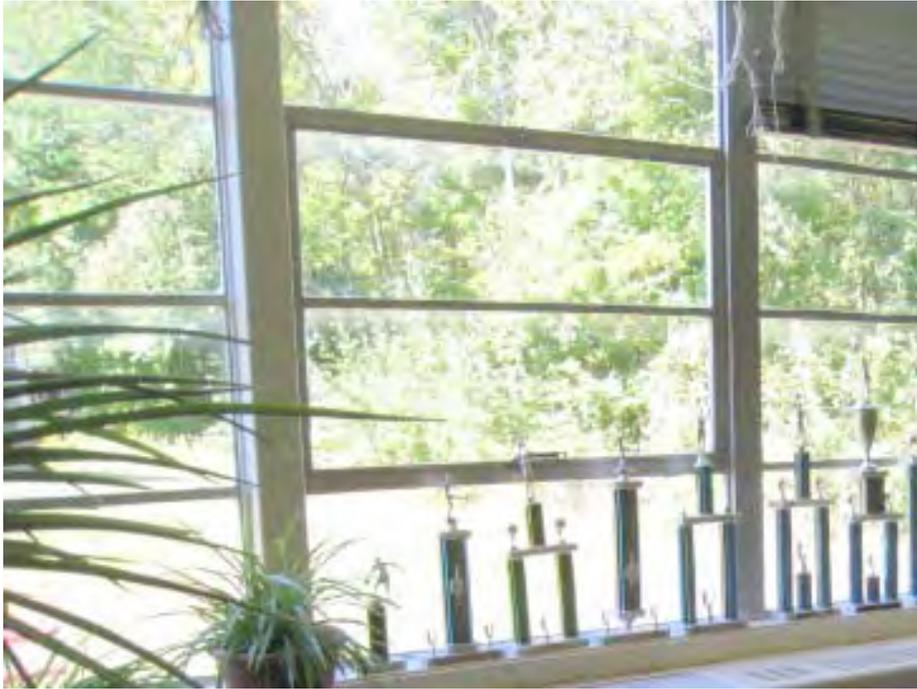
**Picture 7**

Temperature control complaints (primarily heat complaints) were reported by some occupants. The windows in the building are single pane with metal frames (Picture 7) which can allow heat to escape in the winter, creating drafts, and for sunlight to create a condition of solar gain and glare making temperature control difficult. Shades should be used to reduce solar gain as needed.

**Single pane windows with blinds open**

4. Consider installing window mounted air-conditioners in occupied offices to reduce heat in hot weather. Use window shades to modulate room temperature as needed.

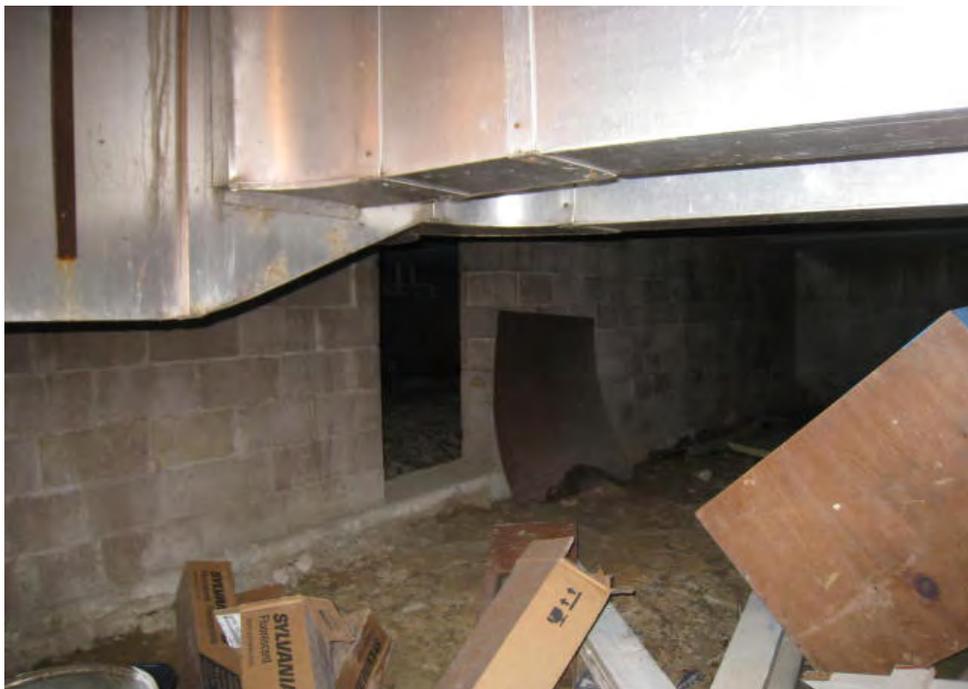
**Picture 8**

Upon entering the building, BEH/IAQ staff noted a musty/wet cellar-like odor, which was pervasive throughout the entire building. The building was constructed with a dirt crawlspace below most occupied areas of the building. Porous materials including boxes, wood and cardboard were observed inside the crawlspace (Picture 8). BEH/IAQ staff did not observe any visible moisture or water accumulation in readily accessible areas of the crawlspace. Building staff reported that the crawlspace below the west wing was subject to chronic moisture due to water penetration following heavy storms. The northwest location of the building which is shaded and surrounded by a forested area (Picture 9), may subject this below-grade area of the building to more water penetration and moisture than other parts of the building.

**Boxes and wood stored in crawlspace**

7. Remove all porous materials from crawlspace (boxes, cardboard, wood etc.) Seal the crawlspace access hatch with weather-stripping/sealant. Inspect all exterior doors for light and/or drafts and repair as needed.

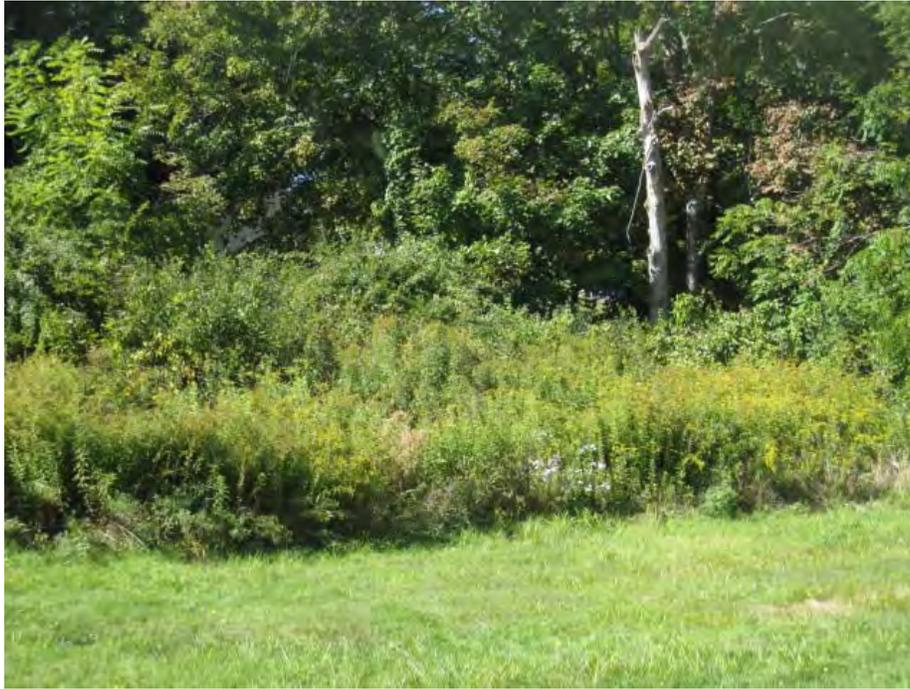
**Picture 9**

**Wooded area surrounding northwest side of building**

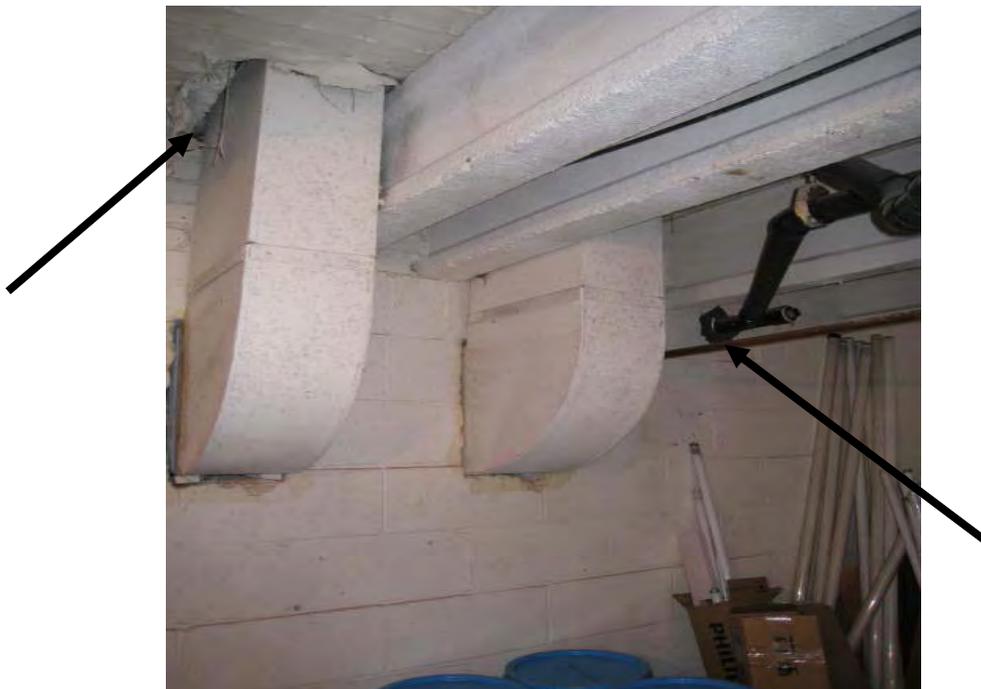
**Picture 10**

Mold spores would be expected to be present in an unconditioned dirt floor crawlspace that is subjected to moisture. Efforts should be made to reduce moisture and circulate air to reduce mold growth in this area and to reduce/eliminate potential pathways for mold, spores, and associated odors to migrate into occupied areas. The means for odors and pollutants to migrate between the crawlspace and occupied areas are holes and spaces that were open in the floor (e.g., space around utility pipes, plumbing, electrical, uninvent) (Pictures 10 and 11). Airflow tends to

rise due to the stack effect and these breaches can serve as pathways to draw air, odors and particulates from the crawlspace into ground floor hallways and office spaces. All holes and gaps should be sealed with fire-rated sealant foam or other appropriate material. In addition, the access hatch to the crawlspace entrance should be closed and sealed to prevent the penetration of odors and particulates into occupied spaces.

**Holes/breaches around ductwork and utility pipes in crawlspace (arrows)**

2. Seal all utility pipes, conduit and other penetrations in the ceiling and walls of the crawlspace, in the floor of ground floor rooms, inside unit ventilators and utility pipes using an expandable, fire-rated sealing compound.

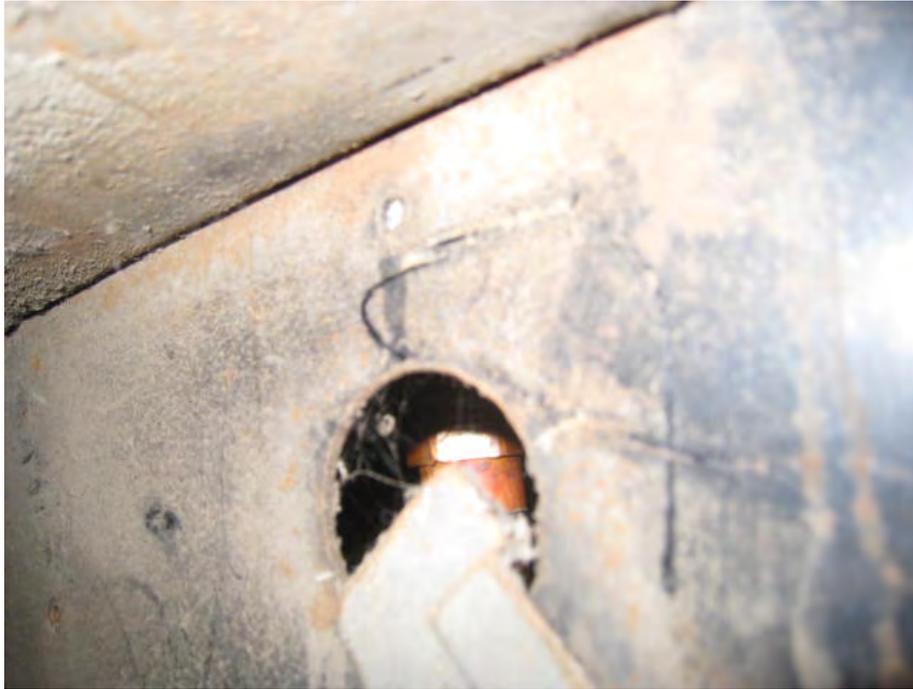
**Picture 11**

**Hole surrounding utility pipe**

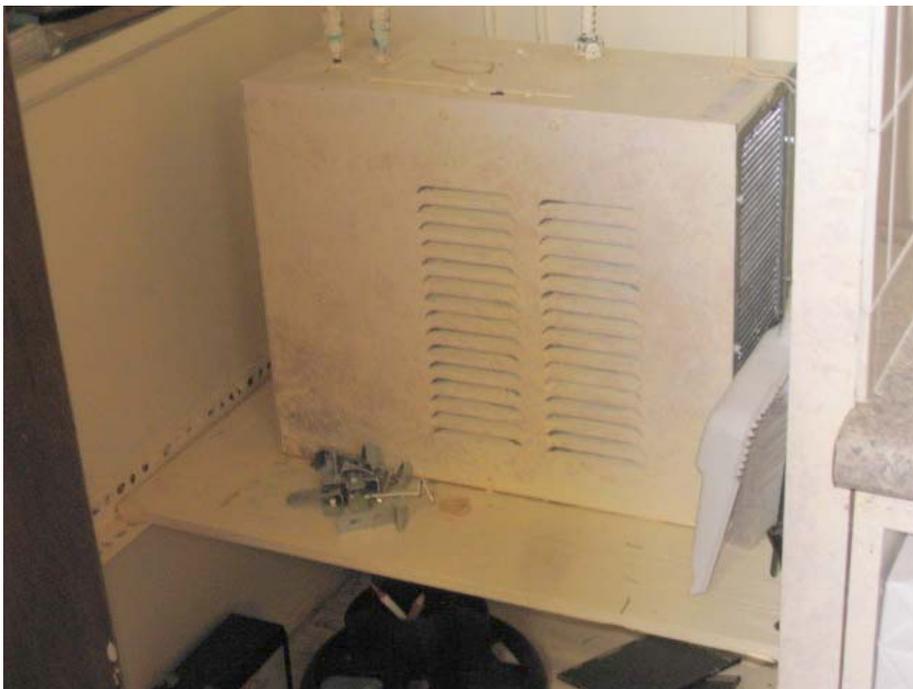
**Picture 12**

As previously noted, room closets contained small unit water heaters equipped with a motorized fan (Picture 12) which were designed to provide hot water to sinks located in the same office space (Picture 13). In Room 7, the water heater had leaked resulting in water damage to the cabinet and surrounding areas including visible mold on wood surfaces (Picture 14). The leaking water heater was removed, the area cleaned and sealant was used to fill holes from the crawlspace (Pictures 15). All water heaters and associated plumbing should be examined for

**Fan-cooled water heater**

8. Continue to monitor for leaks and/or water damage due to malfunctioning portable water heaters, and disconnect and/or repair as warranted.
9. Routinely inspect sinks in offices. Pour water into drains on a regular basis (2 -3 times per week). If possible, disconnect and remove unneeded sinks and associated water heaters.

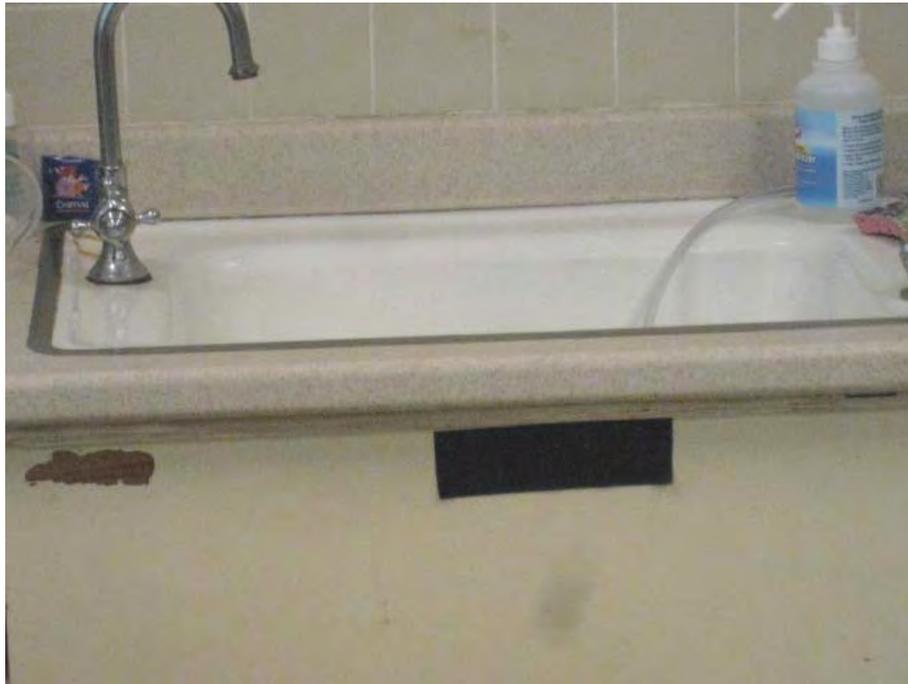
**Picture 13**

Since MTO contains numerous sinks (Table 1), routine inspection of these fixtures should be done to avoid dry drain traps which can occur as these fixtures are infrequently utilized. The purpose of a drain trap is to prevent sewer gases and crawlspace odors from entering the occupied space. When water is poured into a trap, an air tight seal is created by the water in the U-bend section of the pipe. These drains must have water poured into them on a regular basis to maintain the integrity of the seal and eliminate sewer gas from entering the building. If these sinks are not regularly needed, it is recommended that they be removed along with the associated water heaters.

**Example of sink located in office space**

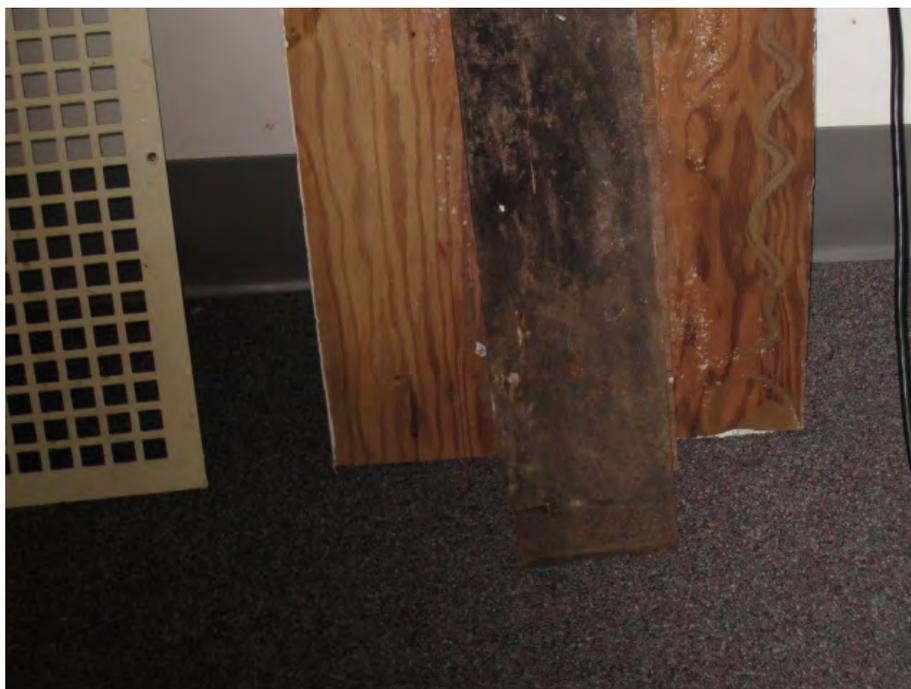
**Picture 14**

**Mold on wood surface as a result of water heater leak**

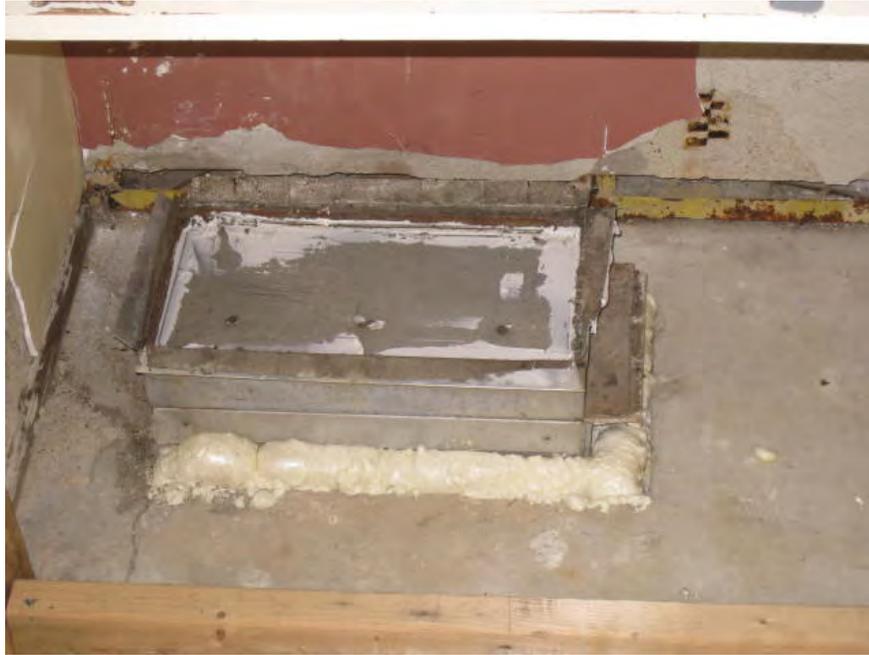
**Picture 15**

leaks and repaired as needed to prevent future water leaks. As shown in Picture 15, spaces around the water heaters are subject to cracks/holes that connect the crawlspace to occupied areas, and fans needed for proper operation of the water heaters also tend to draw air from the crawlspace and distribute it to occupied areas. Spaces and breaches were also observed around pipes in the interior cabinet of univents (Picture 16).

**Example of sealant used to fill gaps from removed water heater**

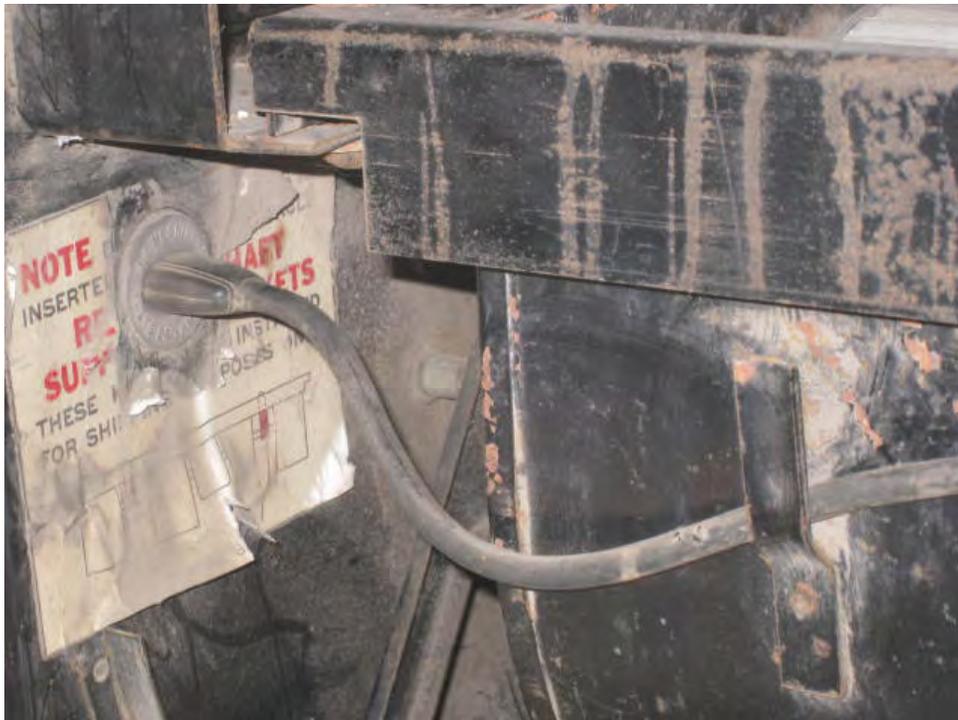
**Picture 16**

**Interior of univent (note electrical outlet)**

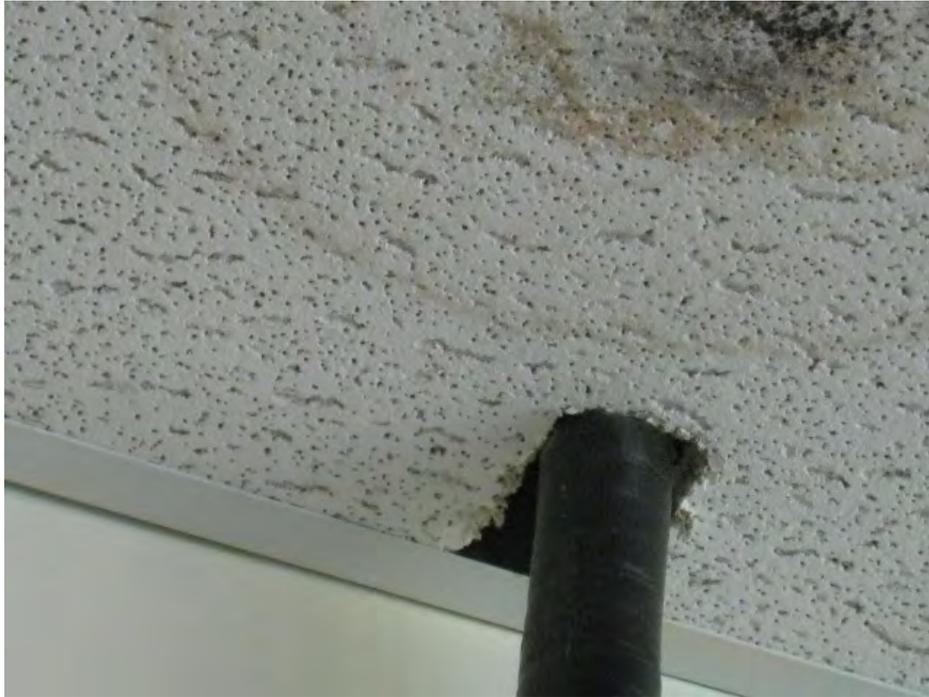
**Picture 17**

Water-damaged ceiling tiles were found in several rooms (Table 1, Picture 17). Water-damaged ceiling tiles indicate leaks from either the roof or plumbing system. If repeatedly moistened, ceiling tiles can be a medium on which mold can grow. Water-damaged tiles should be replaced after a water leak is discovered and repaired.

**Water-damaged ceiling tile**

10. Remove water-damaged ceiling tiles and examine for source of water. Replace all missing and ajar ceiling tiles and monitor for future leaks.

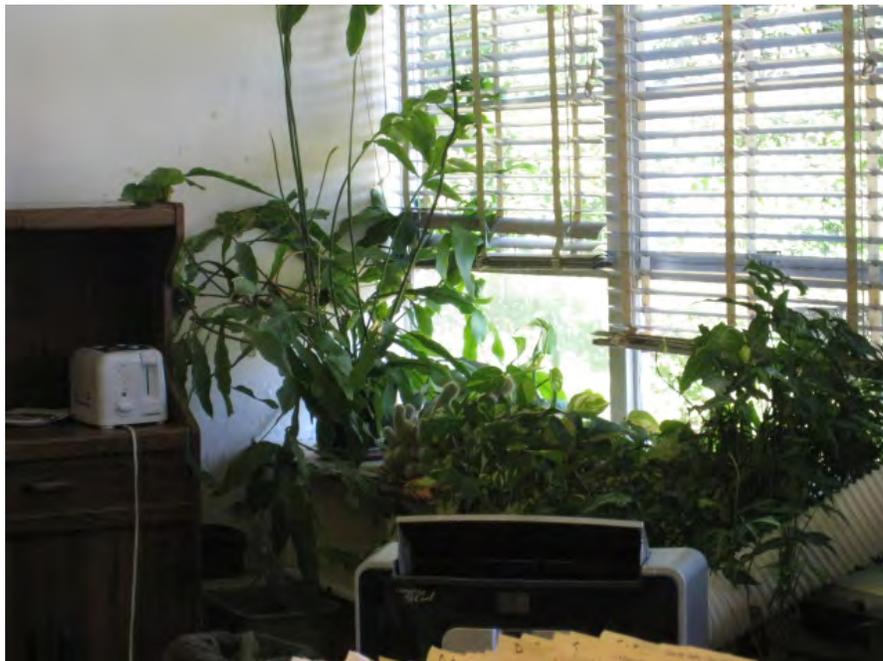
**Picture 18**

Numerous plants were observed in one room (Picture 18). Plants, soil and drip pans can serve as sources of mold growth. Plants can also be a source of pollen. Plants should not be placed on porous materials, since water damage to porous materials may lead to microbial growth. Over-watering of plants should be avoided and drip pans should be inspected periodically for mold growth.

**Plants in office space**

11. Ensure plants have drip pans and avoid over-watering. Examine drip pans periodically for mold growth. Disinfect with an appropriate antimicrobial where necessary. Remove plants from univent air diffusers.

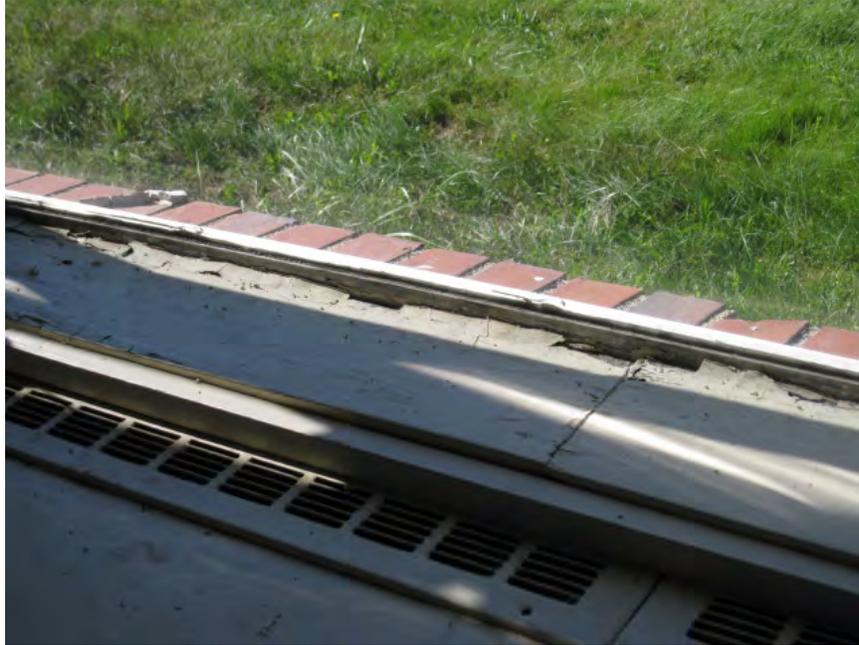
**Picture 19**

Caulking/sealing gaskets around interior/exterior window frames were missing or damaged (Picture 19). Air infiltration was noted around windows, which can result in water penetration through the window frames. Water penetration through window frames can lead to mold growth under certain conditions. Repairs of window leaks are necessary to prevent further water penetration.

**Water-damaged window frames/sills**

12. Continue inspection of windows and the building envelope and repair/replace missing or damaged caulking and seal all cracks and holes in walls to prevent water penetration.

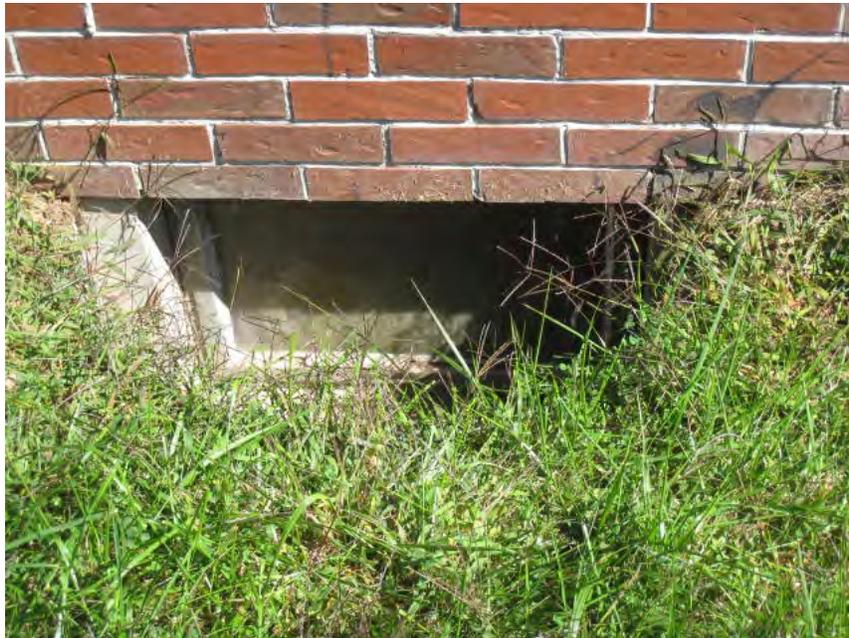
**Picture 20**

BEH/IAQ staff conducted a perimeter inspection of the building's exterior to identify potential sources of water penetration. Basement windows and crawlspaces are below grade and surrounded by grass, plant growth and debris (Picture 20), which can result in the accumulation of rainwater and potential water penetration into the crawlspace/basement. In addition, the growth of grass and roots against exterior walls can bring moisture in contact with the foundation, eventually leading to cracks and/or fissures in the below ground level. Over time, these conditions can undermine the integrity of the building envelope and provide a means of water entry into the building via capillary action through foundation concrete and/or masonry (Lstiburek & Brennan, 2001).

**Basement window surrounded by grass/plants**

13. Remove grass, plants and debris away from the exterior wall/foundation of the building to prevent water penetration into basement and crawlspace.
14. Refrain from use of air deodorizers/fresheners.

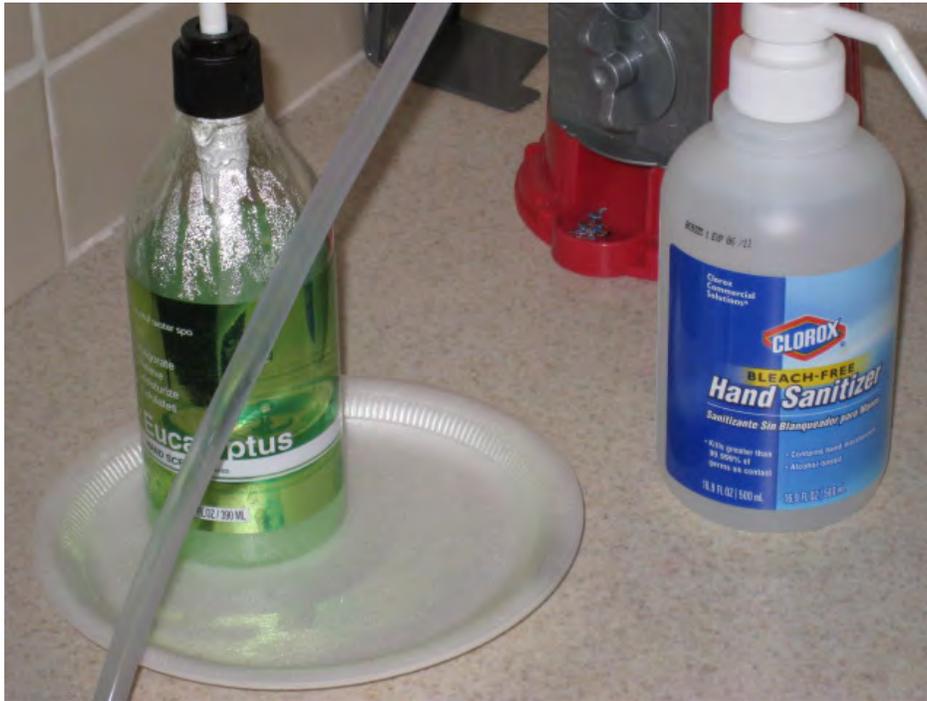
**Picture 21**

Hand sanitizer was observed in some areas (Picture 21). Hand sanitizer products may contain ethyl alcohol and/or isopropyl alcohol which are highly volatile and may be irritating to the eyes and nose, and may also contain fragrances to which some people may be sensitive.

**Hand sanitizer**

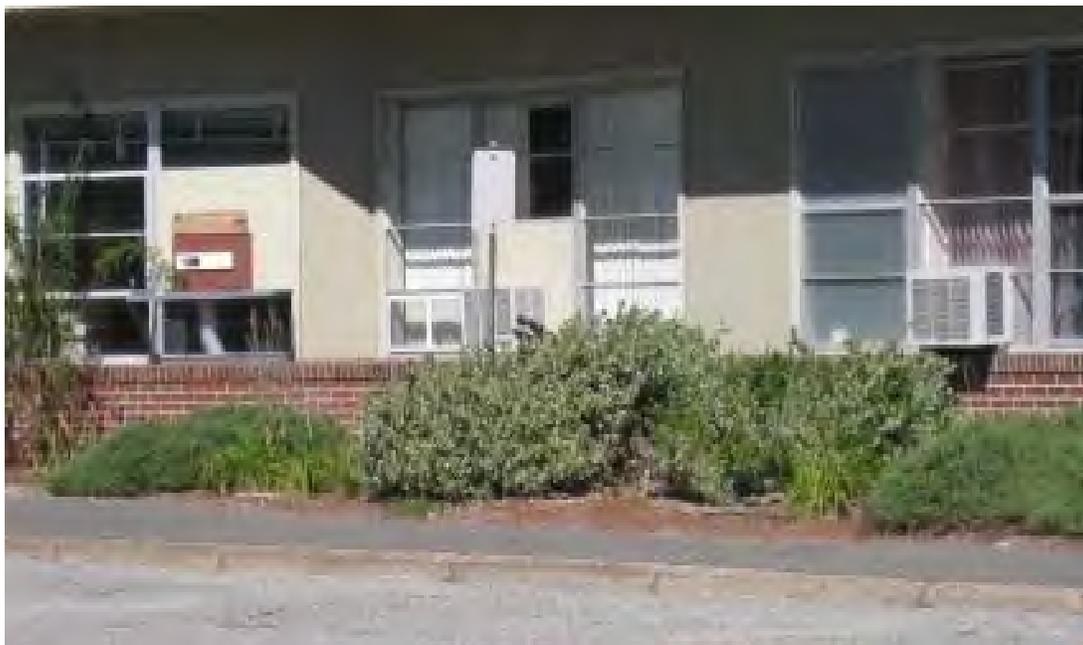
**Picture 22**

Window-mounted air conditioners (ACs) were observed in some areas (Table 1, Picture 22). These units are normally equipped with filters, which should be cleaned or changed as per manufacturer's instructions.

**Window-mounted air-conditioners**

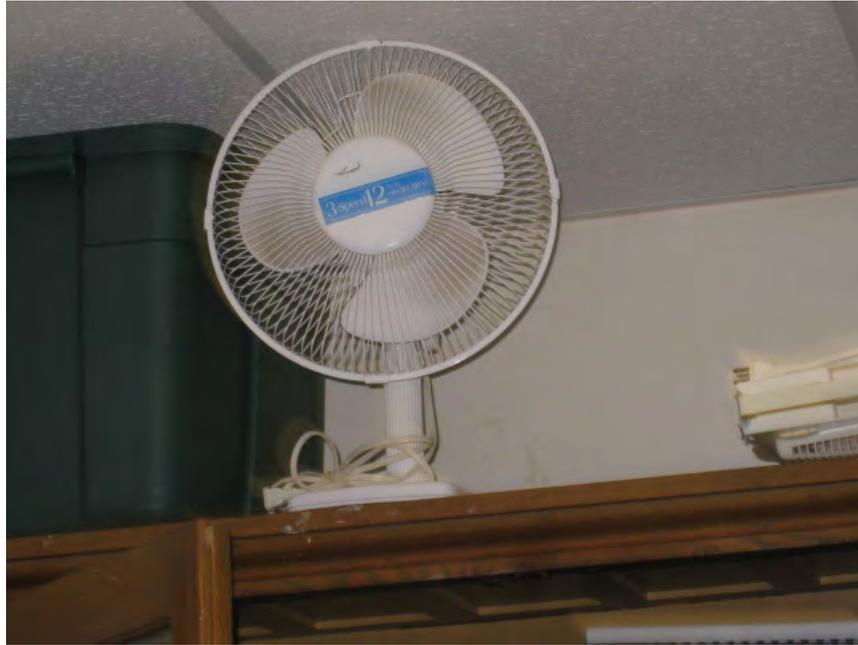
**Picture 23**

A number of air diffusers, exhaust vents and personal fans (Picture 23) were observed to have accumulated dust/debris. These diffusers, vents and fans should be cleaned periodically in order to prevent dust/debris from being aerosolized and redistributed throughout the room.

**Dusty personal fan**
