# **WATER DAMAGE/MOLD INVESTIGATION**

**Massachusetts Department of Transitional Assistance  
160 W. Rodney French Blvd  
New Bedford, Massachusetts**

Prepared by:  
Massachusetts Department of Public Health  
Bureau of Environmental Health  
Indoor Air Quality Program  
March 2014

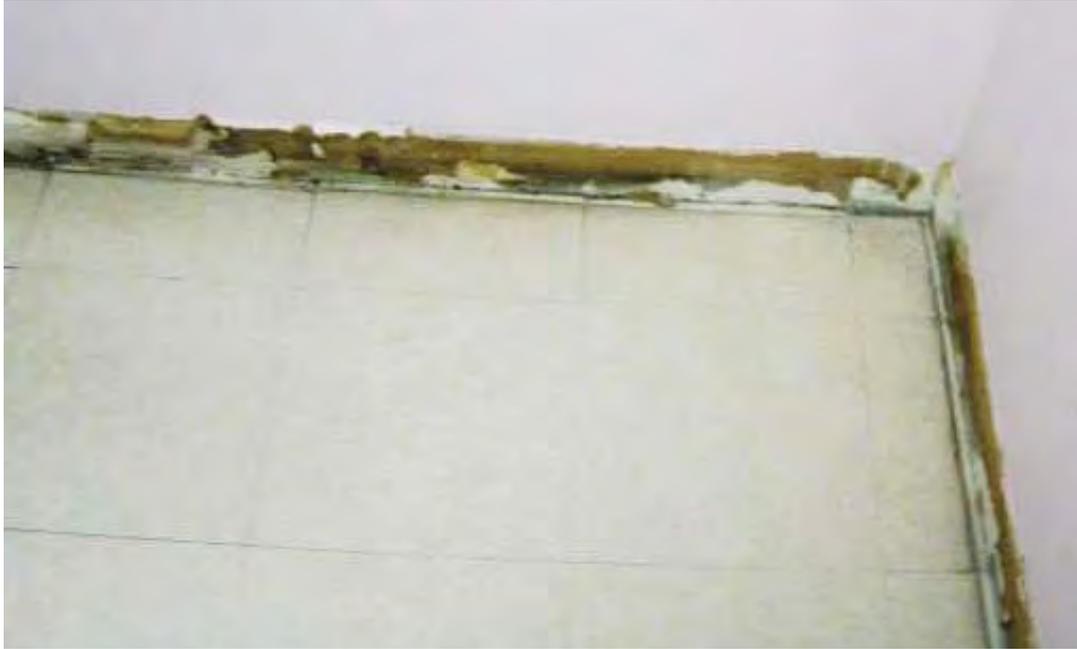
**Picture 1**

At the time of the BEH/IAQ assessment, plans were being made to remove/replace water-damaged GW that resulted from restroom overflows that reportedly occurred in October 2013. These areas were centered around the visitors' restrooms and adjacent office space (Pictures 1 through 4). The carpet installed in office space examined has a water/mold-resistant impermeable material on the underside. Carpeting in the adjacent Assistant Director's office was pulled back to examine conditions beneath it; dark staining was observed that may indicate accumulated dirt/debris that may have gotten wet from moisture trapped beneath the carpet and can serve as a source of mold growth/odors (Picture 4). The area underneath this carpeting should be cleaned.

**Water-damaged gypsum wallboard in visitors' restroom, dark staining indicates likely mold growth**

1. Continue with plans to remove water-damaged/mold-colonized GW in visitors' restrooms and adjacent areas in a manner consistent with recommendations found in "Mold Remediation in Schools and Commercial Buildings" published by the US Environmental Protection Agency (US EPA, 2001).
2. Additional water-damaged/mold-colonized GW (~10-15 feet) outside of work spaces 105-112 along the common wall should also be removed/replaced. If further water-

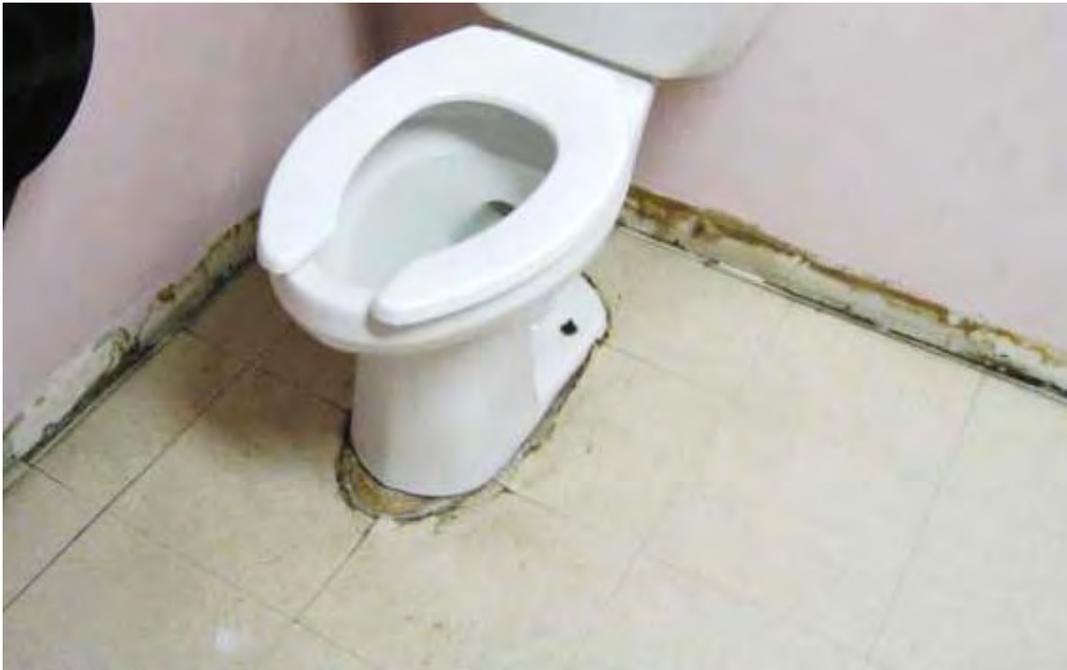
**Picture 2**

**Water-damaged gypsum wallboard in visitors' restroom, dark staining indicates likely mold growth**

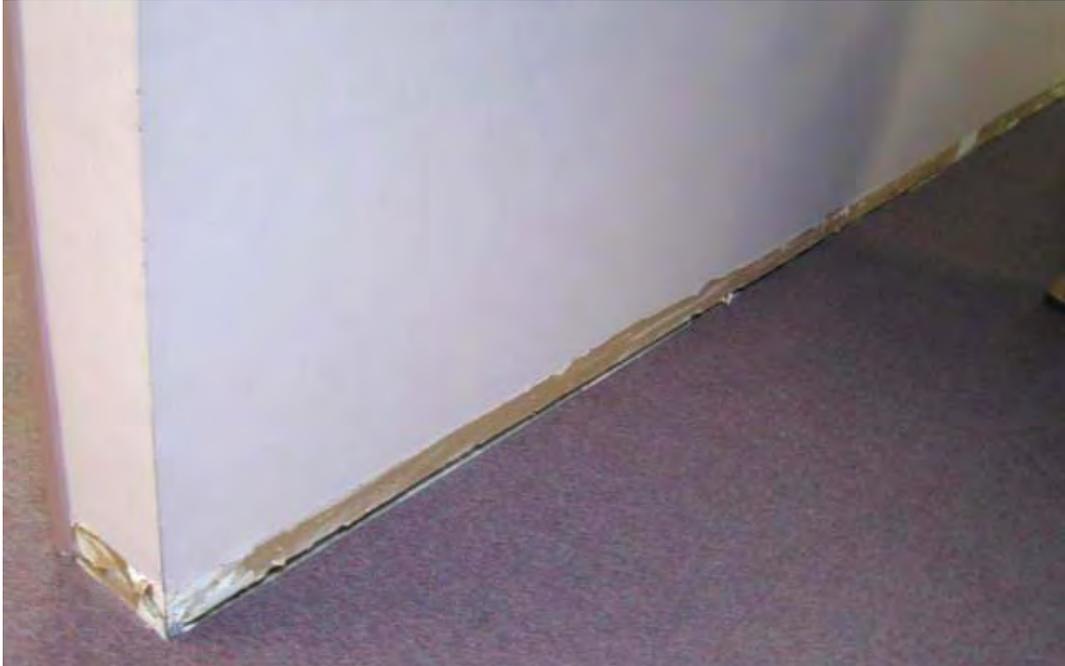
**Picture 3**

**Water-damaged gypsum wallboard in office area adjacent to visitor's restrooms**

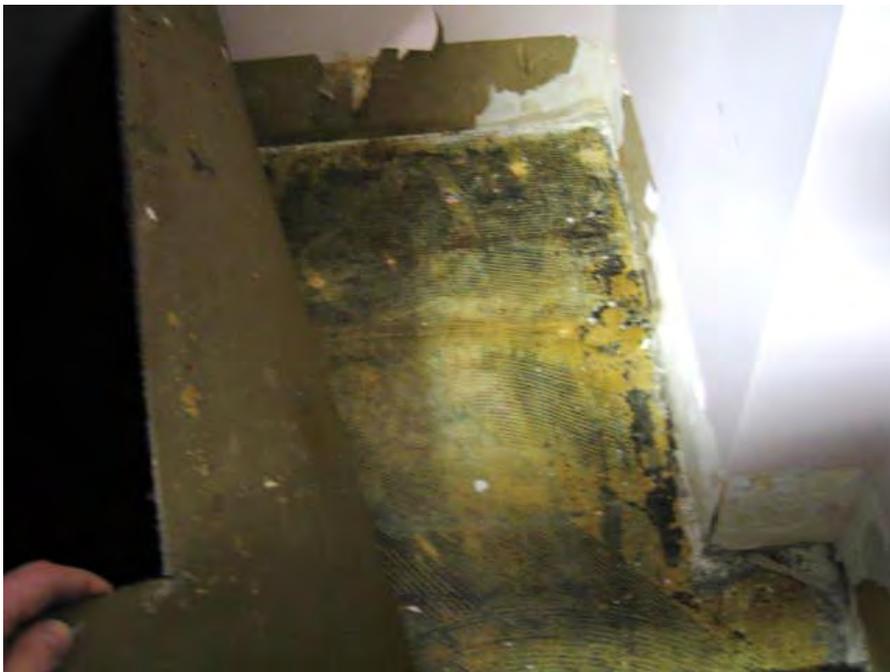
**Picture 4**

**Water-damaged gypsum wallboard in Assistant Director's office adjacent to visitors' restrooms, note dark staining on floor and impermeable barrier on bottom of carpet**

9. Clean beneath carpeting in corner of Assistant Director's office (Picture 4) with an antimicrobial agent.
10. Clean fresh air diffusers, exhaust and return vents on a regular basis; if surrounding ceilings/tiles cannot be cleaned make repairs/replace tiles.

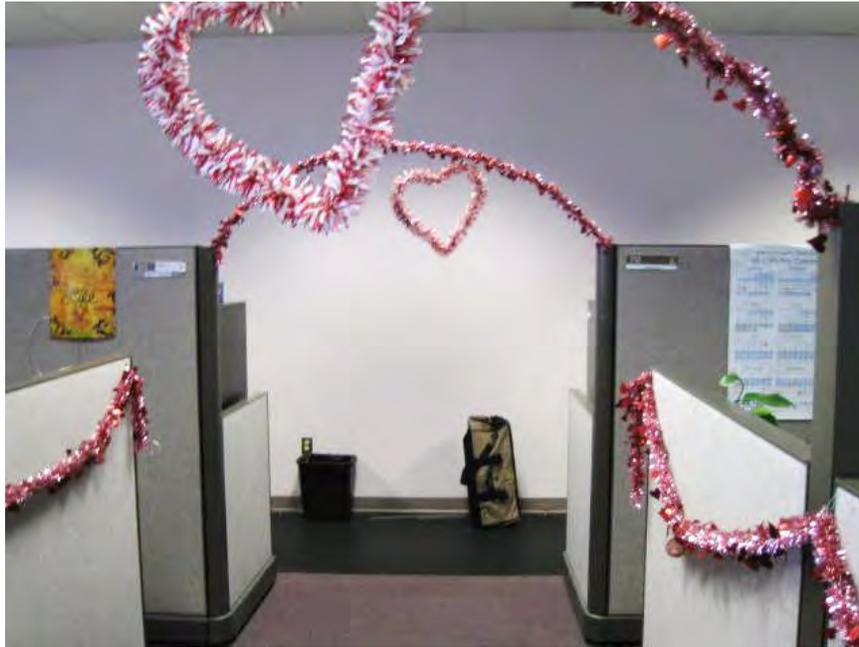
**Picture 5**

During the assessment Ms. Farrell asked BEH/IAQ staff to also examine the common wall that the MDTA shares with the space that formerly contained the laundromat (Picture 5). Although dry at the time of assessment, the vinyl base coving was failing and GW was visibly damaged beneath it (Picture 6). BEH/IAQ staff peeled back vinyl coving in regular intervals along the length of this common wall and found water damage in an approximate 10 to 15-foot section of GW and dark staining, which appeared to be visible mold growth, along the base of the wall (Pictures 7 and 8), presumably from historic water exposure from laundry equipment.

**Long-view of common wall/former laundromat outside work stations 105-112 where water-damaged/mold-colonized gypsum wallboard was found**

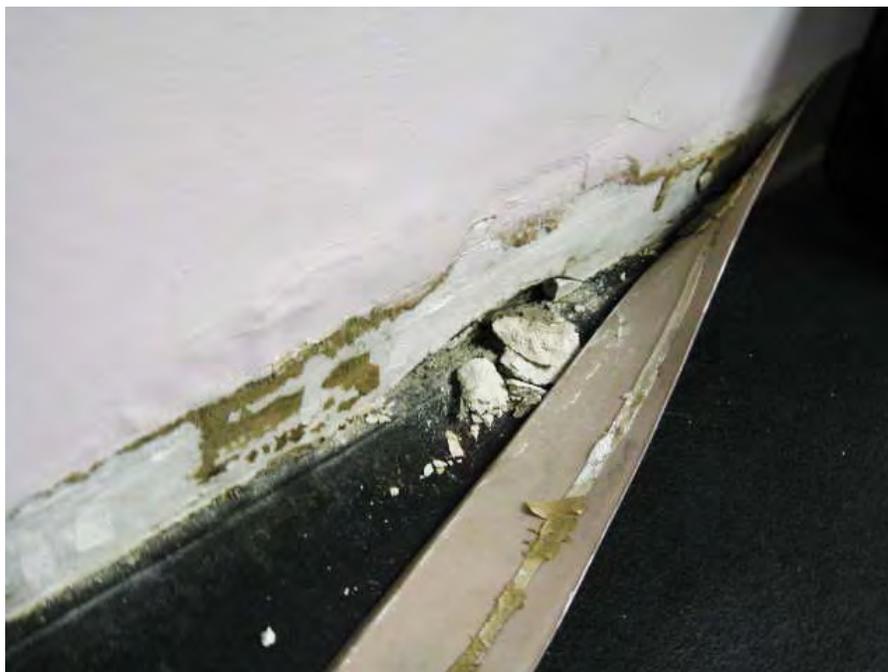
**Picture 6**

**Water-damaged gypsum wallboard along common wall/former laundromat outside work stations 105-112**

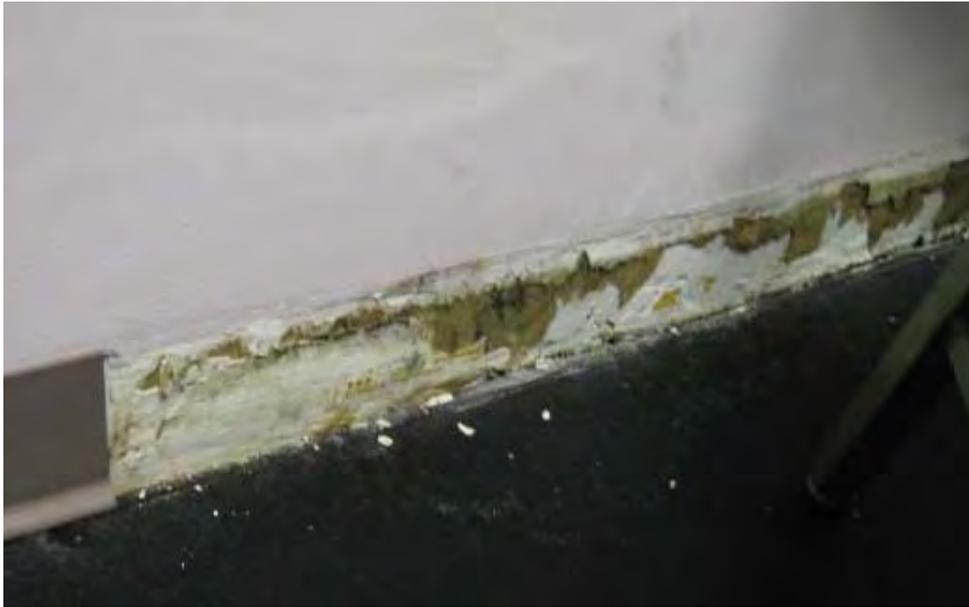
**Picture 7**

**Water-damaged gypsum wallboard along common wall/former laundromat outside work stations 105-112, dark staining indicates likely mold growth**

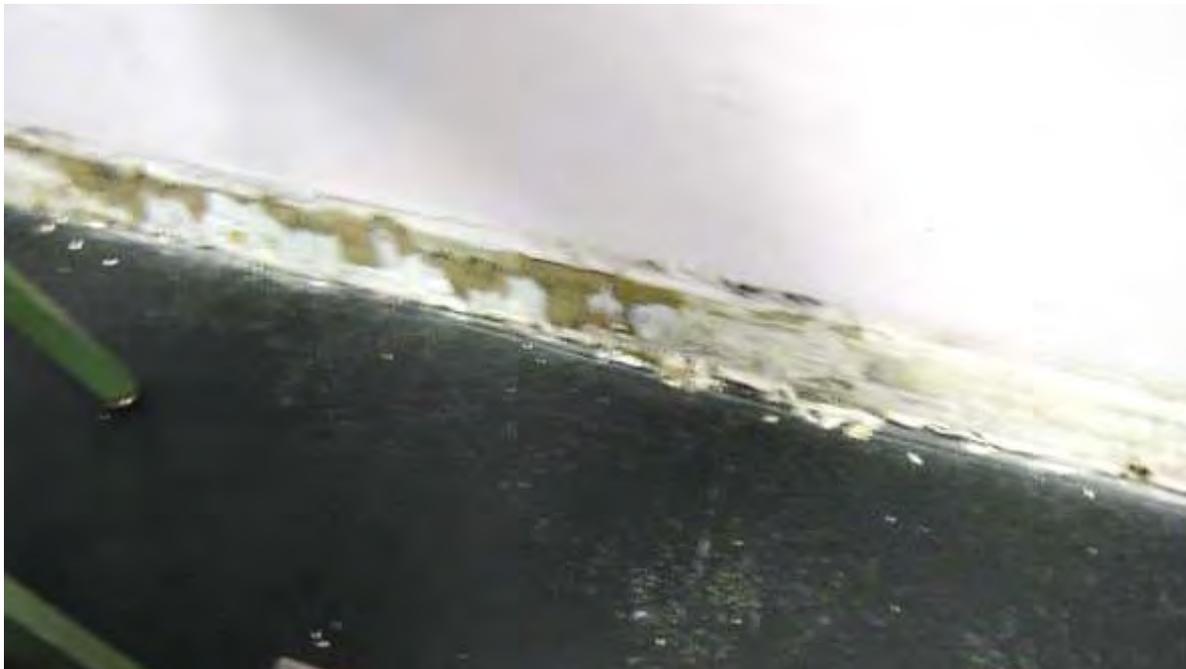
**Picture 8**

**Water-damaged gypsum wallboard along common wall/former laundromat outside work stations 105-112, dark staining indicates likely mold growth**

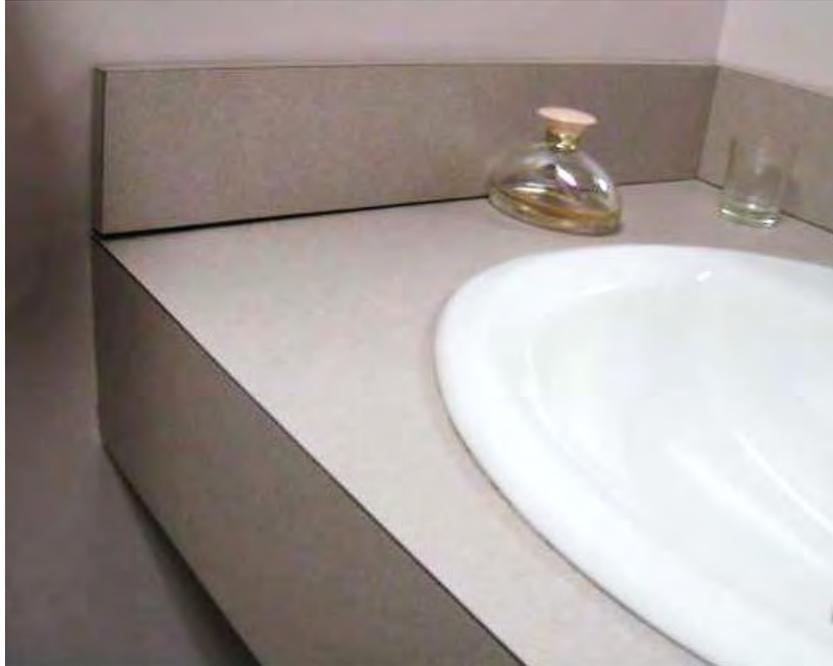
**Picture 9**

Other water-damage issues were noted by BEH/IAQ staff. Open seams between the sink countertop and backsplash were observed in employee restrooms (Picture 9). If seams are not watertight, water can penetrate the seam, causing water damage. Water penetration and chronic exposure of porous and wood-based materials can cause these materials to swell and show other signs of water damage, and can lead to potential mold growth.

**Spaces between sink countertop and backsplash in employee restroom**

12. Seal breaches, seams, and spaces between sink countertops and backsplashes in restrooms to prevent water damage. Consider replacing with a one-piece molded countertop.

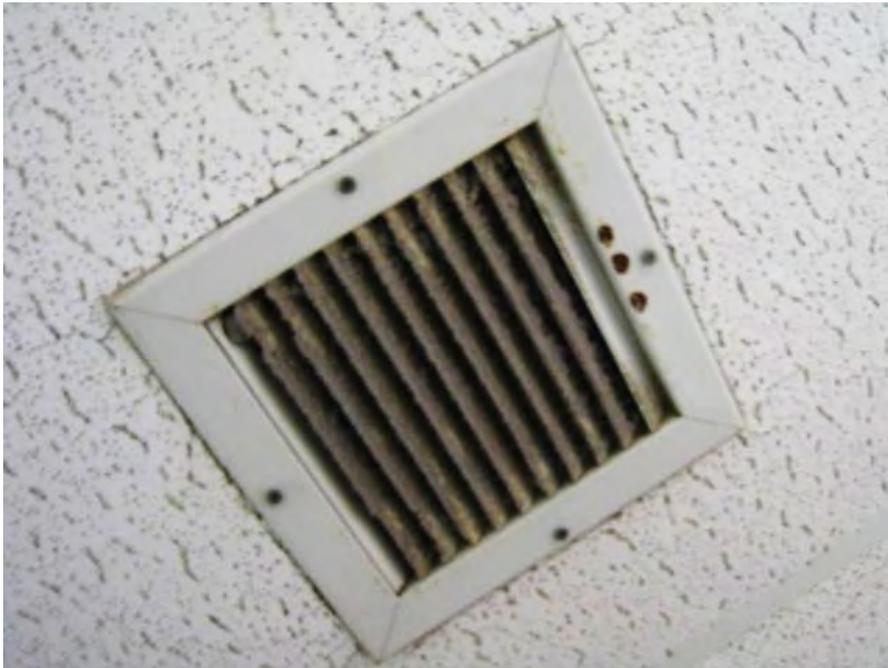
**Picture 10**

Other conditions that can affect indoor air quality were observed during the assessment. A number of supply and exhaust/return vents had accumulated dust/debris accumulation, particularly vents in restrooms (Picture 10). Supply and exhaust vents should be cleaned periodically in order to prevent them from serving as a source of aerosolized particulates.

**Dust/debris accumulation on employee restroom exhaust vent**
