INDOOR AIR QUALITY ASSESSMENT

**Theodore Herberg Middle School
501 Pomeroy Avenue
Pittsfield, Massachusetts**

Prepared by:
Massachusetts Department of Public Health
Bureau of Environmental Health
Indoor Air Quality Program
July 2014

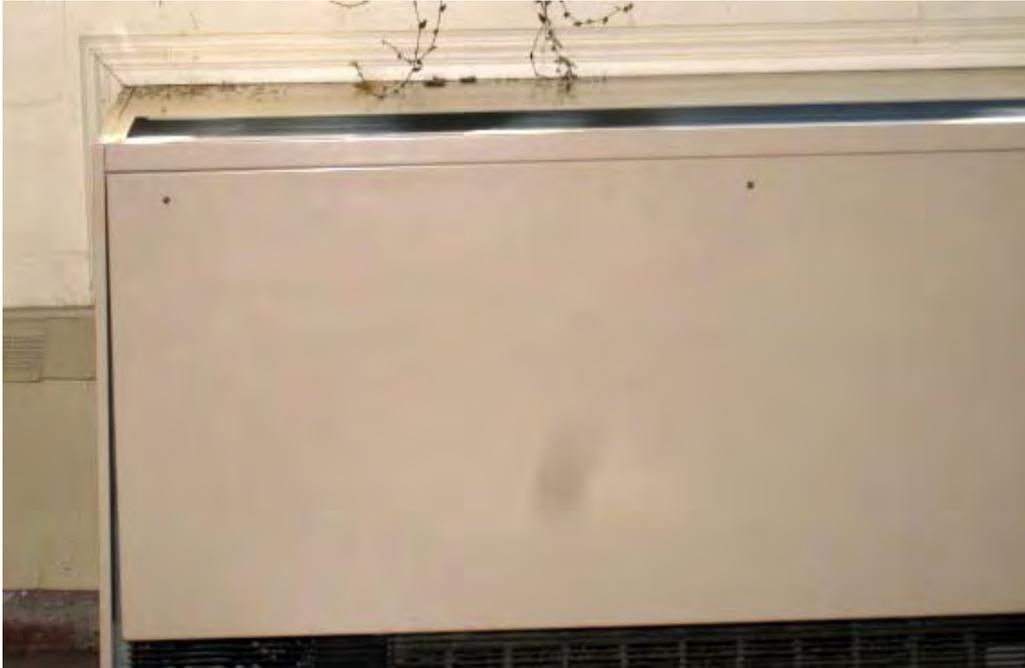
Picture 1

Fresh air to classrooms is supplied by unit ventilator (univent) system (Picture 1). A univent draws air from the outdoors through a fresh air intake located on the exterior wall of the building. Return air from the classroom is drawn through an air intake located at the base of the unit (Figure 1). Fresh and return air are mixed, filtered, heated and provided to classrooms through an air diffuser located in the top of the unit. Univents in several classrooms were found to be obstructed by furniture and other items on top of air diffusers and/or in front of return vents along the bottom of the units (Picture 2). In order for univents to provide fresh air as designed, they must remain on and operating while rooms are occupied. Furthermore, units must remain free of obstructions.

Classroom univent

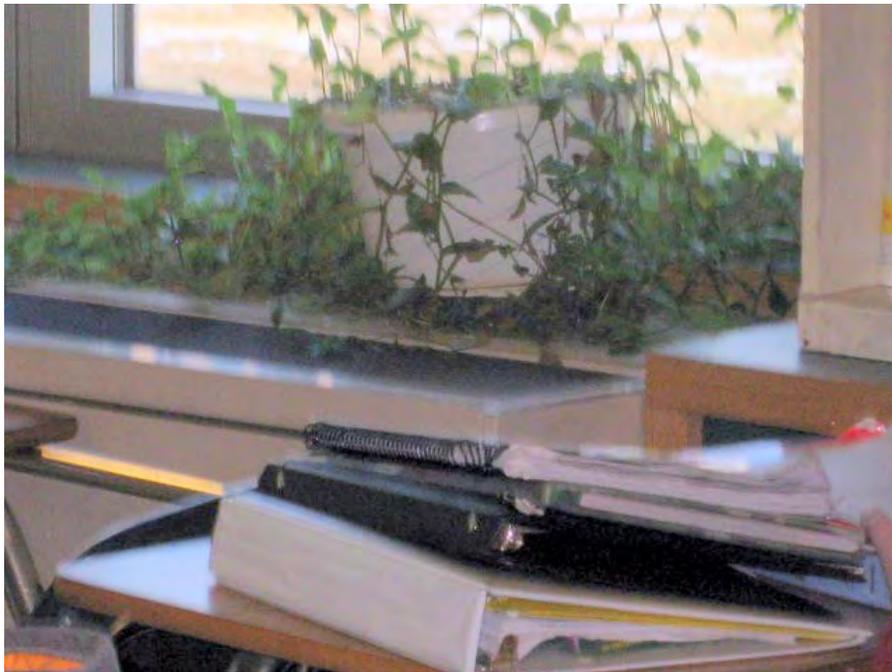
Picture 2

Univent blocked by desk and materials

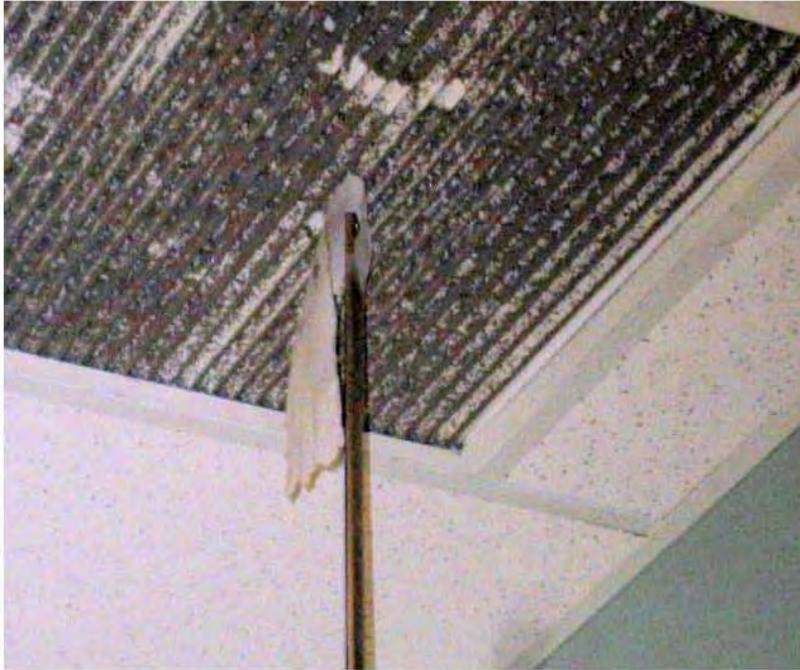
Picture 3

Dust/debris was observed accumulated on univents cabinets, exhaust vents (Picture 3), as well as on the fan blades of personal fans. If rooftop exhaust motors are deactivated, back-drafting can occur, and materials accumulated on the exhaust vent can be re-aerosolized into occupied areas. Vents and fans should be cleaned periodically to prevent dust/debris from being aerosolized and redistributed throughout the room. Univents should be kept free of any foreign materials which may impair function or distribute contaminants and odors throughout the classroom.

Dirty exhaust vent (note: not drawing air)

18. Clean dry-erase marker trays of accumulated dust and debris regularly using a damp cloth.
19. Clean exhaust/supply vents and personal fans periodically of accumulated dust/debris.

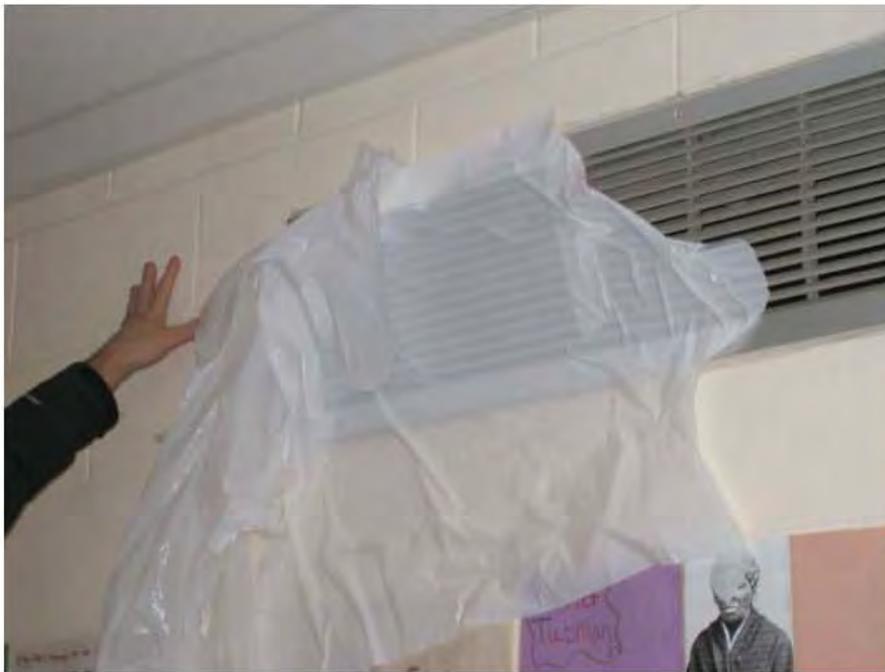
Picture 4

Mechanical ventilation for some areas of the building (science, media/technology, library, theater/stage and administrative) is provided by air-handling units (AHUs). Fresh air is drawn through air intakes on the exterior of the building and distributed via ceiling-mounted diffusers. Air is ducted back to AHUs via ceiling or wall-mounted return vent. Of note, BEH/IAQ staff observed an exhaust vent in Room 202 that was covered with plastic and tape (Picture 4). The plastic should be removed to ensure adequate air flow in this space.

Exhaust vent covered with plastic

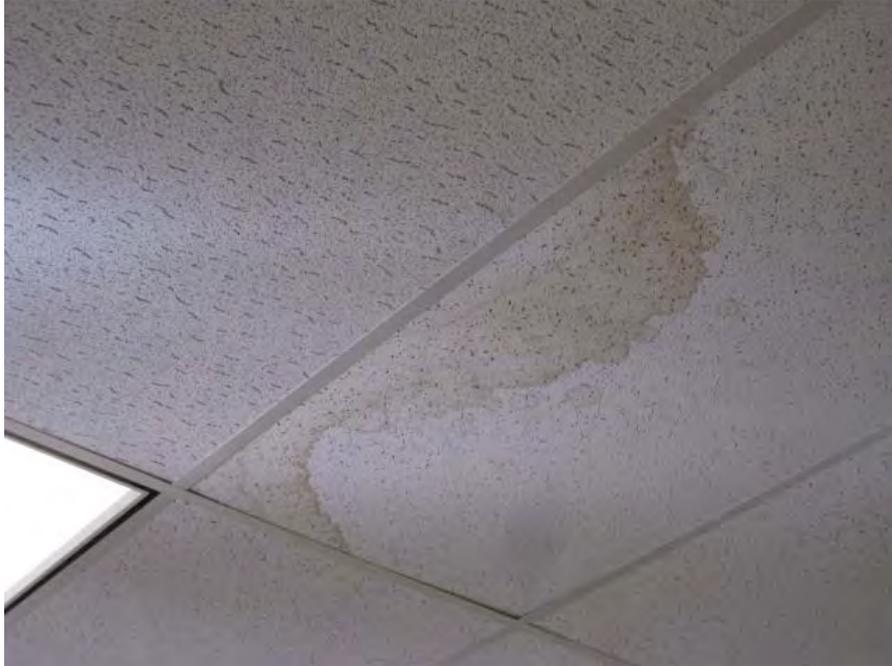
Picture 5

Water-damaged ceiling tiles were found in several rooms (Table 1; Picture 5). Water-damaged ceiling tiles indicate leaks from either the roof or plumbing system. If repeatedly moistened, ceiling tiles can be a medium on which mold can grow. Water-damaged tiles should be replaced after a water leak is discovered and repaired.

Water-damaged ceiling tile

7. Replace all water-damaged, missing and ajar ceiling tiles. Monitor for future leaks.
8. Inspect the ceiling in Classroom A for water damage and/or degraded insulation/sealant. Repair as needed.

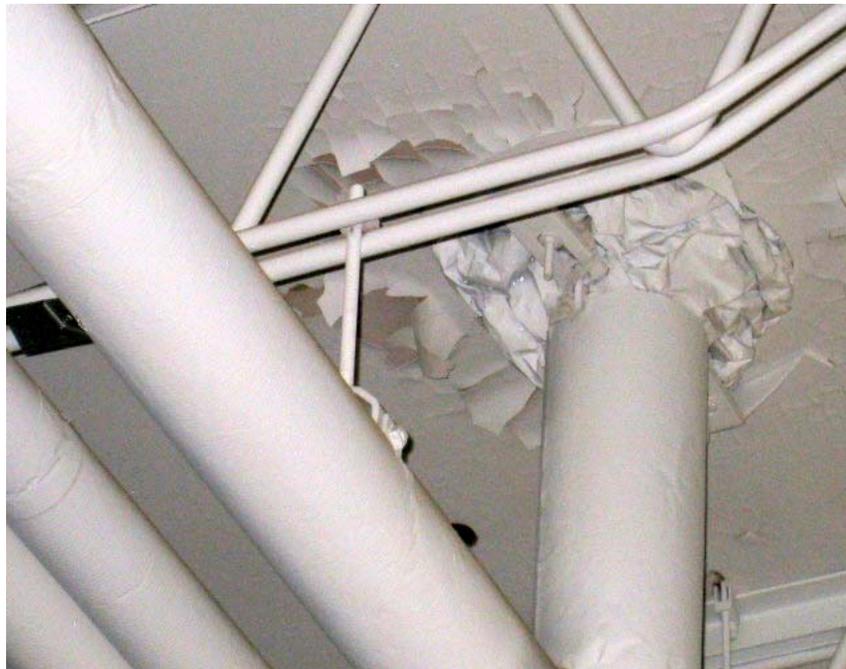
Picture 6

Peeling plaster and paint was noted in the ceiling surrounding utility pipes and the exhaust vent in Classroom A (Picture 6). BEH/IAQ staff observed the space where the exhaust vent meets the roof line, which was filled with a spray foam sealant material, as reported by Pittsfield School Department staff. Spray foam sealant is not an appropriate mater to seal water leaks. The area should be inspected for water damage and repaired as needed including use of an appropriate sealant.

Peeling paint and plaster (note material surrounding ductwork)

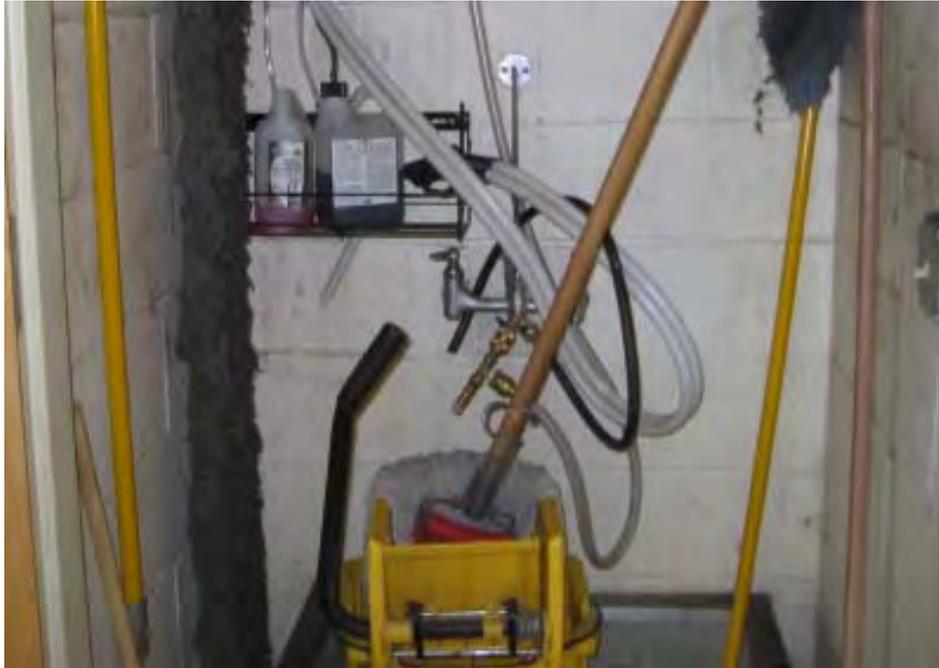
Picture 7

A strong musty odor was noted outside of a custodial closet on the first floor. Mops were found to be wet and mop buckets contained standing water (Picture 7). Both standing water and wet mops can serve as mediums for bacteria, mold growth and result in odors. Mop buckets

Custodial closet with wet mop and standing water in bucket

should be emptied and dried after use. Mop heads should be dried as soon as practicable following use and cleaned regularly to prevent mold growth and associated odors.

9. Empty and rinse mop buckets after each use. Mops should be cleaned, disinfected and set up to dry between uses.
10. Ensure plants have drip pans and avoid over-watering. Examine drip pans periodically for mold growth. Disinfect with an appropriate antimicrobial where necessary. Remove plants from univent air diffusers.

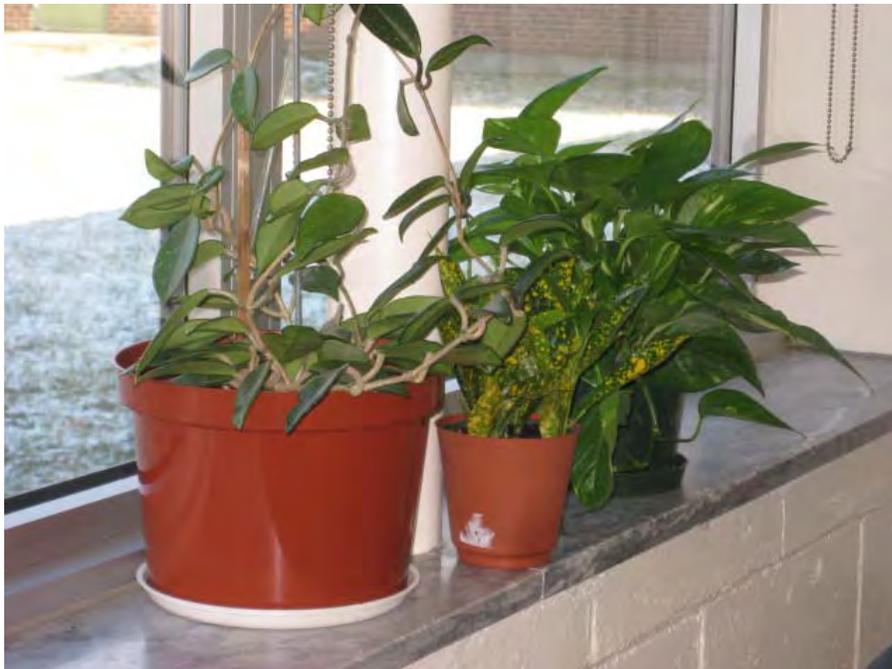
Picture 8

Plants were observed in several rooms (Table 1, Picture 8). Plants, soil and drip pans can serve as sources of mold growth. Plants can also be a source of pollen. Plants should not be placed on porous materials, since water damage to porous materials may lead to microbial growth.

Plants in classroom

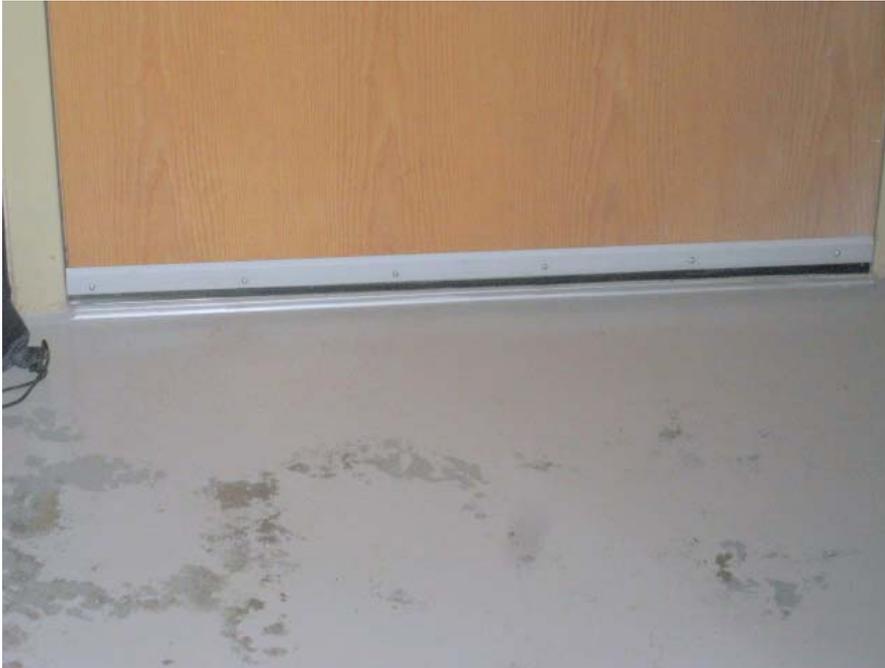
Picture 9

During the May 24, 2013 visit, school officials reported periodic episodes of propane/gas-like odors in Classroom A which is adjacent to the boiler room. BEH/IAQ staff observed holes and gaps surrounding utility pipes that penetrate the common wall of the boiler room and the classroom space. As these breaches can serve as pathways for air, odors and particulates to migrate from the boiler room into the classroom and it was recommended that all gaps and holes in this area be sealed with appropriate fire-resistant materials. In addition, the boiler room access door exists in this room. Light could be seen penetrating through the space underneath this door, indicating it is not airtight. As previously recommended in Appendix A, a door sweep and weather-stripping should be installed to render it airtight. According to the school officials, remediation efforts were complete following the May 24, 2013 MDPH visit. During the January 17, 2014 visit, BEH staff observed that the doorway to the boiler room had a door sweep and weather stripping installed (Picture 9). It was not known if the remediation efforts to seal all breaches in the boiler room walls had been completed. In addition, school officials reported that school staff routinely use the emergency exit exterior door located in Classroom A to enter and exit the building. BEH/IAQ recommended that this door be kept closed except for

Boiler room door with door sweep

11. Discourage regular use of emergency exit door in Classroom A and keep door closed.

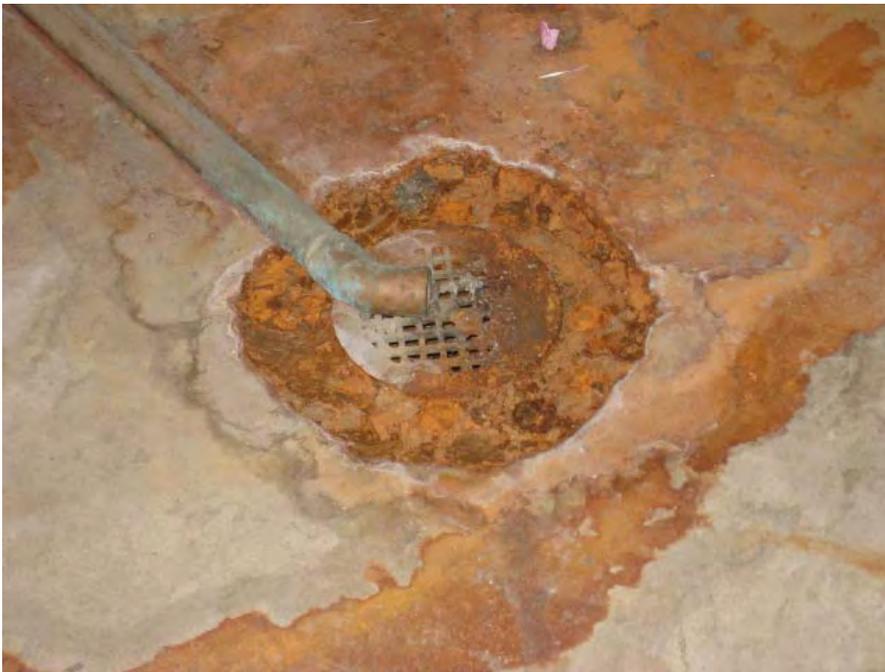
Picture 10

Another area of concern was Room A140, where there were reported complaints of odors by school staff. As there was no identifiable source of the odors in the classroom itself, BEH/IAQ staff inspected the mechanical room directly above Room A140 which houses one of the main AHUs for the building. AHUs that provide air-conditioning require the installation of condensation drains to prevent water build up inside the casing and ductwork. The condensation drain for this unit terminates above a floor drain that is connected to the building drainage system (Picture 10). Drains are typically designed with traps to prevent sewer odors/gases from penetrating into occupied spaces. During air-conditioning operation, condensation enters the drain and the trap fills to form a watertight seal. Both the floor drains and condensation drains have traps. During the heating season, AHUs do not produce condensation, and the traps dry out. This AHU was found to be drawing air into the unit through the condensation drain and floor drain (Picture 11), which was observed to be corroded with scale and debris, thus distributing moisture and odors from the drain into the rest of the building. In order to maintain the watertight seal, water should be poured down the drain routinely (i.e. every other day) during the heating season or the drains should be sealed during the heating season.

AHU condensation pipe terminating over floor drain (note scale and debris)

12. Pour water down the floor drain of the mechanical room every 2- 3 days to ensure a water tight seal during the heating season or temporarily seal the drains.

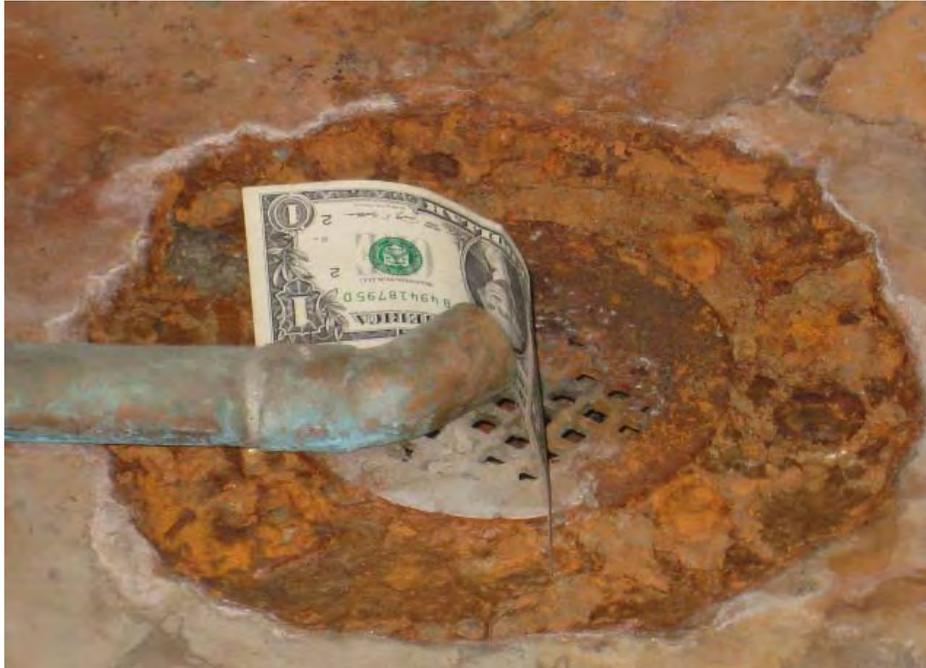
Picture 11

Condensation pipe and floor drain drawing air (depicted with dollar bill)

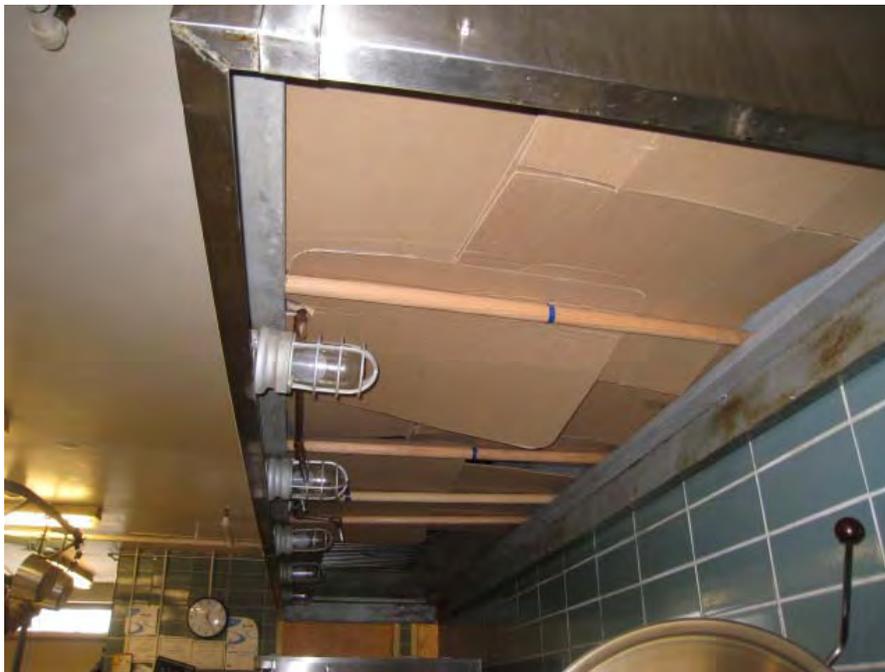
Picture 12

The kitchen exhaust hood was not operating and was blocked with cardboard (Picture 12). The ovens and other appliances are fueled with natural gas. Kitchen exhaust vents must be functioning to prevent odors, vapors and products of gas consumption from migrating from the kitchen into surrounding areas.

Kitchen hood blocked with cardboard

15. Repair the kitchen hood exhaust vent to allow for removal of cooking pollutants from the building. Inspect exhaust ductwork for integrity and seal any breaches/seams as necessary.

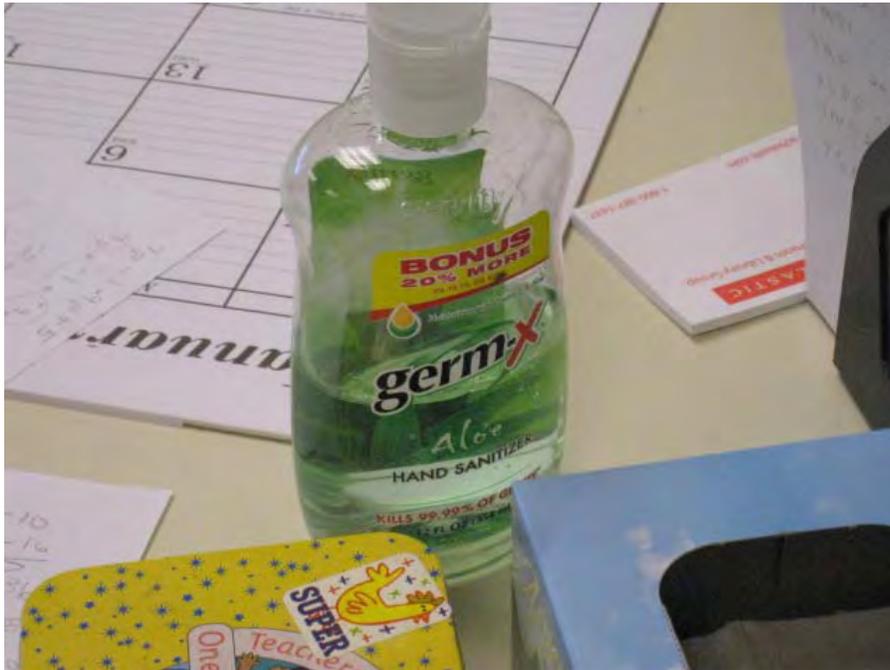
Picture 13

Hand sanitizer was observed in some areas (Table 1, Picture 13). Hand sanitizer products may contain ethyl alcohol and/or isopropyl alcohol which are highly volatile and may be irritating to the eyes and nose, and may also contain fragrances to which some people may be sensitive.

Hand sanitizer

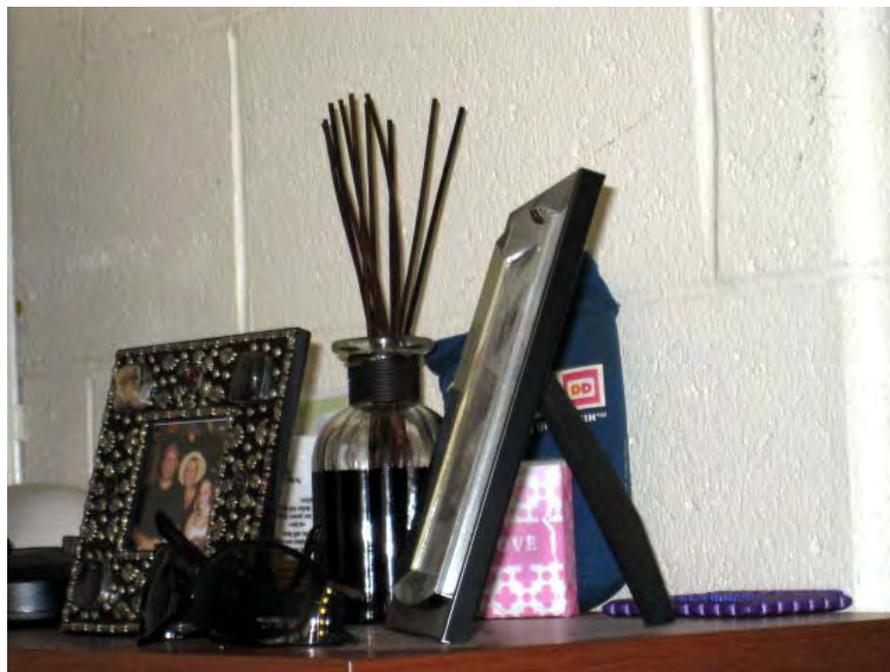
Picture 14

Air deodorizing materials (scented incense sticks in oil) were observed in one classroom (Picture 14). Air deodorizers contain chemicals that can be irritating to the eyes, nose and throat of sensitive individuals. Many air fresheners contain 1, 4-dichlorobenzene, a VOC which may cause reductions in lung function (NIH, 2006). Furthermore, deodorizing agents do not remove materials causing odors, but rather mask odors that may be present in the area.

Scented incense sticks

16. Refrain from using strongly scented materials (e.g., air fresheners/deodorizers) in classrooms.
17. Replace tennis balls on chair legs with latex-free glides.

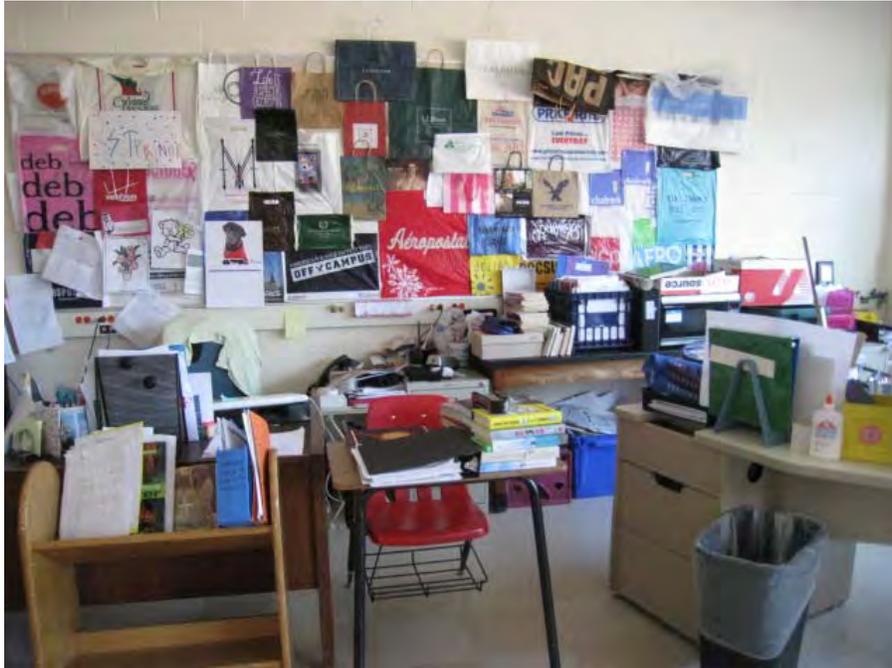
Picture 15

In several rooms, items were observed on floors, windowsills, tabletops, counters, bookcases and desks. Large number of items stored in occupied areas provides a source for dusts to accumulate (Picture 15). These items (e.g., papers, folders, boxes) make it difficult for custodial staff to clean. Items should be relocated and/or be cleaned periodically to avoid excessive dust build up.

Classroom cluttered with material and items

20. Relocate or consider reducing the amount of stored materials to allow for more thorough cleaning. Clean items regularly with a wet cloth or sponge to prevent excessive dust build-up.

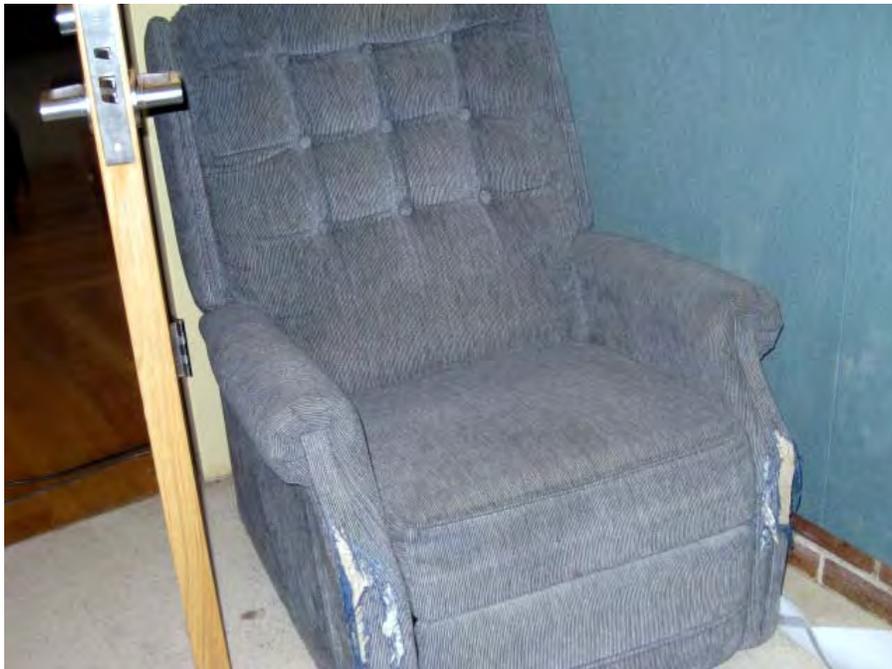
Picture 16

An upholstered chair was observed in one classroom (Picture 16). Upholstered furniture pillows and cushions are covered with fabrics that are exposed to human skin. This type of contact can leave oils, perspiration, hair and skin cells. Dust mites feed upon human skin cells and excrete waste products that contain allergens. In addition, if relative humidity levels increase above 60 percent, dust mites tend to proliferate (US EPA, 1992). In order to remove dust mites and other pollutants, frequent vacuuming of upholstered furniture is recommended (Berry, 1994). It is also recommended that upholstered furniture (if present in schools), be professionally cleaned on an annual basis. If an excessively dusty environment exists due to outdoor conditions or indoor activities (e.g., renovations), cleaning frequency should be increased (e.g., every six months) (IICRC, 2000).

Upholstered chair

21. Clean upholstered furniture/pillows/cushions and area rugs annually. If not feasible, consider removal.
22. Refer to resource manuals and other related indoor air quality documents for further building-wide evaluations and advice on maintaining public buildings. These materials are located on the MDPH's website: <http://mass.gov/dph/iaq>.
