MOLD ASSESSMENT

**Wollaston Elementary School
205 Beale Street
Quincy, MA 02170**

Prepared by:
Massachusetts Department of Public Health
Bureau of Environmental Health
Indoor Air Quality Program
January 2014

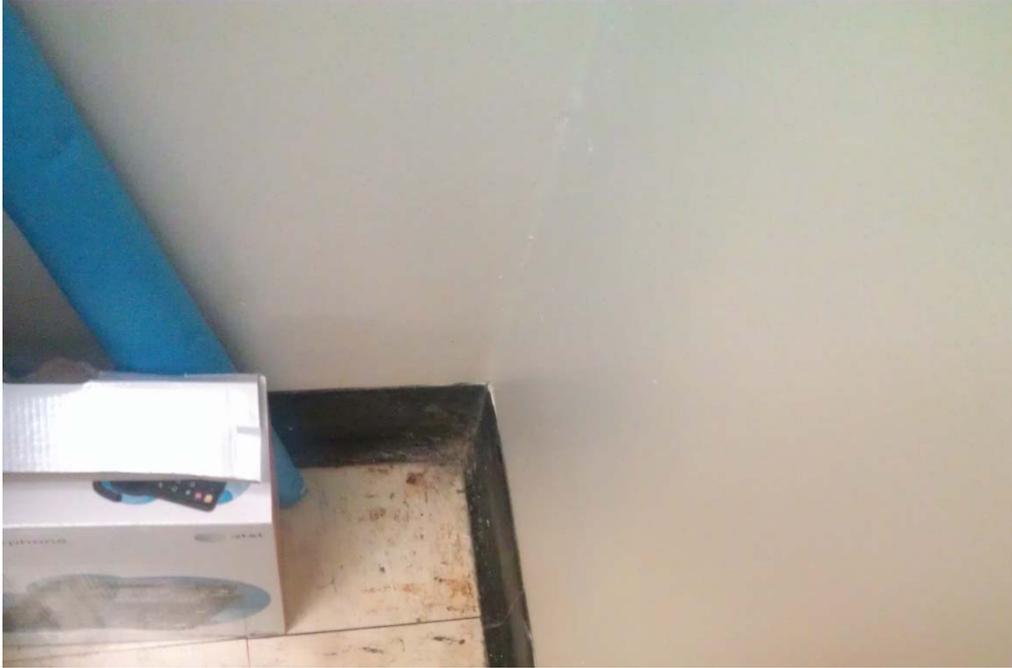
Picture 1

BEH/IAQ staff examined gypsum wallboard (GW) in basement-level offices and classrooms. Water damage was observed on GW in some areas, particularly in a suite of offices including the Guidance office (Picture 1). Mold growth was observed on GW underneath plastic wall coving, which was removed for inspection (Picture 2). Using a moisture meter, BEH/IAQ staff also determined GW in these areas had elevated moisture levels.

Water-damaged GW, note bubbled paint and stained floor tiles

1. Remove water-damaged GW in accordance with the recommendations outlined by the EPA (2001) guidance: “Mold Remediation in Schools and Commercial Buildings”.

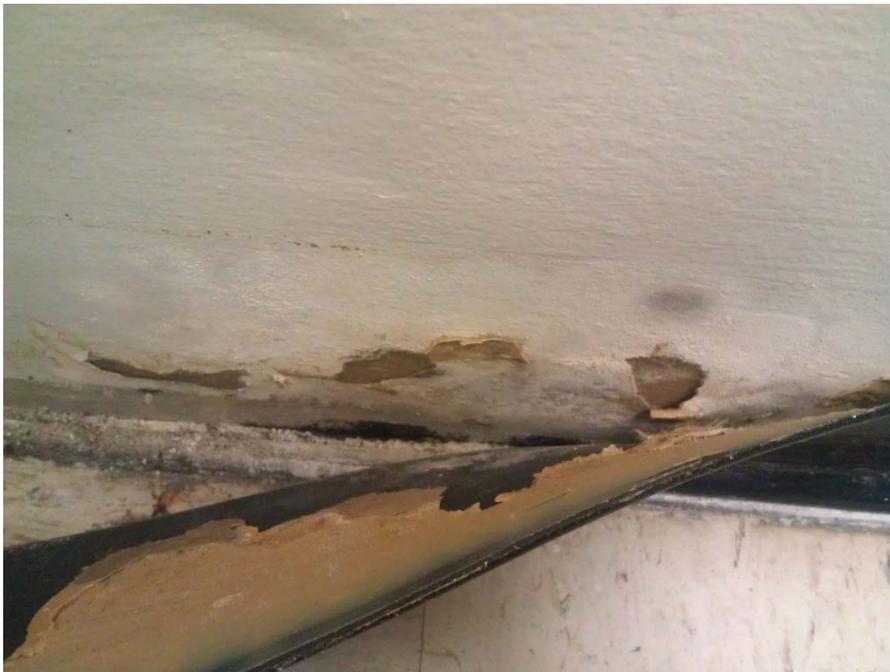
Picture 2

Mold growth behind plastic coving
