INDOOR AIR QUALITY REASSESSMENT

**Winthrop Middle School
151 Pauline Street
Winthrop, Massachusetts**

Prepared by:
Massachusetts Department of Public Health
Bureau of Environmental Health
Indoor Air Quality Program
August 2014

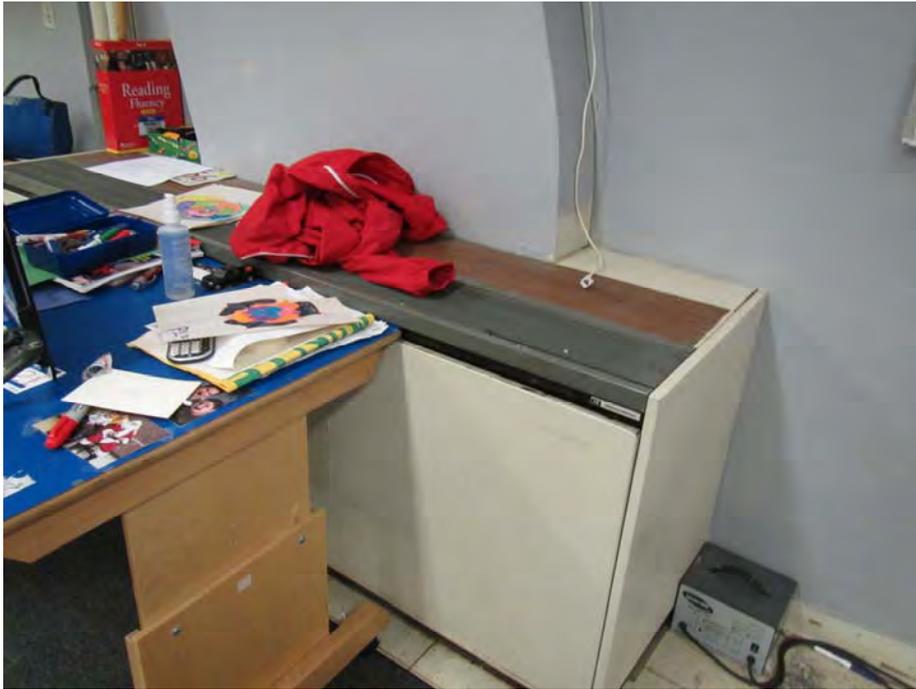
Picture 1

Fresh air to exterior classrooms is supplied by unit ventilator (univent) systems (Picture 1). A univent draws air from the outdoors through a fresh air intake located on the exterior wall of the building (Picture 2). Return air from the classroom is drawn through an air intake located at the base of the unit (Figure 1). Fresh and return air are mixed, filtered, heated and provided to classrooms through an air diffuser located in the top of the unit. As mentioned, the majority of univents were found deactivated at the time of the assessment (Picture 3; Table 1). In addition, some univents were found obstructed by furniture and other items on top of air diffusers and/or in front of return vents along the bottom of the units. Some univent covers were ajar (Picture 1). Other univents had what appeared to be replacement diffusers consisting of a metal panel with holes drilled in it (Picture 4). This non-standard part may not be able to supply adequate fresh air and may also cause backpressure, which can damage the univent. In order for univents to provide fresh air as designed, they must remain “on” and operating while rooms are occupied and remain free of obstructions.

Typical univent, note obstructions, ajar cover, items on top

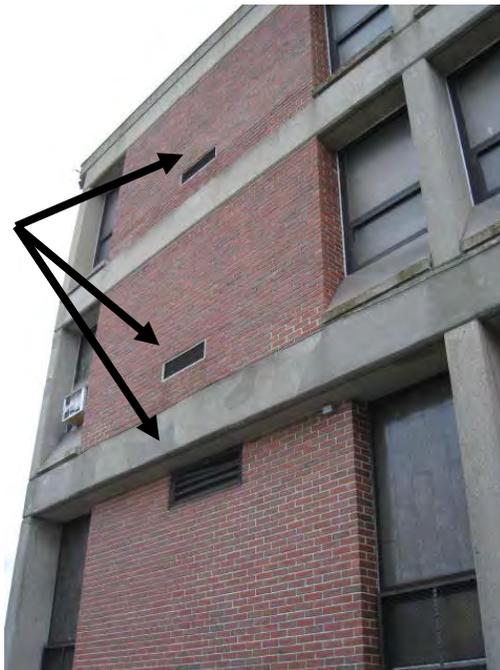
Picture 2

Univent fresh air intakes (arrows)

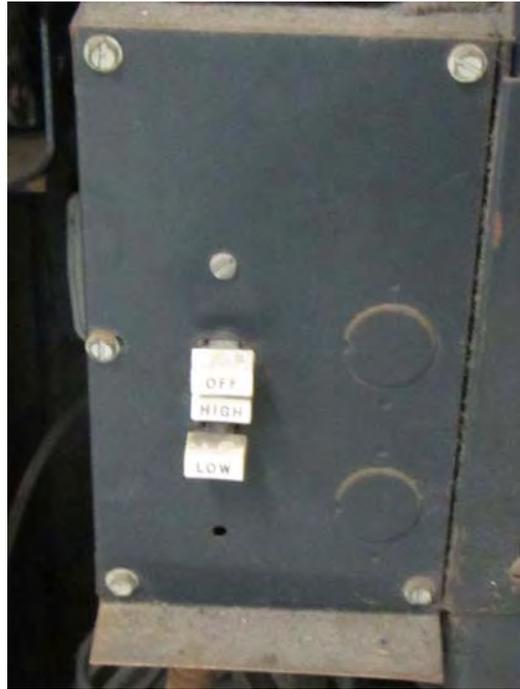
Picture 3

Univent controls, univent is off

1. Complete the recommendations from the 2013 report (Appendix A).
2. Operate all ventilation systems throughout the building including univents and interior classroom HVAC systems *continuously* during periods of occupancy to maximize air exchange, particularly given the high levels of carbon dioxide documented in numerous areas of the school.

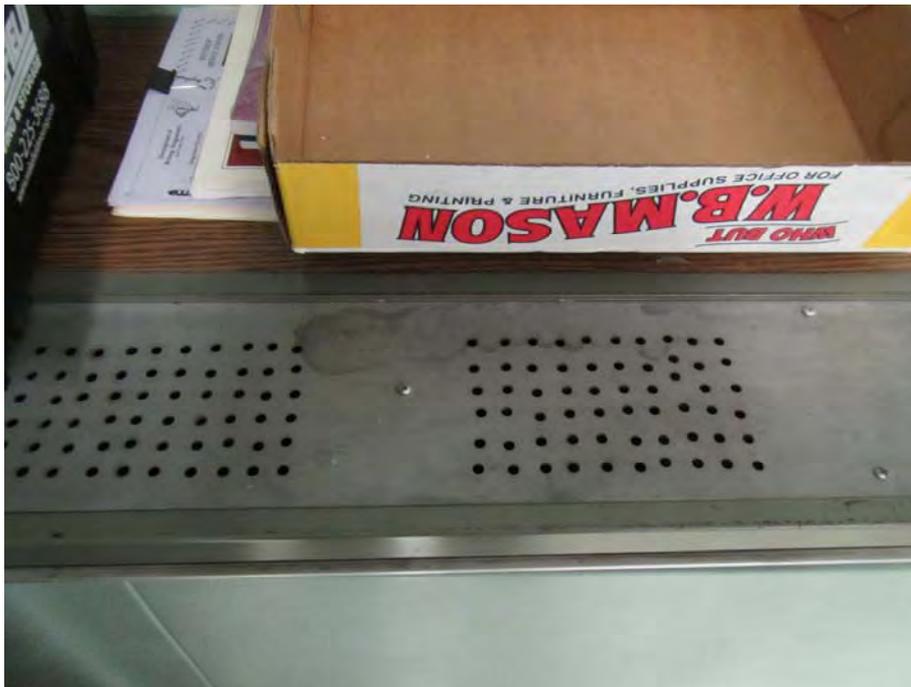
Top of univent showing non-standard replacement diffuser

3. Consult with an HVAC engineering firm regarding the feasibility of repair vs. replacement of ventilation system components given their age. In the interim, work with an HVAC engineering firm to adjust/repair univents and exhaust vents to improve air exchange in classrooms. This should include replacement of the makeshift air diffusers such as those shown in Picture 4 with standard ones.

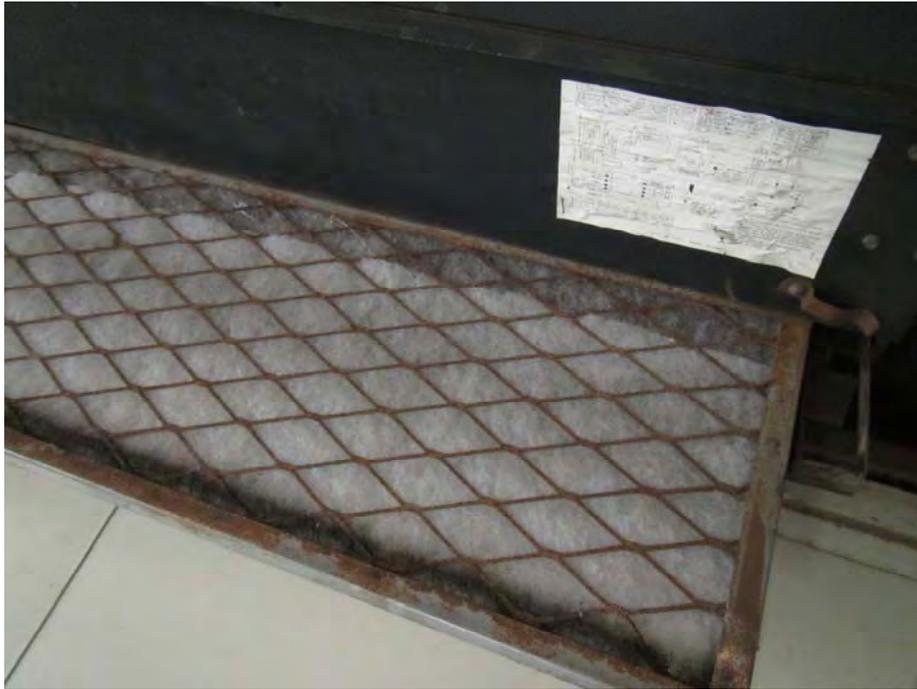
Picture 5

Univalent filter medium in lattice cage, note rust/deterioration of cage

6. Consult with a ventilation contractor to evaluate and repair the kitchen exhaust hood.
7. Consider replacing metal filter racks with proper fitting disposable filters with an equal or greater dust-spot efficiency to eliminate the time needed to replace filters from bulk material rolls. Prior to any increase of filtration, each piece of air handling equipment should be evaluated by a ventilation engineer as to whether it can maintain function with

- more efficient filters. The time saved through this measure may allow an increased frequency of filter changes; changing filters 2-4 times a year is recommended.

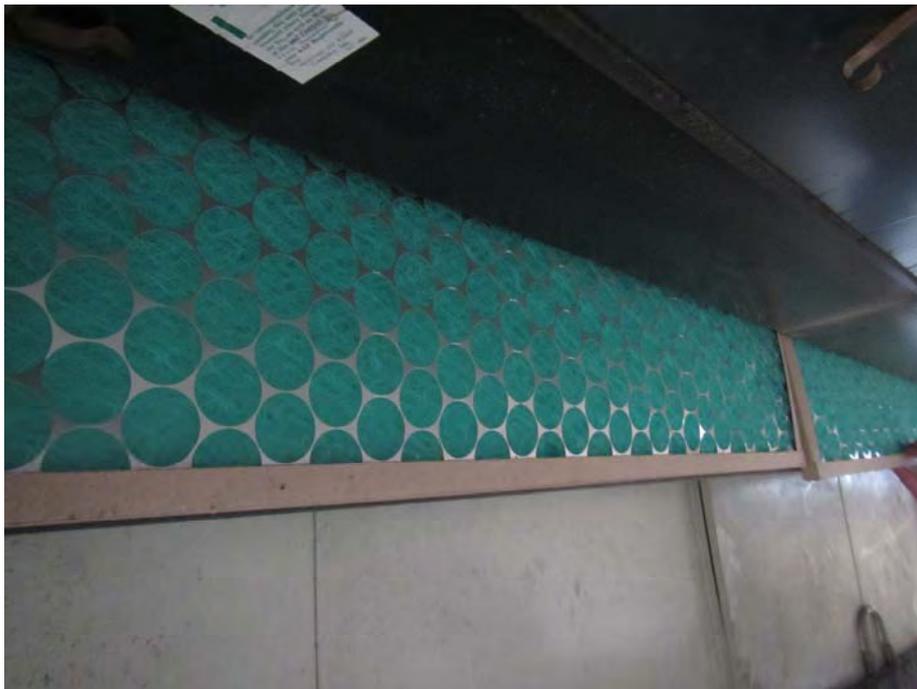
Picture 6

its standard for a dust spot efficiency of a minimum of 40% would be sufficient to reduce airborne particulates (MEHRC, 1997; ASHRAE, 1992). Note that increased filtration can reduce airflow produced by an air handling unit (AHU) or univent due to increased resistance. Prior to any increase of filtration, each unit should be evaluated by a ventilation engineer as to whether it can maintain function with more efficient filters. In one of the univents examined, disposable filters were found to be installed, however these were observed to be of a very low efficiency type (Picture 6), which do not remove significant amount of particulates.

Disposable filter in univalent cabinet; this type of filter has a very low dust spot efficiency

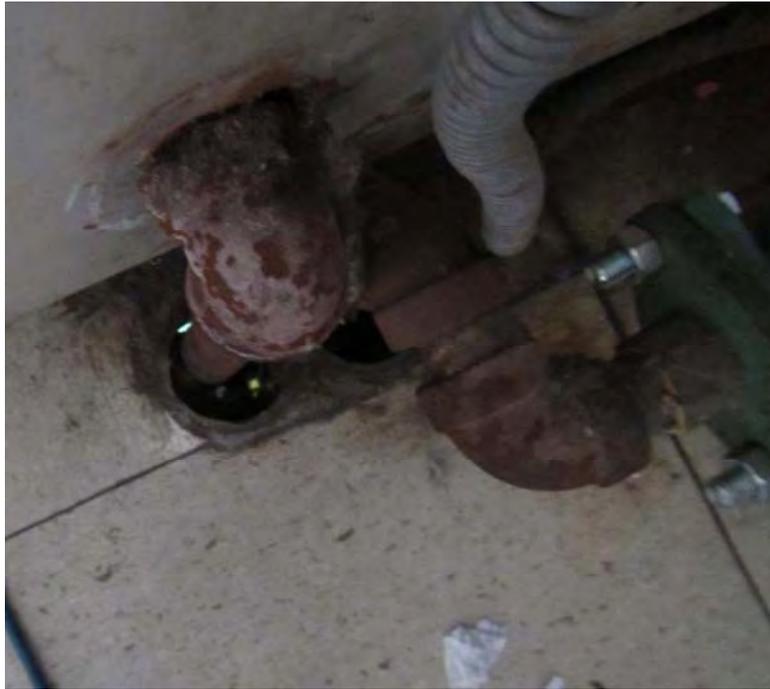
Picture 7

Some of the univents examined had dust and debris accumulated inside cabinets and on radiator fins. This material should be removed through vacuuming during regular filter changes. Spaces were also observed around pipes leading to univent cabinets (Picture 7). In addition, some of the gaps in the rear of univent cabinets had been blocked/filled with what appeared to be insulation batting, which is not only ineffective in blocking air through the gaps, but can also be a source of particulates. These gaps should be sealed with an appropriate fire-rated material to prevent the draw of odors and materials from other areas of the building into the univent.

Pipe to univent cabinet with spaces (see light) around it to floor below

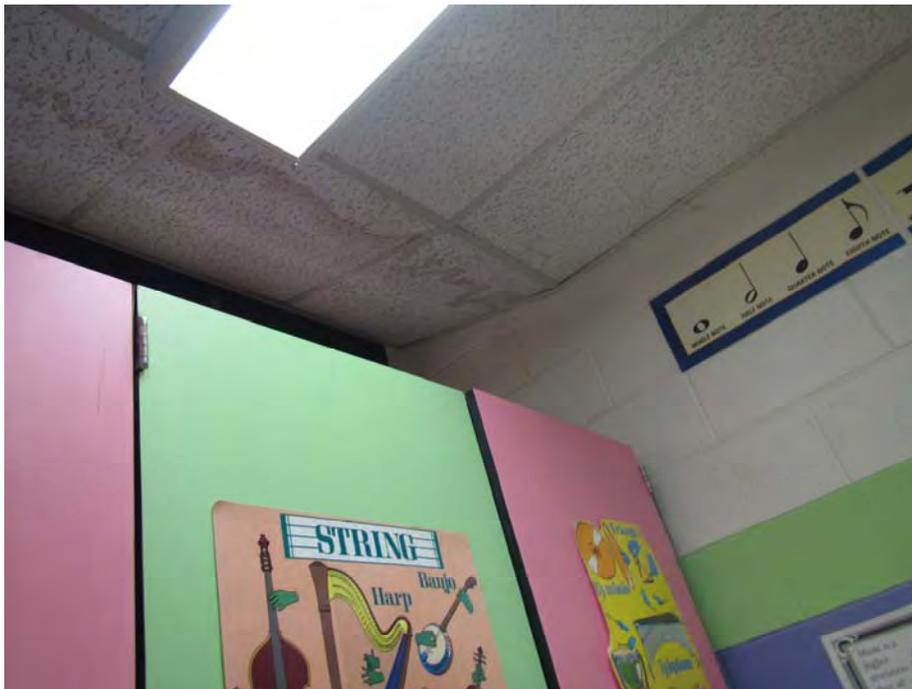
Picture 8

Water-damaged ceiling tiles were observed in many areas (Picture 8), reportedly from leaks from the hot water and/or steam heating system. In other areas, ceiling tiles had been removed due to water damage (Picture 9). A bucket was observed inside the ceiling plenum in a hallway to catch leaks (Picture 10). In room 6C (lower level next to the cafeteria), a ceiling tile was observed to have dark staining indicating mold growth; this stain was reported to be new as the ceiling tile had been recently changed out. This room is located in a partially below-grade area that was also of concern during the 2012 visit.

Water-damaged ceiling tiles

12. Make repairs to the heating system piping to prevent leaks. Replace stained and missing ceiling tiles and ensure that the ceiling plenum is complete/intact to prevent migration of particulates from above the ceiling tile system into occupied areas.

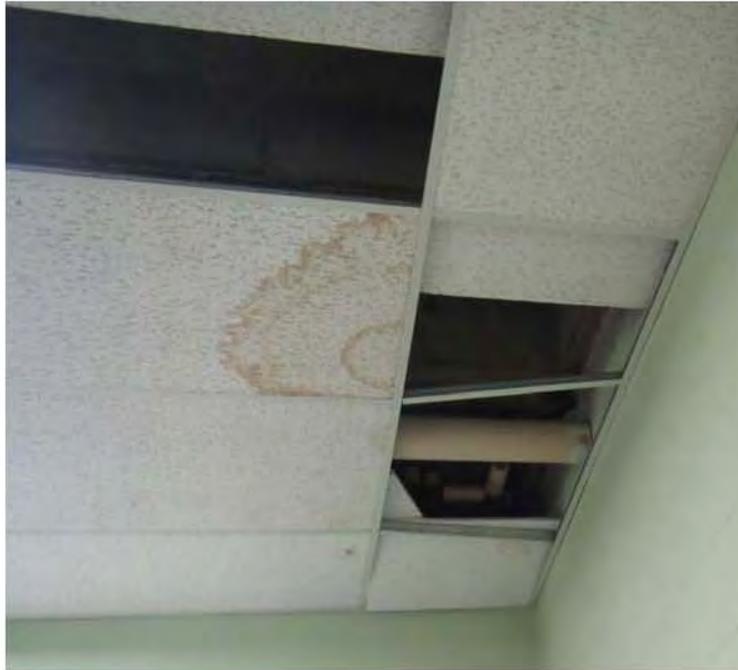
Picture 9

Water-damaged ceiling tiles and missing tiles

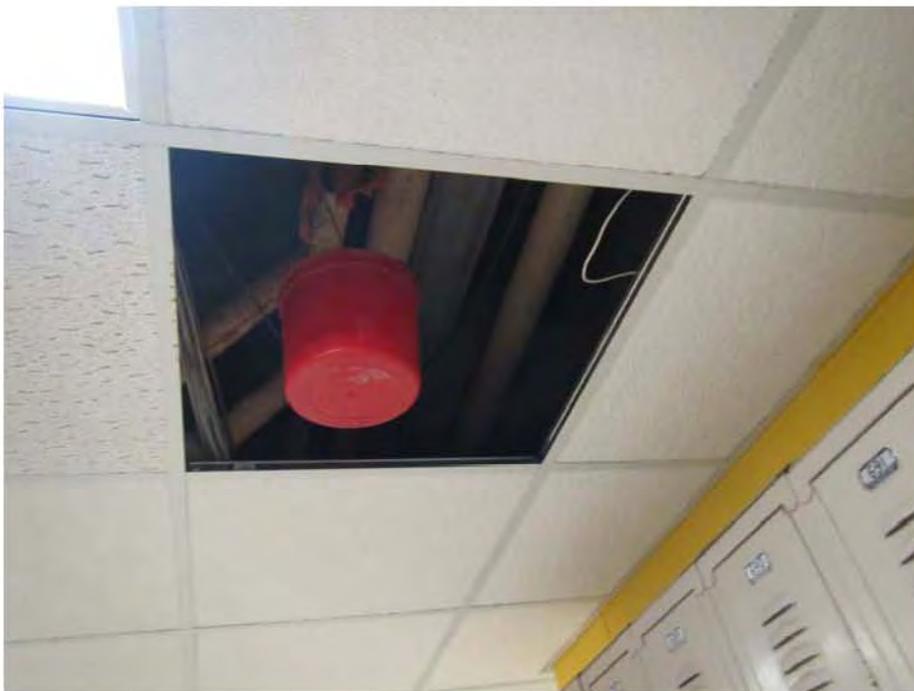
Picture 10

Missing ceiling tile and bucket in hallway

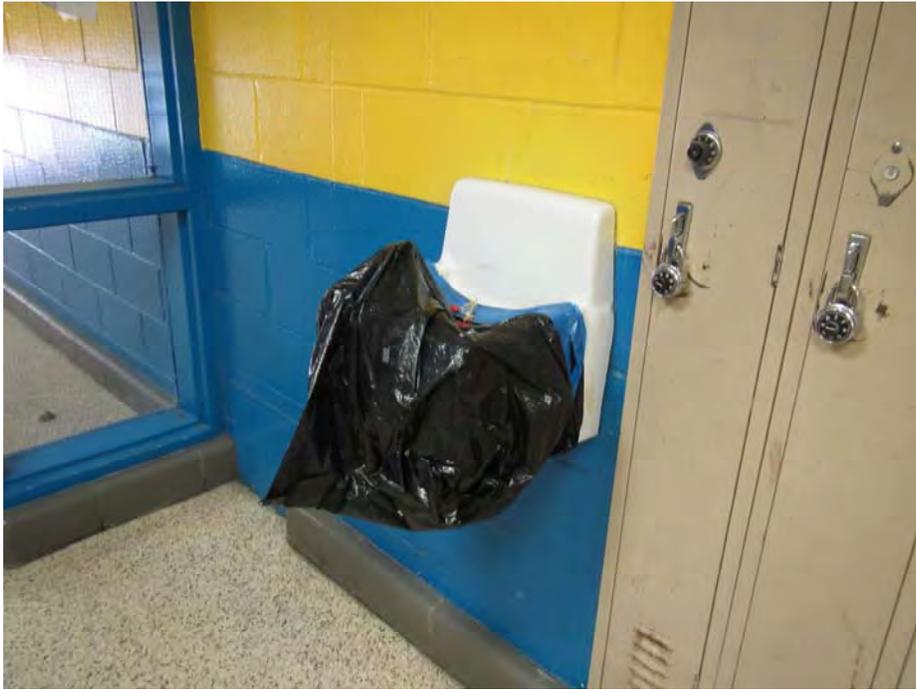
Picture 11

As also observed during the 2012 IAQ assessment, drinking fountains in the main hallways were found to be out of order and covered with plastic (Picture 11). In addition, lab sinks in a science classroom were covered and the cabinets beneath them were locked. It is not known if the water service to these disused fixtures had been shut off. To prevent both water leaks and the infiltration of sewer gases through unused drains, it is recommended that these fixtures be repaired or properly abandoned.

Covered water fountain in hallway

16. Repair broken/unused plumbing fixtures or decommission them completely.
17. Ensure indoor plants are equipped with drip pans. Examine drip pans periodically for mold growth and disinfect with an appropriate antimicrobial, as needed. Move plants away from the air stream of mechanical ventilation equipment.

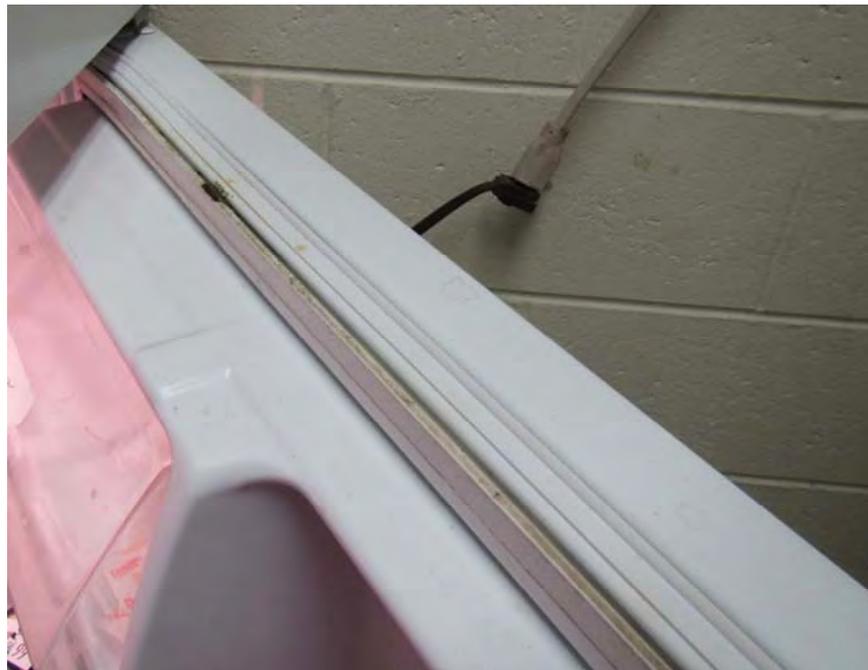
Picture 12

Some refrigerators examined had dark staining indicating mold growth on gaskets (Picture 12). The gaskets should be cleaned with a mild detergent or antimicrobial solution. Frequent/excessive mold staining on gaskets is an indication that the refrigerator does not seal properly and needs to be repaired/replaced.

Refrigerator with dark staining/mold on gaskets

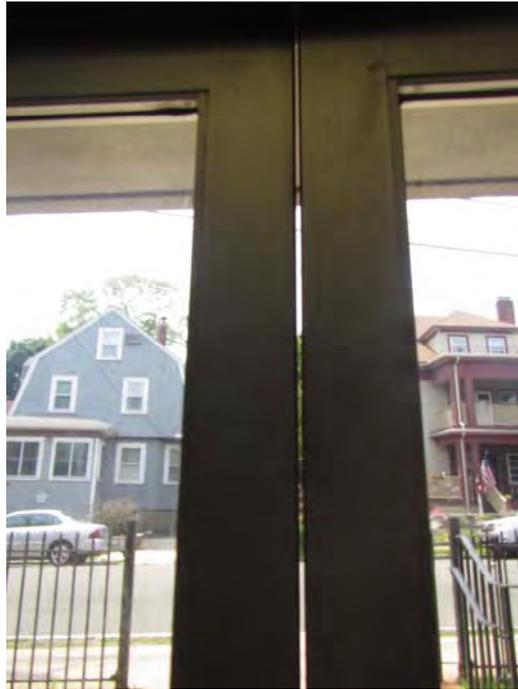
Picture 13

Several doors to the exterior were observed to be broken or lacking weather-stripping. These breaches can allow drafts, moisture and pests into the building (Picture 13).

Gaps where doors to outside lack weather stripping

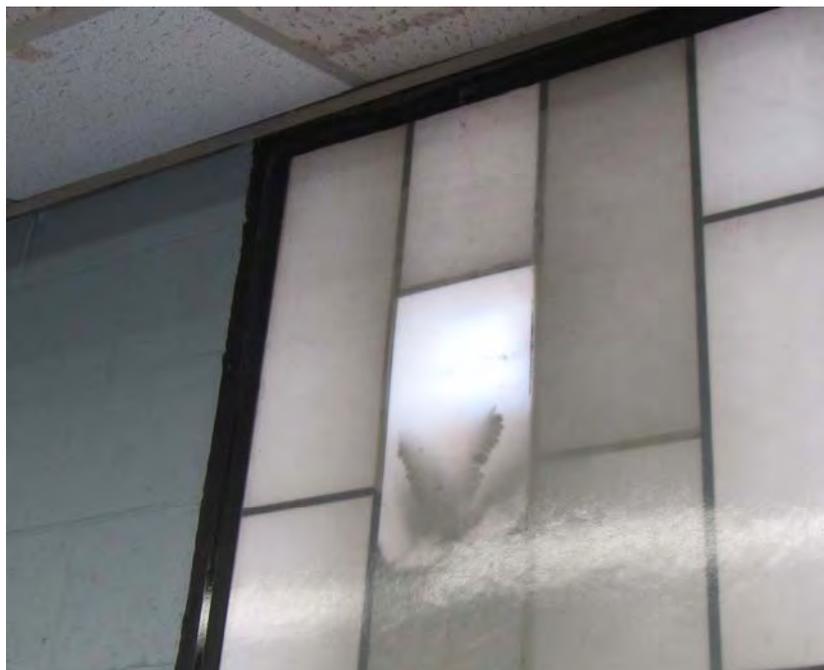
Birds were observed to be nesting inside sections of a window (Picture 14). Birds and bird wastes can be sources of allergens and microbial contamination. The birds should be removed and the windows repaired or replaced.

Bird nesting inside window

21. Remove birds from the window shown in Picture 14 and repair/replace the window to prevent reoccurrence.
22. Relocate or consider reducing the amount of materials stored in classrooms to allow for more thorough cleaning of classrooms. Clean items regularly with a wet cloth or sponge to prevent excessive dust build-up.
