INDOOR AIR QUALITY ASSESSMENT

**Executive Office of Labor and Workforce Development
Hurley Building
19 Staniford Street 5th floor
Boston, Massachusetts**

Prepared by:
Massachusetts Department of Public Health
Bureau of Environmental Health
Indoor Air Quality Program
November 2015

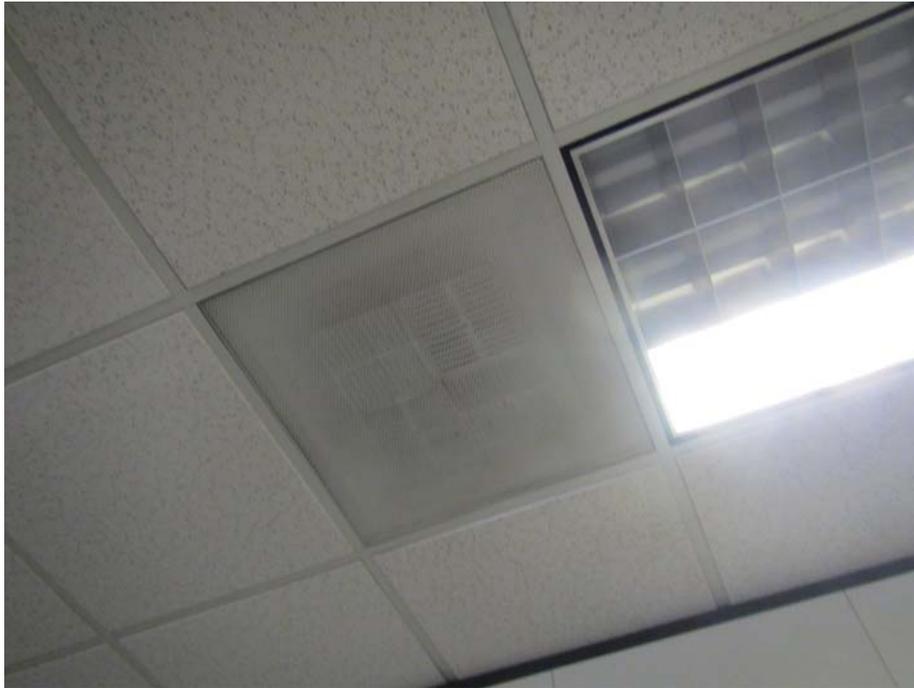
Picture 1

It can be seen from Table 1 that carbon dioxide levels were below 800 parts per million (ppm) in all areas surveyed indicating adequate ventilation throughout the 5th floor. Mechanical ventilation is provided by air handling units (AHUs). Ducts carry air from the AHUs to offices and distribute tempered air via supply vents (Picture 1). Additional air circulation is provided by induction units located along the base of windows (Picture 2). Return air is drawn into ceiling-mounted vents and brought back to AHUs.

Supply vent

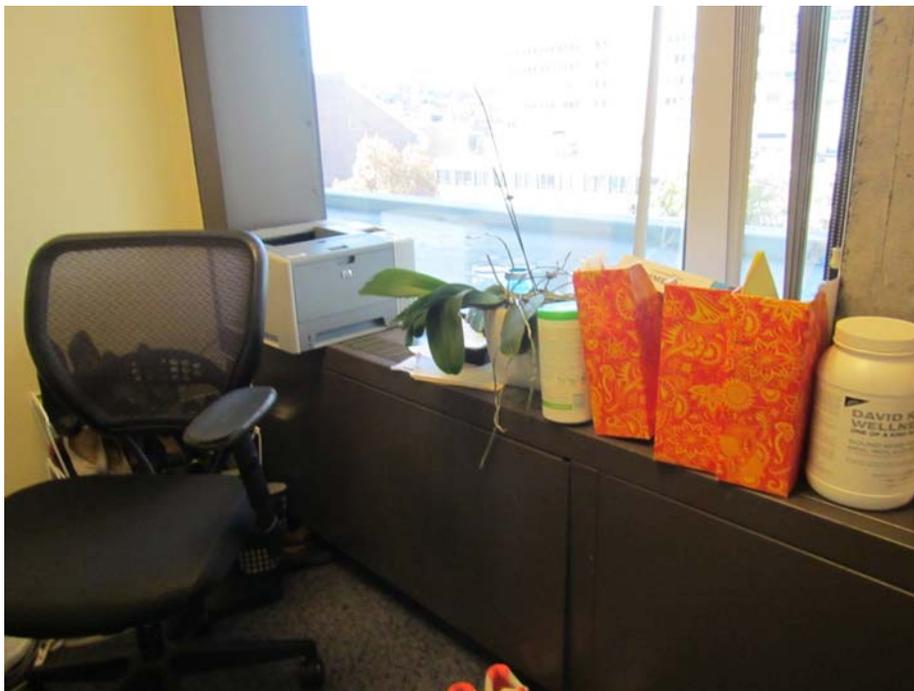
Picture 2

Plants were observed in many areas, including on induction units (Pictures 2 and 6; Table 1). Plants can be a source of pollen and mold, which can be respiratory irritants to some individuals. Plants should be kept away from sources of airflow which may distribute particles, pollen, mold and odors. Plants should be properly maintained, over-watering of plants should be avoided and drip pans should be inspected periodically for mold growth and cleaned or replaced as necessary.

Induction unit with items/plants on it

8. Consider placing water dispensers/small refrigerators in non-carpeted areas or place a waterproof mat underneath them.
9. Maintain indoor plants, use non-porous drips pans, prevent overwatering and refrain from placing them near ventilation equipment.

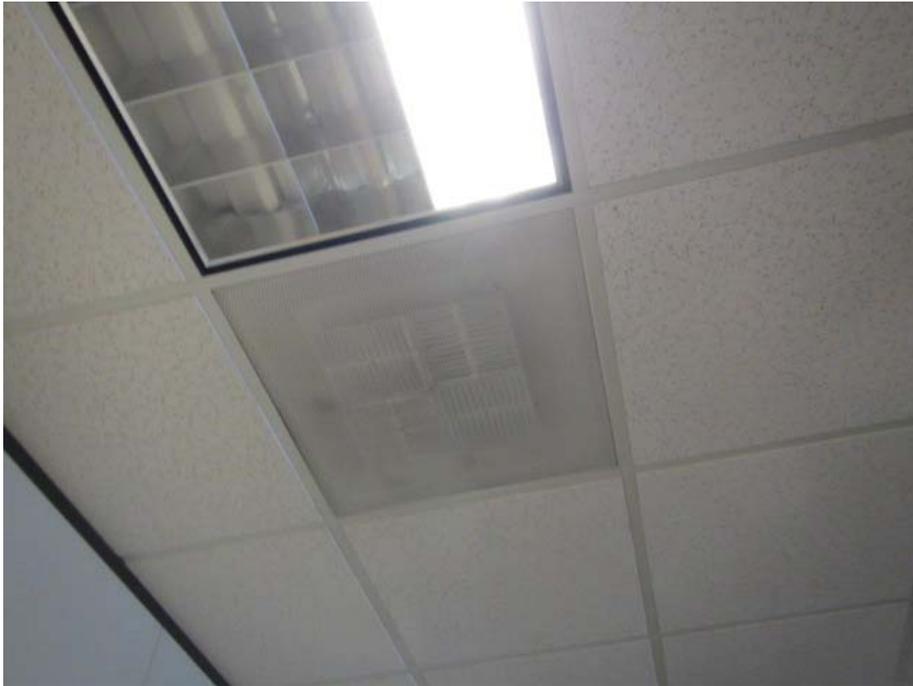
Of note are the components of the ventilation system in this area compared to other locations on the floor. HVAC fresh air supply vents and exhaust vents in the ceiling above the EOLWD space (Picture 3) are different configuration than those on the remainder of the floor (Picture 4). This difference in configuration likely indicated that this section of the HVAC system was added after the original construction of the building. It is likely that the area occupied by EOLWD was originally open space, with the induction units intended as the source of fresh air for the section of the building. At some point after the original construction of the building, private offices walls were installed in the EOLWD area. The HVAC system shown in Picture 3 was installed to provide fresh air for the non-office areas of the EOLWD space.

1. Continue to operate all HVAC systems on the “on” setting to provide continuous airflow/filtration during occupied hours.
2. Investigate the current design of the HVAC ducts to determine where fresh air supplies for various areas are located and how the system is designed to operate. Determine source of marijuana smoke odor and use access controls and/or increased filtration to eliminate the sources.
3. Determine function of exhaust/return systems for the area and repair or modify to provide additional removal of stale air and odors.

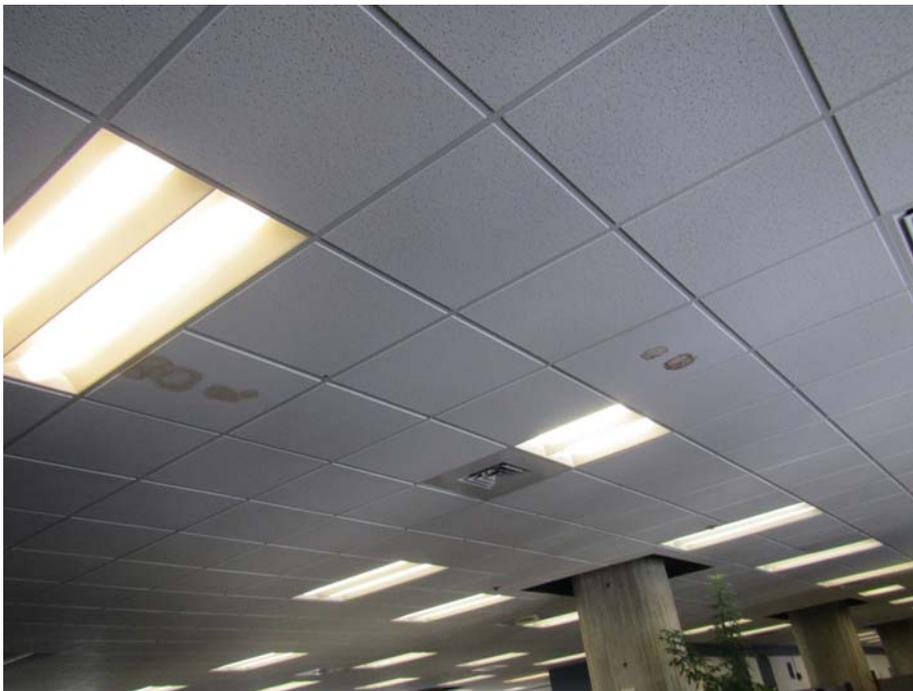
Water-damaged ceiling tiles were observed in some areas (Picture 4 Table 1). In one area, a wall had water staining (Picture 5). The US Environmental Protection Agency (US EPA) and the American Conference of Governmental Industrial Hygienists (ACGIH) recommend that porous materials (e.g., carpeting, gypsum wallboard) be dried with fans and heating within 24 to 48 hours of becoming wet (US EPA, 2001; ACGIH, 1989). If not dried within this time frame, mold growth may occur. Once mold has colonized porous materials, they are difficult to clean and should be removed. The source of the leak above the ceiling tiles should be repaired and the water-damaged ceiling tiles should be removed and replaced.

Fresh Air Supply and water-damaged ceiling tiles

6. Replace water-damaged ceiling tiles once the source of the leak is discovered and repaired.
7. Clean the water-stained wall shown in Picture 4 and check above the ceiling tile system in this area for additional water damage.

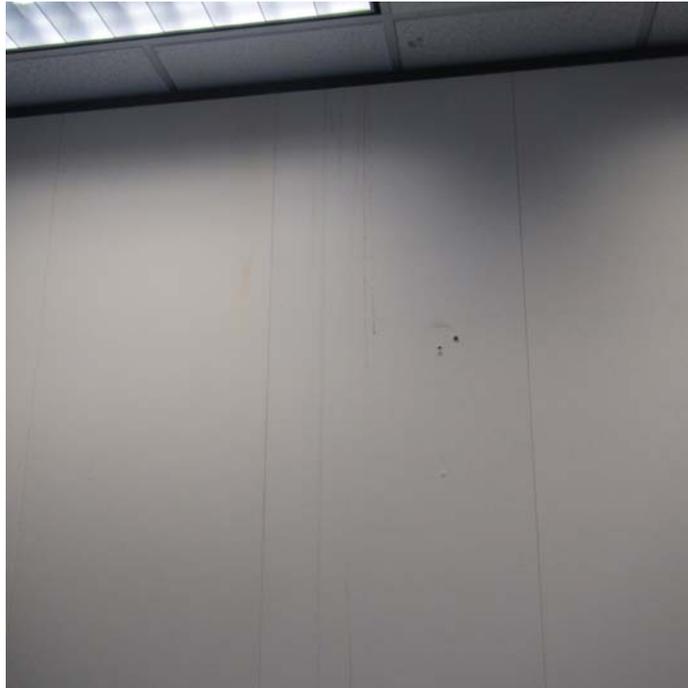
Picture 5

Water staining on wall

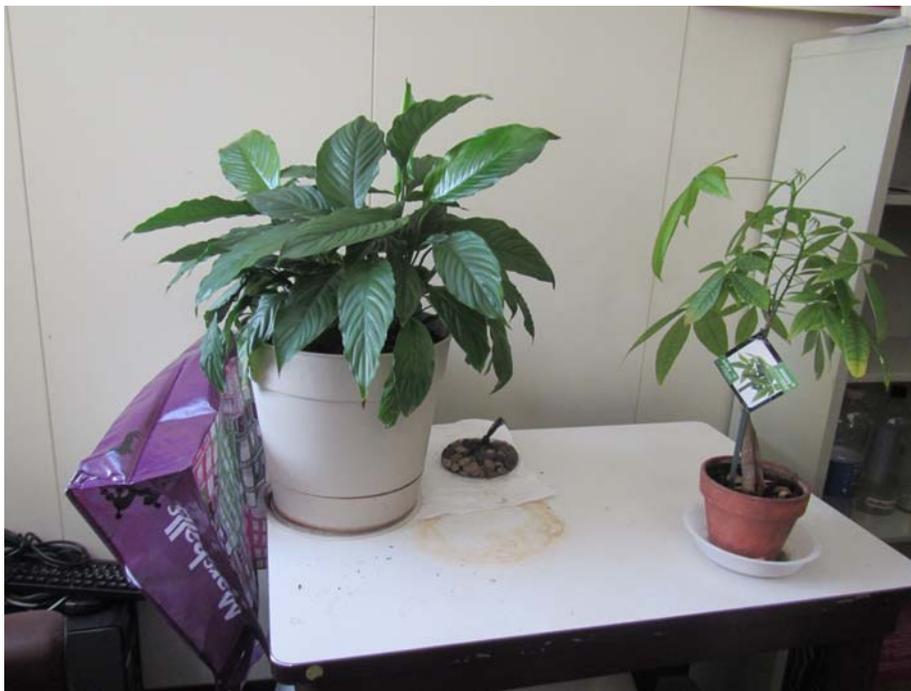
Picture 6

Plants and water damage/stains on table

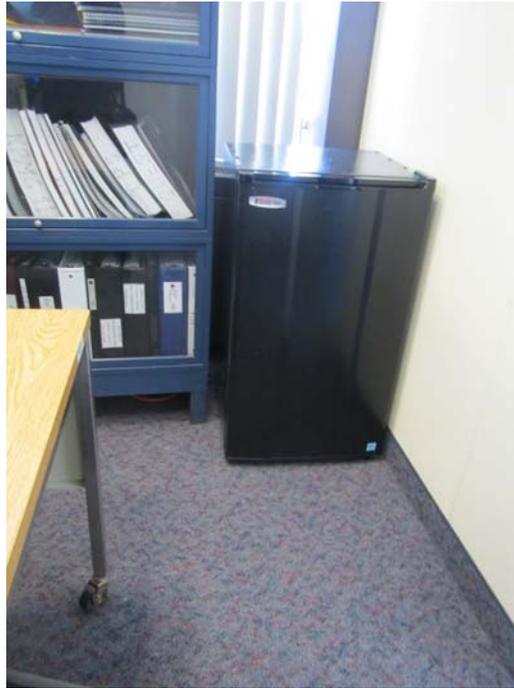
Picture 7

Water dispensing equipment and small refrigerators were observed in carpeted areas (Picture 7; Table 1). Spills or leaks from this equipment can moisten carpet and lead to microbial growth and carpet degradation.

Refrigerator on carpet

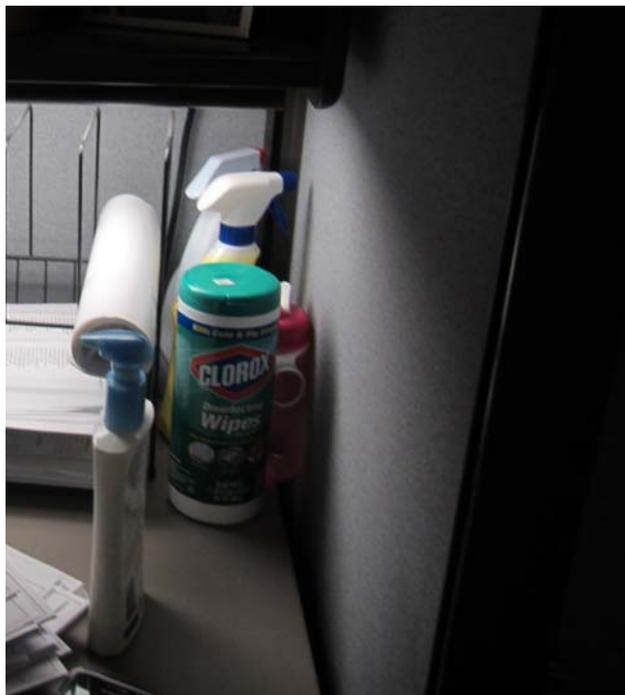
Picture 8

fresheners, hand sanitizer, cleaners (Picture 8) and dry erase materials in use within the space (Table 1). All of these have the potential to be irritants to the eyes, nose, throat and respiratory system of sensitive individuals.

Cleaning products

10. Reduce the use of items containing VOCs including scented cleaners, air fresheners, dry erase materials and hand sanitizer.
11. Clean surfaces, carpets and vents on a preventative maintenance schedule.

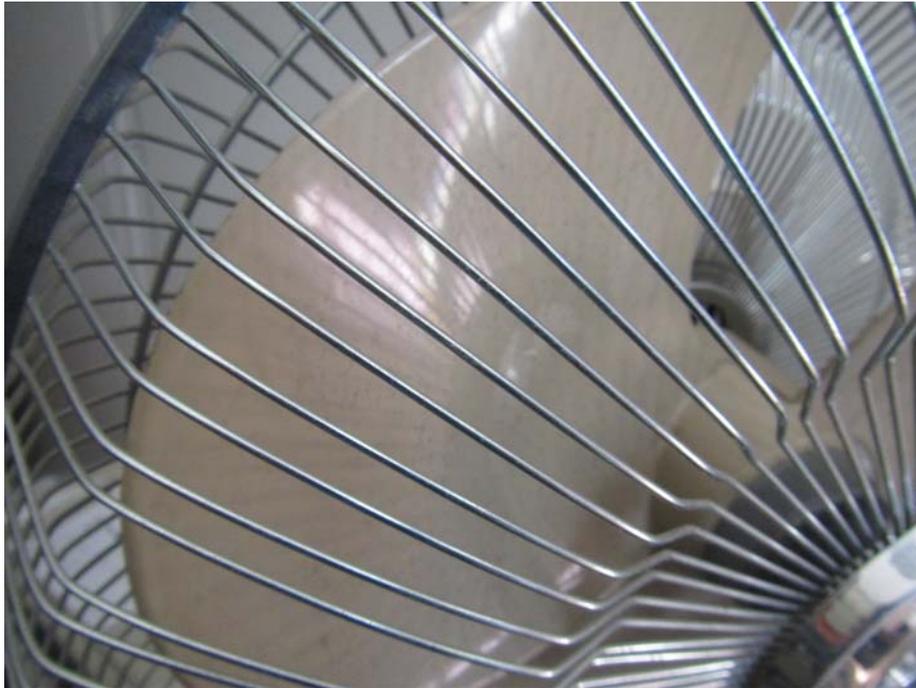
Picture 9

Other conditions that can affect IAQ were observed during the assessment. Some personal fans and supply vents were observed to be dusty (Picture 9). Dust on these items can be re-aerosolized and cause irritation or odors.

Dusty personal fan
