# **INDOOR AIR QUALITY ASSESSMENT**

**Commonwealth of Massachusetts  
Department of Children and Families  
1530 River Street  
Hyde Park, MA**

Prepared by:  
Massachusetts Department of Public Health  
Bureau of Environmental Health  
Indoor Air Quality Program  
December 2015

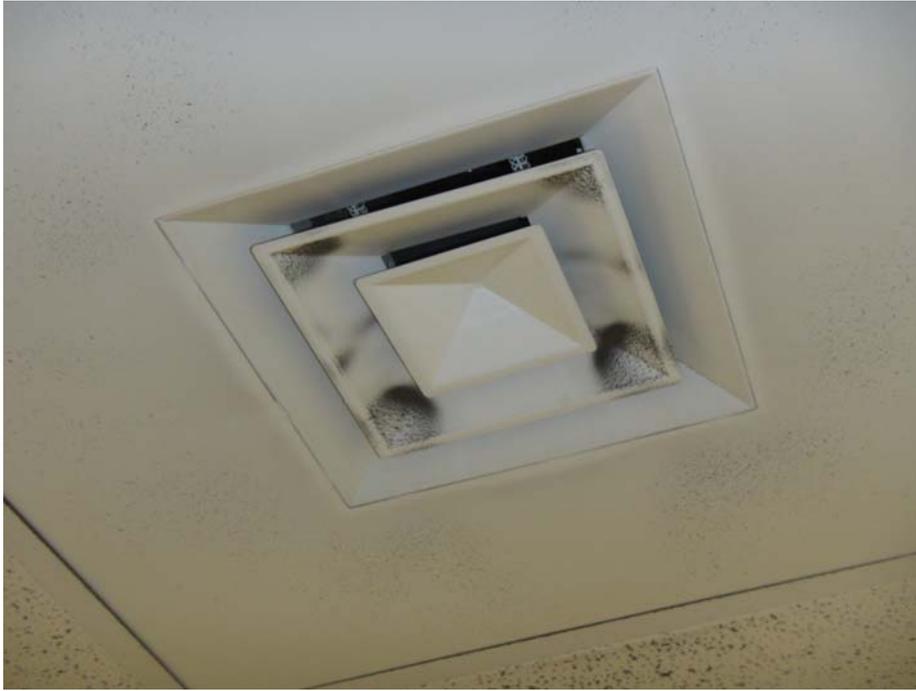
**Picture 1**

Supply vents were found to have accumulated dust on the surface of the diffusers (Picture 1). These vents should be cleaned regularly to avoid aerosolizing the particulate matter.

**Supply air diffuser (note debris accumulation)**

11. Clean supply and return vents regularly to avoid aerosolizing any accumulated particulate matter.
12. Plants should be properly maintained, equipped with drip pans, and located away from air diffusers to prevent the aerosolization of dirt, pollen, and mold.

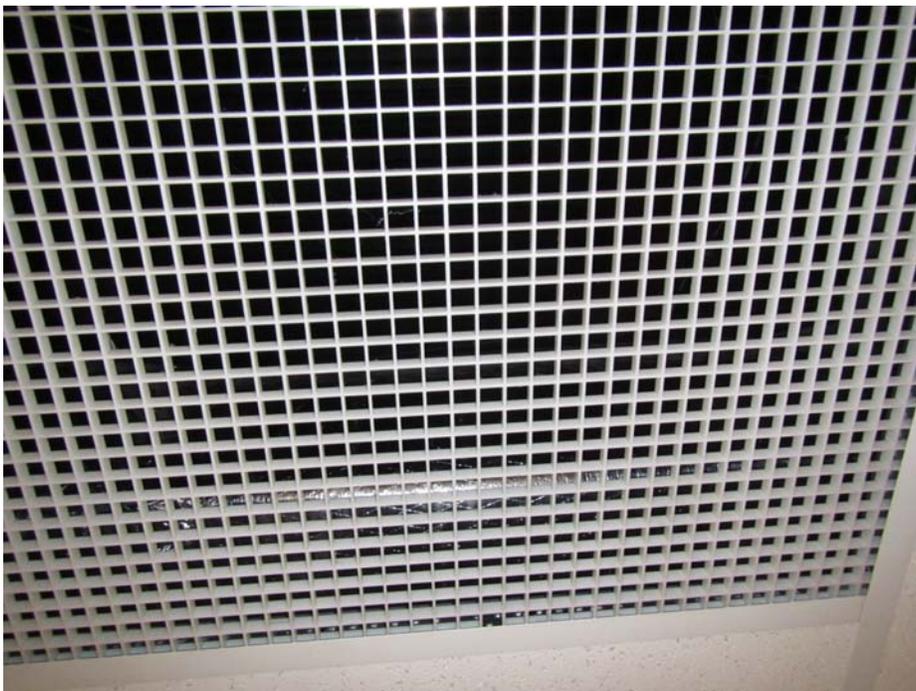
**Picture 2**

**Return air grate**

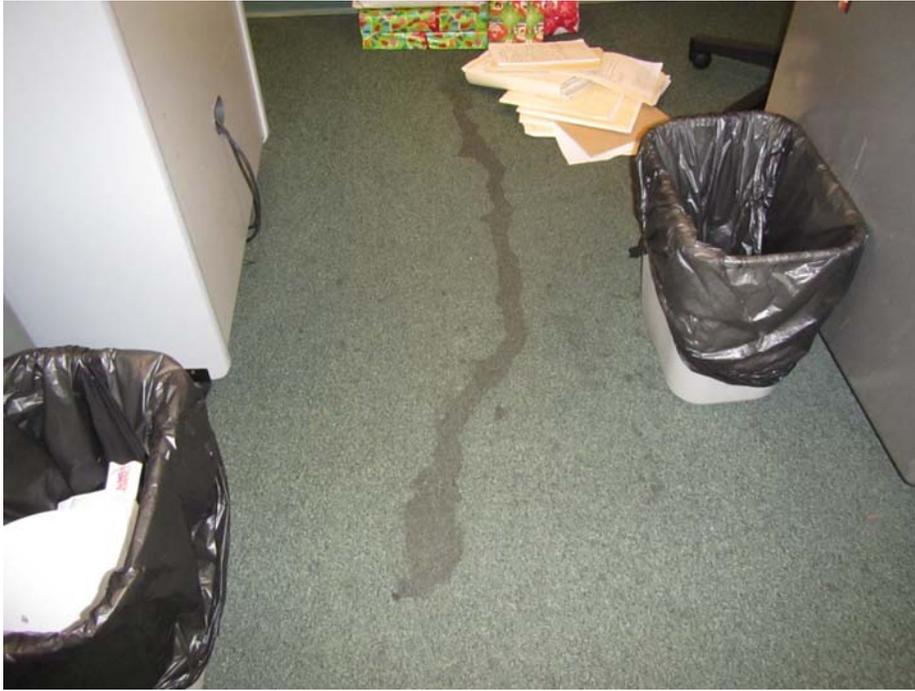
**Picture 3**

DCF staff reported that there were building-wide chronic water leaks in the past due to issues with the old roof. The roof was recently repaired; however the carpeting was reportedly never dried properly after the water damage events. The carpet also appeared to be worn and soiled throughout the DCF space (Pictures 3 to 4). Most ceiling tiles did not appear to have water damage. BEH/IAQ staff did note the presence of one water-damaged ceiling tile near the side entrance (Picture 5).

**Soiled carpeting**

7. Remove water-damaged ceiling tile(s) and replace with new.
8. Consider replacing soiled and water-damaged carpeting with new carpet tiles.
9. Identify/create storage solutions to reduce the accumulated items on surfaces and flooring so that these items do not interfere with thorough cleaning of the space.

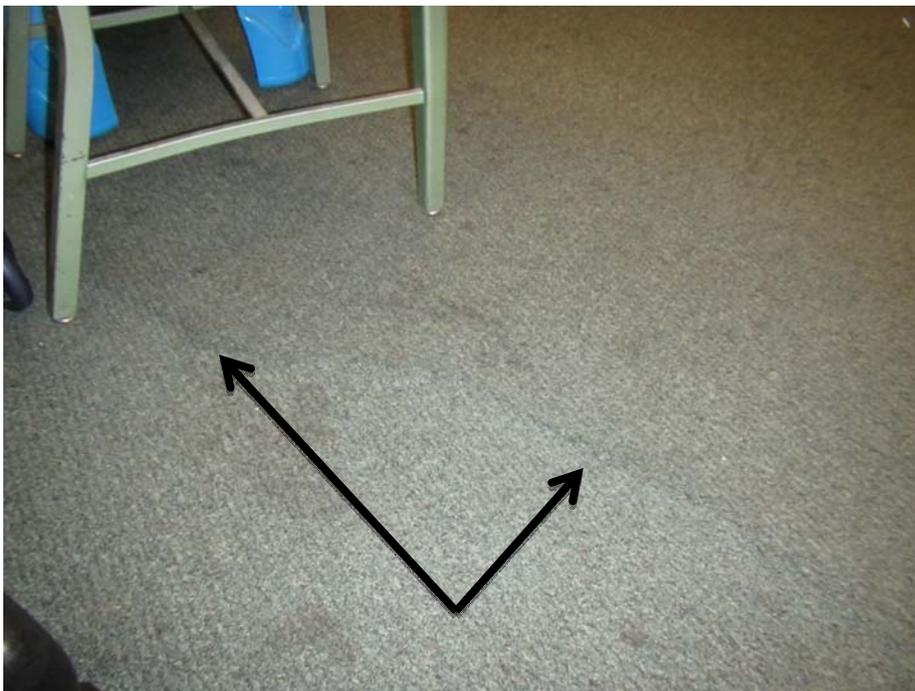
**Picture 4**

**Water-damaged carpeting showing signs of uplifting (arrows)**

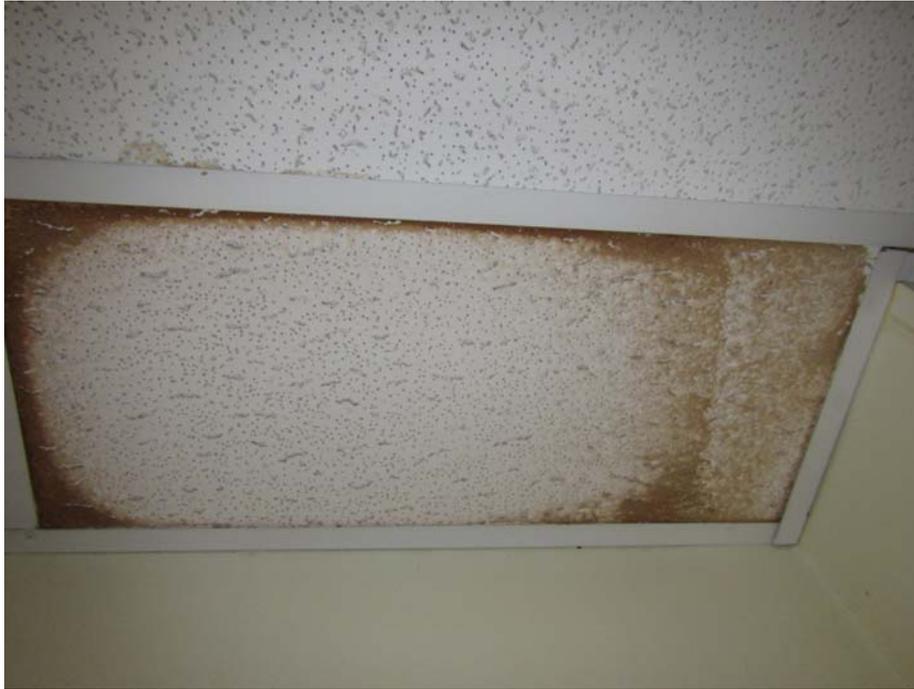
**Picture 5**

**Water-damaged ceiling tile**

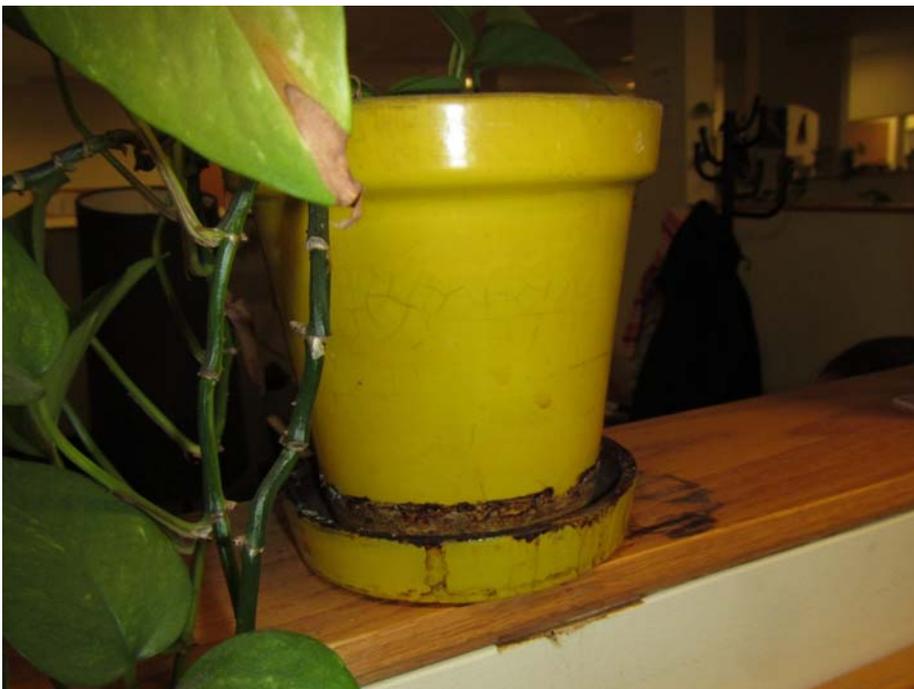
**Picture 6**

Plants were noted in a few areas (Picture 6). Plants can be a source of pollen and mold, which can be respiratory irritants to some individuals. Plants should be properly maintained and equipped with drip pans and should be located away from air diffusers to prevent the aerosolization of dirt, pollen and mold.

**Plant with historic leaks**

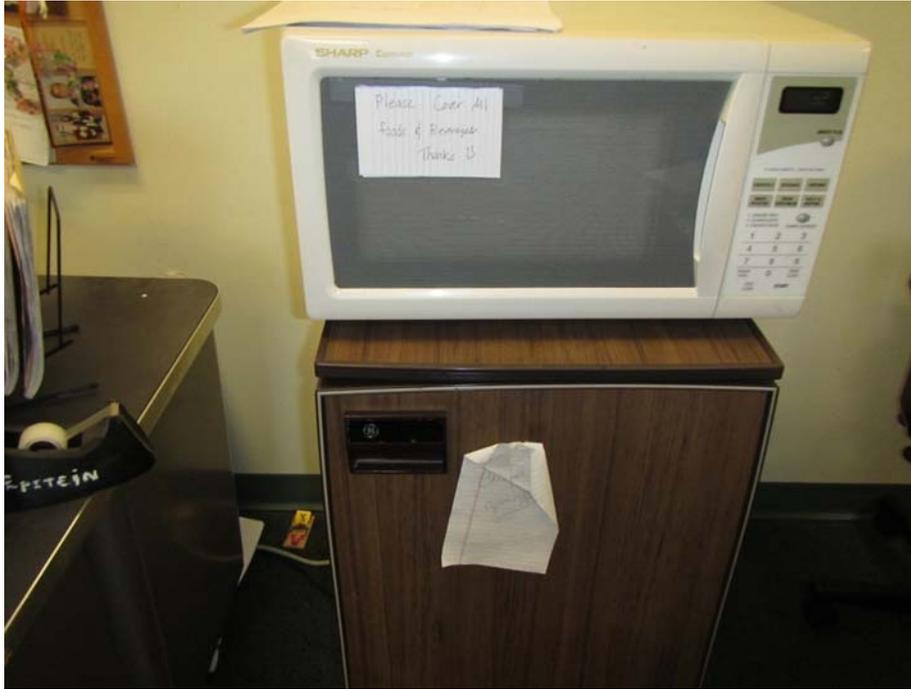
**Picture 7**

Some areas of the DCF had refrigerators placed directly on the carpeting (Picture 7). Spills or leaks from this equipment can moisten the carpet and may cause microbial growth and carpet degradation. Refrigerators and water coolers should be moved to non-carpeted areas or have water proof trays placed beneath them.

**Refrigerator placed directly on carpeting**

13. Refrigerators and water coolers should be moved to non-carpeted areas or water proof trays should be placed beneath them to prevent moistening carpet.

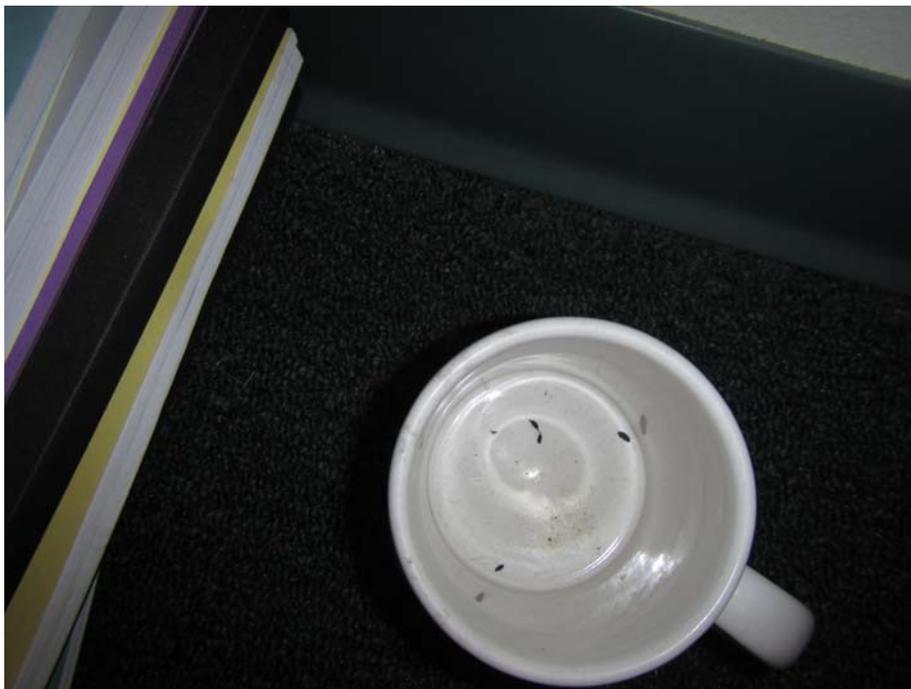
**Picture 8**

Other conditions that can affect indoor air quality were observed during the assessment. BEH/IAQ staff confirmed DCF staff reports of rodent infestation. Mouse droppings were observed throughout the DCF space including on desks, in drawers, behind appliances (Pictures 8 to 9). DCF staff reported that there is a contract in place with a pest control company (Waltham Pest) and numerous mouse traps/bait stations were observed in the space (Pictures 10 and 13).

**Mouse droppings in coffee mug**

5. Contract with a professional cleaning company to remove rodent droppings/waste and sanitize all surfaces in the DCF building.
6. Ensure that the DCF space is cleaned thoroughly on a daily basis. Scrupulous cleaning practices should be adopted to minimize common indoor air contaminants whose irritant effects can be enhanced when the relative humidity is low. To control for dusts/allergens, a high efficiency particulate arrestance (HEPA) filter equipped vacuum cleaner in

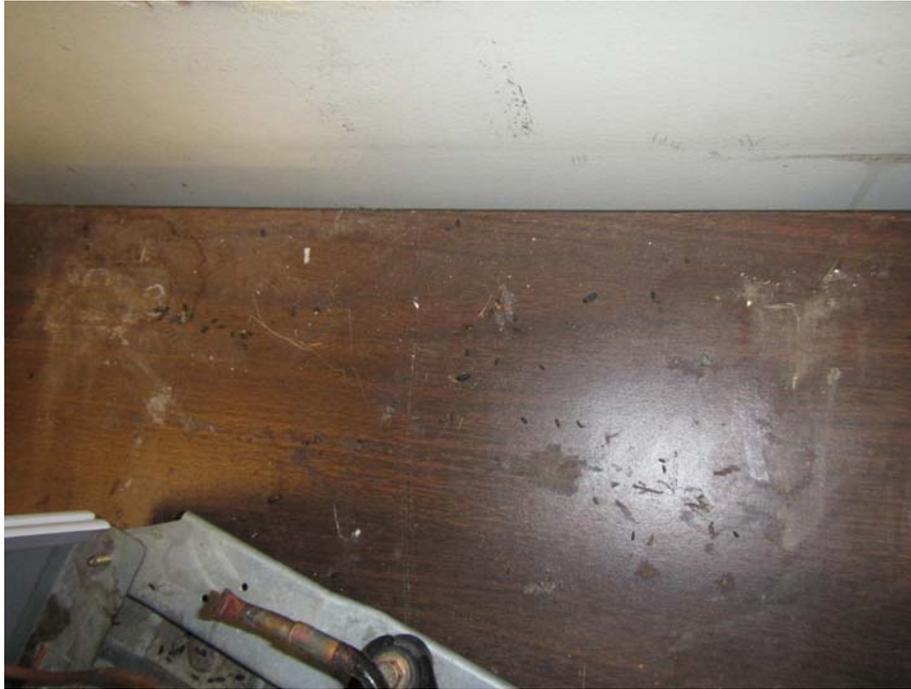
**Picture 9**

**Numerous mouse droppings on table and behind mini fridge**

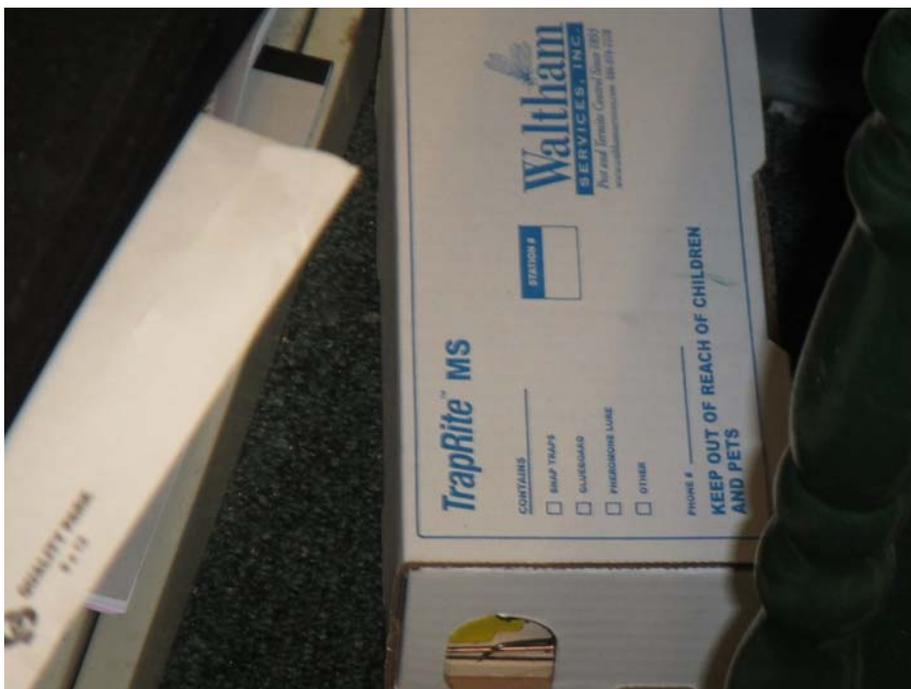
**Picture 10**

**Mouse trap within covered box**

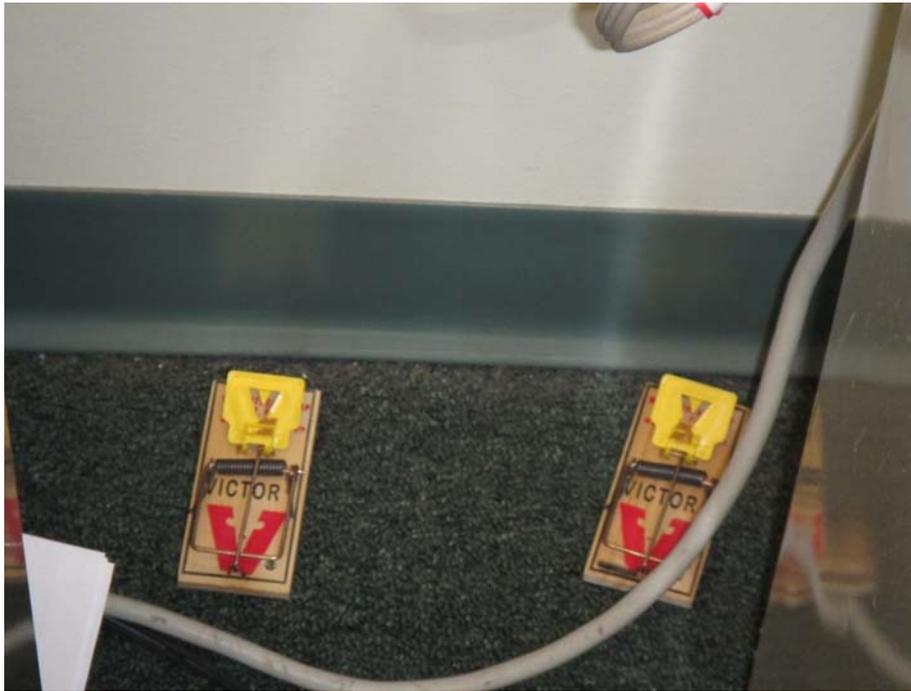
Picture 11

Mouse traps behind desk

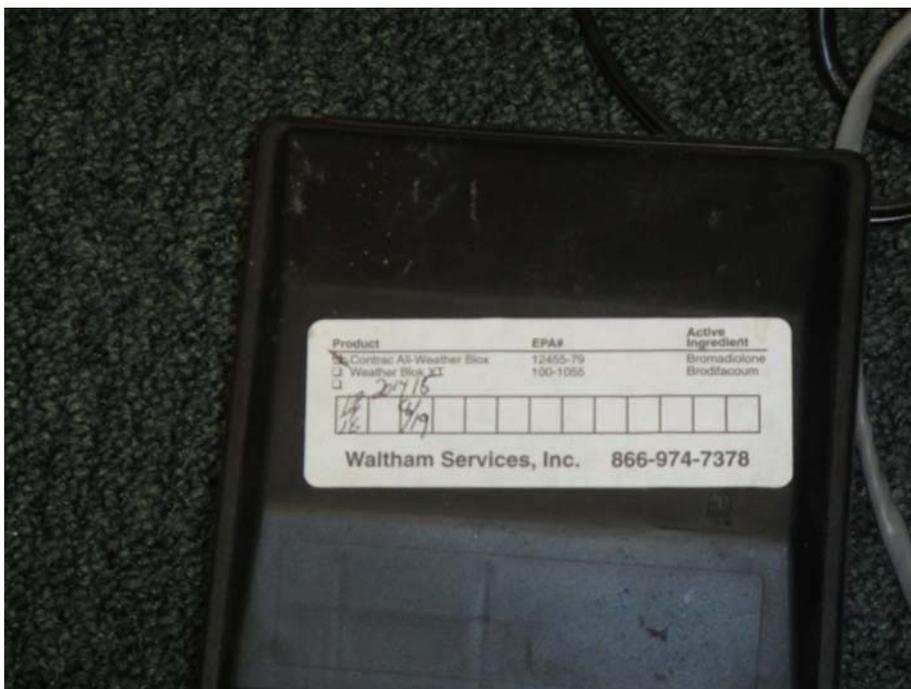
Picture 12

Rodent bait station

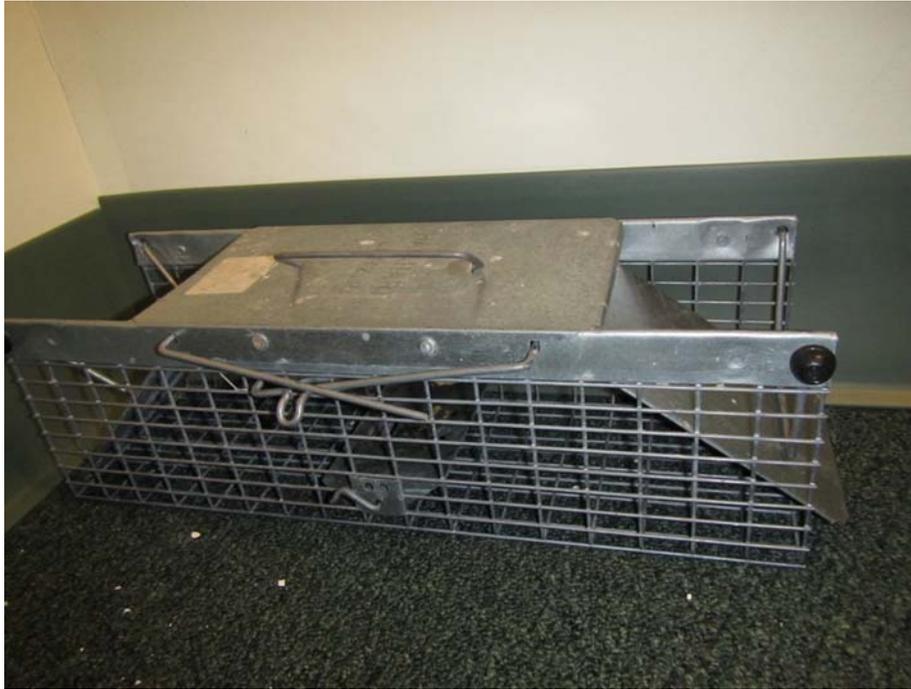
**Picture 13**

**Large live catch trap in closed position**

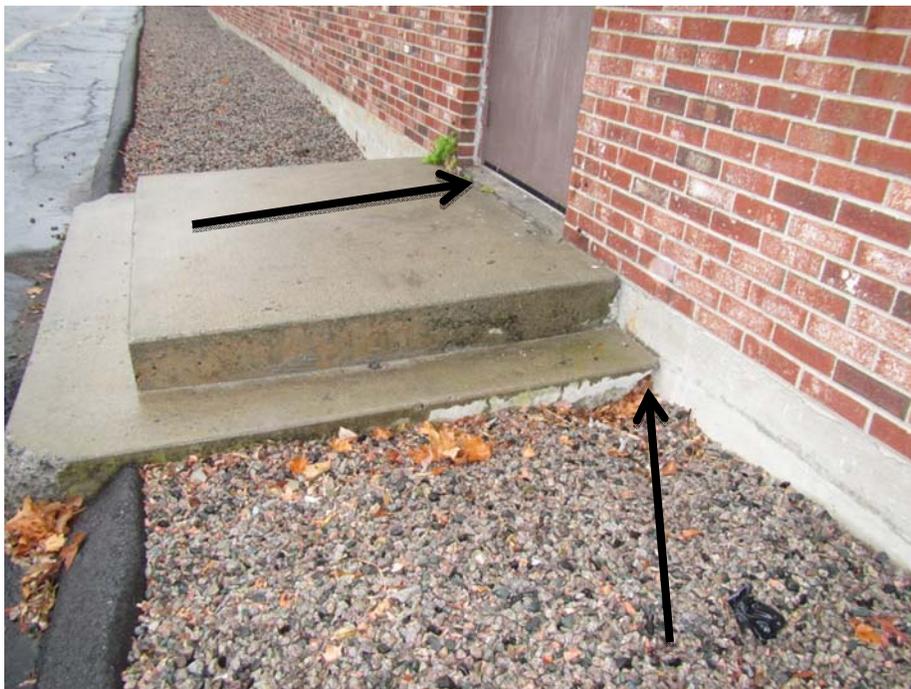
**Picture 14**

Particular attention should be made to sealing the numerous gaps and cracks along the slab foundation and openings around any exterior doors (Pictures 14 to 18) as these are the primary pathways of entry for the rodents according to the pest contractor. Most exterior doors are fitted with ineffective brush style door sweeps that leave large gaps between the door edges. The building appears to be settling. It may be challenging to identify pathways that are not immediately at grade level or clearly visible. Nevertheless, building management should be aggressive in their attempts to find and seal all pathways to eliminate this infestation. In addition, some areas along the cracks at the base of the building appeared to have recurring sumac growth (Picture 15). Plant roots can cause openings to widen.

**Large cracks/gaps created at stairs/slab interface due to settling (arrows)**

3. Continue to work with a pest control company to remove rodent infestation. Building management or their consultant should be aggressive in finding and sealing all pathways that rodents may use to enter the building. Some of these pathways may not be at grade level due to settling of the building's slab foundation. Vegetation, especially the sumac plants along the slab foundation, should be removed.

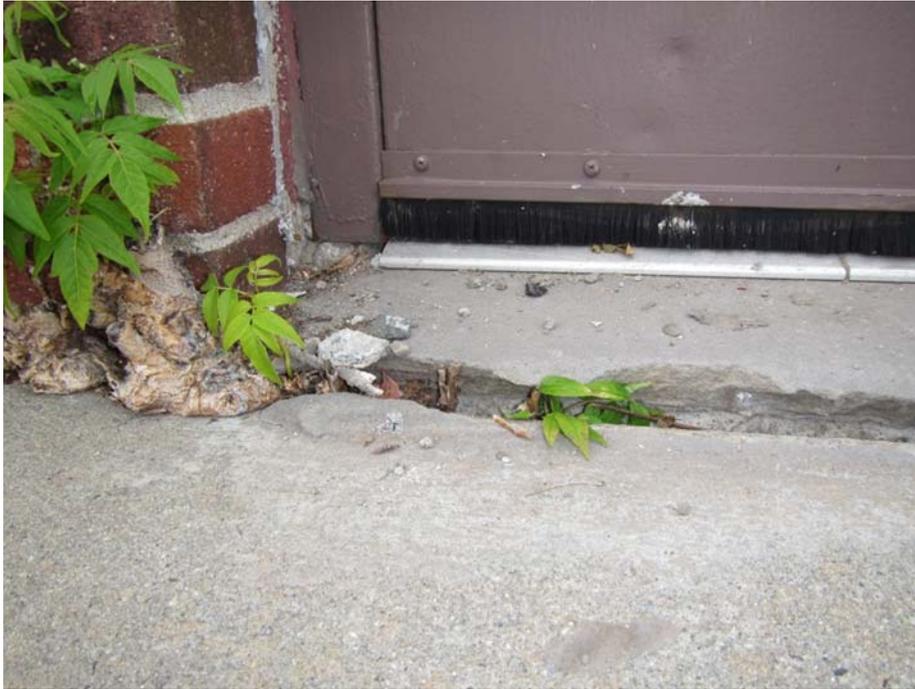
**Picture 15**

**Large gap near side entrance (note sumac growth in gap)**

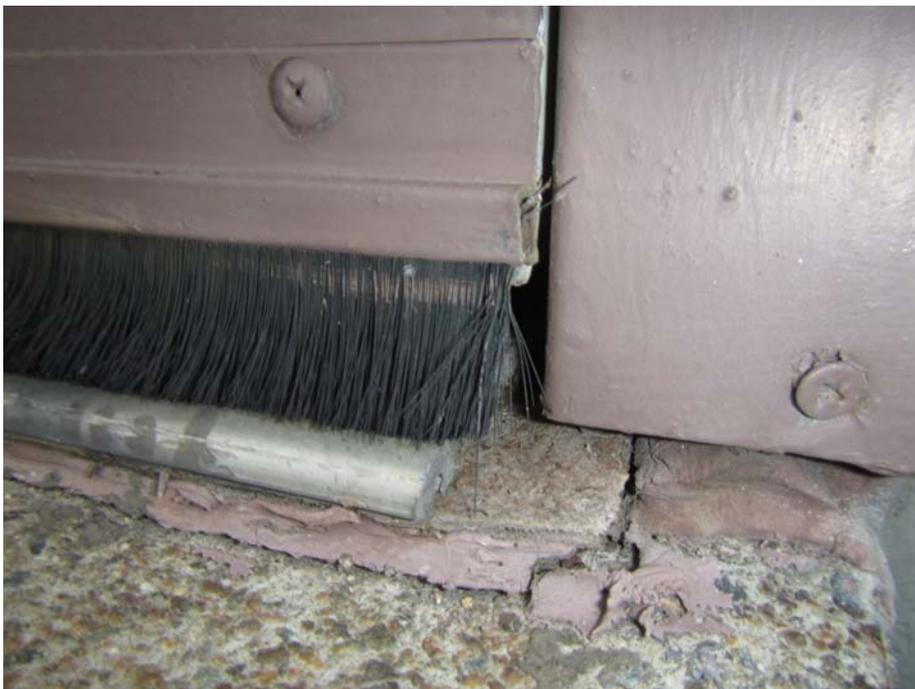
**Picture 16**

**Loose brush style door sweep with gaps on side door**

- f. Regularly clean crumbs and other food residues from toasters, toaster ovens, microwave ovens coffee pots and other food preparation equipment;
  - g. Examine each room and the exterior walls of the building for means of rodent egress and seal appropriately. Holes as small as 1/4" is enough space for rodents to enter an area. If doors do not seal at the bottom, install a weather strip as a barrier to rodents;

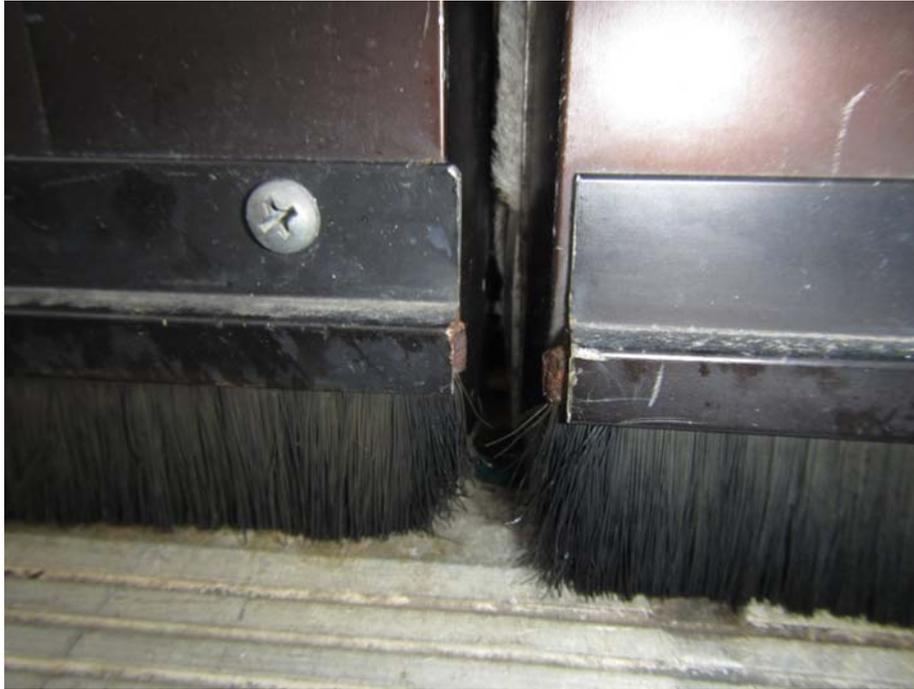
**Picture 17**

**Gaps between front entrance doors equipped with brush sweeps**

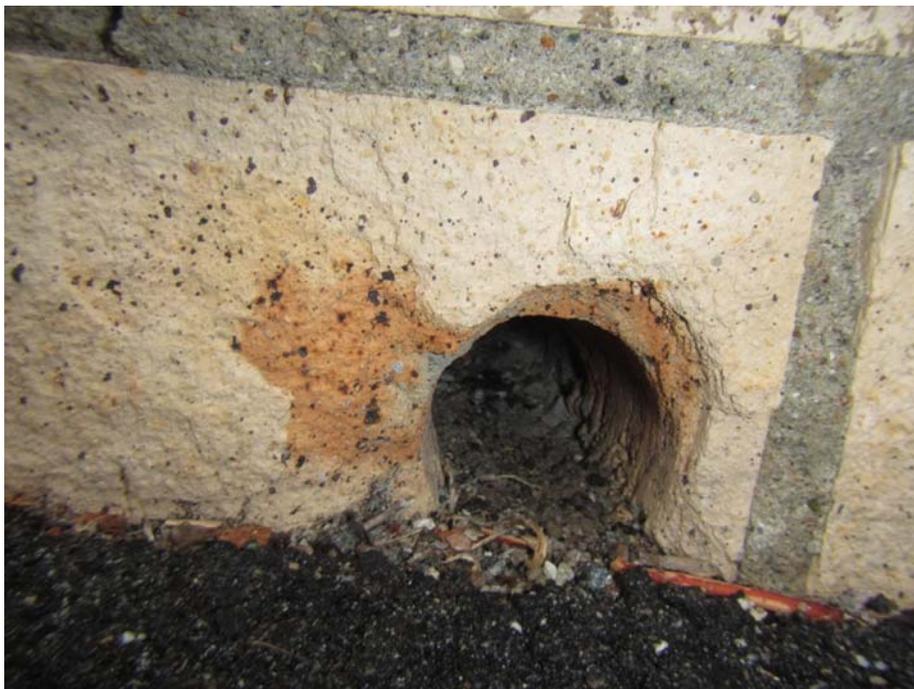
**Picture 18**

**Large (~2") apparent drain hole in masonry wall with no rodent screen**

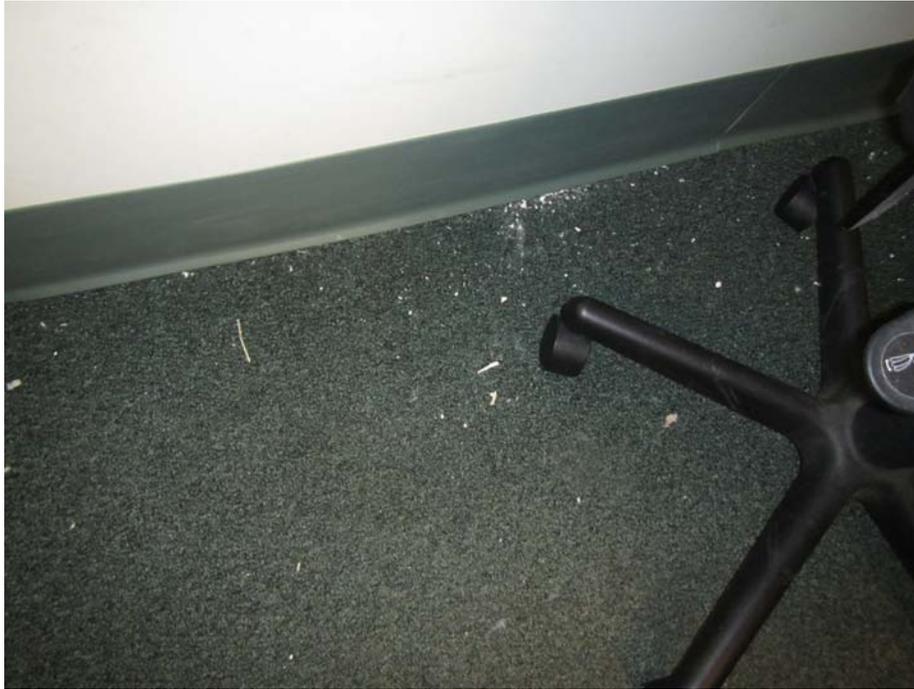
**Picture 19**

Cleaning activities did not appear to be thorough, and many occupants reported that the cleaning company only vacuums main corridors (Picture 19). Cleaning activity can also be hindered by the amount of accumulated items throughout the space (e.g. files, boxes, clothes, car seats) which demonstrates a clear need for further storage solutions (Picture 20).

**Debris on carpeting neglected by cleaning company**

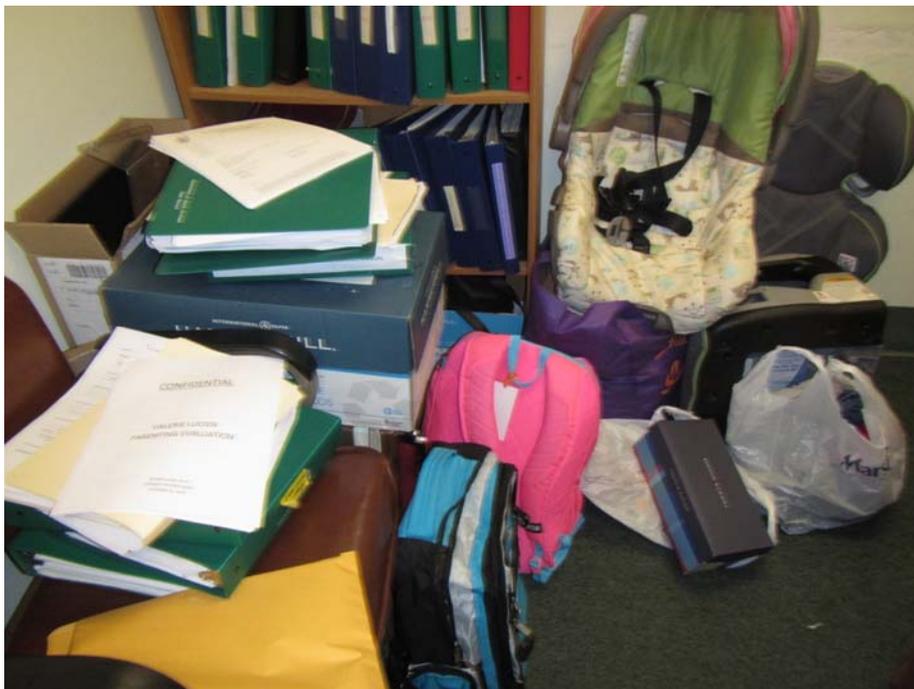
**Picture 20**

**Accumulated items hinder cleaning efforts and highlights storage needs**

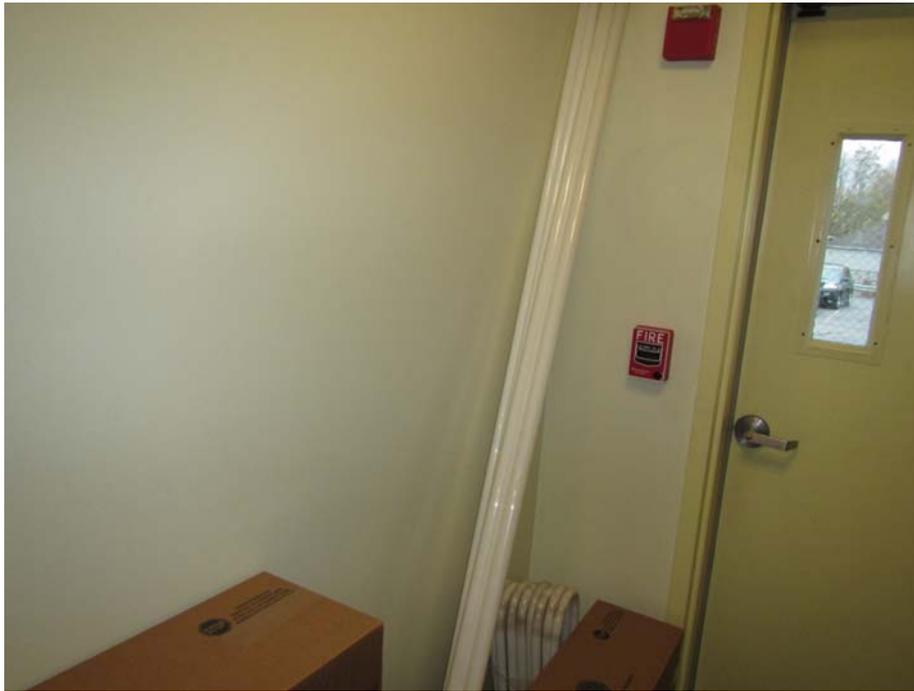
**Picture 21**

BEH/IAQ staff noted improper storage of spent fluorescent bulbs (Picture 21). These bulbs are currently stored unprotected near the side entrance. Accidental breakage of the bulbs could release limited quantities of mercury in the building.

**Fluorescent bulbs improperly stored**

17. Properly secure and store used fluorescent bulbs until recycled to avoid breakage.
18. Refer to resource manual and other related indoor air quality documents located on the MDPH's website for further building-wide evaluations and advice on maintaining public buildings. These documents are available at <http://mass.gov/dph/iaq>.
