INDOOR AIR QUALITY ASSESSMENT

**Massachusetts Registry of Motor Vehicles
490 Forest Avenue
Brockton, MA**

Prepared by:
Massachusetts Department of Public Health
Bureau of Environmental Health
Indoor Air Quality Program
March 2015

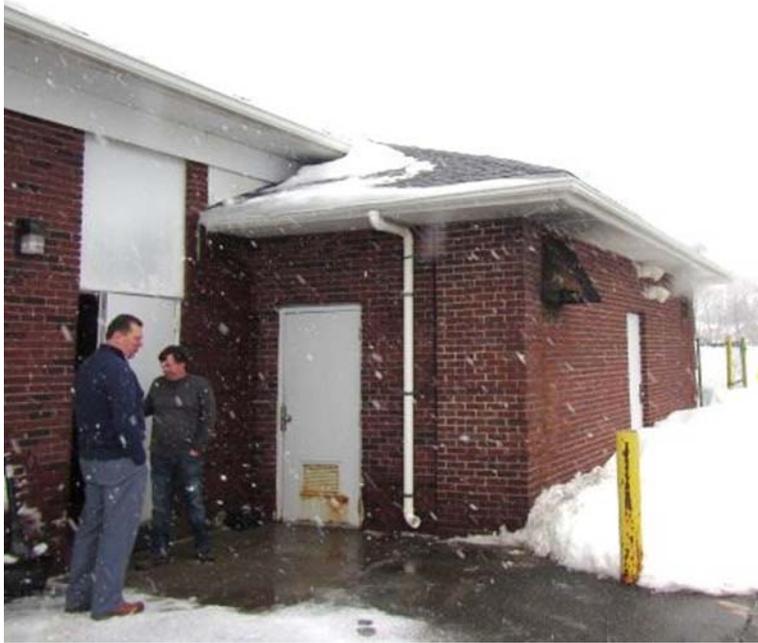
Picture 1

Mechanical room attached to rear of building

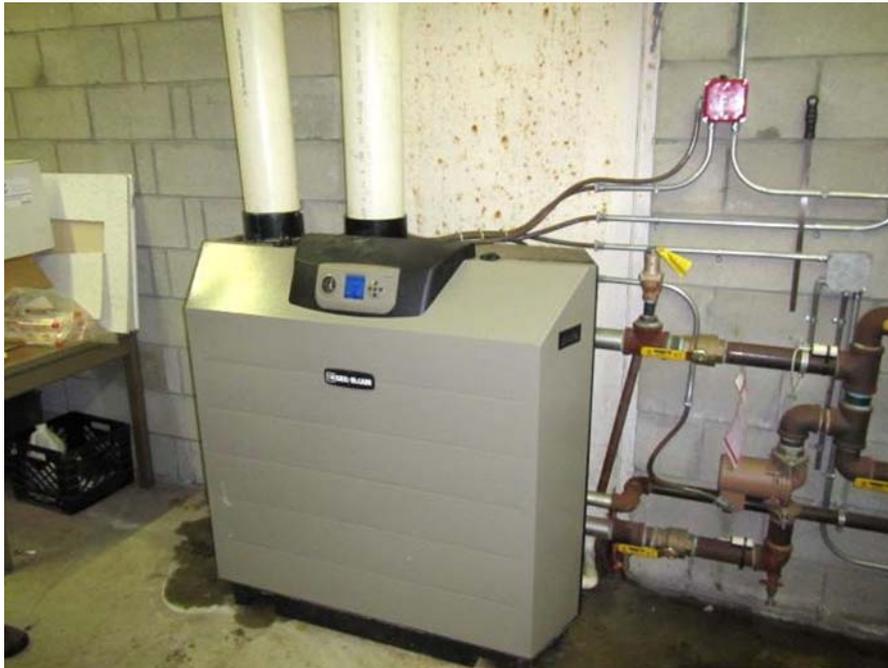
Picture 2

Boiler in mechanical room

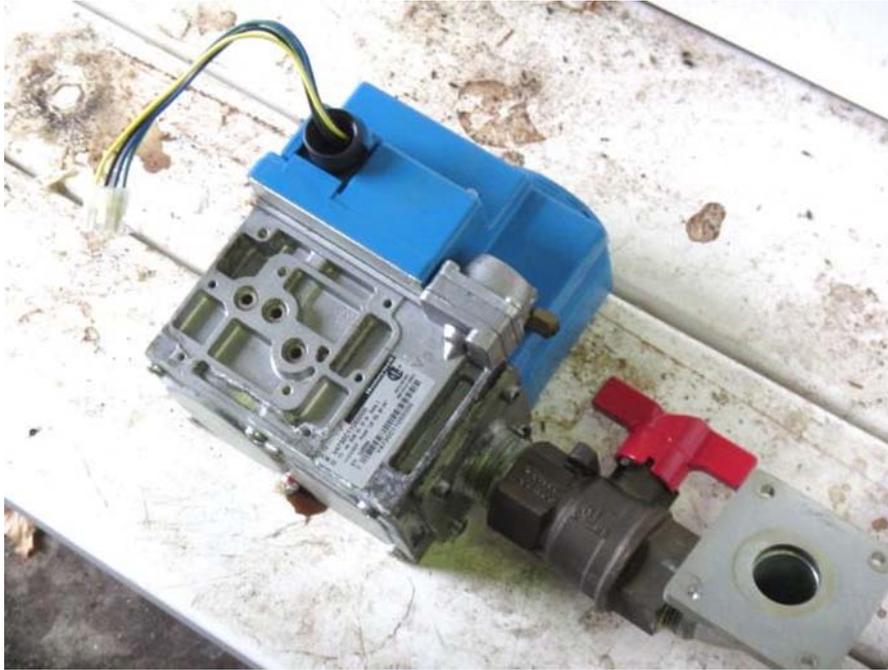
Picture 3

Faulty gas valve removed from boiler

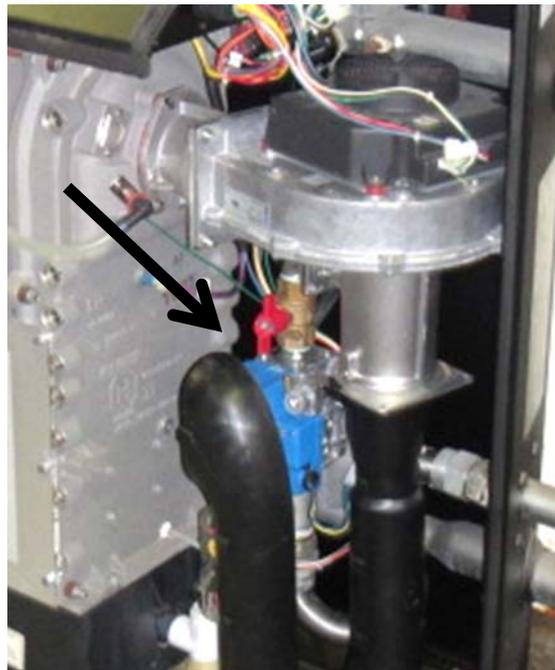
Picture 4

New gas valve (arrow) installed in boiler

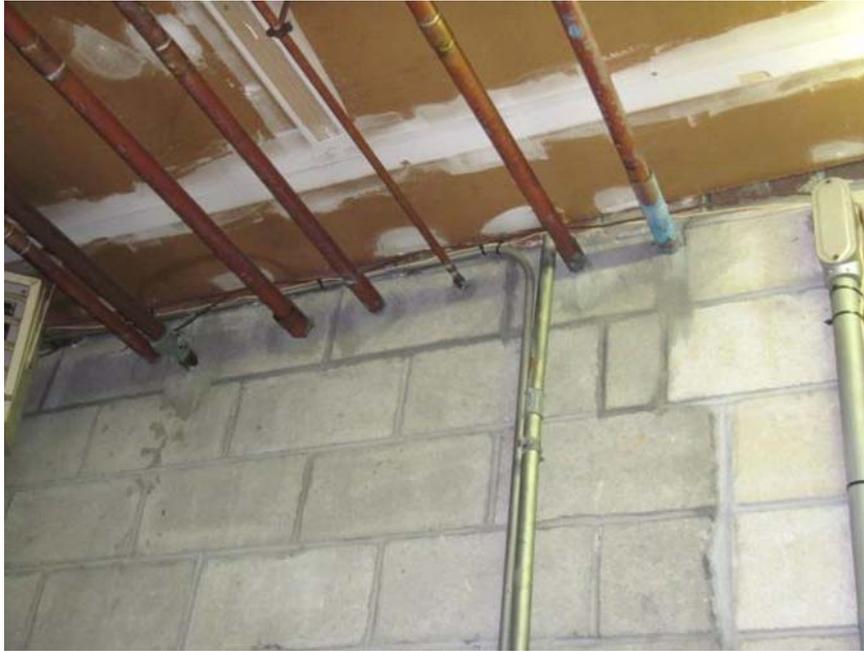
Picture 5

During the assessment several pathways were identified for odors in the mechanical room to migrate into occupied areas. A number of utility penetrations (pipes, wiring, etc.) were observed in the common wall between the RMV and mechanical room (Picture 5). Also observed were two abandoned vents that served the former boiler system (Pictures 6 and 7). In their current condition (i.e., open to the elements) the vents allow drafts/winds to pressurize the mechanical room forcing odors and particulate matter into occupied space via any open utility holes/breaches in the common wall. Finally, the configuration of the new intake and exhaust vents for the current boiler system can also allow for pressurization (Picture 8), therefore BEH/IAQ recommends extending and turning the vent ducts 90° to prevent wind from pressurizing the space through the vents.

Utilities penetrating the common wall between the mechanical room and RMV

1. Seal any open utility holes/ penetrations/breaches in the common wall between the mechanical room and RMV, with a fire-rated sealant. Observe for light penetration and/or drafts to ensure proper sealing.
2. Seal abandoned supply/exhaust vents for the former boiler system.
3. Consider extending the current supply/exhaust vents (e.g., ~90°), to prevent pressurization of boiler/mechanical room.

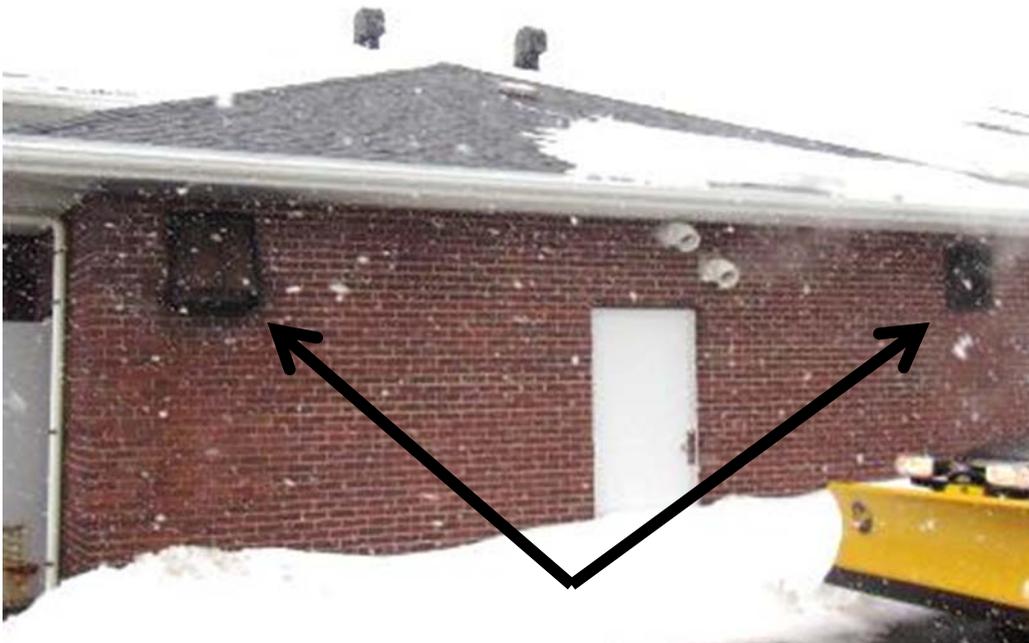
Picture 6

Abandoned vents (arrows) for former boiler system

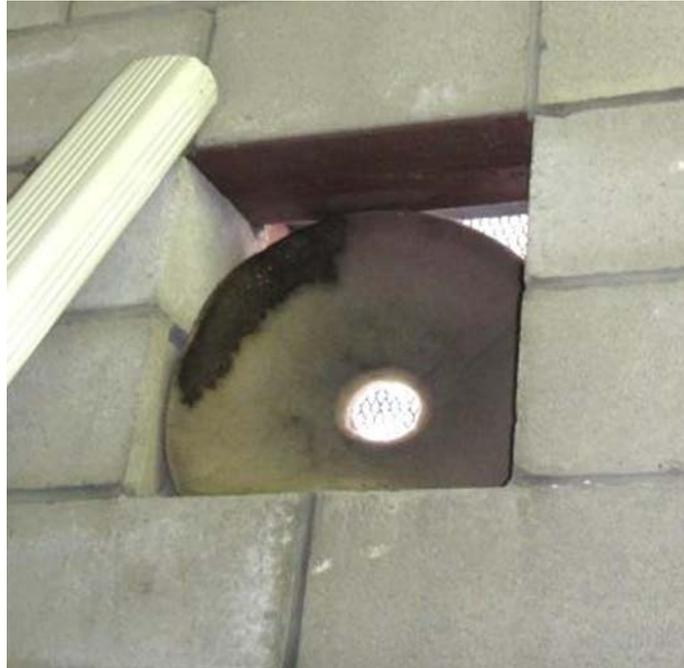
Picture 7

Abandoned supply vents for former boiler system

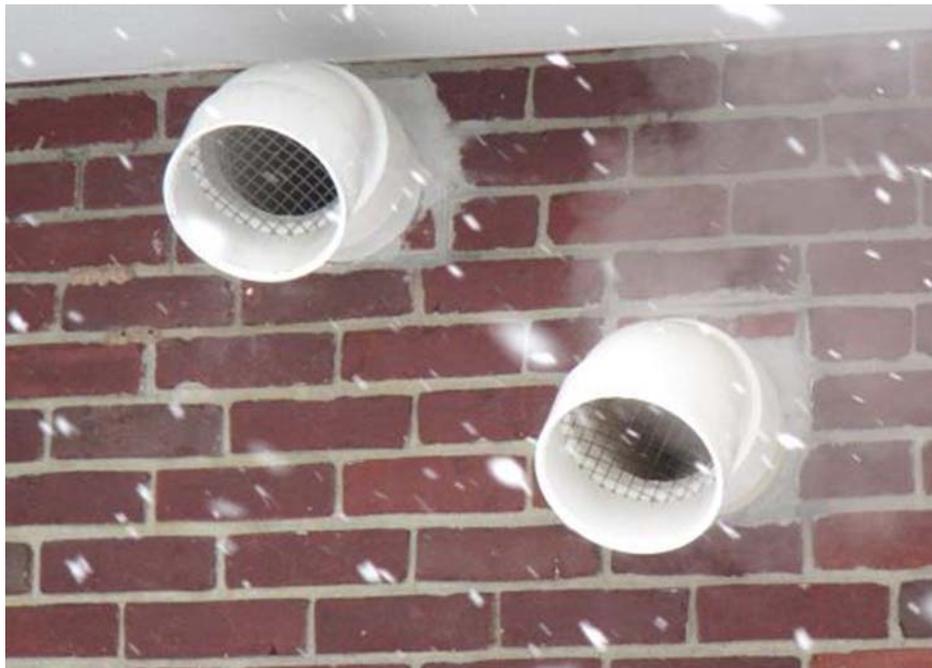
Picture 8

Intake/exhaust vents for current boiler system
