# **INDOOR AIR QUALITY ASSESSMENT**

**Silber Early Education Center  
99 Hawthorne Street  
Chelsea, MA**

Prepared by:  
Massachusetts Department of Public Health  
Bureau of Environmental Health  
Indoor Air Quality Program  
March 2015

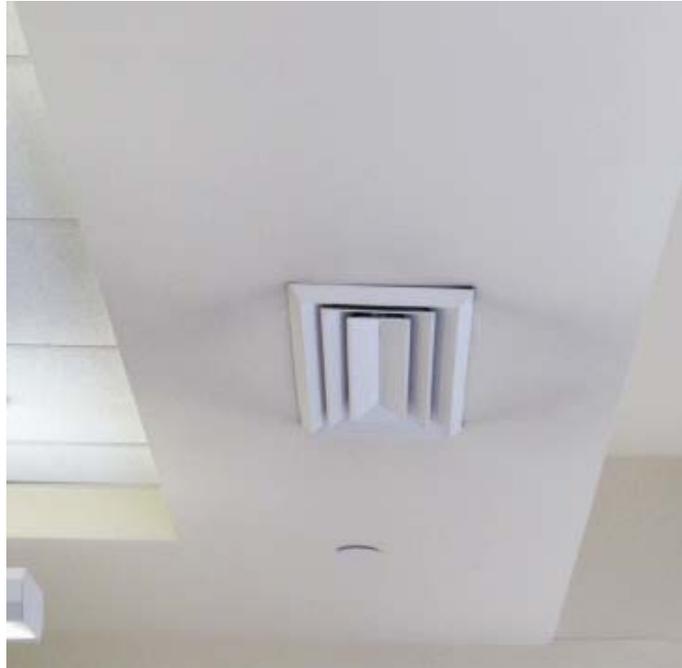
**Picture 1**

Other conditions that can affect indoor air quality were observed during the assessment. BEH/IAQ staff noted the presence of debris adhered to the ceiling of classrooms throughout the building (Pictures 1 and 4). This type of dust pattern is typically associated with a lack of routine cleaning around air diffusers as well as a lack of sufficient filtration of outdoor air drawn into the building by the HVAC system. The SELC is located in an area that has a number of pollutant sources in close proximity, including housing with chimneys at the level of the SELC's roof line on all sides; the Tobin Bridge with highway traffic to the west; the Chelsea Creek fuel depot with oil tankers to the east; and Logan International Airport to the southeast (Figure 1).

**Example of fresh air diffuser (Note darkened areas around diffuser)**

8. Clean fresh air diffusers, exhaust vents, surrounding ceiling tiles and personal fans on a regular basis. If ceiling tiles cannot be cleaned, replace.

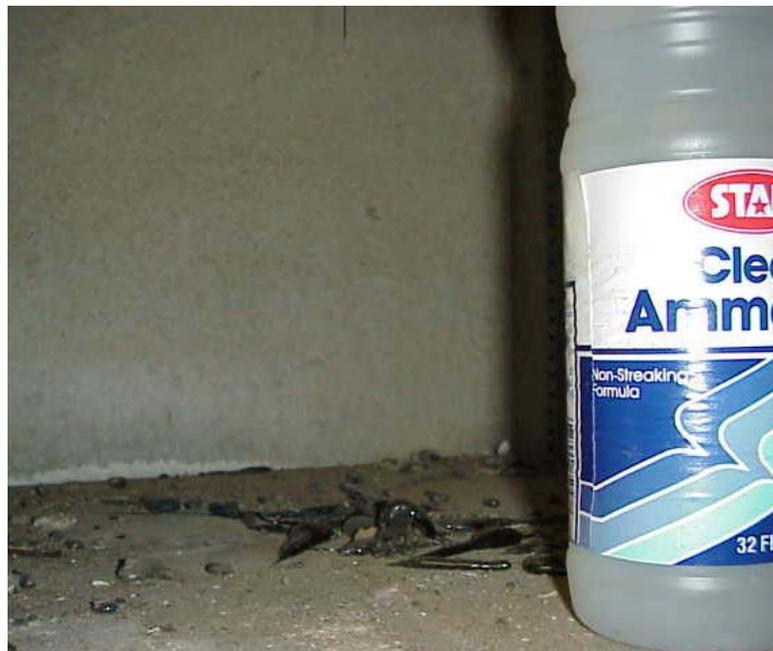
**Picture 2**

It was reported to BEH/IAQ staff that the SELC experiences issues regarding roofing material dripping into top floor classrooms through the suspended ceiling. Chelsea Public Schools (CPS) officials reported that when the building was initially built it had an asphalt roof. When the building was renovated, a decision was made to install a rubber membrane roof over the existing asphalt roof. As sunlight heats the roof, the asphalt temperature is increased and the heat is retained by the rubber membrane roof. This heating is particularly acute around metal penetrations for plumbing/ductwork through the roof, which are likely reaching a temperature at which the asphalt melts, going from a solid into a liquid. The liquid then passes between spaces around exhaust fans and other roof penetrations and drips into the space above the suspended ceiling (the ceiling plenum). Roofing material has reportedly dripped through the suspended ceiling at times.

The melting of roof asphalt is likely tied to warm weather, sunlight conditions and would be highly unlikely to occur during cold weather. Based on these observations, solidified asphalt drippings would not be expected to pose a health hazard in the current circumstances, aside from the odor irritation that sensitive individuals may experience.

Or more importance is the safety hazard posed by dripping asphalt. As noted previously, the temperature of liquid asphalt is at least 150° F, which can cause serious burns if liquid asphalt comes into contact with skin. Measures must be taken to prevent the leakage of liquid asphalt into occupied space.

**Example of solidified asphalt drippings observed by IAQ staff in a school,  
(Photograph taken in 1999)**

1. Install materials to serve as a barrier/catch basin beneath areas with leaking asphalt.  
Work with faculty to determine locations of asphalt drips and install barriers as needed.
2. Institute a reporting system for faculty to report signs of dripping asphalt.
3. Remove all asphalt-covered ceiling tiles if not already done. Ensure that all 4<sup>th</sup> floor classrooms have a complete set of ceiling tiles installed.
4. In order to dilute and remove normally occurring environmental pollutants, it is recommended to increase fresh air supply by the HVAC system in conjunction with recommendation number 5.
5. Ensure AHU filters are changed as per the manufacturers' instructions or more frequently if needed. Consider upgrading to pleated MERV 11 (or higher) dust-spot efficiency filters. Prior to any increase of filtration, HVAC system components should be evaluated

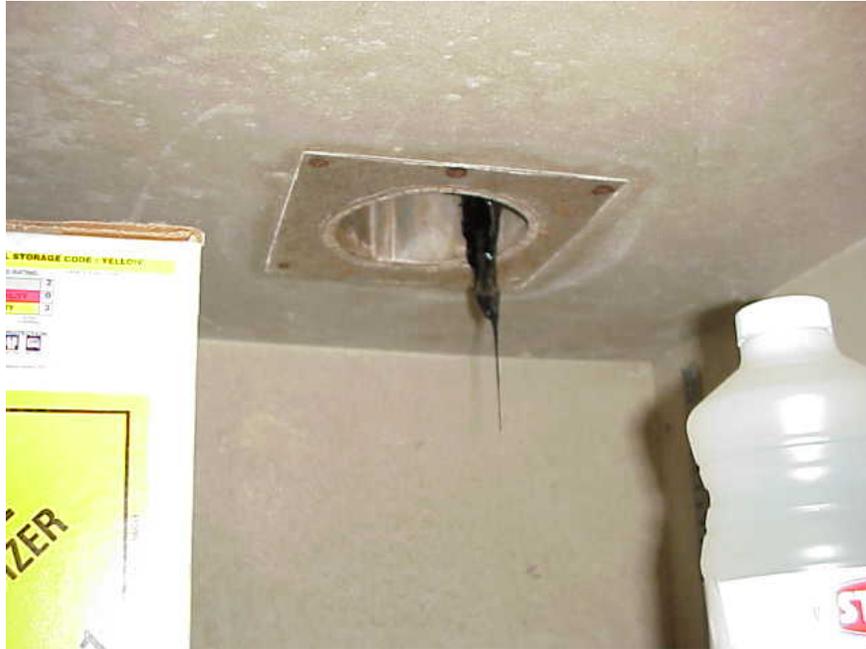
**Picture 3**

**Example of solidified asphalt drippings observed by IAQ staff in a school  
(Photograph taken in 1999)**

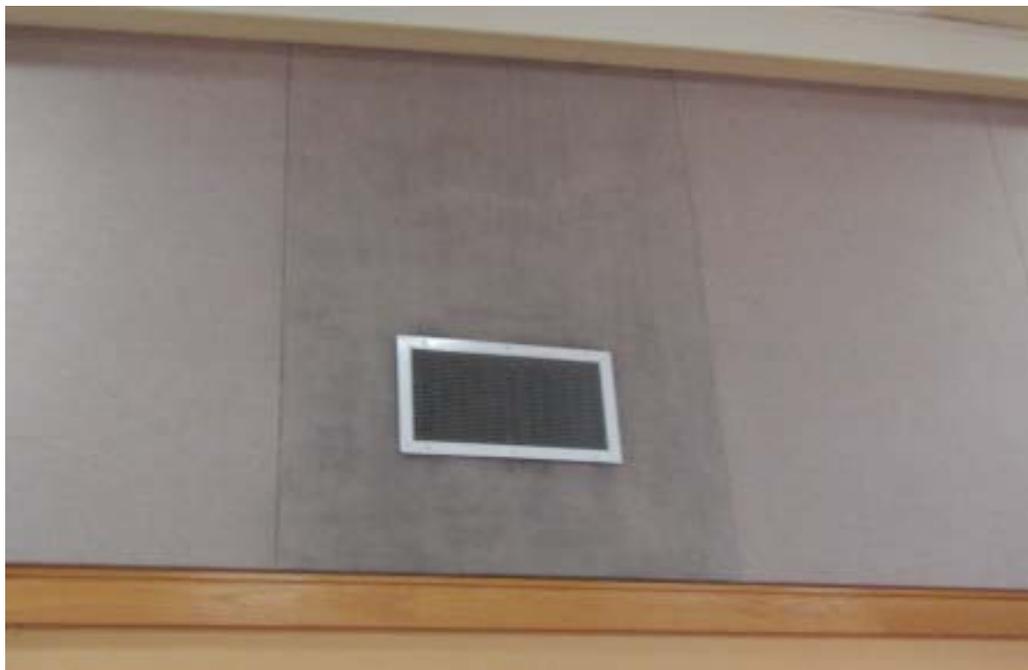
**Picture 4**

**Example of blackened material around fresh air supply on cloth panel in gym**
