INDOOR AIR QUALITY WATER DAMAGE ASSESSMENT

**Dartmouth Middle School
366 Slocum Road
Dartmouth, Massachusetts**

Prepared by:
Massachusetts Department of Public Health
Bureau of Environmental Health
Indoor Air Quality Program
June 2015

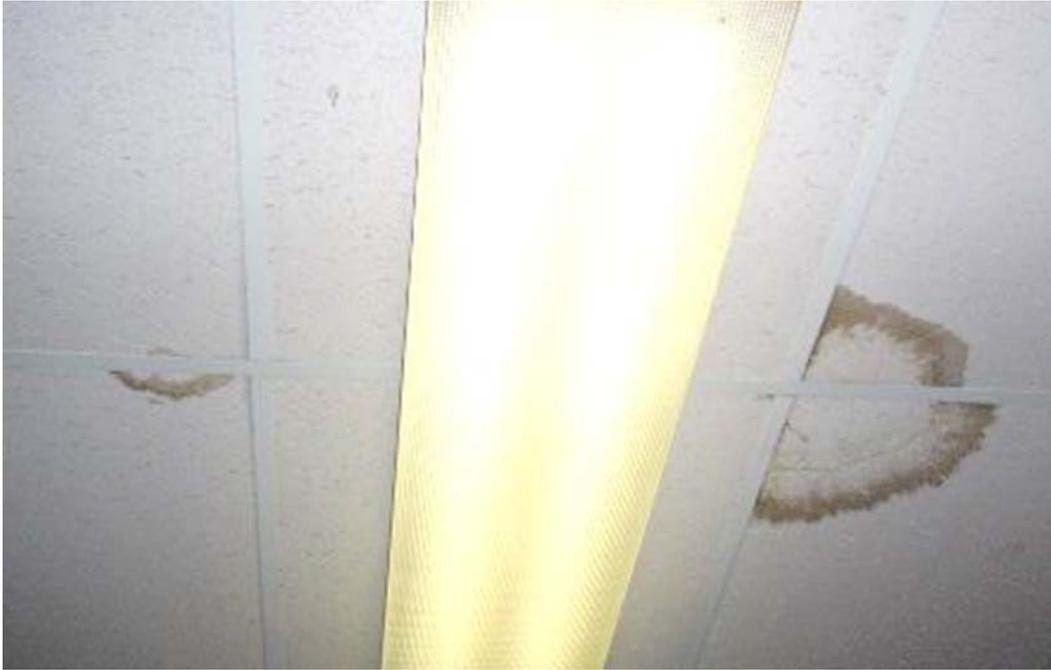
Picture 1

As reported by DPS officials, the DMS, similar to many buildings in the New England area, experienced several issues with water penetration through the building envelope over the winter of 2014-2015 due to higher than normal snowfall. At the time of the assessment, several areas had water-damaged ceiling tiles (Picture 1; Table 1). Water-damaged ceiling tiles can provide a source of mold and should be replaced after a water leak is discovered and repaired. In order to determine if any visible mold was present on building materials, BEH/IAQ staff inspected above these water-damaged ceiling tiles. No water-damaged/mold-colonized building materials were observed above these areas in the ceiling plenum. In fact, the ceiling plenum consisted of a large open space with metal decking/ceilings and support beams (Picture 2) that are non-porous materials and not conducive to mold growth.

Water-damaged ceiling tiles

1. Make temporary repairs to roof and replace any remaining water-damaged ceiling tiles.

2. Continue with capital improvement plans for major roof repairs/replacement.
3. For more information on water damage/mold-remediation consult “Mold Remediation in Schools and Commercial Buildings” published by the US Environmental Protection Agency (US EPA, 2001) (http://www.epa.gov/mold/mold_remediation.html).

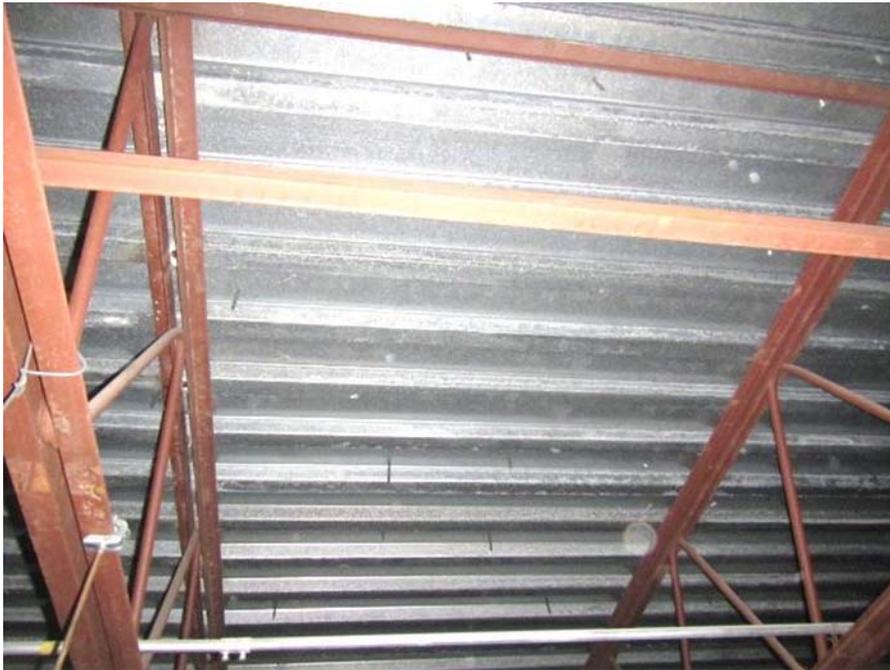
Picture 2

Metal decking and support beams above ceiling tiles

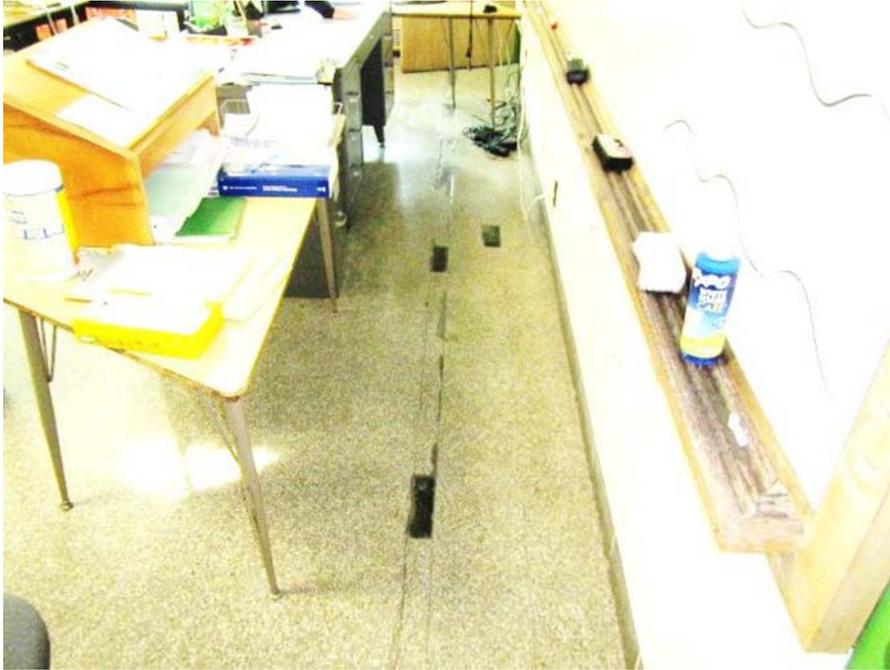
Picture 3

Concerns regarding damaged floor tiles in classroom 110 were expressed. Although the tiles were worn, they did not appear friable and were sealed by a layer of floor wax (Pictures 3 and 4). However, it was noted that classroom furniture, including the teacher's desk was located in this area on top of these tiles (Picture 3). It was recommended that the furniture be relocated to an area where the tiles were intact to prevent further damage to worn tiles. In addition, DPS officials discussed performing an abatement project over the summer, which would remove the tiles from the room.

Intact asbestos-containing material (ACM) does not pose a health hazard. If damaged, ACM can be rendered friable and become aerosolized. Friable asbestos is a chronic (long-term) health hazard, but will not produce acute (short-term) health effects (e.g., headaches) typically associated with buildings believed to have indoor air quality problems. Where asbestos-containing materials are found damaged, these materials should be removed or remediated in a manner consistent with Massachusetts asbestos remediation laws (MDLI, 1993).

Worn floor tiles in classroom 110, note location of desk

4. Continue to follow AHERA regulations including 3-year inspections and updates/availability of the school’s asbestos management plan.
5. Relocate desk/furniture in the front of classroom 110 away from damaged/worn floor tiles.

6. Continue with plans for ACM abatement project in classroom 110, if funds are available.
7. Consider adopting the US EPA (2000) document, “Tools for Schools”, as an instrument for maintaining a good indoor air quality environment in the building. This document is available at: <http://www.epa.gov/iaq/schools/actionkit.html>.

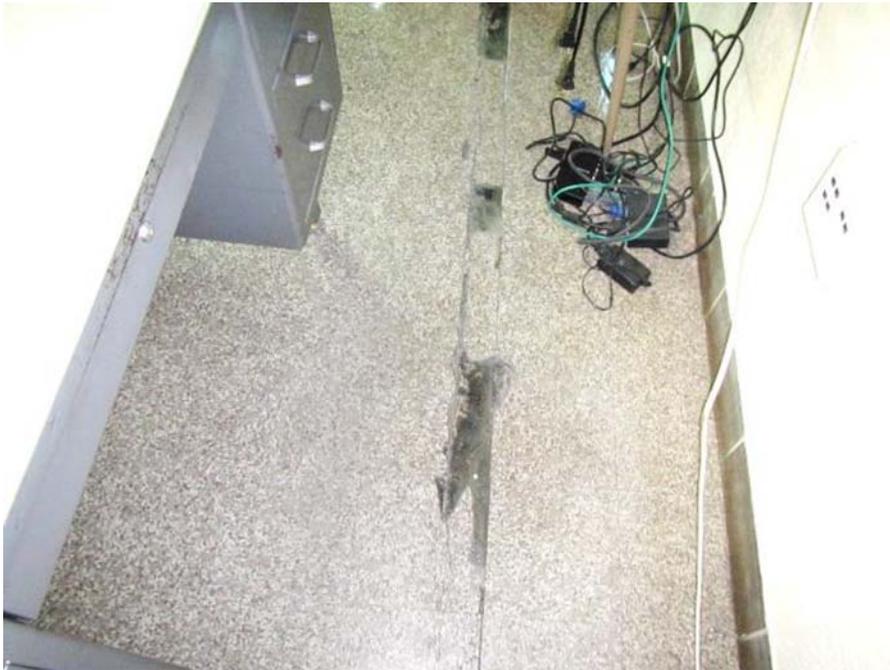
Picture 4

Close-up of worn floor tiles in classroom 110
