WATER DAMAGE INVESTIGATION

**Massachusetts Department of Children and Families
33 East Merrimack Street
Lowell, Massachusetts**

Prepared by:
Massachusetts Department of Public Health
Bureau of Environmental Health
Indoor Air Quality Program
March 2015

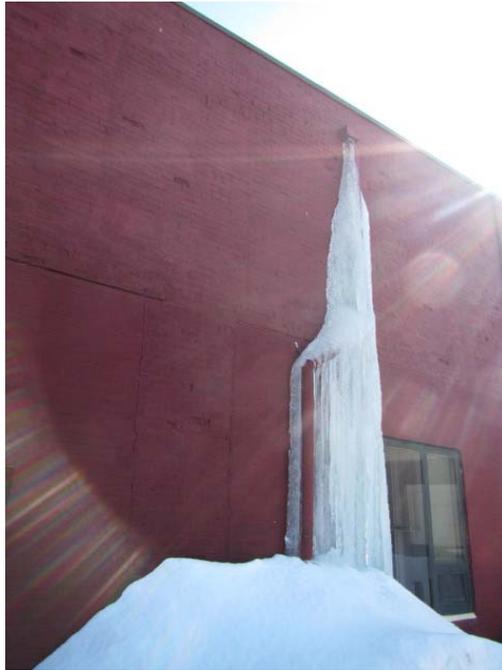
Picture 1

Water infiltration was occurring in three main areas (Lavoie office, Barghi office and DCF space in a separate building called the annex) on February 20, 2015, due to severe snow pack and ice formations along the exterior wall (Pictures 1 and 2). Several buckets/containers were being used to capture ceiling leaks. Ceiling tiles and carpeting in several areas were

Ice and snow accumulation on/around building's exterior

2. Measures to remove snow pack and ice formations along the roof and exterior of the building should be taken.
3. Water-damaged carpeting, ceiling tiles, GW and insulation should be removed in a manner consistent with recommendations found in “Mold Remediation in Schools and Commercial Buildings” published by the US Environmental Protection Agency (US EPA, 2001).

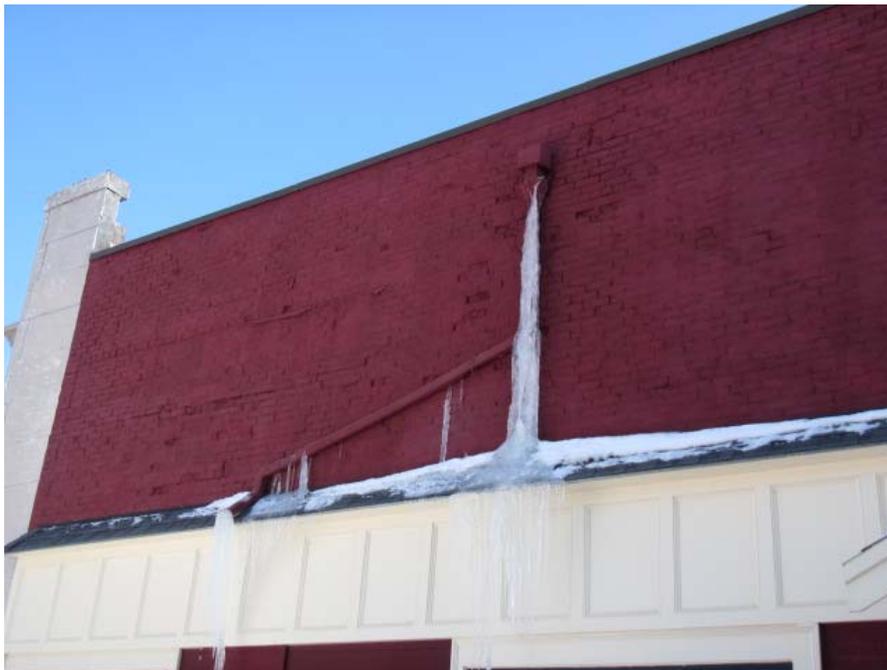
Picture 2

Ice and snow accumulation on/around building's exterior

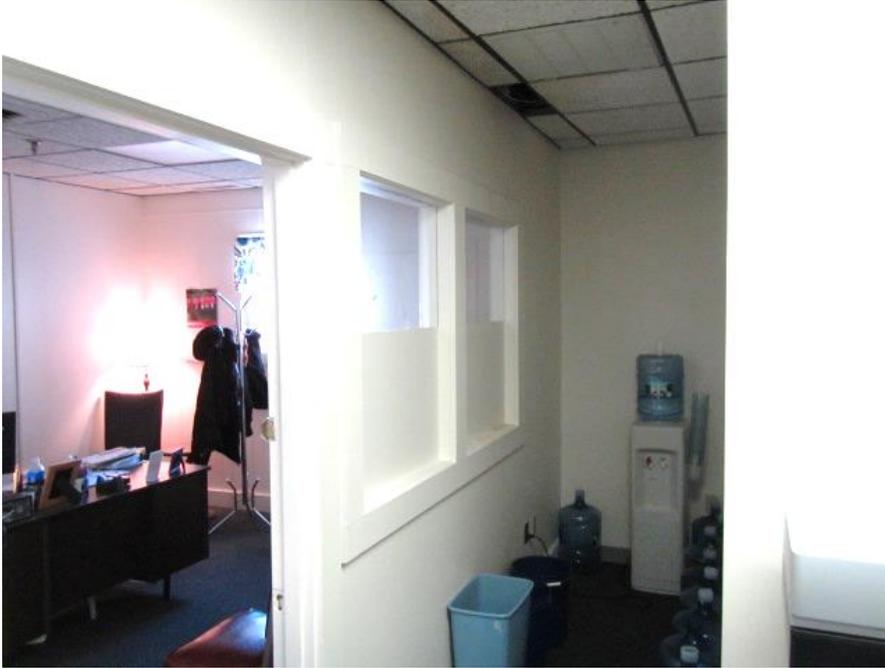
Picture 3

Water-damaged areas/wet carpeting in annex (Jen's office and water cooler area)

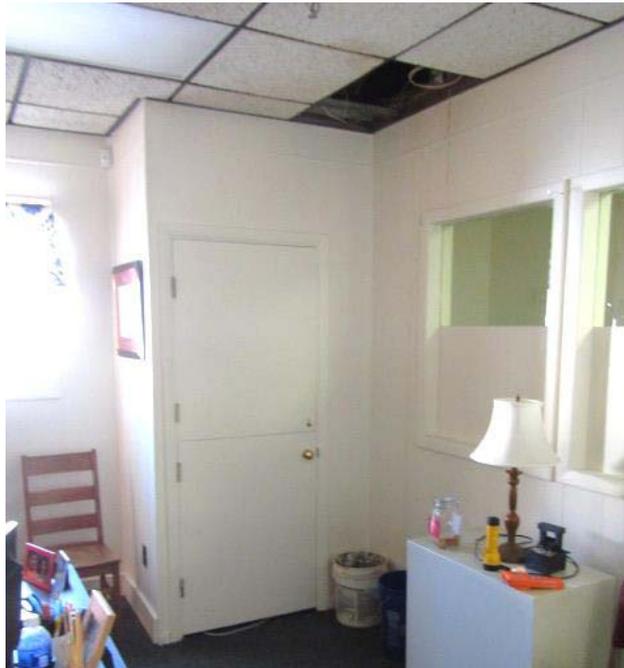
Picture 4

Water-damaged areas/wet carpeting and buckets in annex (Jen's office)

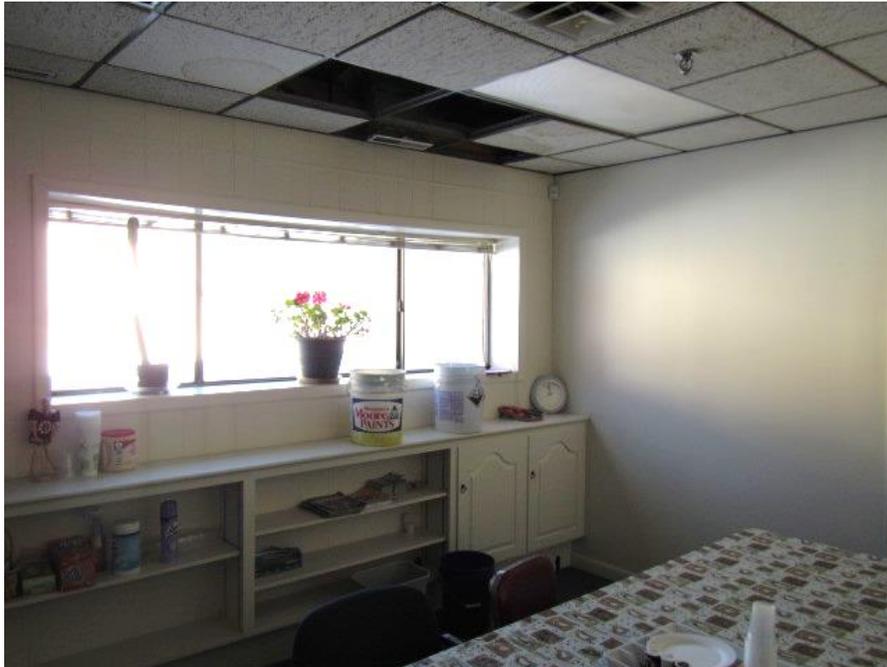
Picture 5

Buckets and water infiltration in annex breakroom

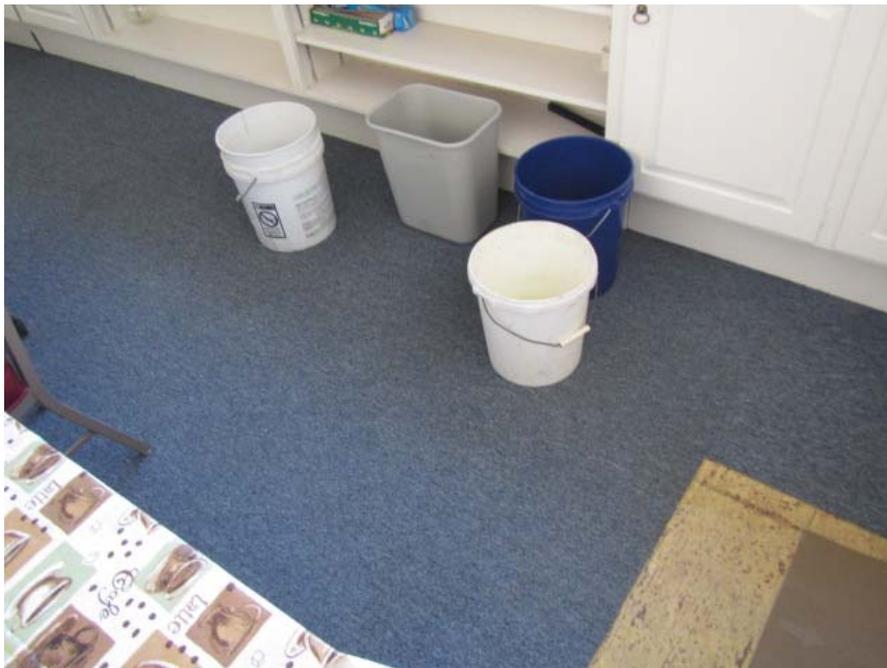
Picture 6

Buckets in annex breakroom

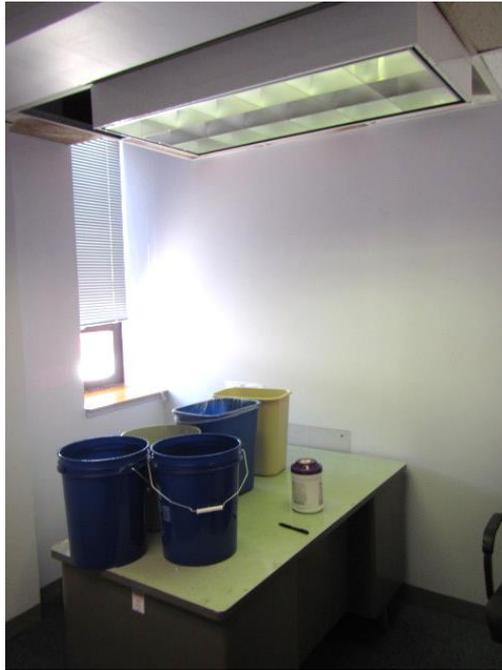
Picture 7

Severe water infiltration in Lavoie office

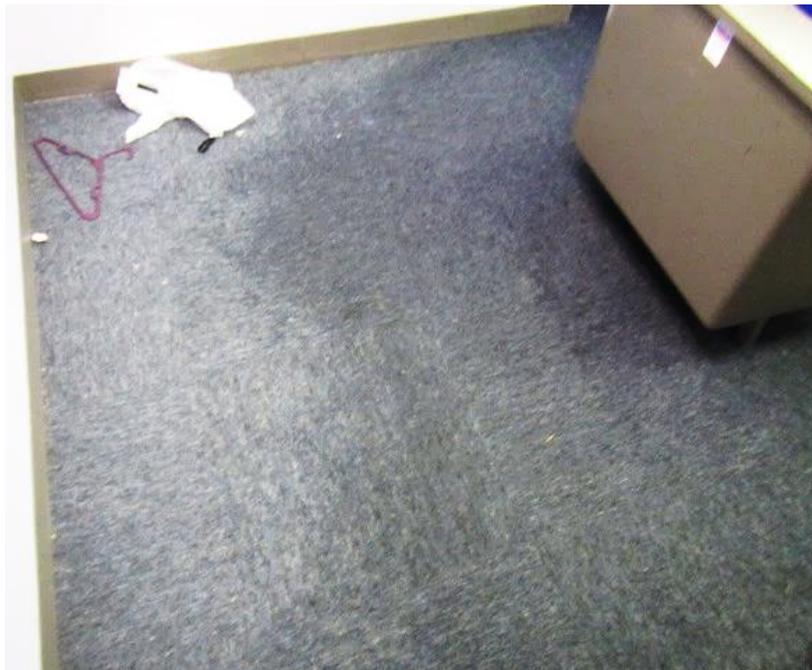
Picture 8

Saturated carpet in Lavoie office

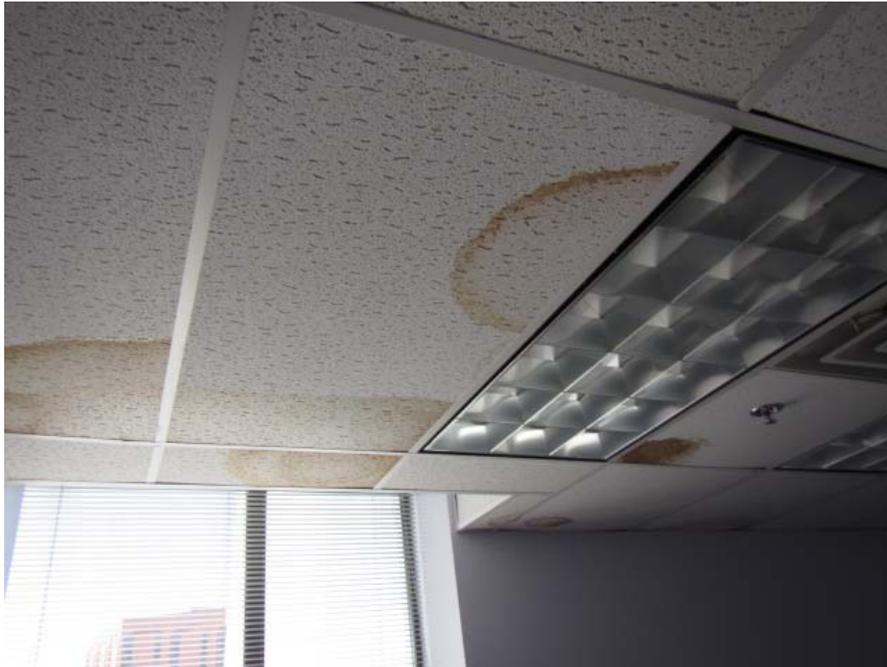
Picture 9

Water-damaged ceiling tiles in Barghi office

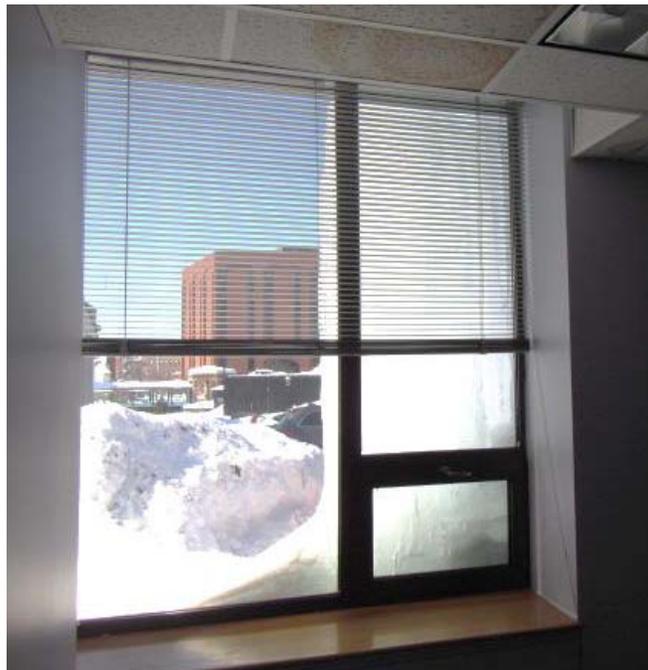
Picture 10

Interior view of ice formation from Barghi office, note ice covers entire right side window

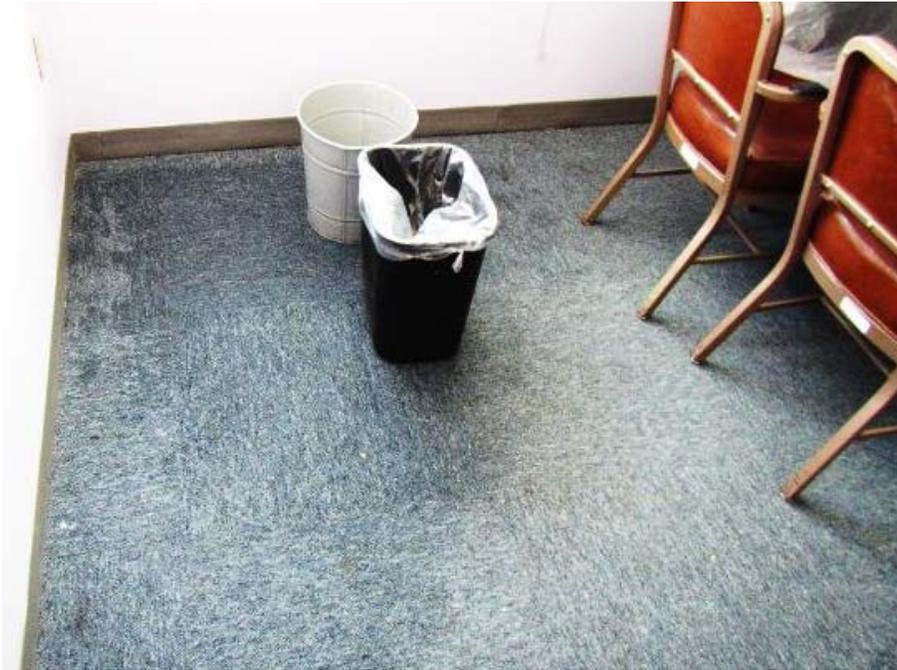
Picture 11

Wet carpeting and buckets in Barghi office

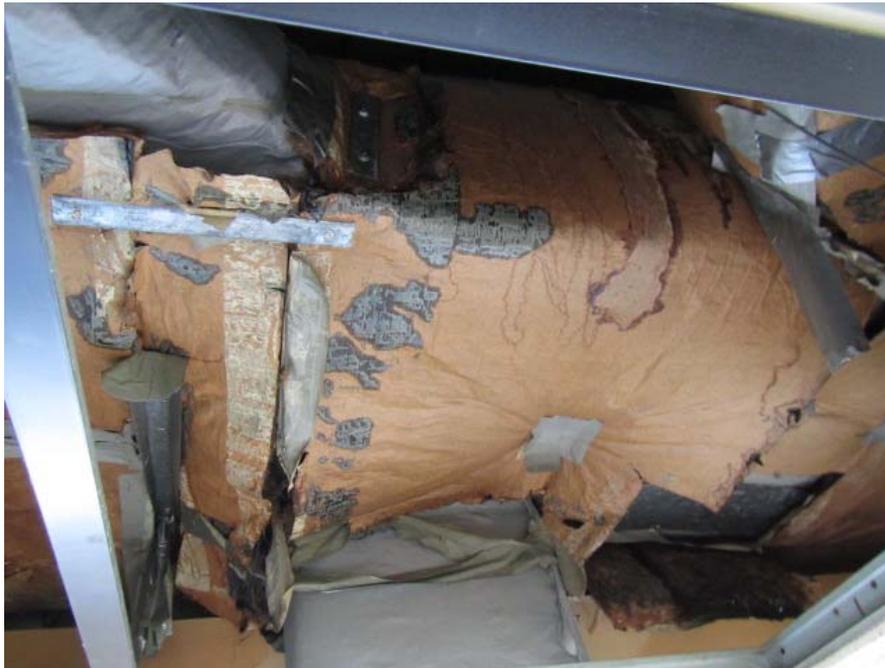
Picture 12

Water-damaged insulation above ceiling in annex breakroom

observed to be saturated with moisture (Pictures 3 through 11; Table 1). Carpeting in the main building consists of carpet squares whereas the annex has commercial grade wall-to-wall carpeting. Due to on-going moisture conditions, DPH recommended that all wet/water-damaged carpeting be removed as much as possible. In addition, water-damaged fiberglass insulation around ductwork and gypsum wallboard (GW) above the ceiling should also be removed to prevent these materials from becoming media for mold growth (Pictures 12 through 14).

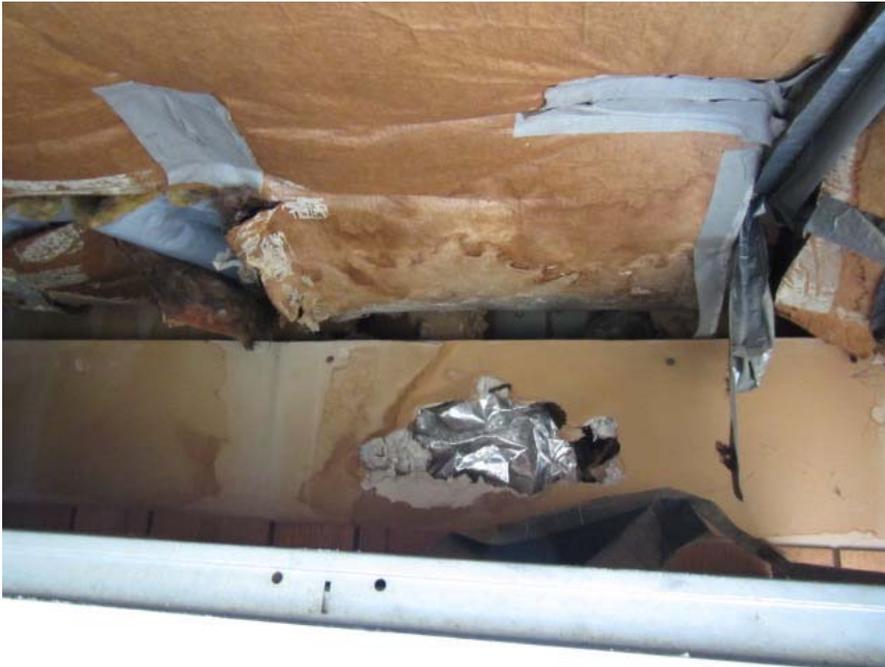
Picture 13

Water-damaged insulation and gypsum wallboard above ceiling in annex breakroom

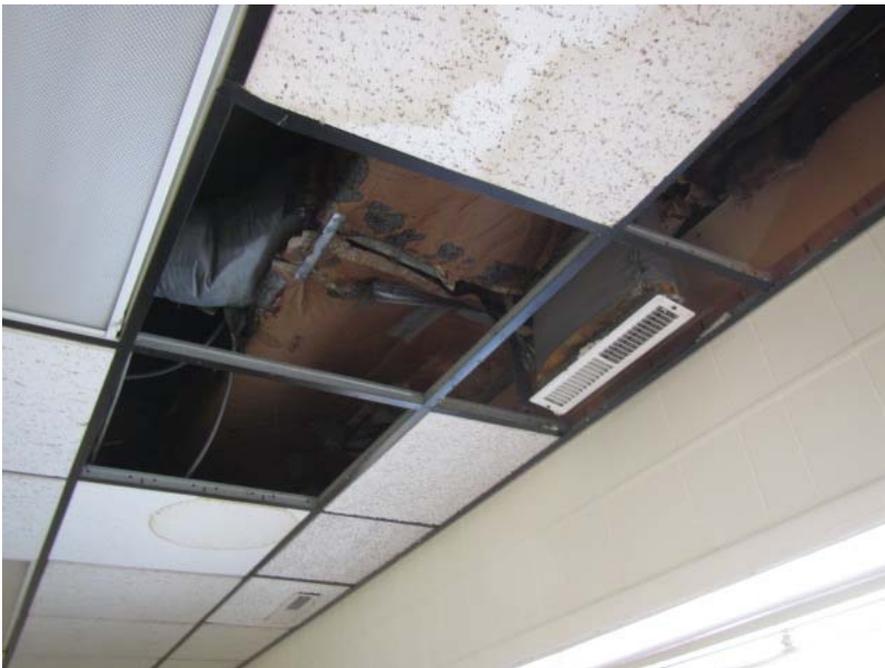
Picture 14

Water-damaged insulation and ceiling tiles in annex breakroom

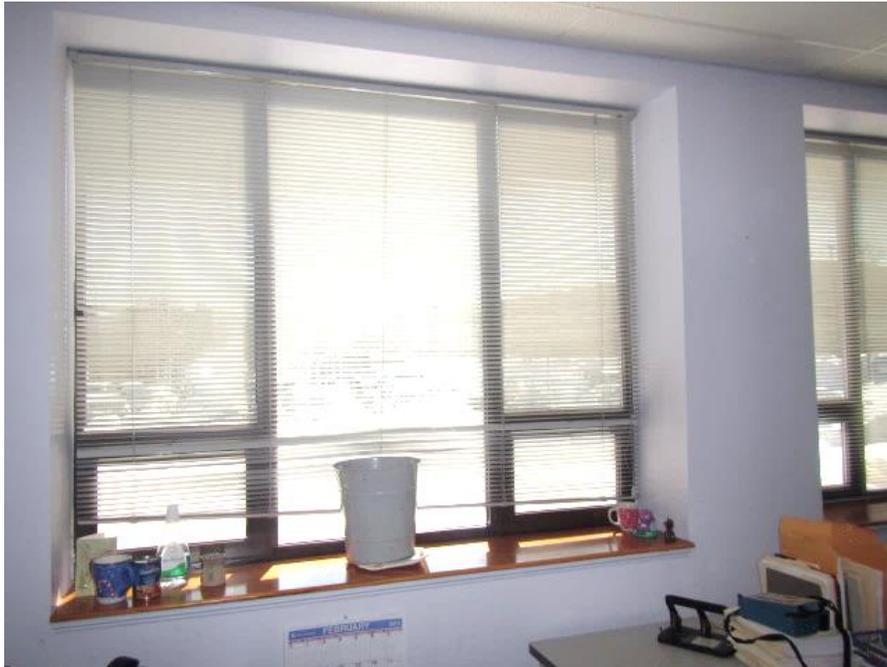
Picture 15

Two other areas (Adoption Unit and Ortiz office) were also found to have moistened GW around window frames. A bucket was positioned on the windowsill of the Adoption Unit; and visible signs of water infiltration in the form of peeling paint and damaged GW were observed in both areas (Pictures 15 through 17). Active leaks were reported in the Intake and Investigation Unit B, where water-damaged ceiling tiles were noted. In this area, a hole was made in a ceiling tile to drain the leaking water (Picture 18).

Moistened GW around window in Adoption Unit, note bucket to catch leaks

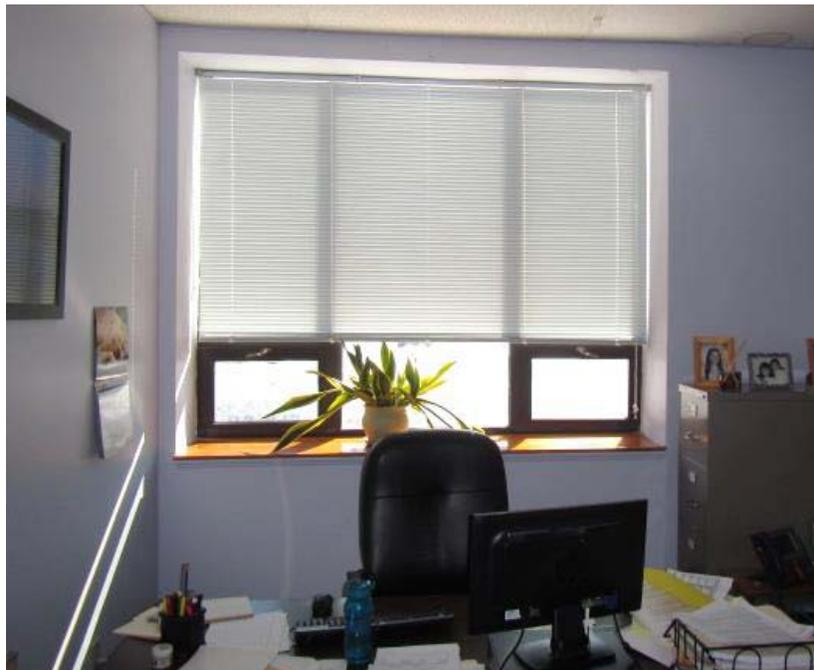
Picture 16

Moistened/damaged GW around window in Ortiz office

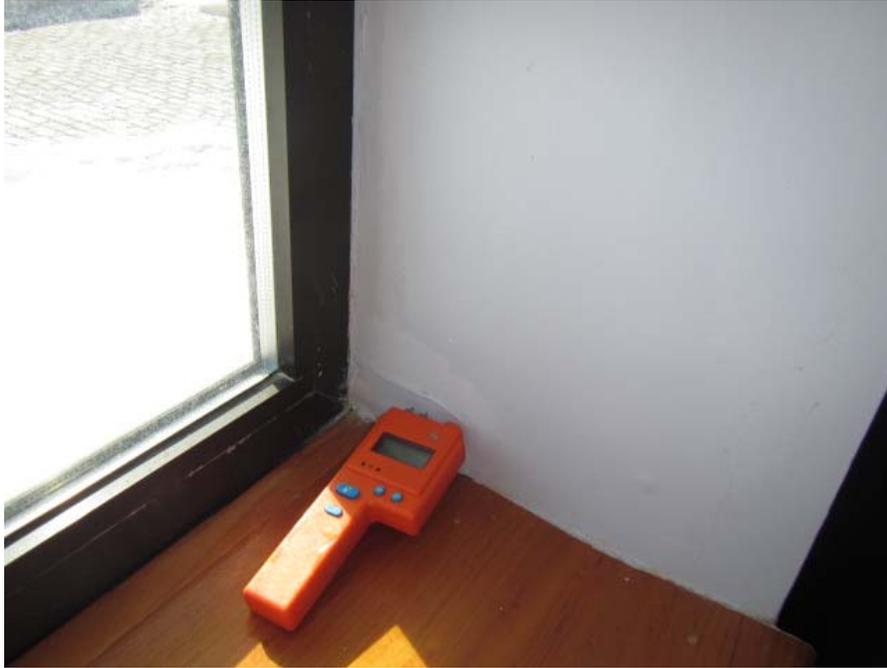
Picture 17

Moistened/damaged GW around window in Ortiz office

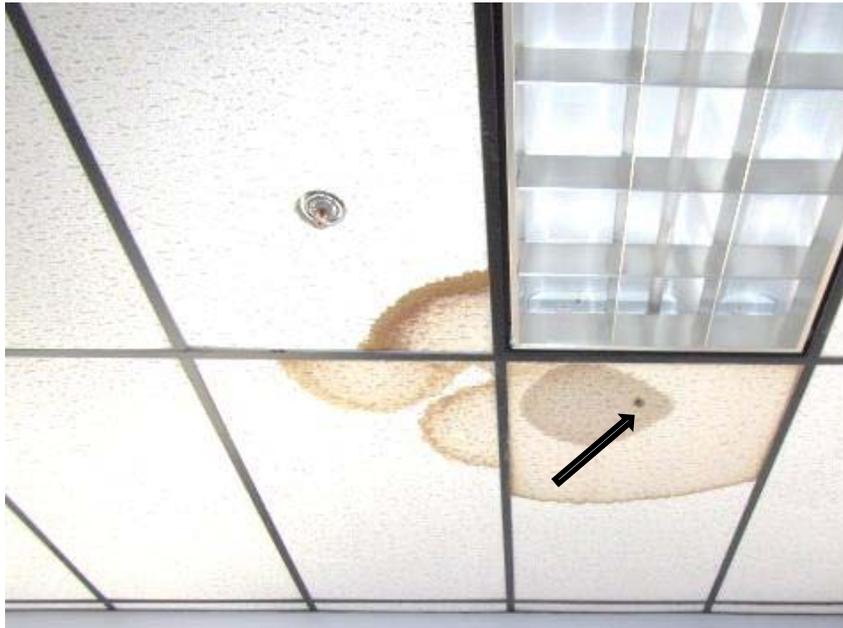
Picture 18

Water-damaged ceiling tiles in Intake and Investigation Unit B, Note hole in tile (arrow) to allow for drainage

Intake Investigation B	Carpet-dry	Active leak reported, water-damaged ceiling tiles (hole for drainage)
