# **WATER DAMAGE INVESTIGATION**

**Hayden-McFadden Elementary School  
361 Cedar Grove Street  
New Bedford, Massachusetts**

Prepared by:  
Massachusetts Department of Public Health  
Bureau of Environmental Health  
Indoor Air Quality Program  
August 2015

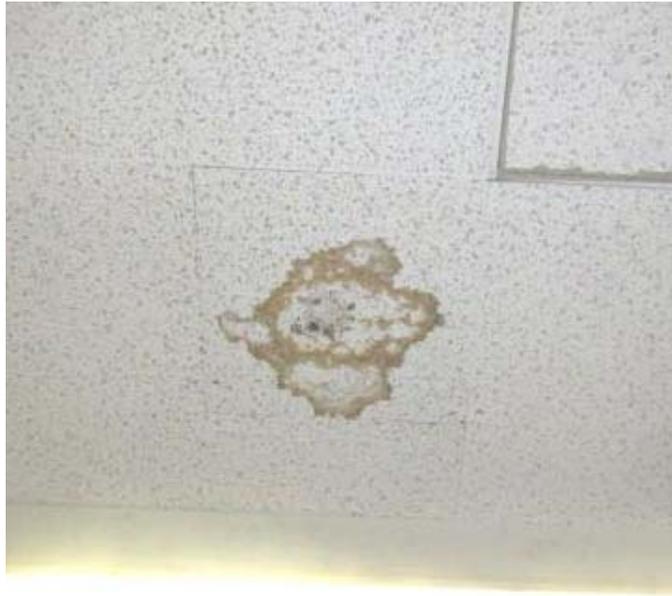
**Picture 1**

building/roof leaks over the years (Pictures 1 through 4). No musty odors and/or visible mold were observed on building components, with the possible exception of a ceiling tile in the art room, which had dark stains (Picture 1). It should be noted that the ceiling in this area is very high and not easily accessible. Water-damaged ceiling tiles can provide a source of mold and should be replaced after a water leak is discovered and repaired.

**Water-damaged ceiling tile with possible mold growth (dark stains) in art room**

1. Remove water-damaged cardboard in the library (Picture 11), ceiling tile in art room (Picture 1) and any other tiles/materials that appear to have mold growth (dark staining).
2. Clean and disinfect mold-colonized refrigerator/freezer gaskets with a mild detergent or antimicrobial agent; if they cannot be adequately cleaned, replace.
3. Evaluate strategies to stop water/moisture from penetrating the greenhouse (sealing/replacing broken/damaged glass, resealing around panes, etc.). Failure to

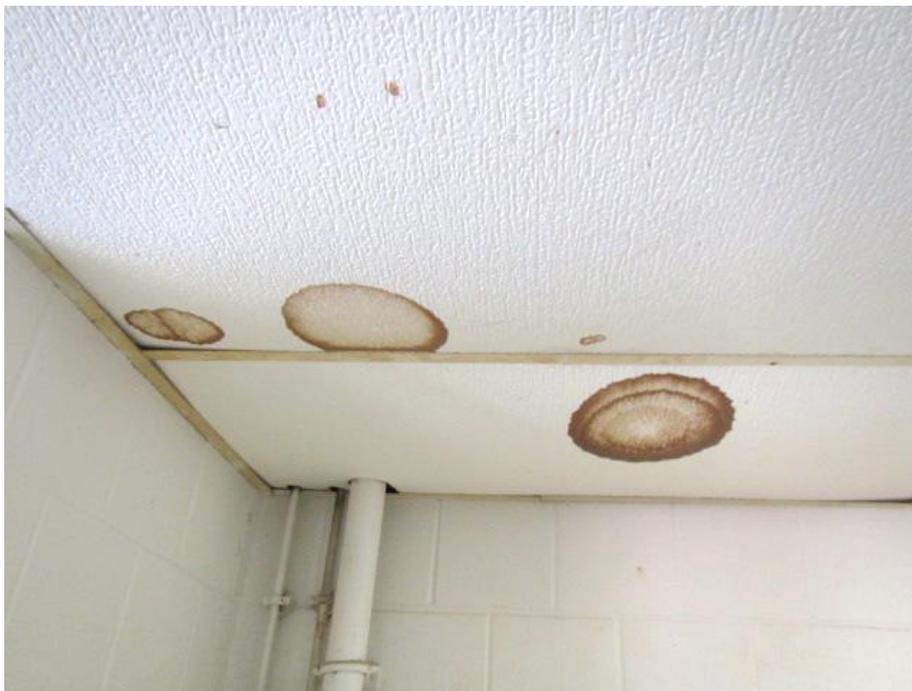
**Picture 2**

**Water-damaged ceiling tiles**

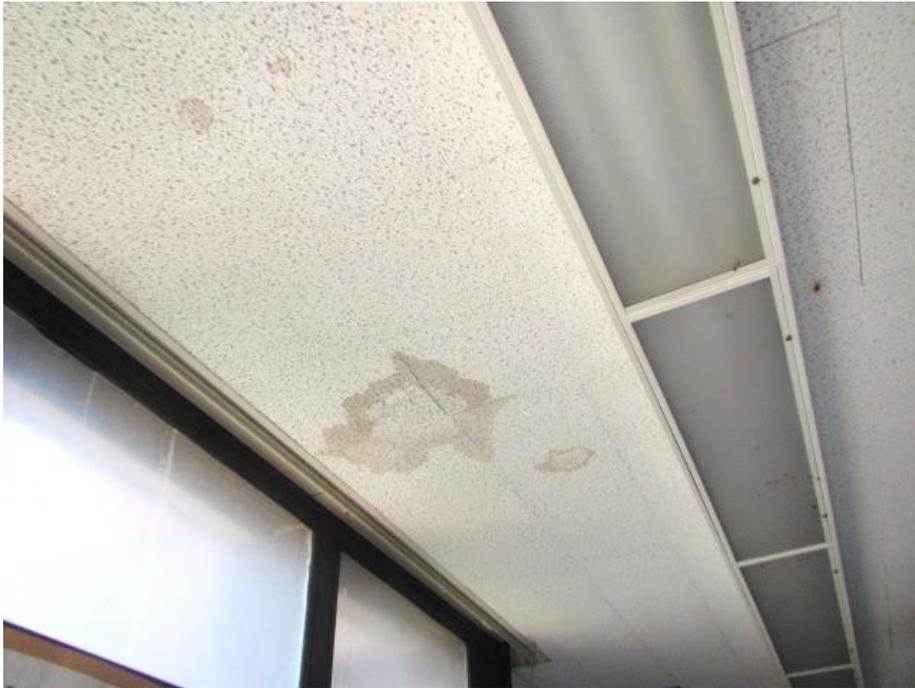
**Picture 3**

However, the majority of ceiling tiles at the HMES are of an interlocking type that cannot readily be removed/replaced (Pictures 1, 3 and 4). It was reported that in the case of some interlocking ceiling tiles that they are treated in-place with an antimicrobial sealant. In other cases, NBPS maintenance personnel remove damaged sections of interlocking tile and replace them with more easily maintained dropped ceiling tiles (Picture 5) in limited areas. As a result of chronic water damage in many areas, ceiling tiles are missing, which can allow dust/debris from above the ceiling tile system to enter occupied areas and be a source of eye and respiratory irritation.

**Water-damaged interlocking ceiling tiles**

12. Contact a ceiling tile manufacture and/or consult with contractor to examine methods of either obtaining comparable replacement tiles or other method of sealing penetrations of the ceiling tile system.

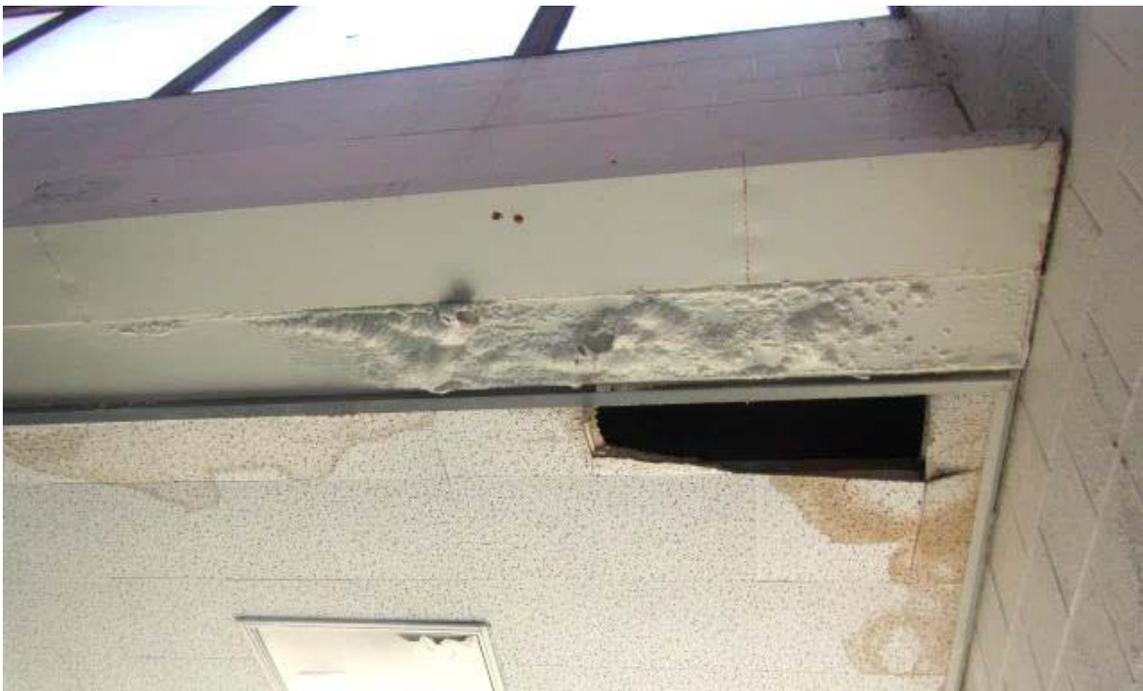
**Picture 4**

Chronic building envelope leaks were also evident by the presence of efflorescence, water stains, and peeling paint on concrete indoors (Picture 4). Efflorescence is a characteristic sign of water damage but it is not mold growth. As moisture penetrates and works its way through mortar, brick or plaster, water-soluble compounds dissolve, creating a solution. As the solution moves to the surface of the material, the water evaporates, leaving behind white, powdery mineral deposits.

**Water-damaged ceiling tiles and efflorescence (mineral deposits) in stairwell**

6. Clean/scrape loose paint and efflorescence in stairwell (Picture 4) and in other areas where found for refinishing.
7. The following general measures should be taken in classrooms at the end of the school year (in any school building) to help prevent moisture “trapping”/condensation/mold growth over summer months:

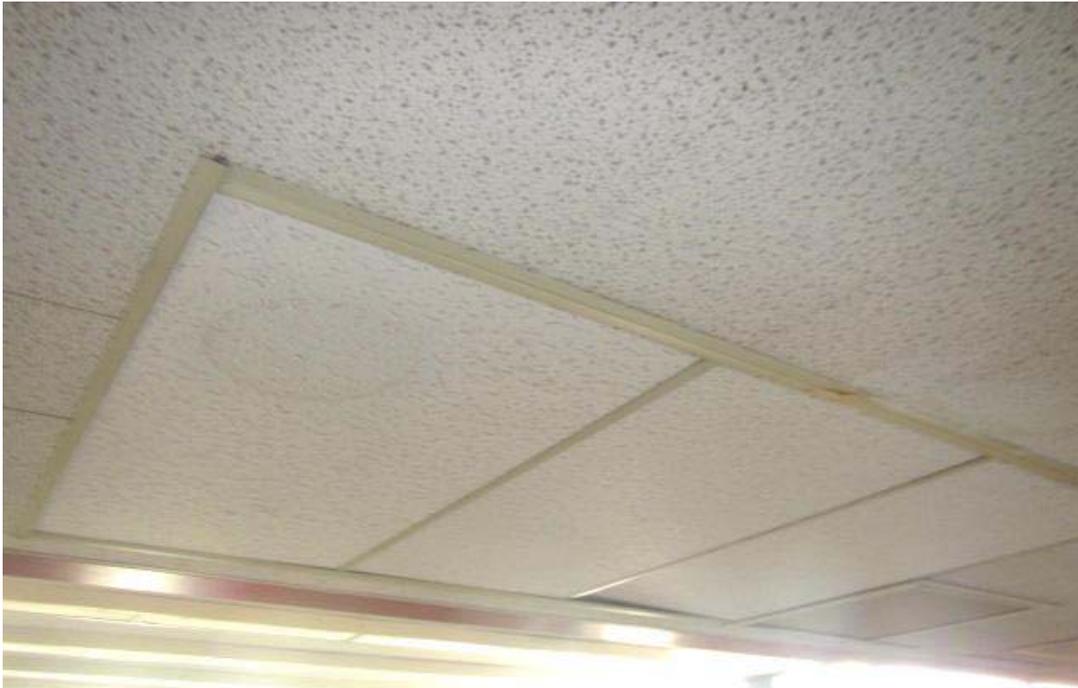
**Picture 5**

**Section of dropped ceiling tiles replacing interlocking type**

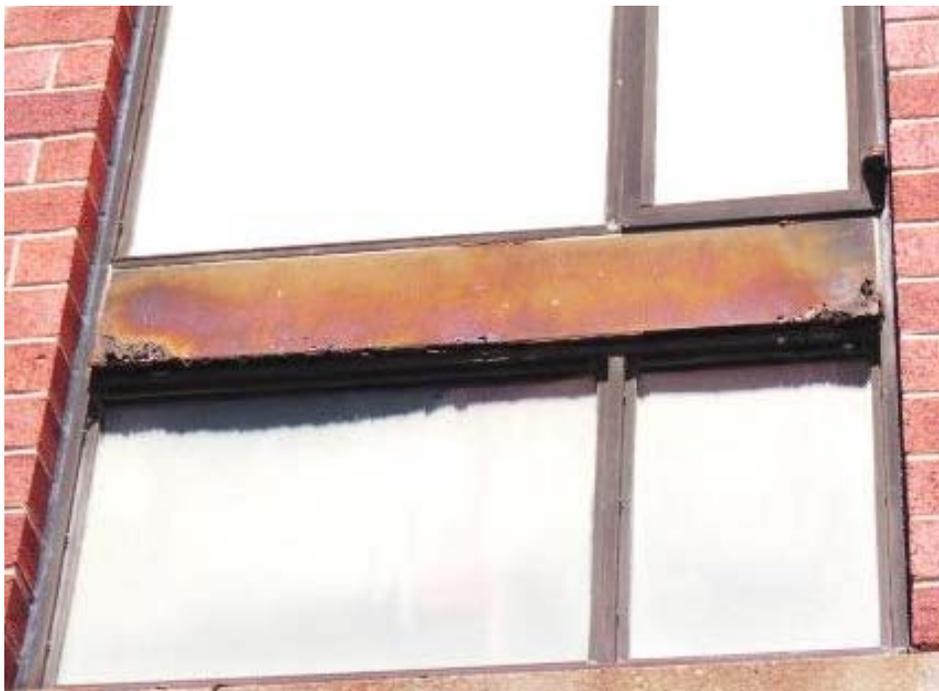
**Picture 6**

As stated previously, the NBPS are creating a capital repair plan to replace windows, which are original equipment and broken/damaged in many areas (Pictures 6 through 8). In addition, the majority of windows appeared opaque (Picture 8) and let limited natural light into rooms. Also noted on the exterior of the building was missing/damaged weather-stripping and

**Corroded metal window frame**

- a. Window/exterior door replacement. Please note that due to the age of the building, sealant around doors/windows may contain regulated materials; address deteriorating sealant/caulking materials in accordance with federal/EPA regulations;
- b. Ceiling tile replacement with dropped ceiling tile systems building-wide; and
- c. Carpet removal/replacement with non-porous surfaces.
- d. Repair of other building envelope issues allowing water penetration.

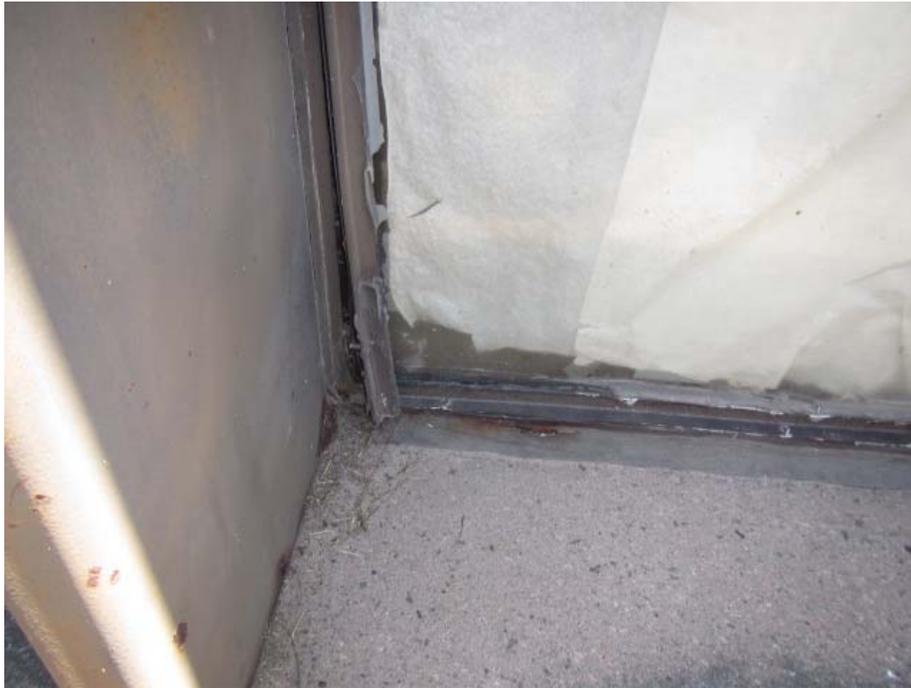
**Picture 7**

**Damaged window frame**

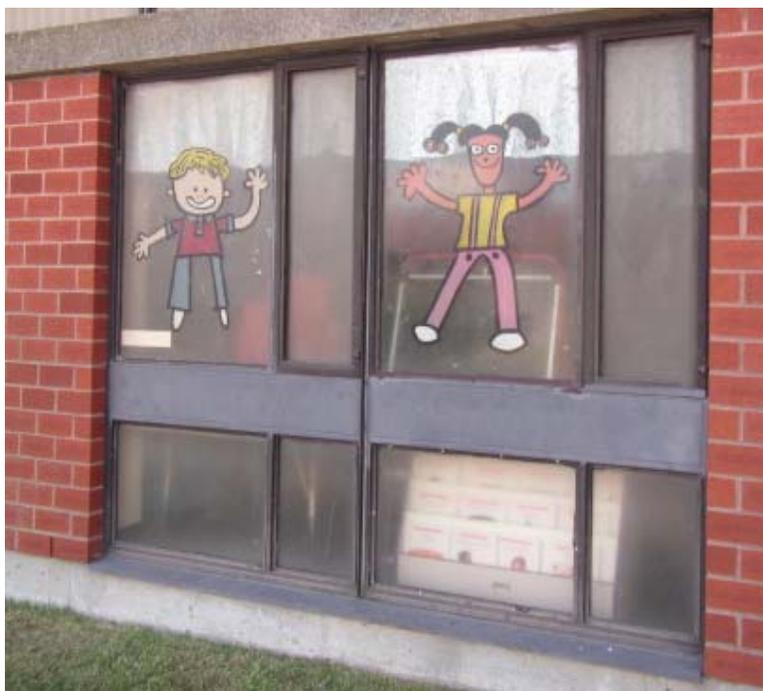
**Picture 8**

**Typical window system, note opaque finish limiting natural light**

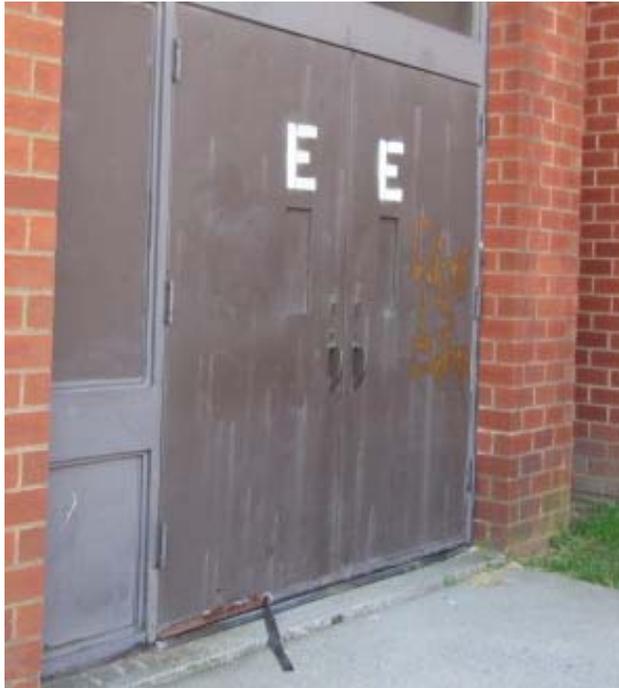
**Picture 9**

corrosion of metal doors (Pictures 9 and 10). These conditions can allow for drafts, water penetration and pest entry into the building.

**Corroded metal exterior door with missing/damaged weather-stripping**

4. Unclog/remove debris from drains in greenhouse floor and ensure proper drainage, make repairs as needed.
5. Replace missing/damaged weather-stripping on exterior doors.

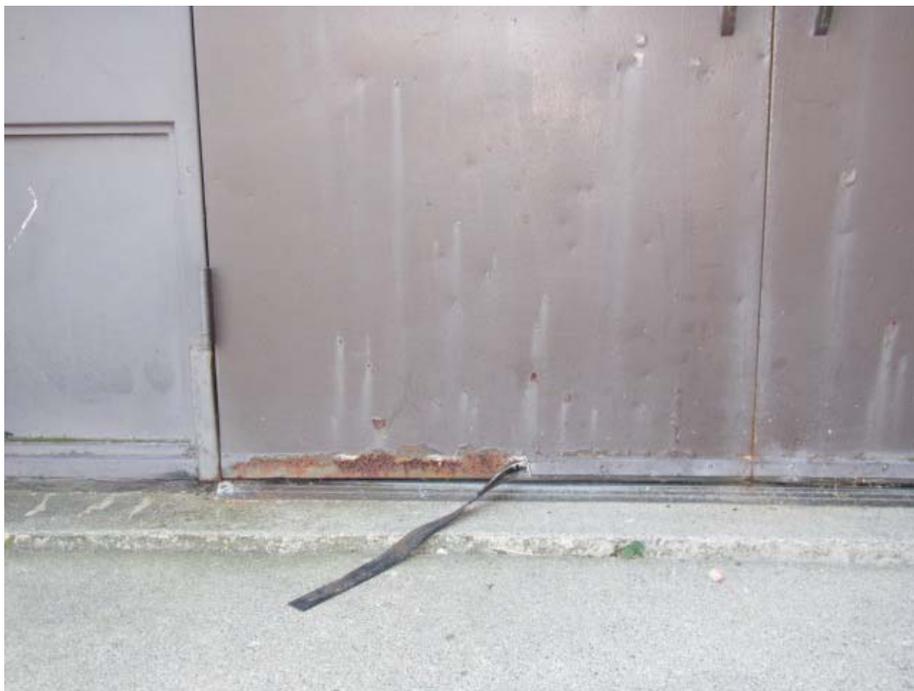
**Picture 10**

**Close-up of corroded metal exterior door with missing/damaged weather-stripping**

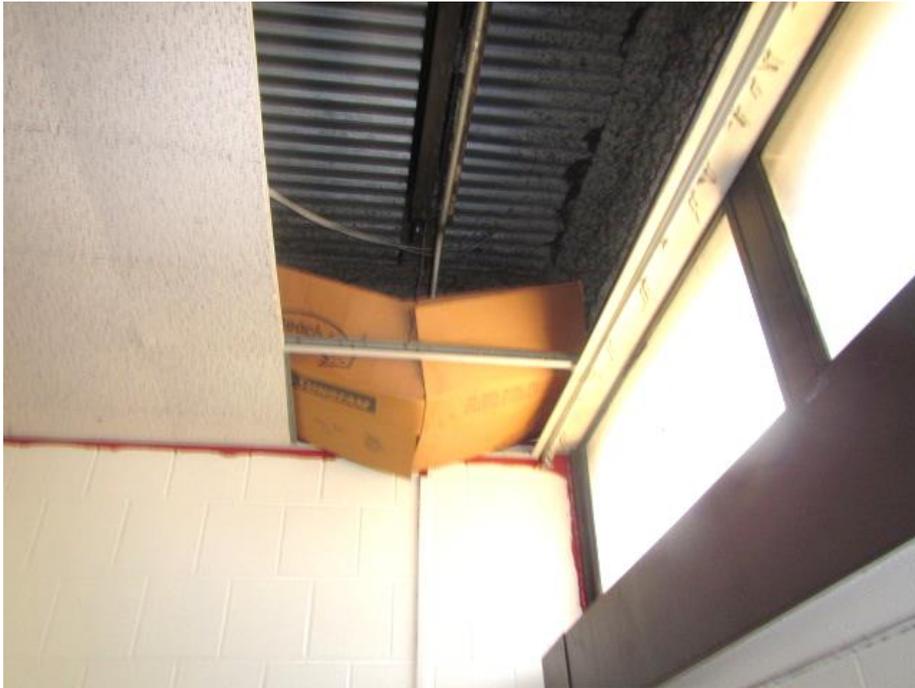
**Picture 11**

Visible mold growth was observed on cardboard that was installed above the ceiling tile system in the library (Picture 11), presumably as a means to catch water leaks. A main area of water penetration indoors is the greenhouse located directly above the library (Picture 12). The original glass for the greenhouse was broken/loose/damaged allowing rainwater to penetrate into the building (Pictures 13 through 15). In addition, hoses used to water plants were inside the greenhouse, which can provide a source of interior water damage, since the floor drains were clogged with growing vegetation (Picture 16). If not properly draining, water will accumulate and drain through utility holes, electrical conduits, and breaches in the floor, resulting in water-damaged ceiling tiles below, as shown in the library (Pictures 11 and 17).

**Water-damaged/mold-colonized cardboard in library**

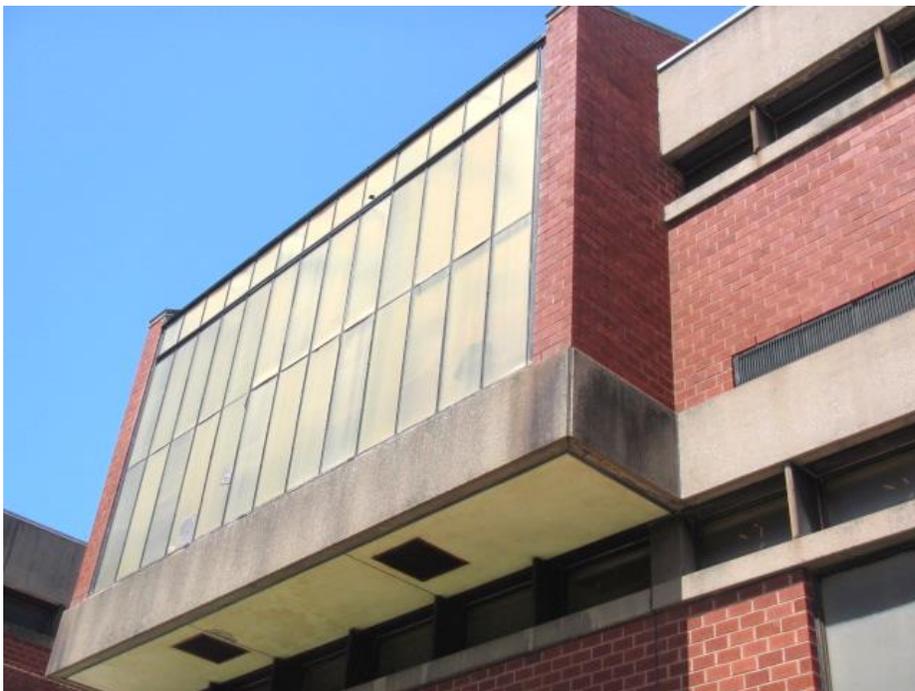
**Picture 12**

**Greenhouse**

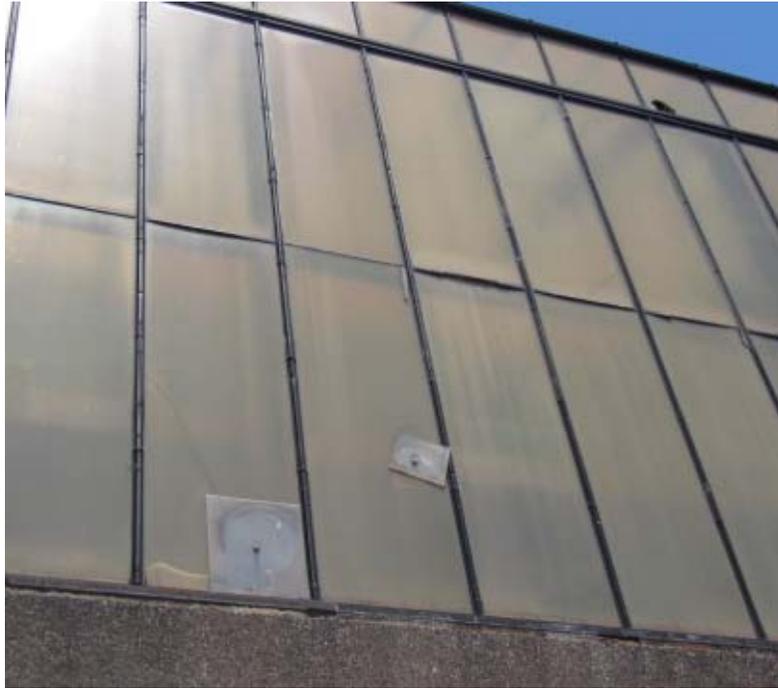
**Picture 13**

**Damaged/loose/broken window panes of greenhouse**

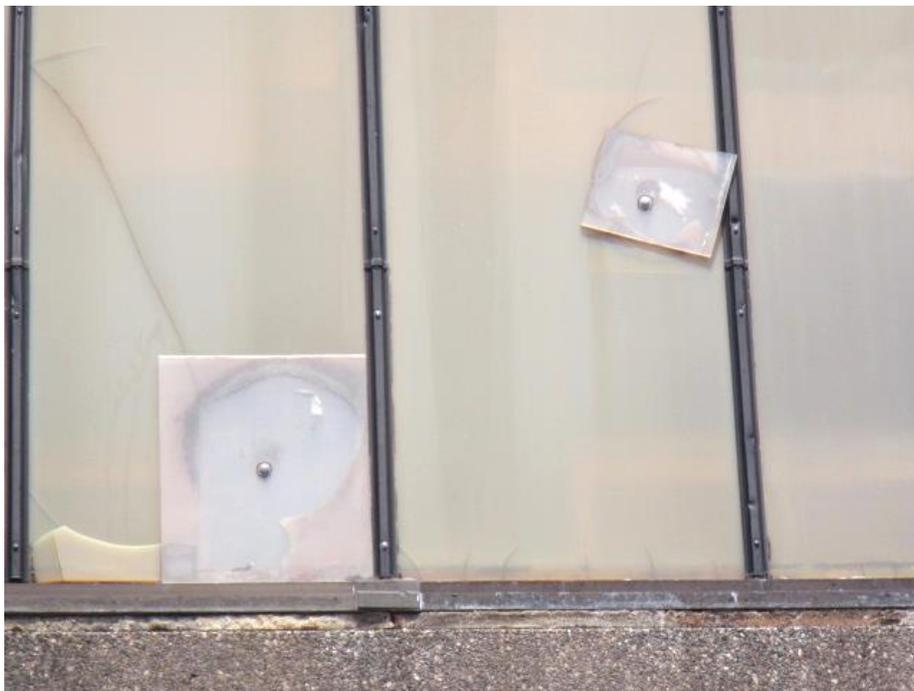
**Picture 14**

**Damaged/loose/broken window panes of greenhouse**

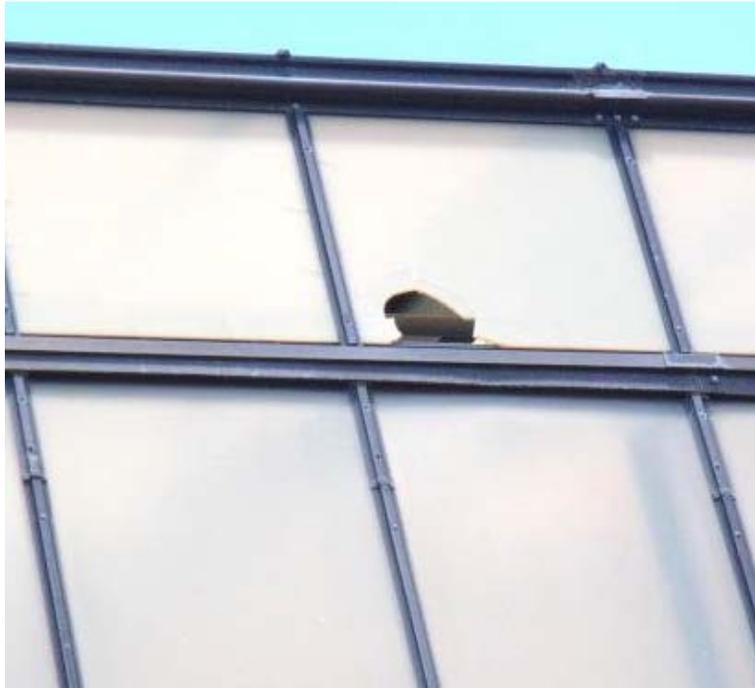
**Picture 15**

**Damaged/broken window pane of greenhouse, note greenhouse is open to the elements**

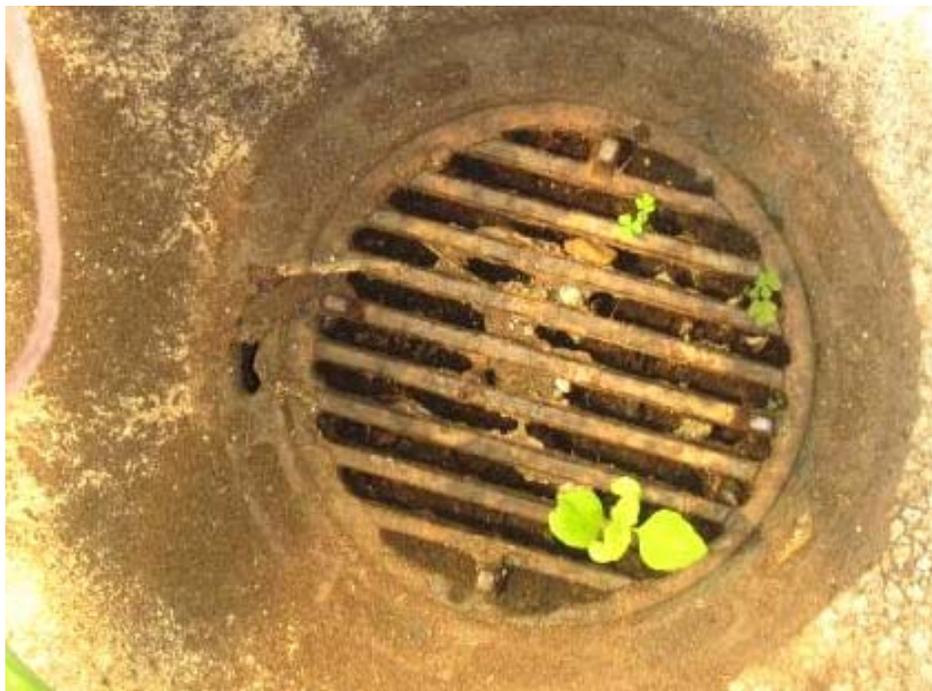
**Picture 16**

**Debris clogging greenhouse floor drain, note plant growth**

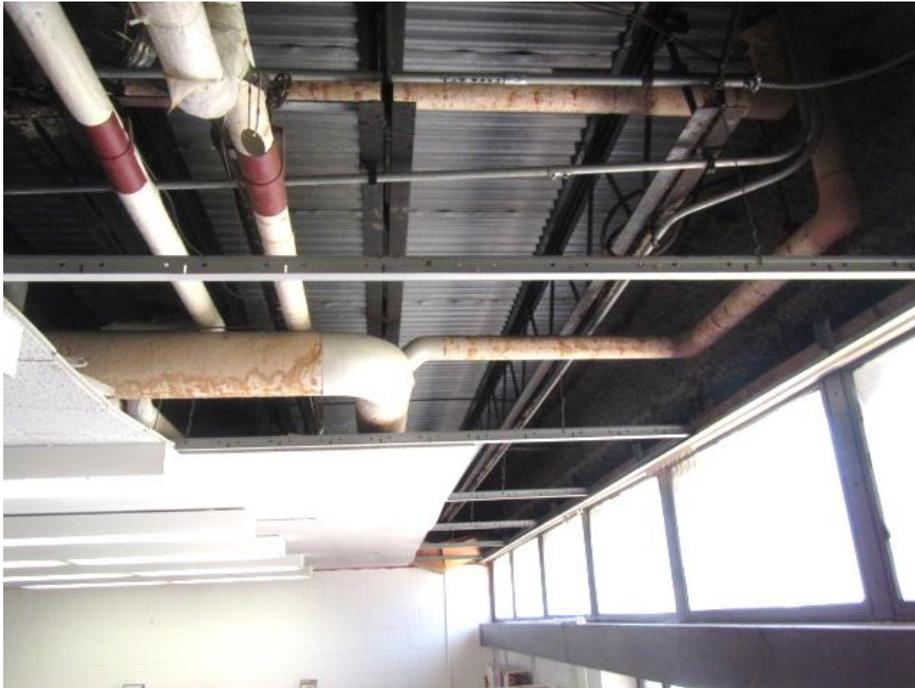
**Picture 17**

**Missing ceiling tiles in the library directly below greenhouse**

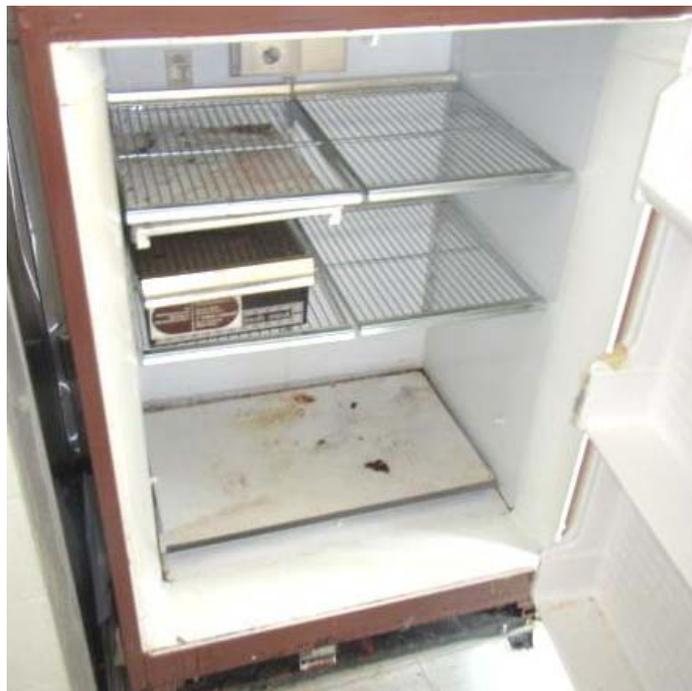
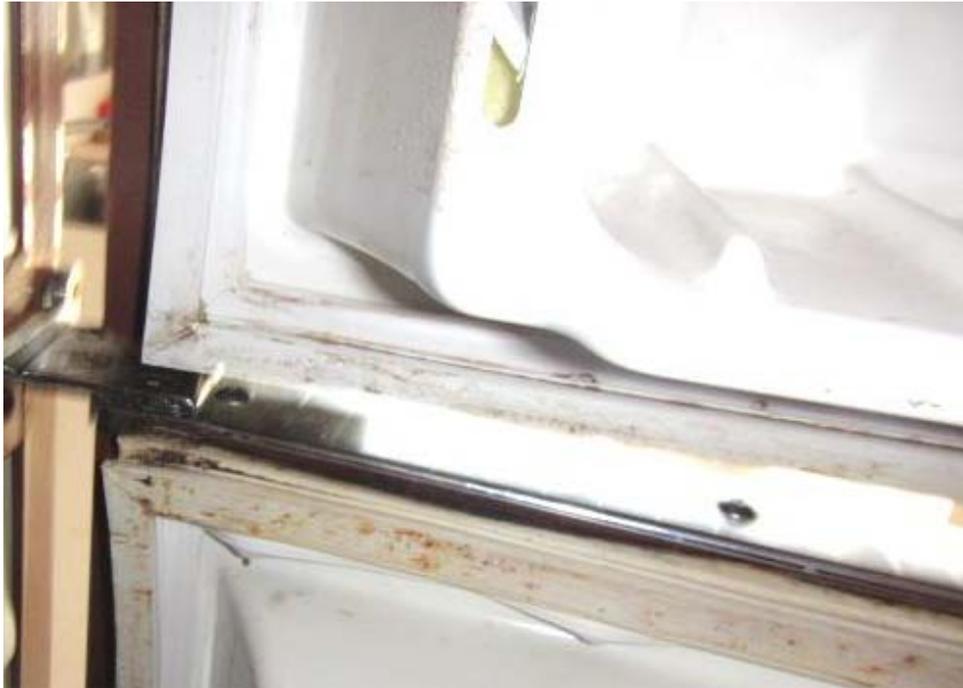
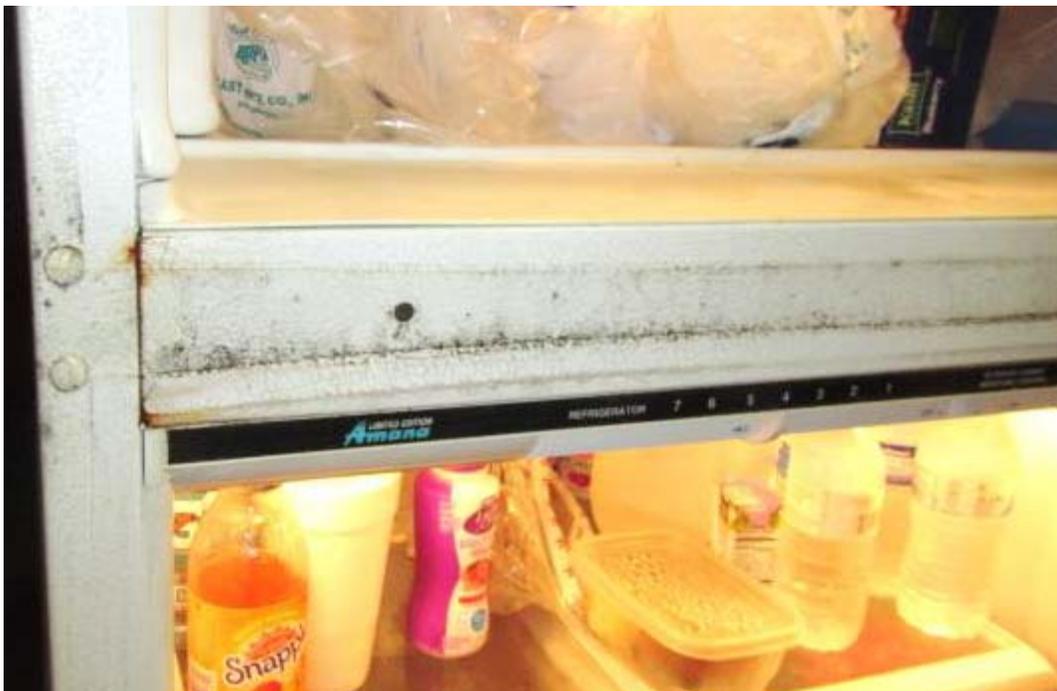
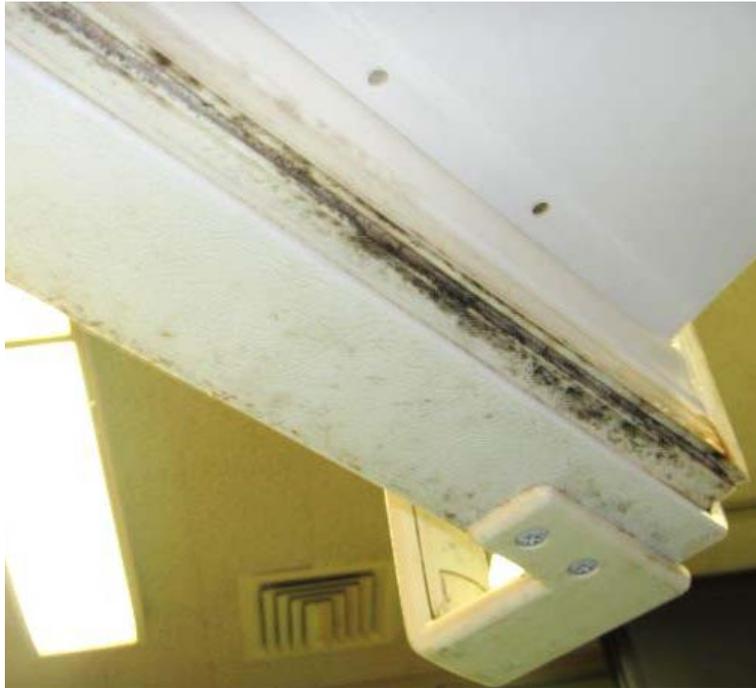
Visible mold was also observed in several refrigerators in the faculty lunch/break areas (Pictures 18 through 21). All refrigerators should be cleaned regularly and if gaskets and other components cannot be adequately cleaned with an anti-microbial agent, they should be replaced.

**Mold-colonized refrigerator in faculty break area**

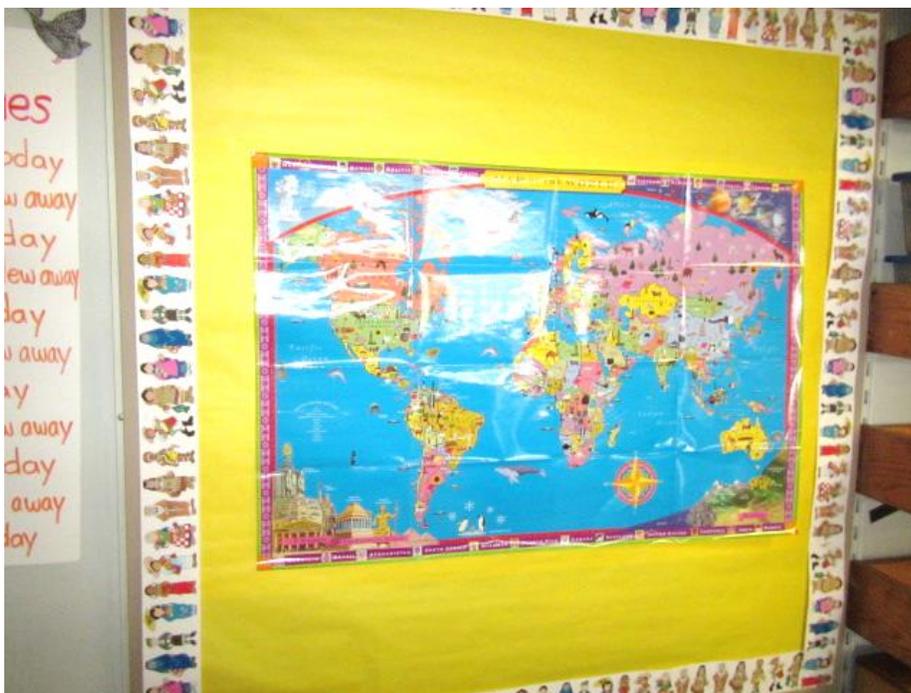
**Picture 22**

**Example of glossy/non-porous material on paper/wall in classroom**

- Removing posted materials, particularly non-porous/glossy items on walls/corkboards, etc.
  - Removing/rolling up area carpets, pads and interlocking floor panels.

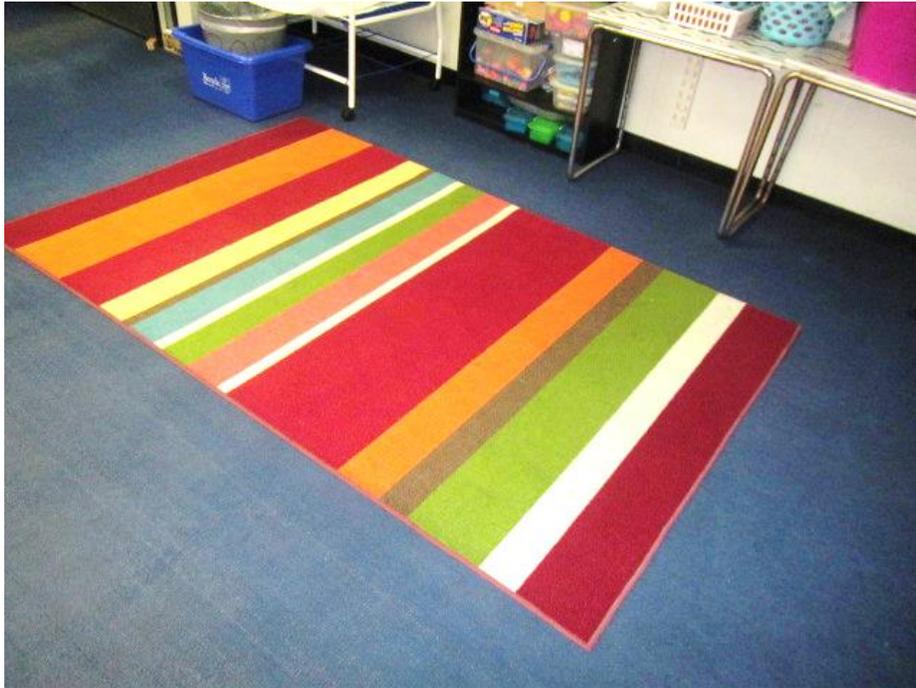
**Picture 23**

**Area carpet on classroom carpet**

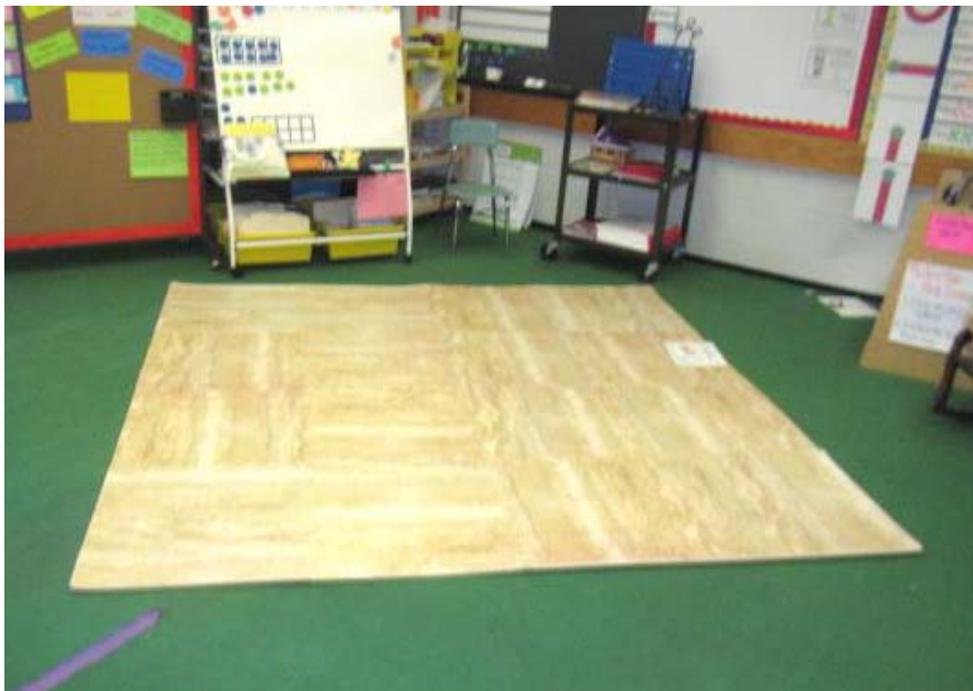
**Picture 24**

**Non-porous floor mats on classroom carpet**

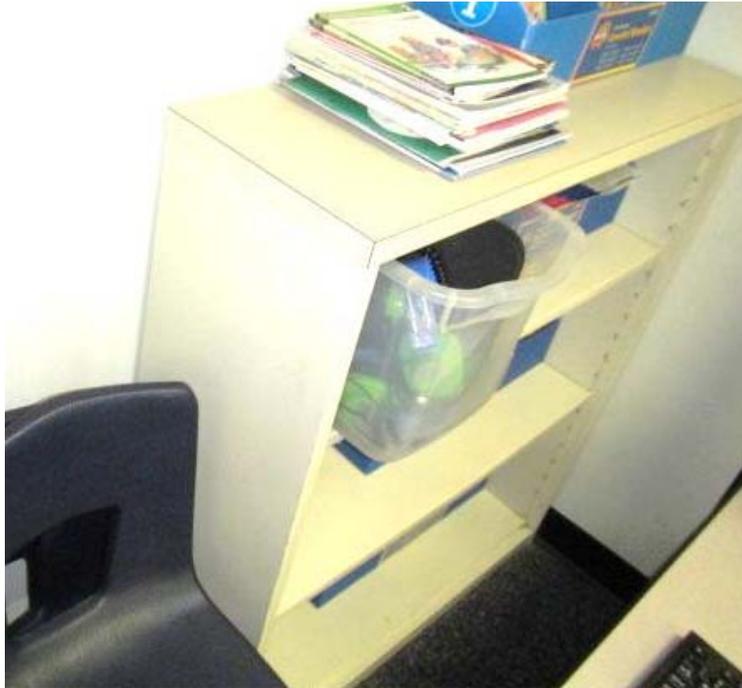
**Picture 25**

**Example of furniture/bookcase directly against wall in classroom**

- Ensuring that furniture (file cabinets, bookcases, etc.) is not flush/directly against walls.
  - Remove porous items (cardboard boxes, paper, etc.) so they are not stored directly on floors.

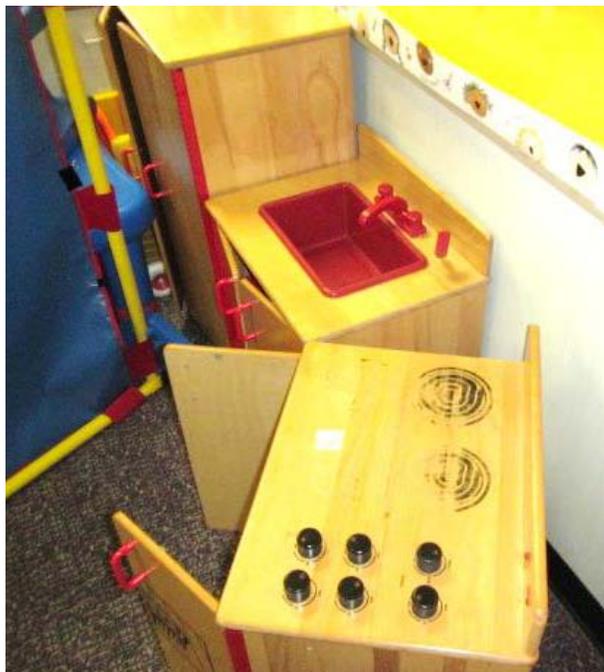
**Picture 26**

**Example of furniture/classroom items directly against wall in classroom (play stove moved by MDPH staff)**

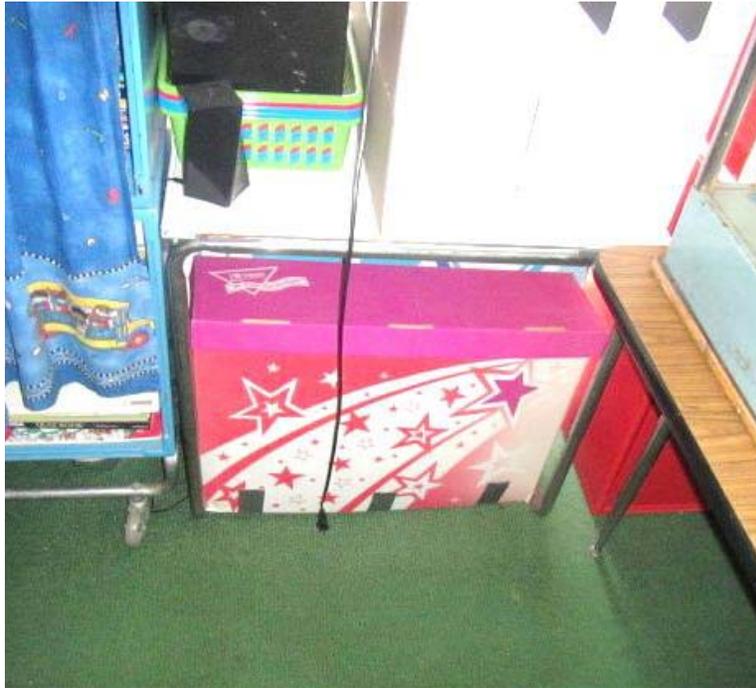
**Picture 27**

**Cardboard box directly on floor**

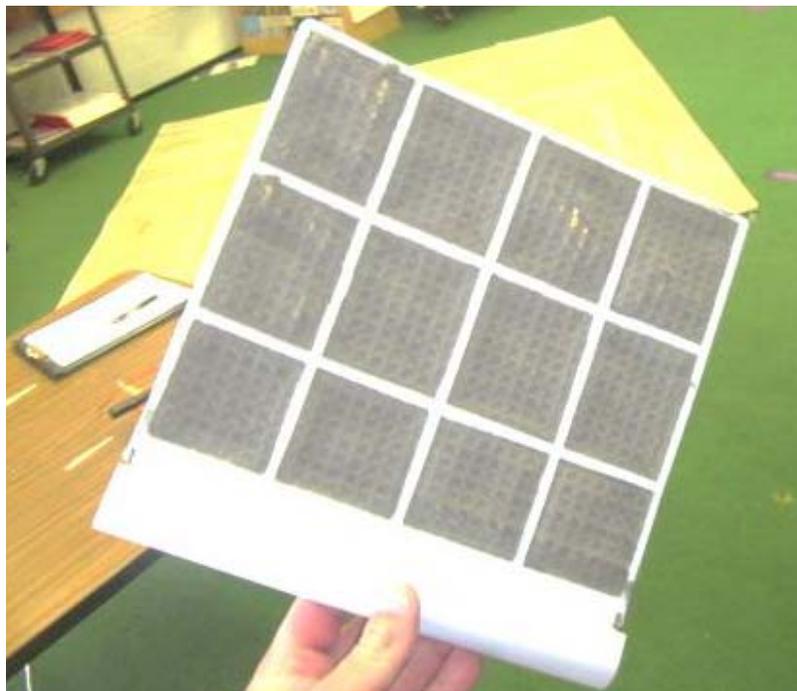
**Picture 28**

Other conditions that can affect IAQ were observed during the assessment. The HMES is not an air-conditioned building; therefore many classrooms had personal fans that were occluded with dust/debris from use. A few classrooms had portable air conditioners, which had filters occluded with dust/debris (Picture 28). Fans and filters should be cleaned periodically in order to prevent them from serving as a source of aerosolized particulates.

**Portable AC filter occluded with dust/debris**

10. Clean/change filters and ensure proper drainage/cleaning/disinfection of portable ACs as per the manufacturers’ instructions or more frequently if needed.

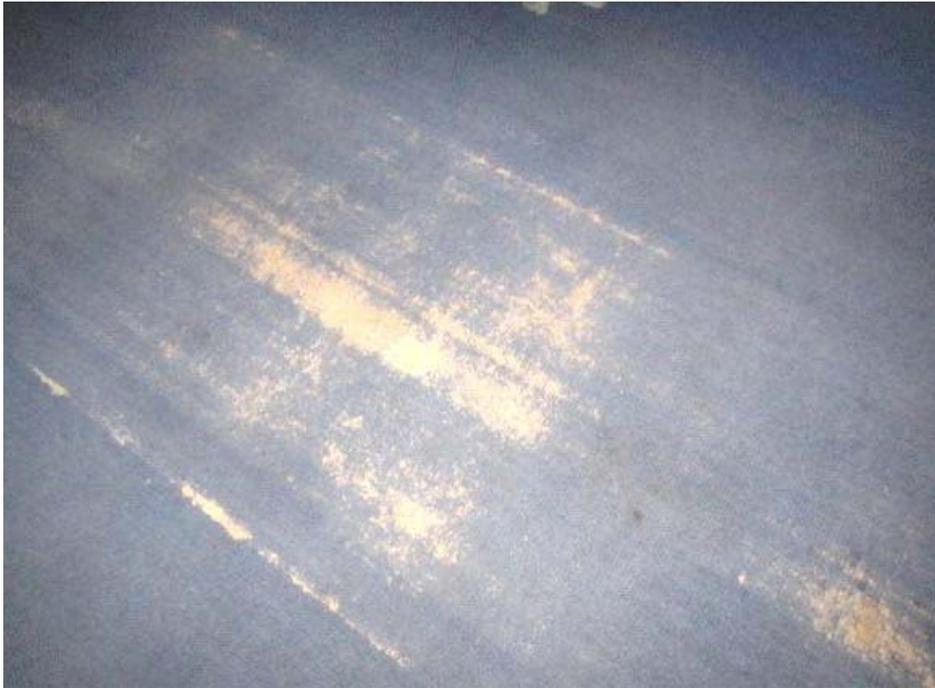
**Picture 29**

Carpeting in many areas was damaged, worn and/or stained (Picture 29), and in some areas original to the building (over 40 years old). The Institute of Inspection, Cleaning and Restoration Certification (IICRC) recommends that carpeting be cleaned annually (or semi-annually in soiled high traffic areas) (IICRC, 2012). NBPS officials reported that carpets are cleaned on an annual basis, usually during summer vacation. Since the average lifespan of a carpet in a school environment is approximately eleven years (Bishop, 2002), it is recommended to continue with plans for carpet removal as funds become available.

**Severely worn/damaged carpeting**

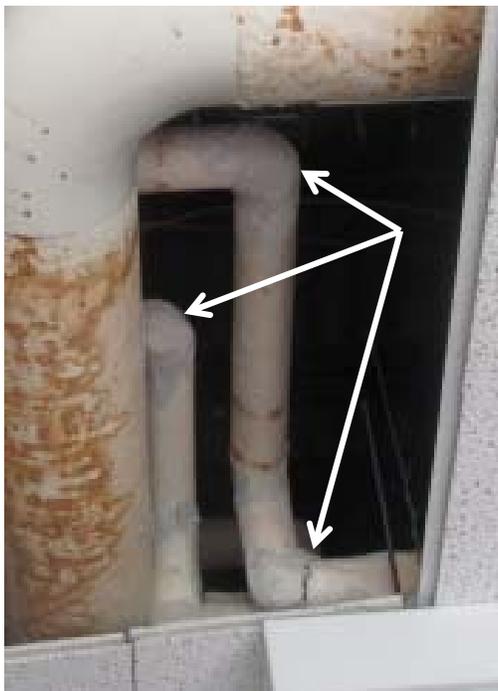
**Picture 30**

Finally, as a result of failing ceiling tiles from greenhouse leaks, several areas of exposed pipe insulation were observed above the ceiling in the library (Picture 30). Due to the age of the school, this may be asbestos-containing material (ACM). Intact asbestos-containing material (ACM) does not pose a health hazard. If damaged, ACM can be rendered friable and become aerosolized. Although the material appeared to be intact, it was recommended at the time of the assessment that the school's asbestos management plan be consulted to determine the content of

**Exposed insulation material (arrows) on pipe elbows in library**

11. Determine if pipe insulation in library consists of ACM. Remediate any exposed/damaged ACM (e.g., encapsulate) in conformance with Massachusetts asbestos remediation and hazardous waste disposal laws and regulations.
