INDOOR AIR QUALITY ASSESSMENT

**Registry of Motor Vehicles
278 Union Street
New Bedford, Massachusetts**

Prepared by:
Massachusetts Department of Public Health
Bureau of Environmental Health
Indoor Air Quality Program
October 2015

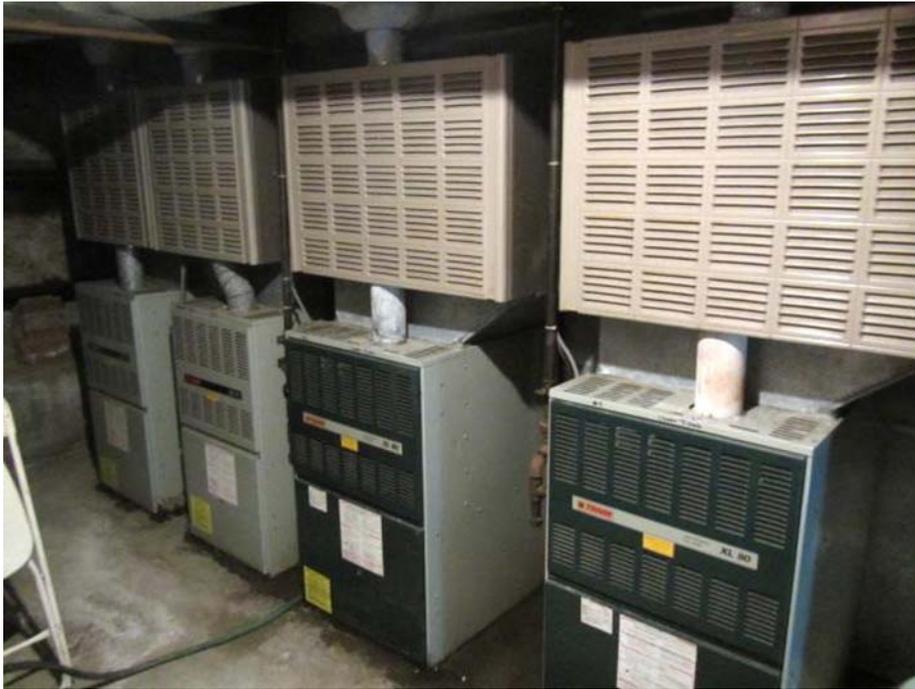
Picture 1

It can be seen from Table 1 that carbon dioxide levels were above 800 parts per million (ppm) in all areas tested, indicating a lack of air exchange. Mechanical ventilation is provided by a number of air handling units (AHUs) located in a basement mechanical room (Picture 1).

Air handling units (AHUs) in basement mechanical room

1. Due to the compromised integrity/condition of AHUs, they should either be rebuilt or replaced. Units should also be elevated and not directly on the basement floor.

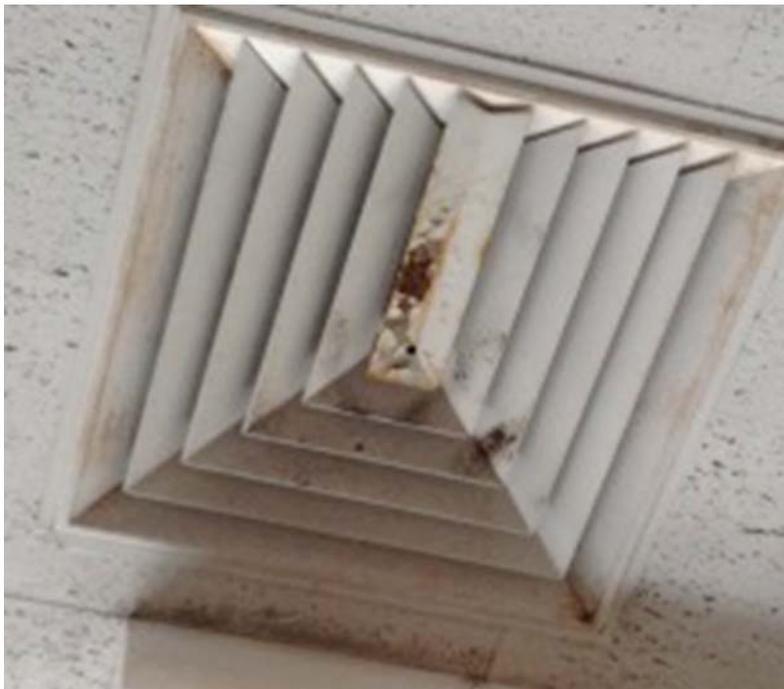
Picture 2

Several other conditions that can potentially affect IAQ were identified. Ceiling-mounted supply vents were noted to have dust/debris build up/corrosion (Picture 2).

Ceiling-mounted supply diffuser, note corrosion and debris (dark stains)

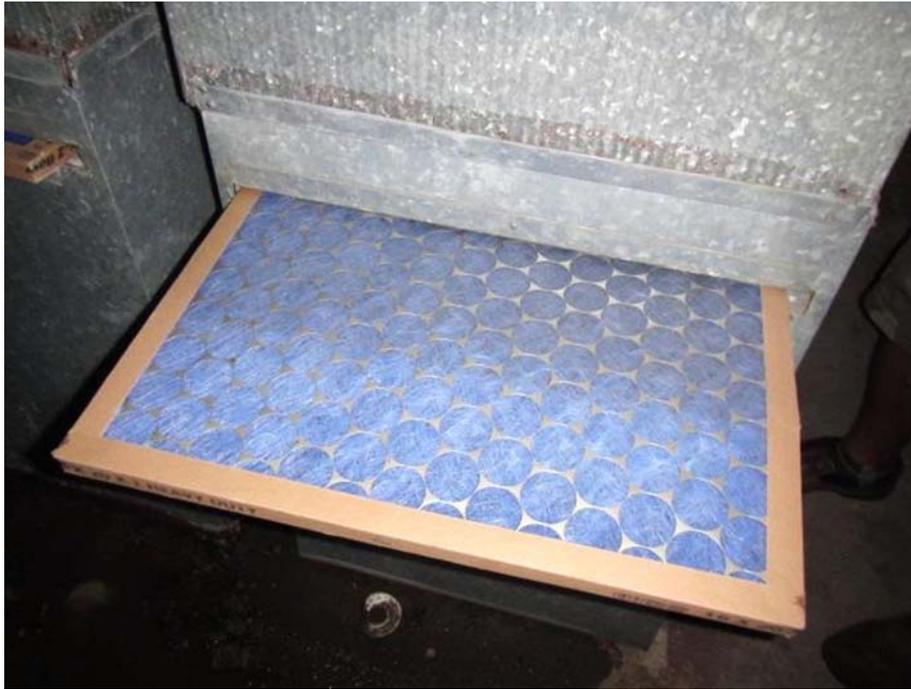
Picture 3

- AHUs had filters that were not properly installed and were of minimal efficiency.
- AHUs were missing filter access panels (Picture 4) that would enclose each filter within the ductwork. This condition allows air to bypass the filter and can draw in odors, debris, and water vapor into the AHU from the basement to be transported throughout the occupied space.
- AHUs have poor drainage of condensation from the cooling coil drip pan. This condition causes pooling water on the floor which has caused severe corrosion of the AHU housing and duct support structures (Pictures 5 through 10).
- Electrical components were corroded due to condensation dripping from poorly insulated chilled water pipes (Pictures 11 and 12).

Improperly sized fibrous mesh filters installed in AHUs

3. Install filter panels to prevent filter bypass on AHUs.
4. Install properly-fitted, higher efficiency (i.e., pleated filters) in AHUs; change 2 to 4 times a year or per the manufacturer's instructions.

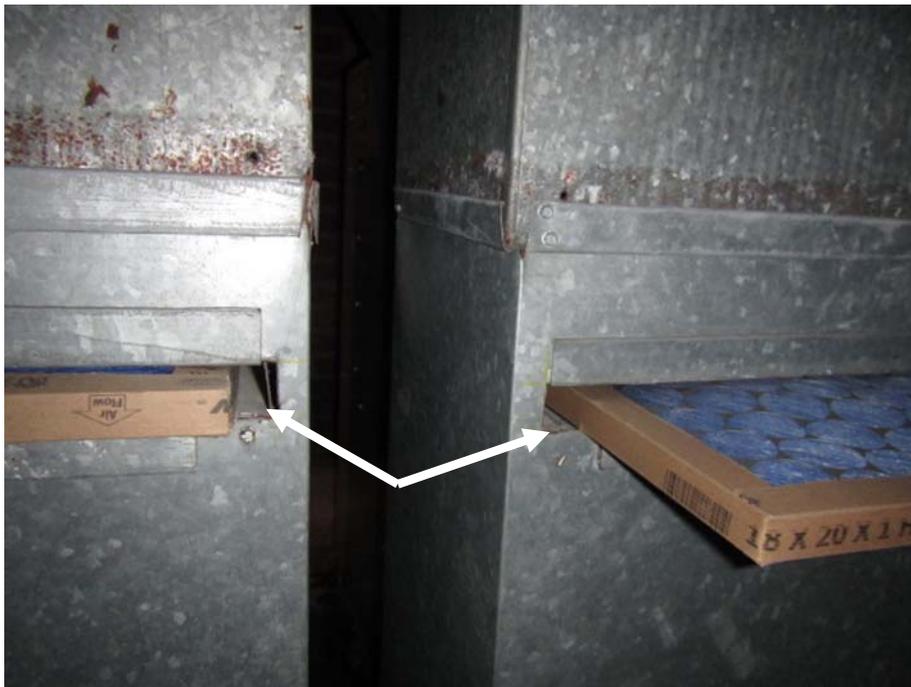
Picture 4

Improperly sized filters, note spaces around filters (arrows) and lack of access panels

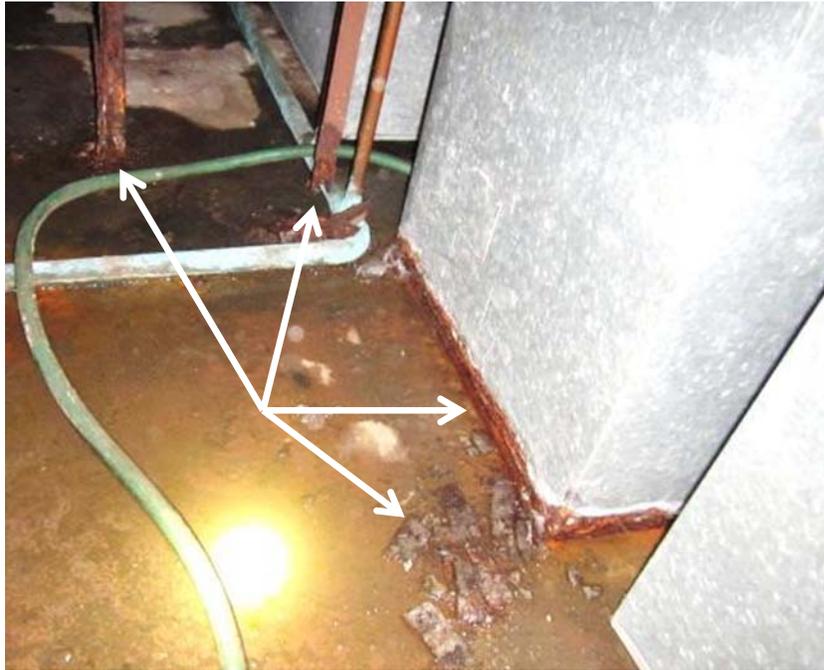
Picture 5

The poor condensation drainage system and resulting standing water in the basement mechanical room may provide the opportunity for microbial growth and associated odors. These odors and moisture may be drawn into the gaps around the filter assembly of the AHUs and be distributed throughout occupied areas of the space.

Standing water on floor of mechanical room, note severe corrosion of bottom of AHUs and ductwork supports (arrows)

5. Extend condensation drains away from units and to a properly installed drain to prevent water pooling/further damage to units.
6. Rebuild/replace metal ductwork supports.

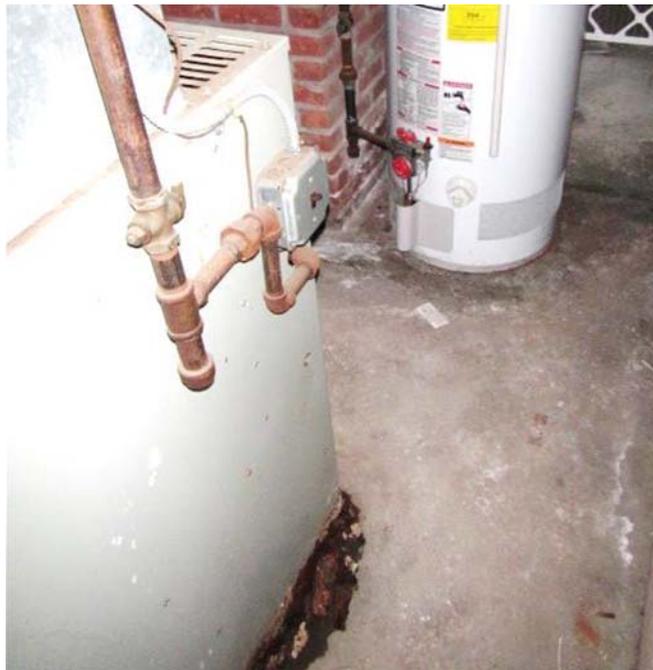
Picture 6

Not only do these issues compromise the integrity of the units, they can also serve as electrical/safety hazards. The holes from corrosion of the AHU housing can result in the draw of combustion gasses from the adjacent water heater (Picture 6).

Severe corrosion of bottom of AHU, note proximity to gas-fired hot water heater

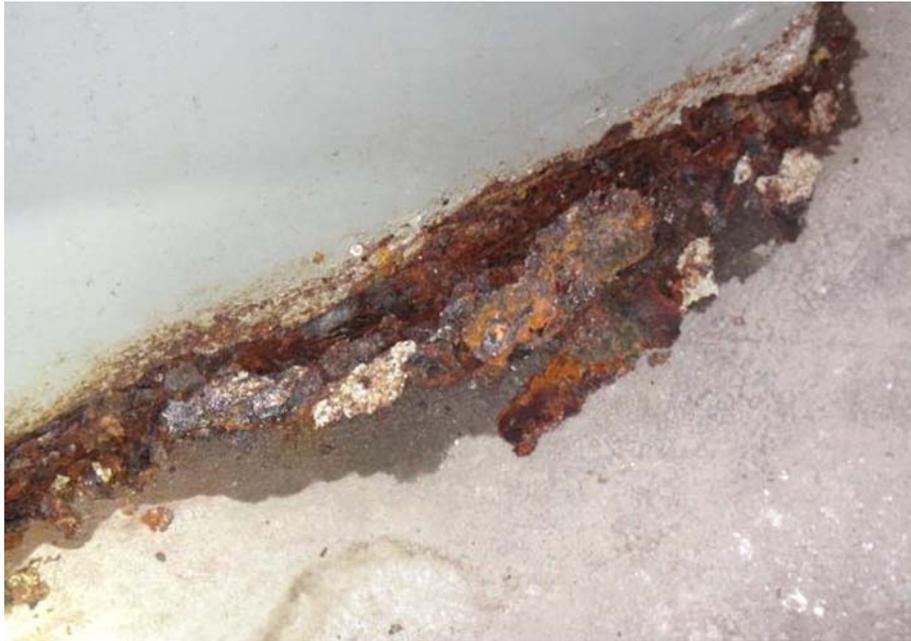
Picture 7

Close-up of severe corrosion to bottom of AHU

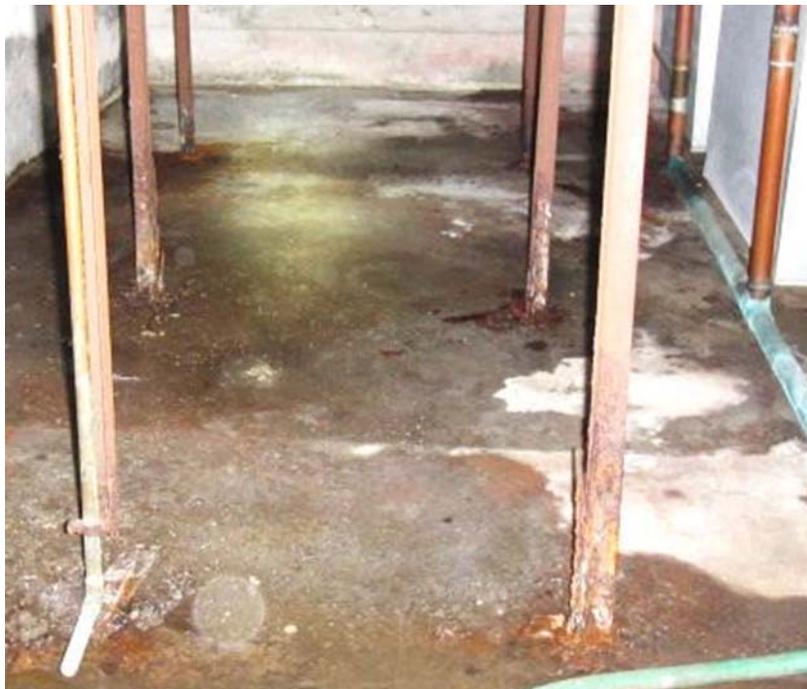
Picture 8

Pooling water on mechanical room floor resulting in severe corrosion compromising the integrity of metal ductwork supports

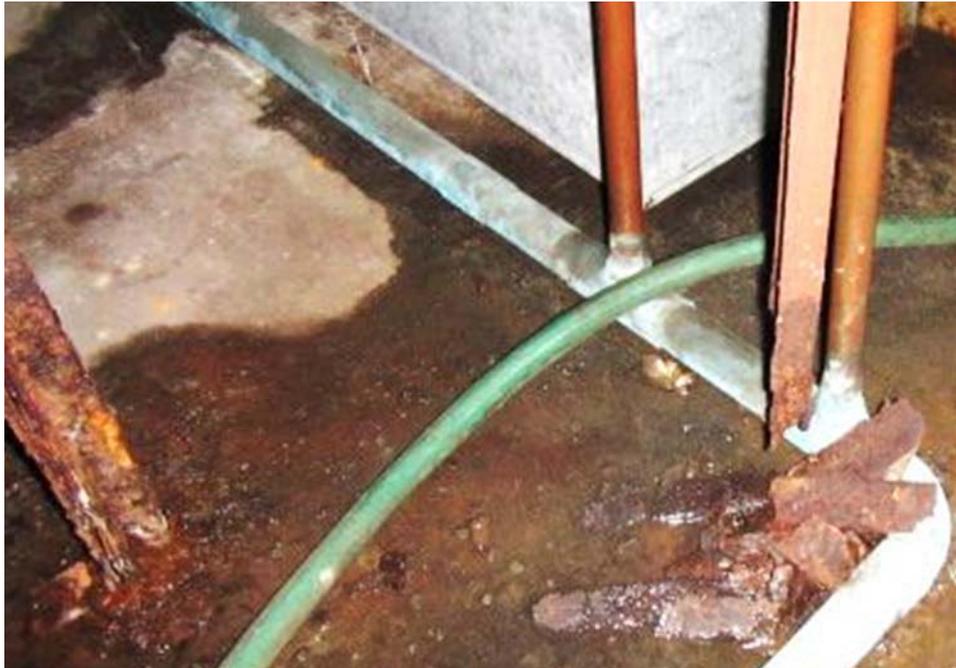
Picture 9

Severely corroded/compromised integrity of ductwork support structures

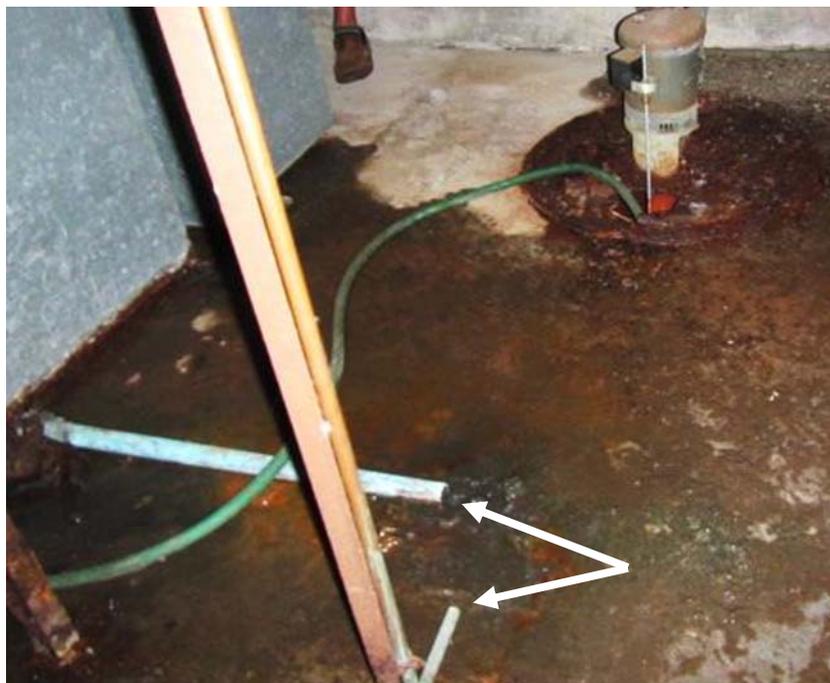
Picture 10

Condensation pipes (arrows) emptying on floor of mechanical room causing corrosion of AHUs and ductwork support beams, note sump pump in background

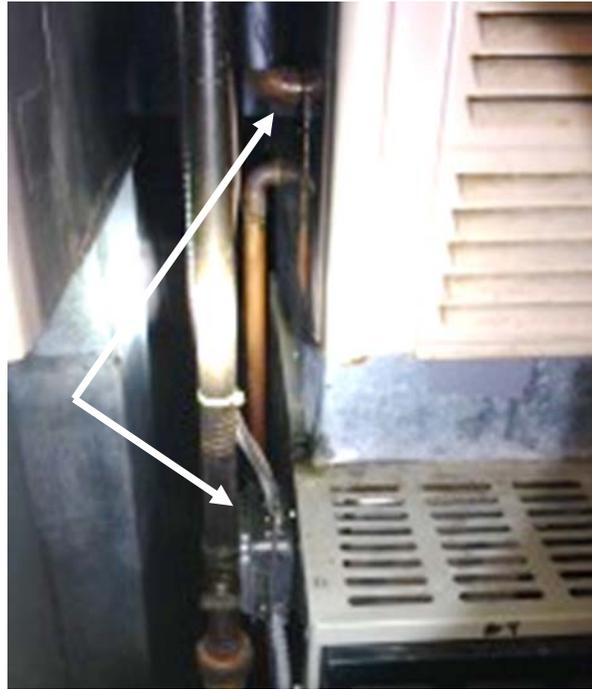
Picture 11

Uninsulated copper elbow dripping condensation on electrical box (arrows)

7. Ensure chilled water pipes are fully insulated to prevent dripping on electrical components (Picture 11).
8. Replace corroded electrical components in basement mechanical room.

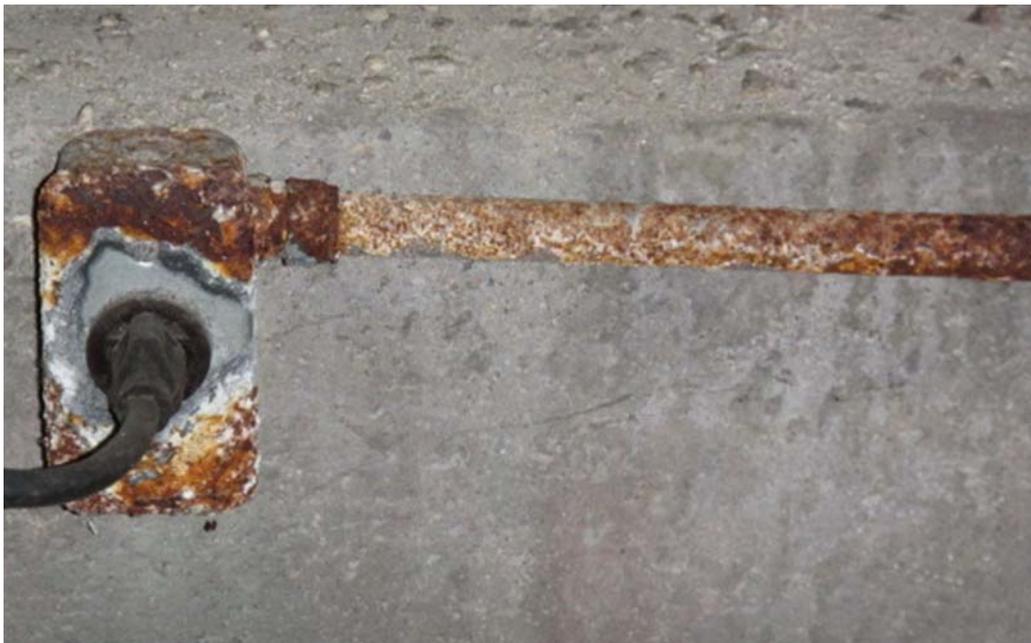
Picture 12

Severely corroded electrical box/conduit

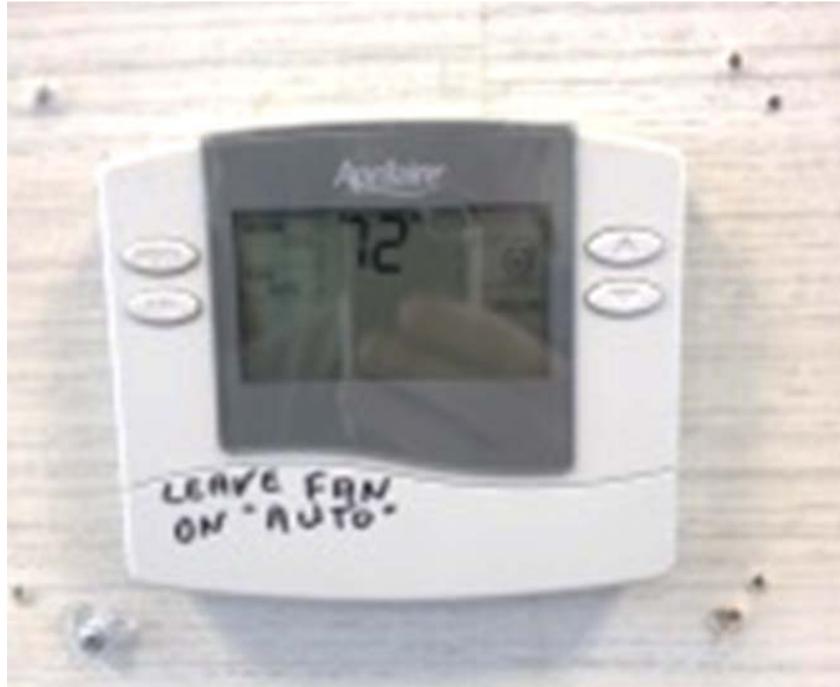
Picture 13

To maximize air exchange, the MDPH recommends that both supply and exhaust ventilation operate continuously during periods of occupancy. At the time of the assessment thermostats were set to the fan “auto” position (Picture 13), which deactivates the HVAC system once the preset temperature is reached. Therefore, no mechanical ventilation is provided until the thermostat re-activates the system. The MDPH recommends that thermostats be set to the fan “on” setting during occupied hours to provide a *continuous* source of fresh air and filtration.

Digital thermostat

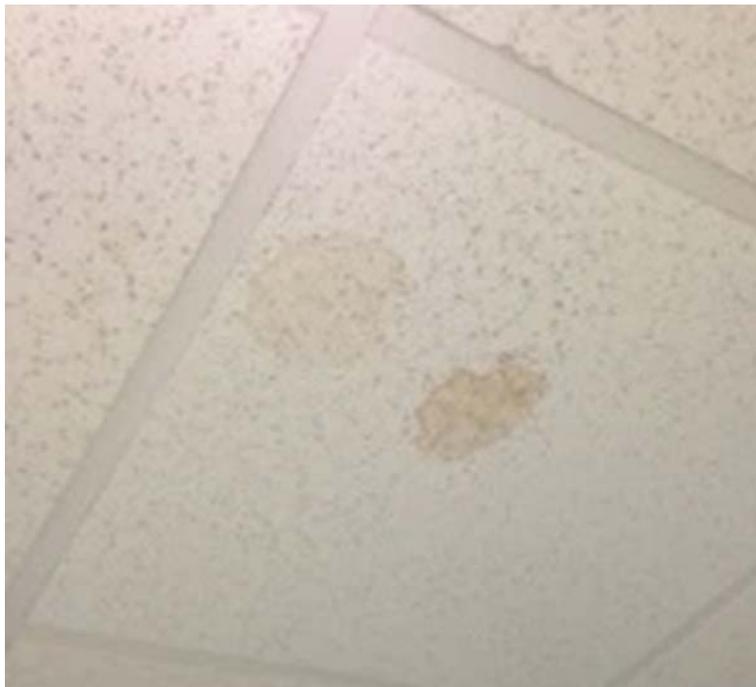
Picture 14

In order for building materials to support mold growth, a source of water exposure is necessary. Water-damaged ceiling tiles were observed in several areas, which could be historic damage from previous roof leaks or current damage from condensation/plumbing leaks (Picture 14). Water-damaged ceiling tiles and walls around the window in the breakroom (Pictures 15 and 16), are indicative of window leaks (Picture 17). The breakroom also had a leaking faucet that was wetting the cabinet underneath, which can lead to damage of the wood cabinet and mold growth.

Water-damaged ceiling tiles

10. Ensure leaks (plumbing, condensation, windows, etc.) are repaired and replace any water-damaged ceiling tiles and building materials, particular attention should be paid to evaluate/repair leaks around breakroom window.

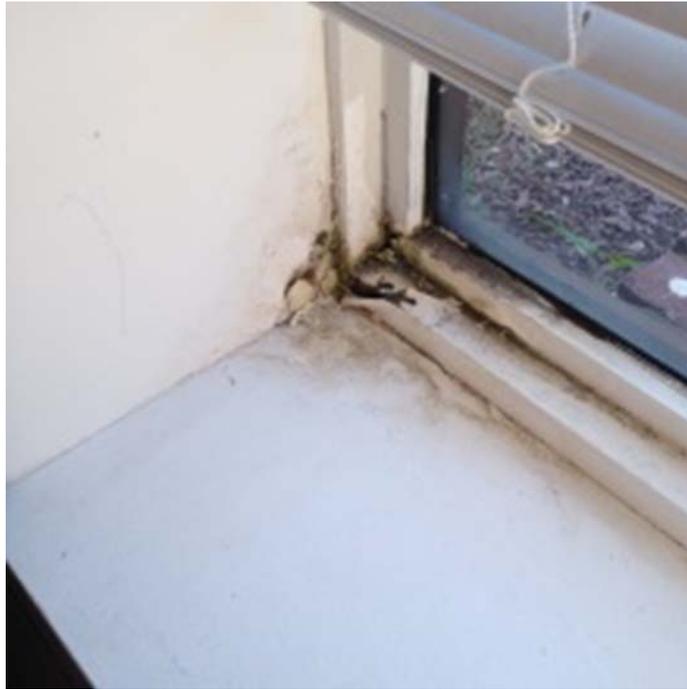
Picture 15

Water damage around window frame in breakroom

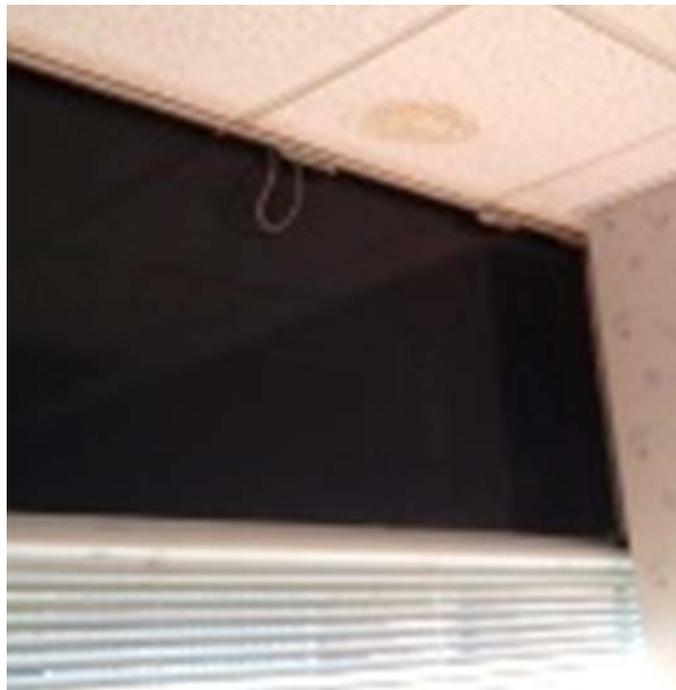
Picture 16

Water-damaged ceiling tile above breakroom window

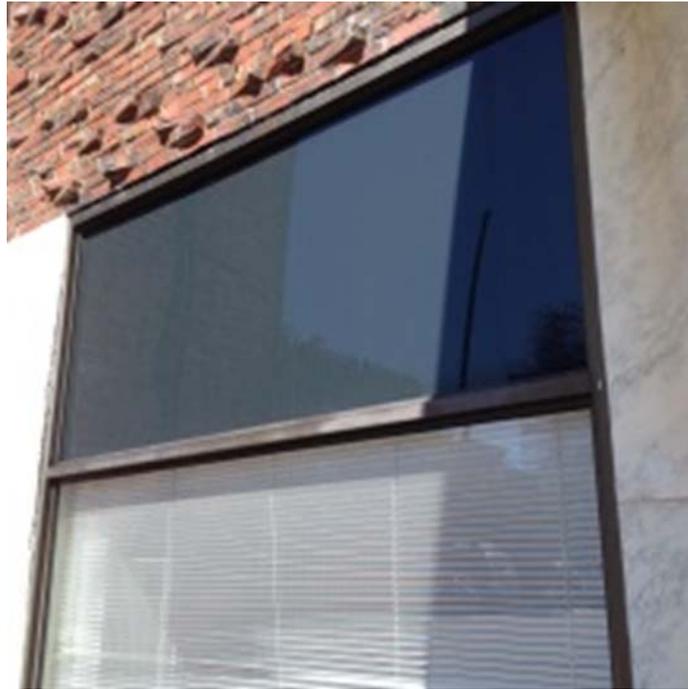
Picture 17

Breakroom window

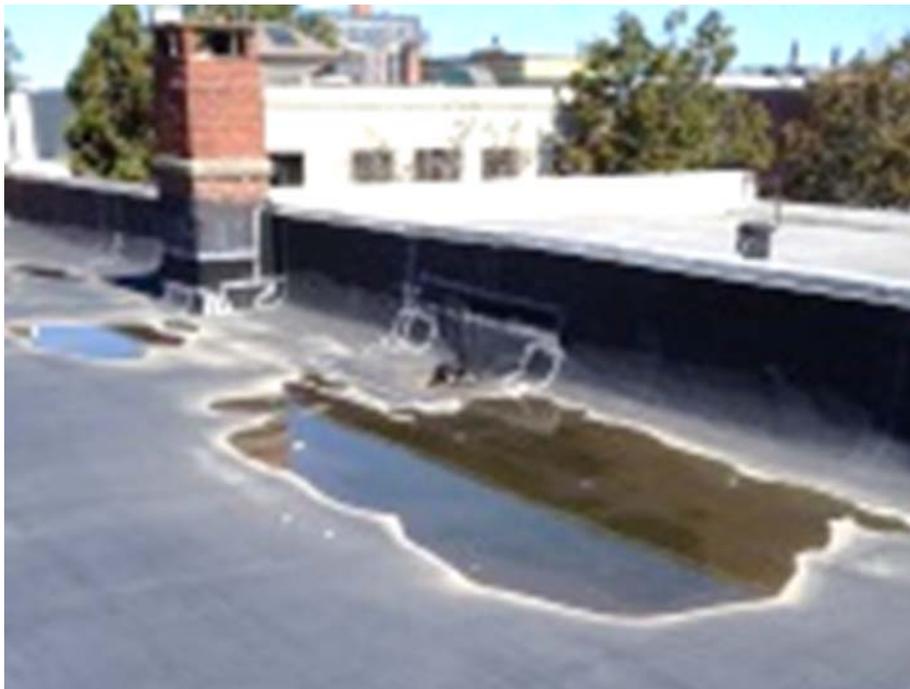
Picture 18

Although the roof was reported to have been replaced recently, pooling water and plant growth were noted in several areas (Pictures 18 and 19) and over the entrance/awning (Pictures 20 through 22). The weight of the water/debris and freezing/thawing action over the winter can cause damage to the roof membrane and lead to structural damage, leaks and mold growth. In addition, stagnant water can serve as a breeding ground for mosquitoes.

Pooling water on roof

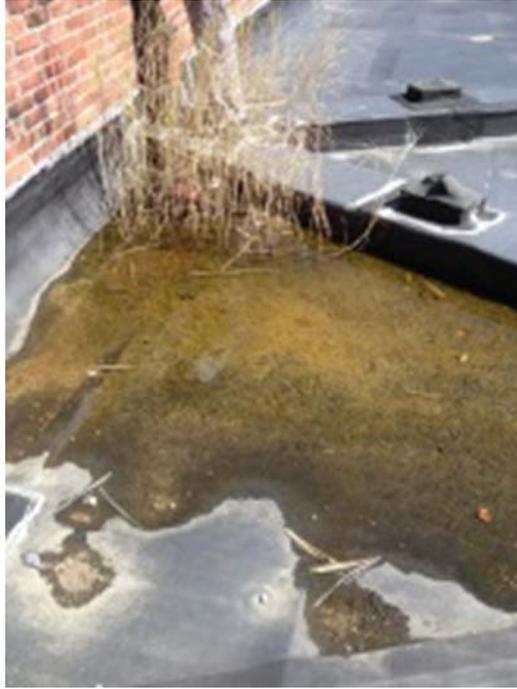
Picture 19

Pooling water, debris and plant growth on roof

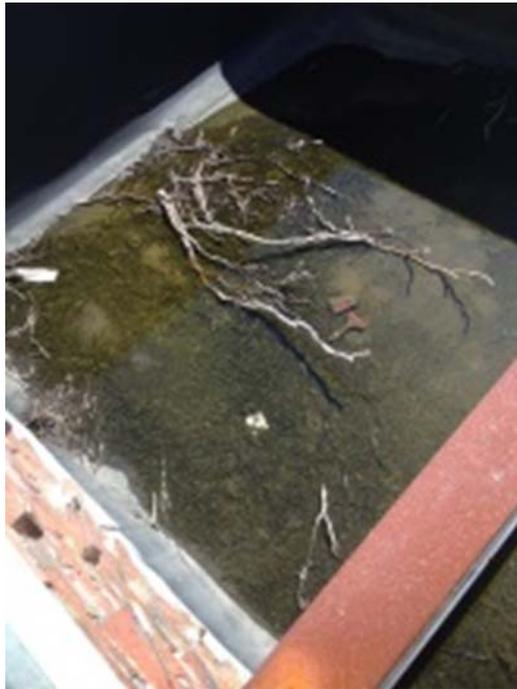
Picture 20

Pooling water, debris and plant growth on entrance/roof

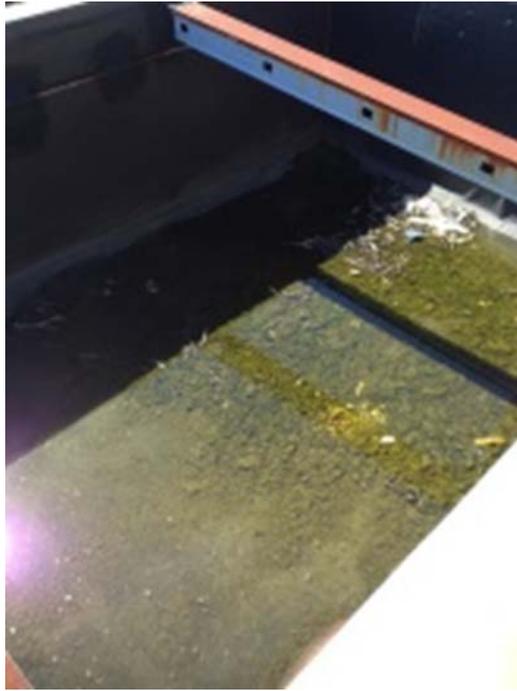
Picture 21

Pooling water, debris and plant growth on entrance/roof

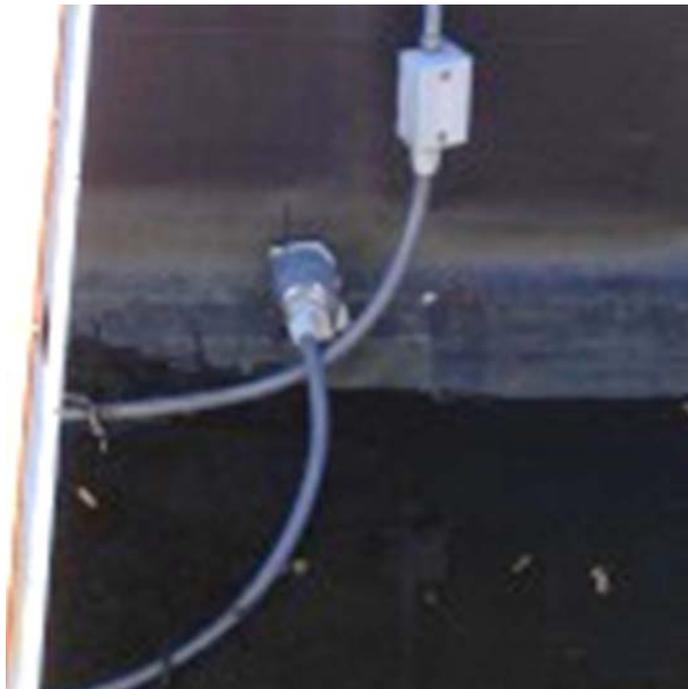
Picture 22

Electrical box sealed with duct tape in pooling water over entrance

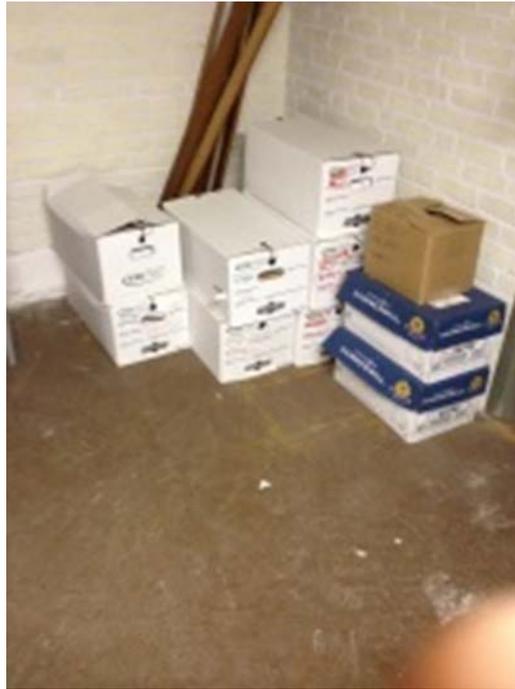
Picture 23

The former bank vault in the basement was being used for storage. This area is prone to moisture/condensation and is not equipped with mechanical ventilation/dehumidification, therefore is not suited for storage of porous materials (e.g., cardboard, paper/Picture 23), which can get wet and grow mold.

Cardboard boxes on floor of former bank vault in basement

13. Refrain from storing porous materials (e.g., books, papers) in the basement due to moisture concerns such as high humidity and flooding.
14. Clean carpeting annually or semi-annually in soiled high traffic areas as per the recommendations of the Institute of Inspection, Cleaning and Restoration Certification (IICRC, 2012).
15. Periodically clean supply diffusers and return grates to avoid re-aerosolizing particulates. Consider replacing damaged/corroded components.
16. Refer to resource manual and other related indoor air quality documents located on the MDPH's website for further building-wide evaluations and advice on maintaining public buildings. These documents are available at <http://mass.gov/dph/iaq>.

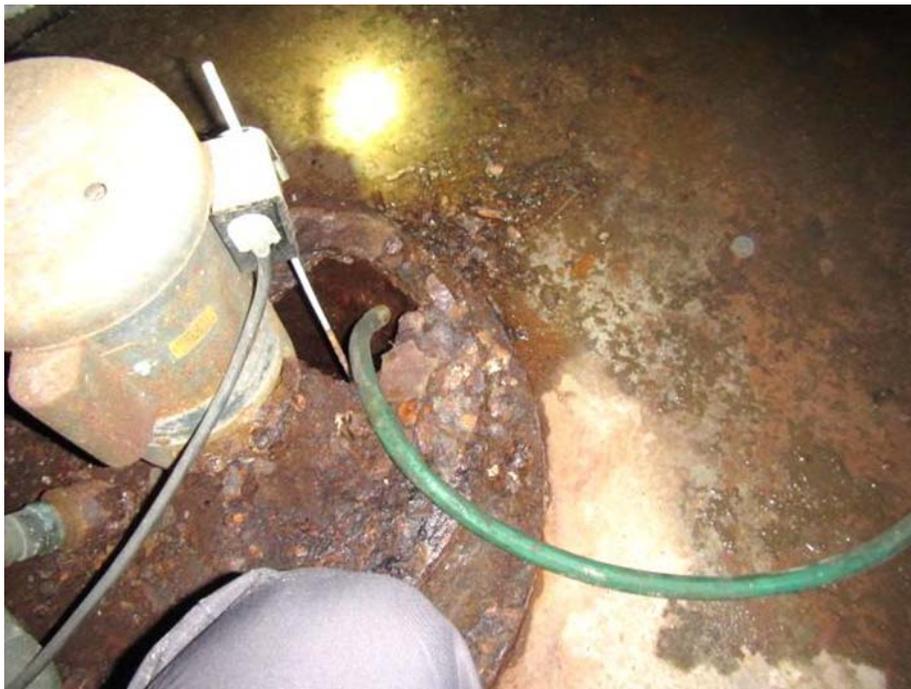
Picture 24

Finally, the basement sump pump was severely corroded, resulting in the development of a large hole in the cover (Picture 24). Breaches in the cover can further increase the relative humidity and allow soil gases, moisture and odors to infiltrate the mechanical room where they can be drawn into and distributed to occupied areas via the HVAC system.

Hole in sump pump cover, note severe corrosion

9. Completely seal any breaches/holes in and around the sump pump to avoid soil gases, pests and added moisture from entering the mechanical room; replace if necessary.
