# **INDOOR AIR QUALITY ASSESSMENT**

**Massachusetts Department of Transportation  
District 2 Office-old wing  
811 North King Street  
Northampton, Massachusetts**

Prepared by:  
Massachusetts Department of Public Health  
Bureau of Environmental Health  
Indoor Air Quality Program  
November 2015

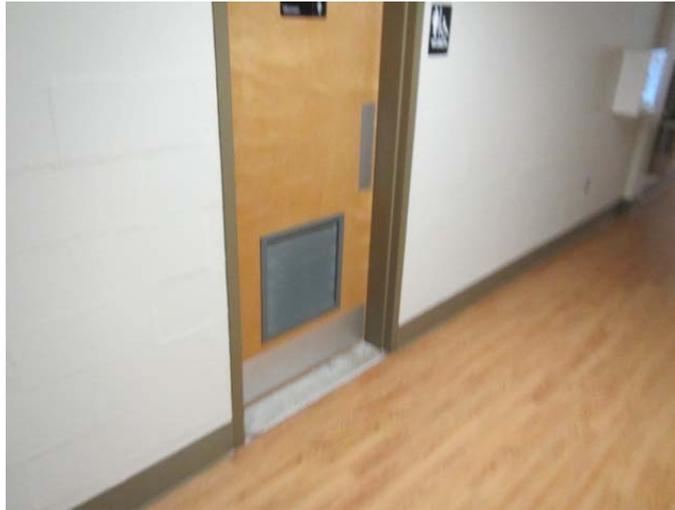
**Picture 1**

Ventilation air in the old wing is provided by univents located in each office. Offices do not have exhaust vent. It is believed that office hallway doors were originally equipped with a transfer air vent, which would allow for air from offices to be vented into the hallways. Exhaust ventilation was provided by ceiling-mounted vents as well as draw of air through transfer air vents (Picture 1) in restroom doors. Exhaust vents are present in the restrooms. At some point of time prior to this assessment, a number of original restroom and hallway doors with transfer air vents were replaced with solid doors. Without the transfer air vent, the original design of the airflow provided by the ventilation system was disrupted. Exhaust ventilation is necessary to remove environmental pollutants from the occupied space.

**Passive vent in rest room door**

7. Consider consulting a ventilation engineer concerning the current configuration of the HVAC system.
8. Refer to resource manuals and other related indoor air quality documents for further building-wide evaluations and advice on maintaining public buildings. These materials are located on the MDPH's website: <http://mass.gov/dph/iaq>.

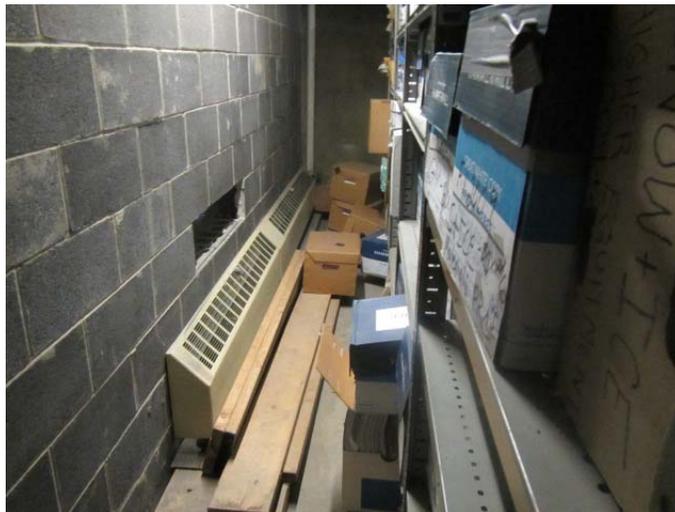
**Picture 2**

DOT staff report a long-standing rodent infestation associated with the building's basement. The basement is used for records storage (Picture 2) and contain large numbers of cardboard boxes. Rodent will use cardboard boxes and other hidden locations to hide, take up shelter and reproduce. The front stairs to the building contain multiple breaches that allow for rodents to enter the building's basement.

**Storage in basement**

- f. Holes as small as ¼" are enough space for rodents to enter an area. Examine each room and the exterior walls of the building for means of rodent egress and seal. If

doors do not seal at the bottom, install a weather strip as a barrier to rodents. Reduce harborages (cardboard boxes) where rodents may reside (MDFFA, 1996).
