INDOOR AIR QUALITY ASSESSMENT

**Massachusetts Department of Transportation
District 2 Office-new wing
811 North King Street
Northampton, Massachusetts**

Prepared by:
Massachusetts Department of Public Health
Bureau of Environmental Health
Indoor Air Quality Program
October 2015

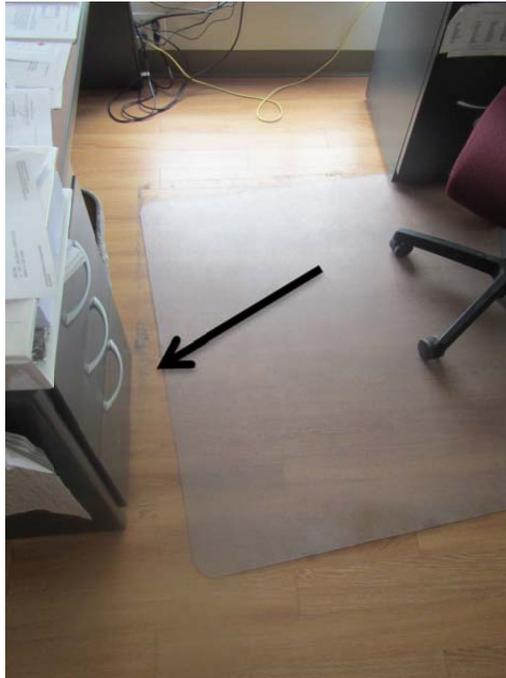
Picture 1

BEH staff examined the second floor and noted the presence of plastic chair mats installed in cubicles having hard laminate floors. Of note was the accumulation of debris beneath the chair mat edges (Picture 1), which likely indicates the floor as swept instead of vacuumed. A used, stand-up dust pan found in a restroom also indicates floors are swept

Accumulation of debris beneath the chair mat edges

6. Have all flat surfaces wet wiped once a week in the Materials Testing Lab.
7. Discontinue the use of plastic chair mats in cubicles with hard wood floors.

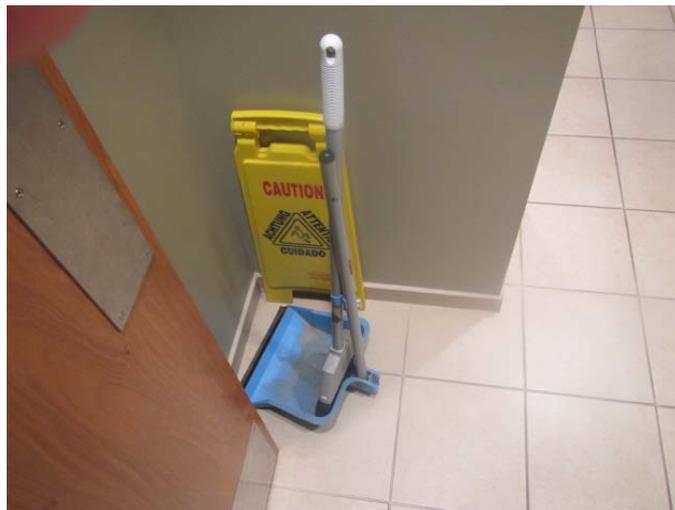
Picture 2

(Picture 2). Floor sweeping can readily aerosolize and suspend in the air respirable dust, which can lead to allergic symptoms in hypersensitive individuals. DOT staff also identified the vacuum cleaners used in the building. None of the vacuum cleaners identified as used in the building are equipped with a high efficiency particle arrestance (HEPA) filter. Non-HEPA filter vacuum cleaners can also readily aerosolize and suspend respirable dust. The Institute of Inspection, Cleaning and Restoration Certification (IICRC) outlines floor covering in its guideline, Standard for Professional Cleaning of Textile Floor Coverings (IICRC, 2015). Based on this standard, the IICRC recommends twice daily vacuuming and/or pile-lifting cleaning for commercial carpeting in heavy traffic areas. This frequency of cleaning of the building as well as the use and upgrade of vacuum cleaners equipped with HEPA filter would remove respirable dust from the indoor air.

Broom and dust pan

1. Discontinue the use of brooms and dust pans.
2. Discontinue the use of wet mops on laminate floors.
3. Acquire and utilize a high efficiency particulate arrestance (HEPA) filter equipped vacuum cleaner in conjunction with wet wiping of all surfaces. Have the high traffic area vacuumed twice daily.

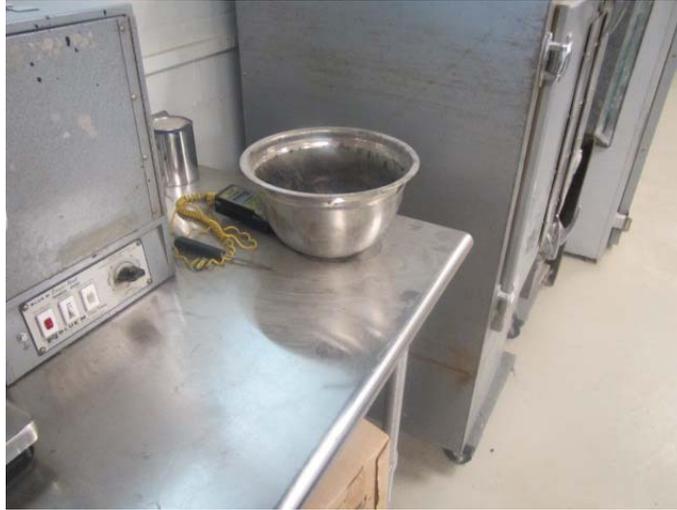
Picture 3

The ground level of the building contains a materials testing lab where concrete cylinders are broken to test compression strength. This process generates a considerable amount of concrete dust. Many flat surfaces in the lab have a thick coating of concrete dust (Picture 3). The lab is equipped with a fume hood to vent waste heat and concrete dust from the lab. The fan for this hood was deactivated. This lab also contains a concrete curing room in which concrete cylinders are continuously misted with water vapor. Of note is the condition of the grilles over the ceiling-mounted return vents for the building's HVAC system which have a circle of discoloration on their surfaces (Picture 4). This corrosion likely indicates that water vapor and dust from the materials testing lab is entrained into the general ventilation system and may be distributed into other areas of the building.

Surfaces in the lab have a thick coating of concrete dust

4. Operate the fume hood in the materials testing lab during normal hours continuously. Have a timer installed to activate and deactivate this system.
5. Seal the general HVAC system return vents in the Materials Testing Lab.

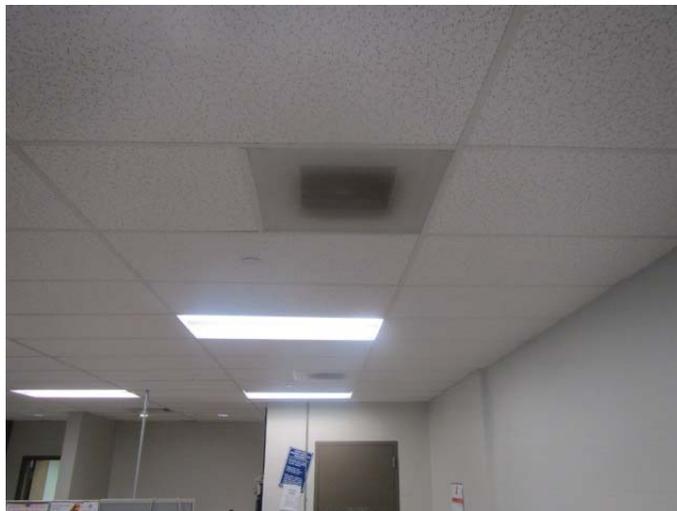
Picture 4

Discoloration on the surface of return vent grills
