# **INDOOR AIR QUALITY ASSESSMENT**

**Executive Office of Health and Human Services Center  
Shetland Park Office Complex  
45 Congress Street  
Salem, MA**

Prepared by:  
Massachusetts Department of Public Health  
Bureau of Environmental Health  
Indoor Air Quality Program  
September 2015

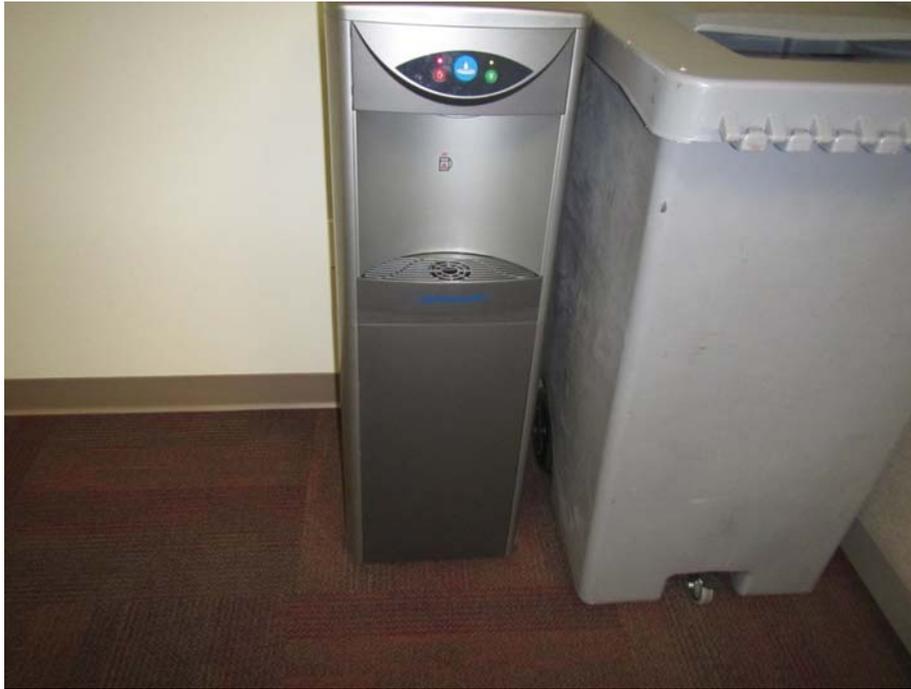
**Picture 1**

Some water coolers were still located directly on top of carpeting (Picture 1). Spills or leaks from this equipment can moisten the carpeting. EOHHS staff reported that more waterproof mats were ordered to place under the water coolers as a protective measure.

**Water cooler located directly on carpeting**

9. Once the waterproof mats are available, place them under all water coolers that are located directly on carpeting or relocate these appliances to non-carpeted areas.

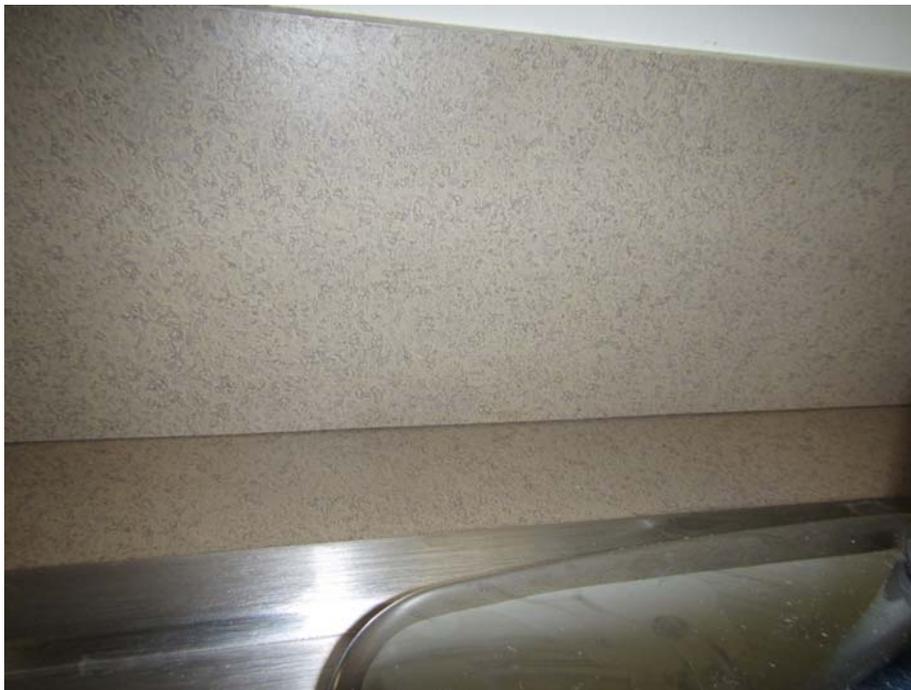
**Picture 2**

The backsplash area of the kitchen was noted to be unsealed (Picture 2). It is recommended that the gap between the upper and lower counter be sealed with a silicone-based caulking to prevent porous building materials to become chronically moistened.

**Gap between backsplash and kitchen counter lacking silicone caulking**

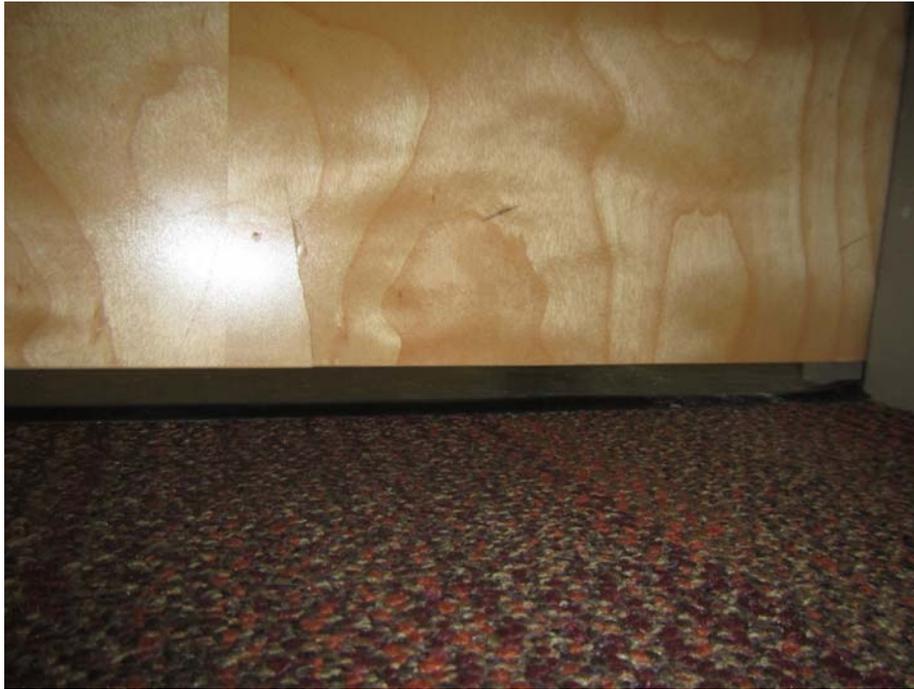
**Picture 3**

BEH/IAQ observed large gaps beneath the rear doors leading to the shared hallway adjacent to light manufacturing space (Picture 3). Installing tight-fitting door sweeps/gaskets under doors leading to the rear hallway will help to avoid any manufacturing-generated pollutants from entering the EOHHS occupied space.

**Large gap beneath door leading to hallway shared with light manufacturing space**
