INDOOR AIR QUALITY ASSESSMENT

**David Prouty High School
302 Main Street
Spencer, Massachusetts**

Prepared by:
Massachusetts Department of Public Health
Bureau of Environmental Health
Indoor Air Quality Program
December 2015

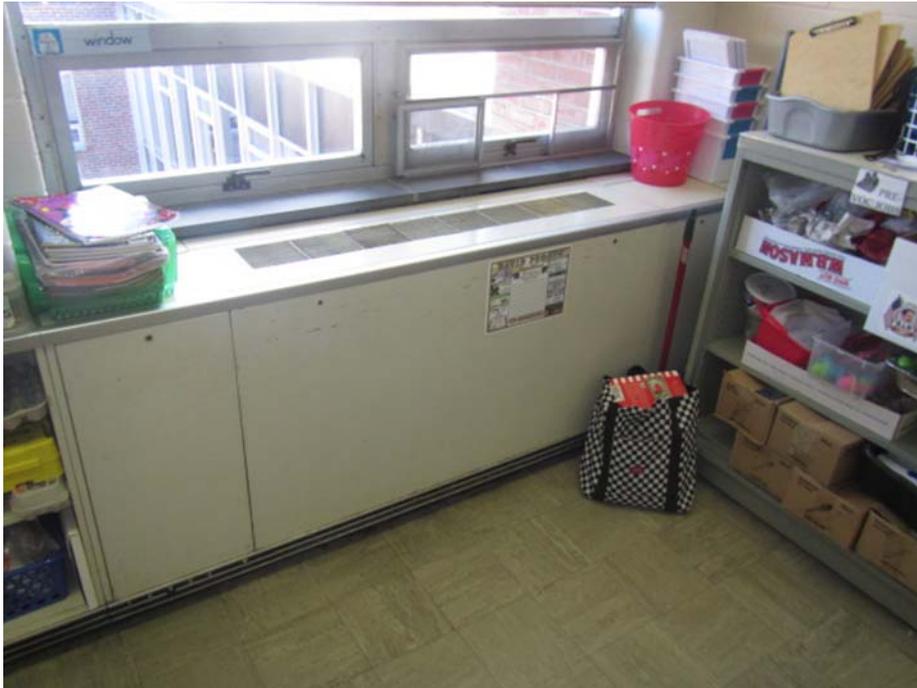
Picture 1

Fresh air is supplied to classrooms by unit ventilator (univent) systems (Picture 1). A univent draws air from the outdoors through a fresh air intake located on the exterior wall of the building (Picture 2) and returns air through an air intake located at the base of the unit (Figure 1). Fresh and return air are mixed, filtered, heated, and provided to classrooms through an air diffuser located in the top of the unit. Univents were found deactivated in many areas (Picture 3, Table 1); therefore there was no means to provide mechanical ventilation to these classrooms at the time of the assessment. Univents were also found obstructed by various items (particularly in the art room, Picture 4) or had missing/damaged diffusers/panels, exposing belts/moving parts of the units (Pictures 5 and 6), which can damage them or be a safety hazard. In order for univents to provide fresh air as designed, intakes/returns must remain free of obstructions. Importantly, these units must remain “on” and be allowed to operate while rooms are occupied.

In addition, although some motors appear to have been replaced, univents are original to the building’s construction, which makes them close to 50 years old. Efficient function of such aged equipment is difficult, since compatible replacement parts are often unavailable. According to the American Society of Heating, Refrigeration, and Air-Conditioning Engineering (ASHRAE), the service life¹ for a unit heater (hot water or steam) is 20 years, assuming routine

maintenance of the equipment (ASHRAE, 1991). Despite attempts to maintain the equipment, the operational lifespan of this equipment has been exceeded.

Classroom univent 1960s vintage

1. Contact an HVAC engineering firm for an assessment of the ventilation system's control system (e.g., controls, air intake louvers, thermostats). Based on the age, physical deterioration, and availability of parts for ventilation components, such an evaluation is necessary to determine the operability and feasibility of repairing/replacing the equipment.
2. Examine the feasibility of initiating capital improvement plans for major roof repairs/replacement.
3. Consider total removal/replacement of ceiling tile system.

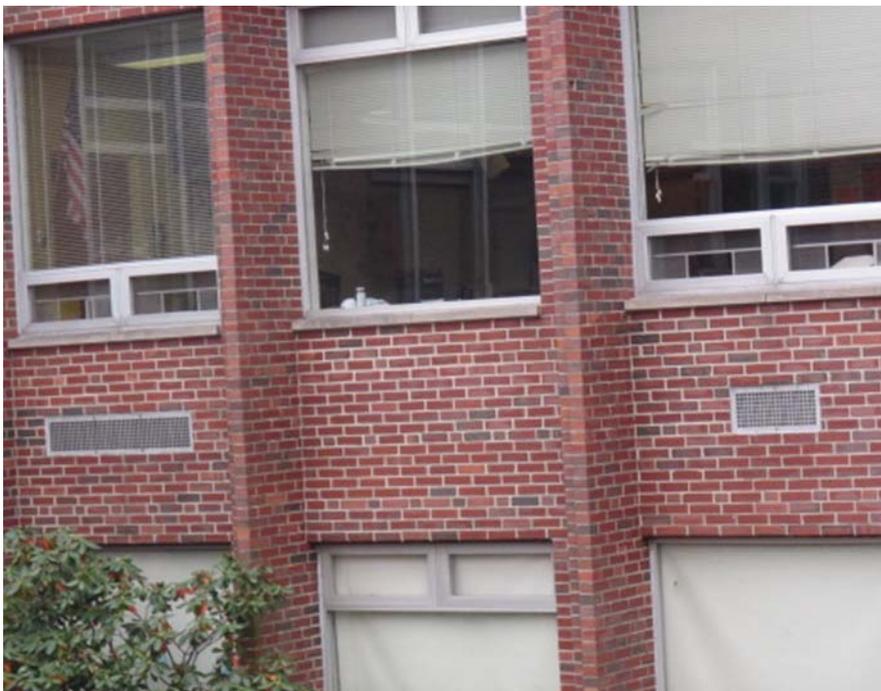
Picture 2

Univent air intake (left), unit exhaust vent (right)

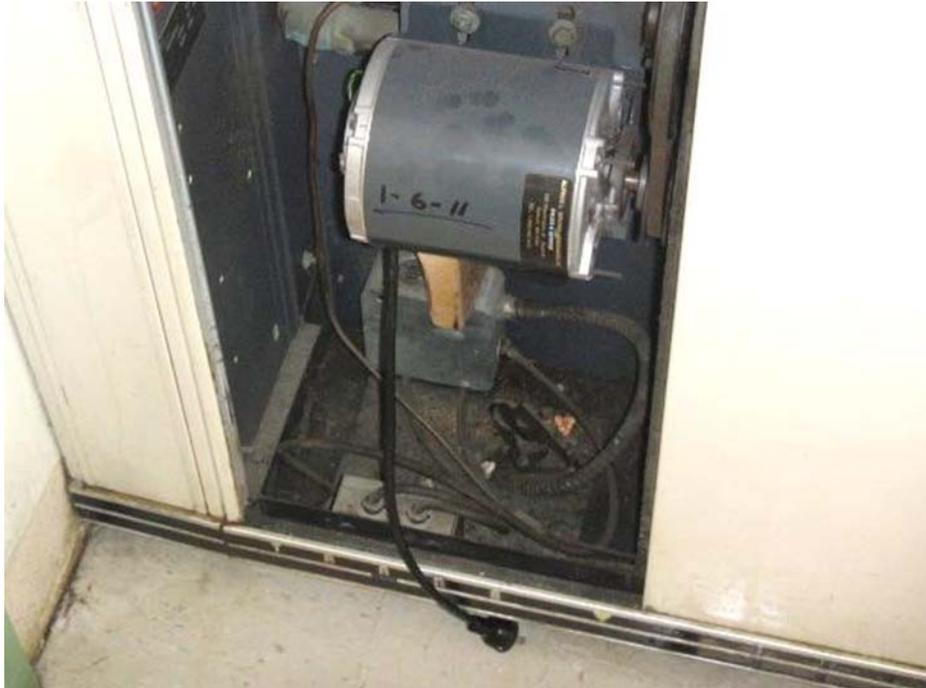
Picture 3

Univent motor unplugged

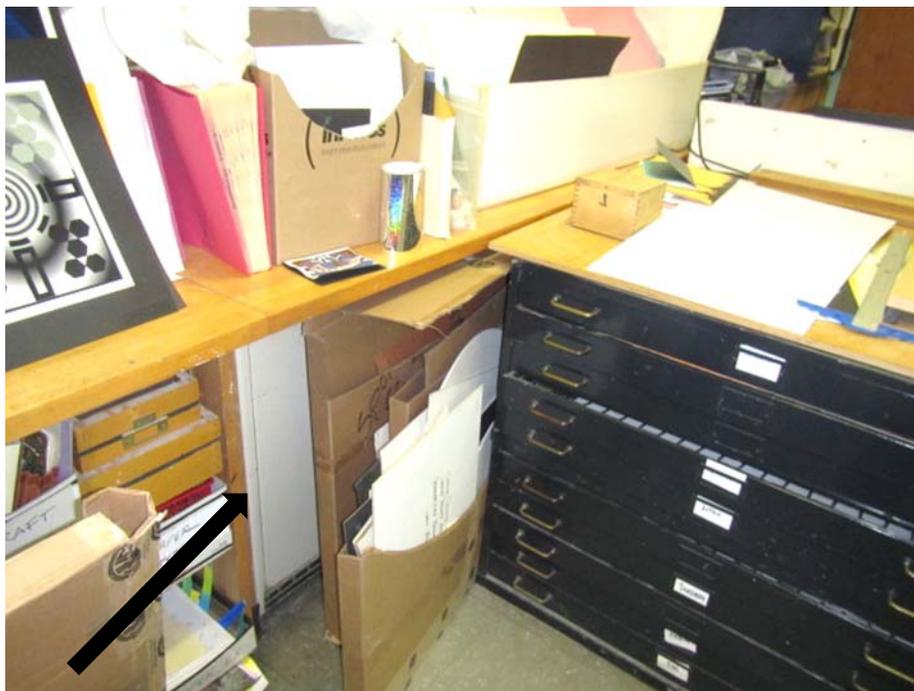
Picture 4

In several classrooms, items were observed on the floor, windowsills, tabletops, counters, bookcases, and desks (Pictures 4 and 19). The large number of items stored in classrooms provides a source for dusts to accumulate. These items (e.g., papers, folders, boxes) make it difficult for custodial staff to clean. Items should be relocated and/or be cleaned periodically to avoid excessive dust build up. In addition, these materials can accumulate on flat surfaces (e.g., desktops, shelving and carpets) in occupied areas and subsequently be re-aerosolized causing further irritation.

Univent (arrow) completely obstructed by items in the Art room

5. Inspect unit exhaust motors and belts for proper function. Repair and replace as necessary.
 6. Remove all blockages from univents and exhaust vents to ensure adequate airflow.

15. Relocate or consider reducing the amount of materials stored in classrooms to allow for more thorough cleaning of classrooms. Clean items regularly with a wet cloth or sponge to prevent excessive dust build-up.

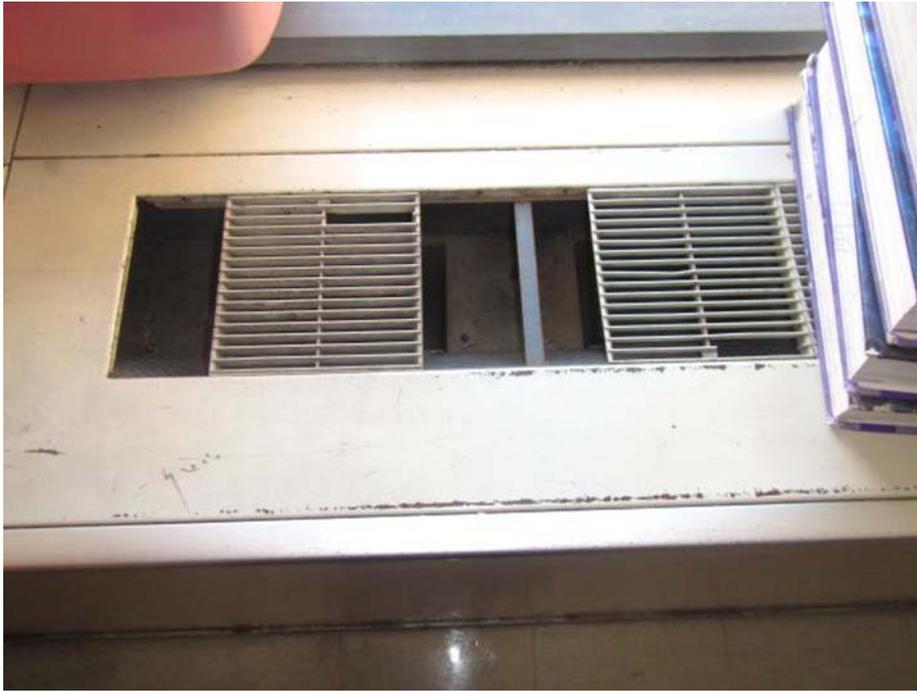
Picture 5

Missing/damaged univent diffuser exposing moving parts

3. Replace missing univent cabinet panels/diffusers, have fabricated if necessary.
 4. Operate all ventilation systems throughout the building (e.g., gym, locker rooms, cafeteria, classrooms) continuously during periods of school occupancy and independent of thermostat control. To increase airflow in classrooms, set univent controls to “high.”

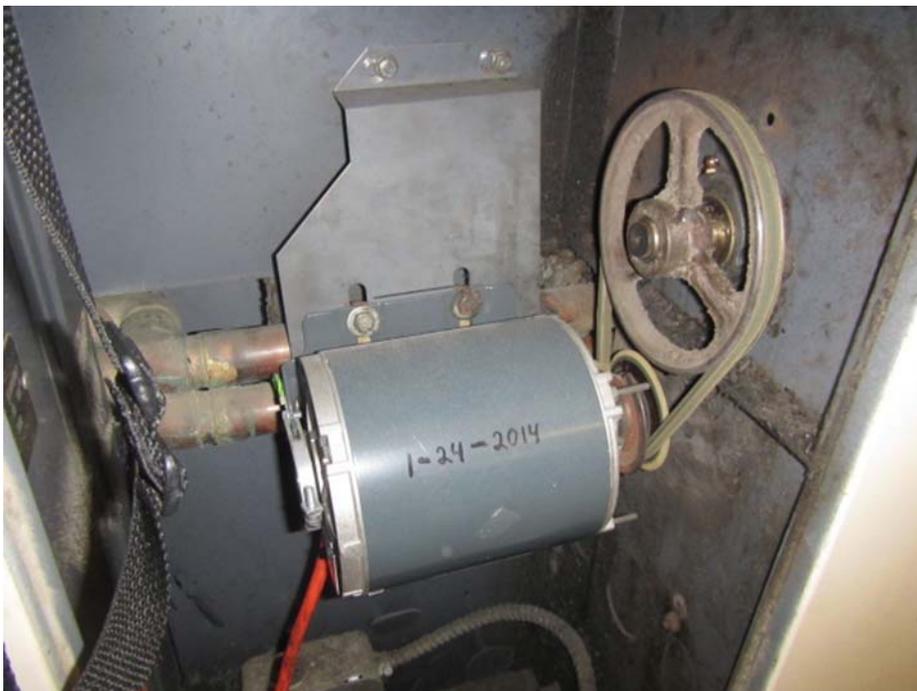
Picture 6

Missing univent panel exposing moving parts

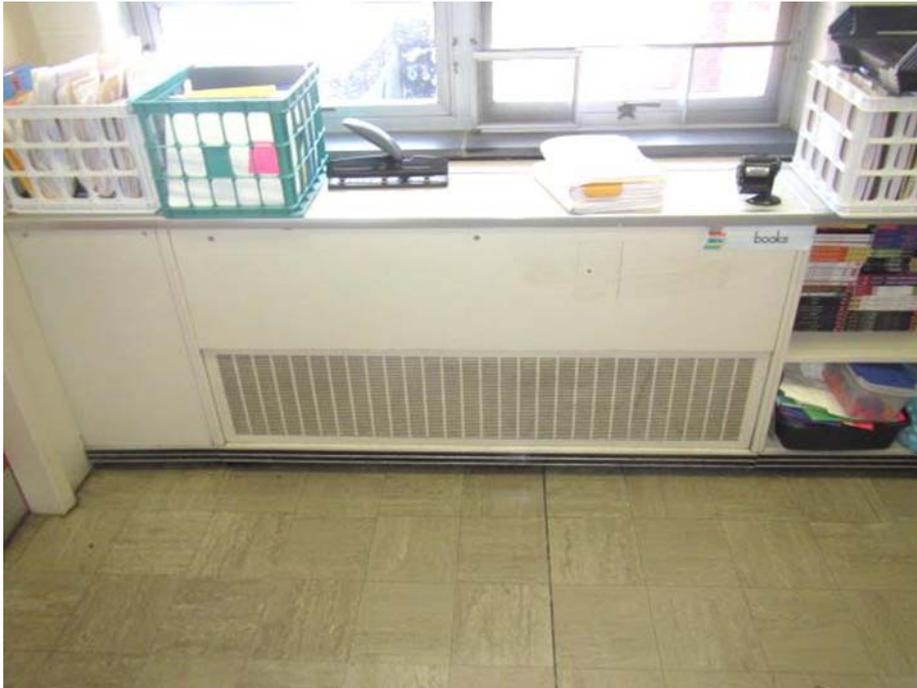
Picture 7

Mechanical exhaust ventilation in the classroom wing is provided by unit exhaust ventilators (Picture 7). A unit exhaust ventilator appears similar to a univent, but removes air from the classroom and exhausts it out of the building (Picture 2). Unit exhaust ventilators were not operating in any of the areas surveyed at the time of the assessment. Mechanical exhaust ventilation for classrooms and specialty areas in the single-story wing are provided by grated wall vents powered by rooftop motors (Picture 8).

Unit exhaust ventilator

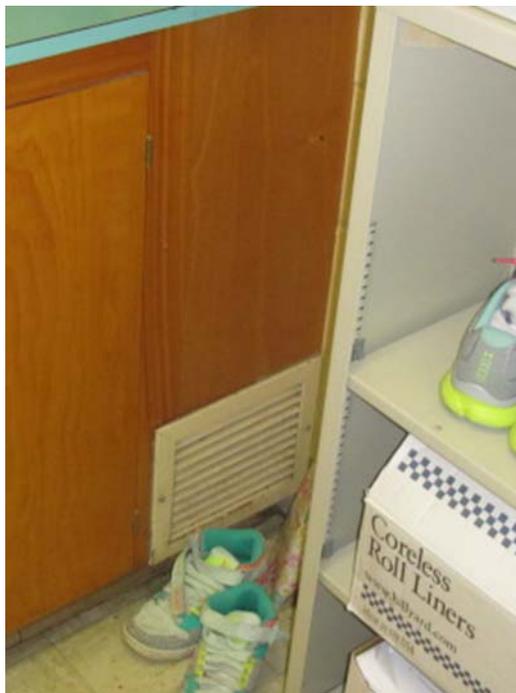
Picture 8

Wall-mounted exhaust vent

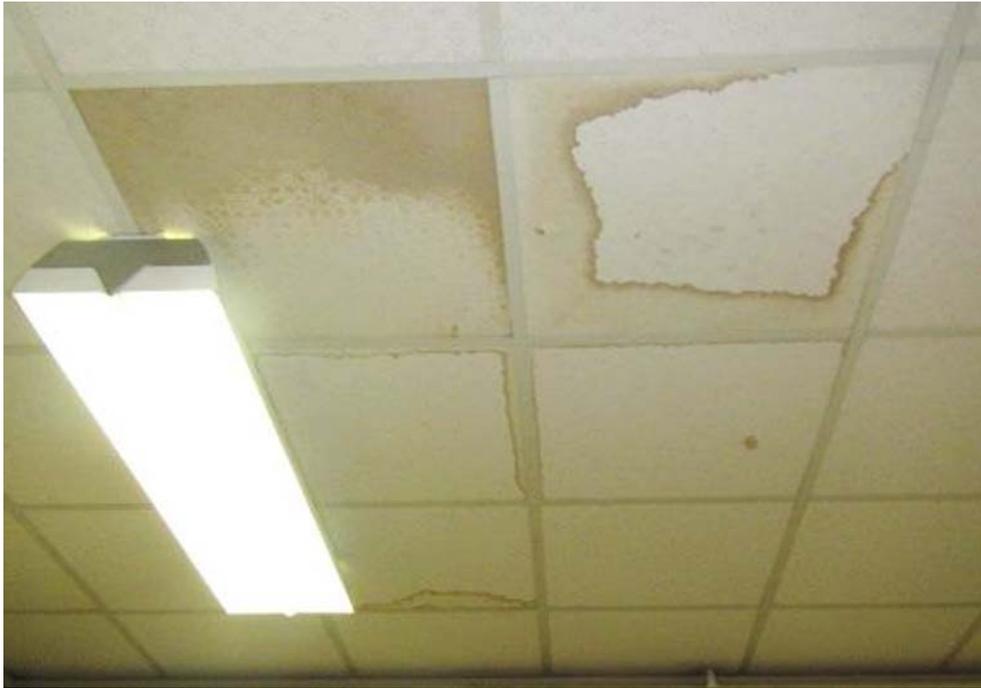
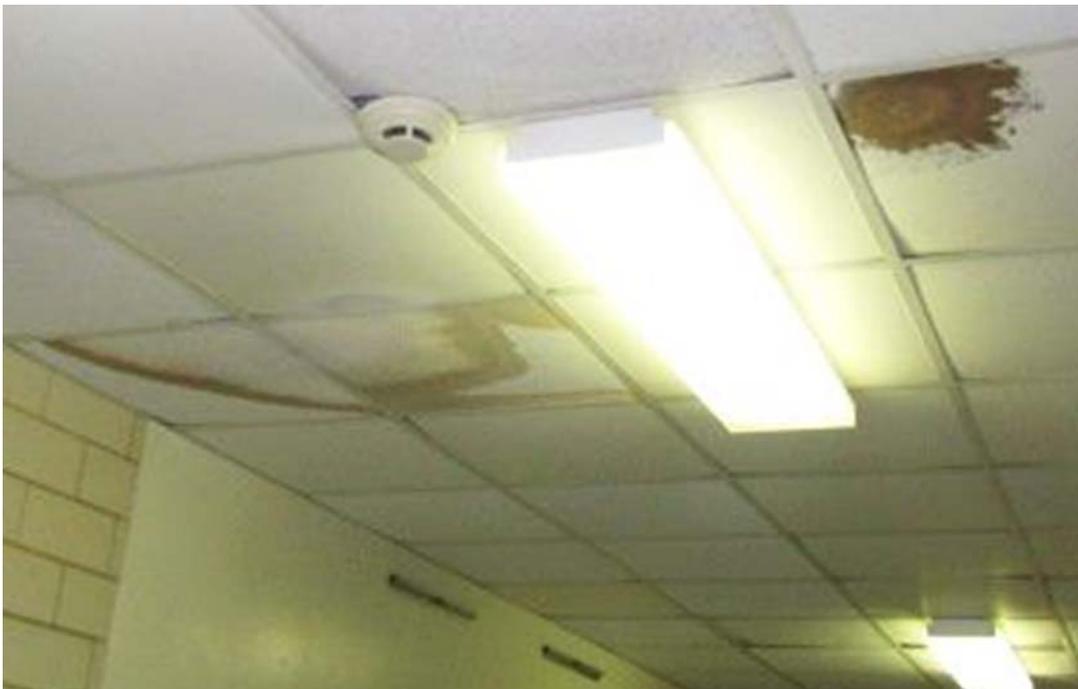
Water-damaged ceiling tiles were observed in many areas (Pictures 9 and 10; Table 1). Typically, the source of the leak above the ceiling tiles should be repaired and the water-damaged ceiling tiles should be removed and replaced. However, it was reported that the ceiling

tiles at DPHS are asbestos containing materials (ACM), therefore caution must be taken when replacing tiles.

Water-damaged ceiling tiles

9. Investigate the source of active water leaks. Make necessary repairs and replace water-damaged ceiling tiles. Follow proper remediation requirements (MDLI, 1993) should these ceiling tiles contain asbestos.

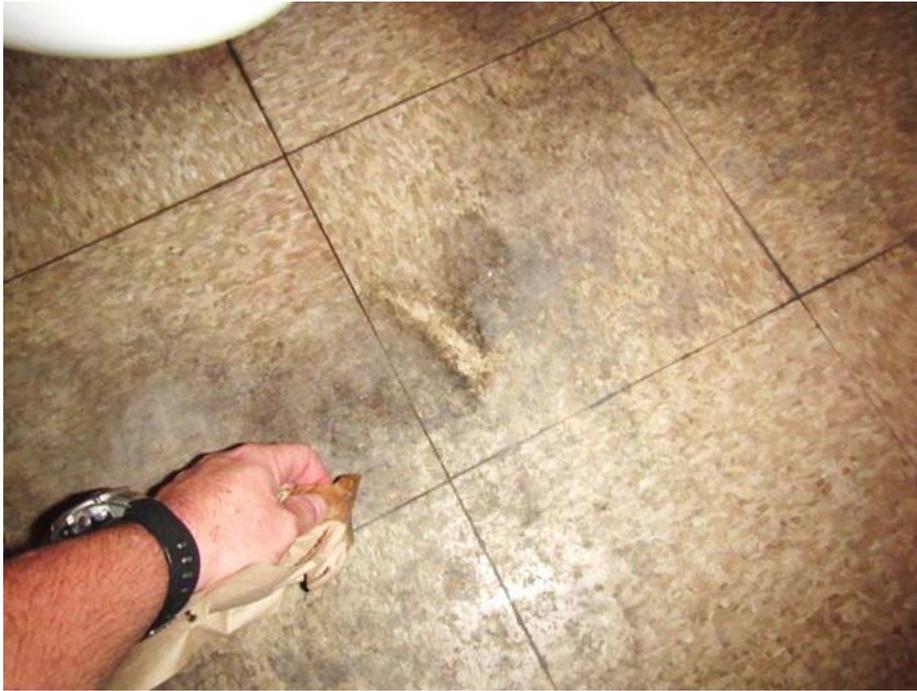
Picture 11

Several faculty members expressed concerns about mold growth on restroom floors. BEH/IAQ staff examined these areas and observed what appeared to be accumulated dirt/debris on floors that should be cleaned (Pictures 11 and 12).

Accumulated dirt/debris on 1st floor faculty restroom (as reported to be mold by staff), note area wiped clean by BEH/IAQ staff

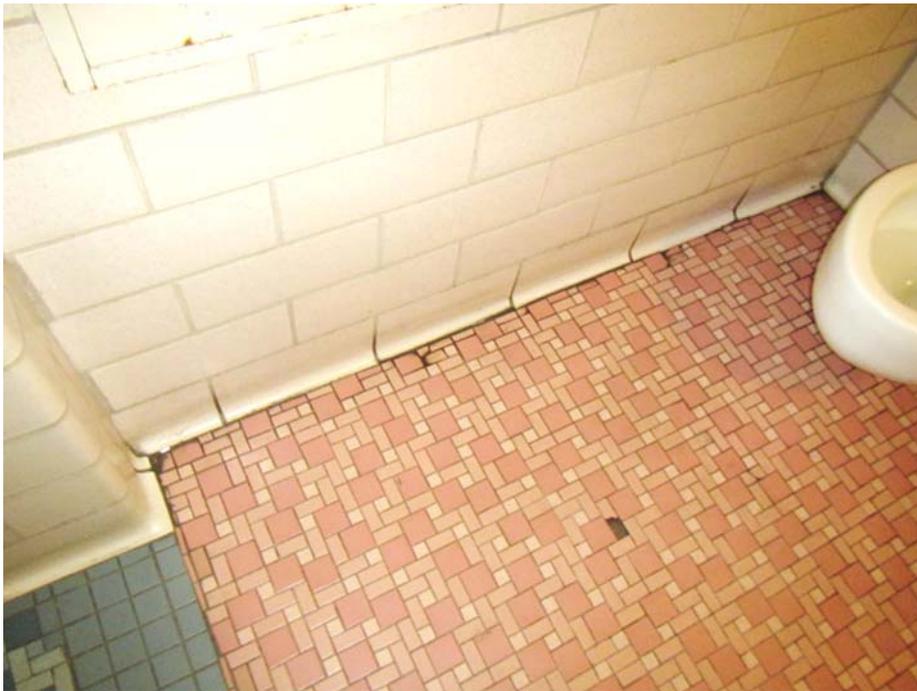
Picture 12

Accumulated dirt/debris around edges of 2nd floor faculty restroom (reported to be mold by staff)

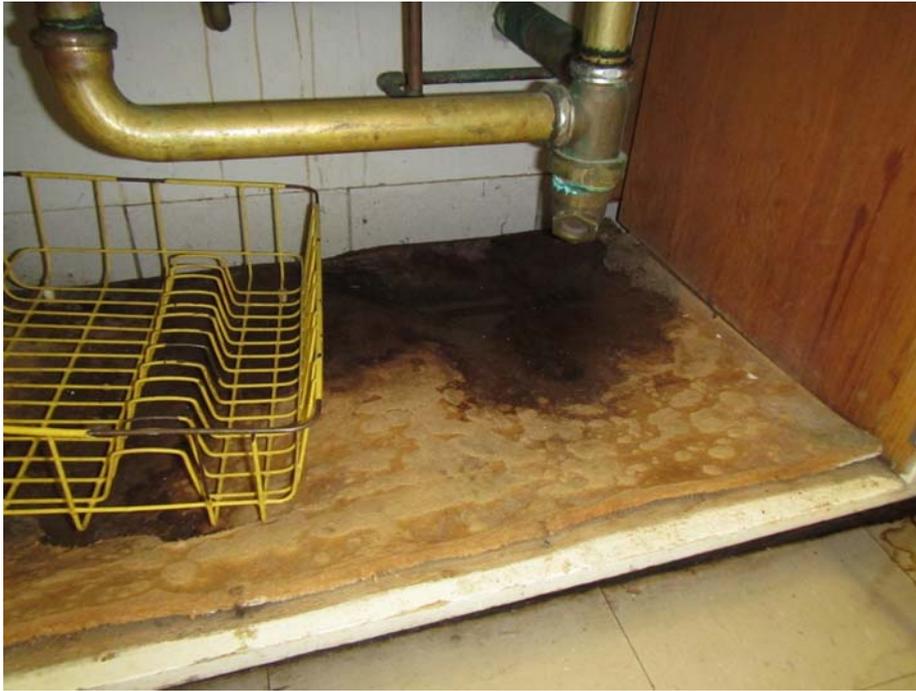
Picture 13

The plumbing beneath a sink in room #201 appeared to be actively leaking (Picture 13). Chronic moistening of porous building materials has the potential to colonize mold. Although BEH/IAQ staff did not note any active mold colonization, this leak should be repaired and any water-damaged porous building materials should be discarded and replaced.

Chronic water leak under sink in room #201

10. Disconnect the flameproof cabinet vent and seal its bunghole with an appropriately size plug.
 11. Repair leaking plumbing under sink in room 201.
 12. Consider adopting a balancing schedule of every 5 years for all mechanical ventilation systems, as recommended by ventilation industrial standards (SMACNA, 1994).

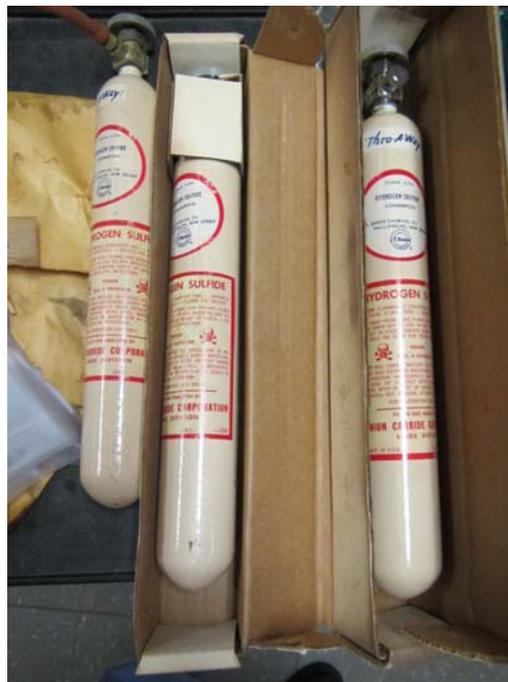
Picture 14

- Gas cylinders were found stored in a drawer (Picture 14). Under both industry regulations and good chemical storage practice standards, cylinders of compressed gas must be fixed to a wall or stand to prevent damage to cylinder valves by tipping (Rose, 1984). A damaged cylinder valve can cause an immediate and uncontrolled release of the cylinder contents and result in the cylinder becoming a projectile. These cylinders must be secured as soon as possible to prevent accidental release and injury.

Gas cylinders in unlabeled drawer

1. Due to the conditions noted in the chemical storage room, it is highly recommended that the Spencer-East Brookfield Regional School District contact Dwight Peavey, of the US Environmental Protection Agency, Toxics Release Inventory Program, Assistance, and Pollution Prevention Office (SPT) (phone: (617) 918-1829) to request assistance regarding classification and the prompt, proper disposal of chemicals stored in this location.
2. Examine each univent for function. Survey classrooms for univent function to ascertain if an adequate air supply exists for each room. Consider consulting a heating, ventilation,

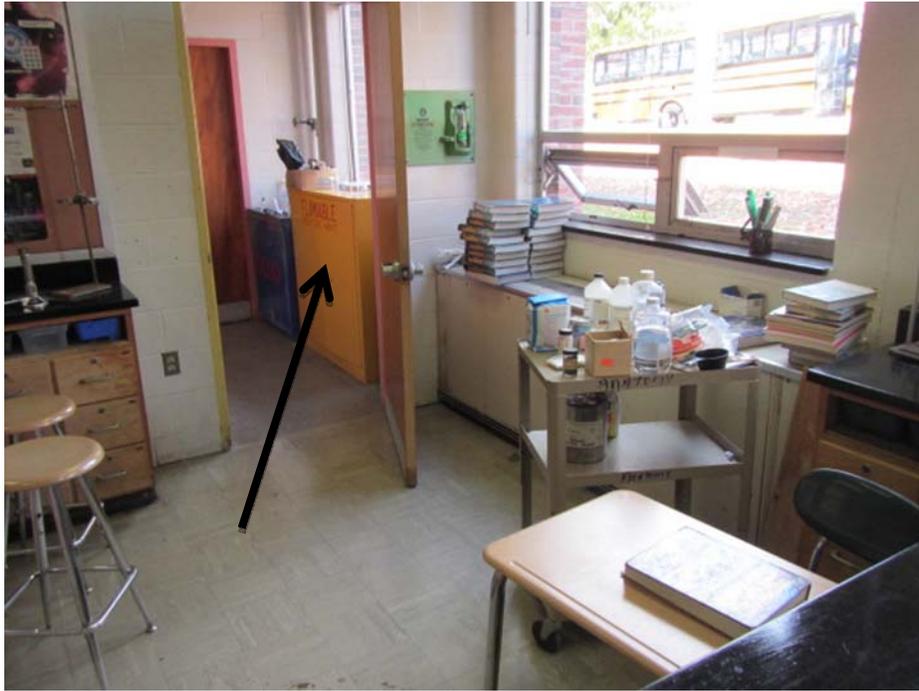
Picture 15

In the outer room, flammable materials are stored in a flameproof cabinet (Picture 15). The National Fire Prevention Association (NFPA) does not require venting in flammable storage cabinets, however, if venting is done, it must be vented directly outdoors and in a manner that does not compromise the specific performance of the cabinet (NFPA, 1996). If air backflow from outdoors into the cabinet through the venting occurs, off-gassing chemicals can be forced from the flammable storage cabinet into the storeroom. Proper design of exhaust vents should prevent air backflow into the cabinet. A pipe was connected to the flameproof cabinet to serve

Flameproof cabinet

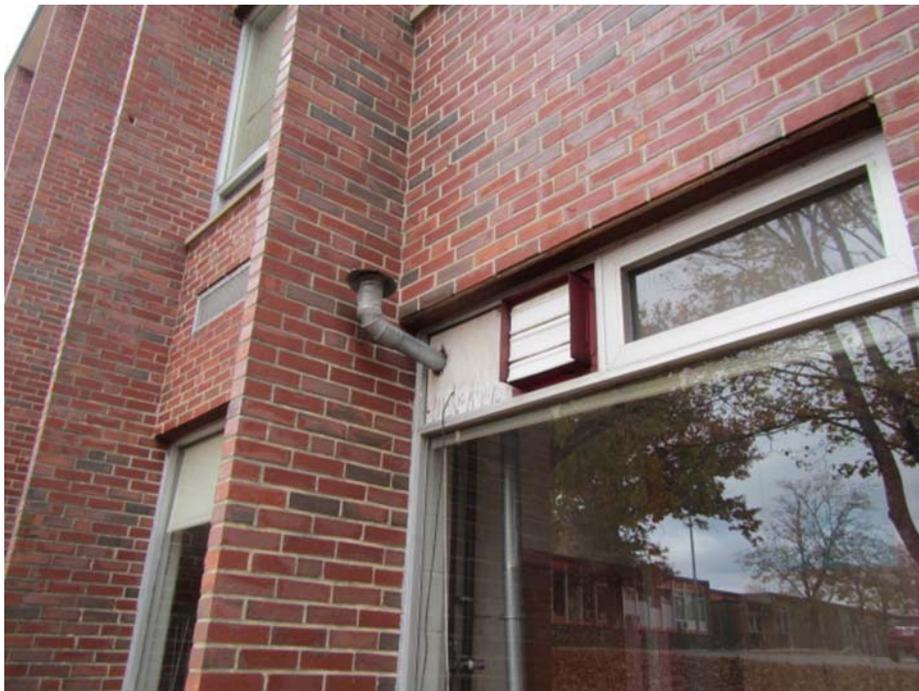
Picture 16

as an exhaust vent (Picture 16). No air backflow device could be identified in this vent pipe. In its current condition, this pipe can provide an oxygen supply to the interior of the flameproof cabinet. It is also important to note that vents for the flameproof cabinet and the chemical hood appear to terminate through the exterior wall below openable windows (Picture 17), which can allow for infiltration of VOCs into occupied areas.

Flameproof cabinet vent next to flapper vent connected to the chemical hood

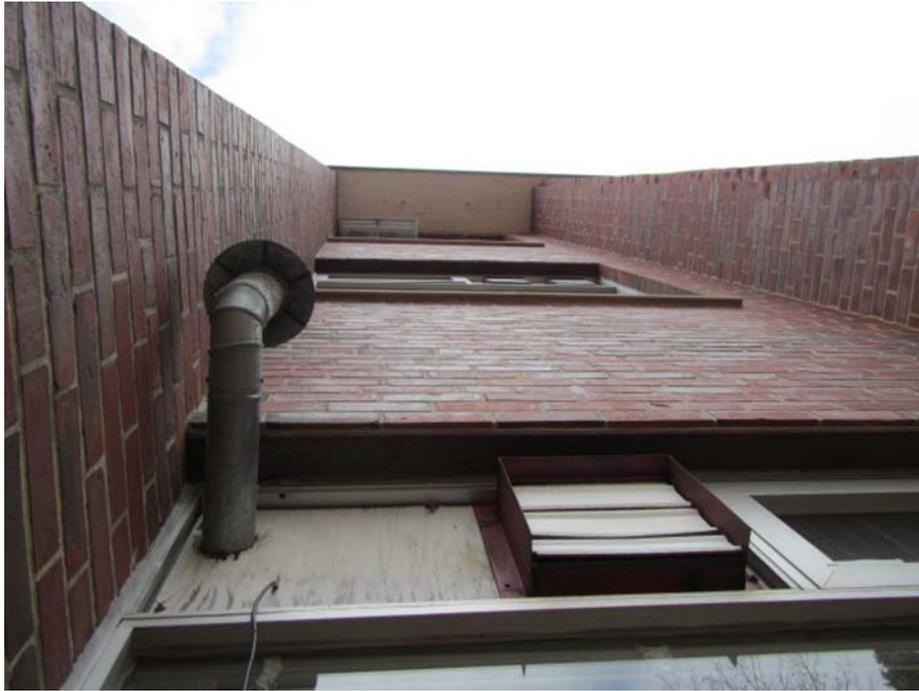
Picture 17

Flameproof cabinet and chemical hood vents below windows

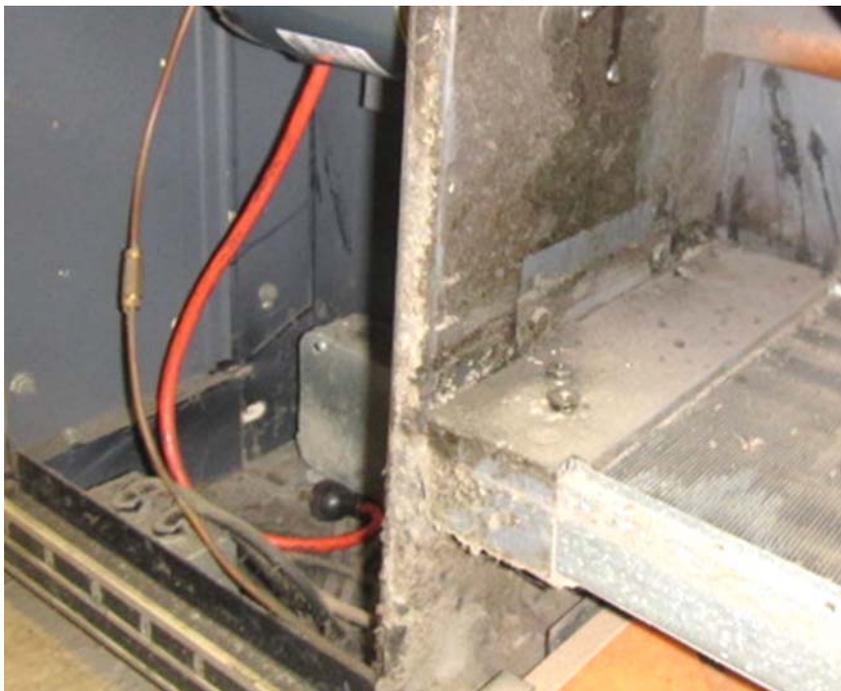
Picture 18

Other conditions that can affect IAQ were observed during the assessment. Some personal fans, univents, and exhaust vents were observed to be dusty (Picture 18; Table 1). Dust on these items can be reaerosolized and cause irritation or odors.

Accumulated dust/debris in univent

16. Clean personal fans, univent air diffusers, return vents, and exhaust vents periodically of accumulated dust.
 17. Clean chalk trays, dry erase board trays, and areas around pencil sharpeners to prevent accumulation of materials.

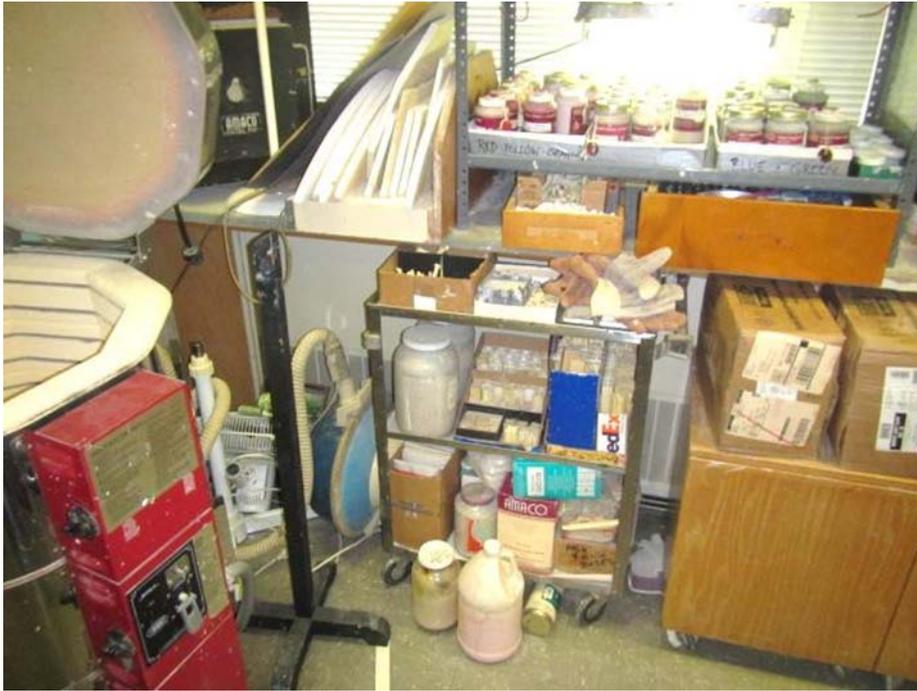
Picture 19

Accumulated items in Art room

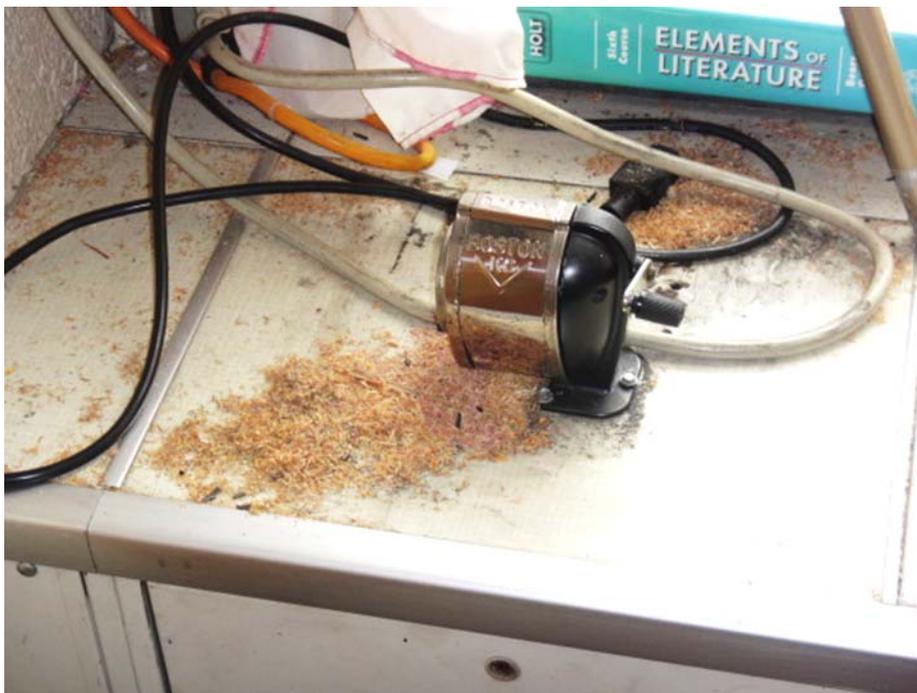
Picture 20

An accumulation of chalk dust and pencil shavings was observed in some classrooms (Picture 20). When windows are opened or univents are operating, these materials can become airborne. Once aerosolized, they can act as irritants to eyes and the respiratory system.

Pencil shavings on top of univent

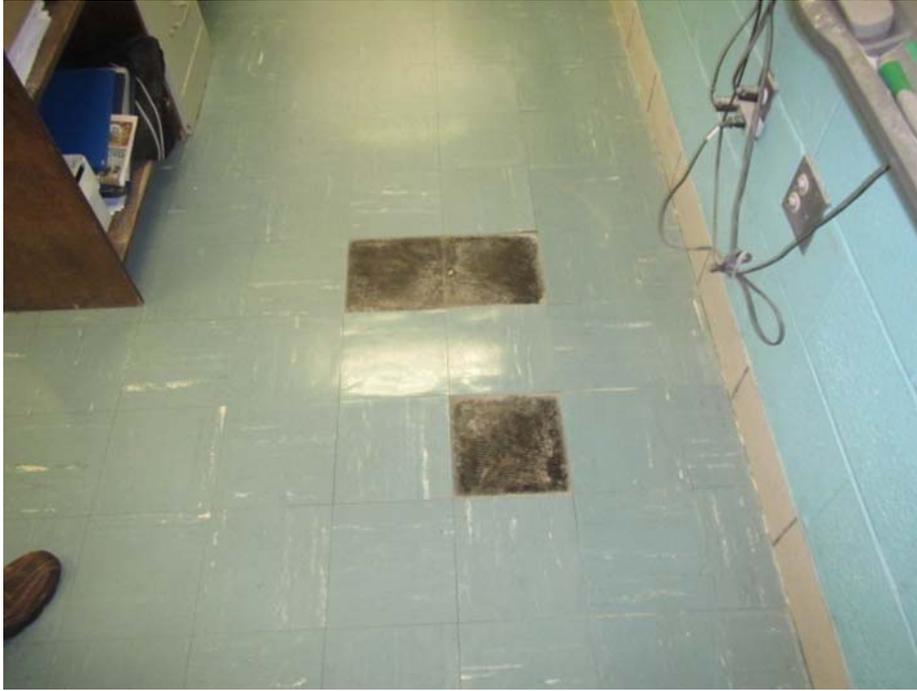
Picture 21

Concerns regarding damaged floor tiles in classroom 107 were expressed. Although the tiles were somewhat loose, they did not appear friable and were sealed by a layer of floor wax (Picture 21).

Removed/loose floor tiles in classroom 107

18. Continue to follow AHERA regulations including 3-year inspections and updates/availability of the school's asbestos management plan.
 19. Make repairs or remove loose floor tiles in classroom 107.
