# **INDOOR AIR QUALITY ASSESSMENT**

**Annex Building  
272 Main Street  
Townsend, Massachusetts**

Prepared by:  
Massachusetts Department of Public Health  
Bureau of Environmental Health  
Indoor Air Quality Program  
June 2015

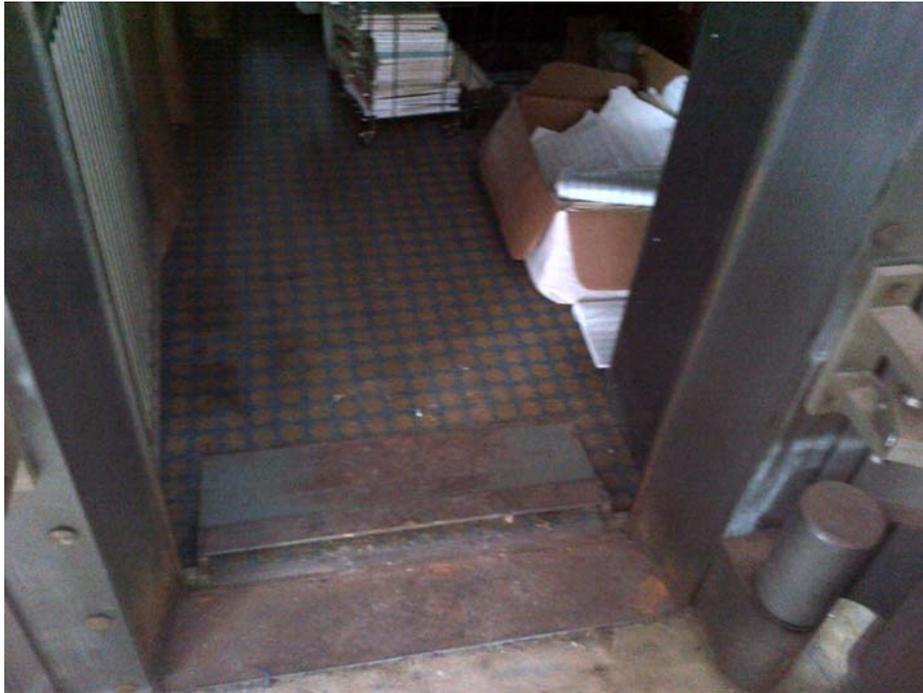
**Picture 1**

- Musty/mold-like odors in carpeted areas of the building, particularly inside of the bank vaults (Picture 1).
- Water-damaged interlocking ceiling tiles (Picture 2).
- Peeling paint and efflorescence<sup>1</sup> were observed on all plaster walls (Picture 3).

**Carpeting inside bank vault**

1. Ensure all water-damaged porous materials (e.g., carpet) are removed from the building and all mold-colonized nonporous surfaces are cleaned in accordance with EPA Guidance for Mold Remediation in Schools and Commercial Buildings (US EPA, 2001).
2. Repair water-damaged plaster.
3. Replace damaged exterior wall surfaces.
4. If damaged ceiling or floor tiles contain asbestos, remediate in conformance with state and federal asbestos remediation and hazardous waste disposal laws.
5. Design and provide gutter/downspout system that deposits rainwater as far as practicable from the foundation.
6. Refer to resource manual and other related indoor air quality documents located on the MDPH's website for further building-wide evaluations and advice on maintaining public buildings. These documents are available at: <http://mass.gov/dph/iaq>.

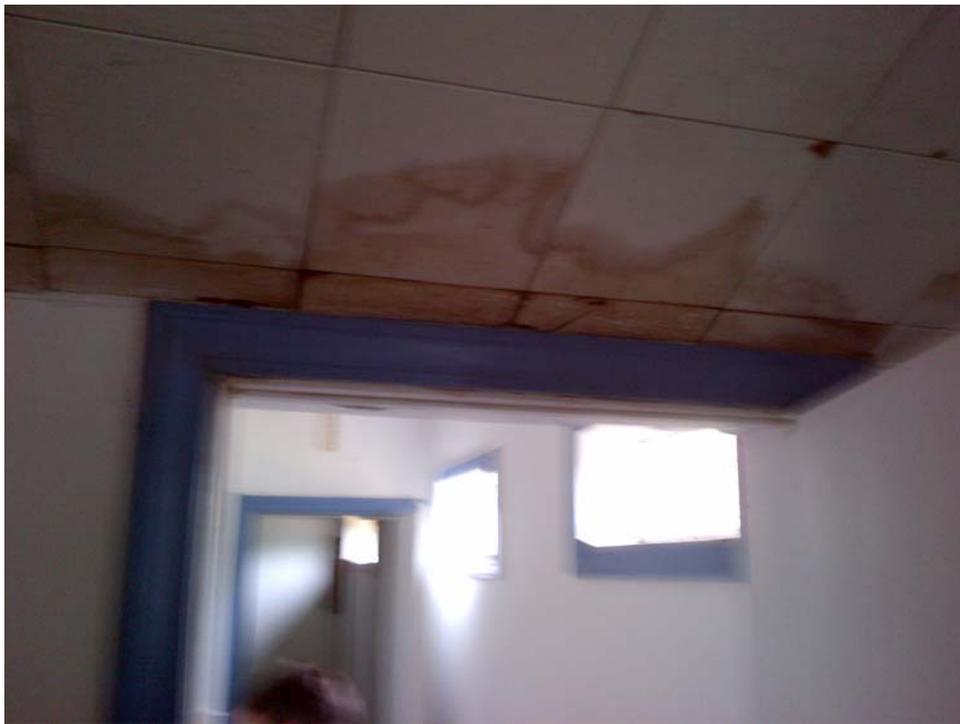
**Picture 2**

**Water-damaged interlocking ceiling tiles**

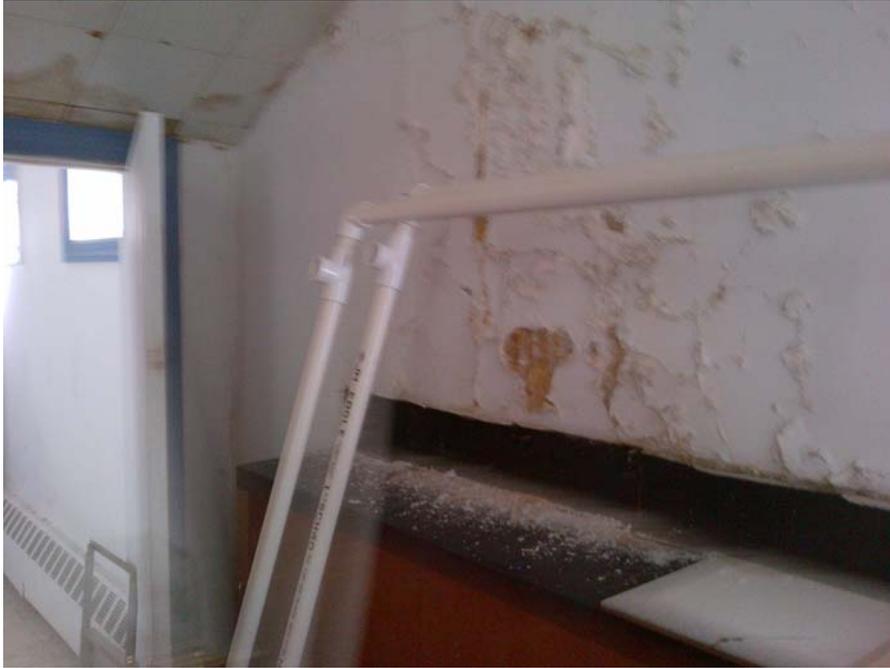
**Picture 3**

**Peeling paint, plaster walls with efflorescence**

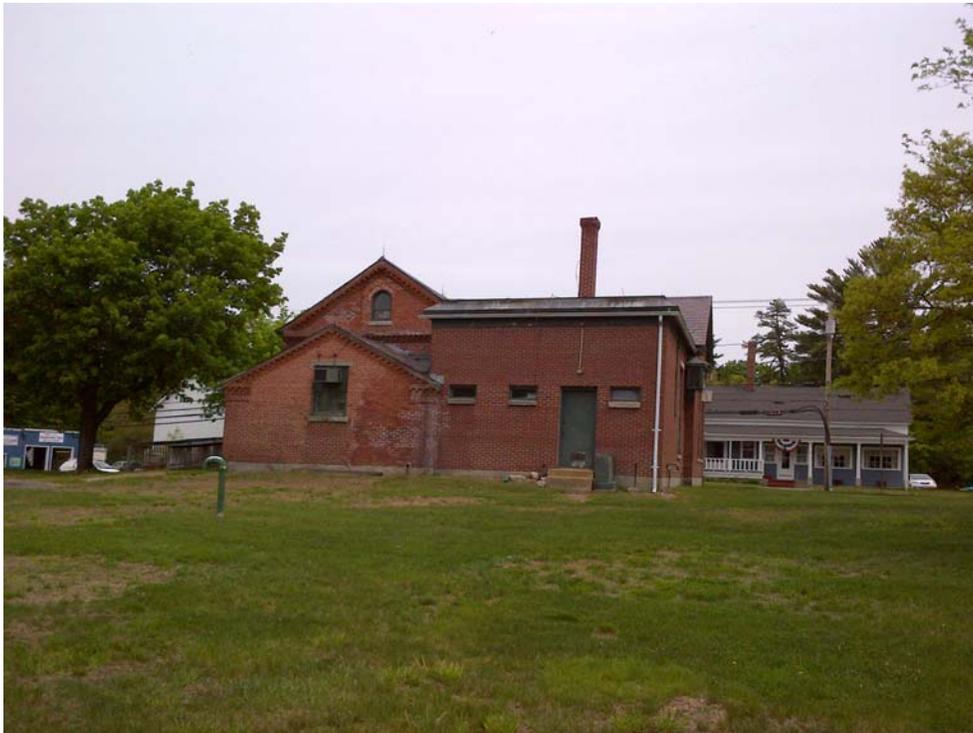
**Picture 4**

- Cracked, missing mortar was observed.
- Efflorescence was observed on exterior masonry (Picture 4), which is indicative of chronically moistened materials but is not mold.
- Crawlspace vents were clogged with leaves (Picture 5) which can prevent the venting moisture from beneath the building.
- Window frames are deteriorated; some have holes.
- Part of the roof system at the rear of the building lacks gutter/ downspouts (Picture 6) which allows water to be deposited directly onto the exterior wall.
- A night deposit box exists in the exterior wall of the building (Picture 7). This opening can allow for hot, moist air to enter the interior of the building.

**Efflorescence was observed on exterior masonry**

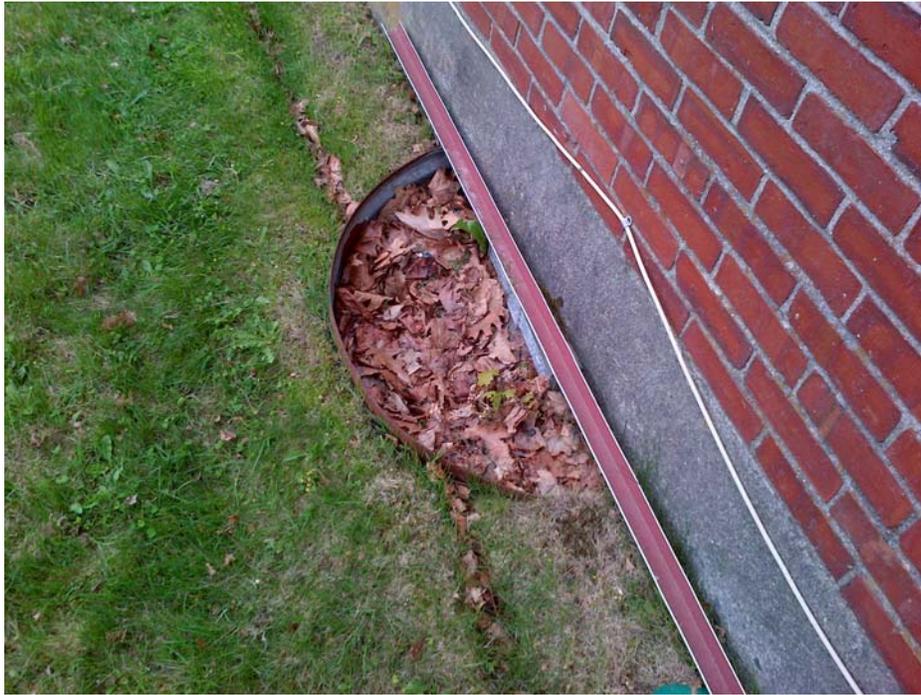
**Picture 5**

**Crawlspace vent clogged with leaves**

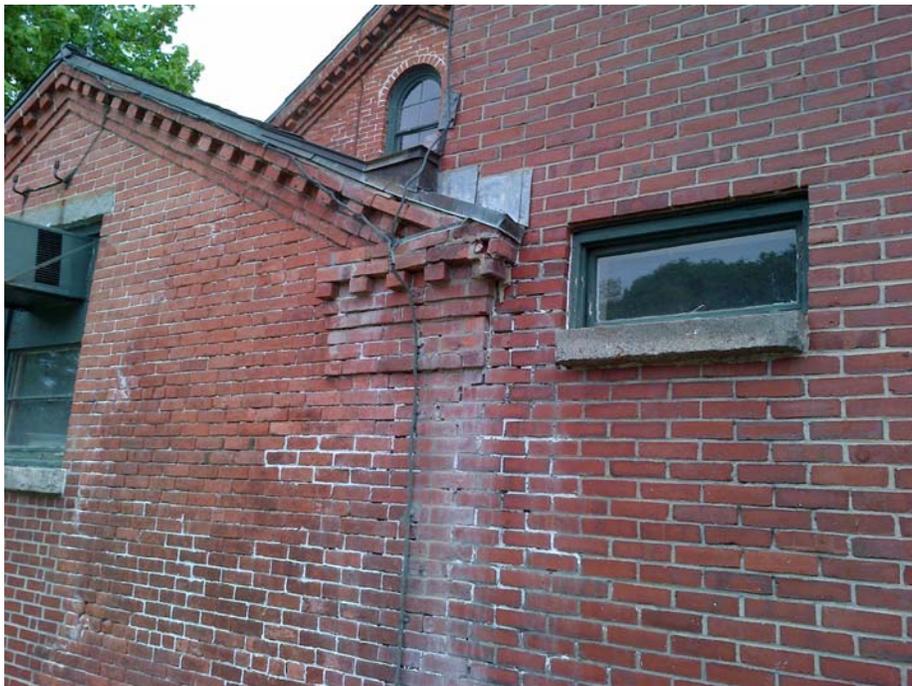
**Picture 6**

**Part of the roof system at the rear of the building lacks gutter/ downspouts**

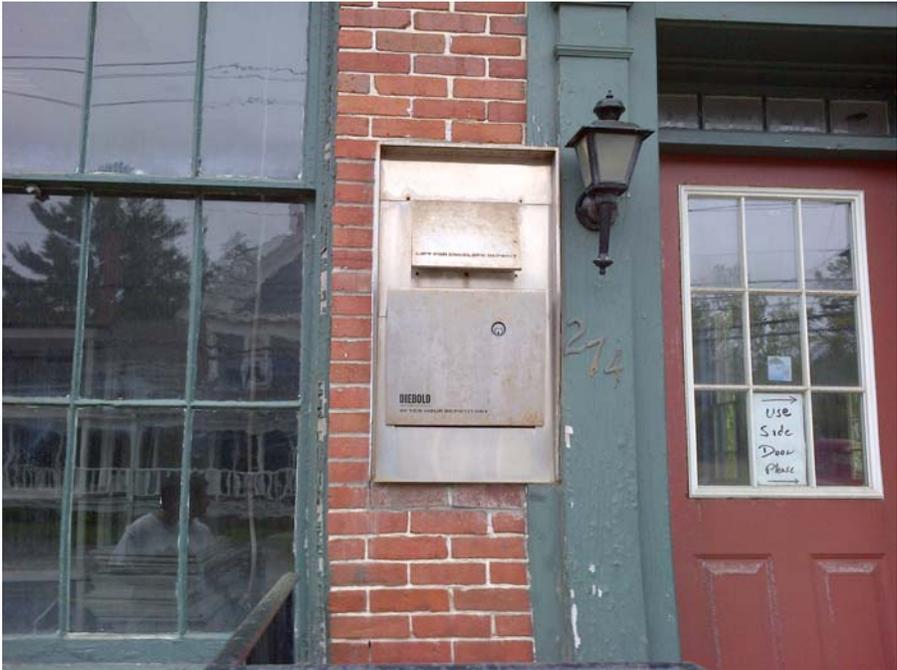
**Picture 7**

**Night deposit box**
