INDOOR AIR QUALITY REASSESSMENT

**Winthrop High School
(Formerly Winthrop Middle School)
151 Pauline Street
Winthrop, Massachusetts**

Prepared by:
Massachusetts Department of Public Health
Bureau of Environmental Health
Indoor Air Quality Program
October 2015

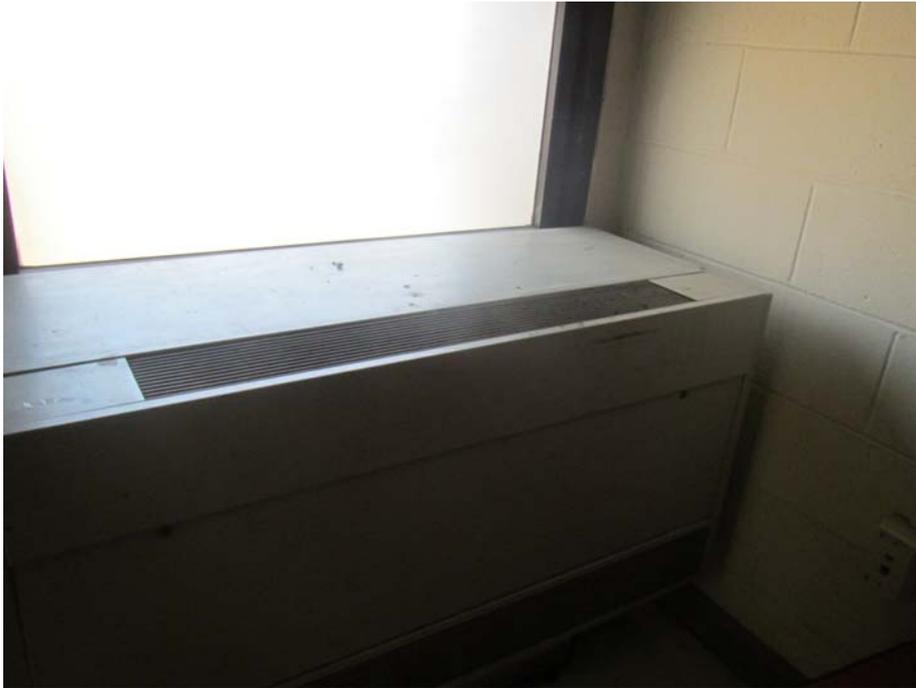
Picture 1

Fresh air to exterior classrooms is supplied by unit ventilator (univent) systems (Picture 1). A univent draws air from the outdoors through a fresh air intake located on the exterior wall of the building. Return air from the classroom is drawn through an air intake located at the base of the unit ([Figure 1](#)). Fresh and return air are mixed, filtered, heated and provided to classrooms through an air diffuser located in the top of the unit. In common areas and some interior classrooms, air handling units (AHUs) provide fresh air and heating via ceiling or wall-mounted diffusers.

Univent

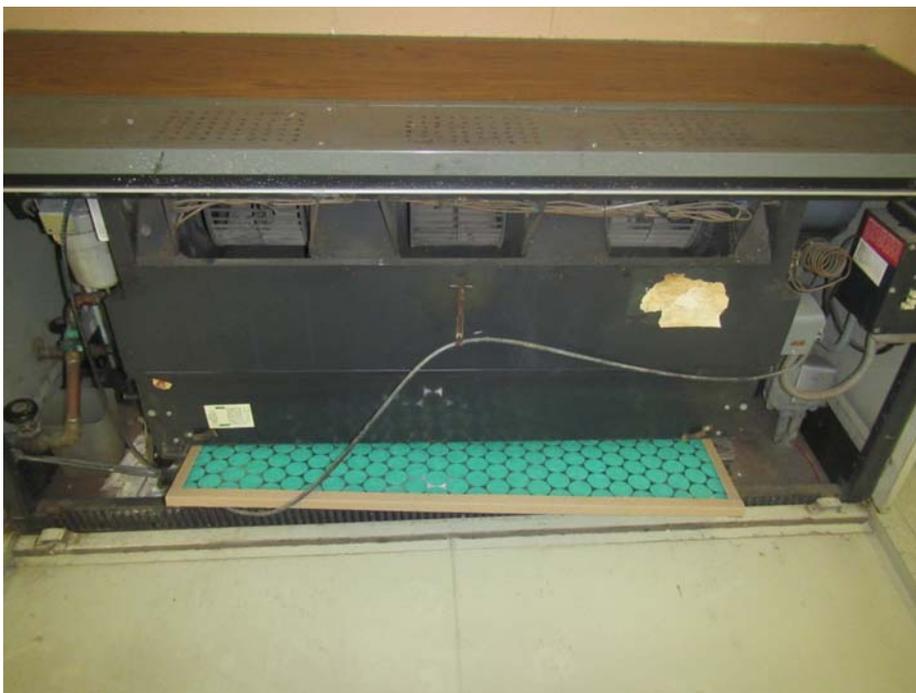
- The majority of univent front covers were properly closed;
- Disposable, properly-fitting air filters were observed in all standard sized classroom univents instead of metal cages with cut-to-fit filters as denoted in previous assessments (Picture 2).
- Most univents (Table 1) were operating at the time of the visit;
- Most univent cabinets appeared to have been cleaned. Some had debris in either the bottom of the cabinet or the top (Pictures 3 and 4);
- Space in univents were sealed as recommended. Some univents still contained gaps (Picture 5).

Disposable filter installed in univent; note filter was clean/new

replacement of the makeshift air diffusers such as those shown in Picture 2 with standard ones.

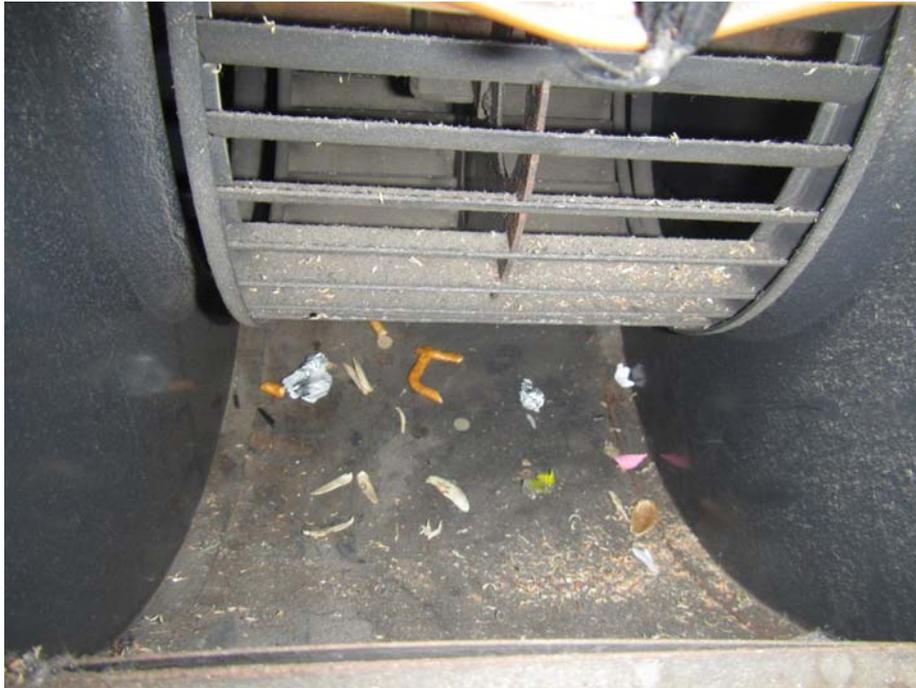
Picture 3

Debris inside univent

4. Ensure removal of all items from the surface of univent air diffusers and return vents (along front/bottom) to ensure adequate airflow.
5. Remove any blockages from exhaust vents.
6. Acquire properly-fitting disposable filters for non-standard sized univents.
7. Use openable windows to supplement fresh air in the classrooms during occupancy. If thermal comfort is a concern, consider opening windows between classes and during unoccupied periods. Care should be taken to ensure windows are closed at the day's end.
8. Seal holes/breaches where pipes from univents and sinks penetrate into the crawlspace or wall cavity with appropriate fire-rated sealant to prevent movement of odors/particles from wall cavities and subfloor areas.
9. Refrain from using air fresheners and deodorizers to prevent exposure to VOCs.

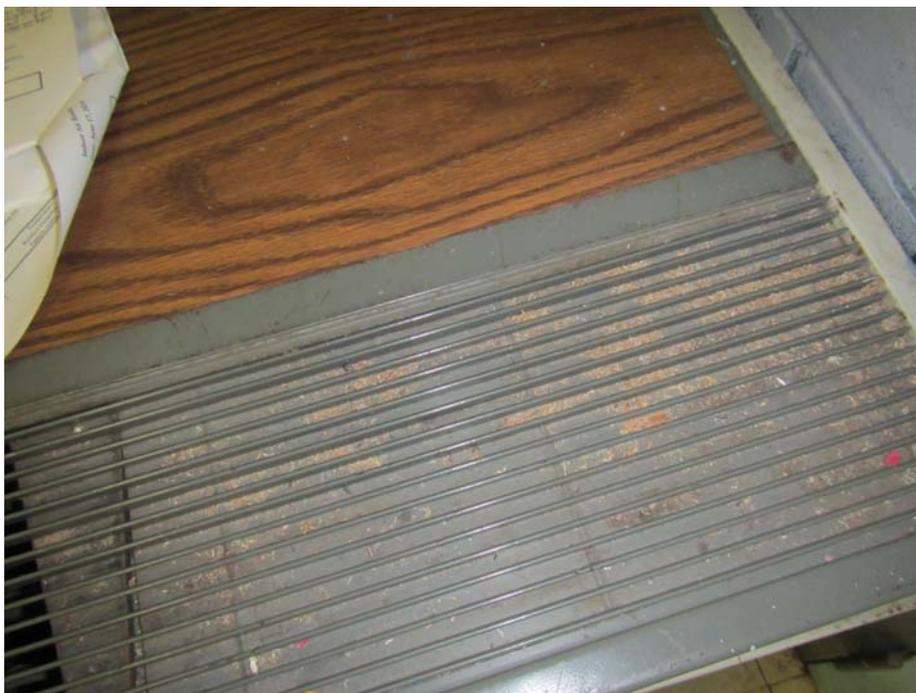
Picture 4

Pencil shavings and other debris in univent diffuser area

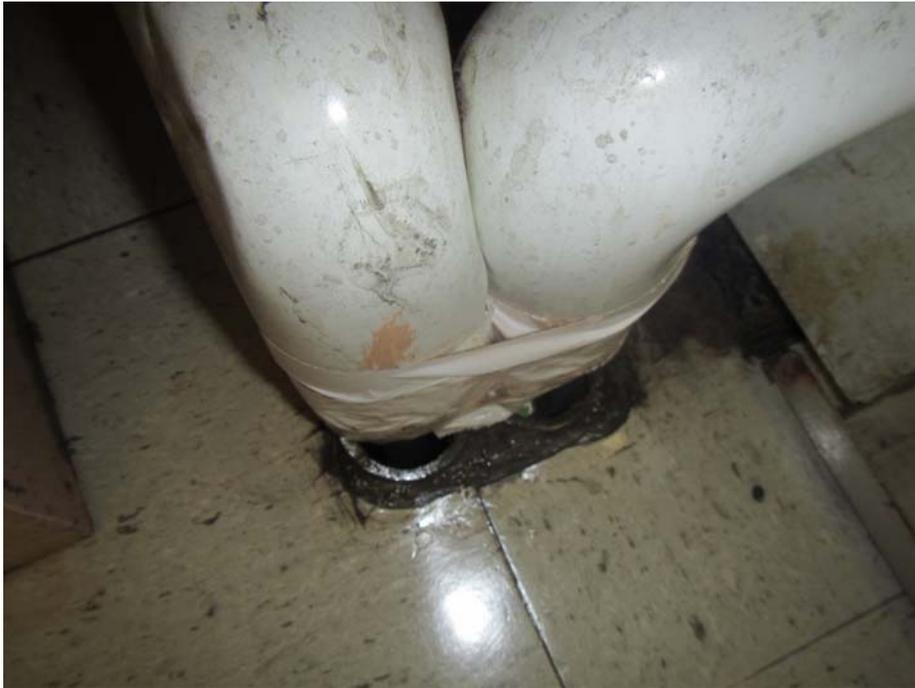
Picture 5

Holes where univent pipes enter the floor

- **Seal holes/breaches where pipes from univents and sinks penetrate into the crawlspace or wall cavity with appropriate fire-rated sealant to prevent movement of odors/particles from wall cavities and subfloor areas.**

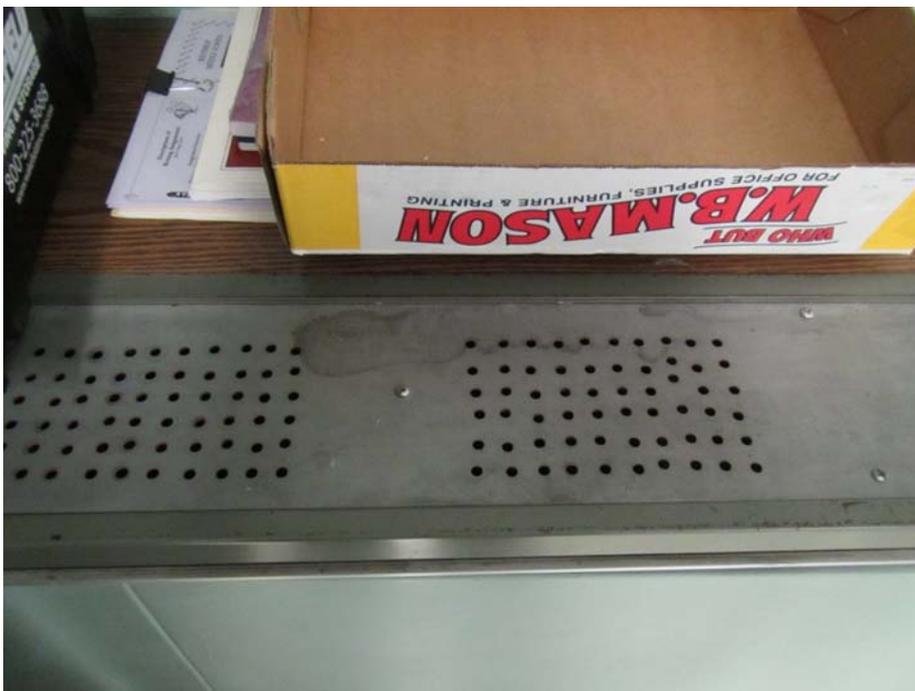
Picture 6

- A number of univents still had jerry-rigged hole punched sheet metal in place of the original vanes fresh air diffusers (Picture 6);
- Univents larger than the standard classroom size (e.g., Music room 08) or smaller than the standard classroom size (e.g., Room 05) continued to have metal cages with cut-to-fit filters;
- Some of the univent pipes still had insulation in poor condition (Picture 7).

Non-standard univent cover

- **Consult with an HVAC engineering firm regarding the feasibility of repair vs. replacement of ventilation system components given their age. In the interim, work with an HVAC engineering firm to adjust/repair univents and exhaust vents to improve air exchange in classrooms. This should include replacement of the makeshift air diffusers with standard ones.**

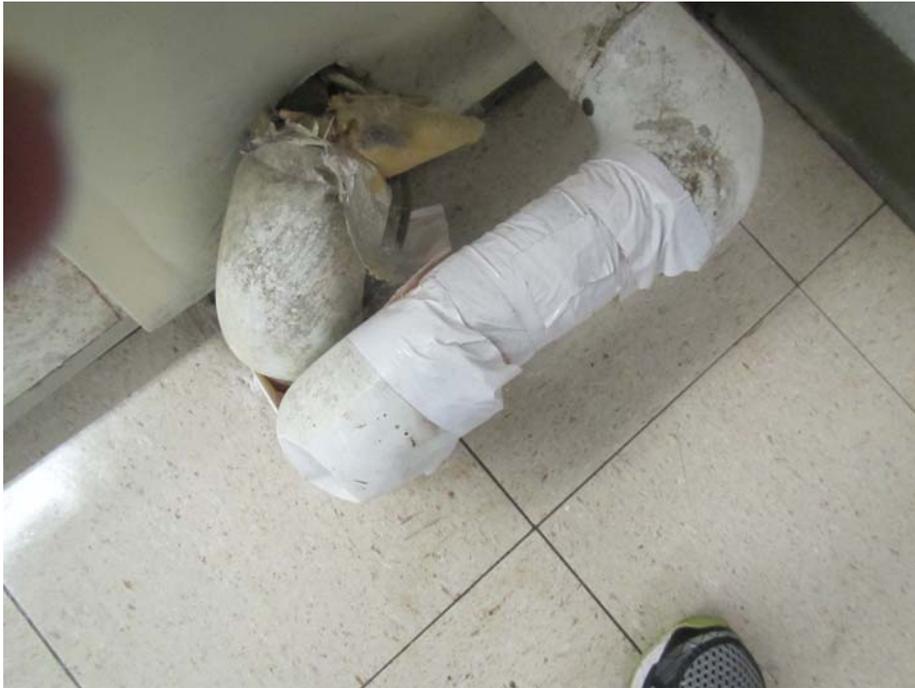
Picture 7

Messy pipe wrap and exposed fibrous materials

- **Encapsulate exposed fiberglass insulation around univent pipes in classrooms.**
- **Action:** Exposed fiberglass insulation was still observed in some areas.

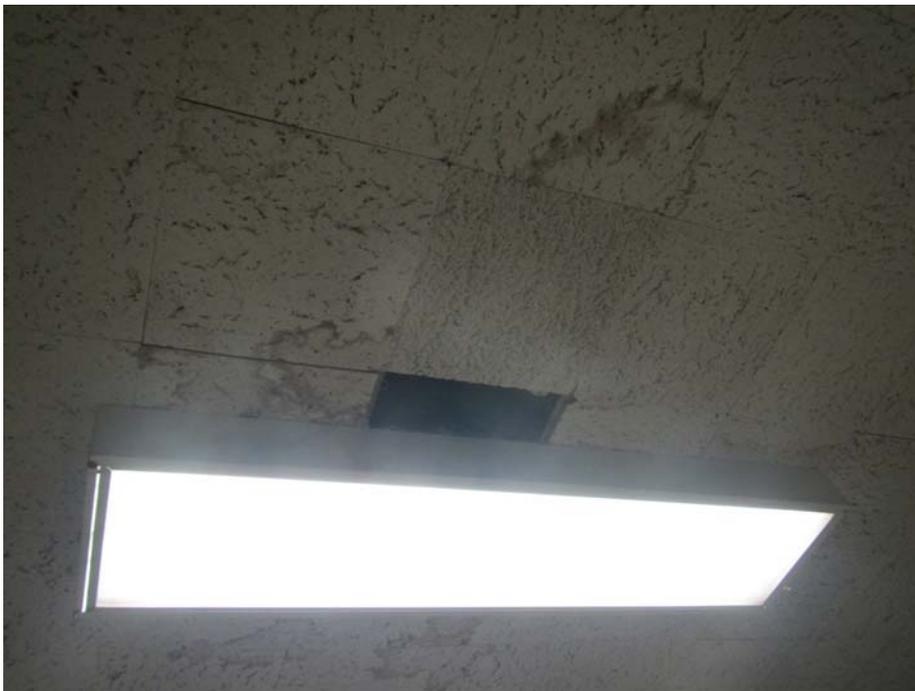
Picture 8

Some areas still had missing and/or water-damaged ceiling tiles (Picture 8). However, it was reported that ceiling tiles were missing in some areas due to a rewiring project being pursued

for life safety systems. Replacement of all remaining water-damaged/missing ceiling tiles would be completed before the beginning of the school year.

Water-damaged and missing ceiling tiles

- **Action:** It was not determined if this had been conducted.
- **Make repairs to the heating system piping to prevent leaks. Replace stained and missing ceiling tiles and ensure that the ceiling plenum is complete/intact to prevent migration of particulates from above the ceiling tile system into occupied areas.**

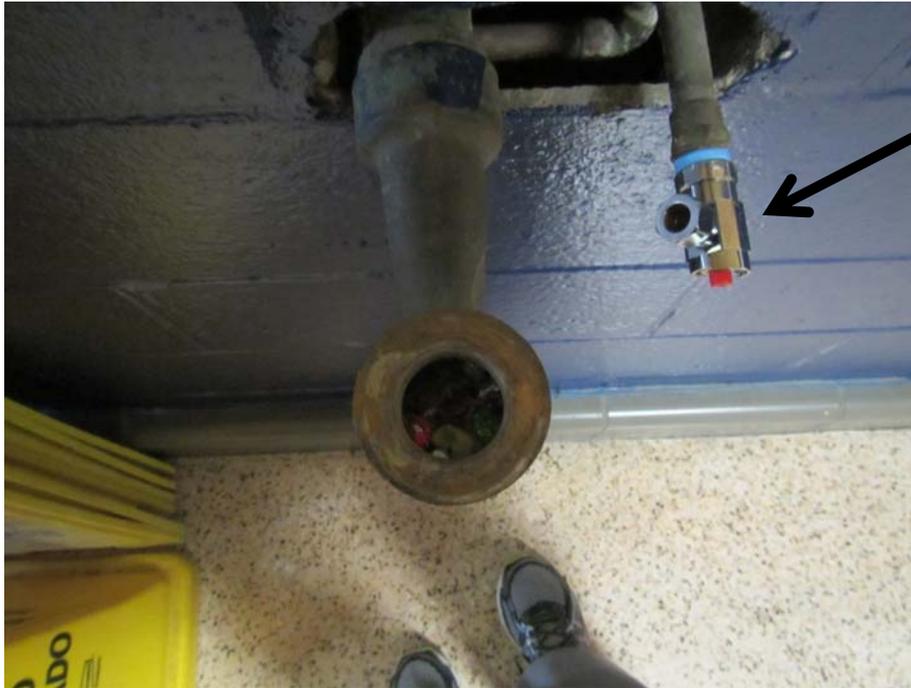
Picture 9

Water bubblers had been removed and the water service capped (Picture 9). The drains were still in place. Some drain pipes were sealed, others had water in their traps. The pipes with water in their traps will eventually dry out and potentially allow sewer gases into the building. The sealing of the drains should be confirmed for all removed fixtures, including any lab sinks if they were also decommissioned. In addition, there were holes in the walls where the fixtures had been hung (Picture 9 and 10), which can allow odors and particulate matter from the wall cavity to enter into occupied spaces. These holes should be sealed. The walls where the fixtures had been were also in need of cleaning (Picture 10).

Capped water service line (arrow) and drain, note debris in drain and hole in wall

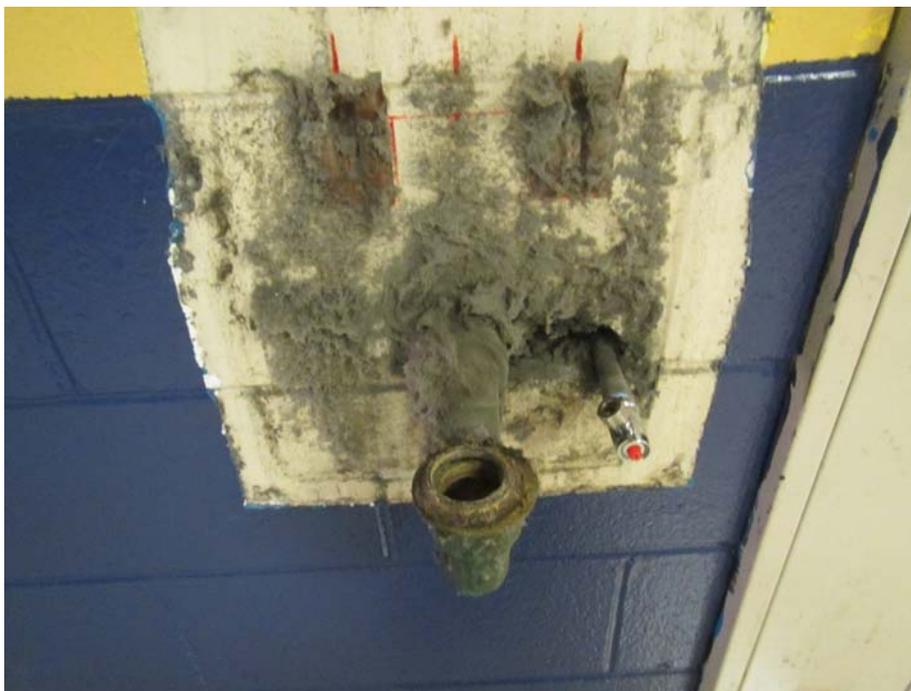
Picture 10

Holes remaining in wall where water fixture was removed, note dust
