INDOOR AIR QUALITY ASSESSMENT

**Department of Developmental Services
24 Southbridge Street
Worcester, Massachusetts**

Prepared by:
Massachusetts Department of Public Health
Bureau of Environmental Health
Indoor Air Quality Program
September 2015

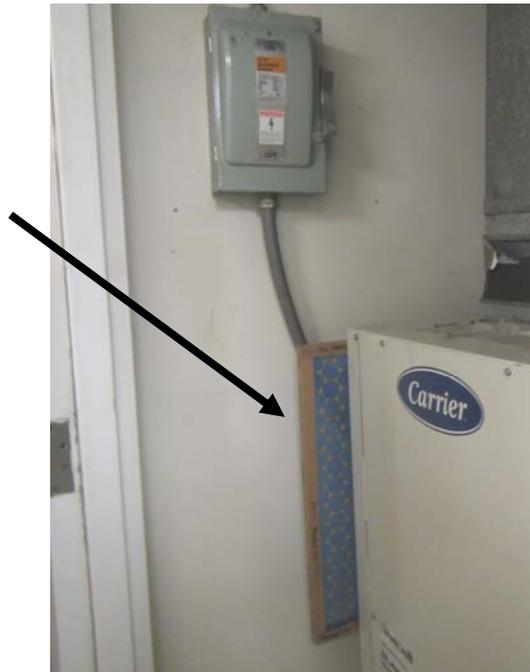
Picture 1

An air handling unit (AHU) was found on the second floor inside the kitchen (Picture 1). This unit appears to draw air from the kitchen (Picture 2). If this is the only AHU for the DDS offices, no supply of fresh outside air exists for this office. Ducts carry air from this AHU to offices on both the first and second floor (Pictures 3 and 4). Passive vents are present in many walls and doors which appear to be for exhaust/return (Picture 5), but apart from the vent to the AHU in the kitchen, there is no source of return air. Exhaust vents are present in the restrooms on the first floor, but these were not operating at the time of the visit. As a result, this building has no means of systematically introducing fresh air into the building or removing stale air and related pollutants. Any fresh air is introduced through openable windows, the front door and incidental air leakage.

Note that the filter in the AHU was not the correct size (Picture 1) and was of a type that provides minimal filtration. The dust spot efficiency is the ability of a filter to remove particulate matter of a certain diameter from air passing through the filter. Filters that have been determined by ASHRAE to meet its standard for a dust spot efficiency of a minimum of 40 percent would be sufficient to reduce many airborne particulates (Thornburg, 2000; MEHRC, 1997; ASHRAE, 1992). Pleated filters with a Minimum Efficiency Reporting Value (MERV) dust-spot efficiency of 9 or higher are recommended. Note that increasing filtration may require evaluation and adjustments to the AHU systems to deal with the increased resistance to flow of higher MERV value filters.

Air handling unit (AHU) in kitchen closet, note poorly fitted filter (arrow)

12. Replace the filter in the AHU with one of correct size. Consider upgrading to a MERV value of 9; change filters regularly.
13. Clean vents and personal fans to avoid reaerosolizing dusts.

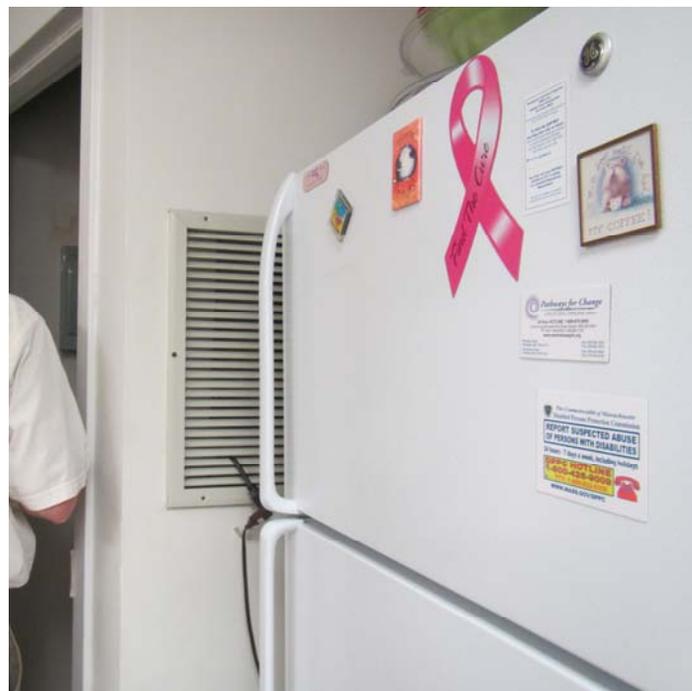
Picture 2

The location of the AHU in the kitchen may be a source of degraded indoor air in the DDS space. The air intake vent is located directly adjacent to the refrigerator, which puts out heat during operation. This will force the AHU to work harder to cool down the space during the

cooling season. In addition, any odors from the kitchen, including food, smoke or trash, would be distributed into the rest of the occupied space through the operation of the AHU.

Air intake for AHU next to refrigerator

5. Consider moving the air supply to the AHU to a location other than adjacent to the refrigerator/in the kitchen to avoid entrained odors and excess heat. Until that can be done, take special care with use and cleanliness of the kitchen to avoid creating odors that can be transported to the rest of the occupied spaces.

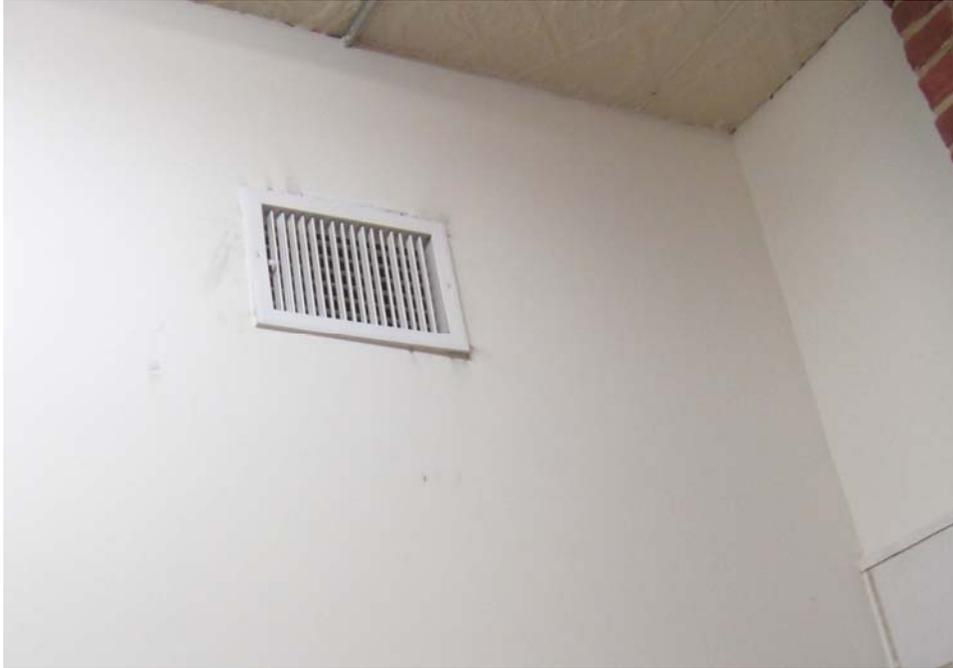
Picture 3

Supply vent in room, note dust

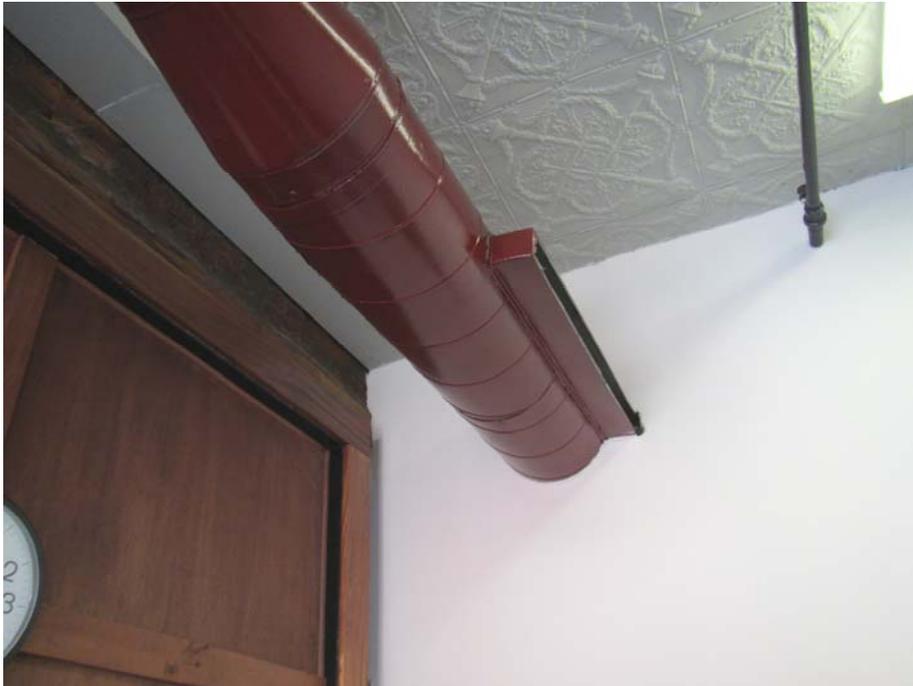
Picture 4

Supply vent off ductwork

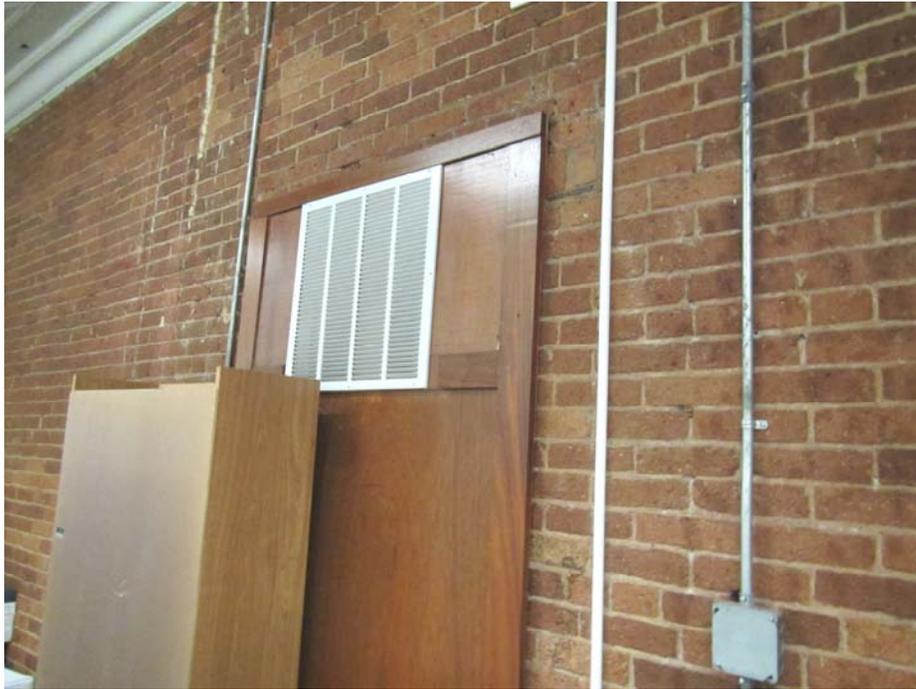
Picture 5

Passive vent in hallway

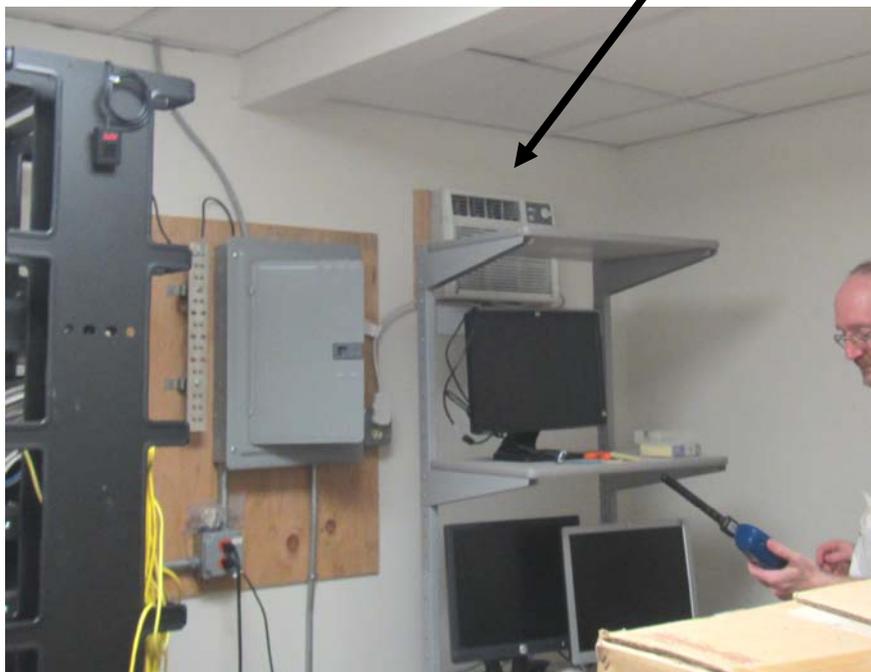
Picture 6

Note that the data room had a higher temperature than any other space. This room was equipped with a very small wall-mounted air conditioning unit (Picture 6). The wall in which it was inserted was not an exterior wall, and the air conditioner appeared to discharge waste heat into an empty space behind the wall which could not be accessed. This is not an effective means of providing cooling to this space. In addition, a wall-mounted air conditioner creates

condensate, which can moisten building materials if not drained properly away from the building.

Data room, note small wall-mounted air conditioner (arrow)

3. Replace the wall-mounted air conditioner in the data room with a correctly-sized portable or ductless unit with appropriate drainage of condensate. Inspect the space behind the wall-mounted air conditioner for water damage and make repairs as needed.

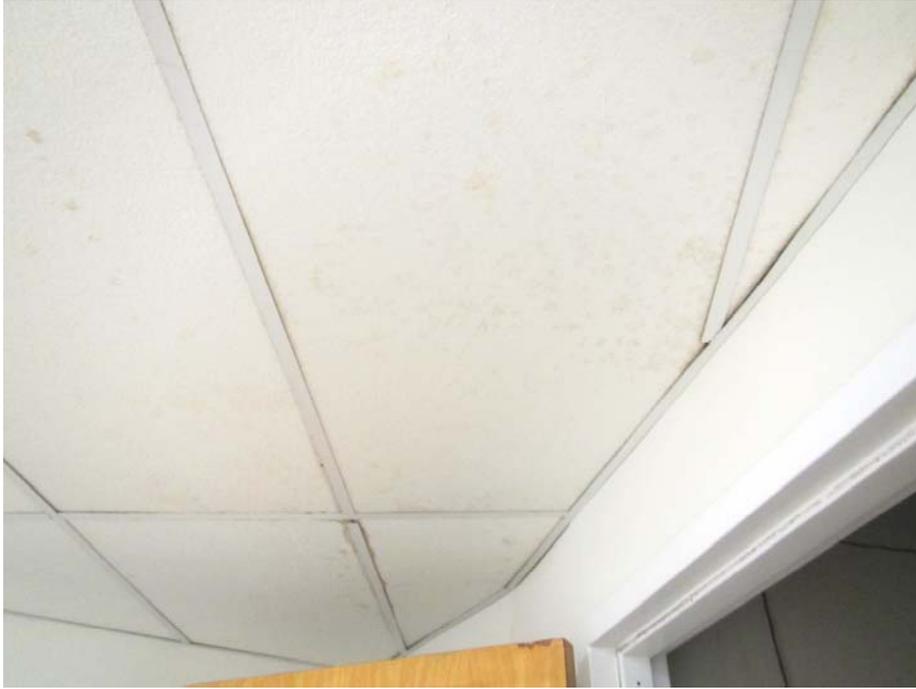
Picture 7

Leaks were also reported in occupied areas previously. Areas impacted had reportedly been dried with fans. Carpeting and coving was examined in the large conference room which had reportedly been subject to leaks, and this material appeared dry and free from microbial growth. Ceiling tiles in the large conference room that had been impacted had reportedly been replaced. Water-damaged ceiling tiles were observed in the kitchen (Picture 7) next to the closet with the AHU. These stained tiles may be from roof or plumbing leaks and should be replaced once the source of water is discovered and repaired.

Water-damaged ceiling tiles in the kitchen above the door to the AHU closet

8. Replace the water-damaged ceiling tiles in the kitchen once the source of water has been discovered and repaired.
9. Consider placing water dispensers on non-carpeted areas or place a waterproof mat underneath them.

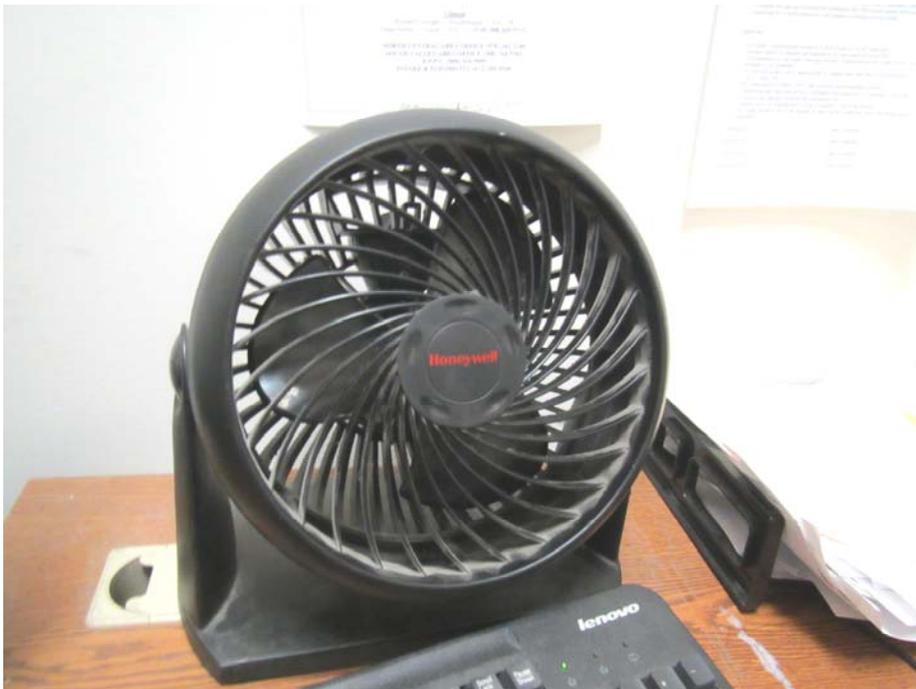
Picture 8

Other conditions that can affect IAQ were observed during the assessment. Personal fans, air purifiers and heaters were observed in some offices. Some of these appliances were dusty (Picture 8). Dust on these items can be reaerosolized and cause irritation or odors. In addition, air purifiers may have filters or other components that need to be cleaned and maintained so that they do not become a source of air pollution.

Dusty personal fan

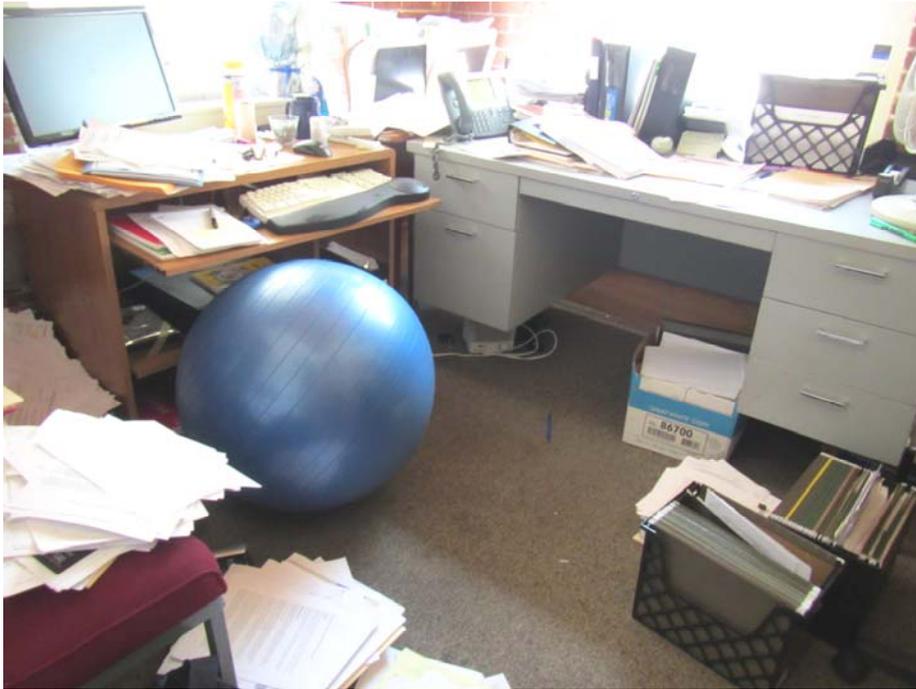
Picture 9

In some areas, accumulation of items, including papers, boxes and personal items were stored on floors desks, tables and counters (Pictures 9 and 10). Large numbers of items provide a source for dusts to accumulate. These items make it difficult for custodial staff to clean. Items should be relocated and/or cleaned periodically to avoid excessive dust build up.

Items in an office

14. Store items in an organized manner and move them to clean periodically to prevent a buildup of dust.
15. Store new and spent fluorescent bulbs in sturdy closed containers to prevent breakage and dispose of in accordance with relevant environmental regulations.

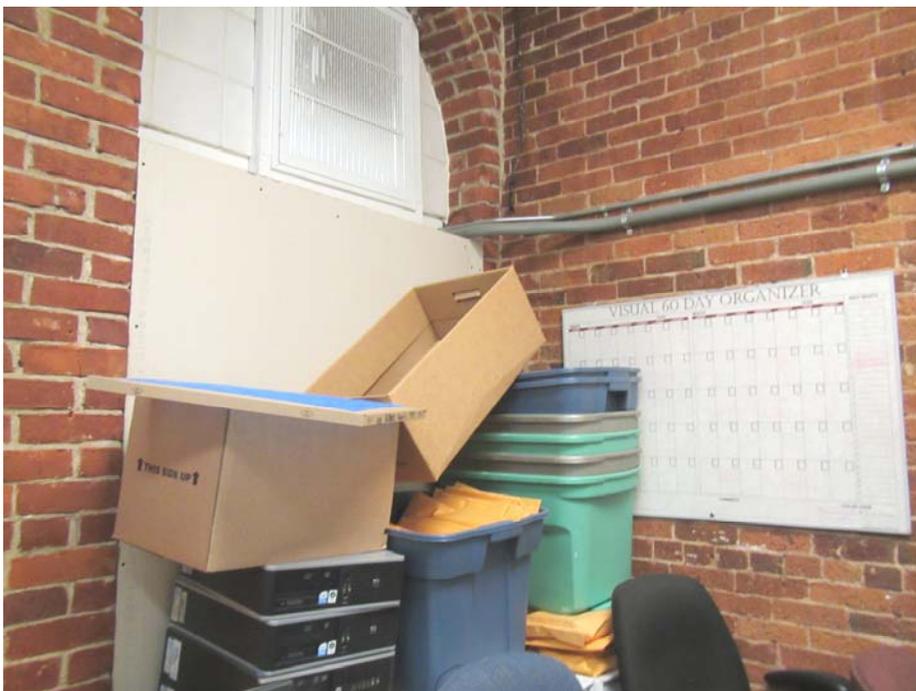
Picture 10

Items in a storeroom

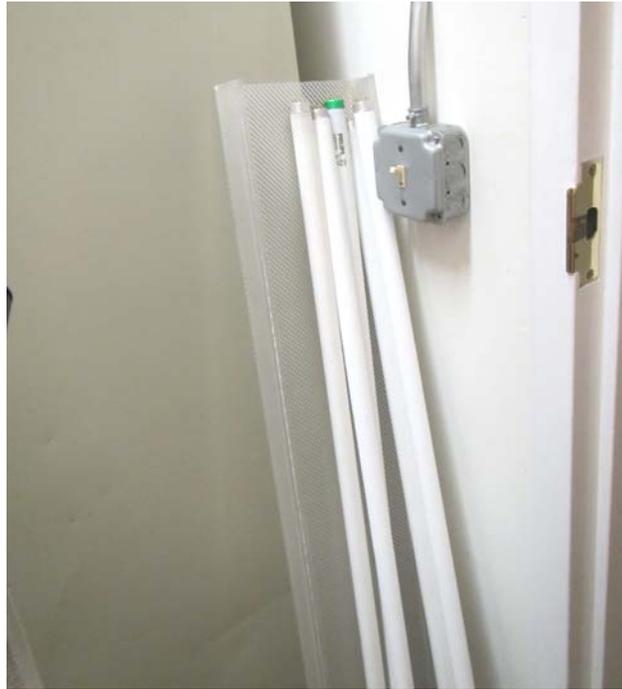
Picture 11

Fluorescent bulbs were observed stored loosely (Picture 11). New and spent bulbs can release mercury and create shards of glass if broken.

Poorly stored fluorescent bulbs
