INDOOR AIR QUALITY ASSESSMENT

**Pleasant Street School
1060 Pleasant Street
Athol, Massachusetts**

Prepared by:
Massachusetts Department of Public Health
Bureau of Environmental Health
Indoor Air Quality Program
March 2016

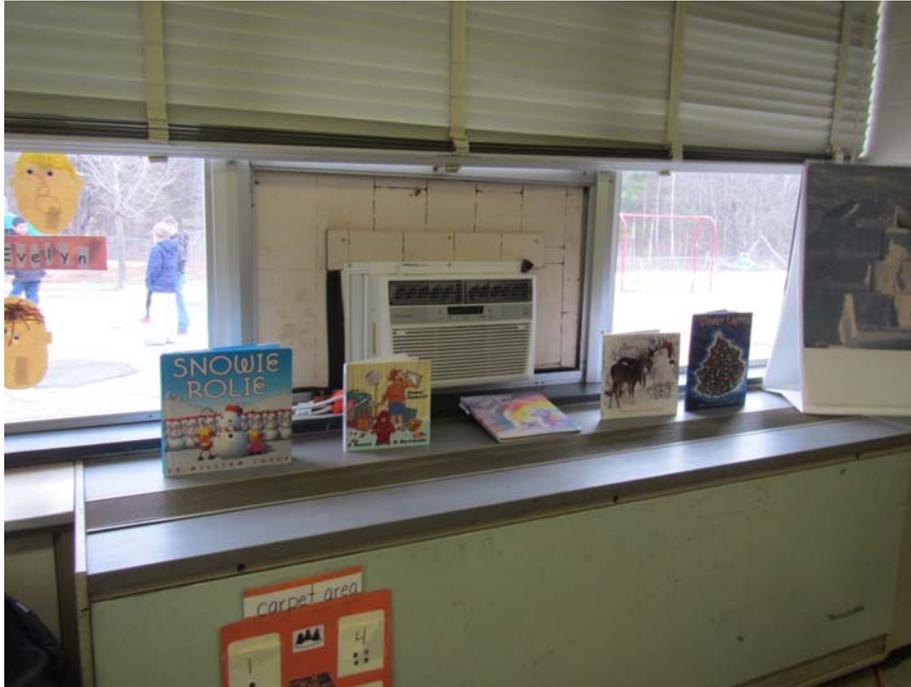
Picture 1

The HVAC system consists of unit ventilators (univents) located in classrooms along the outside wall of the building (Picture 1). Although most of these were functioning at the time of the visit, many were obstructed by items on top or in front of the units, which can restrict airflow (Picture 2). The outside of most of the fresh air vents was also obstructed with a plastic material (Picture 3) that was likely placed on them to save energy at some point in the past. Another univent fresh air intake has louvers arranged in such a way that debris can accumulate in them (Picture 4) restricting airflow and potentially contributing particulates and odors to the classrooms.

- Window and wall-mounted air conditioners were found in many classrooms (Picture 1; Table 1). These appliances were not always sealed well against the window or wall, which can allow moisture into the building. In one location, fabric material was observed around an air conditioner, presumably to block drafts or leaks. Porous materials used in this manner can become mold-colonized.

Unit ventilator (univent) and window air conditioner

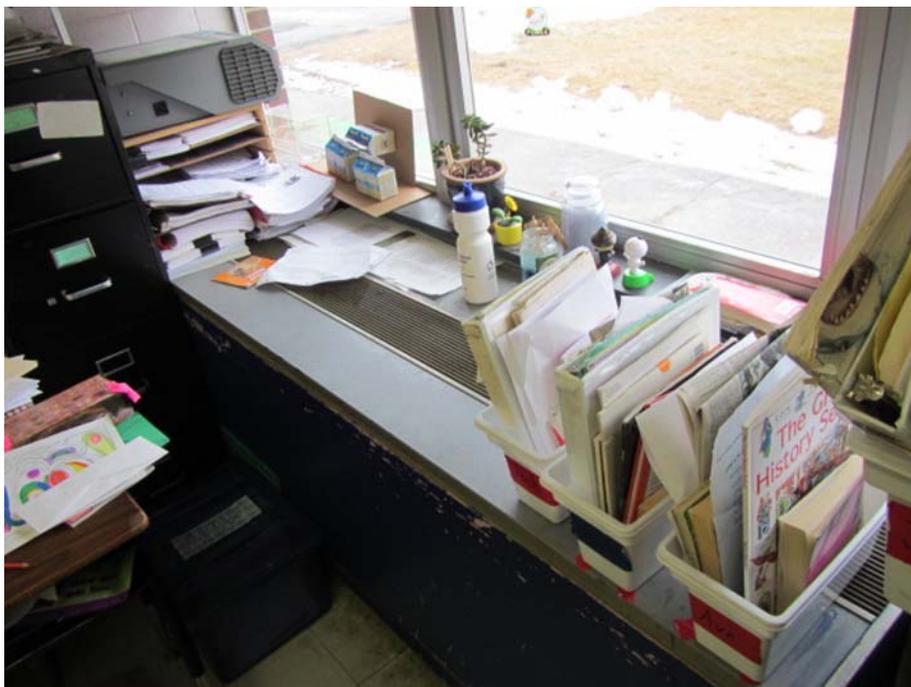
Picture 2

Univent with items on top

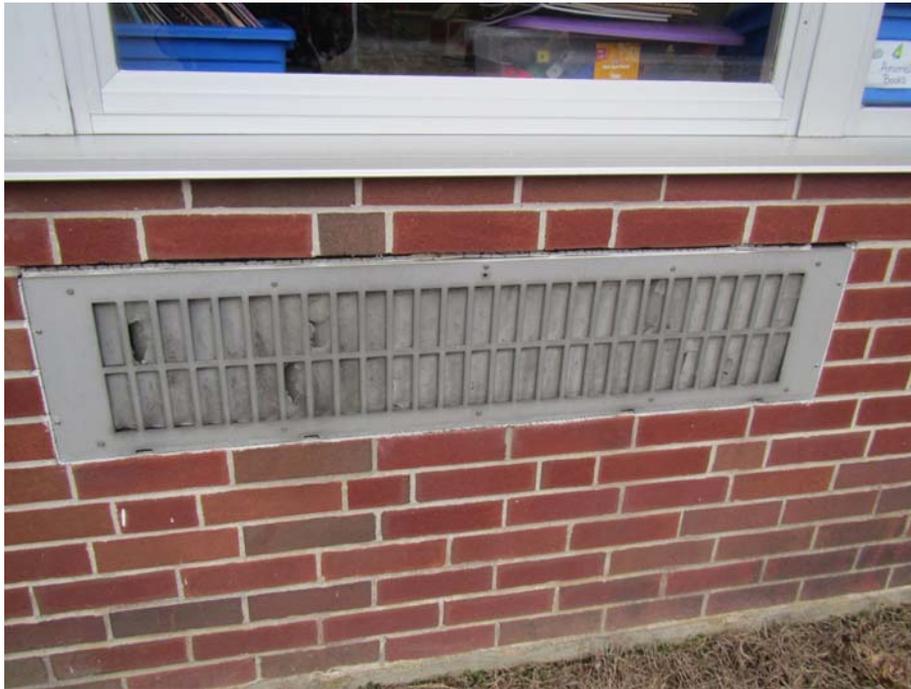
Fresh air intake on outside of building with plastic covering

1. Operate all ventilation systems in the building during occupied periods. Supplement fresh air with openable windows when possible. Be sure to close windows tightly at the end of the day.
2. Remove the plastic over the fresh air vents as shown in Picture 3 to allow adequate fresh air exchange.
3. Change the filters in the univents and clean the interior of each unit with a vacuum cleaner.
4. Investigate the functioning of the exhaust vents for the building and repair if possible.
5. Remove all blockages from univents and, most importantly, exhaust vents to allow for proper functioning.
6. Undercut the door to the Learning Center (Picture 7) by approximately two inches to allow for airflow from the hallway.

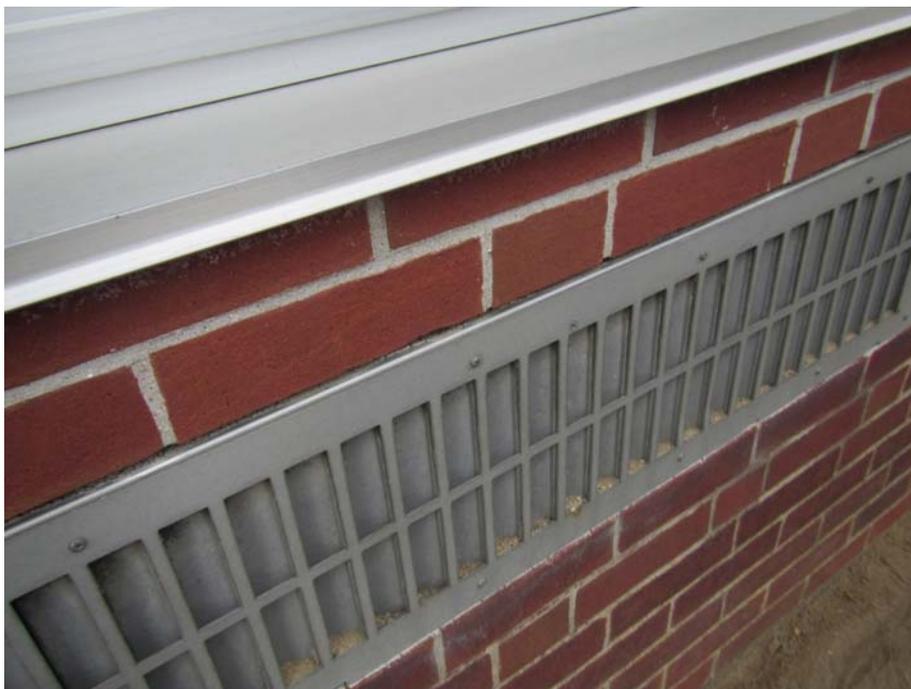
Picture 4

Debris in univent intake louvers

3. Repair or replace all exhaust motors if the existing system is to be used.
4. If the univents are replaced with similar units, consider having fresh air vent grills with the slats facing horizontally to better shed water and debris installed in place of the current ones.

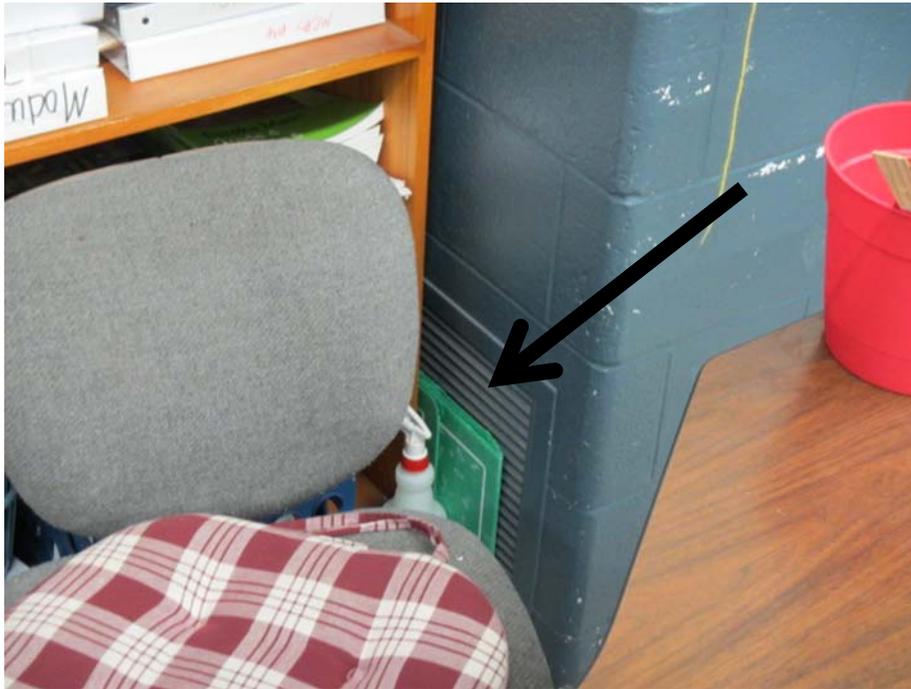
Picture 5

Exhaust of stale air from classrooms is provided by vents typically located near the door which are tied to vents on the roof. In most classrooms these vents were obstructed by furniture and items (Picture 5). A few that were accessible were not functioning. Lack of exhaust ventilation can allow pollutants and odors to build up in occupied spaces. Exhaust vents were also located in toilet rooms both inside classrooms and off of hallways. Those examined also had a lack of draw from the exhaust vents.

Exhaust vent (arrow) obstructed by furniture and other items

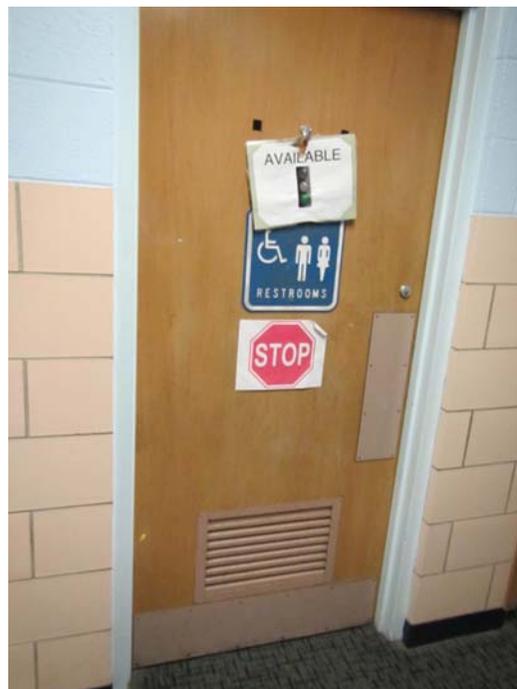
Picture 6

The Learning Center is a former stockroom/closet that has been turned into an occupied area. This room has an exhaust vent that may not have been drawing air and no source of supply air. It is possible that the original door on this room, when it functioned for storage, had a vent in it such that air could be drawn in from the hallway and then exhausted via the vent, providing

Restroom door with vent, similar to the door that used to be on the Learning Center

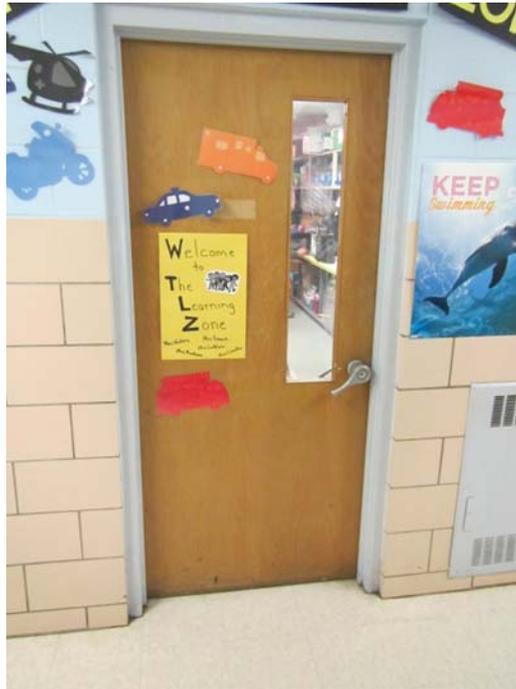
Picture 7

airflow (Picture 6). However, a solid door is now in place and to avoid noise, this door is typically kept closed (Picture 7). This door should be undercut by approximately two inches to allow for airflow into the room with the door closed.

Current Learning Center door with no vent

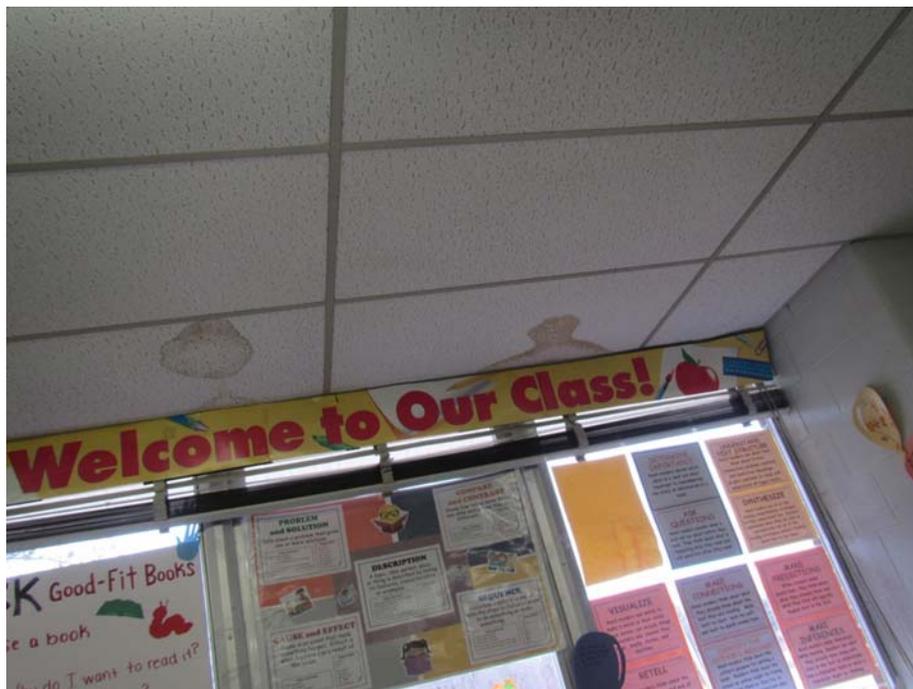
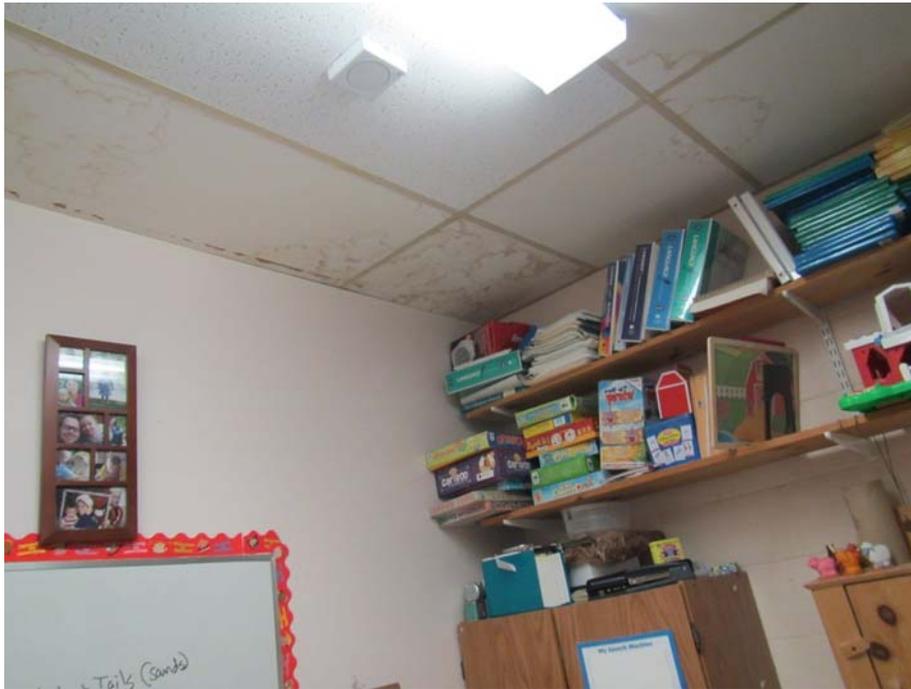
- Water-damaged ceiling tiles were observed in classrooms, particularly but not solely above window areas where roof dams had been reported in this and previous winters (Pictures 8 and 9; Table 1). Although none of the tiles appeared to be mold-colonized, the number of stained tiles indicate that the roof, flashing, and drainage systems are not functioning well.

Water-damaged ceiling tiles

8. Investigate the areas of roof/window leaks leading to stained ceiling tiles and repair. Replace stained tiles. Check above ceiling for microbial growth and clean with an antimicrobial solution as needed.

1. Repair the roof to reduce/eliminate leaks. Investigate/repair drainage and insulation to reduce the potential for ice dams. Replace all ceiling tiles once this work is completed.

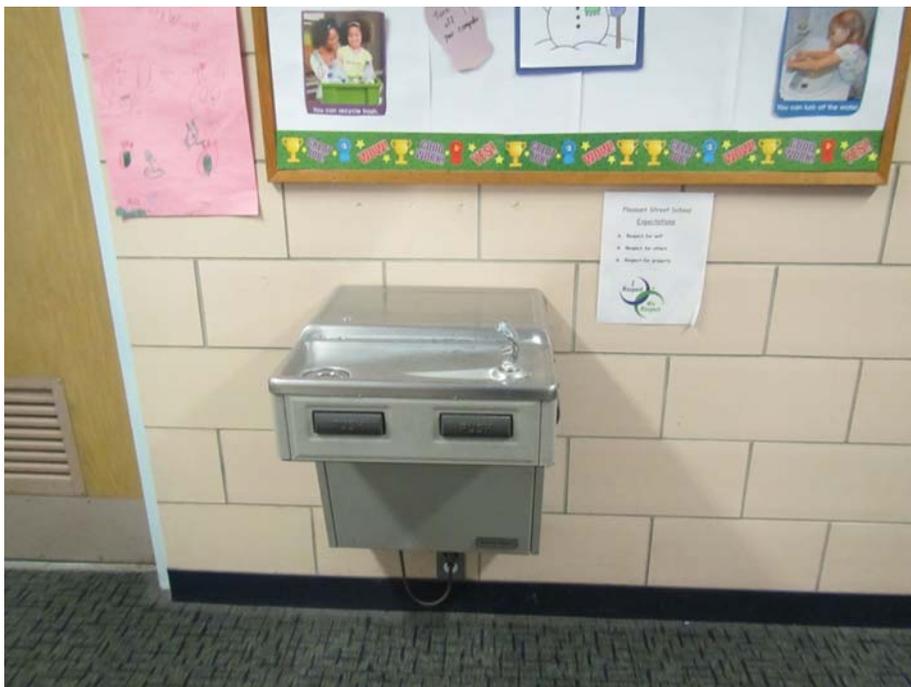
Picture 10

- Water dispensers were observed in carpeted areas (Picture 10). Spills/leaks from this equipment can moisten carpeting and lead to odors/mold colonization.

Water cooler over carpet

11. Consider placing a waterproof mat under water dispensing equipment or removing carpeting in these areas.
12. Ensure that all refrigerators are cleaned regularly to avoid odors and microbial growth.

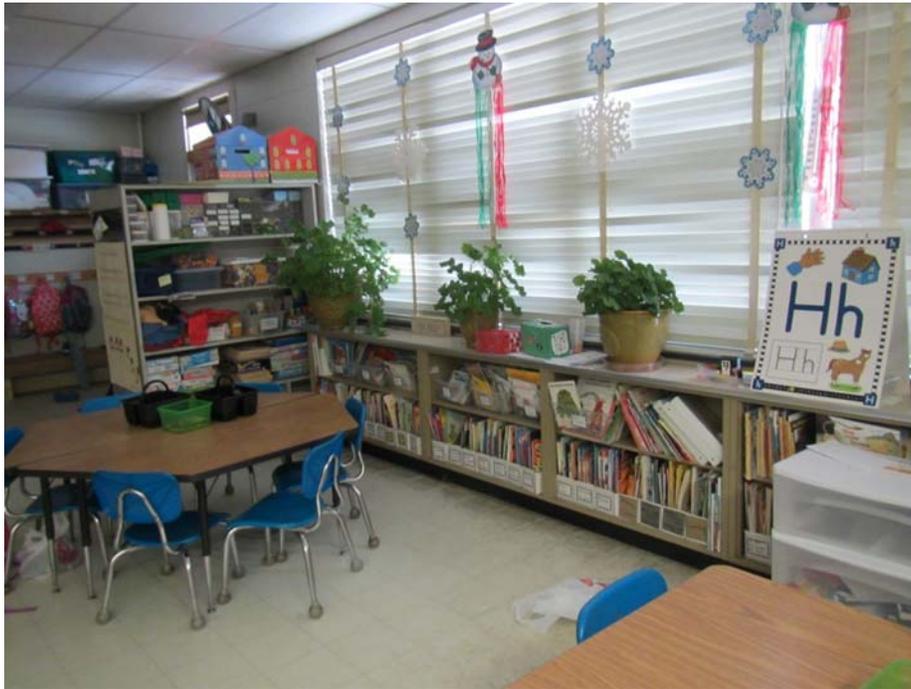
Picture 11

- A number of refrigerators of various sizes are located in the school. Improperly maintained refrigerators can be a source of mold, odors and spills.
- Plants were observed in classrooms (Picture 11). If not maintained properly or overwatered, plants can be a source of pollen, mold and odors.

Plants in a classroom

13. Properly maintain plants or remove them.
14. Properly maintain aquariums.
15. Reduce the use of products containing volatile organic compounds including hand sanitizer, dry erase materials and cleaners. Ensure that only school-issued products are used to avoid product interactions.

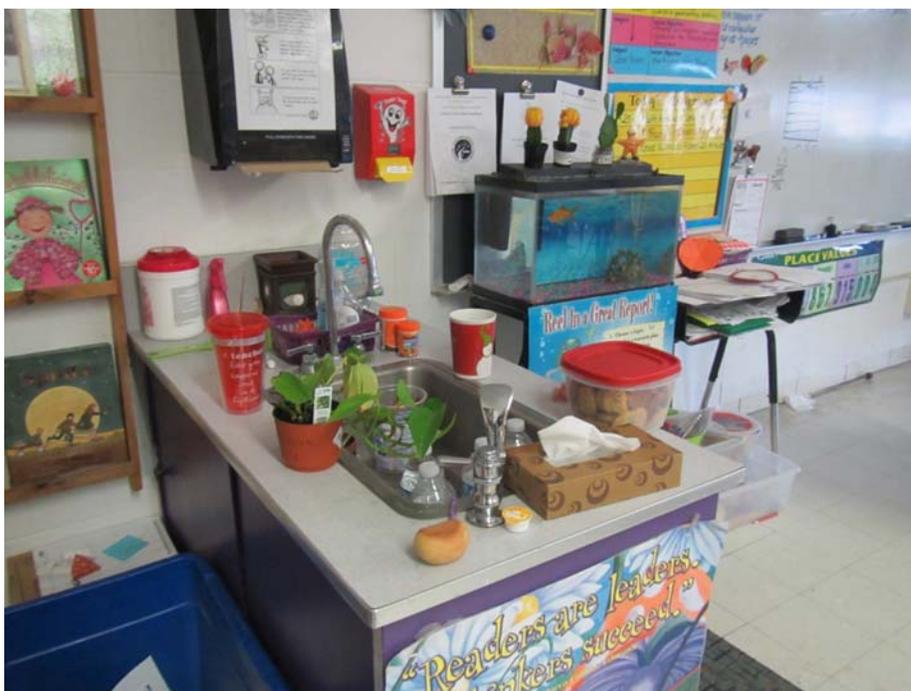
Picture 12

- Aquariums were observed in a few classrooms (Picture 12). These can be a source of water spills and odors if not maintained properly.

Aquarium in a classroom

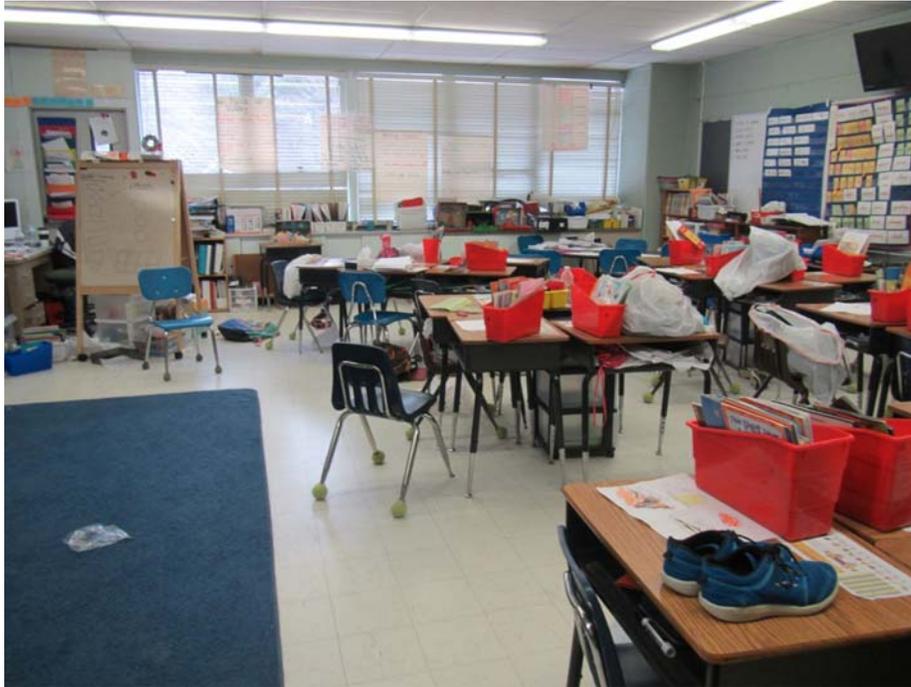
Picture 13

Other conditions that can affect IAQ were observed during the assessment. In a few classrooms, tennis balls were found sliced open and placed around chair legs to reduce noise (Picture 13). Tennis balls are made of a number of materials that are a source of respiratory irritants. Constant wearing of tennis balls can produce fibers and off-gas VOCs. Tennis balls are made with a natural rubber latex bladder, which becomes abraded when used as a chair leg pad. Use of tennis balls in this manner may introduce latex dust into the school environment. Some individuals are highly allergic to latex (e.g. spina bifida patients) (SBAA, 2001). It is recommended that the use of materials containing latex be limited to reduce the potential for symptoms in sensitive individuals (NIOSH, 1997). Latex-free glides should be used for this purpose. Some areas of the school already had glides.

Tennis balls used as glides, also note items on desks and other flat surfaces

16. Replace tennis balls with latex-free glides.
17. Ensure that food is properly stored and clean all food preparation equipment (microwaves, toasters, coffee makers, etc.) to prevent odors and pests. Consider reducing the number of location where food is stored and prepared.

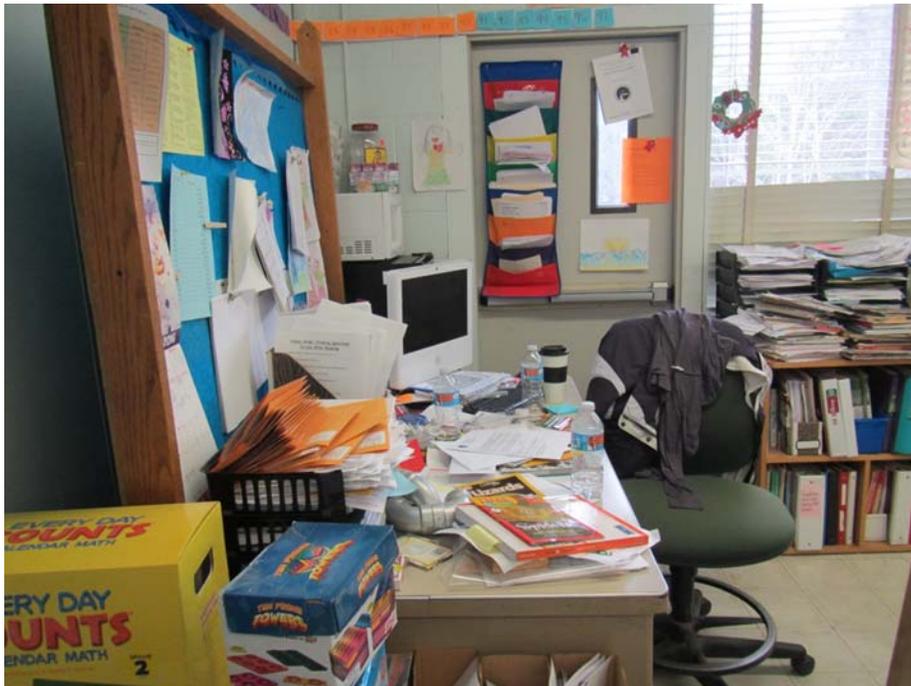
Picture 14

Floors and other flat surfaces in many classrooms had dirt and debris on them. Aerosolization of this material can lead to irritation. Note that many flat surfaces had accumulations of items, such as books, papers, art supplies and other materials (Pictures 13 and 14). This can make cleaning more difficult.

Accumulated items in a classroom

19. Clean flat surfaces regularly; consider removing or better organizing materials to make areas easier to clean, including in the Learning Center.

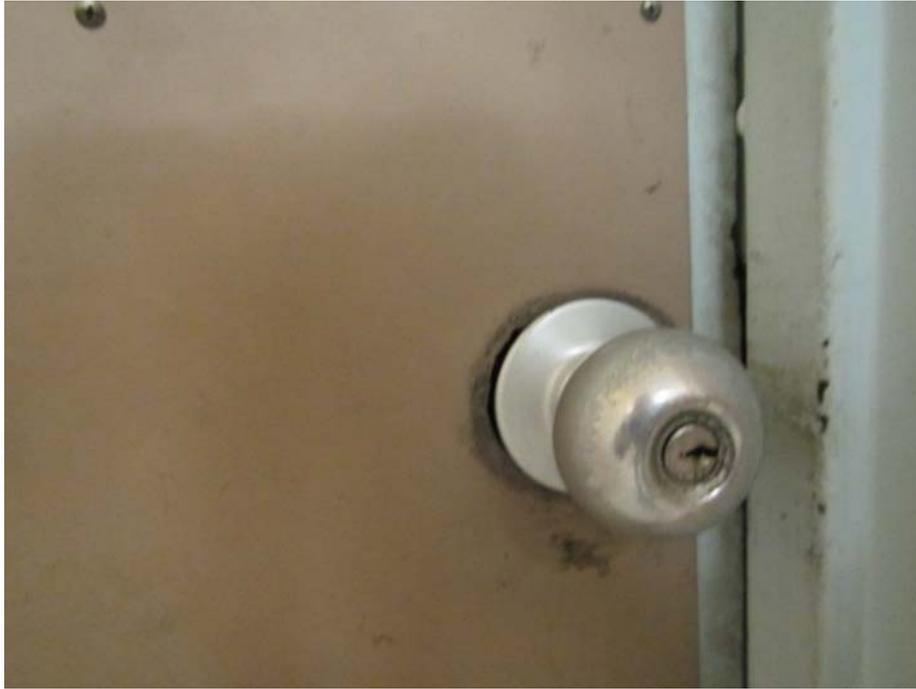
Picture 15

The door to the mechanical room, which contains the boilers as well as maintenance equipment and supplies, is located near occupied areas. This door had a hole next to the door knob (Picture 15) that could allow pollutants from the mechanical room to penetrate into other areas. This hole should be sealed.

Hole around doorknob for mechanical room
