INDOOR AIR QUALITY ASSESSMENT

**Department of Transitional Assistance
1010 Massachusetts Avenue
Boston, MA 02118**

Prepared by:
Massachusetts Department of Public Health
Bureau of Environmental Health
Indoor Air Quality Program
February 2016

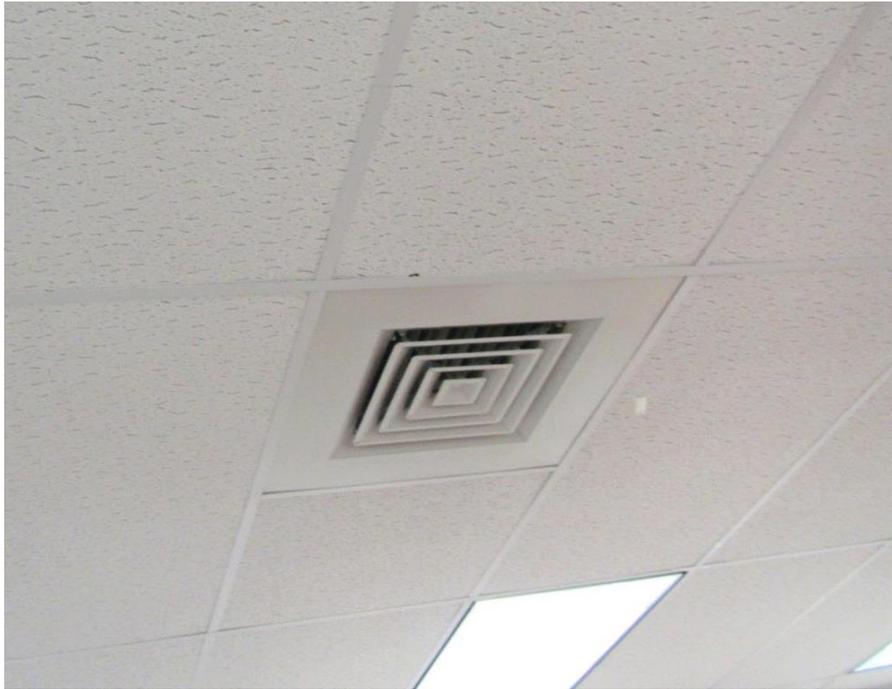
Picture 1

Fresh air is provided by rooftop air-handling units (AHUs) and ducted to air diffusers in DTA cubicle areas and offices (Picture 1). Air is returned to the AHUs via vents into the ceiling plenum (Picture 2). DTA staff reported thermal comfort concerns, particularly in areas adjacent to windows. AHUs are regulated by thermostats, which staff reportedly adjust to improve comfort. At the time of assessment, the temperature settings for some thermostats were beyond the MDPH recommended comfort range. Additionally, some thermostats were not set to the correct time, day, occupant, or recommended fan settings. The BEH/IAQ program recommends that thermostats be set to the fan “on” setting rather than “automatic” setting during occupied periods to provide continual air circulation.

Ceiling-mounted supply vent

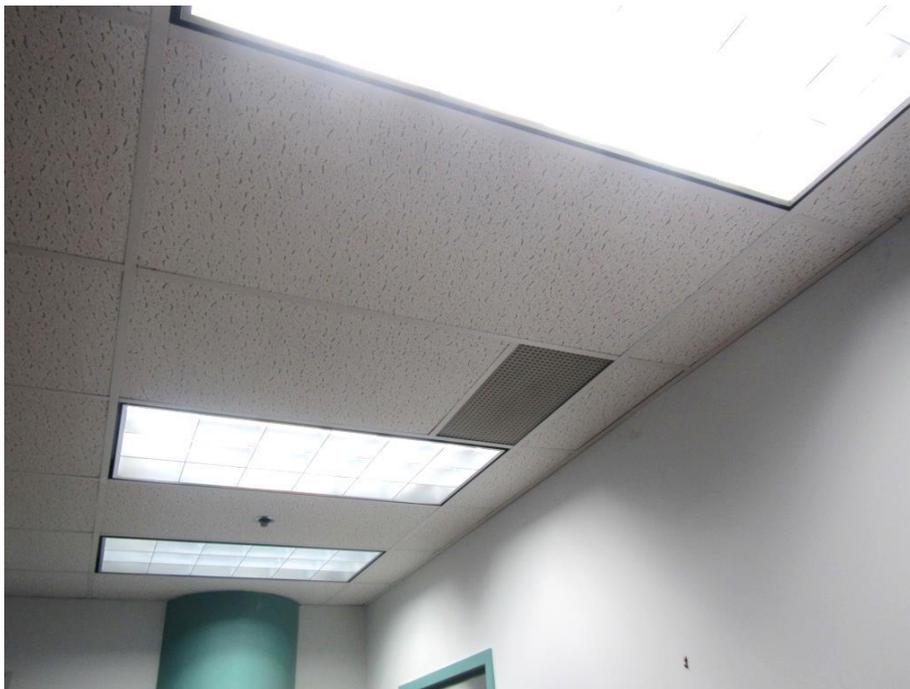
Picture 2

Ceiling-mounted return vent

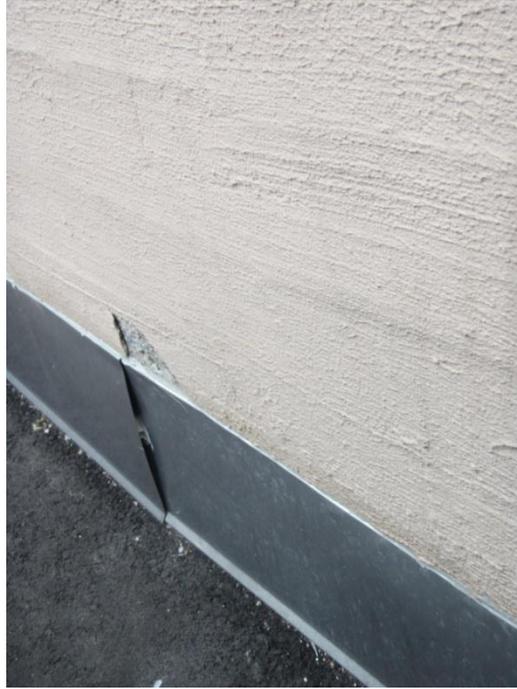
Picture 3

A previous assessment was conducted by BEH/IAQ staff in 2012. At that time, staff observed water-damaged materials (e.g. wallboard and carpeting) resulting from water penetrating the building through the breaches/damage to the exterior insulation and finishing system (EIFS) wall system. During this most recent visit, BEH/IAQ staff observed flashing installed along the base of the northeast exterior wall to prevent water from entering the building. Flashing in some areas was damaged or no longer adhered to exterior wall (Pictures 3 and 4). It should be also noted that damaged EIFS was observed on exterior walls lacking flashing (Picture 5); damage to exterior walls create opportunities for pests and water to enter the building.

Damage to EIFS wall and flashing installed around building exterior

3. Assess flashing installed into the building's EIFS wall system. Repair/replace damaged flashing to prevent water infiltration.
4. Cove base should be installed to seal breaches between the floor and wallboard as shown in Picture 6, which can serve as pathways for rodents and other pests.

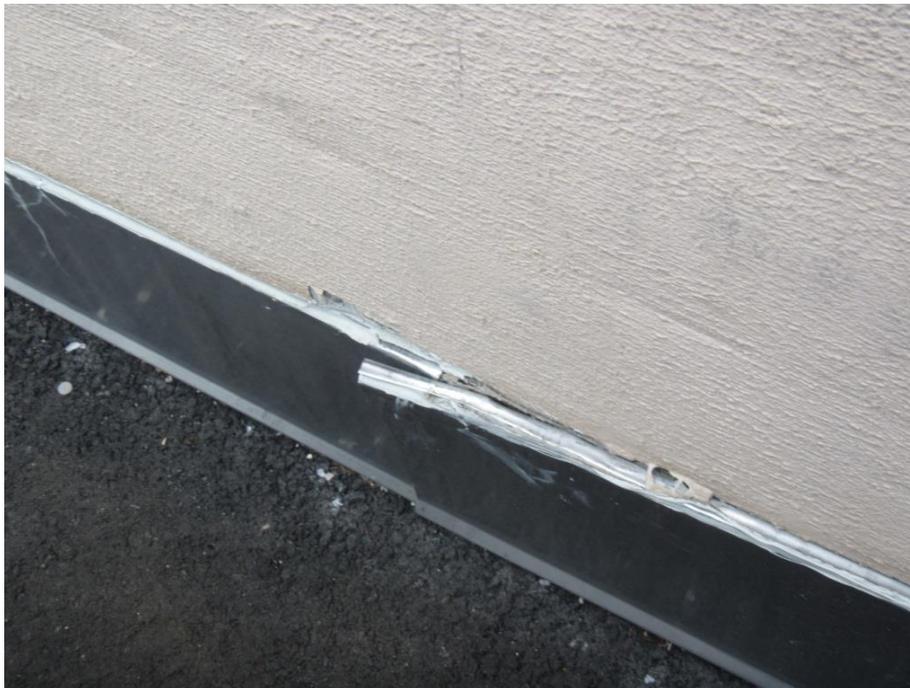
Picture 4

Damage to flashing installed into EIFS building exterior

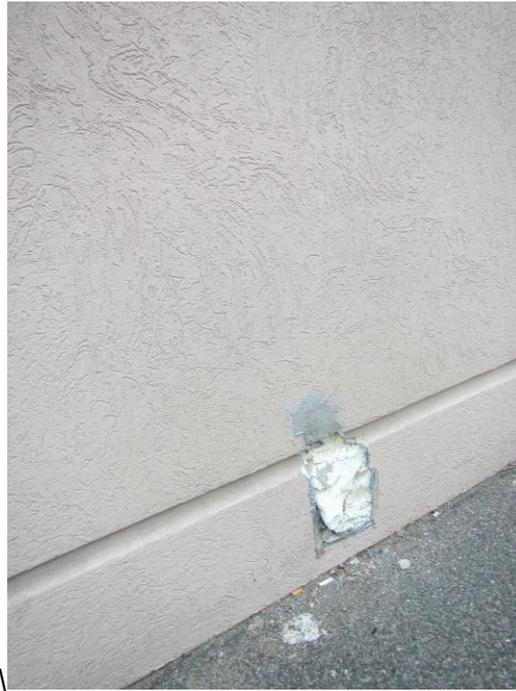
Picture 5

Damaged EIFS exterior surface

1. Replace carpeting with carpet tiles throughout the building to prevent aerosolization of carpet fibers, which occurs when there is high traffic on aged carpet. Fraying or damaged carpet can be an irritant source.
2. Consider installing flashing in EIFS wall exteriors where it is not currently present.

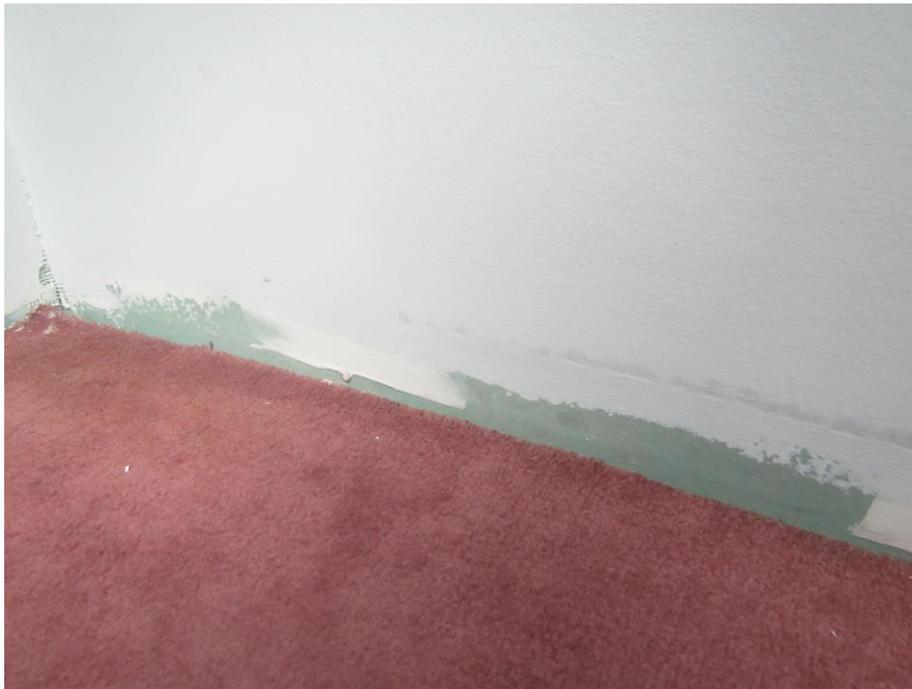
Picture 6

Wallboard and carpeting that were damaged at the time of the previous assessment had been replaced in some office areas; however, vinyl coving typically located at the base of wallboards was missing (Picture 6). Base coving creates a finishing that protects walls and reduces pathways for rodents and pests.

Wall with missing base coving

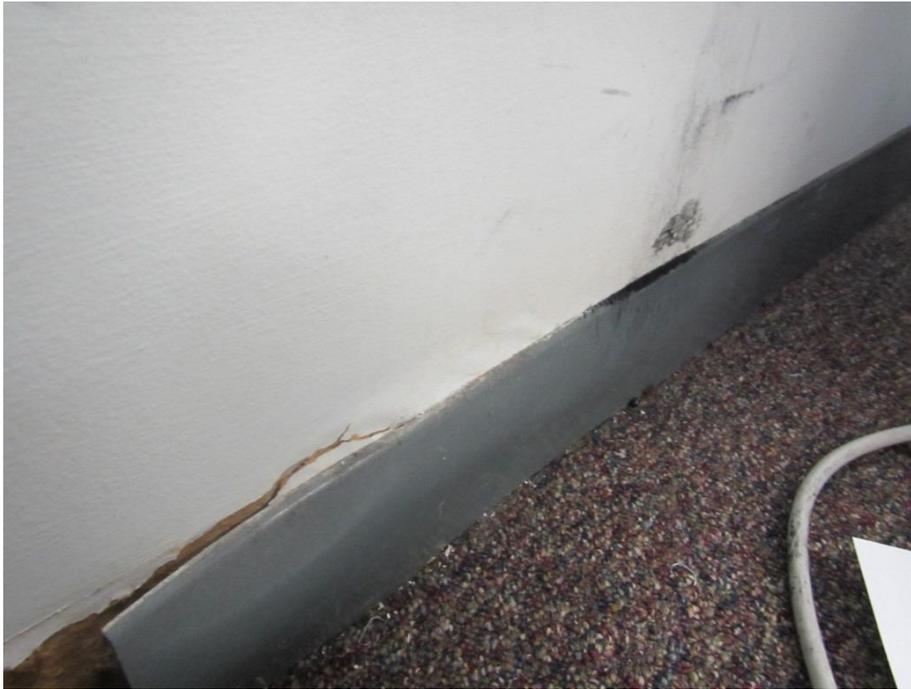
Picture 7

While water-damaged materials in some areas were replaced, evidence of historic damage was observed in other areas. For example, water-damaged wallboard and carpeting was observed in the SNAP reception office. Wall coving was observed peeling away from the wallboard due to repeated water damage, and potential mold growth was also observed (Pictures 7 and 8). Carpet tiles in this area appear to be installed on top of previously existing carpet, which had signs of water damage.

Peeling/damaged coving indicative of water damage

5. Repair/replace water-damaged carpet and wallboard in the SNAP reception office.
6. Replace ceiling tiles after a water leak is discovered and repaired.

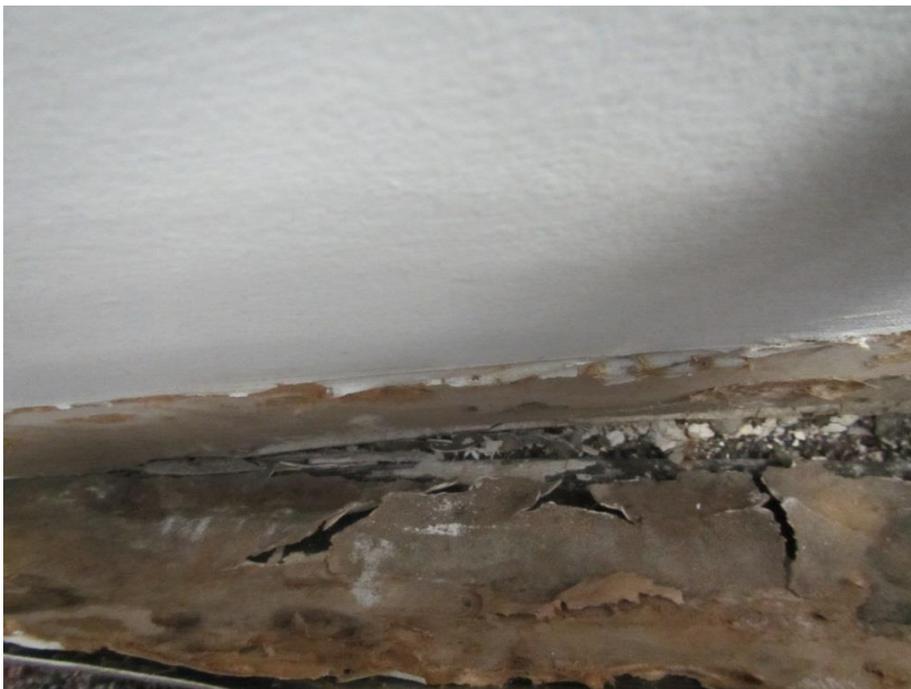
Picture 8

Black staining from mold growth

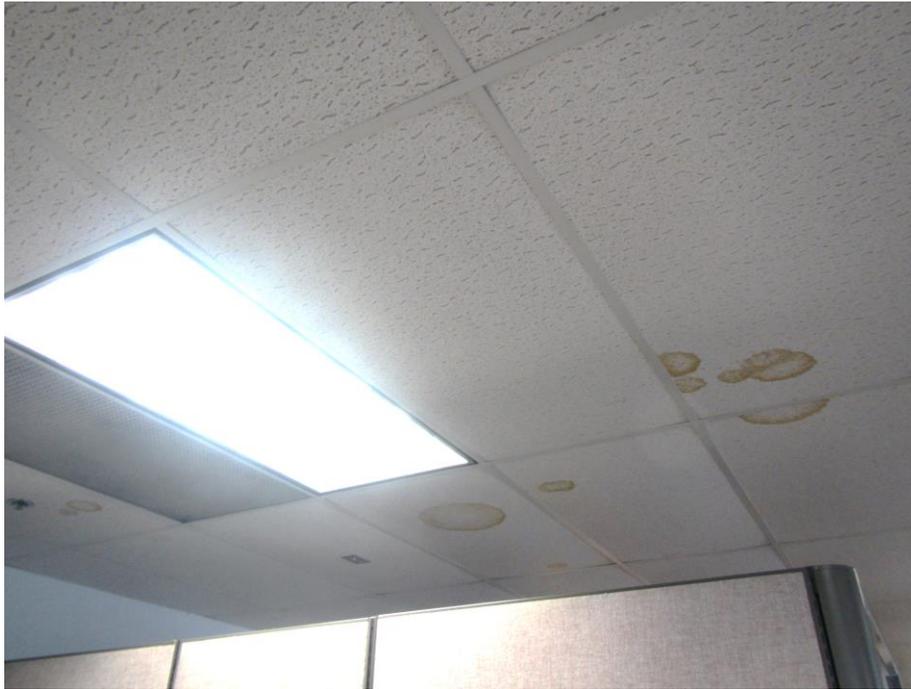
Picture 9

- Water-damaged ceiling tiles in a number of areas (Picture 9), reportedly damaged by a rainstorm that occurred the week prior to the BEH/IAQ site visit. The source of water was reportedly blockage to a downspout, resulting in a roof leak. In observing the conditions of the roof, it appears that the roof is not continuously flat (Picture 10). As a result, a portion of the roof serves as a basin allowing water and debris to accumulate. Additionally, a seam where two rubber membranes overlap runs along this area; this seam can allow water to enter the building.

Water-damaged ceiling tiles

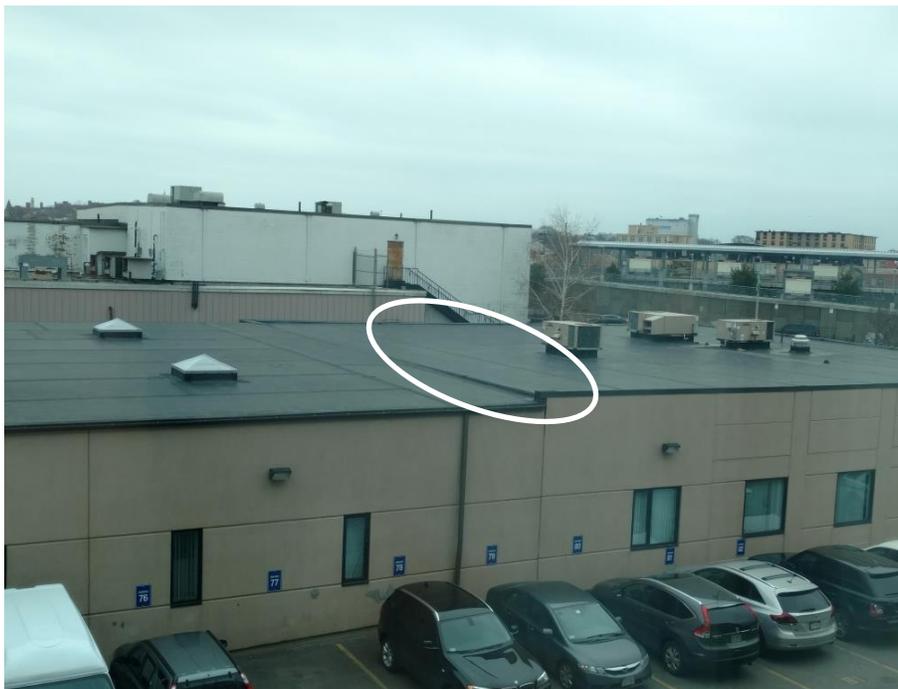
Picture 10

Discontinuous roof which creates a water catchment area

15. Monitor downspouts to ensure proper drainage, which would prevent water build-up on the roof.
16. Periodically examine seams to the rubber roof membrane to ensure integrity of the system.

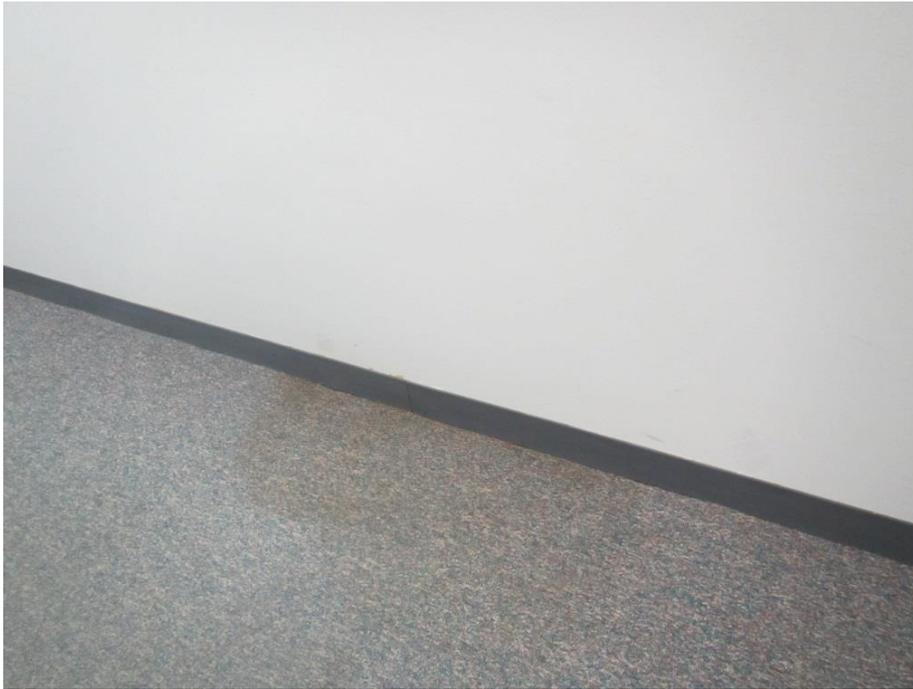
Picture 11

- Water damage in the kitchen area and surrounding hallways, reportedly from a clog in the kitchen drain pipe trap. No visible damage was observed in sink cabinets; however, carpeting and wallboard in the hallway behind the kitchen appeared stained (Picture 11). Staff should refrain from emptying food materials and coffee grinds directly into the sink.

Stained carpeting in hallway behind kitchen sink

7. Install a fine mesh strainer in the kitchen sink to prevent debris from washing into drains.
8. Consider using a video camera line inspection to examine the interior of the kitchen sink pipe and determine whether other causes may be contributing to repeated drain line backups, slow drains, or clogs.

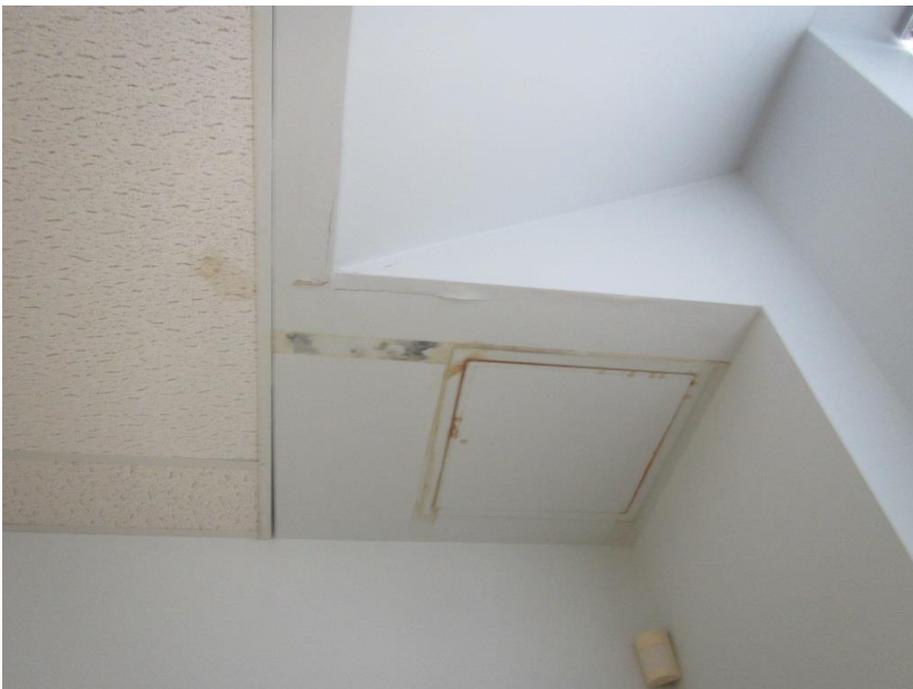
Picture 12

- Black staining indicating mold growth on tape residue on a metal panel within an office (Table 1; Picture 12). It appears that tape was used to seal the access panel door. Rusting was observed on the metal panel indicating repeated water exposure. Dust and other materials trapped in the tape for the door were likely exposed to moisture, resulting in the mold growth and staining observed.

Rusting and staining from historic water leak

9. Repair the sink backsplash to prevent water penetration.
10. Remove tape residue and clean area around metal panel shown in Picture 12. Monitor office for future leaks.

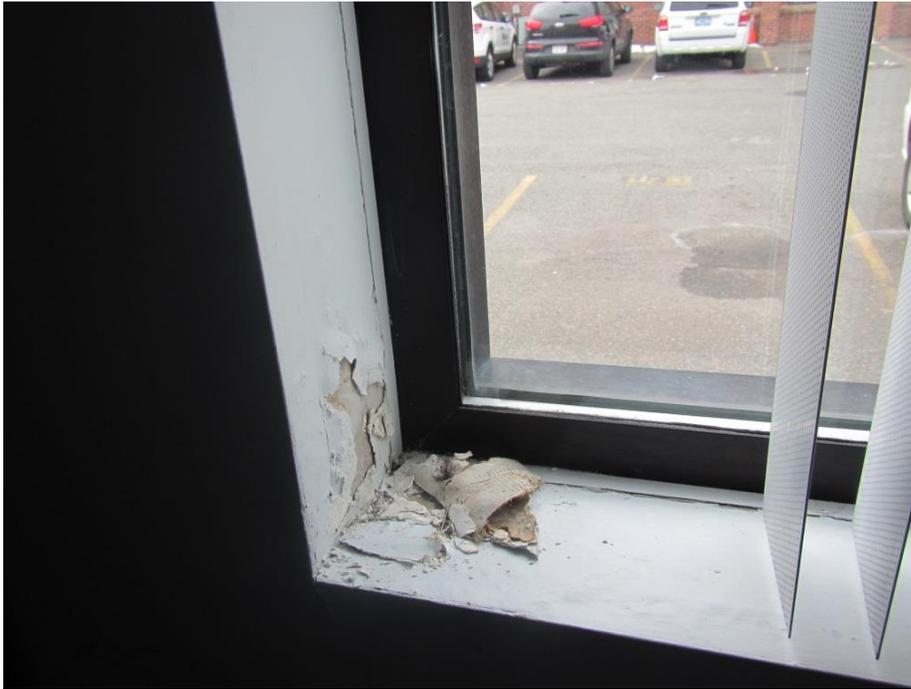
Picture 13

- Water dispensers on carpeting, which can be leak/spill and cause water damage.
- Peeling/chipping paint in some window bays, likely due to water infiltration or condensation (Picture 13).

Peeling, chipping, and bubbled paint from water infiltration

11. Place tray below water dispensers to collect water from spills/leaks.
12. Vacuum paint chips from damaged windows.
13. Reinstall/repair rubber gaskets in windows. Periodically examine windows to ensure gaskets are in place.

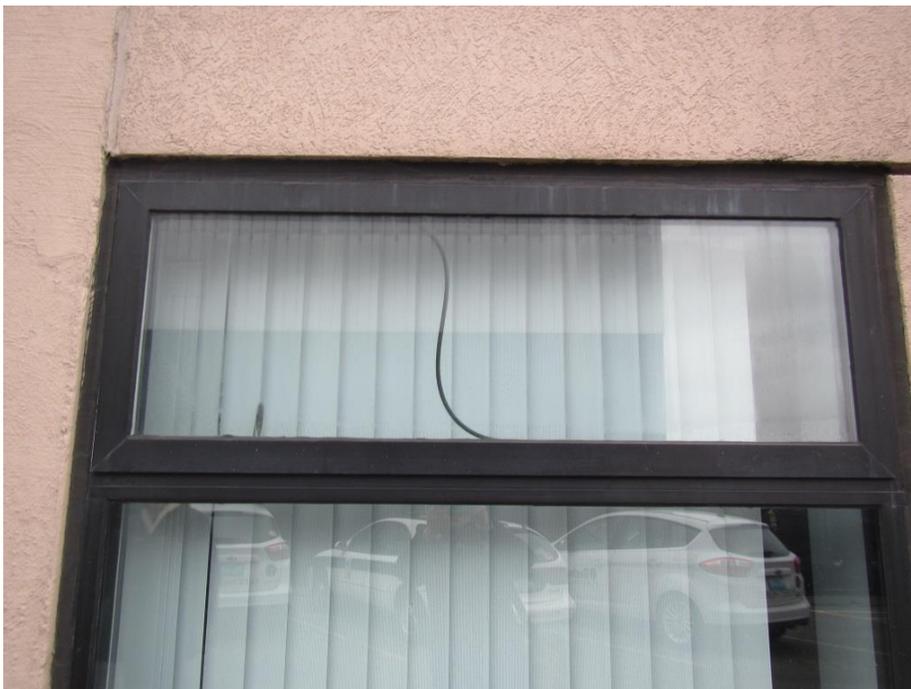
Picture 14

- Failing gaskets, observed in windows throughout the building (Picture 14), which can contribute to water infiltration and drafts.
- Breach/gap between the backsplash and the sink countertop (Picture 15).

Failing window gasket

14. Consider sealing windows with silicon caulking to reduce draft/heat loss and maintain indoor temperatures within the comfort range throughout the building.

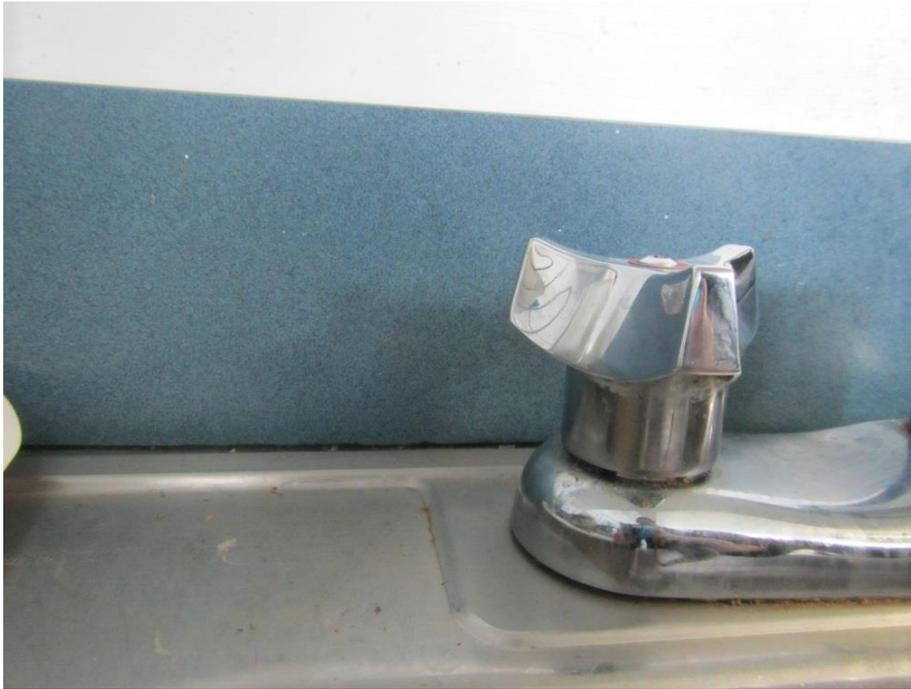
Picture 15

Breach between sink countertop and backsplash

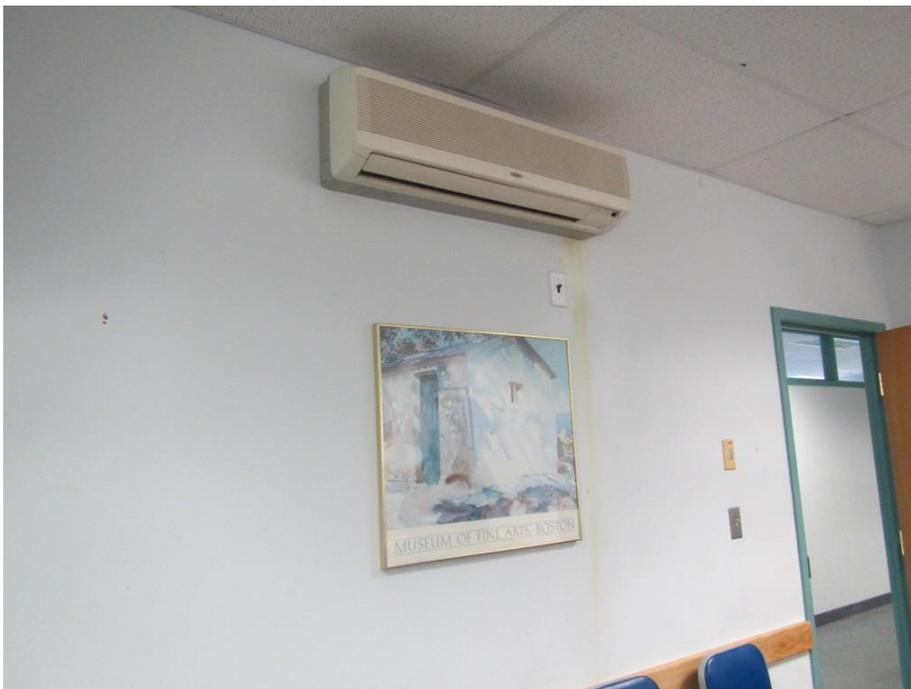
Picture 16

- Staining below the air-conditioning unit in the conference room, reportedly from condensation (Picture 16).
- Plants in some areas (Table 1).
- A humidifier in one office.

Staining below air conditioner in conference room

17. Contact a heating, ventilation, and air-conditioning technician to service the air-conditioning unit in the conference room and determine whether the unit is appropriate for size of room. Ensure that the condensate lines are clean and removing condensation to the outdoors.

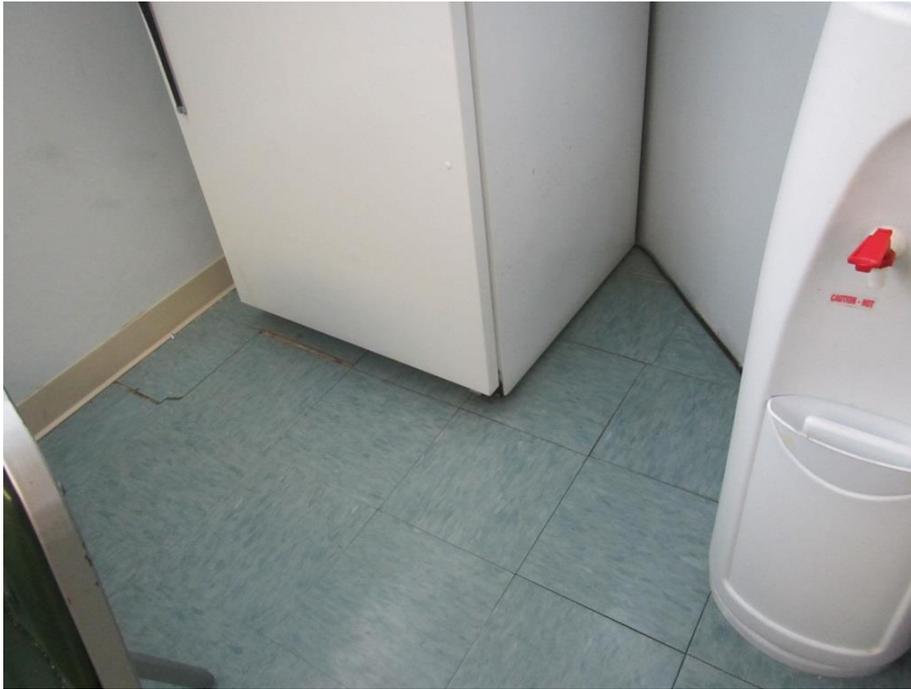
Picture 17

- Damaged floor tiles in kitchen (Picture 17). These tiles should be replaced to prevent tripping hazards and to ensure a flat, cleanable surface is maintained.

Kitchen floor tiles no longer adhered to floor

20. Repair floor tiles in kitchen.
21. Reframe from using air deodorizers, which contain eye and respiratory irritants.
22. Label and store cleaning products in an appropriate area. Ensure Material Safety Data Sheets (MSDSs) are available at a central location for each product in the event of an emergency.

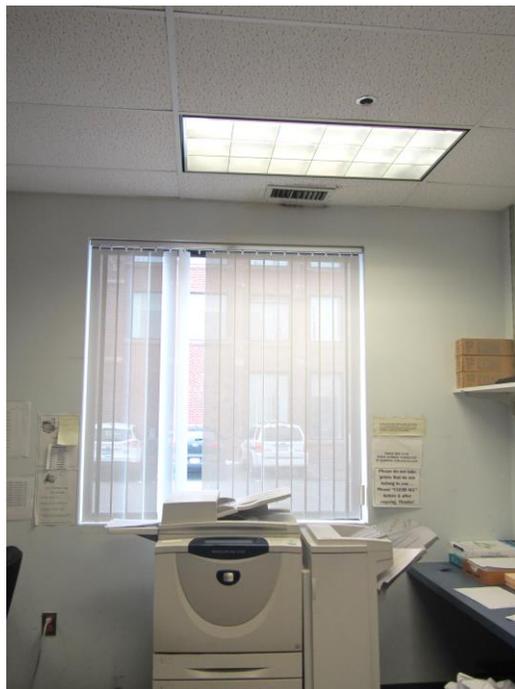
Picture 18

Photocopiers at the DTA were not located in proximity to return vents or dedicated exhausts. Instead, it was located below a supply vent (Picture 18); air from the vent can circulate VOCs and ozone produced by the photocopier. VOCs and ozone are respiratory irritants. Without appropriate removal, heat, chemicals, and odors produced by photocopiers can persist in the indoor environment.

Photocopier located directly below supply vent

23. Relocate photocopiers near exhaust vents or openable windows to allow removal or dilution of VOCs and ozone generated by the equipment.
24. Vacuum carpets with a high efficiency particulate air (HEPA) filtered vacuum and conduct an annual cleaning to reduce accumulation and potential aerosolization of materials from carpeting.

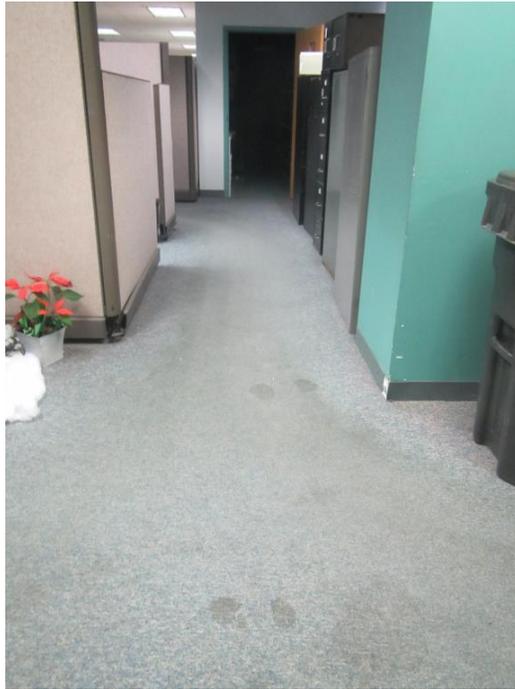
Picture 19

Many areas of the DTA office are carpeted, some of which is stained, worn, and frayed due to use and age (Picture 19). The Institute of Inspection, Cleaning, and Restoration Certification (IICRC) recommends that carpeting be cleaned annually (or semi-annually in soiled high traffic areas) (IICRC, 2012).

Worn and stained carpeting

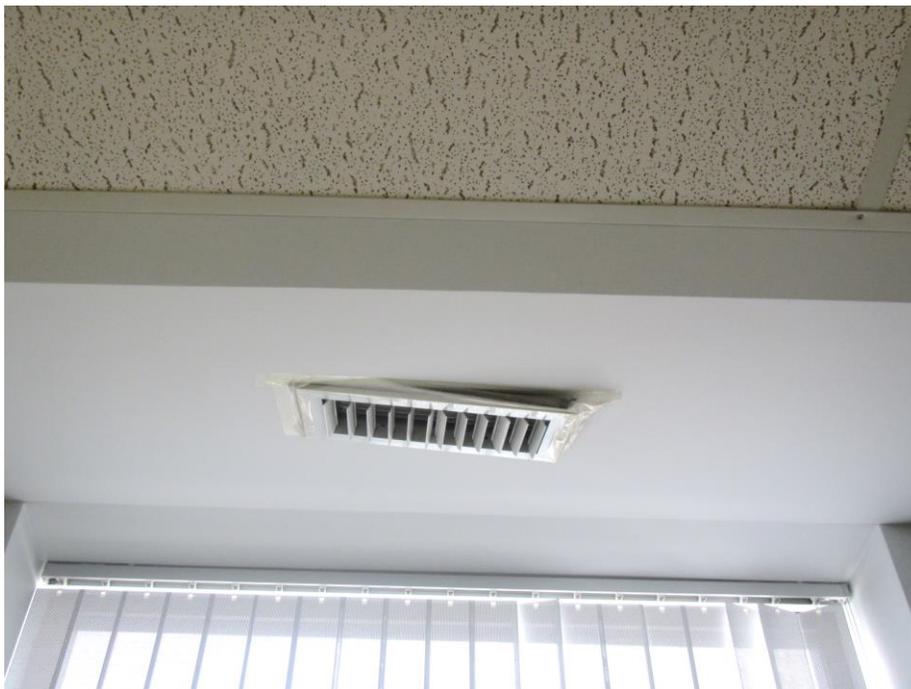
Picture 20

A supply vent in an assistant director's office was not secured to the ceiling (Table 1; Picture 20). Measures should be taken to secure the vent to prevent injury and allow for proper air flow.

Unsecured supply vent in an assistant director's office

25. Remove items hanging from the ceiling tile system to prevent movement of dust and debris from above ceiling tiles into occupant space.
26. Secure the supply vent in the Assistant Director's Office.
