WATER DAMAGE INVESTIGATION

**North Shore Community College
McGee Building
300 Broad Street
Lynn, Massachusetts**

Prepared by:
Massachusetts Department of Public Health
Bureau of Environmental Health
Indoor Air Quality Program
March 2016

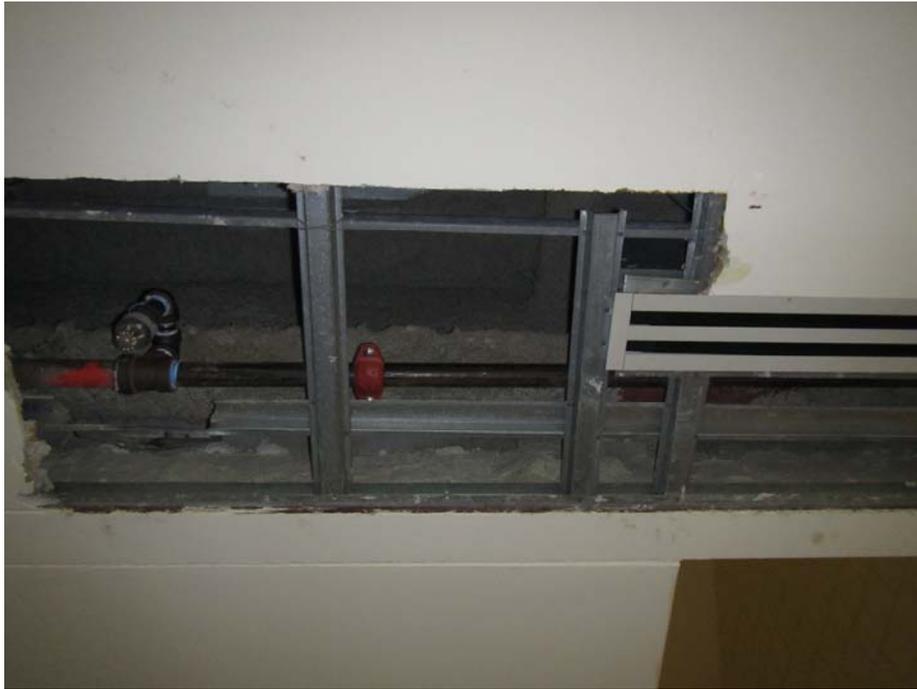
Picture 1

Due to the severely cold weather experienced on the evening of February 14, 2016, a sprinkler pipe in the ceiling of the first floor of the McGee building failed and flooded most of the first floor (Picture 1). The flooding affected gypsum wallboard (GW), insulation, carpet, and some ceiling tiles.

Sprinkler pipe that failed in ceiling above the first floor

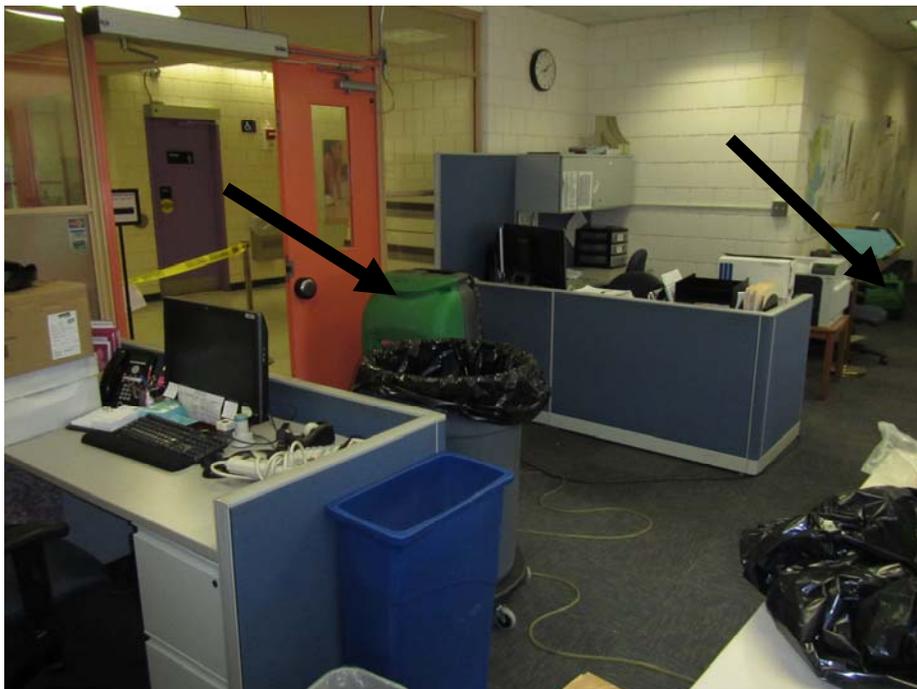
Picture 2

Dehumidifier and fans (arrows) being used to facilitate drying

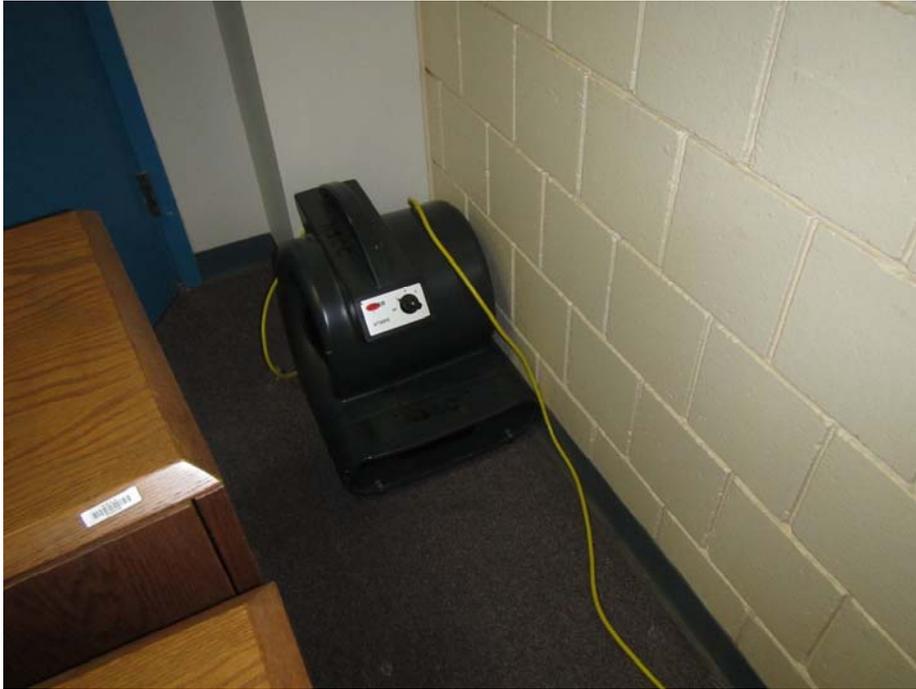
Picture 3

Office furniture moved to assist in drying of carpet with fan

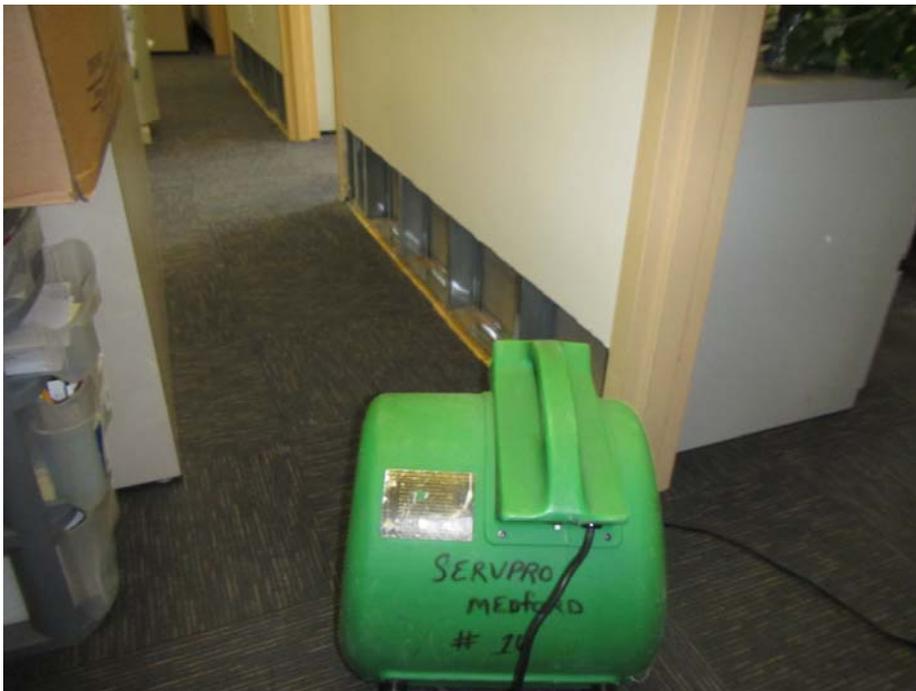
Picture 4

Fan drying inner hall of office space

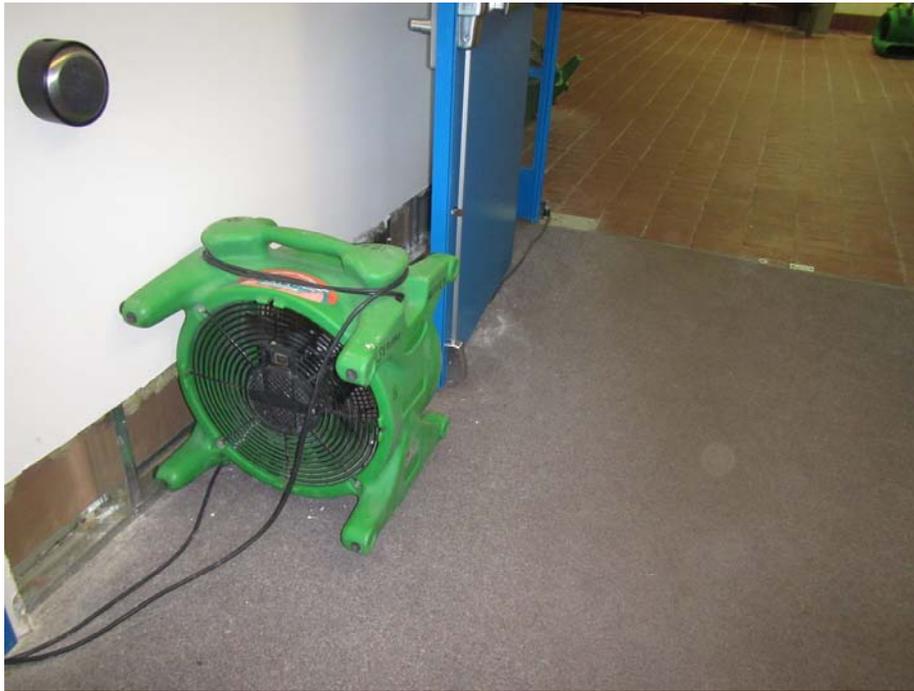
Picture 5

Fans located near foyer where sprinkler failed

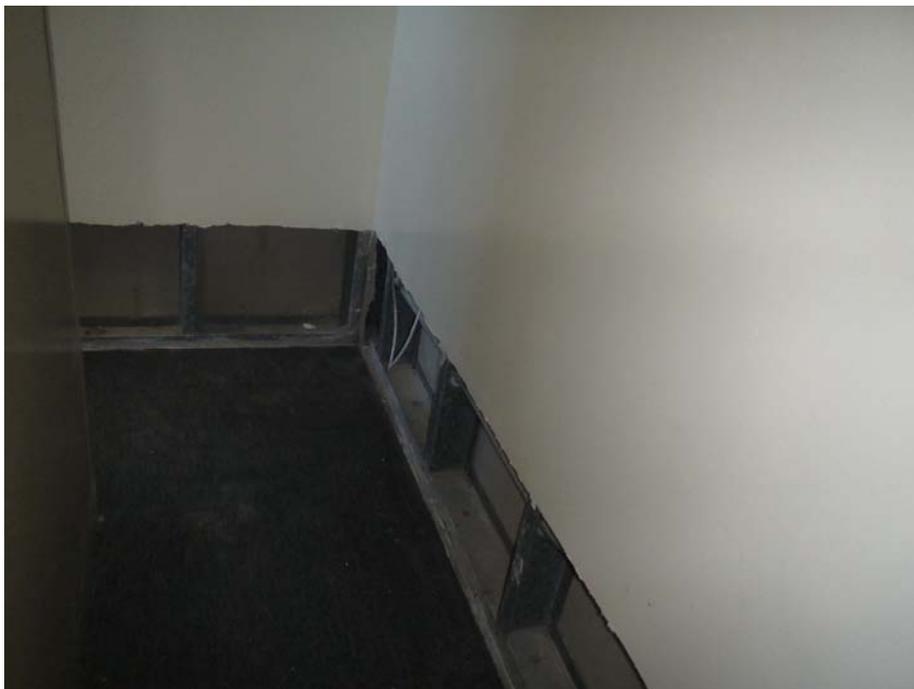
Picture 6

One side of GW wall removed to dry wall cavity

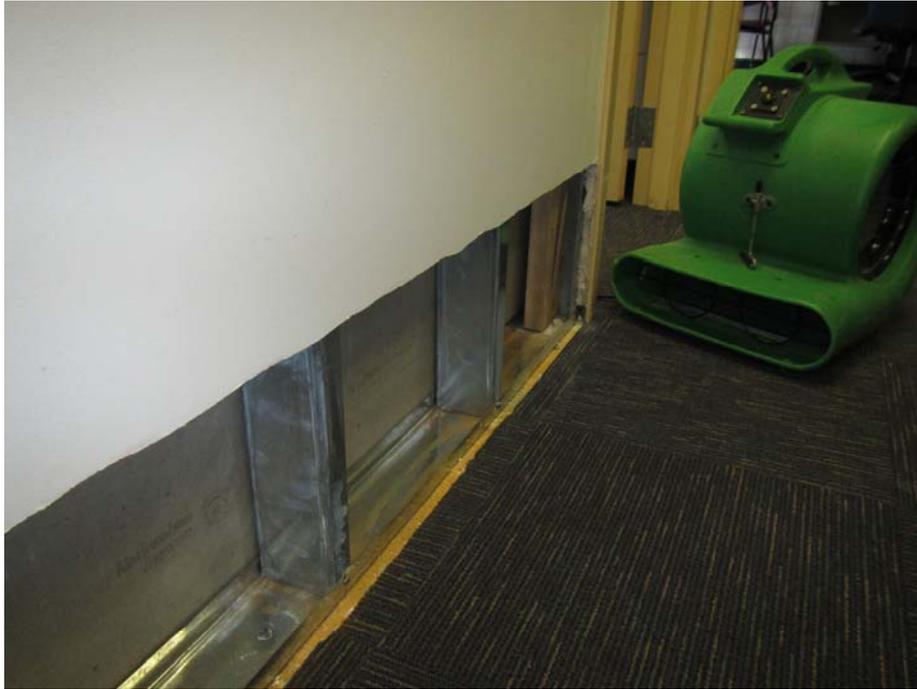
Picture 7

Fan drying wall cavity and back side of GW on opposing wall

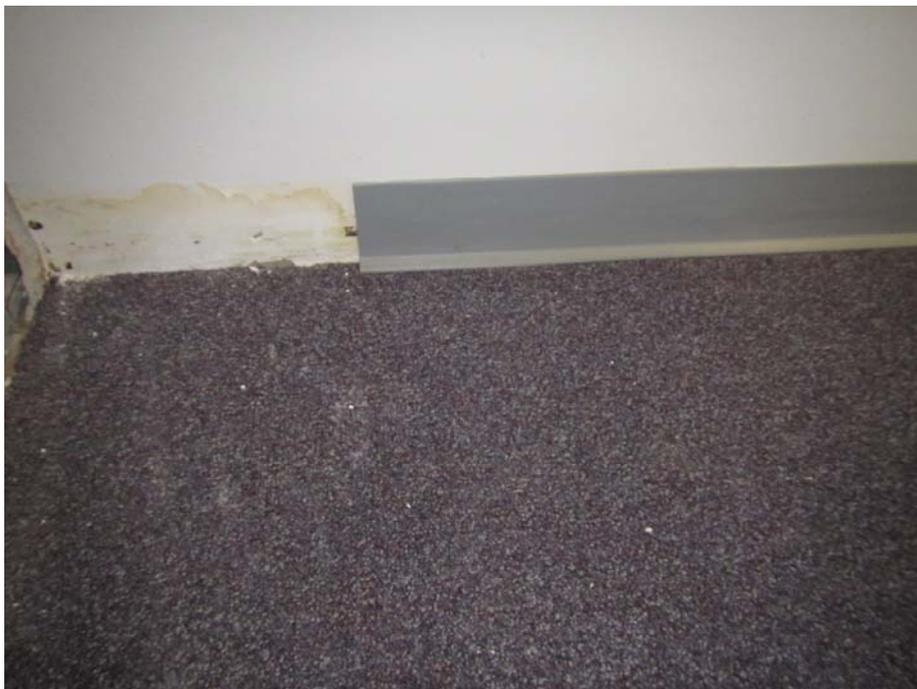
Picture 8

In some areas of the NSCC, the GW was cut away on one side of the wall to dry the wall cavity as well as remove any accumulated water that may have been standing in the metal framing members (Pictures 5 to 7). In other areas, GW remained with vinyl base coving intact (Picture 8), which can hinder drying. Using the moisture meter, BEH/IAQ staff found many areas throughout the NSCC to have elevated moisture levels in the GW despite more than 72 hours of drying time (Pictures 9 and 10). The height of moistened GW in most areas was between the floor and one foot above. The BEH IAQ program recommends that GW that is not dried within 48 hours should be removed, plus an additional 12 inches from the level where it was moistened to prevent the occurrence of mold growth. Carpeting tested with the moisture meter appeared dry in most areas tested.

GW with vinyl coving left intact

2. Continue to work with remediation contractor to identify all porous building materials that were not dried within 48 hours. These water-damaged materials should be removed. Typically, the lower portion of GW is removed from a height of flood level plus 12 inches. Consider replacing any removed carpeting with carpet tiles.

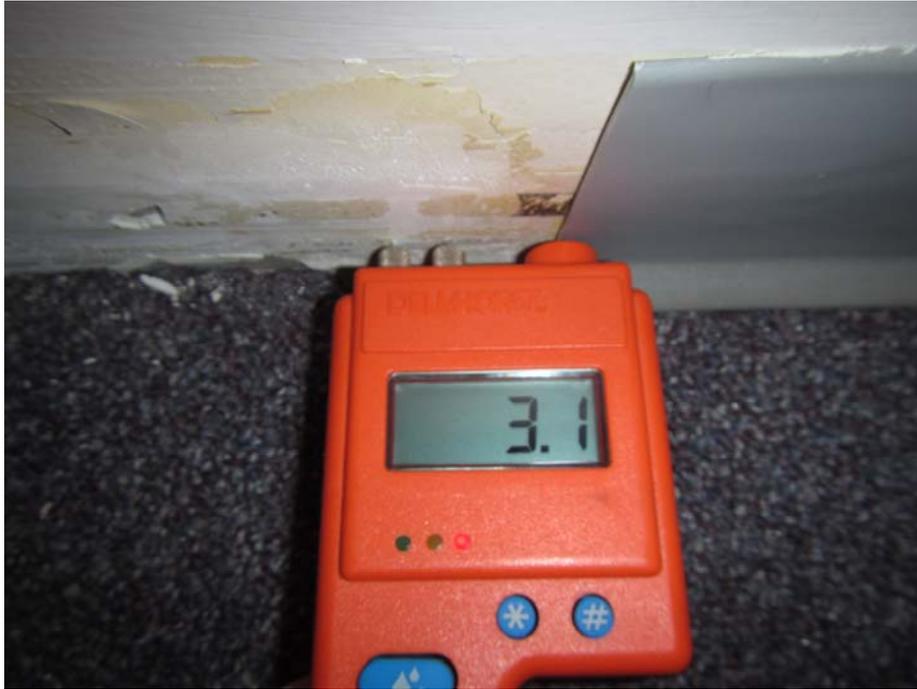
Picture 9

Moisture meter showing elevated moisture in GW

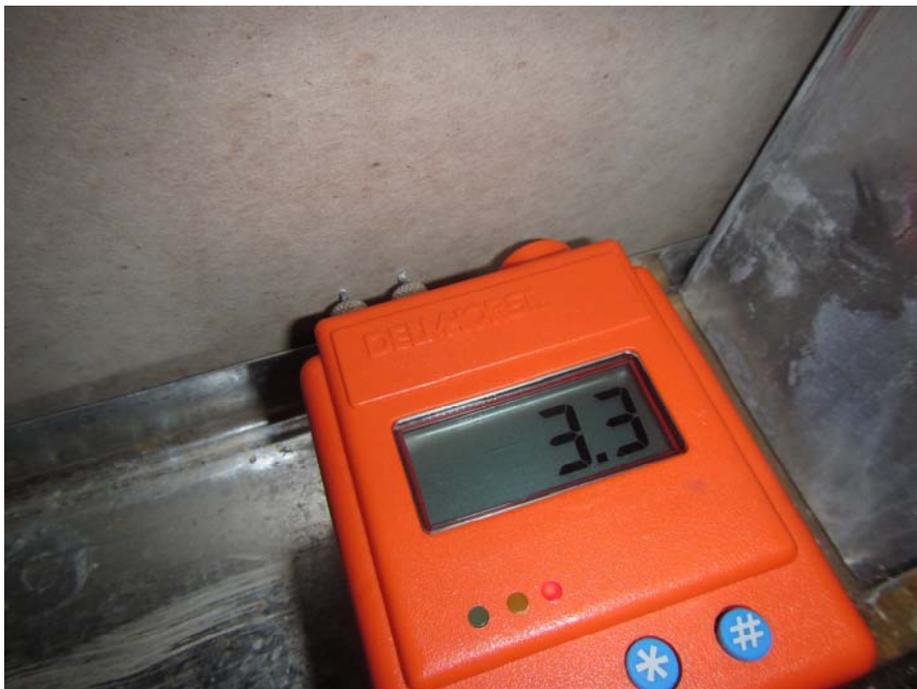
Picture 10

Moisture meter showing elevated moisture in GW
