INDOOR AIR QUALITY ASSESSMENT

**Methuen City Hall
41 Pleasant Street
Methuen, MA**

Prepared by:
Massachusetts Department of Public Health
Bureau of Environmental Health
Indoor Air Quality Program
June 2016

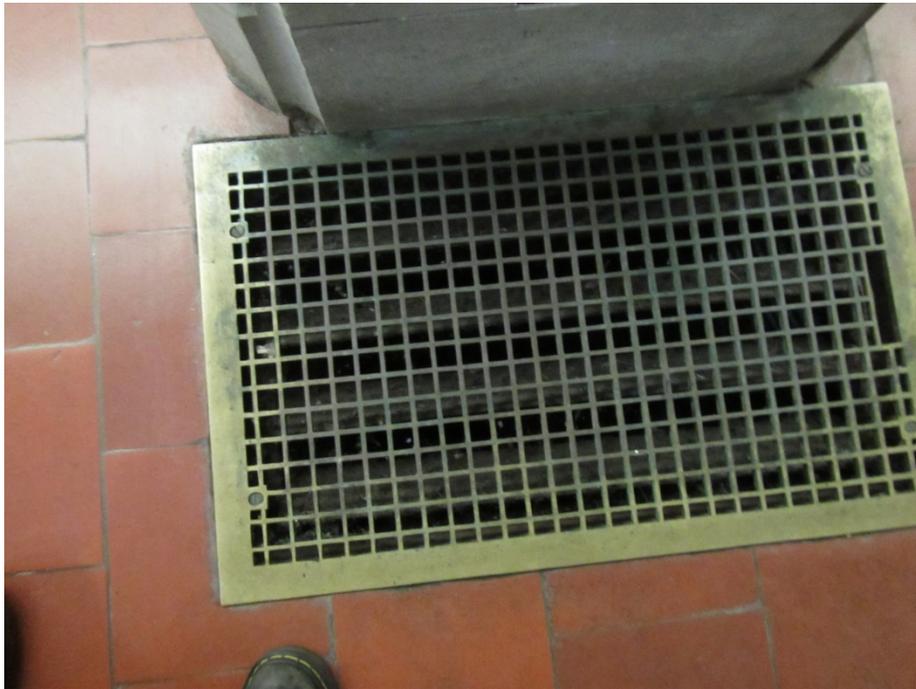
Picture 1

The school building originally had a gravity ventilation system, which consisted of grated, louvered, wall-mounted exhaust vents and floor-level supply vents (Picture 1). Air shafts connected the floor vents to vault-like “air-mixing” rooms in the basement. Fresh air from the outdoors was drawn into the air-mixing rooms through open windows. Under operation, heating elements located in the base of the ventilation shaft of the air mixing room would warm the fresh air, which causes the air rise up the ventilation shaft (via the stack effect) and be distributed to classrooms by floor-level supply vents. Sinking cool air and rising warm air in the room would

Old floor-mounted supply vent

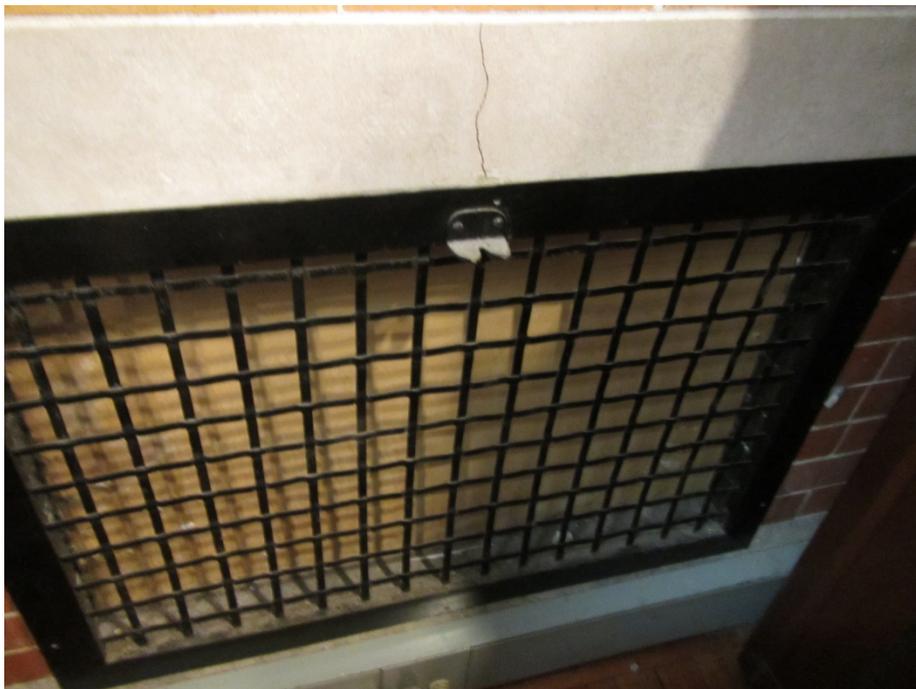
Picture 2

Exhaust vent, now boarded up with gypsum wallboard

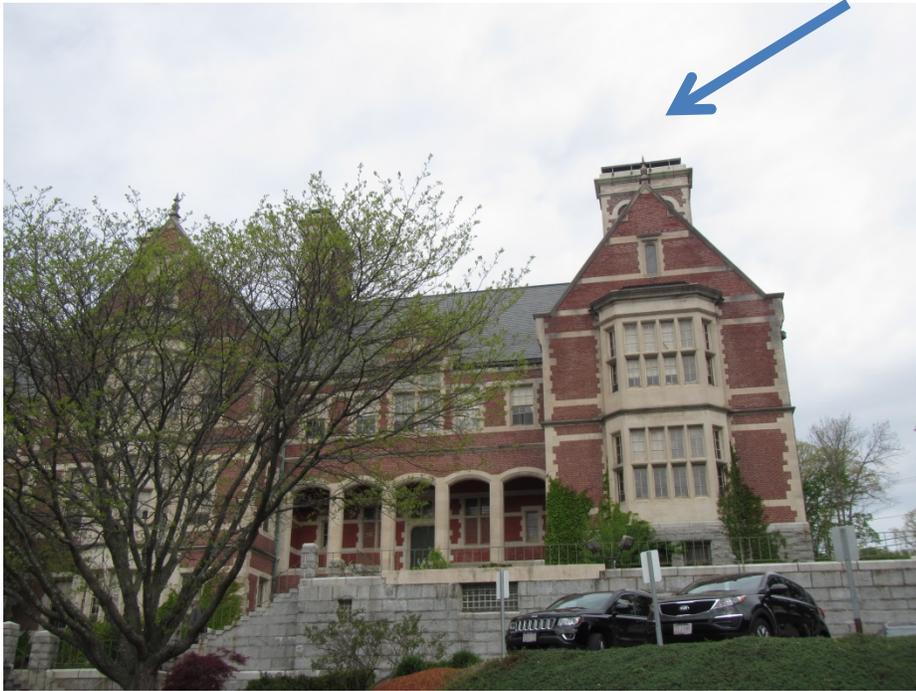
Picture 3

Chimney-like exhaust vents from the old gravity system (top right, arrow)

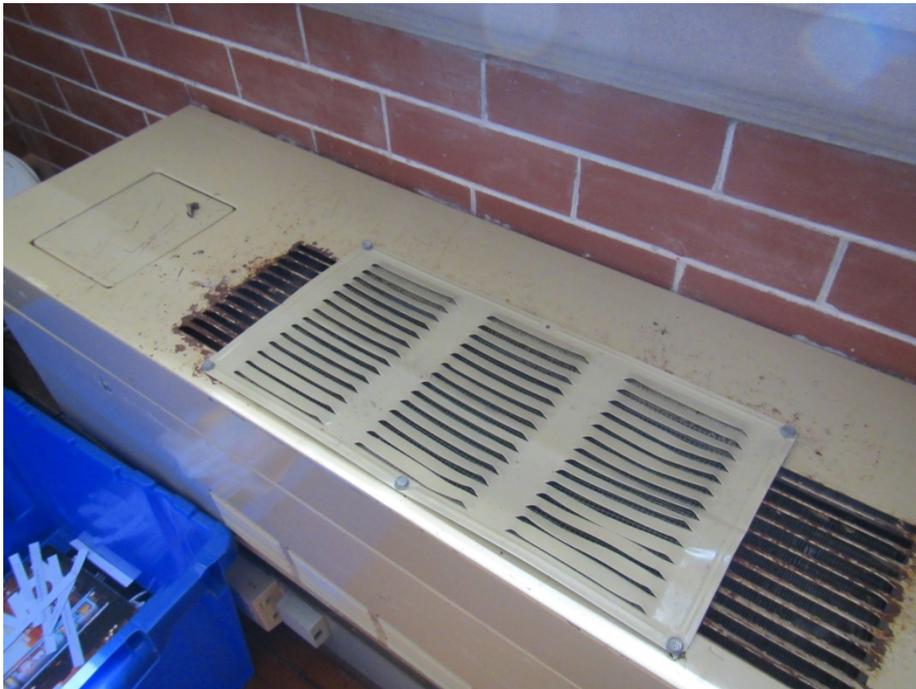
Picture 4

Fan coil unit showing rust and modified louver vent attached

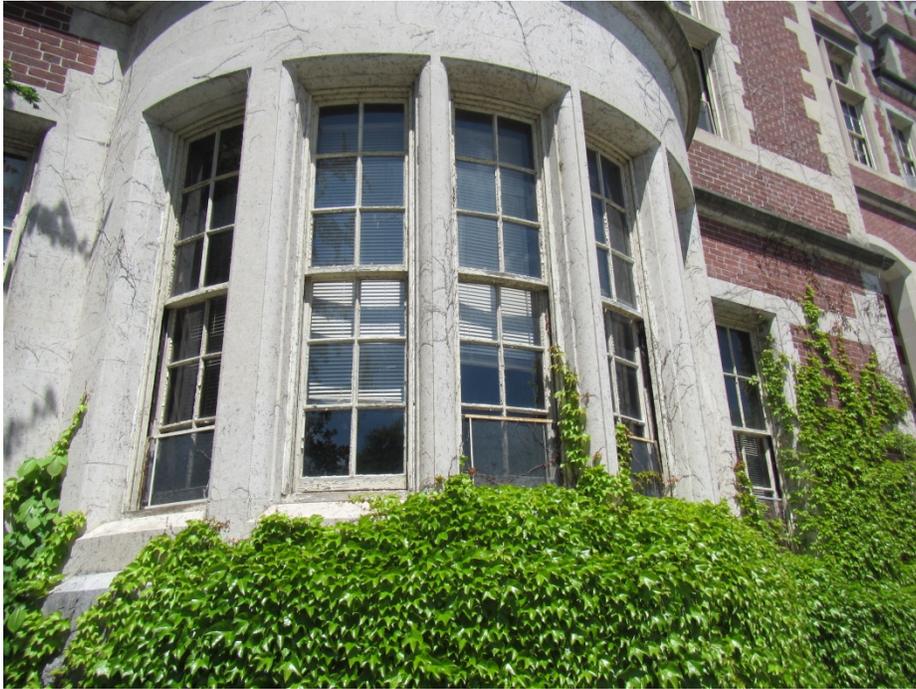
Picture 6

Although most windows were originally designed to be openable, they are in poor condition (Picture 6). Many are stuck closed or are not able to remain open since the sash cord connecting the sash to the window counterweights is broken. Other windows have been sealed with plastic to prevent drafts (Picture 7). Because of the condition of the windows, many areas in the MCH *do not have any* source of fresh air.

Windows showing missing/partial screens and deterioration

4. Repair windows, sashes, sash cords, and screens where possible to restore functionality and allow windows to open and close tightly.

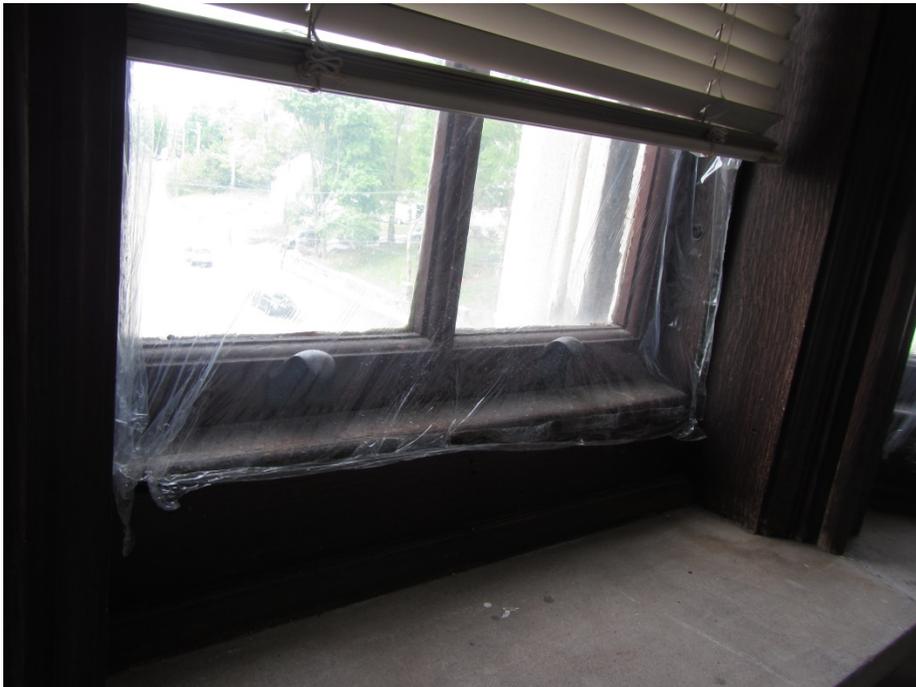
Picture 7

Window with plastic sheeting

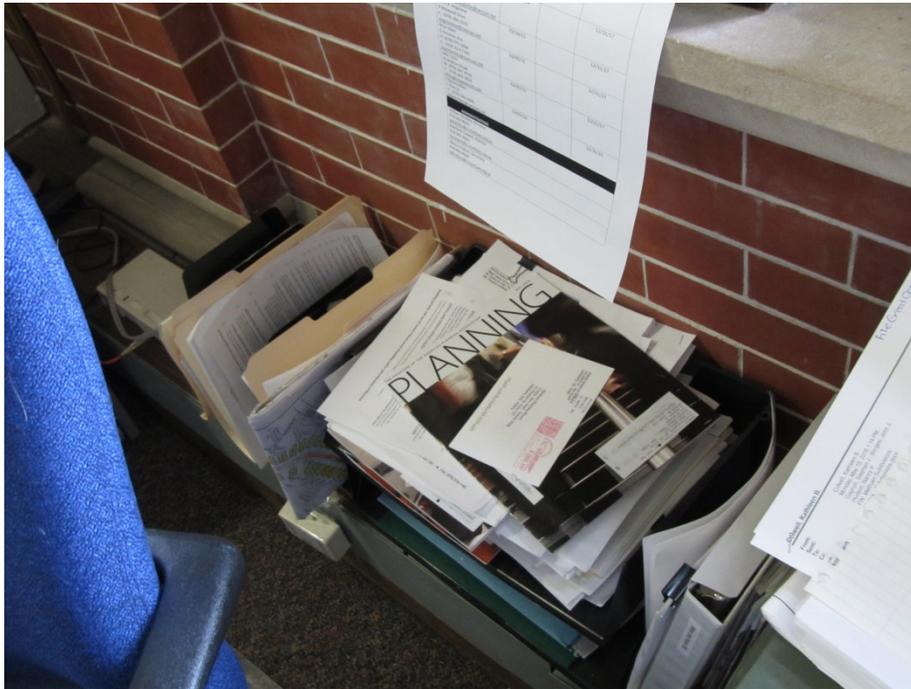
Picture 8

FCUs were blocked or obstructed by desks, boxes, and other items (Picture 8). Airflow to and from FCUs should be unrestricted to allow the equipment to function properly. Most FCUs were in poor condition, with signs of rust and deterioration visible from the outside (Picture 4). Internal FCU components were also poor condition, with signs of corrosion and damage (Pictures 9 to 12). Note that these units were likely installed sometime around 1983, which would make them over 30 years old. Function of equipment of this age is difficult to maintain,

FCU covered with items

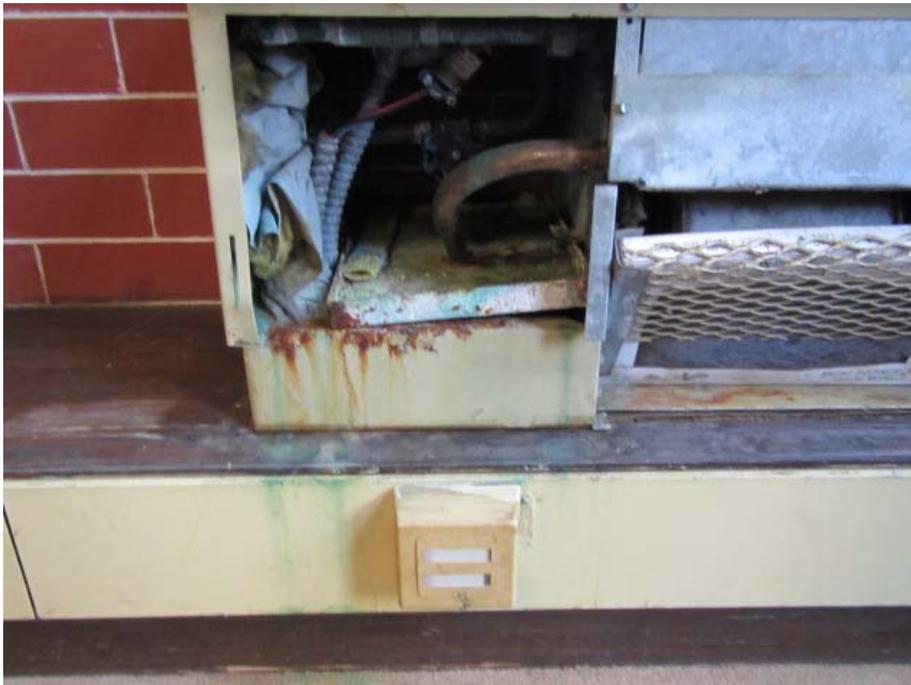
Picture 9

- The condensation collectors were uniformly coated with scale (Pictures 9 to 11). Scale refers to metal corrosion and mineral deposits that can occur when standing water remains in drip pans or on coils. Standing water can cause metal corrosion. As water evaporates over time, mineral and debris can coat the drip pans, coils, and pipes.

Fan coil unit with corrosion to internal components

5. Repair/maintain the FCUs to the greatest extent possible, given the age and current condition of the units. Inspect the condition of the drip pans beneath the coils in each FCU to ensure proper drainage and prevent clogs.

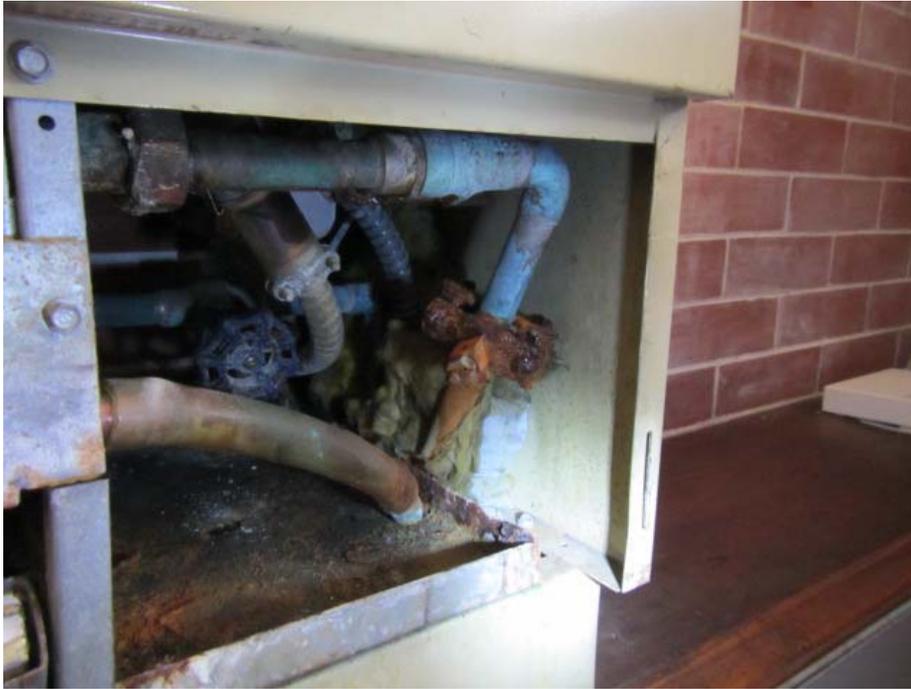
Picture 10

Internal components of fan coil unit showing corrosion

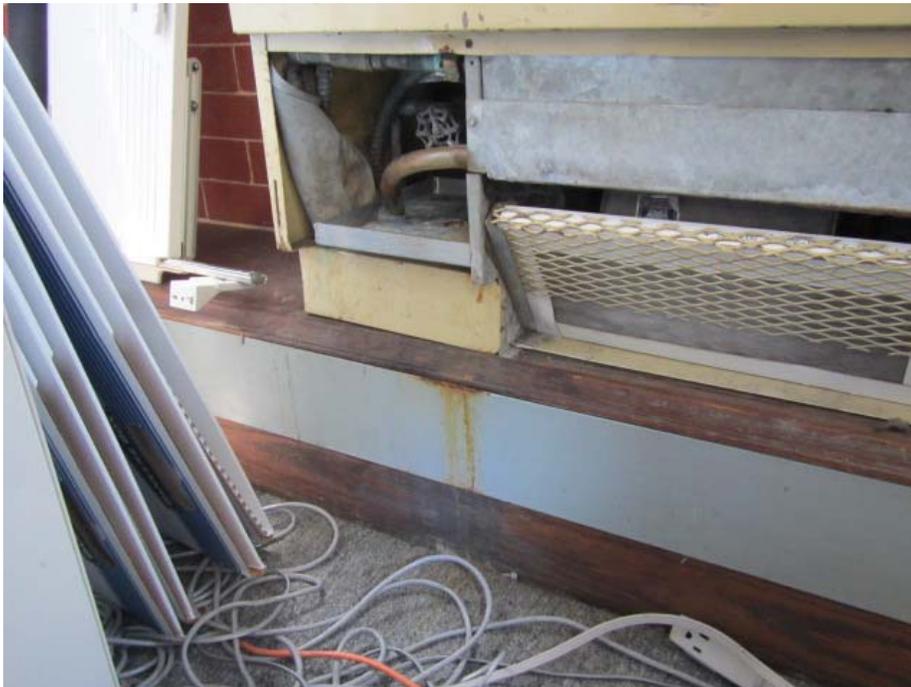
Picture 11

Water damage occurring due to the conditions described above has also impacted materials on or adjacent to the FCUs. Signs of damage include mold growth spots from debris settled on FCUs (Picture 16) stained walls above the top of the FCU (Picture 17), green staining from copper pipe corrosion at the front of the units (Pictures 11 and 12), and stained carpeting.

Corrosion on fan coil units and water damage to wood, wall and carpeting due to FCU leaks

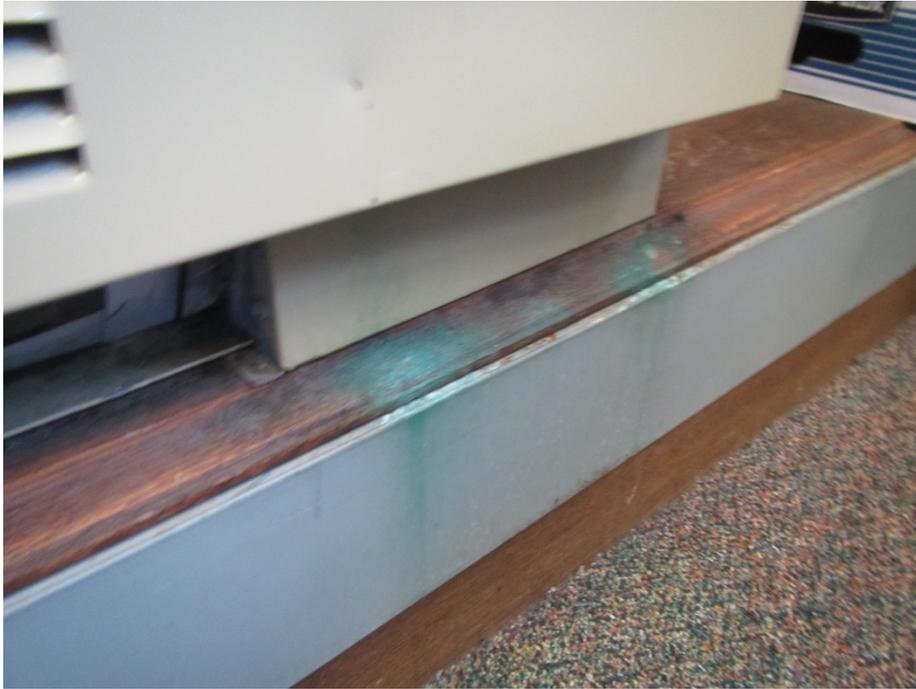
Picture 12

Evidence of corrosion from FCU and leaks onto wood and carpeting

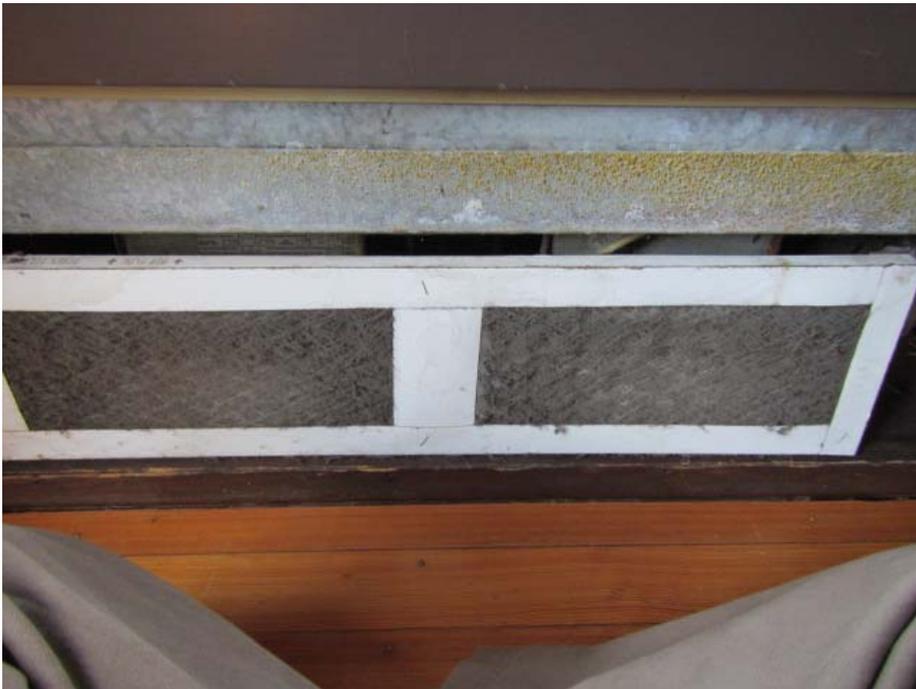
Picture 13

BEH/IAQ staff noted a thick layer of dust and debris on FCU filters (Picture 13). In addition, filters are of the type that provides minimal filtration. The dust spot efficiency is the ability of a filter to remove particulate matter of a certain diameter from air passing through the filter. ASHRAE indicates that filters with a dust spot efficiency of a minimum of 40 percent would be sufficient to reduce many airborne particulates (Thornburg, 2000; MEHRC, 1997; ASHRAE, 1992). Pleated filters with a minimum efficiency reporting value (MERV) dust-spot efficiency of 8 or higher are recommended. Consideration should be given to installing pleated filters. Note that increasing filtration may require evaluation and adjustments to the FCUs to manage increased flow resistance created from using higher MERV value filters.

Fan coil unit showing filter occluded with dust and debris

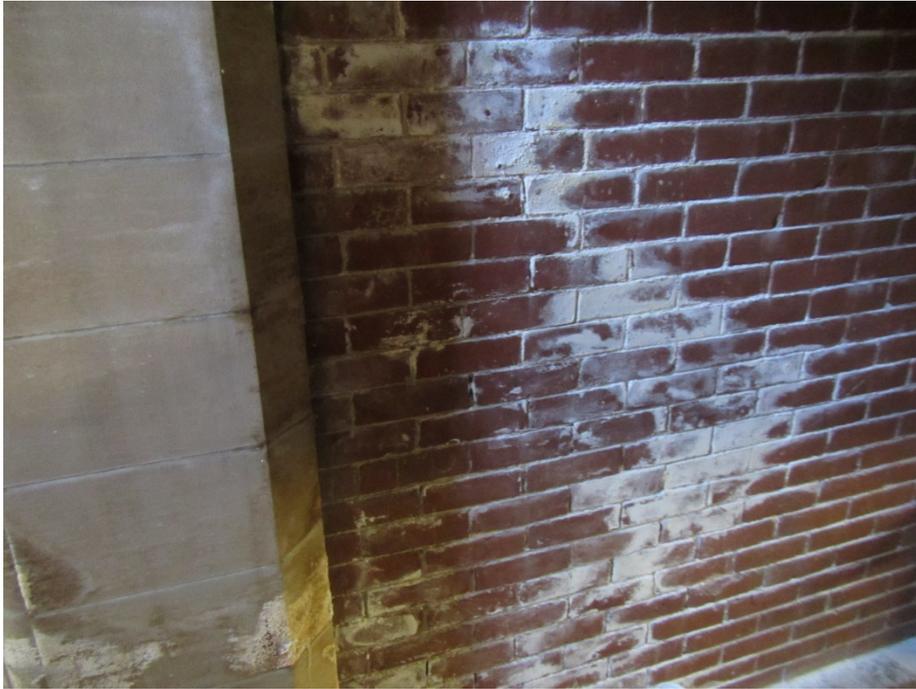
Picture 14

Brick work showing efflorescence

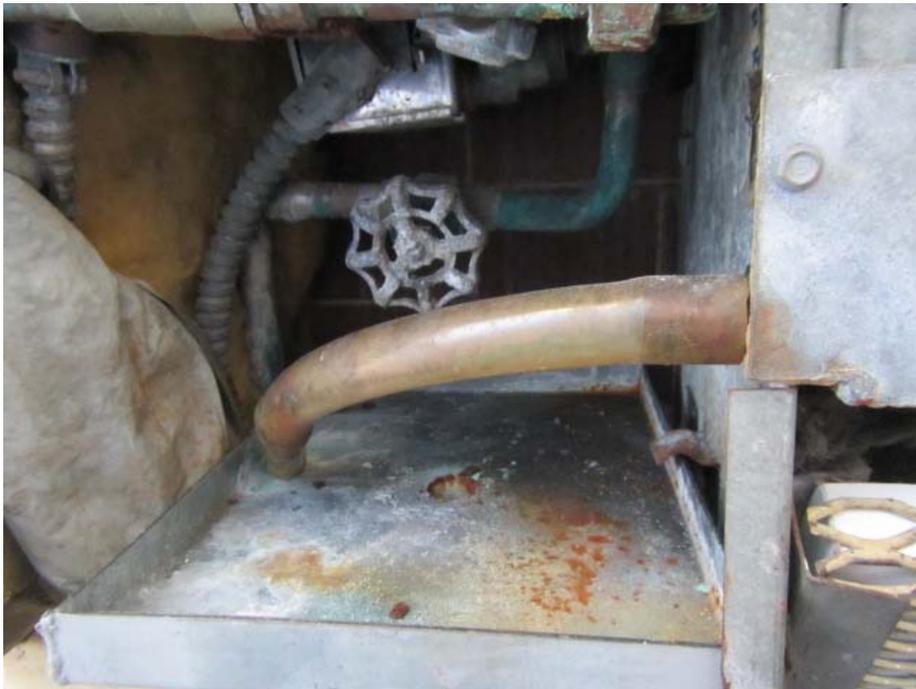
Picture 15

- The plastic hoses connecting the condensation collectors is made of a flexible plastic. These flexible plastic hoses were coated with scale, dust, and the remnants of biofilm (Picture 15). It is likely that these hoses lay flat on the floor of the pipe chase, with no pitch to aid drainage. Without proper drainage, the plastic hoses are susceptible to clogs from scale, debris, and biofilm; clogs cause water to back up into the FCU. Biofilm is a

Dirty hose to drip pan

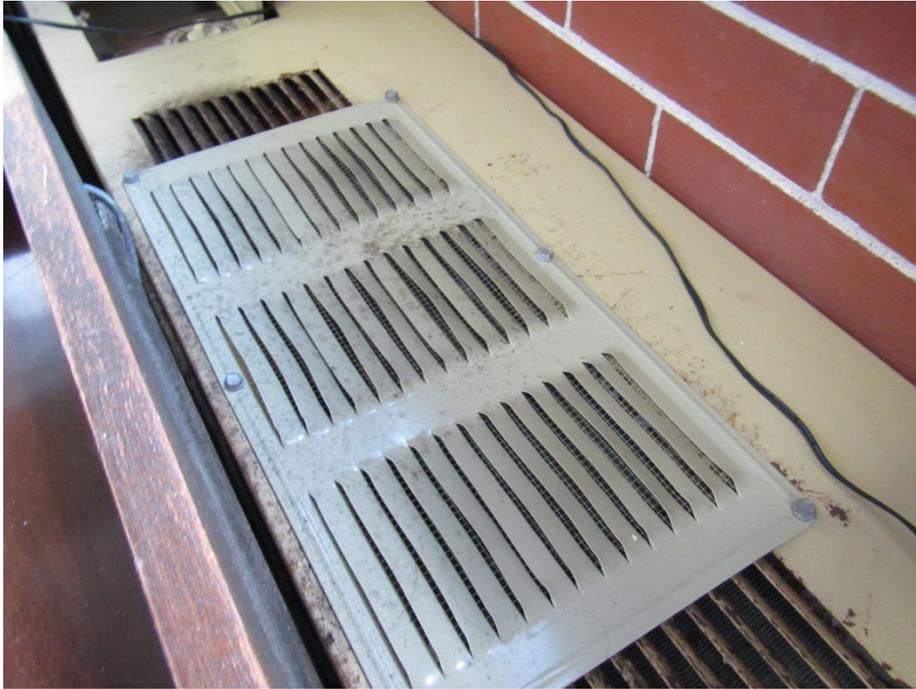
Picture 16

Dark staining that is likely mold growing on debris on top of FCU

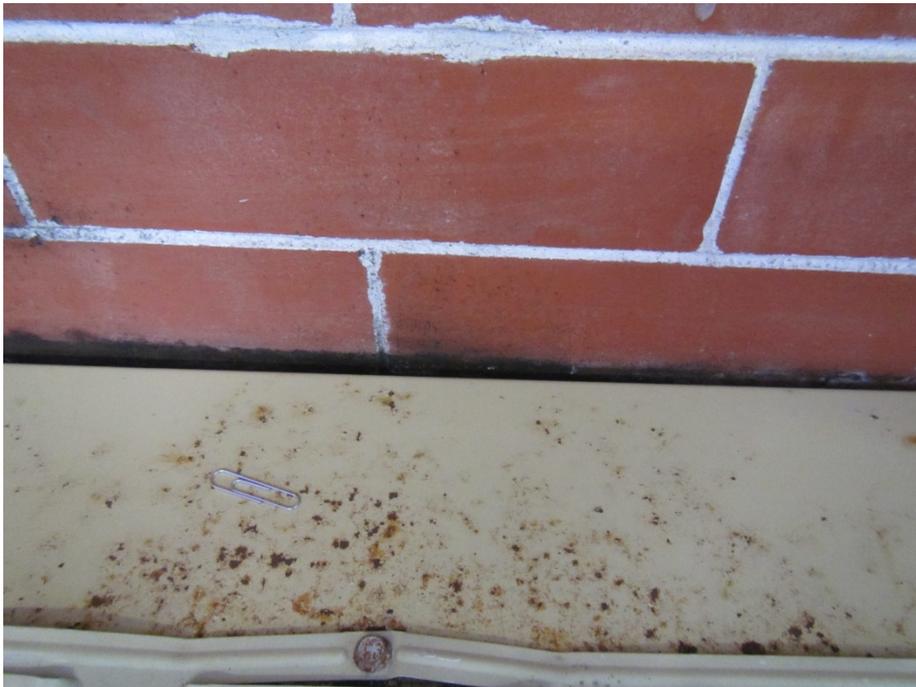
Picture 17

Rust on FCU and staining and water damage on bricks above FCU

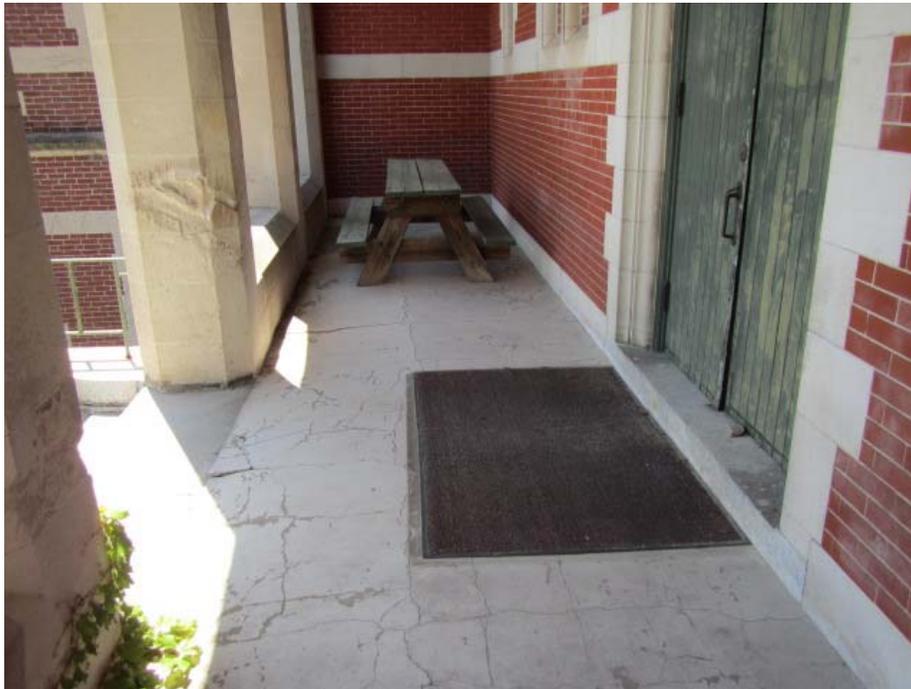
Picture 18

Location of abandoned restroom underneath patio, note spalling of concrete and entry door

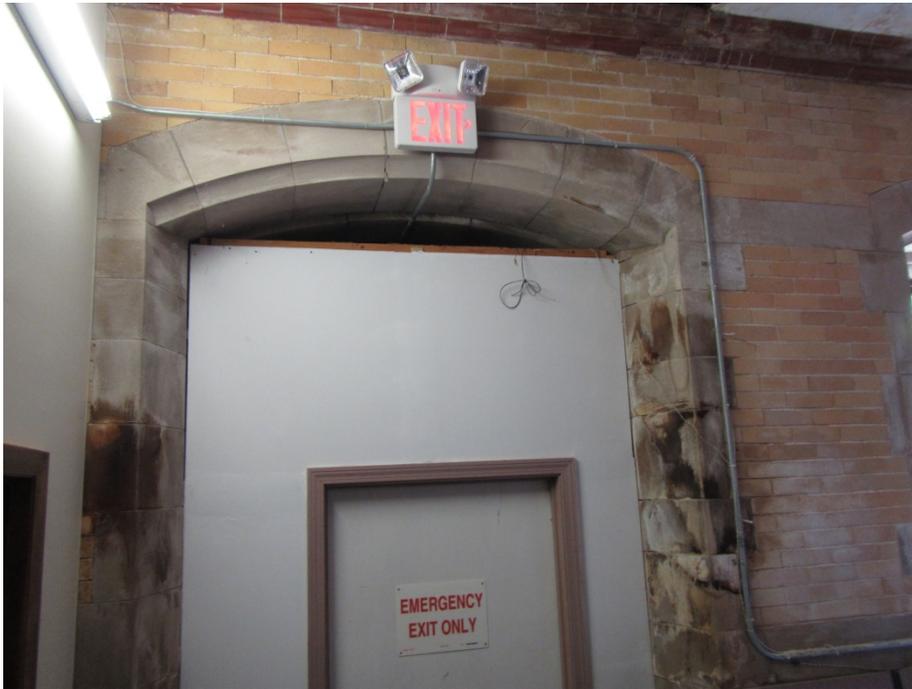
Picture 20

Partially-sealed archway between the abandoned restroom and the occupied areas of the MCH

1. Seal the gap below the archway (Picture 20) until item 2 can be completed.
2. When the MCH is unoccupied, remove water-damaged GW adjacent to the archway in a manner consistent with the recommendation made in the US EPA (2008) document *Mold Remediation in Schools and Commercial Buildings*. Replace the GW with cement board and completely seal the archway. Apply a sealant between the cement board and archway stone. Install weather-stripping on the door frame and install a door sweep at the bottom of the door to render this wall airtight.

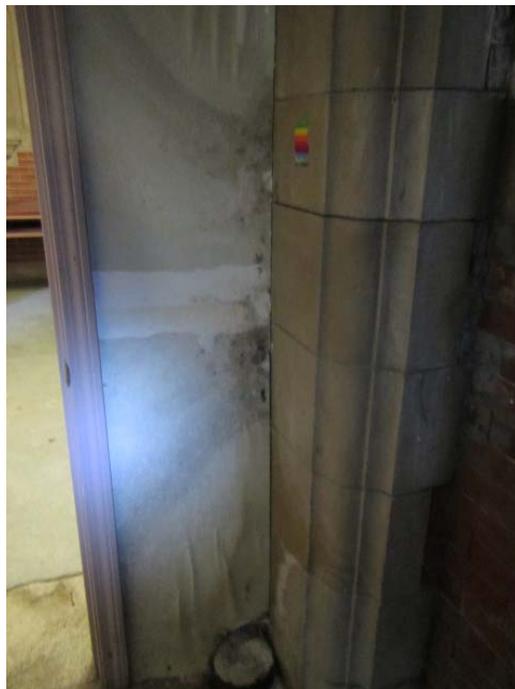
Picture 21

Water-damaged gypsum wallboard at entry to main hall from abandoned restroom

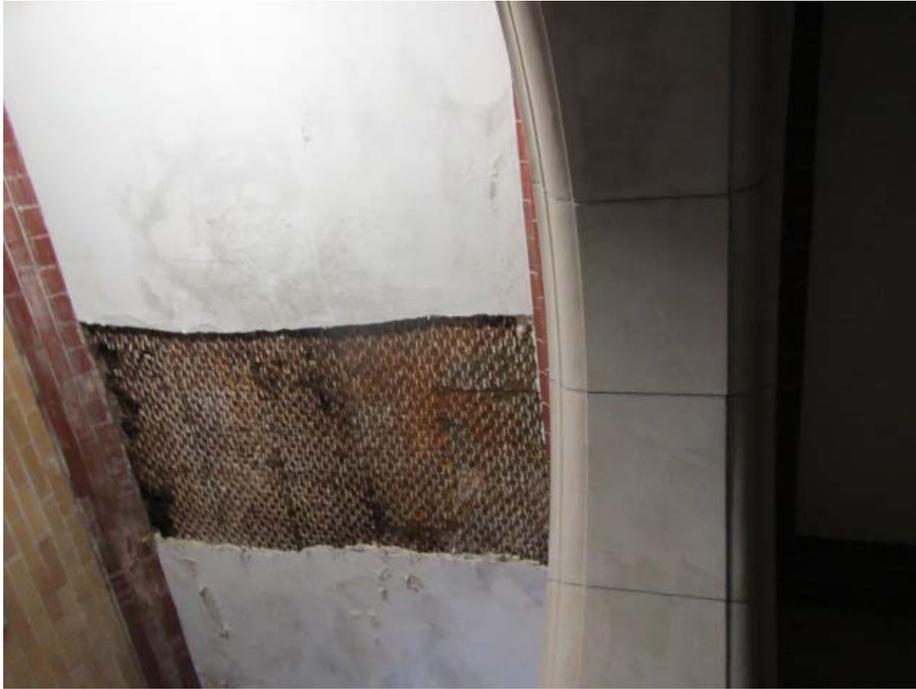
Picture 22

The stairwell/hallway leading to the abandoned building had exposed metal lathe due to rainwater damage to plaster (Picture 22). The location of the exposed lathe is directly below the outdoor door threshold for the first floor entrance (Picture 18). Cracked/spalling cement likely provides a pathway for water to enter, resulting in damaged ceiling plaster and cement stains (Picture 23). BEH/IAQ staff did not note musty odors beneath the damaged plaster.

Corroded metal and missing plaster adjacent to the doorway

13. Repair/repaint areas of peeling plaster on walls and the ceiling. If lead paint is a concern, ensure that lead-safe procedures are used in accordance with the Department of Labor Standards Regulations, 454 CMR 22.

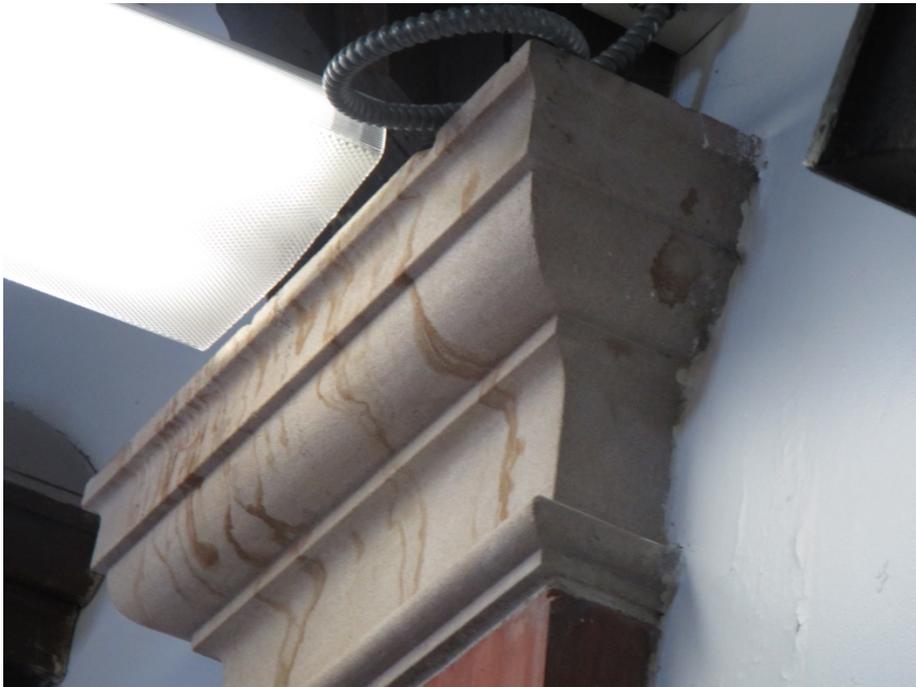
Picture 23

Water stains on concrete pillar

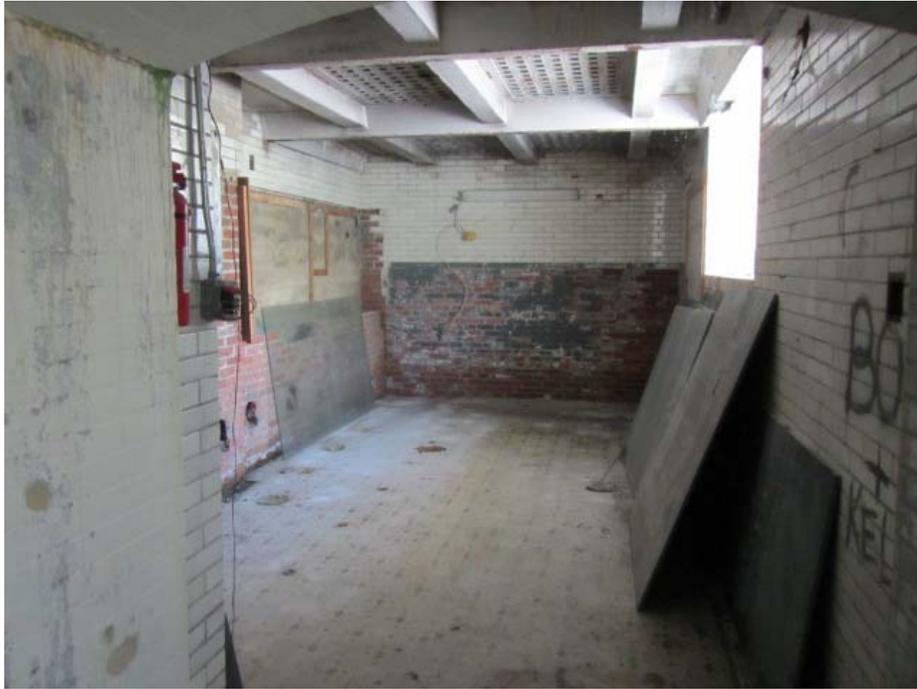
Picture 24

The abandoned restroom was completely decommissioned, with all restroom fixtures, pipes, and drains sealed (Picture 24 and 25). Peeling paint and efflorescence on walls indicate water exposure; however, no mold growth was noted on the brick walls of this structure. Other than two containers, nothing is stored within this area, and it is never occupied by MCH staff or building visitors.

Inside abandoned restroom

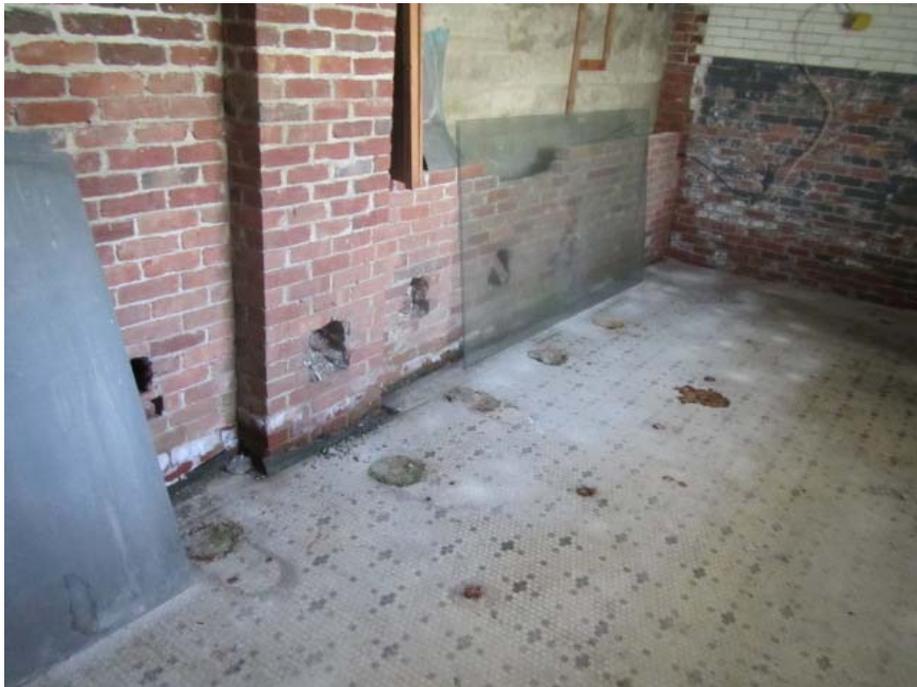
Picture 25

Sealed fixtures inside abandoned restroom

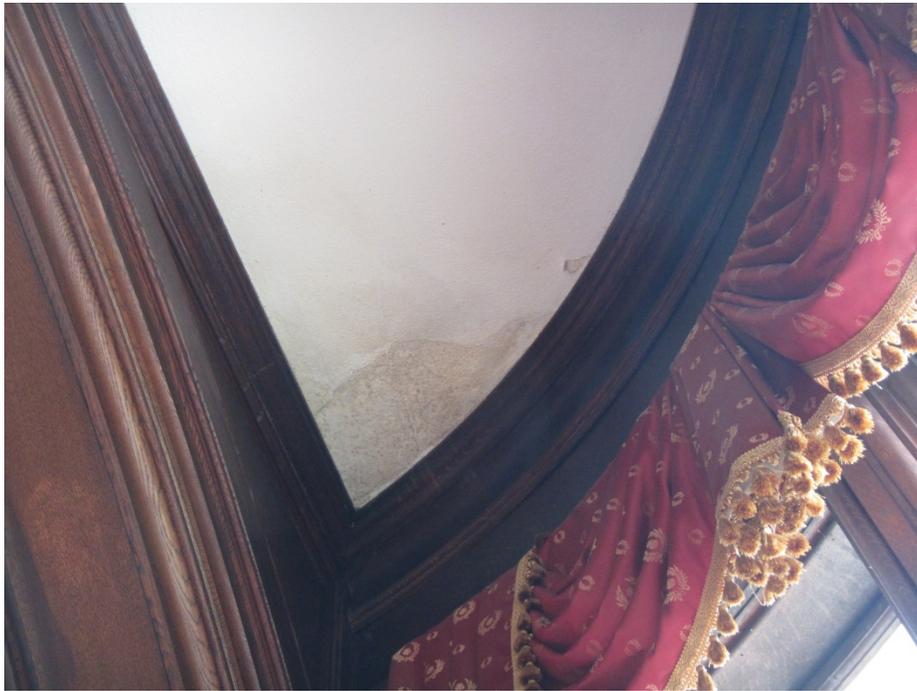
Picture 26

- Water-damaged wall and ceiling plaster and ceiling tiles (Pictures 26 to 28), indicating leaks from the building envelope (e.g. roof, windows, and walls). Reported ice dams from the previous winter also contribute to leaks and damage.

Water-damaged plaster ceiling

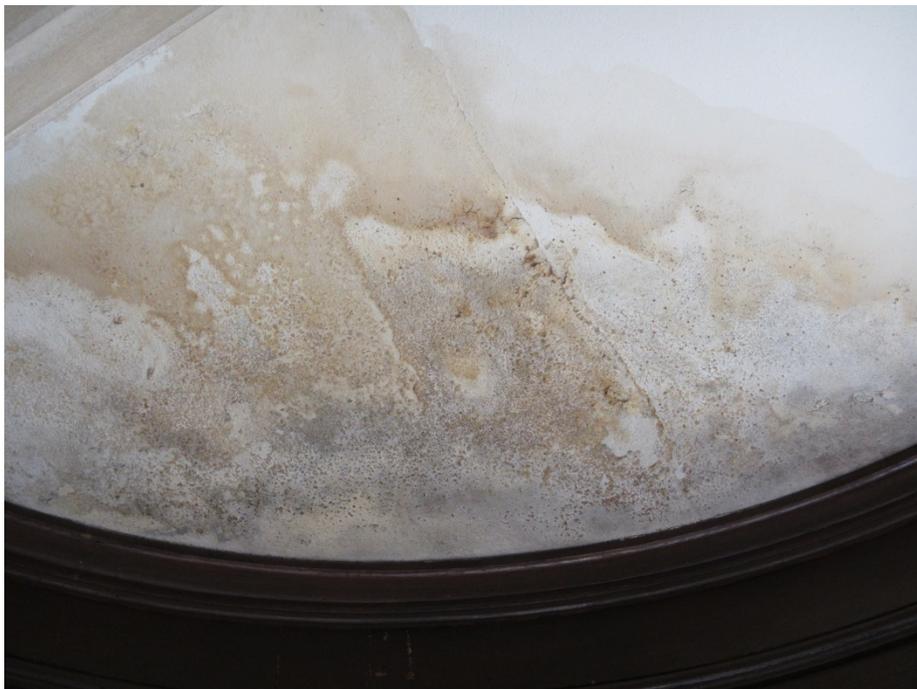
Picture 27

Water-damaged plaster ceiling

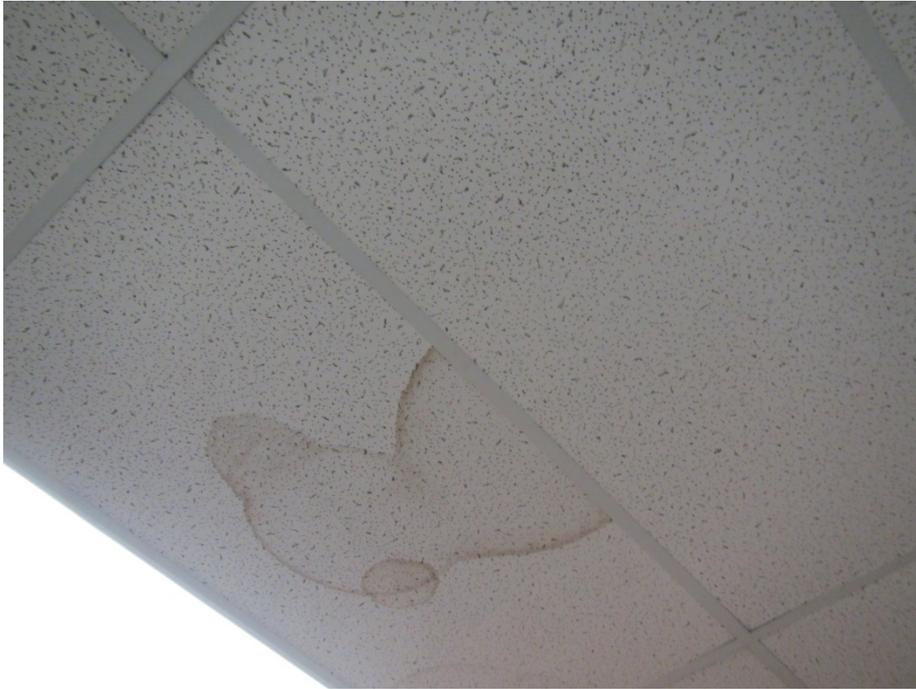
Picture 28

Water-damaged ceiling tile

10. Repair roof leaks, and replace missing slate.
11. Examine the exterior of the building for leaks in interior areas where efflorescence is observed.
12. Replace stained ceiling tiles. Inspect and clean the area above the stained tiles to remove dust/debris that may be colonized with mold.

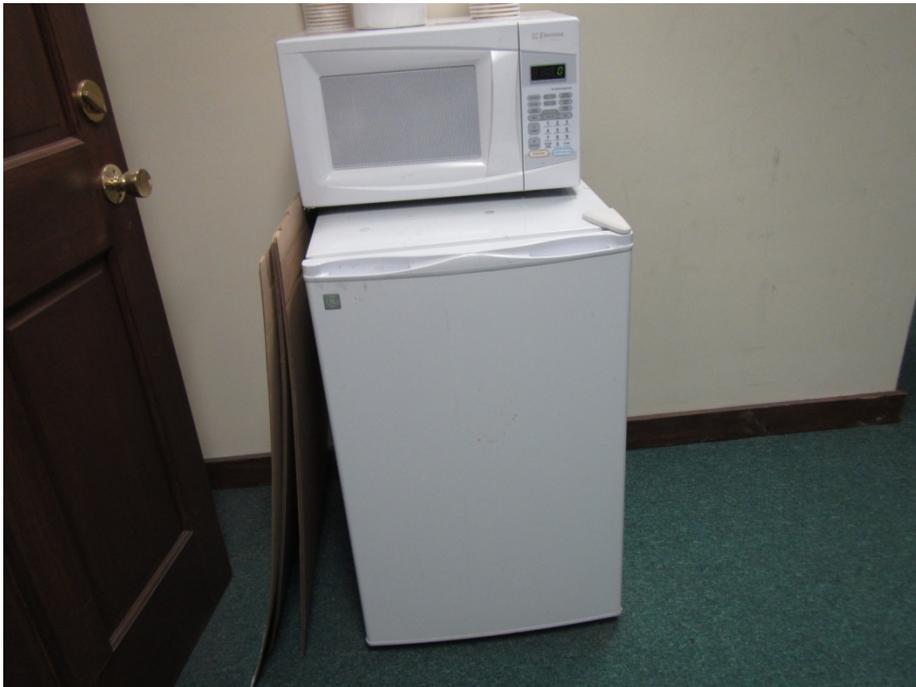
Picture 29

- Lack of exhaust ventilation in restrooms, which results in the accumulation of restroom-generated moisture.
- Water coolers and small refrigerators were observed on carpeting (Picture 29). Spills and leaks from these appliances can moisten carpeting, which can lead to microbial growth and odors.
- Plants were observed in a few areas (Table 1), including on porous surfaces (e.g. carpet). Plants can be a source of pollen and mold, which are respiratory irritants to some individuals. Plants should be properly maintained and equipped with drip pans to prevent water damage to porous materials. Plants should also be located away from air diffusers to prevent the aerosolization of dirt, pollen, and mold.

Refrigerator placed directly on carpet

16. Consider relocated refrigerators and water dispensers to areas with vinyl floor tiles, or place waterproof mats beneath these appliances.
17. Keep plants in good condition, avoid overwatering, and avoid placing them on porous items such as carpets or paper.

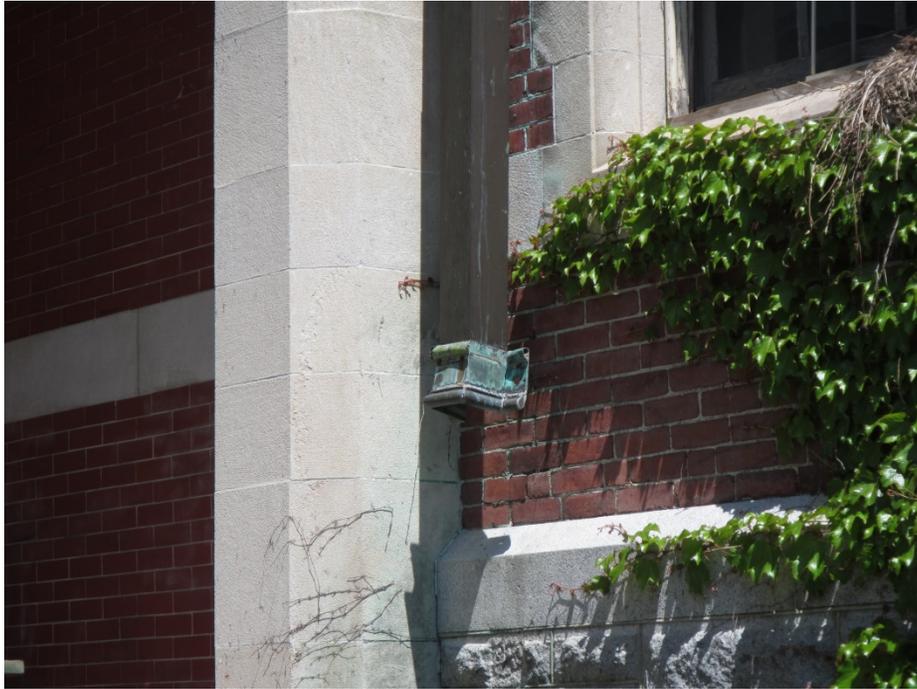
Picture 30

- Missing slate tiles from a few areas of the roof that can lead to leaks.
- Several downspouts were broken/incomplete (Pictures 30 and 31). Lack of proper drainage can cause water to splash against the walls and pool along the foundation, which may lead to damage to the building envelope and infiltration.

Downspout missing lower connection to drainage system

18. Repair the gutter/downspout system to direct water away from the building.
19. Clean the basement window wells of debris and check drainage to prevent the accumulation of water.

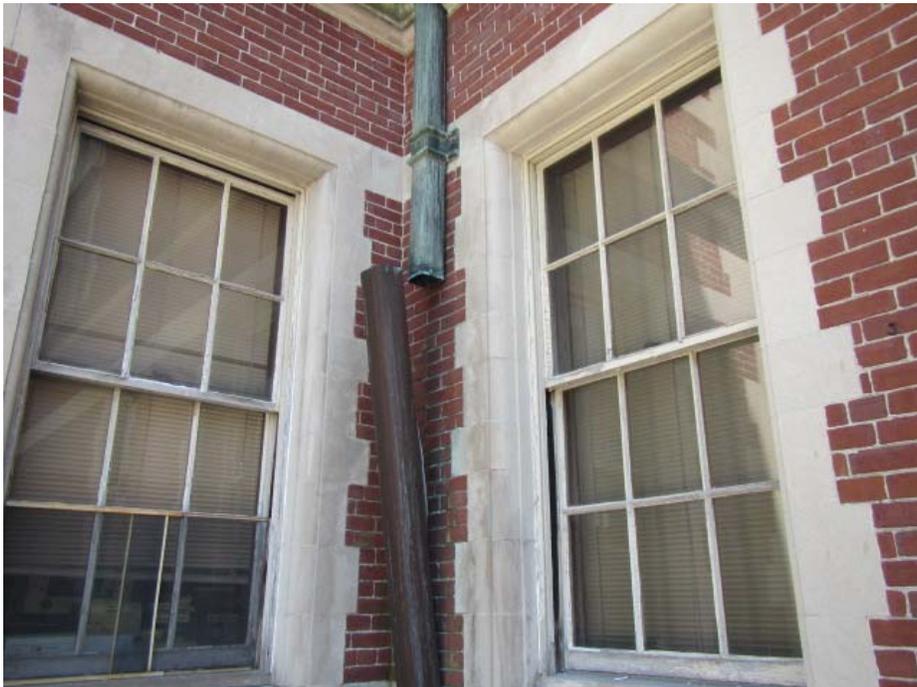
Picture 31

Disconnected downspout

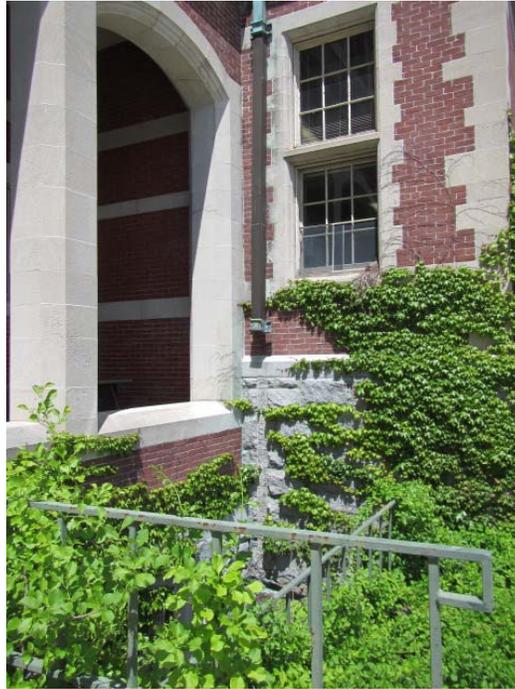
Picture 32

- BEH/IAQ staff noted vegetation on or against the building exterior (Picture 32). Vegetation holds moisture against the building envelope. The plants and moisture may damage mortar, leading to increased water infiltration.

Vegetation against building envelope (note missing downspout section also)

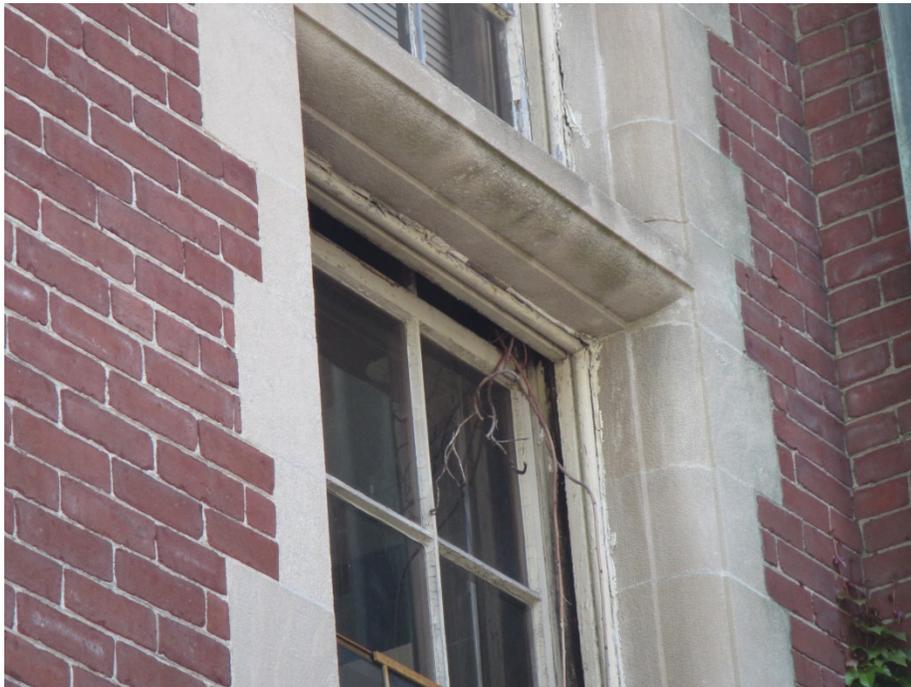
Picture 33

- Several windows were noted to have plant vines growing within the window system (Picture 33). This will increase moisture infiltration, damage, and pest entry.

Window shown partially ajar and having vine growth

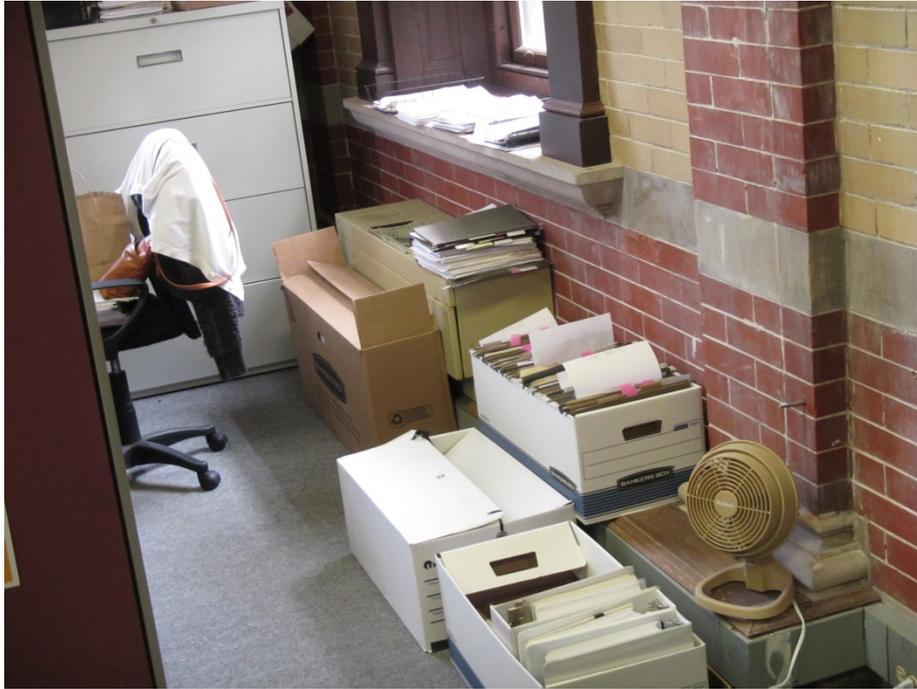
Picture 34

Accumulated items were observed on desks, floors, and other flat surfaces (Pictures 34 to 36). Boxes, papers, and other items were found stored directly in contact with floors, which may be subject to condensation that leads to water damage. In addition, large quantities of paper can provide harborage for pests and may present a fire hazard. A systematic review of stored paperwork and other items should be conducted, with a goal of reducing the overall amount of items and reorganizing the remaining items to be stored in a manner that will prevent further damage, deterioration, and odors (e.g. contained and away from floors).

Boxes on the floor
