INDOOR AIR QUALITY ASSESSMENT

**Methuen City Hall
41 Pleasant Street
Methuen, MA**

Prepared by:
Massachusetts Department of Public Health
Bureau of Environmental Health
Indoor Air Quality Program
June 2016

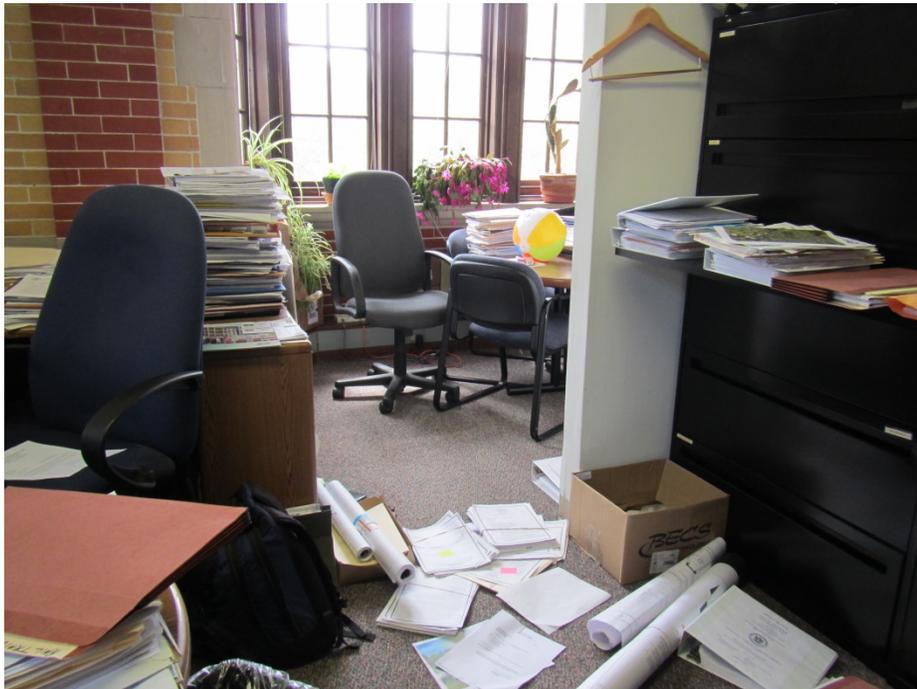
Picture 35

Papers and items on flat surfaces

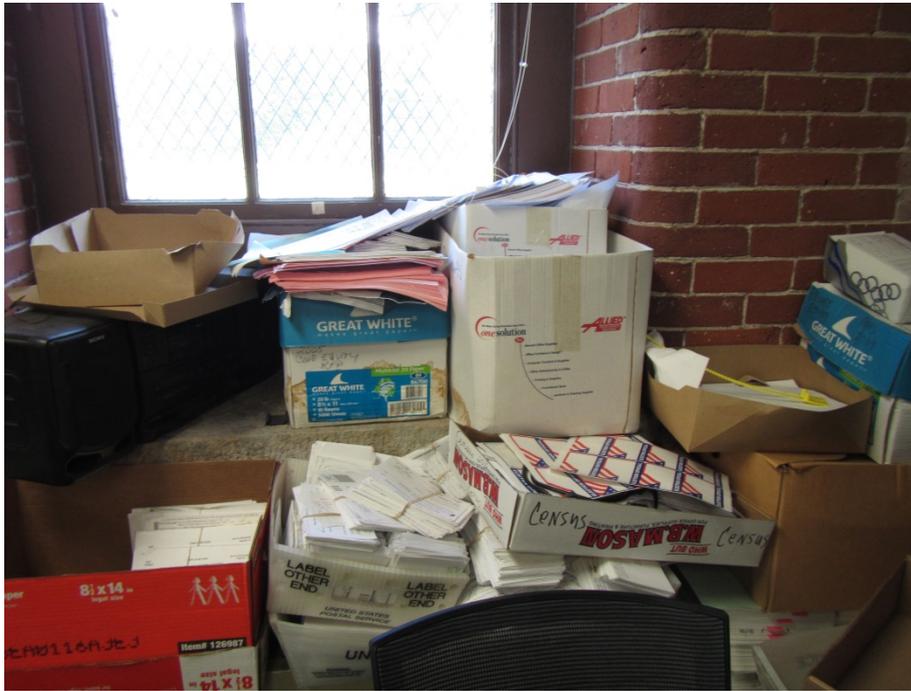
Picture 36

Items in a storage area

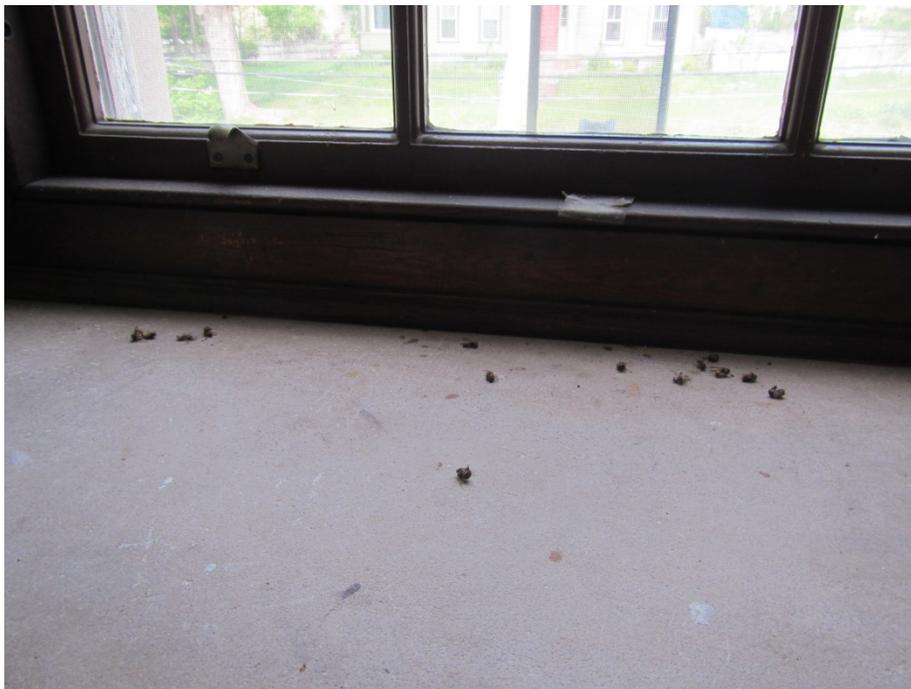
Picture 37

Both living and dead bees were noted inside and outside near the windows of the MCH in several second floor rooms (Picture 37; Table 1). Bees were also reported on the third floor. Bee

Dead bees on a windowsill

23. Consult with a professional exterminator or bee-removal/relocation company to address issues with bees inside and outside the building. Merely removing the bees will create conditions that will cause the bees to return. Any remaining honey in the walls will need to be extracted to prevent microbial growth and additional pest issues.
