INDOOR AIR QUALITY ASSESSMENT

**Henry B. Burkland Intermediate School
41 Mayflower Avenue
Middleborough, Massachusetts**

Prepared by:
Massachusetts Department of Public Health
Bureau of Environmental Health
Indoor Air Quality Program
February 2016

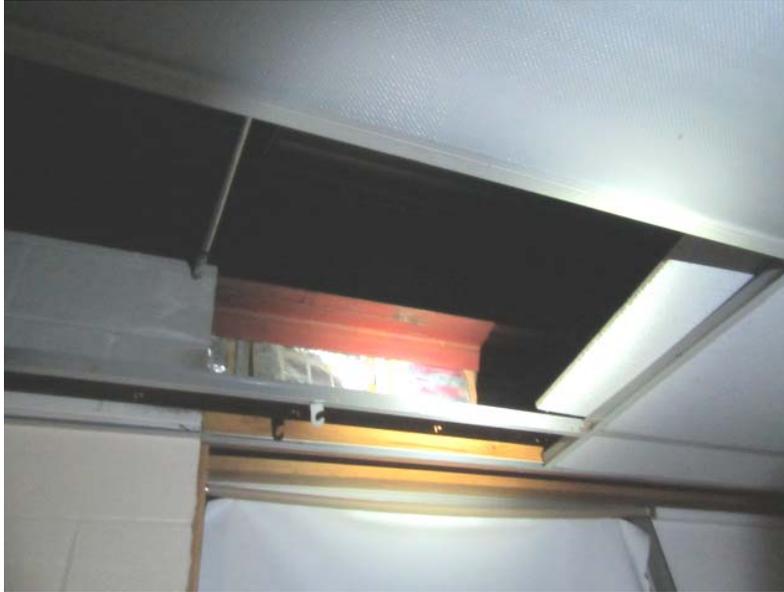
Picture 1

As noted in our previous report (MDPH, 2015b), the building has a flat roof that overhangs the exterior wall of the building (Figure 1). This vertical section of the roof overhang inside the ceiling plenum had fiberglass insulation batts installed against a gypsum wallboard

(GW) material, which appears to have been subjected to chronic water damage (Picture 1) to the materials as well as fiberglass insulation (Picture 2).

Affected gypsum wallboard (behind insulation) above ceiling tile system in classroom found during January 12, 2015 assessment

1. The fiberglass batts were removed.
2. The interior roof surface was treated with an antimicrobial agent.
3. Each location was then sealed using spray foam insulation (Picture 3).

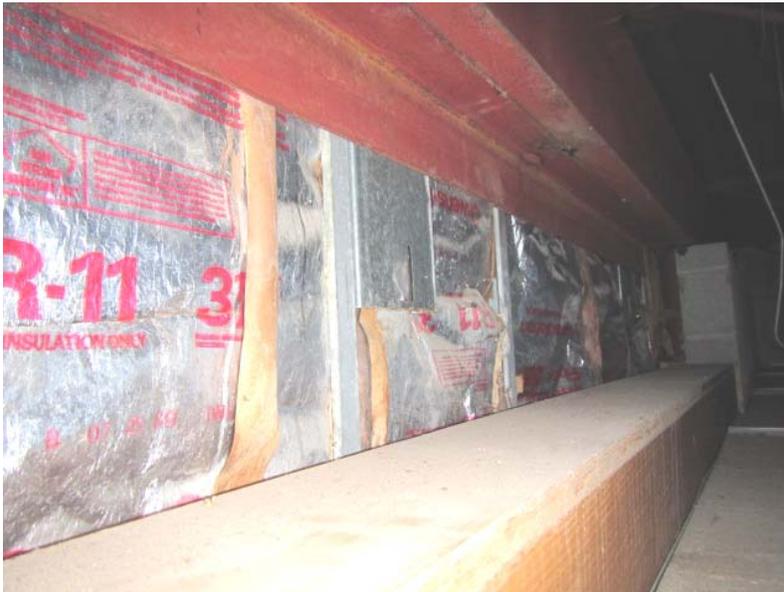
Picture 2

Affected gypsum wallboard (behind insulation) above ceiling tile system in classroom found during January 12, 2015 assessment

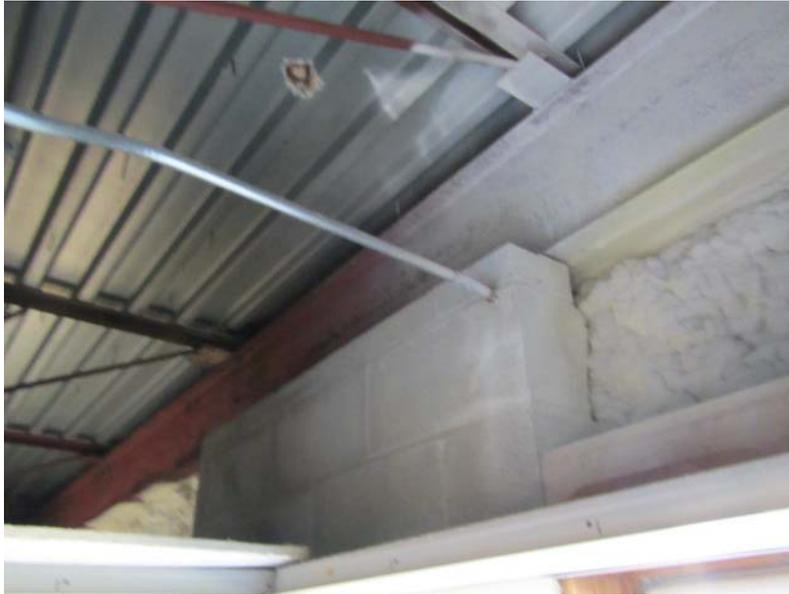
Picture 3

Based on the observations at the time of the visit, the remediation efforts have removed/eliminated mold-colonized materials that were noted in the BIM ceiling plenum during the January 12, 2015 visit by BEH staff.

Soffit sealed with spray foam insulation
