INDOOR AIR QUALITY ASSESSMENT

**Department of Public Health
Southeastern Regional Health Office
1736 Purchase Street
New Bedford, MA 02740**

Prepared by:
Massachusetts Department of Public Health
Bureau of Environmental Health
Indoor Air Quality Program
March 2016

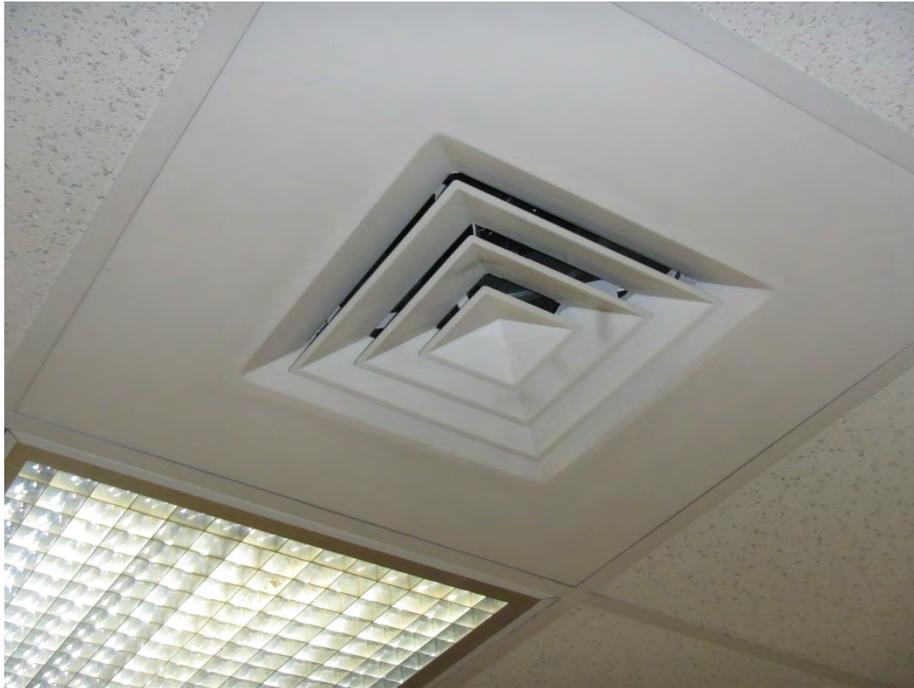
Picture 1

Fresh air is provided by rooftop air-handling units (AHUs) and ducted to supply air diffusers in cubicle areas and offices (Picture 1). Air is returned to the AHUs via ducted vents in the ceiling (Picture 2). SERHO staff reported thermal comfort concerns, particularly in areas adjacent to windows. Use of adjustable blinds and shades and/or the application of tinted window film should help to prevent heat complaints due to solar gain.

Supply air diffuser

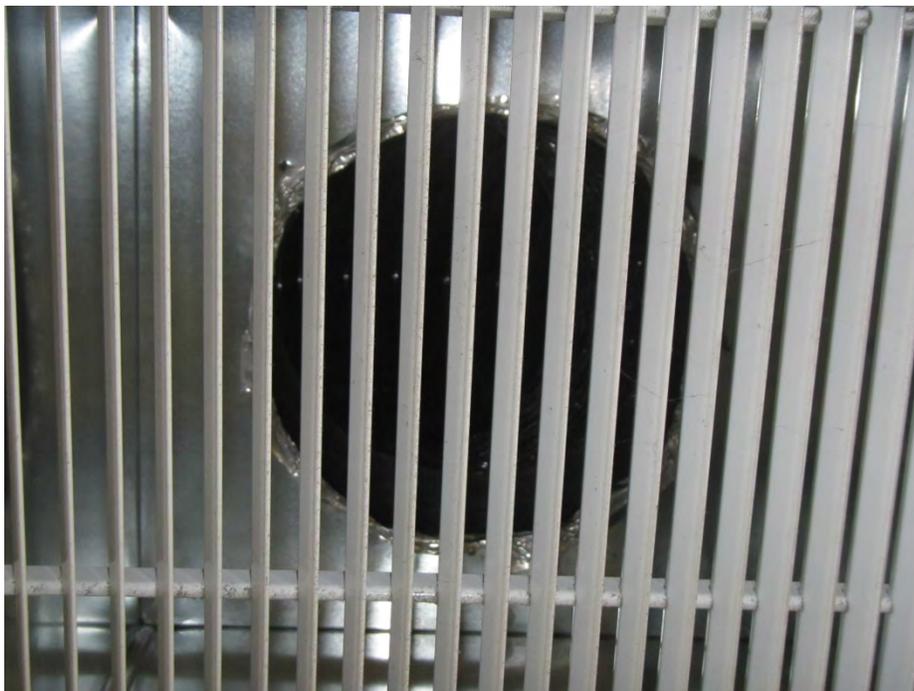
Picture 2

Ducted ceiling exhaust vent

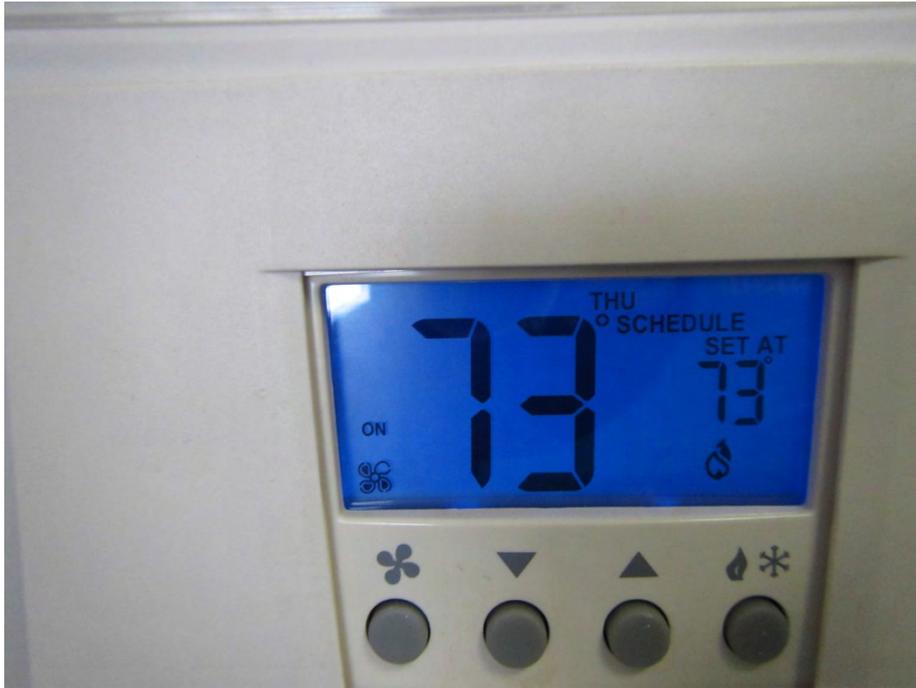
Picture 3

Thermostat showing correct fan setting of “on”

thermostats be set to the fan “on” setting during occupied periods to provide continual air circulation and filtration.

4. Operate thermostats in the fan ‘on’ setting during occupied periods to allow for continuous fresh air circulation and filtration.
5. Consider installing a new kitchen toaster in a manner that does not impact the electrical supply cord.

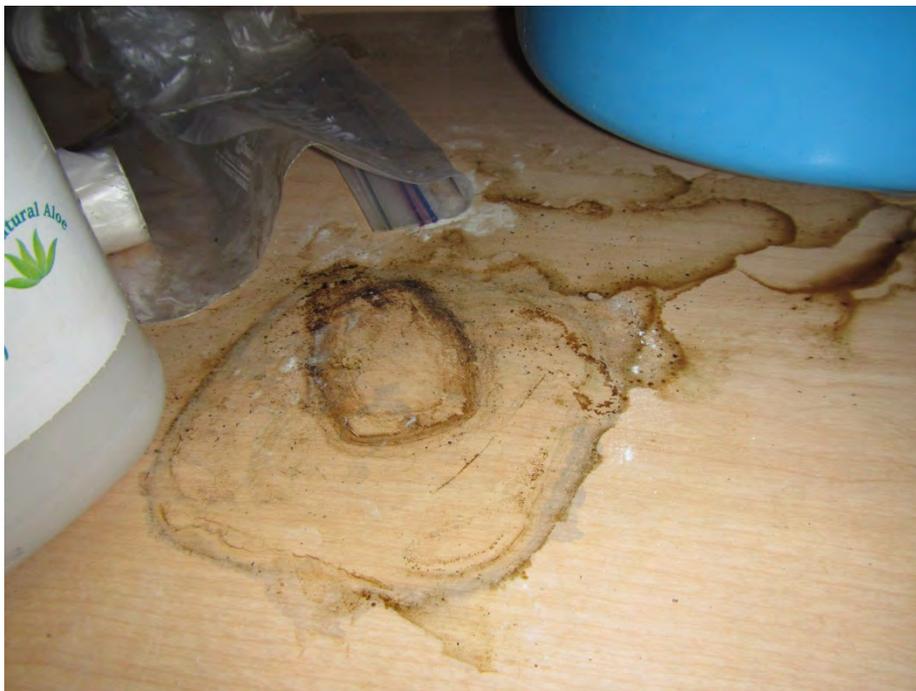
Picture 4

BEH/IAQ staff noted the presence of water staining under the sink in the break room (Picture 4). It was not clear whether the leak is from the plumbing or from containers of liquids under the sink. This area should be cleaned and monitored for future leaks. Any necessary repairs should be made promptly to avoid wetting porous building materials. Containers of compatible liquids should be stored together in a waterproof container.

Water staining under kitchen sink

6. Clean the area under the kitchen sink and monitor for future leaks. Any necessary repairs should be made promptly to avoid wetting porous building materials. Compatible liquids/cleaners should be kept in waterproof containers.

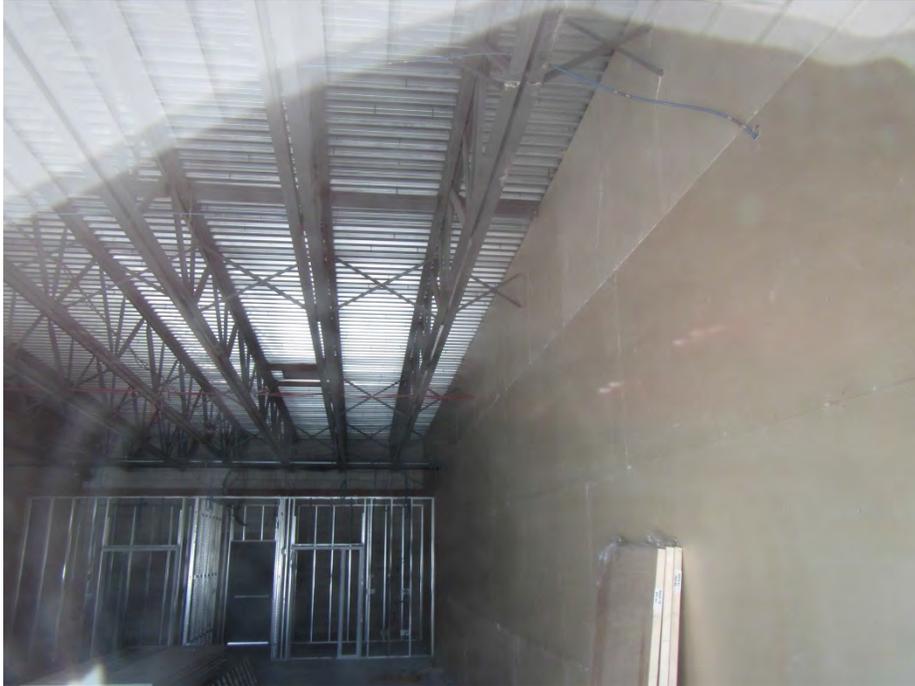
Picture 5

As mentioned previously, no VOCs were detected by BEH/IAQ staff most likely due to the dissipation and dilution of the substance prior to this assessment. The walls of the vacant space did not appear to have been finished/painted (Picture 5) so it is likely that the product used was some type of solvent or primer. Workers were not present, so BEH/IAQ staff could not inquire about specific products used.

Vacant space adjacent to SERHO office (note unfinished GW)

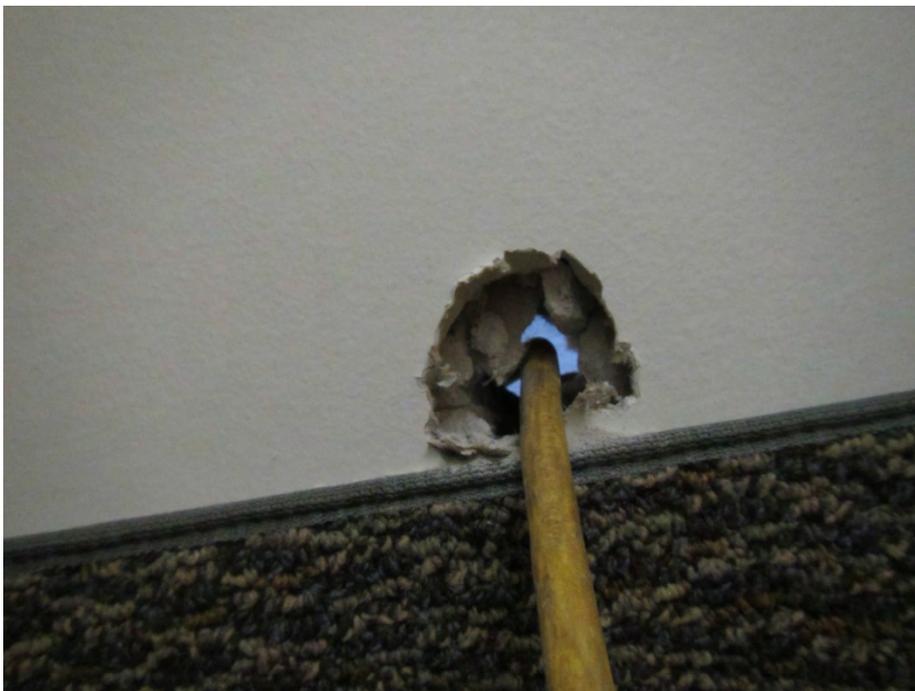
Picture 6

- A hole, which appears to be recently punched through the shared wall, had an extension cord running from the vacant space and plugged into a SERHO office outlet. The hole was not well sealed, and light could be seen coming from the adjacent vacant space that was under construction (Picture 6).
- The GW shared wall extends up to the corrugated roof deck but it could not be determined if the spaces between the corrugated roof deck have been sealed on either side of the shared wall (Picture 7).
- Air could be felt coming from electrical outlets on the shared wall between the two units.

Hole in shared wall showing light from vacant space and power cord

These pathways should be sealed to prevent pollutants from traveling to occupied spaces.

1. Perform construction work involving strong odors, VOCs, and dust during unoccupied hours.
2. Seal pathways between the shared wall between the two space (hole in GW, gaps around electrical outlets, verify spaces in corrugated roof deck have been sealed).

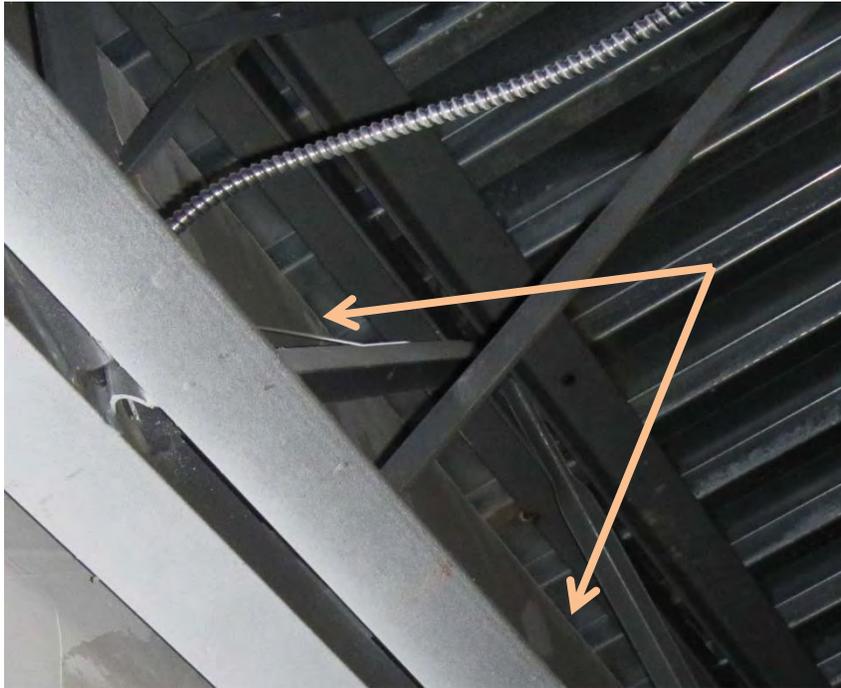
Picture 7

GW against corrugated roof decking does not appear to be sealed in spaces

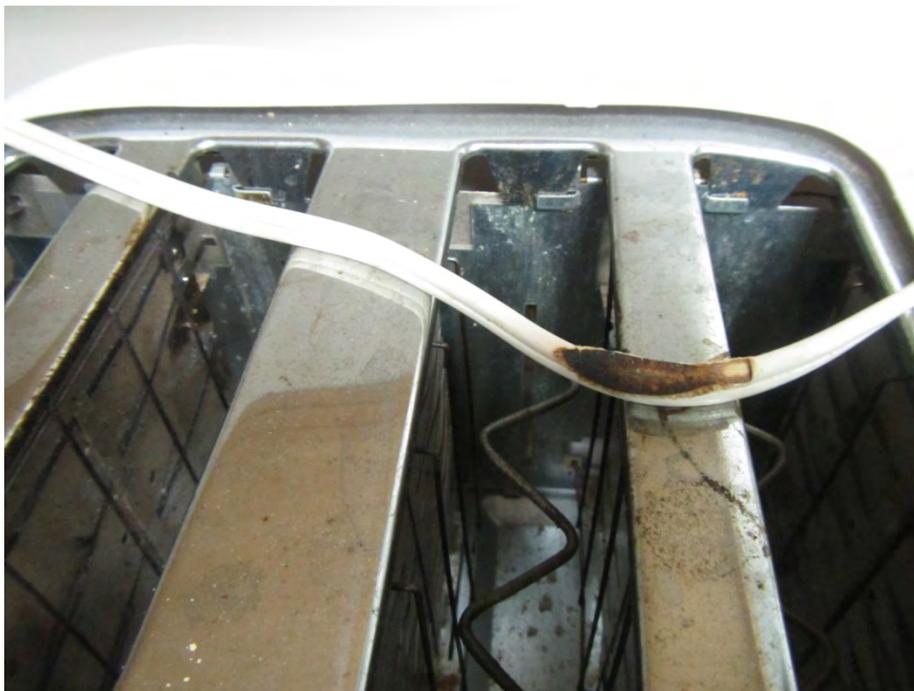
Picture 8

BEH/IAQ staff noted an electrical cord resting on top of a toaster. This cord appeared melted due to the heat from the toaster (Picture 8). Foul odors, smoke, and an electrical hazard could result from this situation. It is recommended that a new toaster be installed in a manner which does not impact the electrical supply cord.

Melted electrical cord on top of toaster

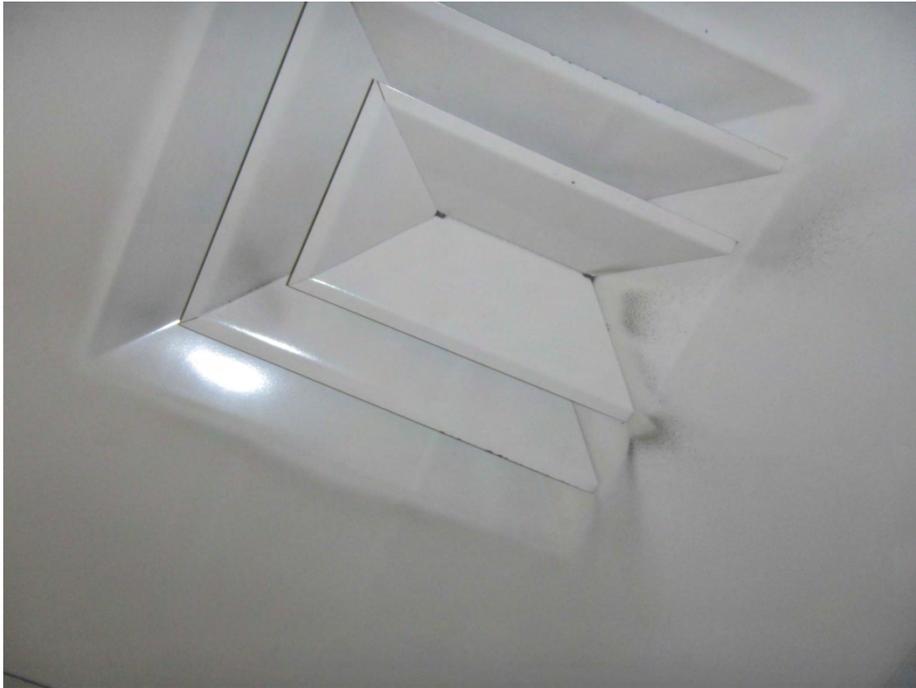
Picture 9

Dusty supply vents were observed in several areas (Picture 9). Dust can be irritating to the eyes, nose and respiratory tract. These items should be cleaned periodically in order to prevent them from serving as a source of aerosolized particulate matter. In addition, it should be verified that HVAC filters are changed semiannually (e.g., per heating/cooling season) utilizing MERV 9 pleated filters or higher to ensure removal of airborne dusts.

Dust accumulated on supply vent

14. Clean supply and return vents as well as personal fans periodically of accumulated dust.
15. Verify that HVAC filters are changed semiannually (e.g., per heating/cooling season) utilizing MERV 9 or higher pleated filters.

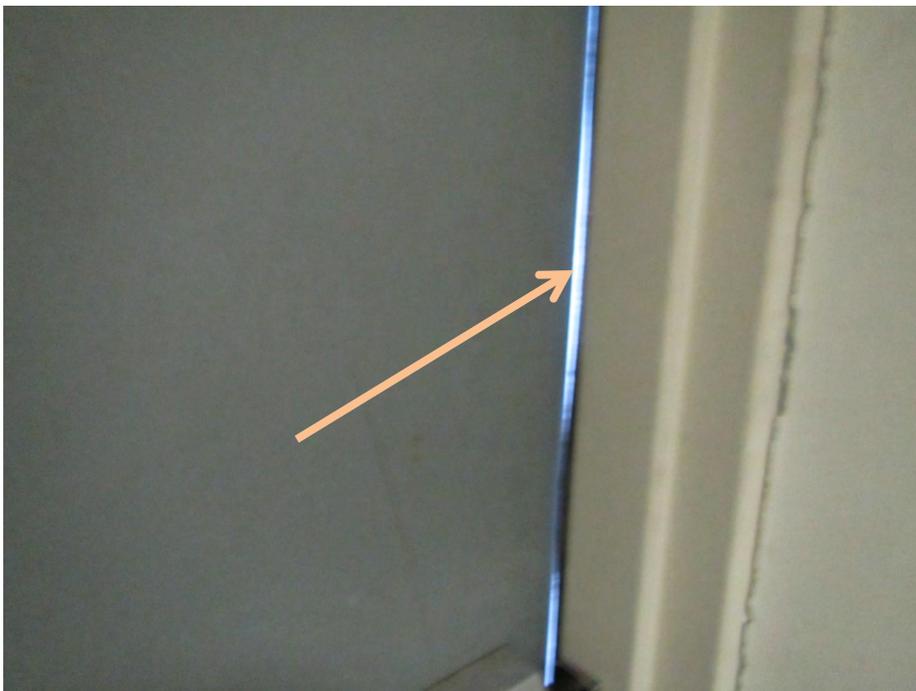
Picture 10

The rear exit door for the SERHO office lacked a tight-fitting gasket around the door frame. Light could be seen around the door (Picture 10). Weather stripping or a tight-fitting door gasket should be installed to prevent moisture, odors, and pollutants from entering the space.

Gaps around rear exit door; note light penetrating (arrow)

16. Weather stripping or a tight-fitting door gasket should be installed around the rear exit door frame to prevent moisture, odors, and pollutants from entering the space.
