INDOOR AIR QUALITY ASSESSMENT

**Department of Developmental Services
Berkshire Regional Office
333 East Street, 5th Floor
Pittsfield, MA**

Prepared by:
Massachusetts Department of Public Health
Bureau of Environmental Health
Indoor Air Quality Program
September 2016

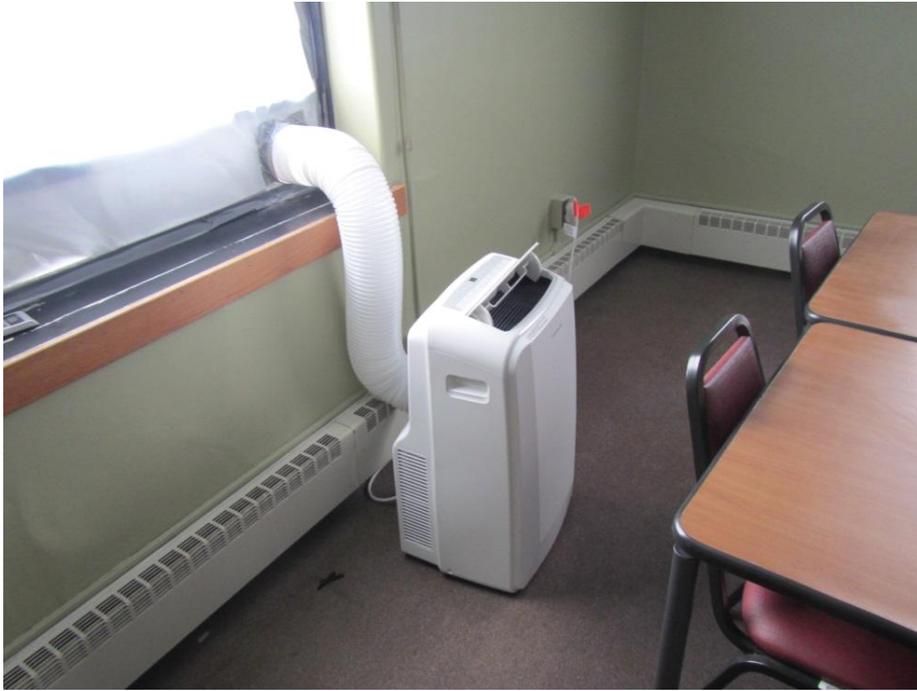
Picture 1

It is important to note that the building is not equipped with a functioning ventilation system. The sole source of ventilation in the building is openable windows. Air-conditioning (AC) is provided by window-mounted units. In an effort to reduce the impact of odors from the brick repointing, the window-mounted AC units were removed from the windows frames, which were then sealed with plastic. A number of offices were equipped with portable AC units (Picture 1) to provide temperature relief while windows were sealed.

The installation of the portable AC units coincided with the reports of odors inside the building. BEH IAQ staff noted that odors in the hallways seemed to originate from offices that did not have operating AC units. It appears the use of the portable AC units is causing depressurization (e.g., negative pressure), which draws odors from offices, storage space and the elevator shafts into the hallways and into offices with operating equipment. A number of different sources of odors were noted throughout the 5th floor:

Example of portable AC unit

1. Install a fan with a filter in the hallway window at near the north elevator to direct fresh air indoors to *pressurize* the hallway.
2. Use a fan to direct air *towards* the north elevator to contain hydraulic fluid odor.

3. Ascertain if a second fan with filters can be installed in another exterior window on the 5th floor to provide additional pressurization.
4. Reduce/eliminate odorous products in office space.
