# **INDOOR AIR QUALITY ASSESSMENT**

**Department of Environmental Protection  
436 Dwight Street  
Springfield, Massachusetts**

Prepared by:  
Massachusetts Department of Public Health  
Bureau of Environmental Health  
Indoor Air Quality Program  
May 2016

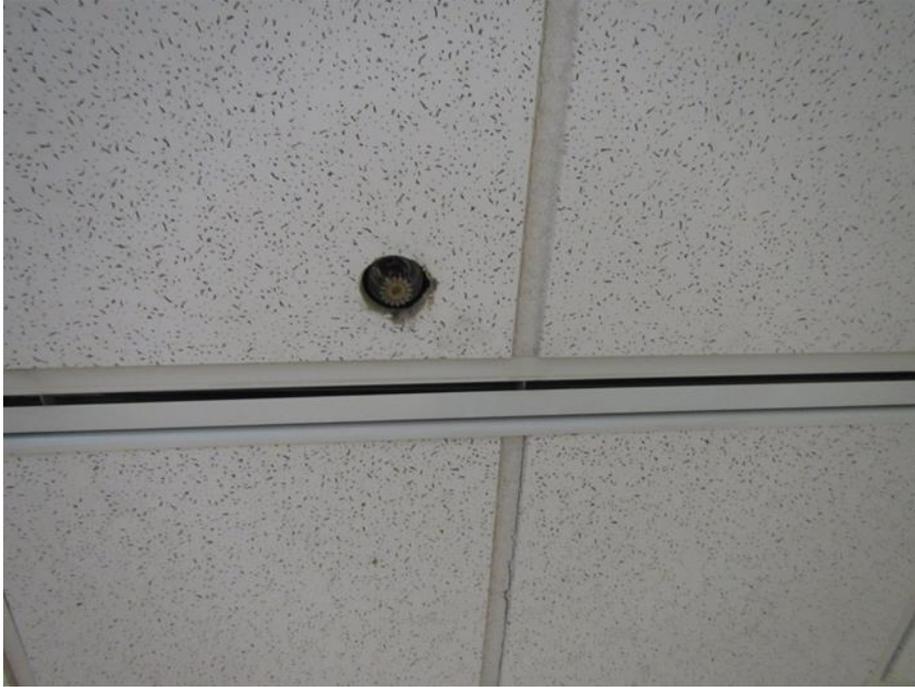
**Picture 1**

It can be seen from Table 1 that carbon dioxide levels were below 800 ppm in all areas surveyed. Fresh air is provided by air-handling units (AHUs) located on the roof. Fresh air is ducted to supply air diffusers located throughout the space (Picture 1). Air is returned to the AHUs via ceiling plenum exhaust vents (Picture 2).

**Ceiling-mounted, slotted supply diffuser**

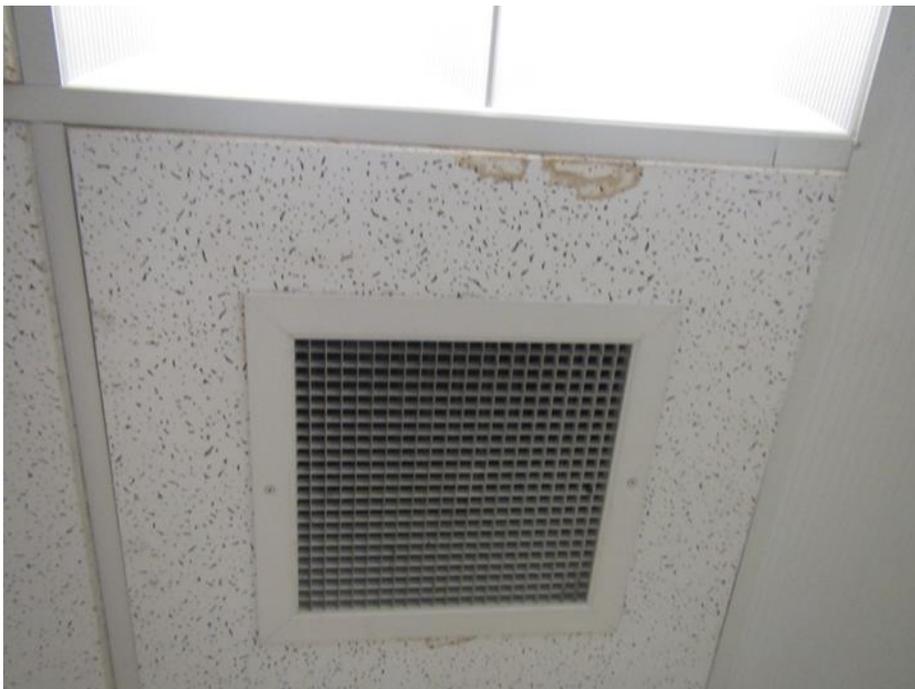
**Picture 2**

**Ceiling plenum return vent**

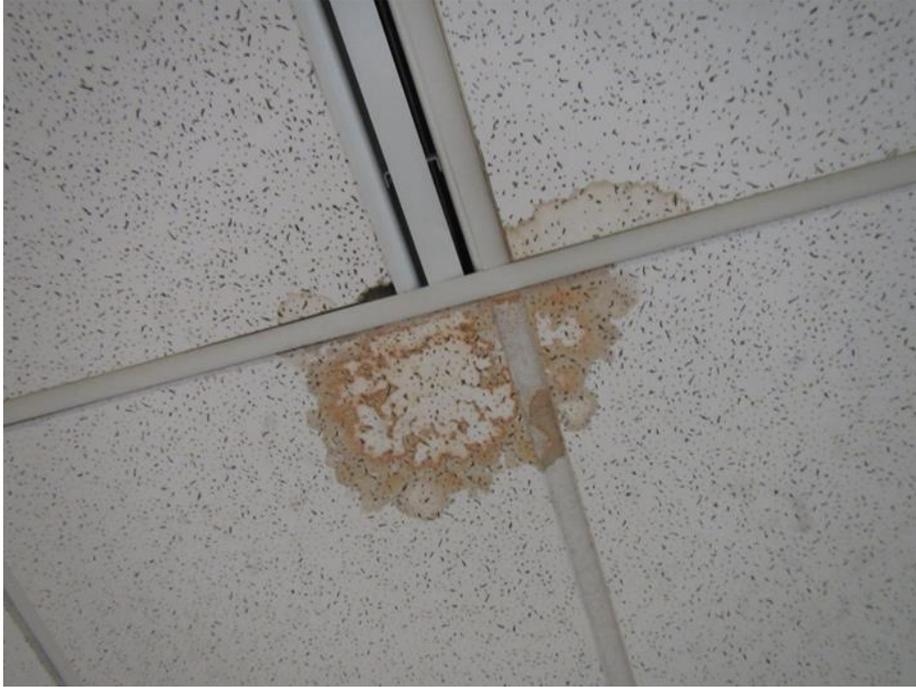
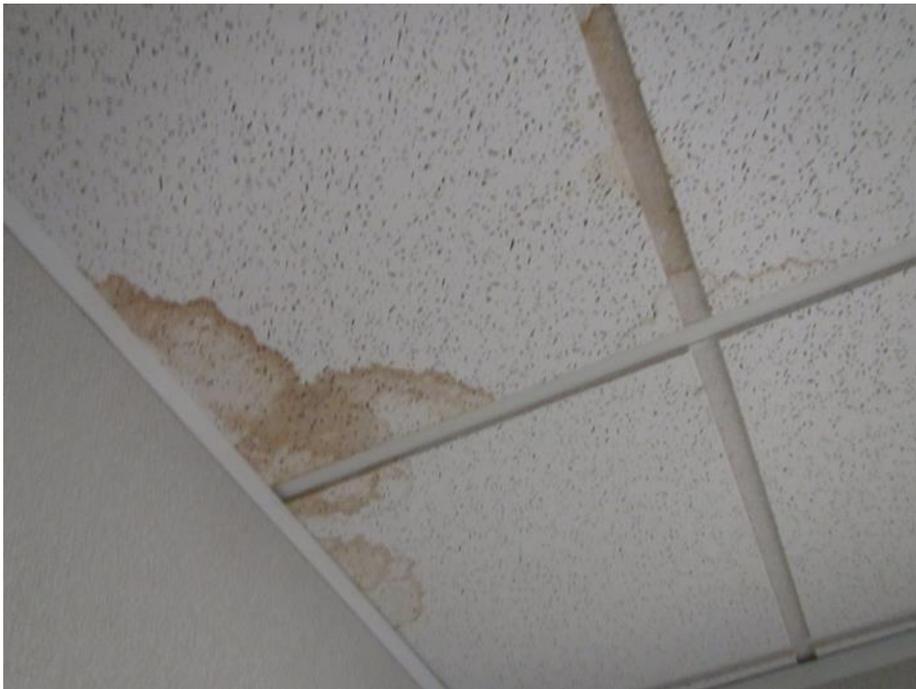
- Water-damaged ceiling tiles were observed in several areas throughout the DEP office space (Pictures 3 and 4, Table 1). DEP staff reported that most water damage was historic except for the leak in the entry hall of the DEP space on the fifth floor just after the Reception area (Picture 5). The source of this leak should be investigated and repaired.
- Any porous materials (e.g., ceiling tiles) not dried within 48 hours should be discarded and replaced.
- Plants were noted in several areas (Pictures 6 to 8). Plants can be a source of pollen and mold, which can be respiratory irritants to some individuals. Plants should be properly maintained and equipped with drip pans and should be located away from air diffusers to prevent the aerosolization of dirt, pollen and mold.

**Water-damaged ceiling tiles**

3. Investigate the source of the active leak on the fifth floor (through door past the Reception area) and repair as necessary.
4. Remove any water-damaged porous materials (e.g., ceiling tiles) that were not dried within 24 to 48 hours and replace new.

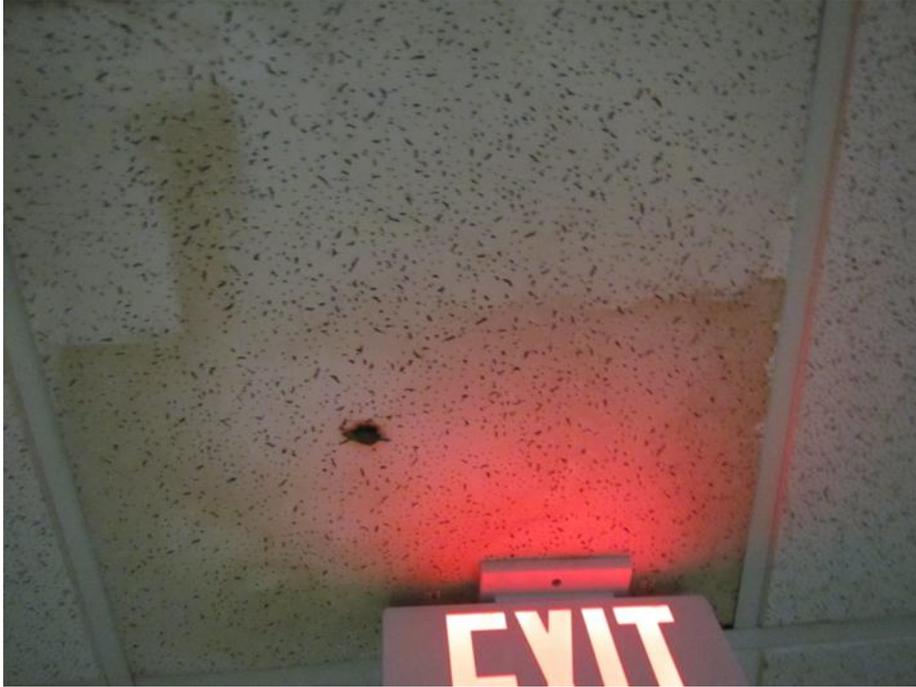
**Picture 5**

**Area of reported active leak on 5<sup>th</sup> floor**

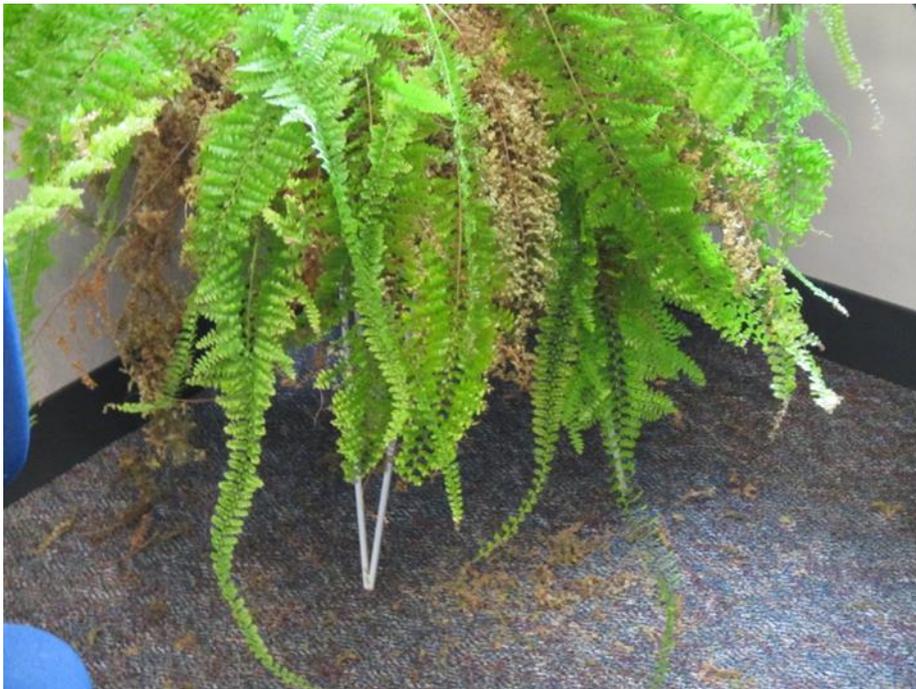
**Picture 6**

**Plant and debris in office area**

15. Plants should be properly maintained and equipped with drip pans and should be located away from air diffusers to prevent the aerosolization of dirt, pollen and mold.

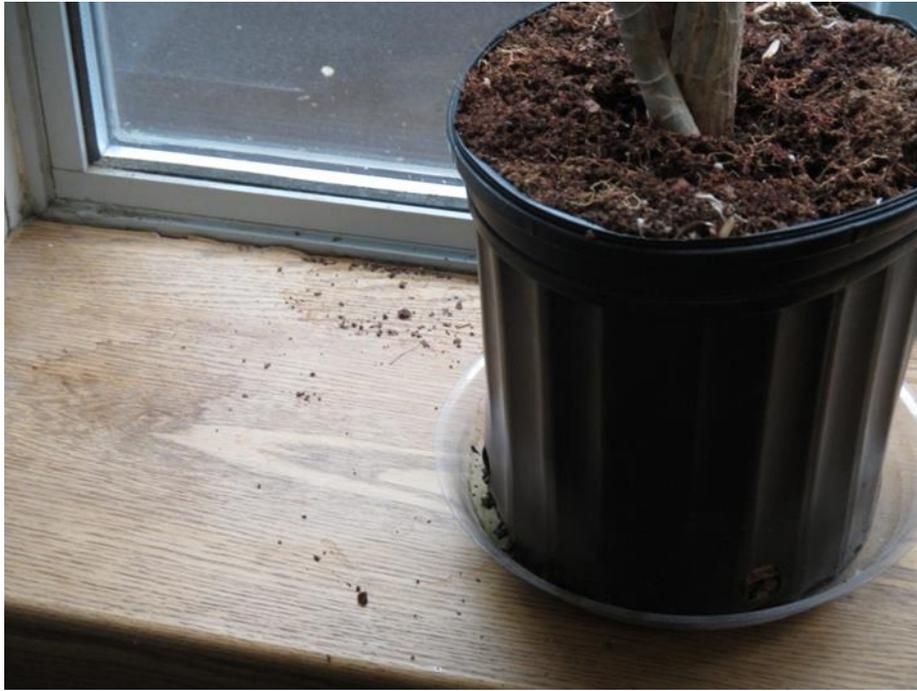
**Picture 7**

**Plant with debris and water staining**

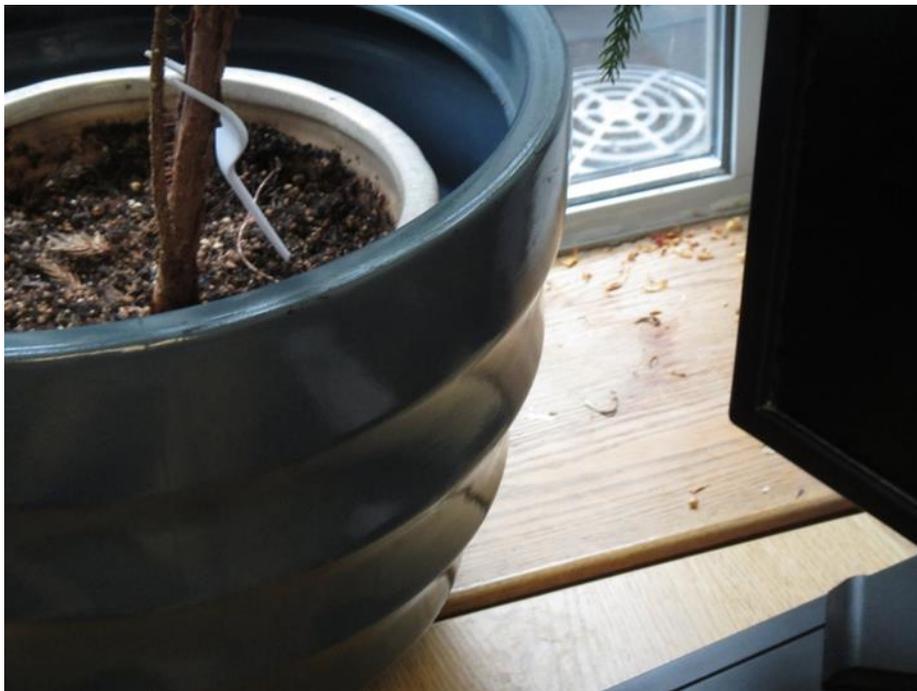
**Picture 8**

**Plant with debris and water staining**

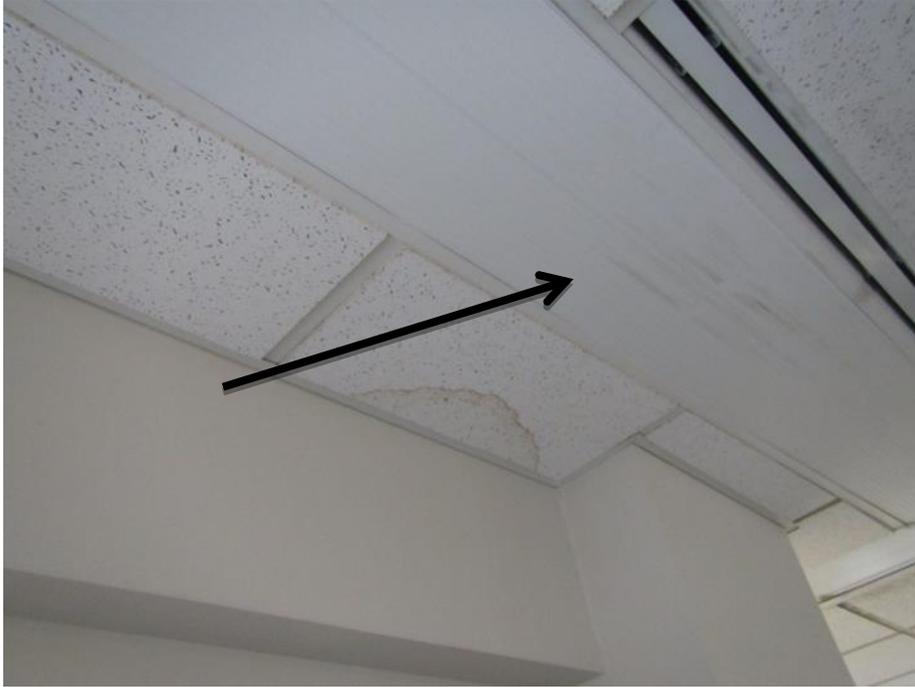
**Picture 9**

BEH staff examined the suspended ceiling, which contain a radiant heating loop near the perimeter walls of the entire 5<sup>th</sup> floor space (Picture 9). BEH staff noted the heating loop was installed in the beams of the suspended ceiling without any separation or insulation between the heating loop housing and the suspended ceiling beams. BEH staff found that the heating loop had a temperature range of 135°F to 147°F in several areas (Table 2). The metal beams adjacent to the heating loop housing had a temperature range of 115°F to 128°F, which then heated the adjacent ceiling tiles to a temperature within a range of 92°F to 103°F. Ceiling tiles have an operational temperature range set by the manufacturer. If the operational temperature range is

exceeded, it is likely to accelerate off-gassing of odor and breakdown of the ceiling tiles. DEP staff reported that these ceiling tiles had a strong odor when they arrived for installation. According to the manufacturer, the temperature range recommendation for use is 60 °F to 85 °F (Armstrong, 2016). It is likely that the odors reported are starches and other compounds in the ceiling tiles which are being off-gassed due to the high heat in close proximity to the new ceiling tiles. In addition, the exhaust vent was not operating in this area, which would result in off-gassing odors to accumulate in this location. Other locations in the DEP offices had similar ceiling temperature measurements; however each area had a functioning exhaust vent.

**Section of perimeter heating loop pipe inspected (arrow)**

1. Repair and activate the exhaust vent in the area where the odors was denoted.
2. Investigate strategies to mitigate the probable ceiling tile odor in areas of elevated temperature surrounding the ceiling heating pipe loop. Some strategies may include improving insulation techniques near the ceiling tiles or replacing the ceiling tiles in those areas with a more heat resistant material.

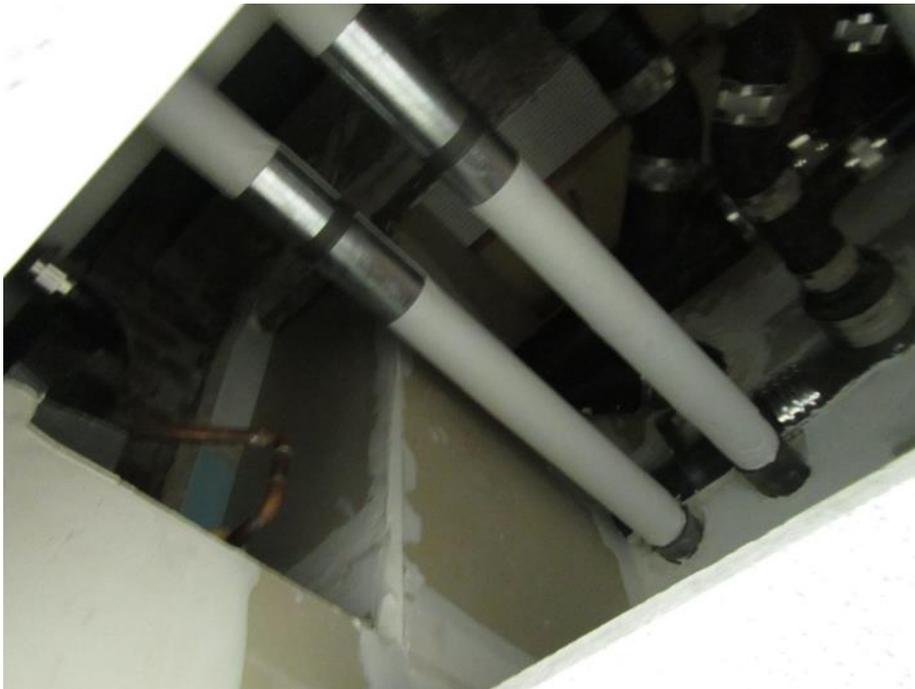
**Picture 10**

The 4<sup>th</sup> floor men's bathroom was noted to have several missing ceiling tiles (Picture 10). These tiles should be replaced as soon as possible to avoid the entrainment of bathroom odors and moisture into the ceiling return plenum.

**Missing ceiling tiles in 4<sup>th</sup> floor men's bathroom**

11. The missing ceiling tiles in the 4<sup>th</sup> floor men's bathroom should be replaced as soon as possible to avoid the entrainment of bathroom odors and moisture into the ceiling return plenum.

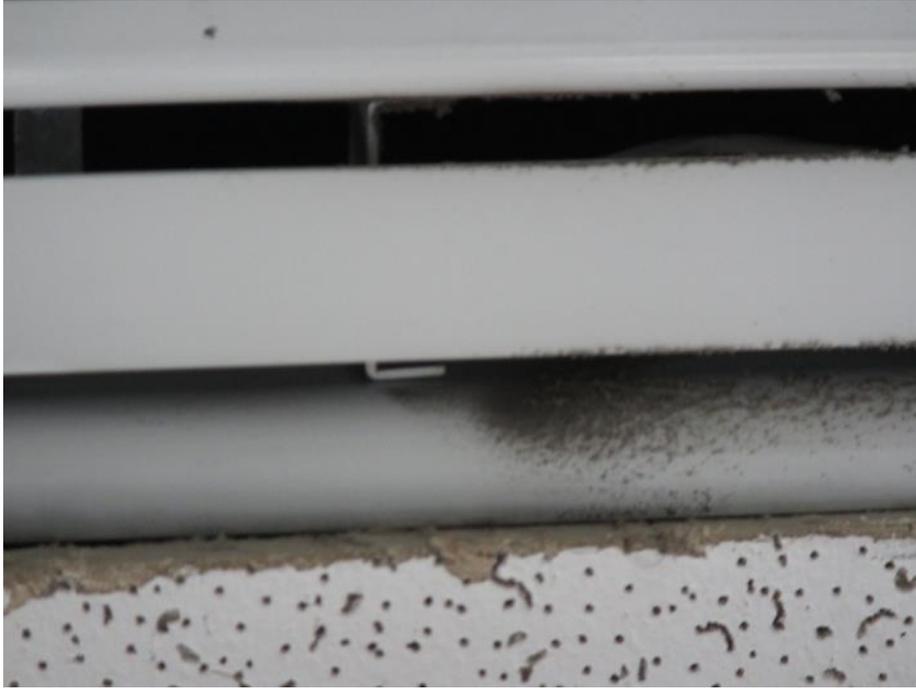
**Picture 11**

Supply and exhaust vents were noted to be dusty in several areas throughout the DEP space (Pictures 11 and 12). Some of this debris may be the result of filter bypass. These vents should be cleaned regularly to avoid aerosolizing accumulated particulate matter.

**Dust/debris accumulated on supply vent**

12. Supply and exhaust vents should be cleaned regularly to avoid aerosolizing accumulated particulate matter.
13. The large number of stored items (e.g., papers, folders, boxes) makes it difficult for custodial staff to clean. Items should be relocated and/or be cleaned periodically to avoid excessive dust build up. Consider implementing further storage solutions.

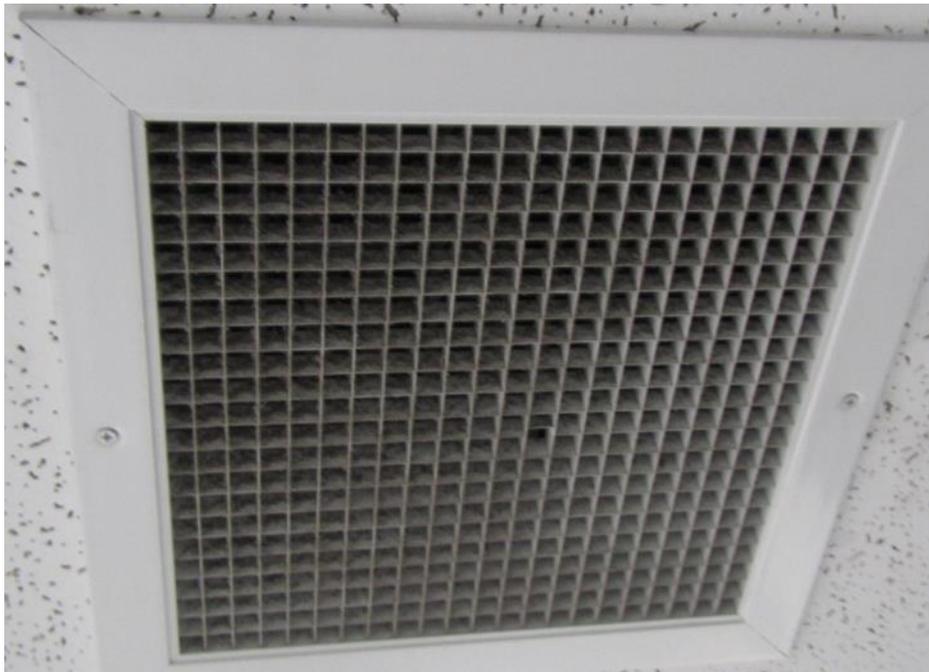
**Picture 12**

**Dusty return vent**

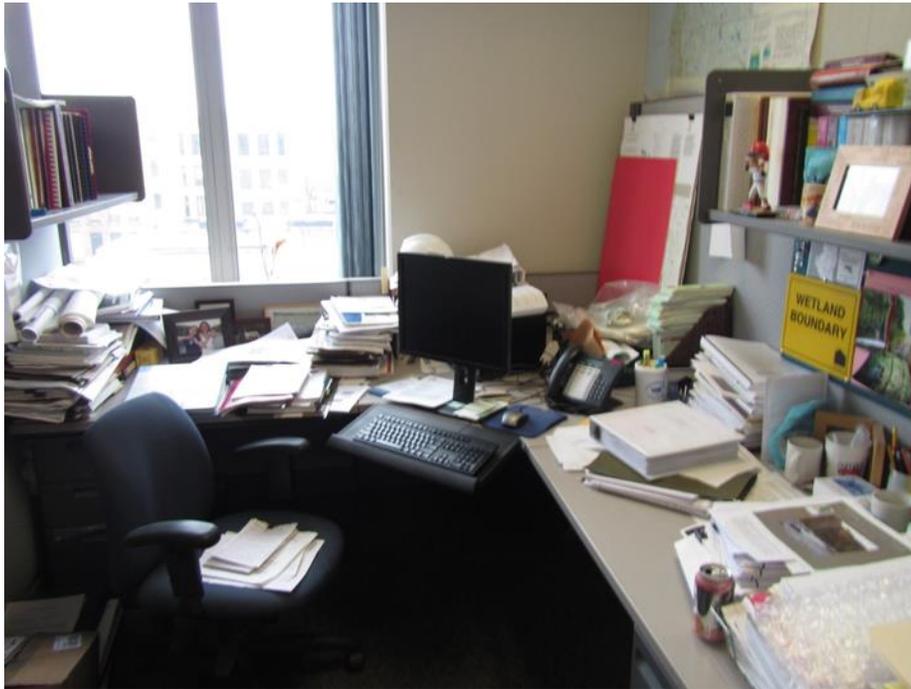
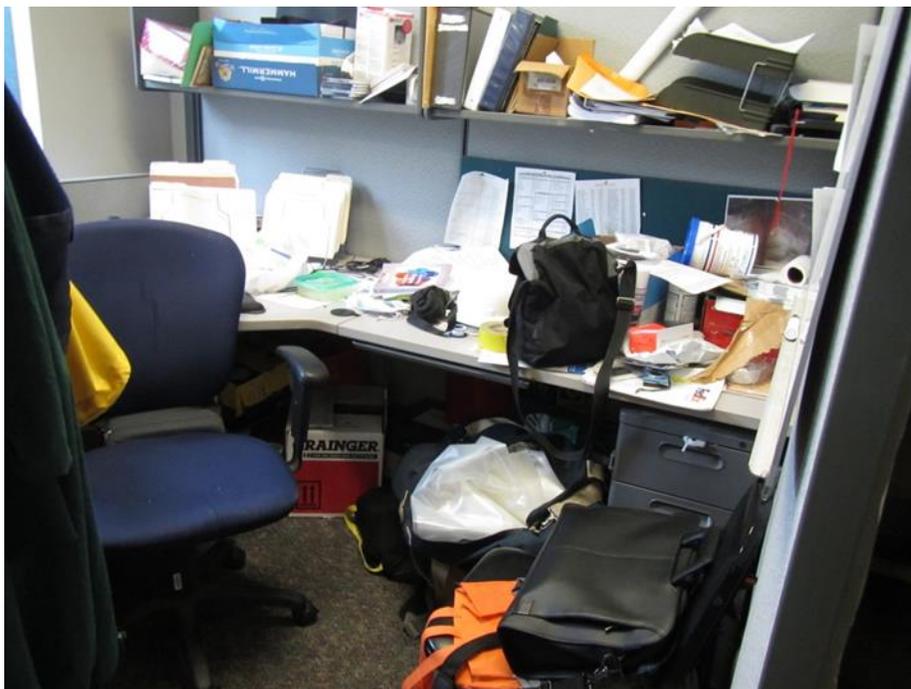
In several areas, items were observed on the floor, windowsills, tabletops, counters, bookcases, and desks (Pictures 13 and 14). The large number of stored items provides a source for dusts to accumulate. These items (e.g., papers, folders, boxes) make it difficult for custodial staff to clean. Once aerosolized, they can act as irritants to eyes and respiratory system. Items should be relocated and/or be cleaned periodically to avoid excessive dust build up. In addition, further storage solutions should be implemented.

**Accumulated items in office space**

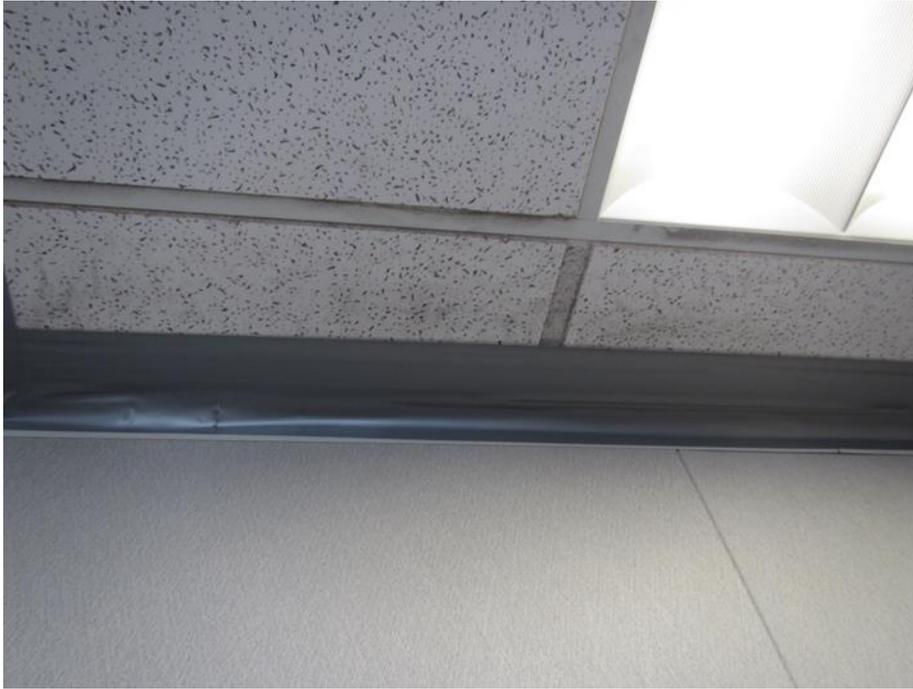
**Picture 15**

Some supply diffusers were noted to be covered with duct tape (Picture 15). Any obstructions to the supply or return vents will interfere with the HVAC system balance and should be removed. Dedicated local exhaust vents should be installed in kitchen/breakrooms to remove food odors/smoke. Also, consider sealing pathways (Picture 16) in these areas to avoid entraining food odors/smoke into the return plenum system.

**Supply diffuser blocked with duct tape**

8. Any obstructions (e.g., duct tape) to the supply or return vents will interfere with the HVAC system balancing and should be removed.
9. Consider programming AHU controls to condition and exchange air an hour before early staff arrival times. Alternatively, staff arrival schedules could be delayed until the AHU system adequately conditions and exchanges the air in the space.

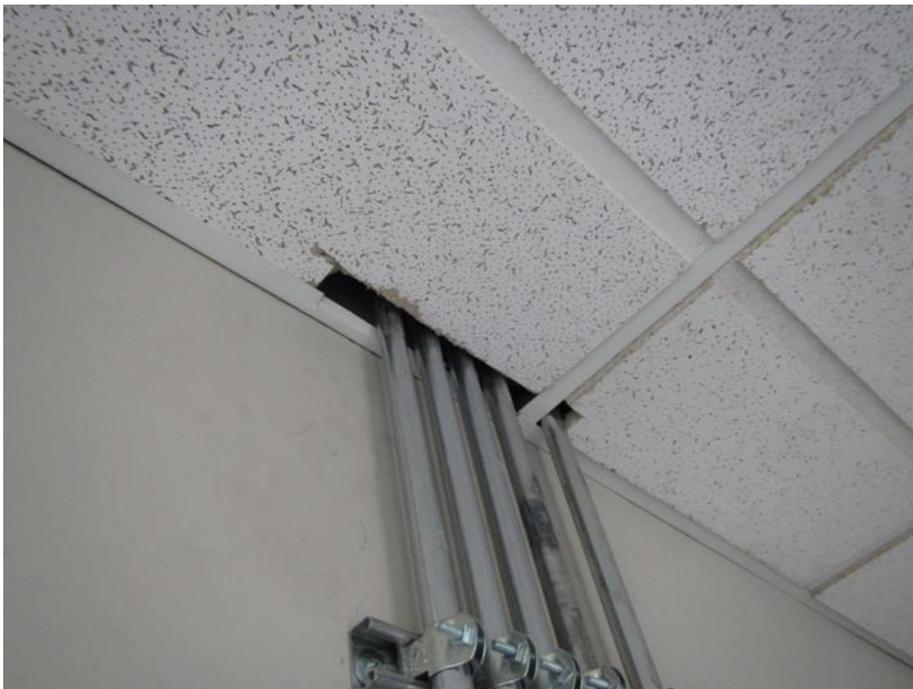
**Picture 16**

**Pathways around utilities in kitchen area**

18. Dedicated local exhaust vents should be installed in kitchens/breakrooms to remove food odors/smoke and eject the exhaust to the outdoors. Also, consider sealing pathways in these areas to avoid entraining food odors/smoke into the return plenum system.
