INDOOR AIR QUALITY ASSESSMENT

**MassHealth Enrollment Center
333 Bridge Street
Springfield, Massachusetts**

Prepared by:
Massachusetts Department of Public Health
Bureau of Environmental Health
Indoor Air Quality Program
August 2016

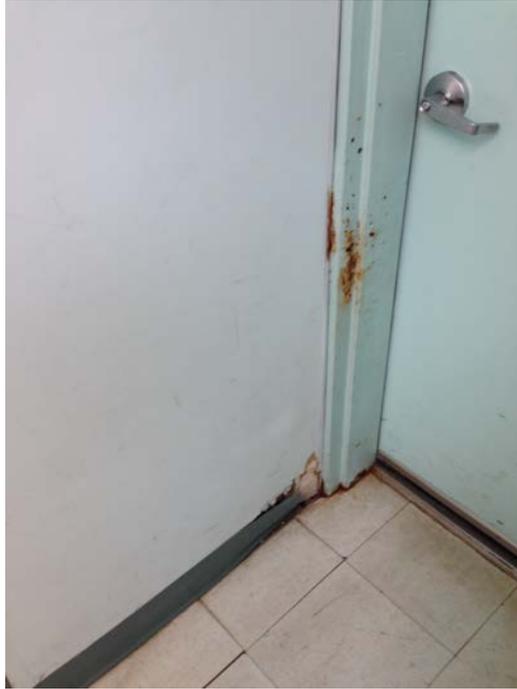
Picture 1

Water-damaged gypsum wall board (GW) was noted around an exterior door on the first floor (Picture 1). In addition, the splash guard behind the breakroom sink was warped and water-damaged (Picture 2). Water-damaged GW and wood can provide a source of mold and should be replaced after a water leak is discovered and repaired.

The US Environmental Protection Agency (US EPA) and the American Conference of Governmental Industrial Hygienists (ACGIH) recommend that porous materials be dried with fans and heating within 24 to 48 hours of becoming wet (US EPA, 2008; ACGIH, 1989). If not dried within this time frame, mold growth may occur. Once mold has colonized porous materials, they are difficult to clean and should be removed.

Water-damaged GW around exterior door on first floor

1. Consider removing all flowers and other plants from the workplace.
2. Remove any water-damaged GW and the damaged sink backsplash in a manner consistent with recommendations found in “Mold Remediation in Schools and Commercial Buildings” published by the US Environmental Protection Agency (US EPA, 2008).

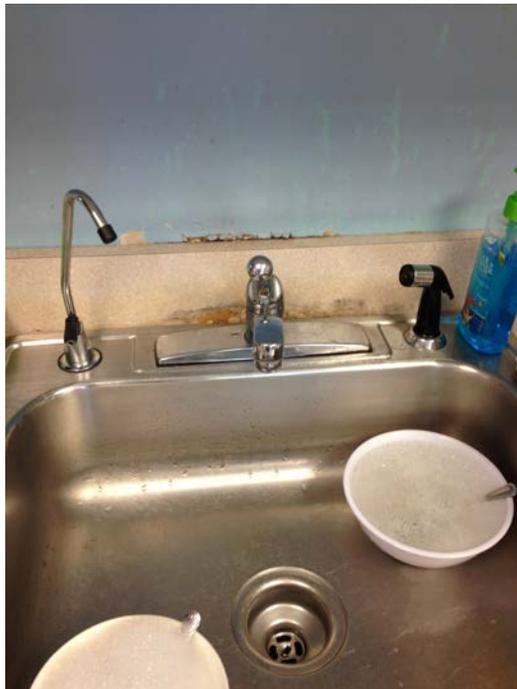
Picture 2

Water-damaged sink backsplash in break room

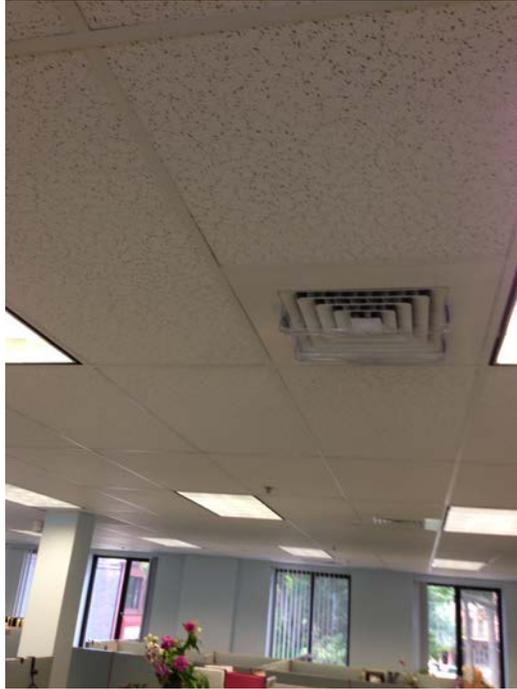
Picture 3

IAQ staff examined the second floor for sources of irritants. Of primary concern was the presence of an extensive number of potted plants, including flowering types (Pictures 3 and 4). Plants, soil, and drip pans can serve as sources of mold spores. Plants can also be a source of pollen. In addition, some plants were located directly on carpet, which can become moistened from overwatering. Plants should not be placed on porous materials, since water damage to porous materials may lead to microbial growth. In addition, plants should be kept away from sources of airflow, including supply and exhaust vents and fans which can distribute odors, pollen and mold around the building.

Flowering plants in office on second floor

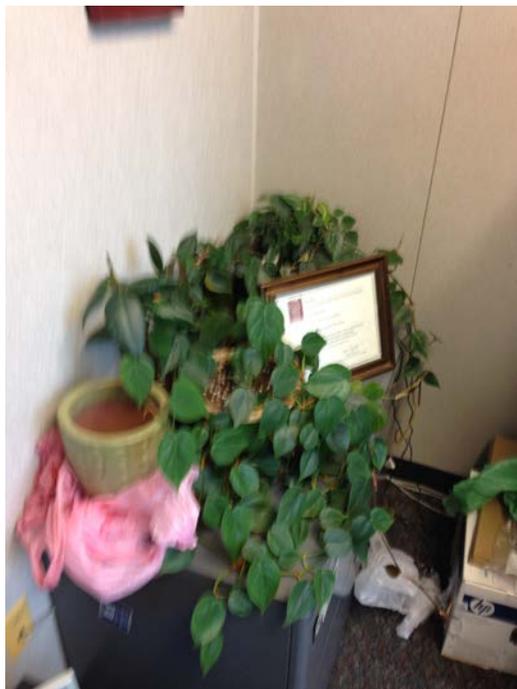
Picture 4

Example of plants on second floor
