INDOOR AIR QUALITY ASSESSMENT

**Webster Town Hall
350 Main Street
Webster, MA**

Prepared by:
Massachusetts Department of Public Health
Bureau of Environmental Health
Indoor Air Quality Program
June 2016

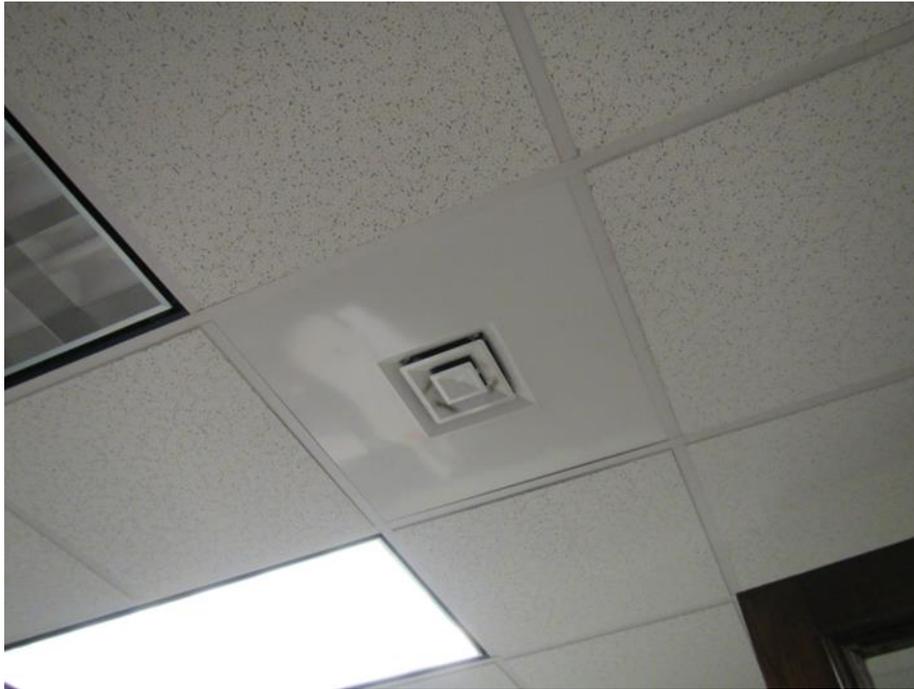
Picture 1

Some areas in the basement of the WTH (e.g., the Health offices) have supply vents (Picture 1) which receive air ducted from air handling units (AHUs) located in the attic (Picture 2). Note that these vents require long ductwork to traverse the intervening floors of the building and so may not be able to deliver air efficiently.

Supply vent in the basement

4. Use and maintain the HVAC system that serves the basement area, including changing the filters every 6 months or more frequently if needed.
5. Use openable windows in other areas of the building to provide fresh air during temperate periods. Ensure that all windows are closed tightly at the end of the day. Do not open windows while air conditioning/cooling is occurring to prevent condensation.

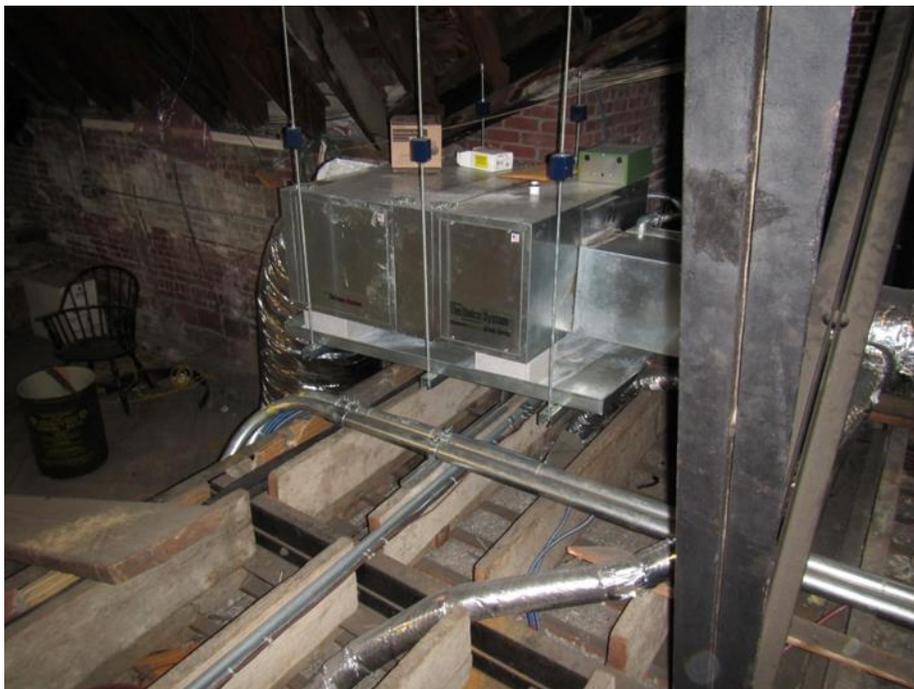
Picture 2

Air handling unit in attic

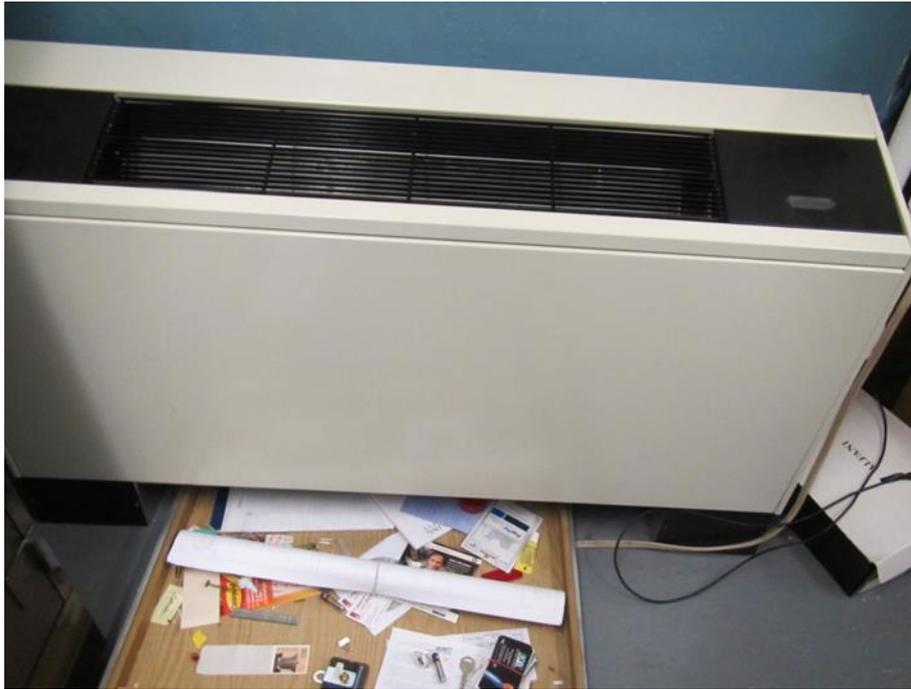
Picture 3

Heating/cooling in some areas of the office is accomplished through the use of fan coil units (FCU) that are located in offices (Picture 3). Fan coil units heat/cool and filter the air but do not supply a source of fresh air. Many were blocked or obstructed by items in front or on top.

Fan coil unit, note items blocking airflow

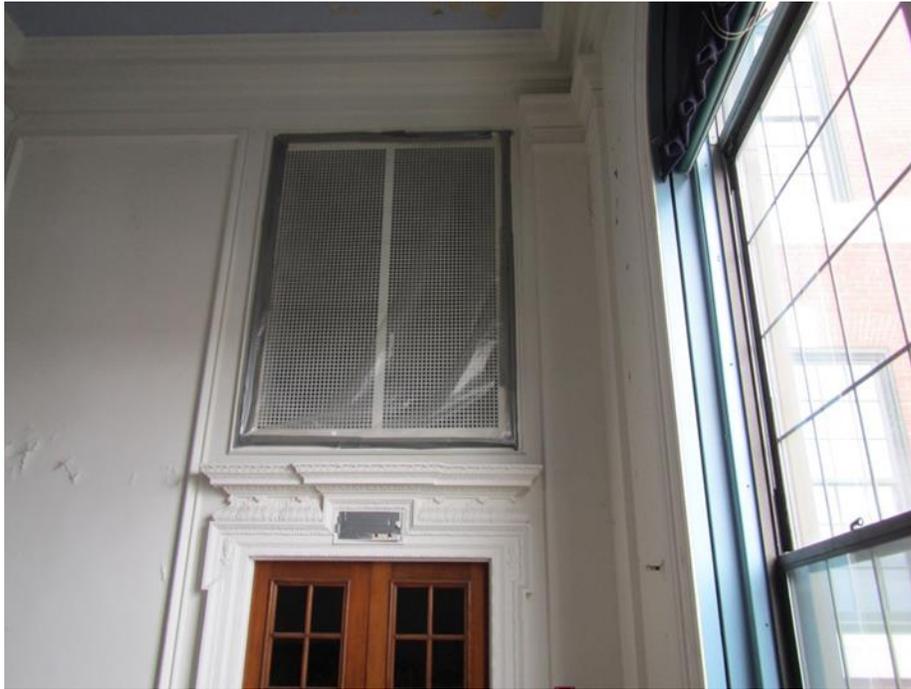
Picture 5

The auditorium is a large two-floor open area which is between the main part of the WTH and the attached building, which contains the Webster senior center and residential units (Picture 4). It appears that the two buildings had previously shared a ventilation system. The vents for this system have been blocked off with plastic and tape from the auditorium side (Picture 5).

Taped off vents into the auditorium from the attached senior center/residential building

6. Investigate a way to provide fresh air and temperature control for the auditorium area during the periods when it is used as a temporary library. This may include portable ventilation equipment or window-mounted heating/cooling units. Ensure that systems installed will not promote condensation on library materials.

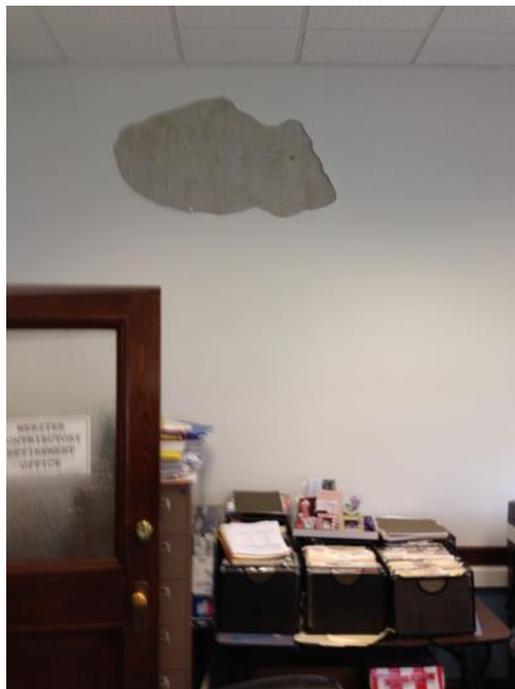
Picture 6

Several sources of microbial concerns were identified in this building. In one area of concern, the Retirement Office, musty odors and numerous signs of water damage were observed in an adjacent room used for storage (Pictures 6 and 7). Observations of the location of damaged plaster suggest several sources of moisture in this area, primarily roof leaks from ice dams that occurred during the winter of 2015. Given the location of the water-damaged wall plaster, carpeting beneath filing cabinets was also likely moistened for an extended period of time. It is recommended that carpet should be dried with 24 hours of becoming moist to prevent mold growth (US EPA, 2008). If not dried with 24 hours, the carpeting should be removed. Another possible source of chronic moisture to carpet is due to this room sharing a wall with the unheated auditorium. The Retirement Office is along an outside wall and abuts the auditorium which is a seldom-used space that is often kept unheated. The shared wall between the auditorium and the Retirement Office may be chilled below the dew point during humid weather and lead to condensation on the wall. While plaster itself does not readily grow mold, paint and dust/debris on the wall, ceiling tiles, the carpeted floor and porous items near the wall may become mold-colonized.

Cracked plaster in the retirement office

1. Remove carpeting from the Retirement office storeroom.
2. Replace stained ceiling tiles, including those in the Retirement Office. Inspect and clean the area above the stained tiles to remove dust/debris that may also be colonized with mold.

3. Remove items from the floor and on/against the wall in the Retirement Office that abuts the auditorium to prevent trapped air and condensation. While the auditorium is used as a library, temperature control in this adjoining space should reduce the potential for thermal bridging.

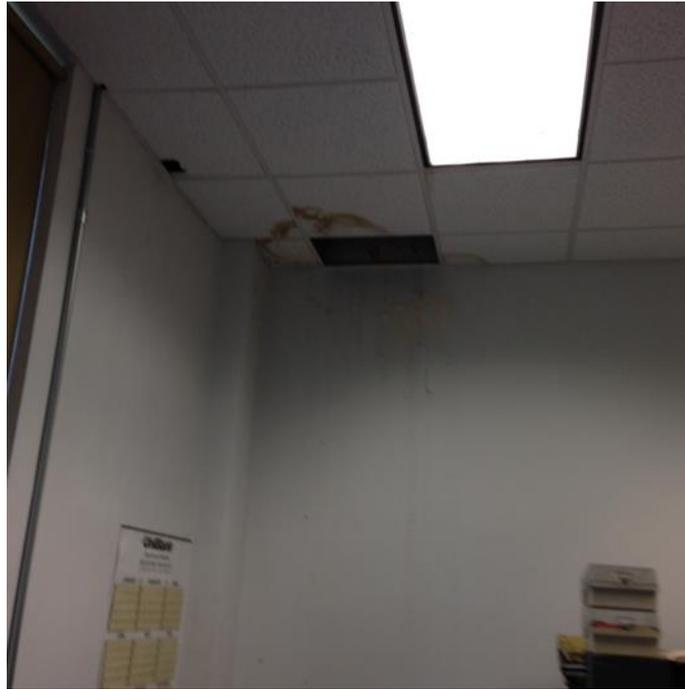
Picture 7

Water-damaged ceiling tile/wall in the room adjacent to the retirement office

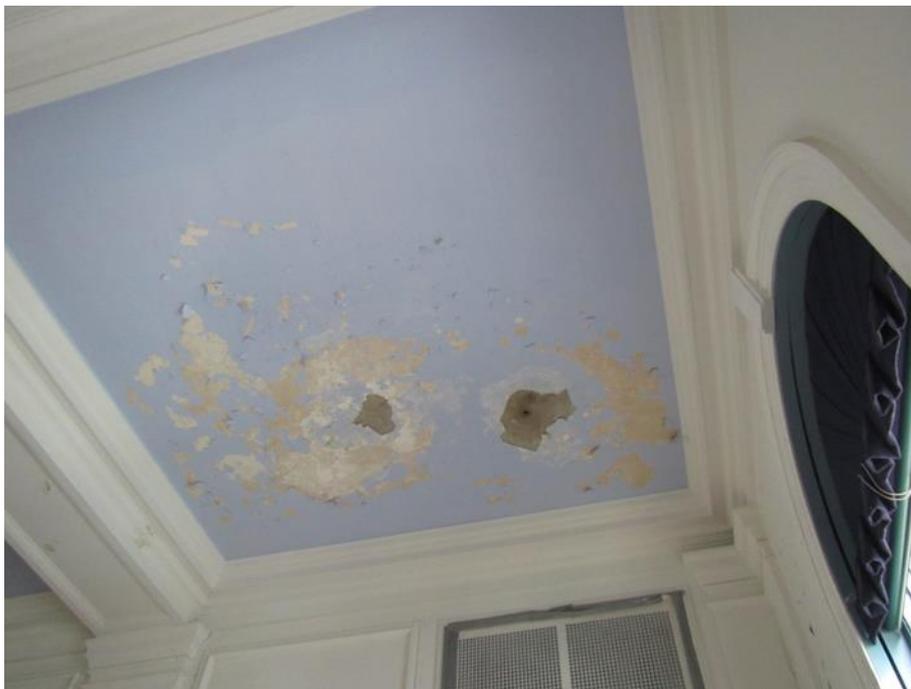
Picture 8

The auditorium has numerous areas of water-damaged and cracked ceiling and wall plaster (Picture 8). Similar conditions were observed in other offices and hallways (Pictures 9 through 11). These likely originate with leaks from the building envelope (roof and walls) that should be repaired. Although the plaster itself does not appear to be mold-colonized, any porous items stored in contact with or beneath the areas of leaks may be subject to moistening and microbial growth. In addition, flaking paint and paint dust may present a lead hazard, depending on the age of the paint. Water-damaged ceiling tiles can be a source of mold and odors and should be replaced once a leak has been repaired.

Water-damaged plaster in the auditorium

7. Repair roof leaks.
8. Repair/repaint areas of peeling plaster on walls and the ceiling. If lead paint may be an issue, ensure that lead-safe procedures are used in accordance with the Department of Labor Standards Regulations, 454 CMR 22.

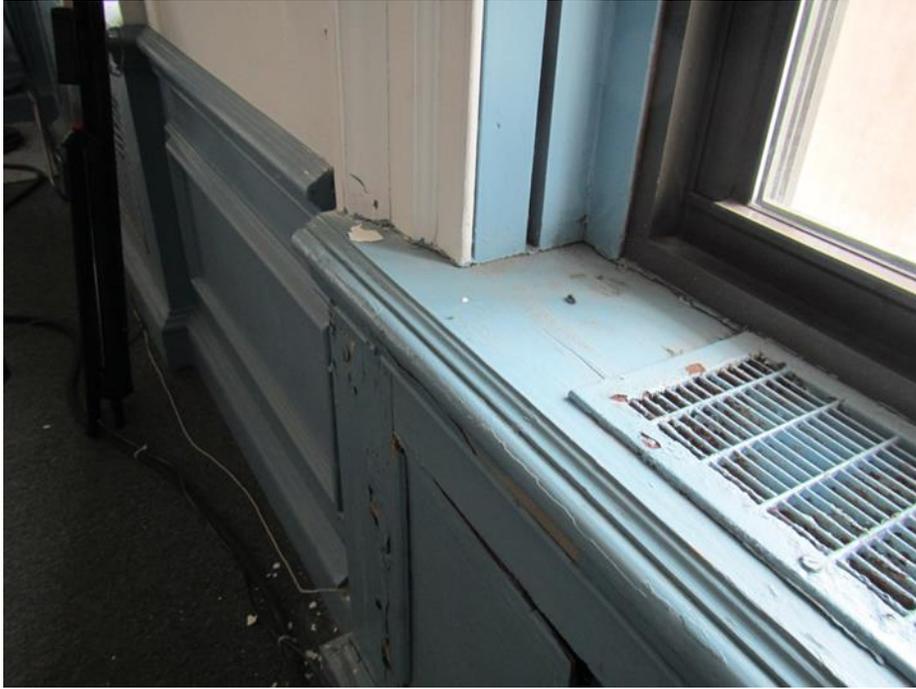
Picture 9

Water-damaged plaster, windowsill, and wall in a meeting room

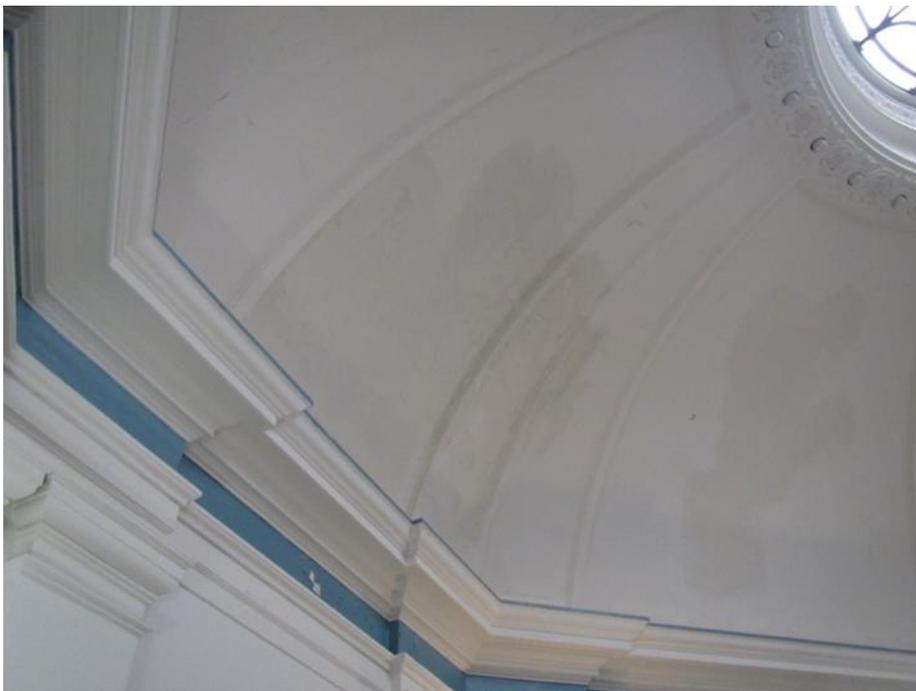
Picture 10

Water-damaged plaster in the central dome

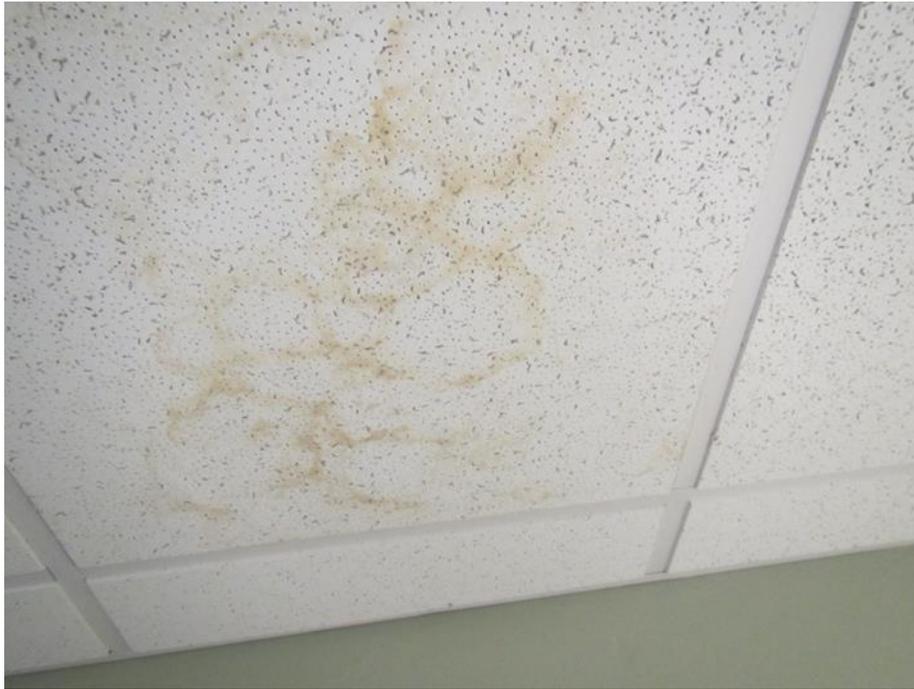
Picture 11

Water-damaged ceiling tile

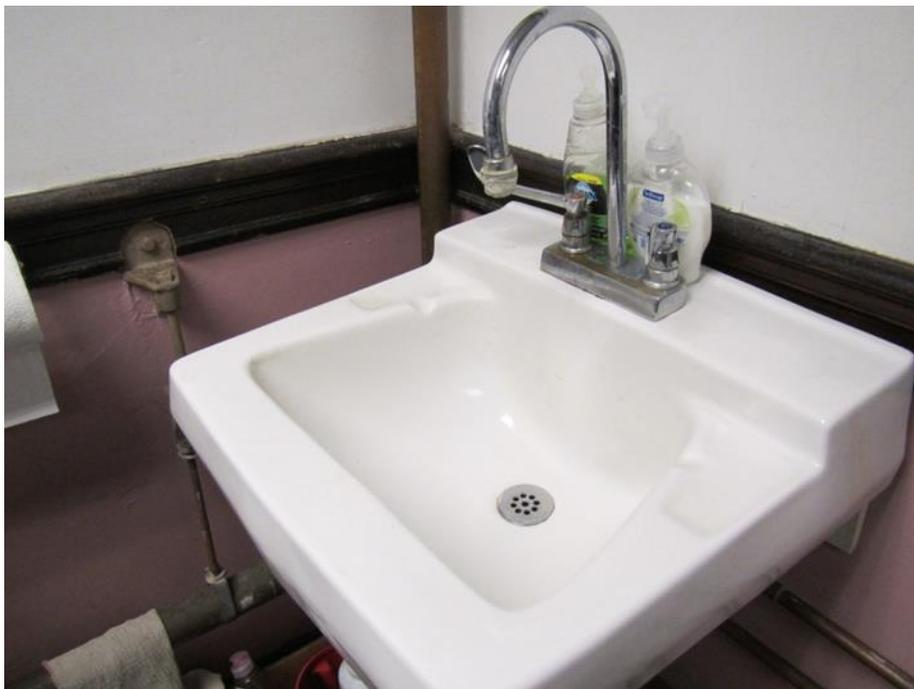
Picture 12

Several offices on the lower level had small sinks, some of which reportedly did not function, but had not been properly abandoned/capped (Picture 12). One occupant reported that he poured water down the drain of a sink regularly to prevent the drain from becoming dry and allowing sewer odors into the occupied space. Keeping these traps wet will prevent the infiltration of sewer gases; however unused/unusable fixtures should be properly removed with all associated piping capped.

Small sink in basement

10. Continue to add water to broken or seldom-used sinks to ensure water trap/seal until they can be properly removed and capped.

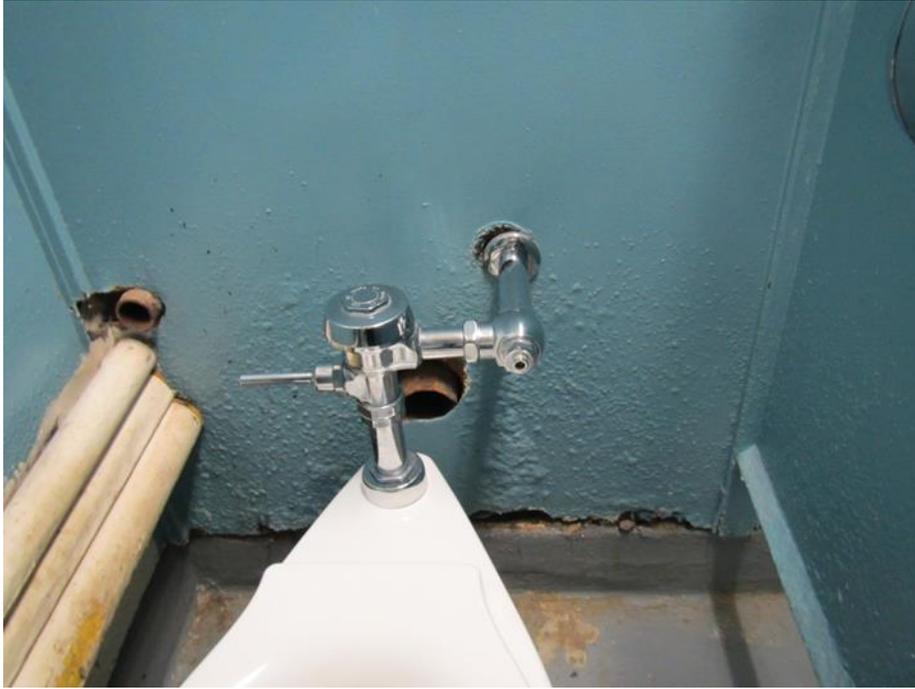
The restrooms were examined and, as mentioned above, no exhaust ventilation was present, which would allow restroom-generated moisture and odors to build up. In the women's restroom on the lower level, there was an open pipe, gaps around pipes, and other holes in the walls next to the toilet (Picture 13). This can allow air from the sewer system or unconditioned areas to penetrate into the bathroom and provide pathways and harborage for pests.

Broken pipe and gaps around pipes in women's restroom

11. Consider installing fans or windows to the outside in restrooms to provide exhaust ventilation.
12. Ensure that the open pipe in Picture 13 does not connect to the sewer system and cap/repair. Seal gaps around pipes in the restrooms with an appropriate sealant.

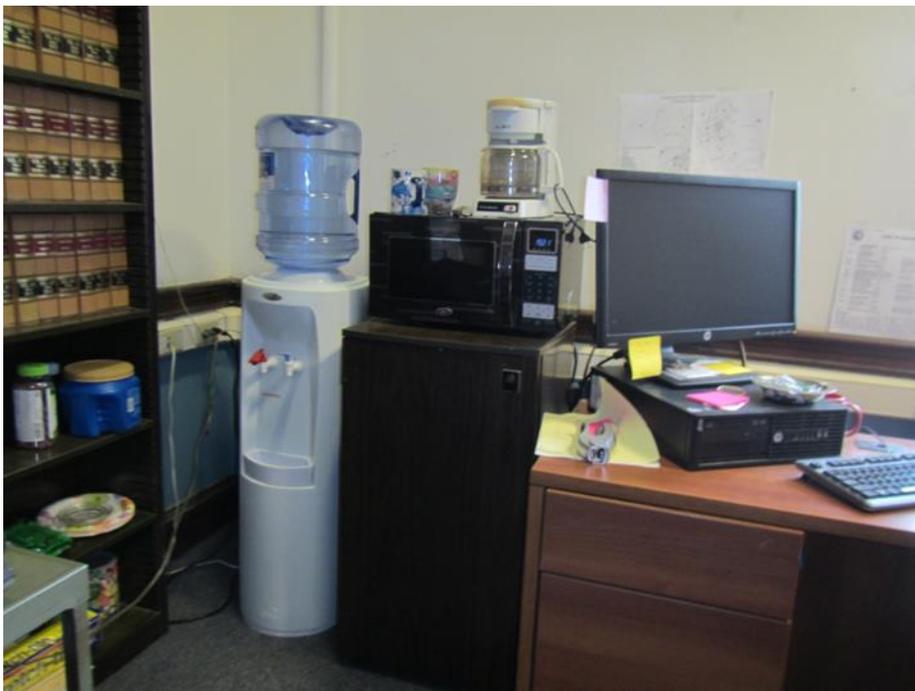
Picture 14

Water coolers and small refrigerators were observed on carpeting (Picture 14). Spills and leaks from these appliances can moisten carpeting and lead to microbial growth and odors.

Water cooler and refrigerator on carpet

15. Consider placing refrigerators and water dispensers in areas without carpeting, or use a waterproof mat beneath them.
16. Keep plants in good condition, avoid overwatering, and avoid placing them on porous items such as carpets or paper.

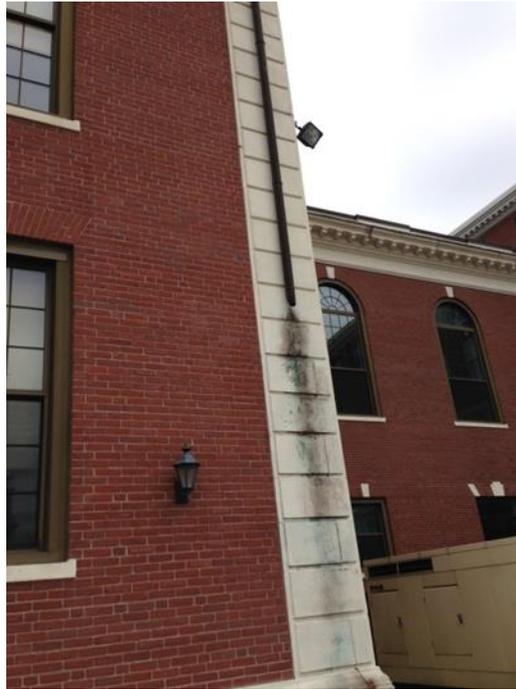
Picture 15

The exterior of the building was also examined for sources of water damage and odors. Several downspouts were broken (Picture 15) which allows water to splash against the walls and foundation and may lead to damage to the building envelope and infiltration. Window wells beneath some of the basement windows had water and debris accumulated in them (Picture 16) which can lead to pests and odors which can enter occupied spaces when the windows are open.

Broken downspout

17. Repair the gutter/downspout system to direct water away from the building.
18. Clean the basement window wells of debris and check drainage to prevent the accumulation of water.

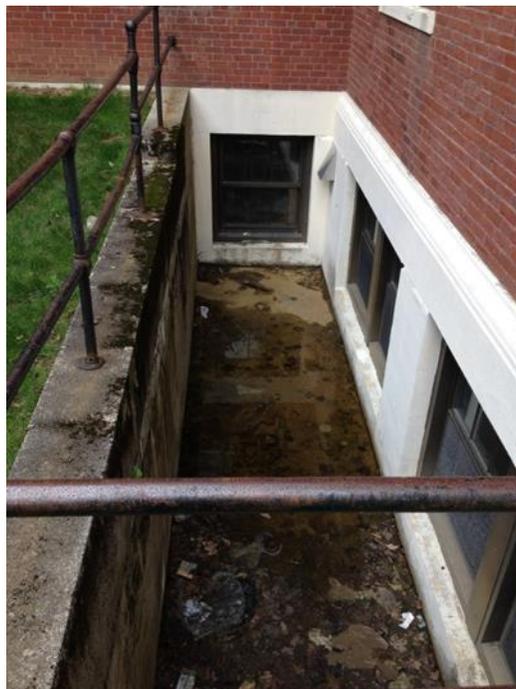
Picture 16

Water and debris in window well

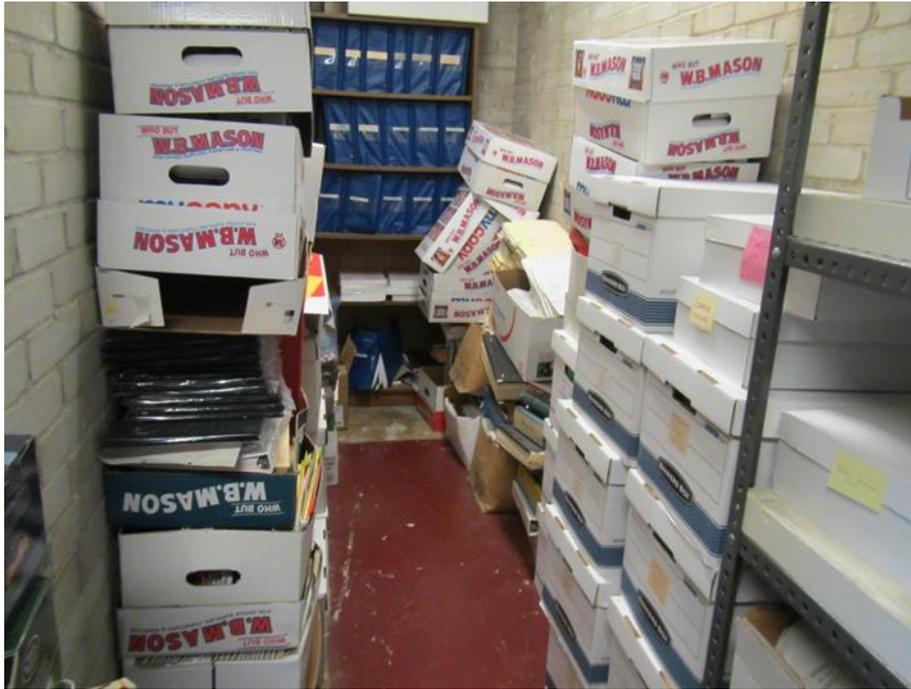
Picture 17

Accumulated items were found stored on floors and other flat surfaces. In addition, there were several storerooms, including the attic, containing boxes, rolls of old plans, old books, other paper items, decorative items, and furniture (Pictures 17-23). As discussed above, some of these items had musty odors, which indicates that they had been water-damaged in the past. Boxes and other items were often found stored directly in contact with floors, which may be subject to condensation and lead to additional water damage. In addition, large quantities of paper can provide harborage for pests and may represent a fire hazard. A systematic review of stored paperwork and other items should be conducted with a goal of reducing the overall amount of items and reorganizing the remaining items to be stored in a manner (contained and away from floors) that will prevent further damage, deterioration and odors.

Stored items, including boxes on the floor of a below-grade area

14. In general, the large quantity and variety of stored items, including papers, books, furniture and decorative items may be a source of moldy odors and dust, may provide harborage for pests, and may represent a fire hazard. A comprehensive program to sort and catalog these items should be conducted, discarding those items that are no longer needed, making electronic copies of items for accessibility when possible, and storing the rest in an organized, water-resistant manner (e.g. in cabinets, on shelves, or in plastic containers). Non-porous stored items should be cleaned periodically using a HEPA-filter-equipped vacuum cleaner followed by wet wiping to prevent the buildup of dusts that can become reaerosolized or dampened and mold-colonized.

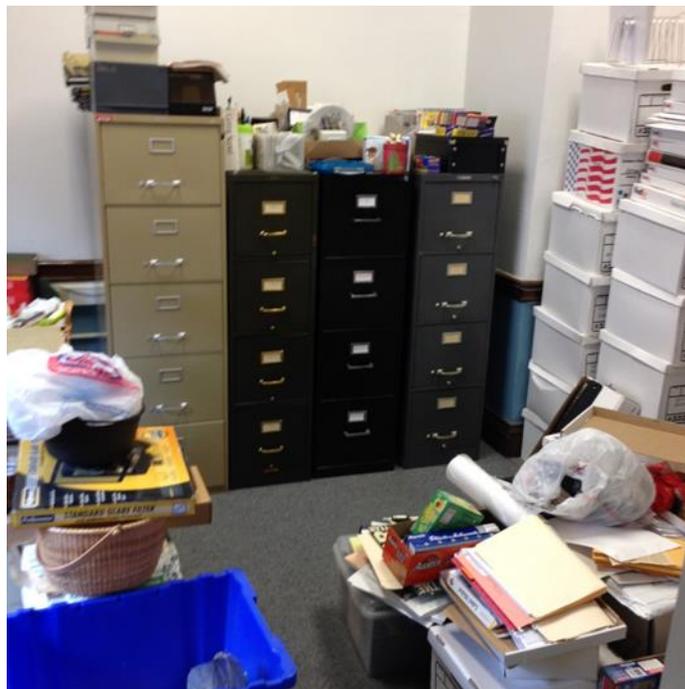
Picture 18

Stored items in an office

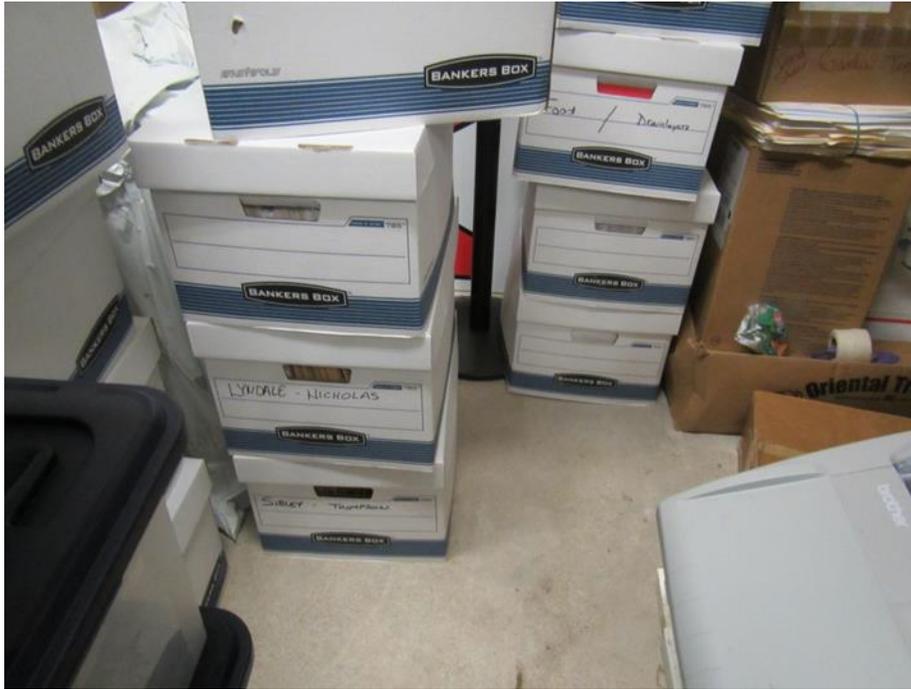
Picture 19

Stored boxes

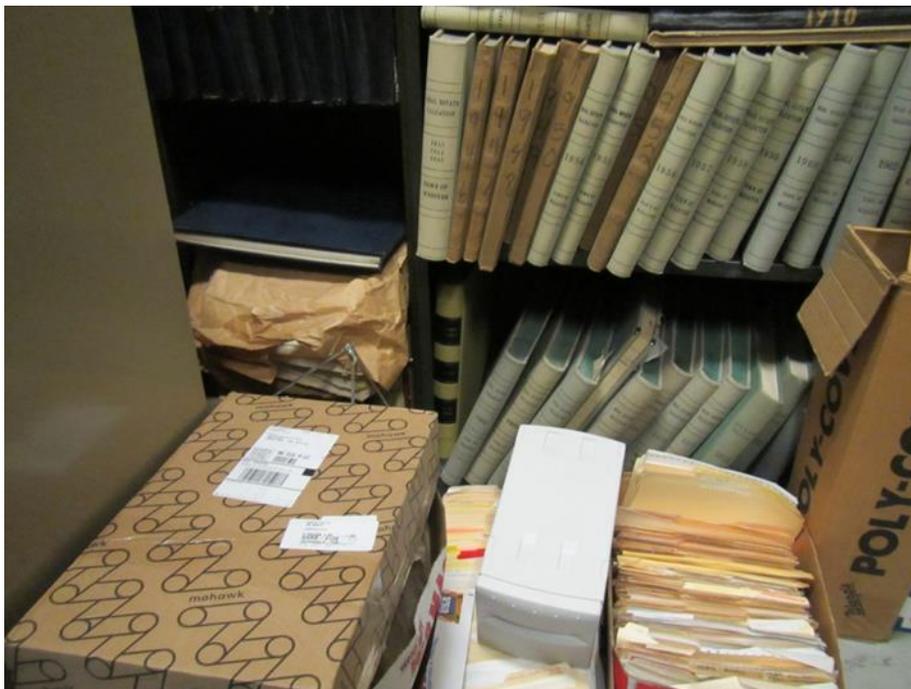
Picture 20

Old books and other stored items, some on the floor

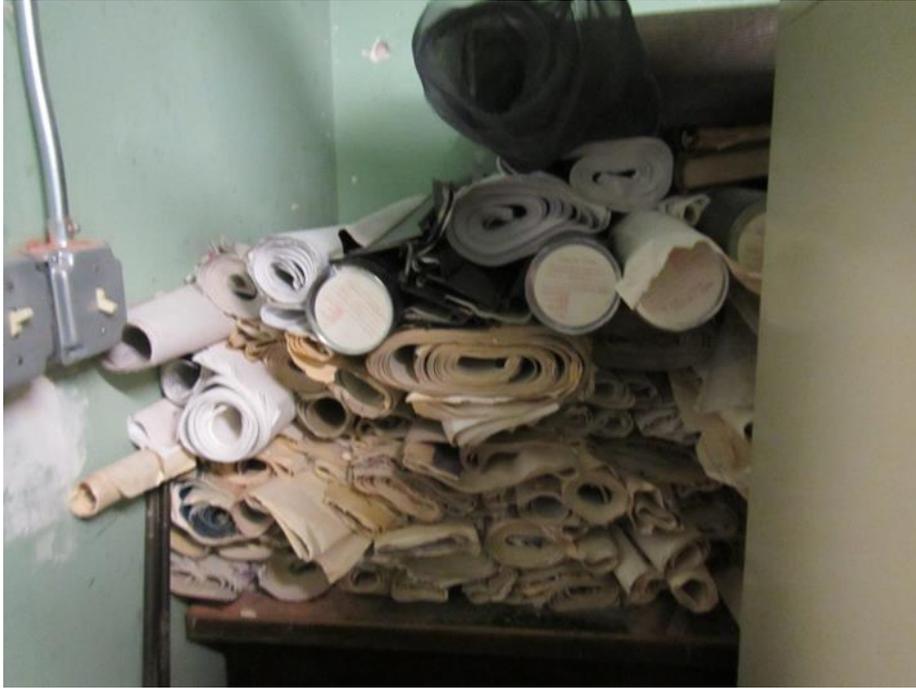
Picture 21

Old stored plans

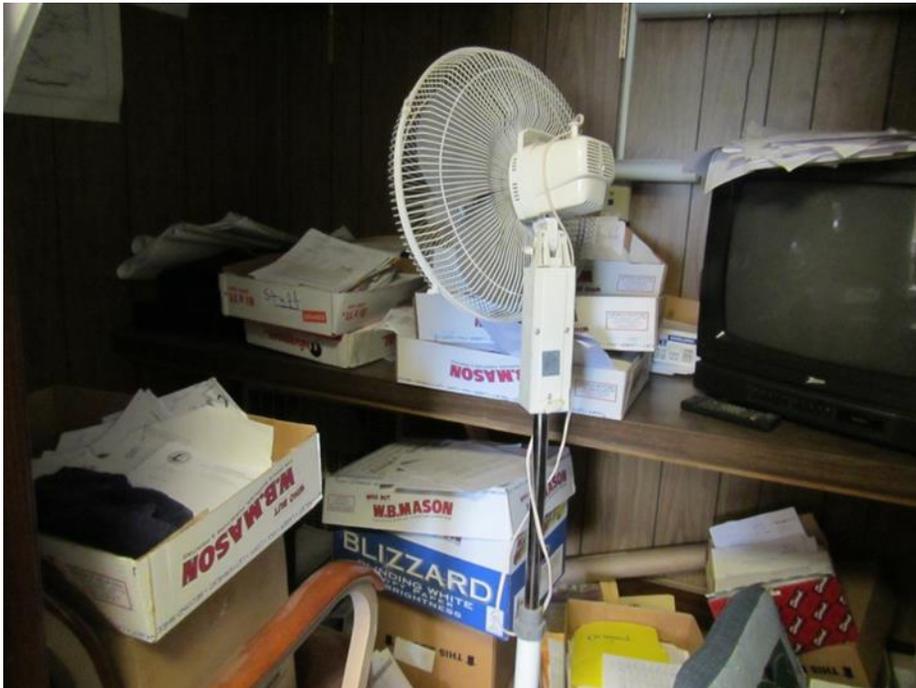
Picture 22

Items in one of the vault areas

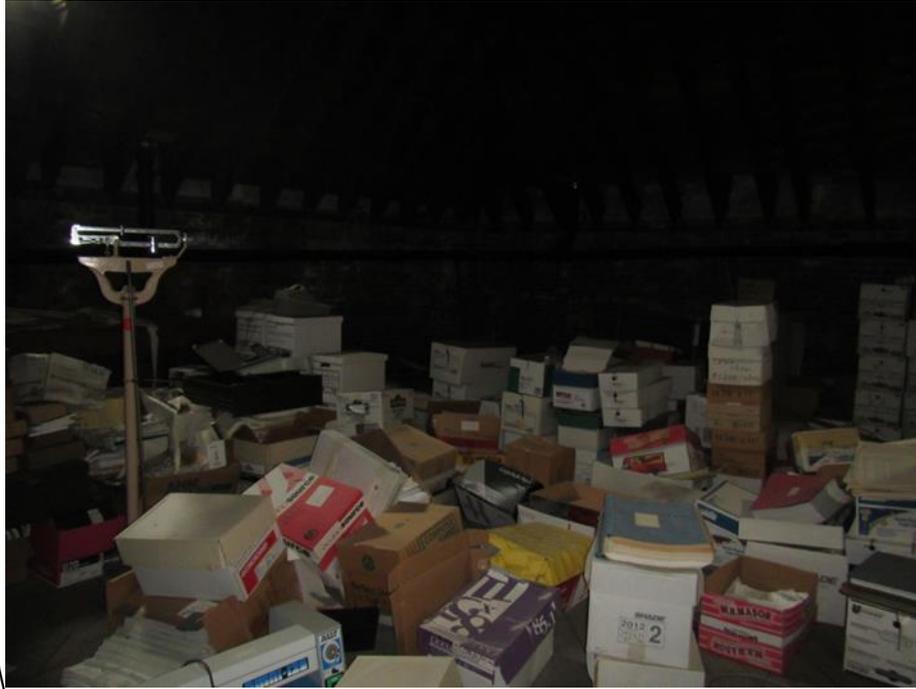
Picture 23

Items stored in the attic

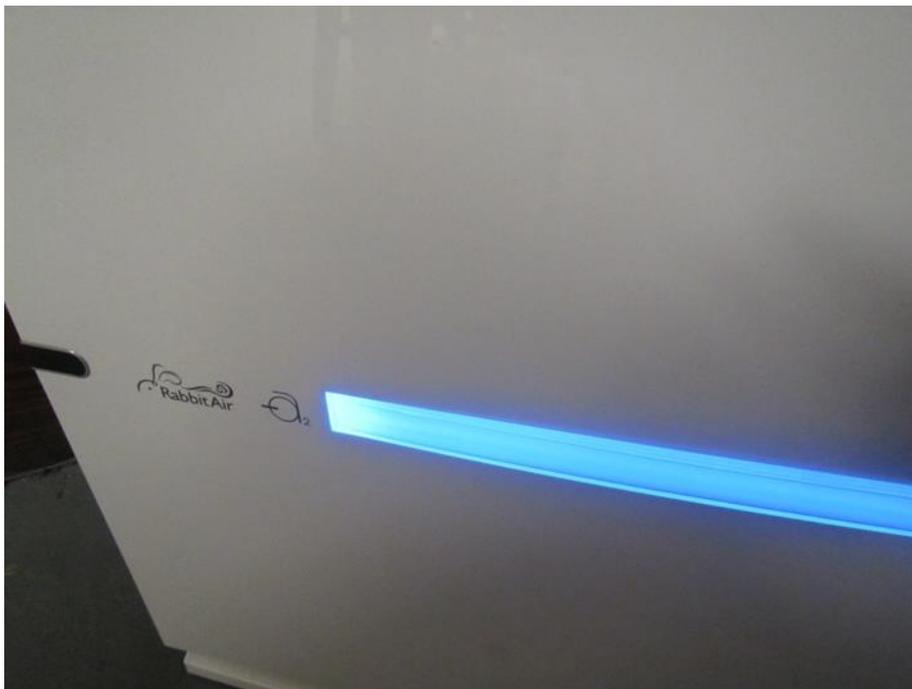
Picture 24

Air purifiers were found in offices in the WTH (Pictures 24 and 25). Some of these were a brand called RabbitAir™. The product literature for these units suggests it has both filtration and “negative ion generation” with a separate switch (Rabbit Air, 2016). This means it produces ozone, which is a respiratory irritant and should not be used in occupied spaces (US EPA, 2003). The units should be operated with the “negative ion” generator off. In addition, all air purifiers should be maintained, with filter changes and cleaning, per manufacturer’s instructions.

RabbitAir™ air purifier

20. Use the RabbitAir™ air purifiers with the “negative ion generation” turned off. Maintain all air purifiers in accordance with manufacturer’s instructions.

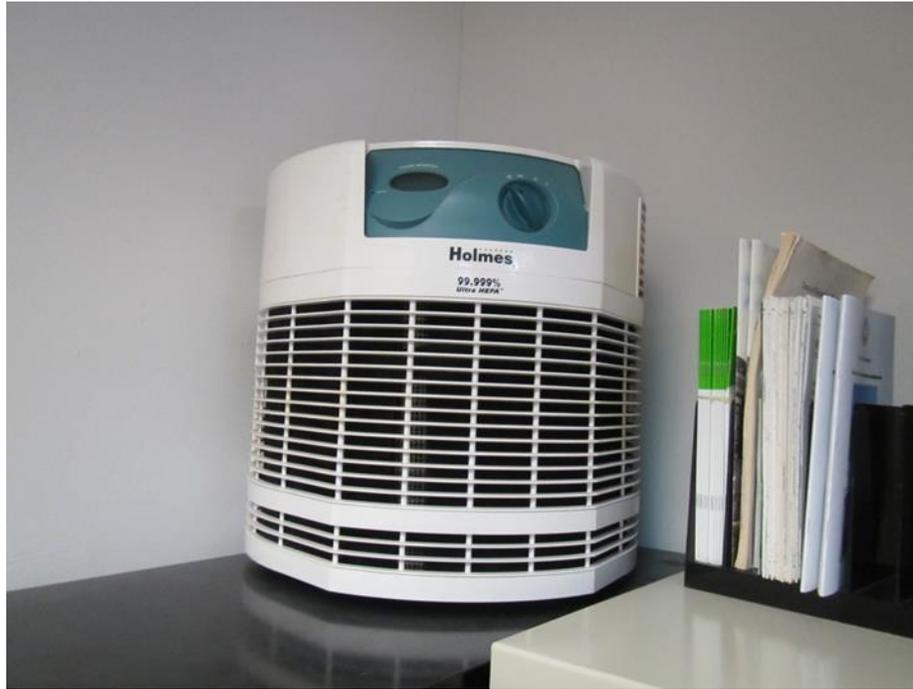
Picture 25

HEPA air purifier

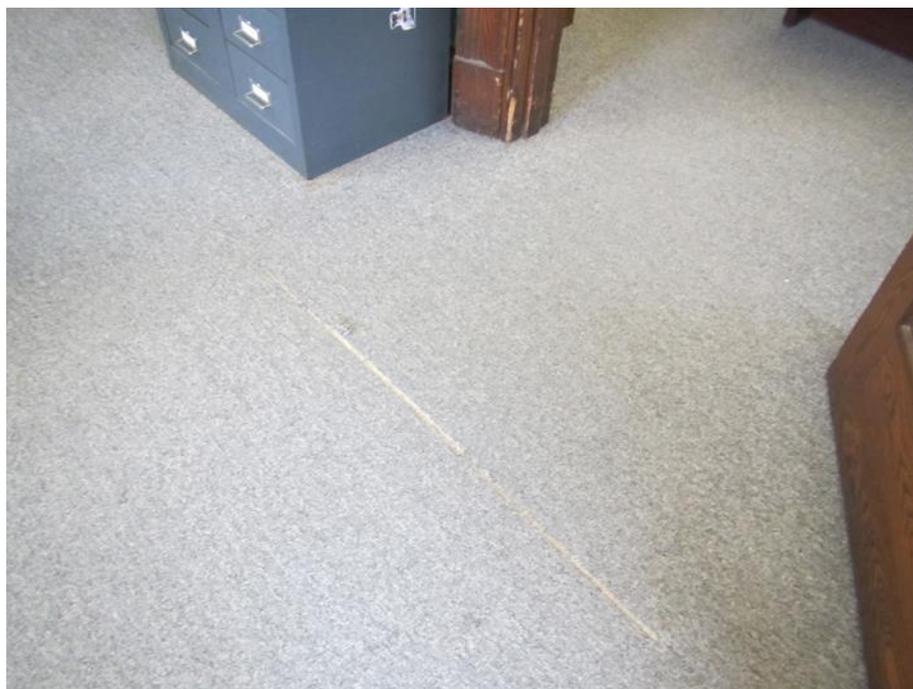
Picture 26

Some offices are carpeted. Carpets should be cleaned regularly in accordance with Institute of Inspection, Cleaning and Restoration Certification (IICRC) recommendations (IICRC, 2012). Many of the carpets in the WTH were worn and taped up and should be replaced (Picture 26).

Worn, stained carpeting

1. Consult with a building and HVAC expert to determine the feasibility of installing supply and exhaust ventilation in the WTH.
2. Repair or replace the roof including appropriate insulation to prevent ice dams.
3. Replace all carpeting in the WTH. Do not install carpeting in any below-grade areas; use floor tiles or other non-porous flooring. Consider the activities in each room, so that non-porous flooring can also be used in kitchens, file/storage areas and in areas where refrigerators and water dispensing equipment may be used. Carpet squares are recommended for ease of replacement when small areas are moistened or damaged.

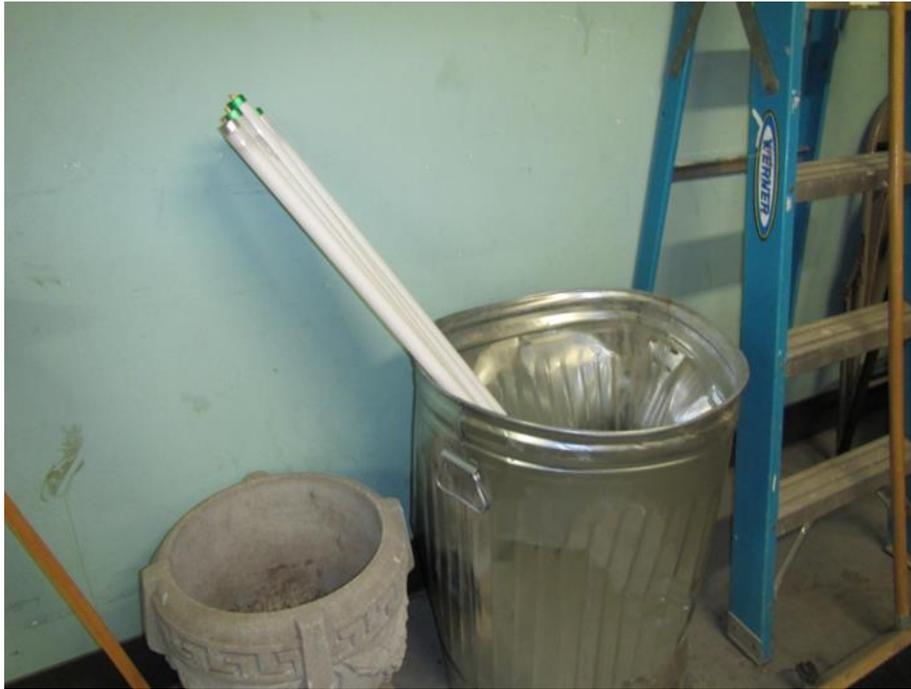
Picture 27

Fluorescent light bulbs were found stored in a manner where they could become broken (Picture 27). These bulbs contain mercury that can be released if the bulbs are broken, and they will also create broken glass. Fresh and spent bulbs should be stored in sturdy packaging to prevent breakage, and spent bulbs need to be discarded as universal waste.

Improperly stored fluorescent bulbs

21. Clean supply and exhaust vents and personal fans regularly to prevent aerosolization of debris.
22. Clean carpeting and upholstered items regularly in accordance with IICRC recommendations (IICRC, 2012).
23. Store fluorescent light bulbs in a secure manner to prevent breakage.
24. Refer to resource manual and other related IAQ documents located on the MDPH's website for further building-wide evaluations and advice on maintaining public buildings. These documents are available at: <http://mass.gov/dph/iaq>.
