WATER DAMAGE/REMEDIATION ASSESSMENT

**Department of Mental Health
167 Lyman Street
Westborough, Massachusetts**

Prepared by:
Massachusetts Department of Public Health
Bureau of Environmental Health
Indoor Air Quality Program
April 2016

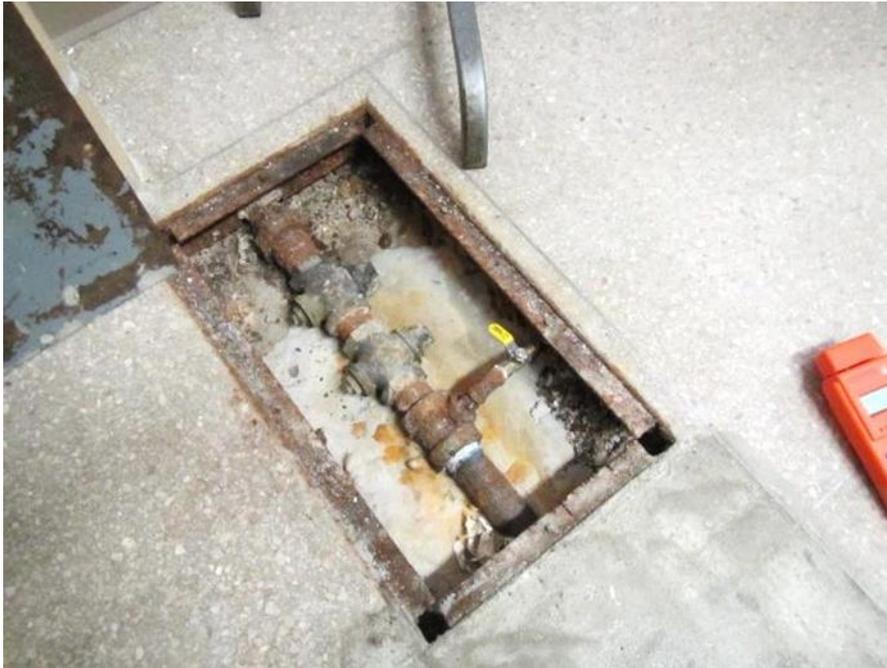
Picture 1

As reported by Mr. Gundlach, during the extreme cold weather in February 2016, heating pipes had frozen and burst on the 2nd floor of the Hadley Building in area 223-C, which resulted in flooding and water damage to building materials directly below. Water-damaged materials included the gypsum wallboard (GW) ceiling and carpeting, primarily in area 124. Once discovered, the water was shut off and the pipes repaired (Pictures 1 and 2). Occupants were relocated and all materials/furniture was reportedly moved in order to conduct remediation efforts.

Area of pipe burst in Room 223-C, note several plumbing components have been replaced

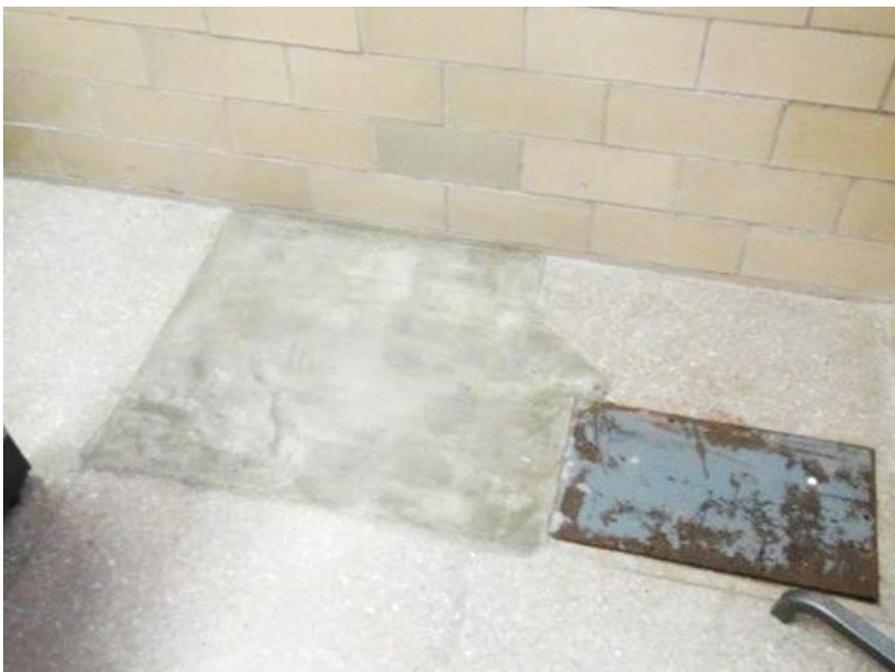
Picture 2

Area of pipe burst in Room 223-C, note concrete patch

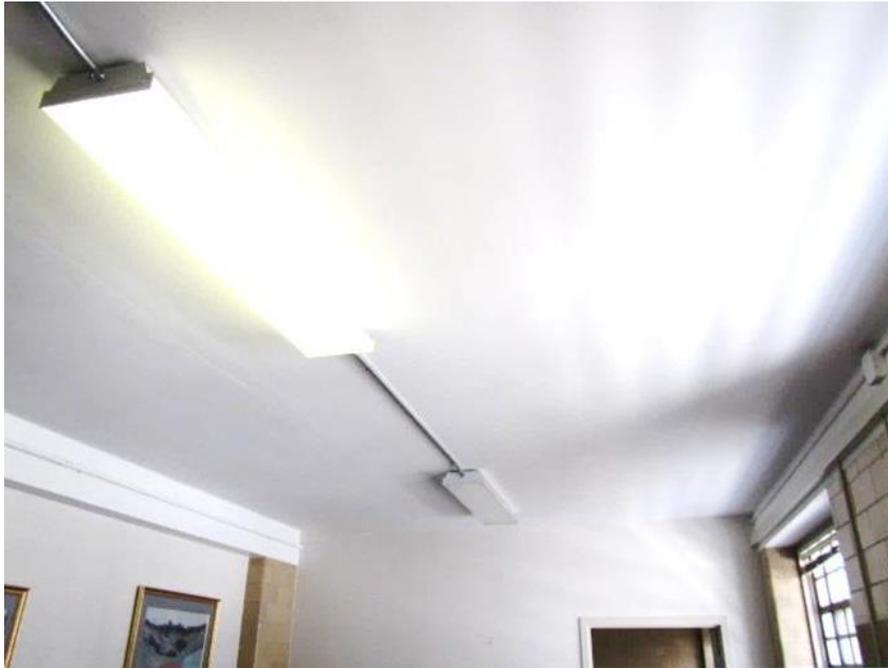
Picture 3

In order for building materials to support mold growth, a source of water exposure is necessary. The US Environmental Protection Agency (US EPA) and the American Conference of Governmental Industrial Hygienists (ACGIH) recommends that porous materials (e.g., wallboard, carpeting) be dried with fans and heating within 24 to 48 hours of becoming wet (US EPA, 2008; ACGIH, 1989). If porous materials are not dried within this time frame, mold growth may occur. At the time of the BEH/IAQ assessment, remediation had been completed and consisted of replacing the damaged GW ceiling and carpeting in room 124 (Pictures 3 and 4). Carpeting in the adjacent hallway was reportedly shampooed and dried.

Replaced gypsum wallboard Ceiling in Room 124

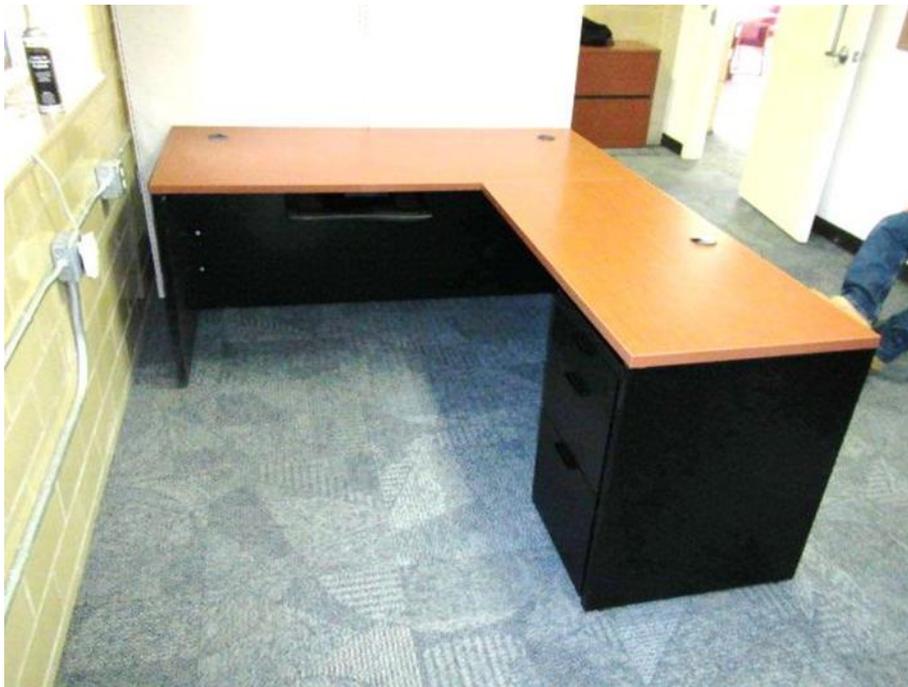
Picture 4

Newly installed carpet squares in Room 124

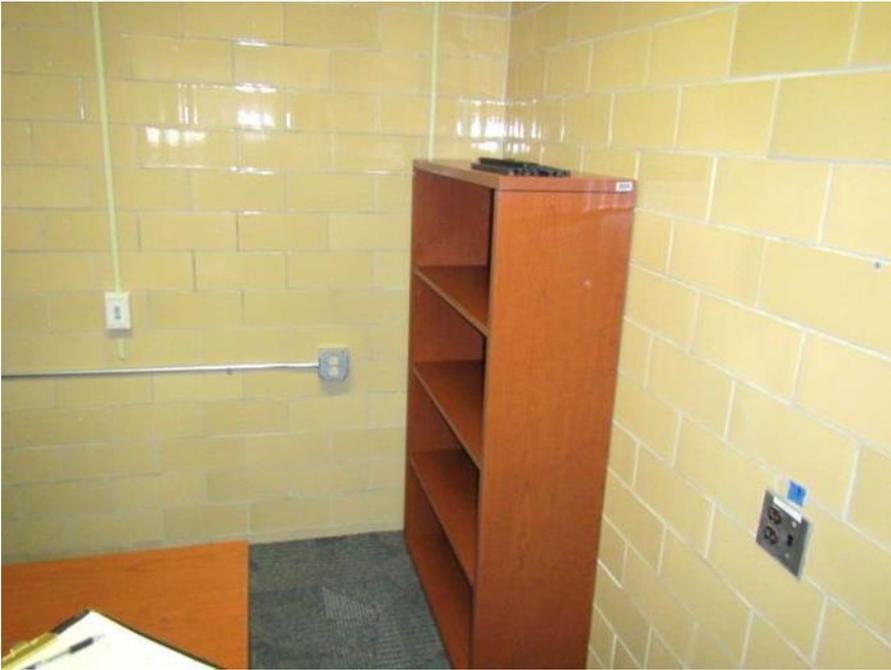
Picture 5

BEH/IAQ staff performed moisture testing of GW and carpeting in the affected areas, as well as adjacent areas for comparison to determine if porous materials were properly dried. In addition, a visual inspection of building materials for any residual water damage and/or microbial growth was conducted. All tested materials were dry at the time of assessment and no residual water damage, mold growth or associated odors were observed/detected (Table 1). It should also be noted that in many areas walls consist of glazed block, which are water impermeable/mold resistant (Picture 5).

Glazed block walls
