INDOOR AIR QUALITY ASSESSMENT

**Massachusetts Attorney General Office
10 Mechanic Street
Worcester, MA**

Prepared by:
Massachusetts Department of Public Health
Bureau of Environmental Health
Indoor Air Quality Program
April 2016

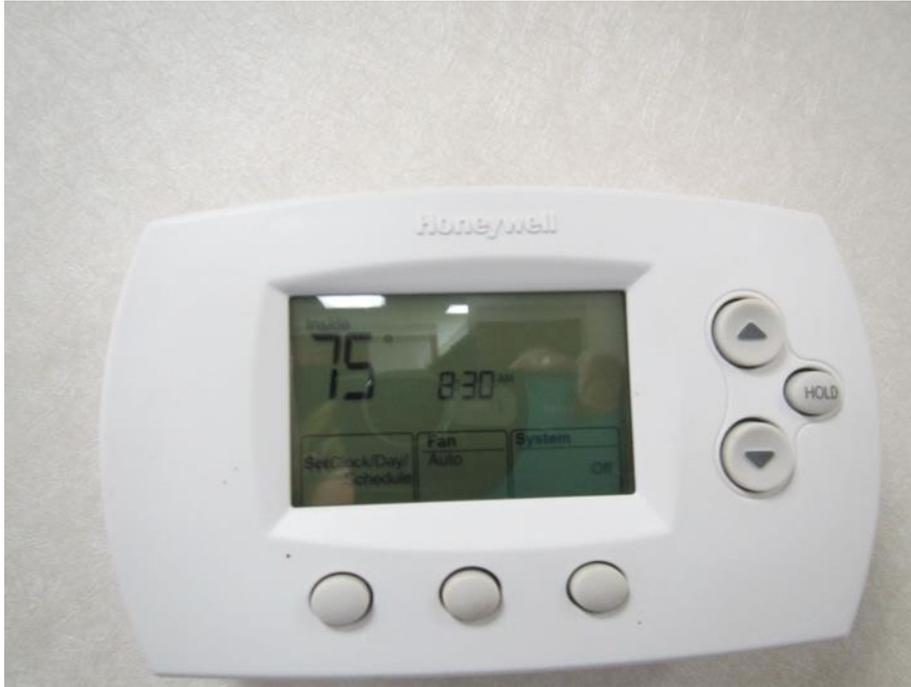
Picture 1

This sampling indicates that the ventilation system is providing adequate fresh air for the occupancy in the building. However, please note that many areas were empty or sparsely occupied, which reduces the creation of carbon dioxide in the space. One thermostat was observed, and it was found in the “off” setting (Picture 1). To maximize air exchange, the BEH recommends that mechanical ventilation systems operate continuously during periods of occupancy. Without the system operating as designed, normally occurring pollutants cannot be diluted or removed, allowing them to build up and lead to IAQ/comfort complaints.

Thermostat set to “off”

1. Operate supply and exhaust ventilation in all areas during occupied periods. Work with building occupants to resolve comfort concerns without reducing fresh air supply, which may include relocating supply and exhaust vents in some areas.

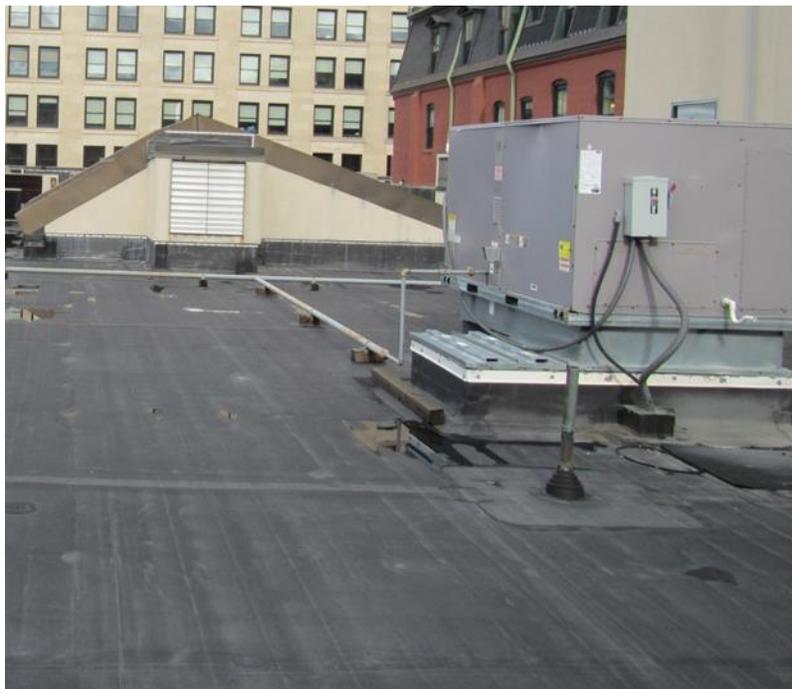
Picture 2

Fresh air is provided by two air handling units (AHUs) located on the roof (Picture 2). Air from the AHUs is filtered, heated/cooled and delivered to rooms via ducted supply vents (Picture 3). Return vents are located on ceilings (Picture 4) and are ducted back to the AHU. Additional exhaust vents are located in toilet rooms and other areas with direct venting to a fan on the roof. Building maintenance staff reported that the HVAC system was balanced when the renovations were complete. It is recommended that HVAC systems be re-balanced every five years to ensure adequate air systems function (SMACNA, 1994).

Air handling unit

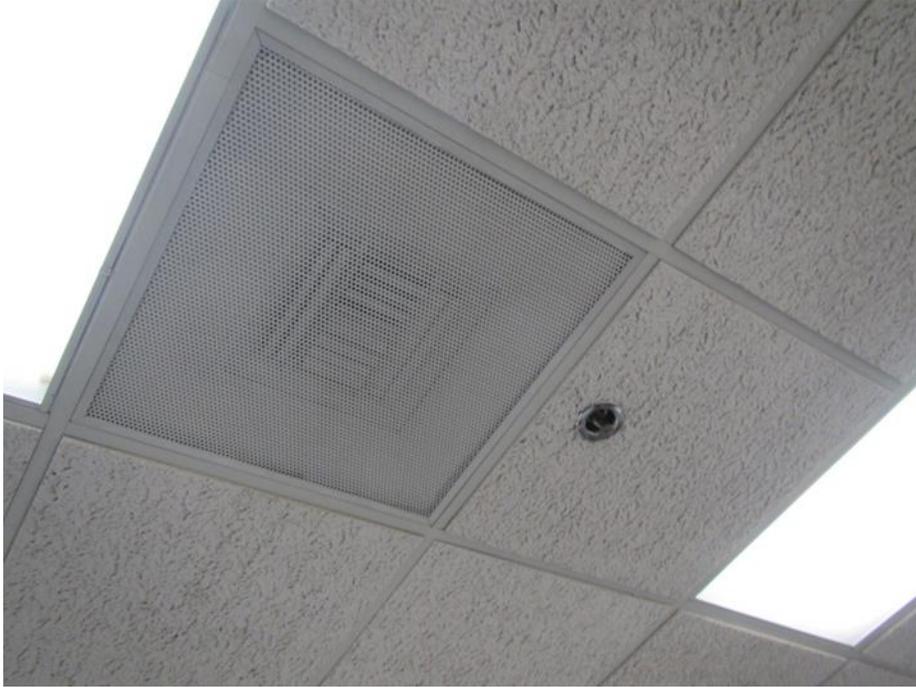
Picture 3

Supply vent

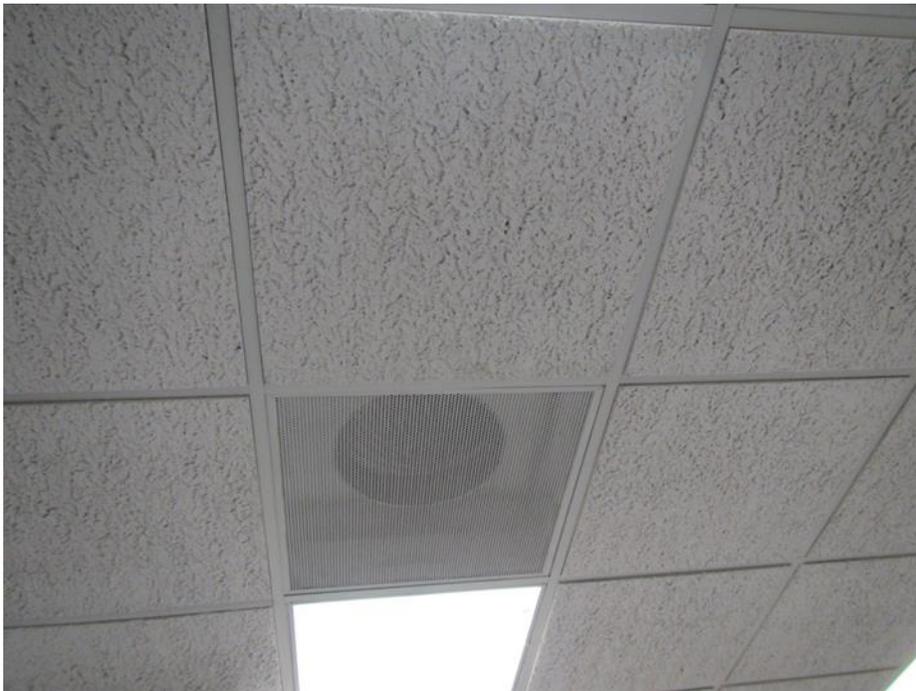
Picture 4

Return vent (direct)

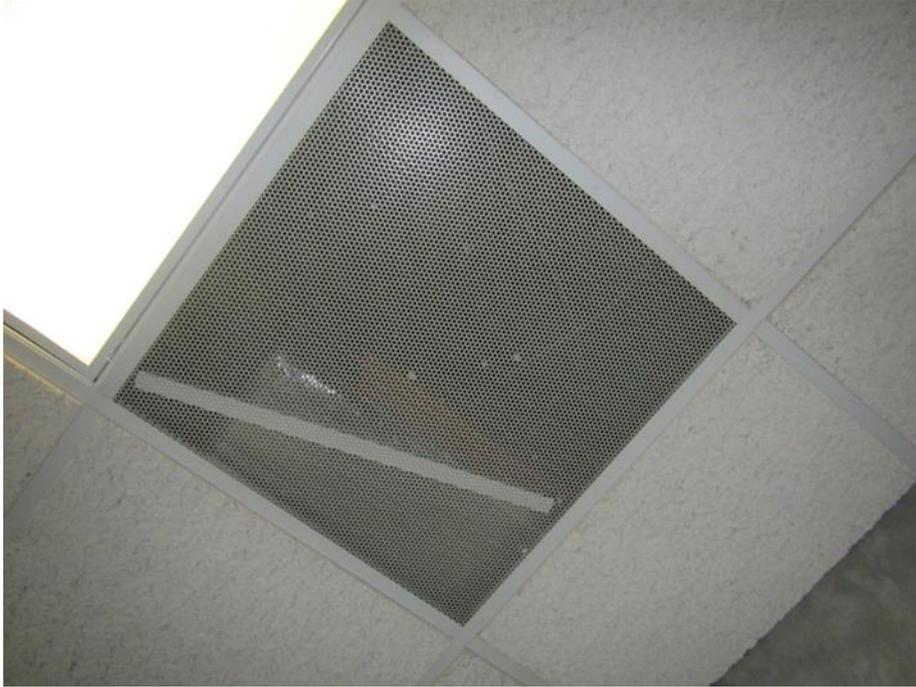
Picture 5

A vent in one office appeared to be damaged or improperly installed (Picture 5). This discontinuity in the vent system may lead to improper circulation and should be repaired.

Broken vent in office

2. Repair the vent shown in Picture 5.
3. Use blinds to moderate temperature in areas subject to direct sunlight.
4. Repair roof/plumbing leaks and replace stained ceiling tiles. Ensure that the roof gets examined regularly for deterioration and leaks, and that debris is removed regularly.

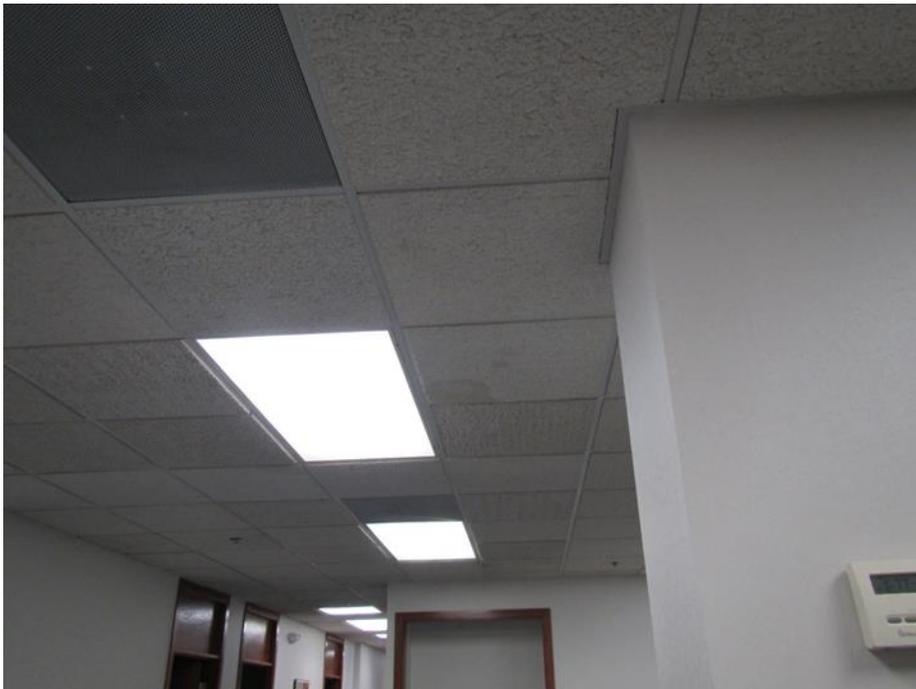
Picture 6

Stained ceiling tiles were observed in one area (Picture 6; Table 1). AGO staff reported that the roof had leaked in the past. Water-damaged ceiling tiles can be a source of mold and should be replaced after a water leak is discovered and repaired.

Water-damaged ceiling tiles

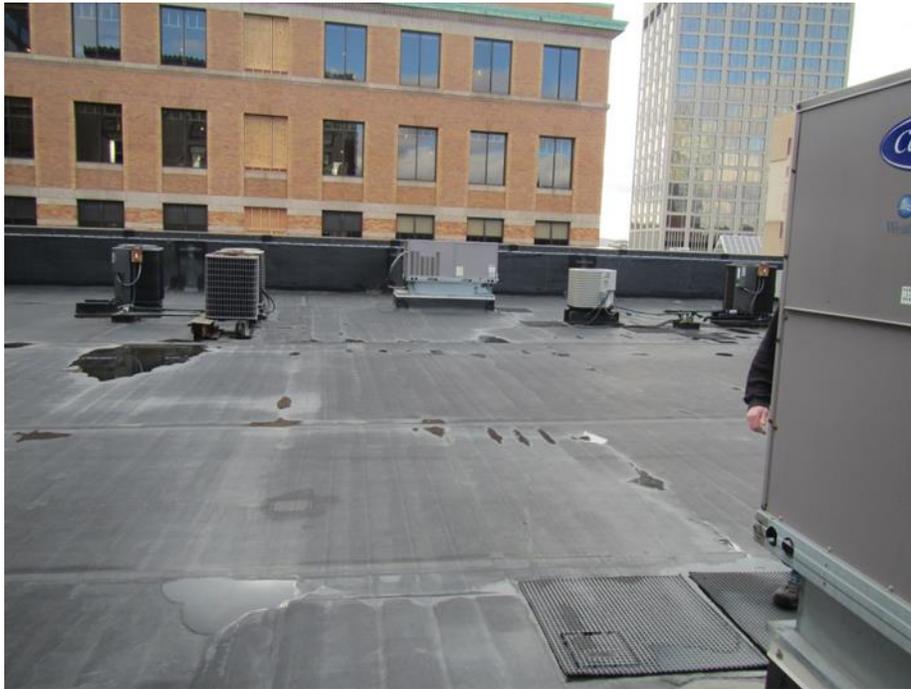
Picture 7

The roof of the building was examined. Water was observed pooling on the roof in a few areas (Picture 7), which makes leaking more likely. Procedures should be implemented to report suspected leaks (e.g., wet ceiling tiles) as well as to periodically examine and clean the roof as needed. It was reported that the roof may be the end of its at its service life and may need to be replaced soon.

Pools of water on the roof

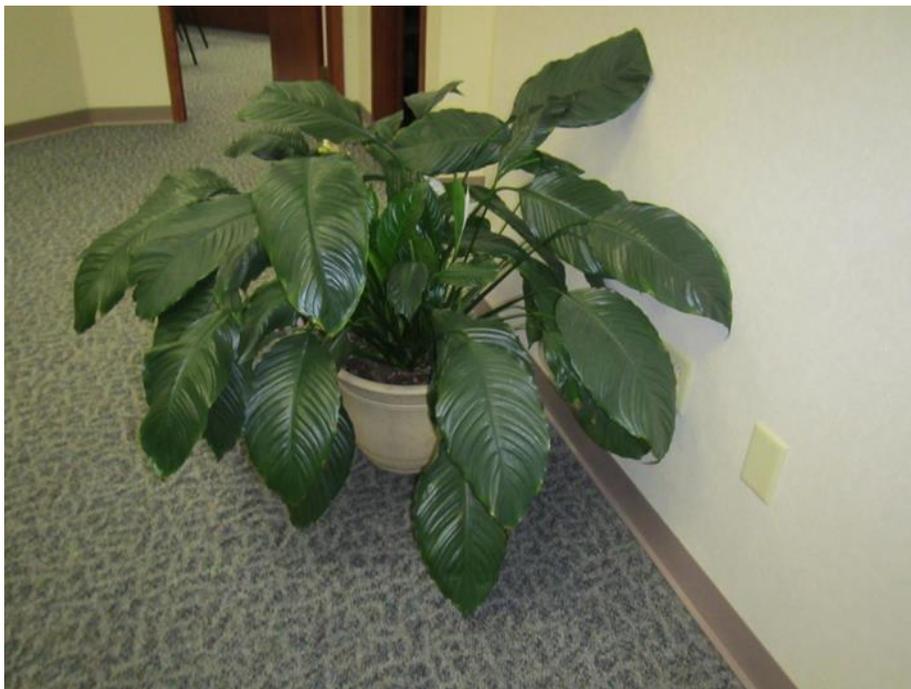
Picture 8

Plants were observed in a few areas (Picture 8; Table 1) including on porous surfaces (e.g. carpet). Plants can be a source of pollen and mold, which can be respiratory irritants to some individuals. Plants should be properly maintained and equipped with drip pans to prevent water damage to porous materials. Plants should also be located away from air diffusers to prevent the aerosolization of dirt, pollen and mold.

Plant on carpet (porous surface)

5. Keep plants in good condition, avoid overwatering, and avoid placing them on porous items such as carpets or paper.
6. Reduce the use of VOC-containing cleaners and sanitizers.

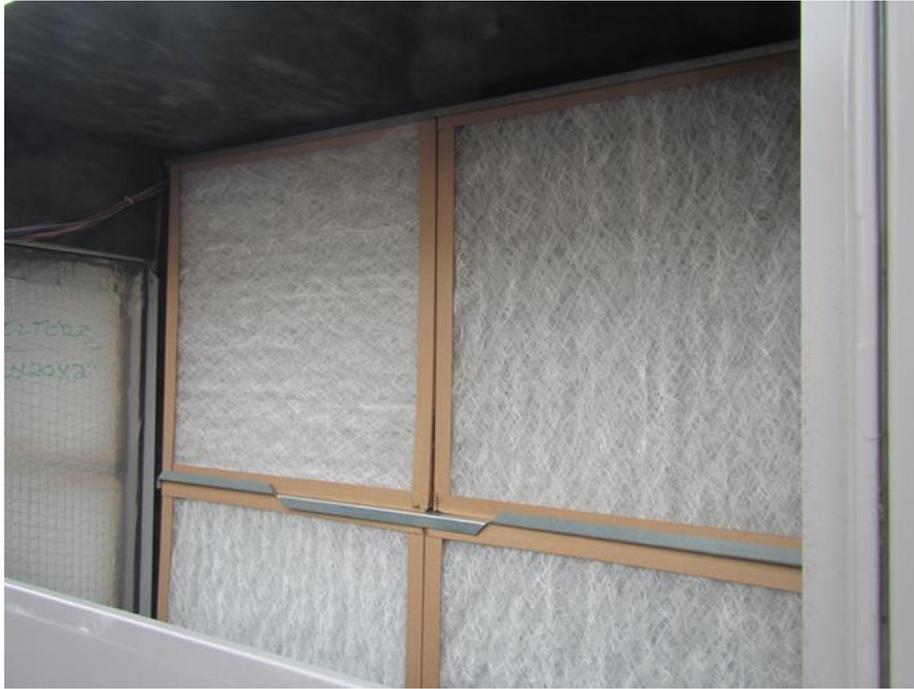
Picture 9

Filters in the AHUs were examined. They were reportedly changed recently and appeared clean, well-fitted and in good condition (Picture 9). However, they appear to be of a mesh type

that provides less filtration than the recommended pleated filters. A Minimum Efficiency Reporting Value (MERV) value of at least 9 is recommended for use in AHUs.

Mesh-type filter in AHU

7. Change HVAC filters regularly (2 to 4 times a year). Consider upgrading to pleated filters with a MERV 9 rating.
8. Clean supply and exhaust vents and personal fans regularly to prevent aerosolization of debris.
