Massachusetts FACE • Occupational Fatality Report

Forklift Operator Crushed Between Forklift Cage and Mast while Loading Waste Paper into a Trailer - Massachusetts

Investigation: # 08-MA-019-01

Release Date: March 16, 2010 (revised June 2010)

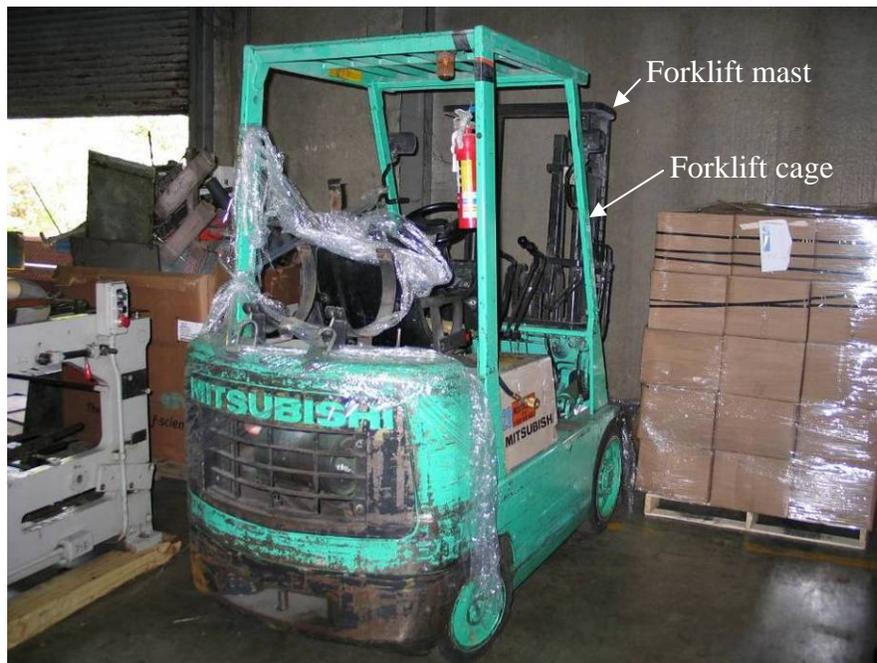
The vendor's forklift was a sit-down propane powered forklift. The forklift was manufactured in 1987 and has been located at the company since 2001 (Figure #1). The forklift is equipped with a cage around the operator's area and two lights attached to the two pillars that make up the front of the cage. Three control levers are located to the right of the forklift's steering wheel (Figure #2). These levers are used to adjust the forklift tines and mast. The lever closest to the steering wheel raises and lowers the tines. The middle lever, when pulled down, tilts the mast back towards the forklift's cage, which in turn angles the far end of the tines up. When the middle lever is pushed forward it tilts the forklift mast forward away from the forklift cage and angles the far end of the tines back towards the ground. The lever furthest to the right of the steering wheel shifts the tines from side to side.

Figure 1 – Forklift involved in the incident.

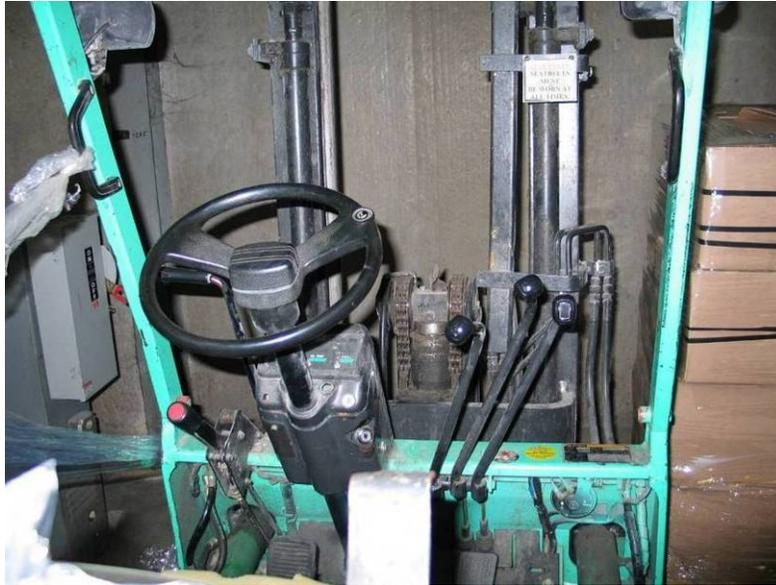
Discussion: In this case, the forklift was running while the victim was standing partially on the dashboard and reaching between the forklift's upright mast and the operator's cage to see what the raised load was caught on. While he was standing on the dashboard, his foot had engaged the lever that controls the tilting of the mast, causing the mast to tilt back towards the operator's cage, crushing him.

Figure 2 – Forklift's controls.

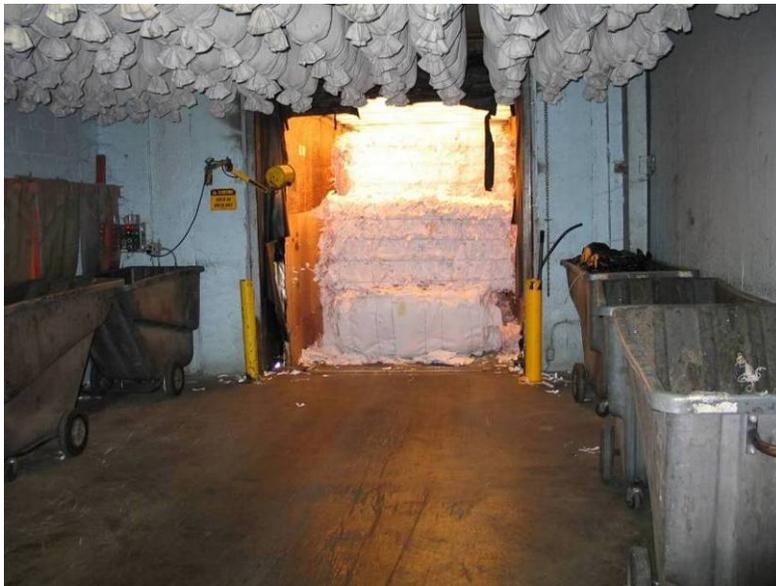
Figure 3 – Incident location with a tractor trailer loaded with paper bales not on pallets.

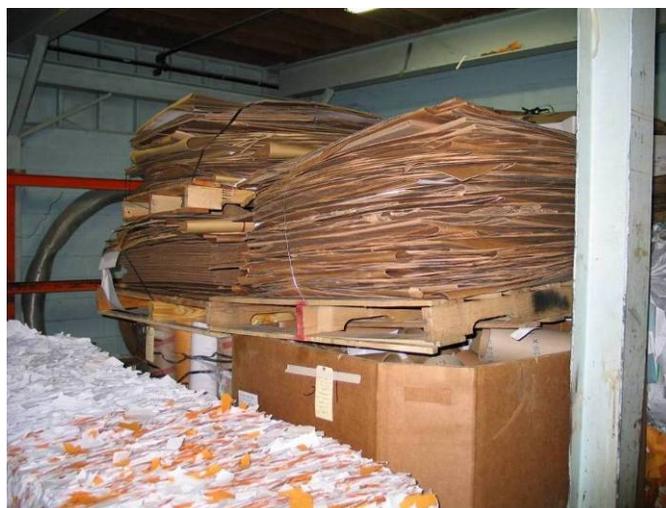
Figure 4 – Similar loaded pallet to the one being moved during the incident.

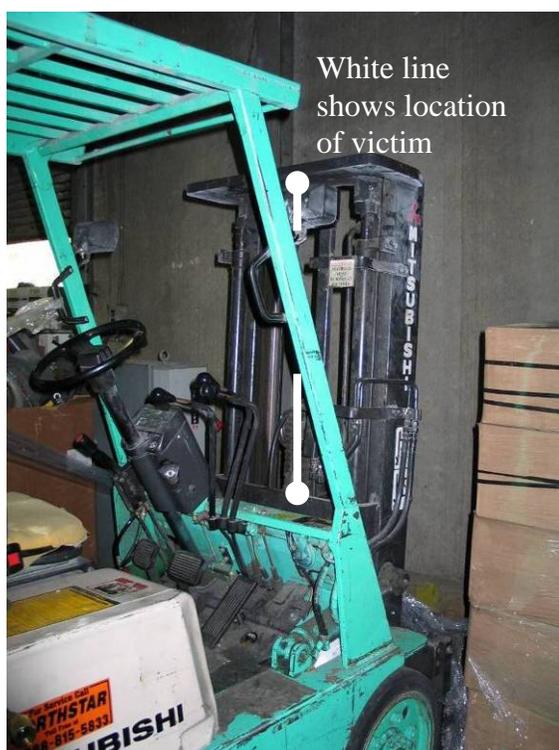
From this point forward it is unclear if the victim was trying to fix the problem or if he was attempting to get a better look at why the pallet was hung up. While the forklift was running and the tines were still raised approximately six feet, the victim engaged the forklift's emergency brake and exited the forklift operator's area. Evidence indicates that the victim then climbed up onto the exterior of the forklift between the forklift mast and the forklift cage and placed at least one of his feet on the forklift's dash board (Figure #5a and 5b). His foot came in contact with and engaged the forklift's middle control lever, pushing it in the downward direction. This caused the forklift mast to tilt back towards the forklift cage, crushing the victim between the mast and the cage.

Figure 5a – Forklift's cage and mast.

1. A guard at the front of the operator's cage designed so a worker could not contact the forklift controls while in the area between the cage and mast. The guard should be designed so that it does not impair the operator's vision and prevents objects from falling back into the operator's area.
2. A safety interlock, requiring forklift operators to engage two controls before moving the forks and mast.
3. A pressure interlock within the operator's seat that would engage by locking the forklift controls in place when the operator is no longer seated, or a sensor device attached to the forklift's seatbelt that when the seatbelt is disconnected the forklift's power shuts off.

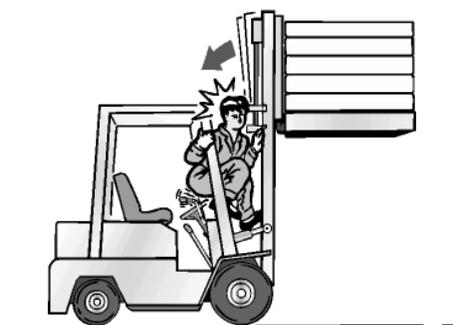
Figure 5b – Diagram of hazard.
