Massachusetts FACE • Occupational Fatality Report

Trackman Dies after Being Caught Between a People Mover and a Clip Applicator while Replacing Railroad Ties- Massachusetts

Investigation: # 06-MA-024-01

Release Date: June 22, 2009

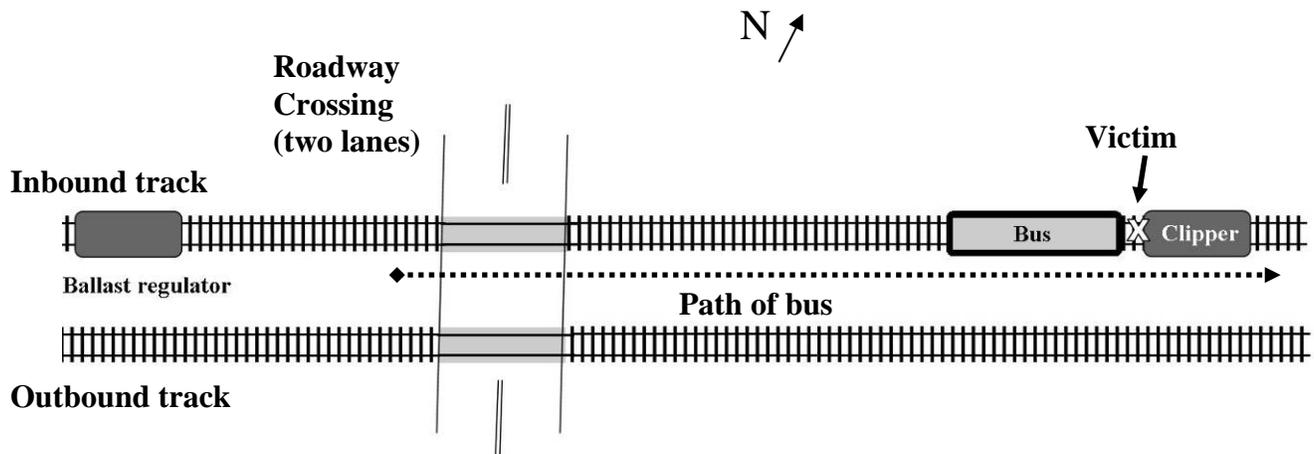
Figure 2 – Diagram of the incident location

The company reported that typically a tie gang can replace approximately 300 – 600 ties per day and that approximately 41,000 ties are replaced per year. The number of ties replaced depends on the complexity of the section of track and the number of train stations within that section of track. The work location where the incident took place consisted of two sets of tracks that are adjacent to each other and run in the east and west directions. The task of replacing the ties was taking place on the northern most track (Figure 2).

The incident occurred just after 3:00 p.m. with approximately 60 ties left to replace that day. The ballast regulator was the only piece of equipment that had not yet been moved in the forward direction, easterly, across a motor vehicle roadway crossing located approximately 300 feet to the west of the incident location. At the time of the incident, the bus operator was in the process of moving the bus forward to bring it in line with the rest of the equipment, behind the clipper. The clipper was not moving and the clipper operator was in the operator's seat.

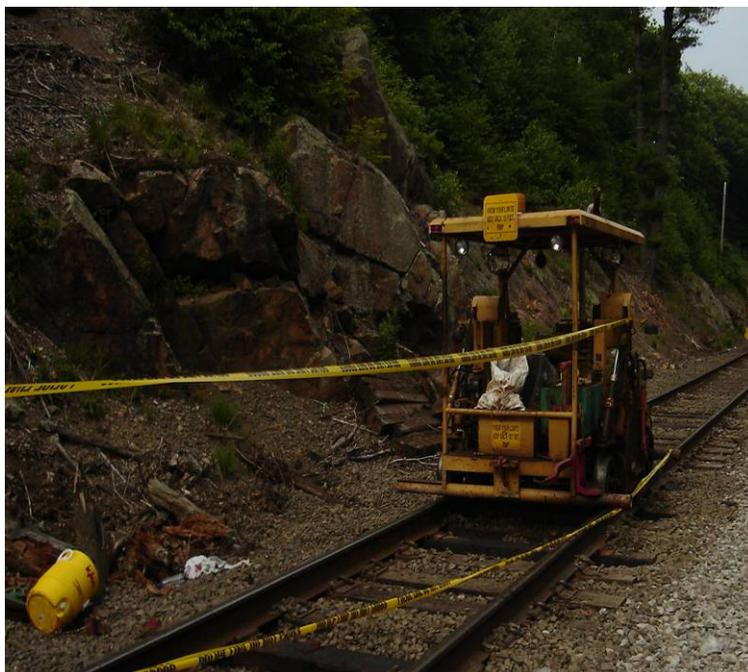
Figure 3 – Clipper involved in the incident

The two pieces of equipment directly involved in the incident were the clipper and bus. The clipper (Figure 3) was manufactured in 1985 and is equipped with steel wheels. At the rear of the clipper there are two signs warning other equipment and workers on foot to keep ten feet away. The main function of the clipper is to tighten/squeeze the clips once they are set in place on the tie plates (Figure 1). These clips fasten the track to the tie plate. One machine operator and four trackmen are typically assigned to the clipper, and this was the case on the day of the incident. The four trackmen, including the victim, were workers on foot and their main task was to put clips into place on the tie plates for the clipper to tighten.

As the bus approached the clipper, the victim fouled when he entered the track's gauge, the location between a track's two rails, to retrieve a clip from the clip bag located at the rear of the clipper. It was reported that about the same time, the bus operator applied the bus's brakes and that the bus started to skid along the tracks. It was also reported that the bus operator then cut the bus's throttle and released the air in the bus's air tank in an attempt to stop the bus. As the bus skidded towards the clipper, the victim was still standing in the track's gauge behind the clipper with his back to the bus. The bus then struck the victim and the rear of the clipper crushing the victim between the two pieces of equipment and resulting in the two pieces of equipment to become jammed together. During the impact, the clipper was pushed forward five feet. At this same time the three other workers on foot assigned to the clipper were standing in front of the clipper and jumped out of the way as it was pushed forward when impacted by the bus.

Recommendation #1: Railroad transportation companies/agencies should ensure that routinely accessed items, such as clip bags, are not located where roadway workers have to repeatedly foul tracks (position themselves in between or near) to access them.

Discussion: The Federal Railroad Administration (FRA) standard 49 CFR 214.313 *Railroad Workplace Safety* states that "A roadway worker shall not foul a track except when necessary for the performance of duty." In this case, one of the victim's main tasks was to manually set clips into the tie plates. The storage location for the clips was in a bag located at the rear of the clipper. When trackmen needed to retrieve clips to continue their task, they had to access the clip bag located at the rear of the clipper, therefore fouling the track. To help minimize the number of times workers need to foul tracks, the single rear clip bag should be replaced with two clip bags, one located on each side of the clipper.

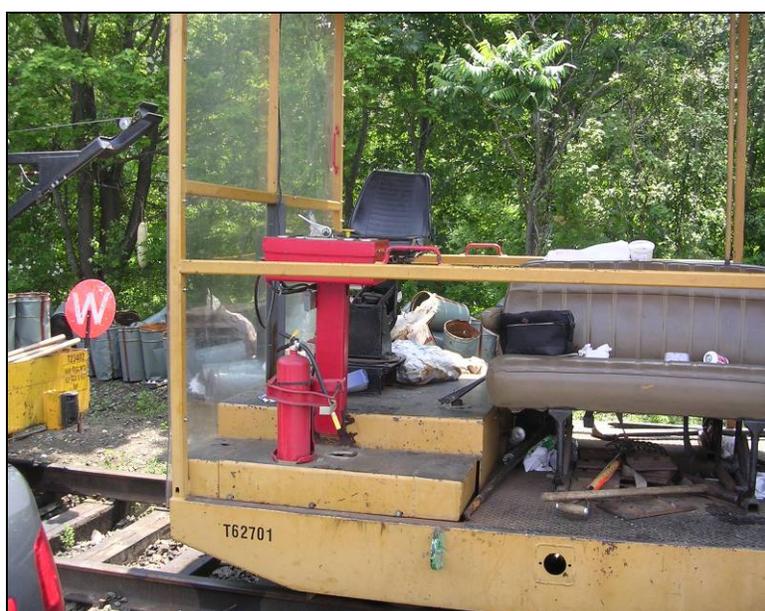
Figure 4 – Operator's area of the bus involved in the incident

The bus (Figure 4), which was originally manufactured in 1981 as a tie mover, was converted in 1997 to a bus by the company that had previously operated the commuter rail. The bus is used to transport both supplies and tie gang members who are not assigned to operate equipment to the work location when the work location is a distance from access roads. When needed, the bus is

also used to pull a tool trailer. The bus is rectangular in shape and has steel wheels that are for on-track use only. Top speed for the bus is approximately 30 miles per hour, and the bus has a pneumatic breaking system. The front and rear of the bus have large plastic windows and the sides of the bus are open. The main part of the bus has seating for workers that face perpendicular to the movement of the bus, therefore when the workers are seated they are facing and looking out the sides of the bus. The operator's area is located at the front of the bus and the operator's seat faces the left side of the bus. When the operator is seated in the operator's seat, the operator is looking out to the left side of the bus. To look through the windshield of the bus, the operator's head has to be turned 90 degrees to the right (Figure 4).

When purchasing or acquiring equipment, especially equipment that has been altered by an entity other than the original manufacturer, the equipment should be thoroughly inspected and evaluated to ensure that all aspects of the equipment are safe to operate. In this case when seated in the bus operator's seat, the operator faces the side of the bus. When operating the bus, the operator has to turn their head 90 degrees to look in the direction that the bus is moving.

Recommendation #3: Railroad transportation companies/agencies should inspect and evaluate all purchased or acquired equipment, especially equipment altered by another entity, to ensure it is safe to operate prior to placing it in operation.
