# MA FACE

## Occupational Fatality Report

### Laborer Compressed Between the Top Rail of a Scissor Lift Guardrail and a Steel Beam - Massachusetts

Release Date: May 22, 2015  
Investigation: # 13-MA-032-01

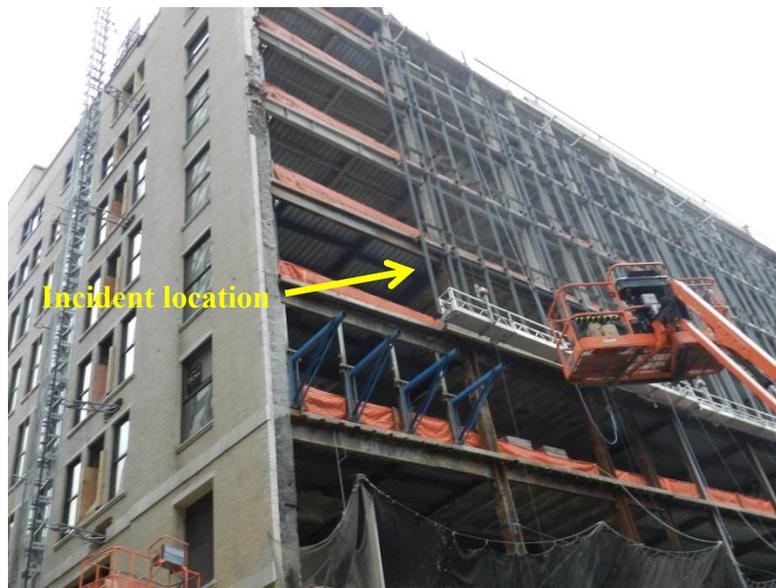
**Figure 1 – Building where incident occurred**

The incident occurred on the fourth floor of an eight story building that was in the process of going through a complete renovation (Figure 1). The building was located in the downtown section of a large city and the construction site encompassed an entire city block. At the time of the incident, the inside of the building had been gutted and one entire side of the building's exterior wall was completely open (Figure 2).

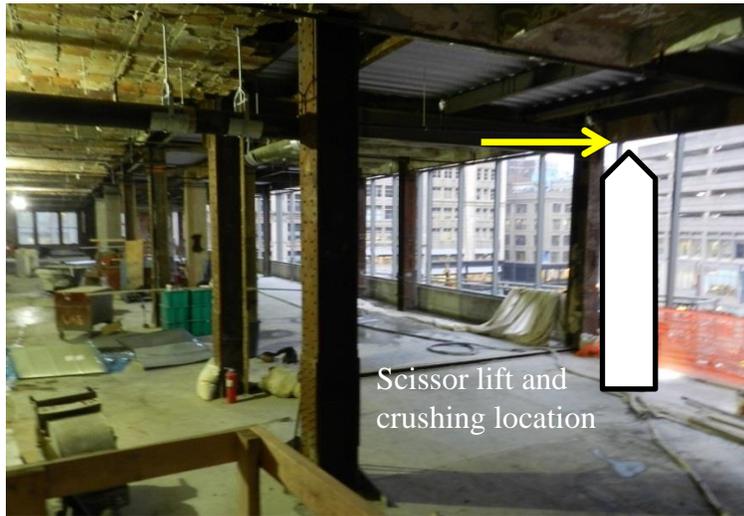
**Figure 2 – Location where scissor lift was positioned**

As part of the preparation for the next day tasks, the victim was using a scissor lift to install a large polyethylene tarp that would function as a barrier to protect the surrounding areas from overspray. The tarp was being fastened to a steel column located at an exterior wall of the building. This was one of the building's walls that was completely open to the elements. The exterior wall opening where the incident occurred was approximately 13 feet high and 20 feet wide (Figure 2).

At the time of the incident, the victim was alone on the fourth floor of the building, although workers from other subcontractors were performing tasks throughout the building. The victim had the scissor lift positioned at an exterior wall of the building and was working from the lift's raised platform. It appears that the victim, who was wearing a hardhat, at the time of the incident, was leaning out and over the scissor lift's guardrail when the tarp became caught on and around the joystick control lever. The tarp engaged the trigger switch and joystick causing the scissor lift to rise up. The victim's head and neck area were crushed between the scissor lift's guardrail and an overhead steel beam.

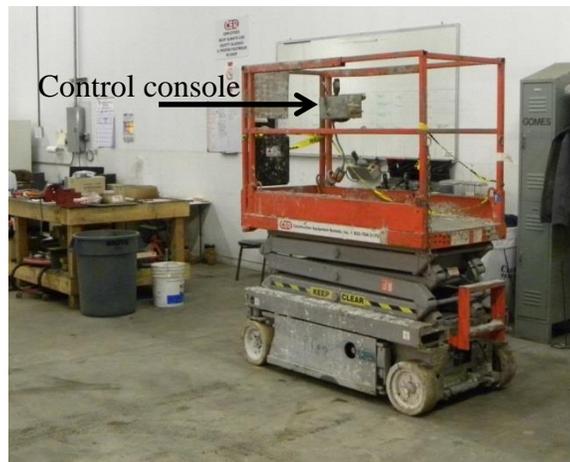
**Figure 3 – Scissor lift involved in the incident**

The equipment involved in the incident was an electric powered mobile elevating work platform (scissor lift) that was manufactured in 2005 (Figure 3). The scissor lift was being rented by the insulation company and had been on site for about one month at the time of the incident. The scissor

After the incident the scissor lift went through a complete inspection by both OSHA and the manufacturer and both found that the scissor lift was not defective and functioning normally at the time of the incident.

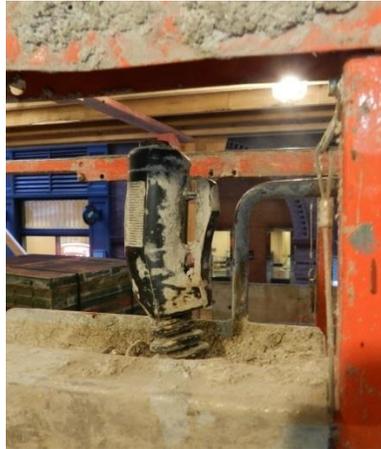
**Figure 4 – Scissor lift control console**

The lift's platform was equipped with a removable control console that was mounted at the right front corner of the platform near the top of the guardrail (Figure 4). This console contains multiple controls, one of which was a joystick that controls lifting, driving direction, speed, and steering functions. The joystick had a trigger switch that energizes the joystick and must be continuously depressed in order to engage the other functions the joystick controls. When the joystick is released, the control automatically goes back to a neutral setting. The console also had an emergency stop button, a horn, battery charging status gauge, a lift/drive off switch, and a joystick bar guard. In addition, the lift had a load sensing system and when the rated load was exceeded a light flashes, an alarm goes off and all electrically controlled platform movements stop until the overload is removed from the platform.

**Discussion:** The scissor lift's operating manual states that materials should not be placed on the guardrails and that materials should not exceed the confines of the guardrails.<sup>1,2</sup> When the victim was found, a tarpaulin (tarp) was draped over the victim's left shoulder and over sections of the lift's guardrail. The tarp was hanging off the left side of the lift's guardrail and was also draped to the right where it was hung up on the joystick control lever. The joystick was being held in the forward position by the weight of the tarp causing the lift to be stuck in the lifting mode.

In this case, the manufacturer had equipped the control console with a joystick trigger switch and a bar guard. These features were developed to prevent the joystick control from being un-expectedly engaged, but the tarp was still able to become entangled on the joystick causing the lift to rise un-expectedly. The scissor lift, which is still being manufactured with the same features, serves as an excellent example of the potential for eliminating or minimizing injury risks through a comprehensive PtD review of the equipment.

If PtD was applied to the scissor lift, the potential for the worker and equipment interaction that led to the incident could have been identified and highlighted the need to redesign and/or incorporate additional engineering controls to the control console. For example, the control console could have been redesigned with a guard or shield that encompasses the entire joystick, which would better prevent an un-expected engagement of the lift's joystick. PtD could also have led to a more advanced load sensing system, such as a system that can detect when a lift's guardrail is up against a stationary object while its controls are still engaged. The system could then sound an alarm and lower the work platform a few inches; this could have possibly limited the victim's injuries.
