Occupational Fatality Report

Municipal Foreman Killed When Struck by a Backhoe Loader Outrigger While in an Excavation - Massachusetts

Release Date: March 30, 2016
Investigation: # 14-MA-003-01

Massachusetts Department of Public Health
Occupational Health Surveillance Program

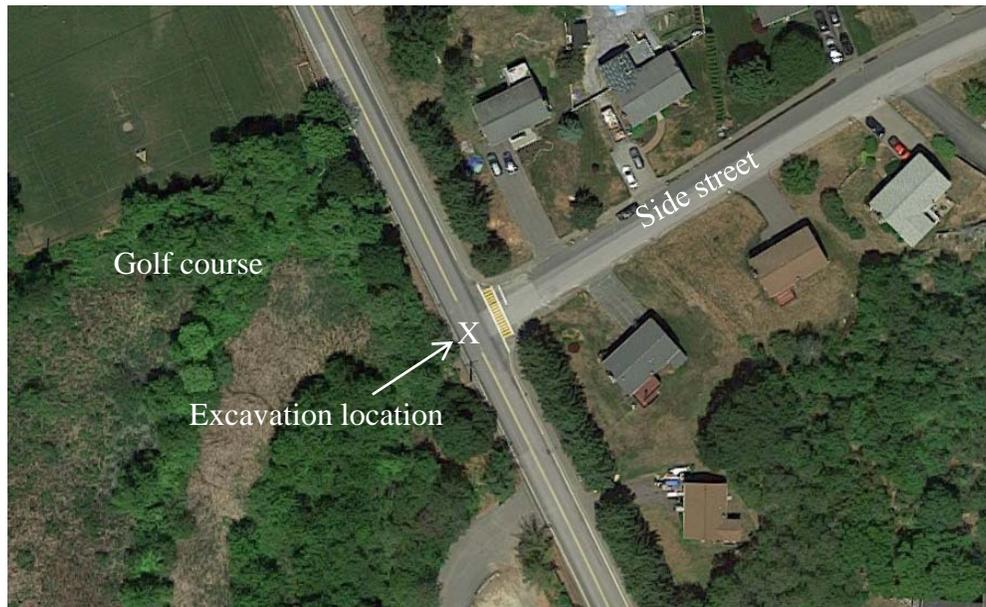
The incident occurred in a suburban area that was mostly made up of a residential neighborhood with single family homes, municipal playing fields and a golf course (Figure 1). The roadway where the incident occurred was an asphalt roadway that primarily ran north and south. The roadway had two travel lanes, one for each direction. The travel lanes were approximately 12 feet wide each and were separated by painted solid double yellow lines. The outer edges of the lanes had painted solid white fog lines followed by a two foot wide paved shoulder and then granite curbing. The east side of the northbound travel lane had a paved sidewalk and the west side of the southbound travel lane had a grass sidewalk. Both sidewalks were about six feet wide. The posted speed limit for this street was 30 miles per hour. The roadway was relatively straight and flat in this area.

Figure 1 – Aerial view of the T-shaped intersection where the incident occurred

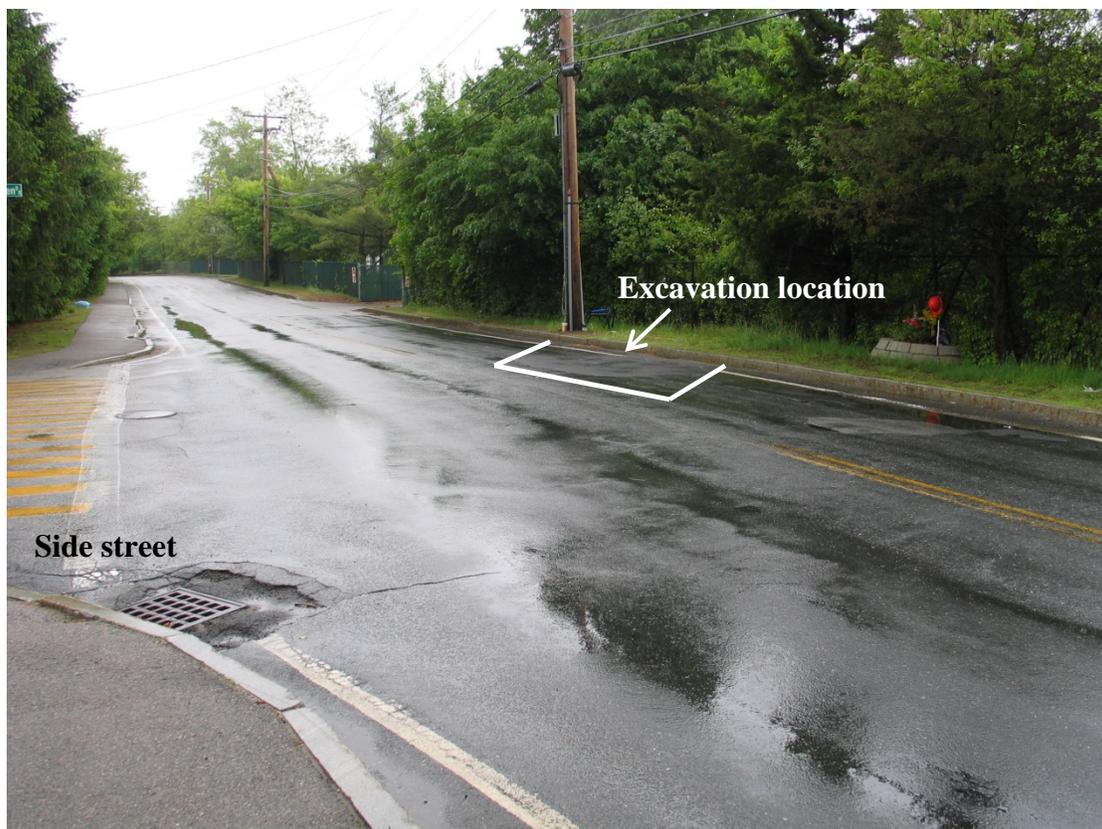
The incident occurred at a T-shaped intersection with a residential side street that intersected the main roadway from the east (Figure 2). The side street was asphalt, had one lane for both directions of travel and no roadway marking except at the intersection with the main roadway. At the intersection there was a painted crosswalk across the side street and a white painted stop line, but no stop sign. The area beyond the west side of the T-shaped intersection was vegetation that abutted the golf course property.

Figure 2 – Roadway view of the T-shaped intersection with excavation location outlined

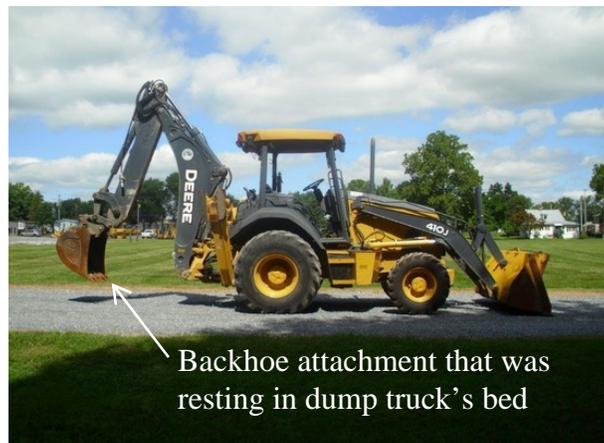
The machine involved in the incident was a backhoe loader that was purchased new by the town in 2008. One end had a loader attachment and the other end of the machine had a backhoe attachment (Figure 3). There were two outriggers (stabilizers) at the end where the backhoe attachment was located. The backhoe loader's dimensions were 9.3 feet high to the top of the cab, 7.7 feet wide with outriggers stowed, and 13.3 feet wide with the outriggers extended. The backhoe loader had an operating weight of about 15,000 pounds.

Figure 3 – Backhoe similar to the one involved in the incident

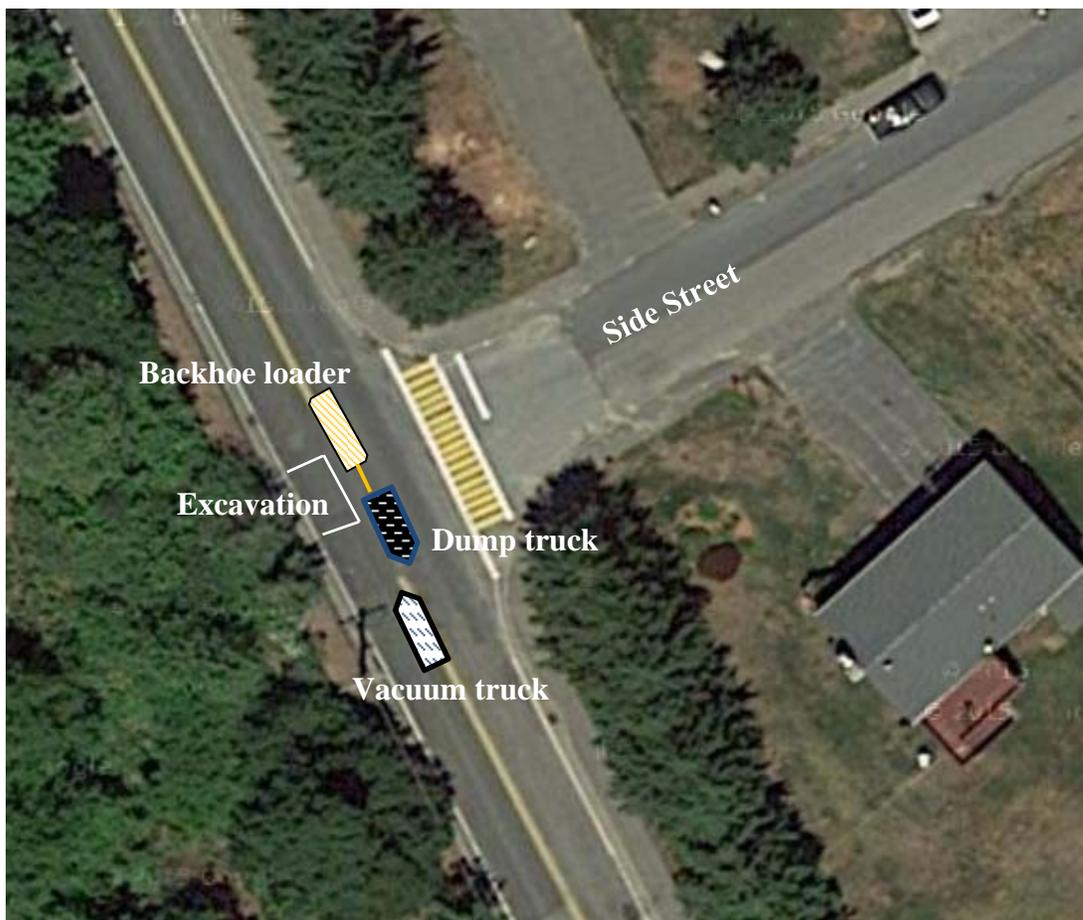
The work crew arrived at the work site location with the backhoe loader, dump truck, and a vacuum truck (Figure 4). They also brought a light tower to illuminate the work area, due to it being dark outside. The work crew estimated the break location and excavated a hole that was approximately ten feet long by six feet wide and five feet deep to locate the break. The excavated hole was located in the T-shaped intersection southbound travel lane, directly across from the side street. The backhoe section of the backhoe loader was used to excavate the hole and was positioned in the southbound travel lane just north of the hole. The backhoe loader's outriggers were in use and extended while digging the excavation and at the time of the incident. The dump truck was positioned next to and immediately east of the hole. This position placed the dump truck over the painted solid double yellow line and partially in the northbound travel lane. The light tower was located to the west of the hole. The vacuum truck was positioned in the southbound travel lane just south of the hole to control the water level in the excavation. The northbound travel lane was kept open during the repair process and a town police officer was on site with a police car conducting traffic control as part of a traffic detail.

Figure 4 – Roadway view of the T-shaped intersection with outline of vehicles and excavation location
