APPENDIX C:  
CONDITIONS ASSESSMENT

# **Certified Building Study 12 Brainard Street Hyde Park, Boston, MA**

**DCR Project No. P22-3471-S3A**

**December 27, 2022**

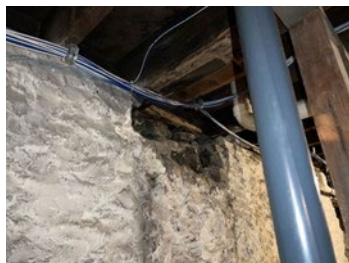
Missing Stone at Foundation Wall

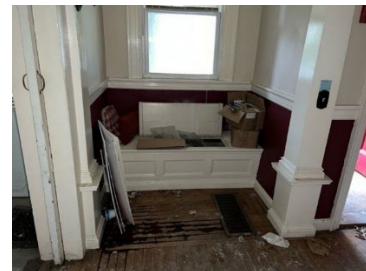
Source of Water from 1<sup>st</sup> Floor

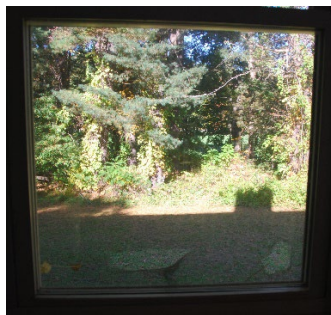
Damaged Screen & Damaged Glass

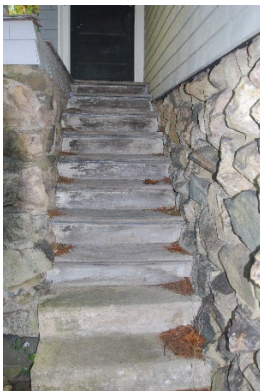
- E. Rear Stairs: These stairs are falling apart and are extremely dangerous. The tread and Risers are unequal and coming loose. No handrail.

Rear Stairs

- D. Rear Stairs and Wood Decks: The rear stairs that exit from the kitchen do not meet code and they are in such disrepair that they cannot be considered safe. They should be rebuilt with new stringers that are pressure treated and new risers and treads. The risers and treads should be fabricated out of PVC or composite decking material to reduce maintenance and wear and tear.

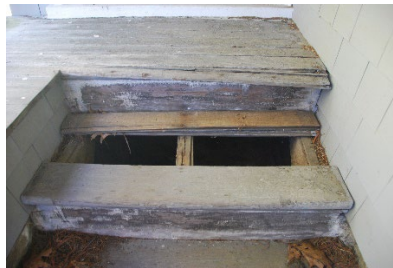
Missing Tread

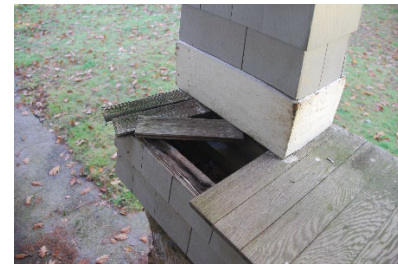
Broken Decking

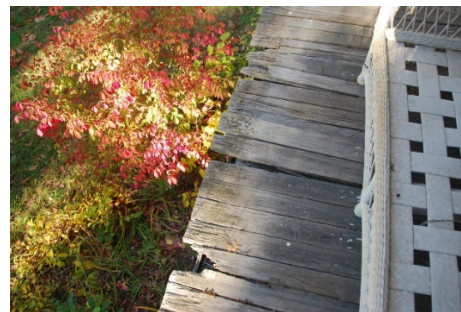
Deteriorated Decking at Rear Porch

The side porch off of the living room needs to have the deck completely replaced. The deck itself pitches to the side yard and it appears that the decking is located above the subfloor of the first floor framing. It is assumed that the subfloor has either building paper or a peel and stick rubber membrane as no water penetration was observed in the basement below. Before replacing the new PVC or Composite decking, the weather membrane should be evaluated to see if it requires repair or replacement.

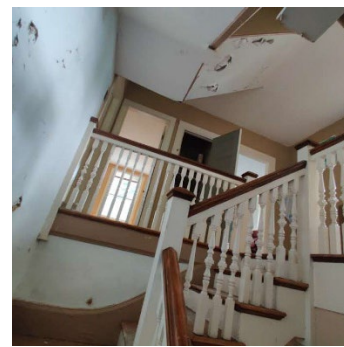
Peeling Paint at Main Stair

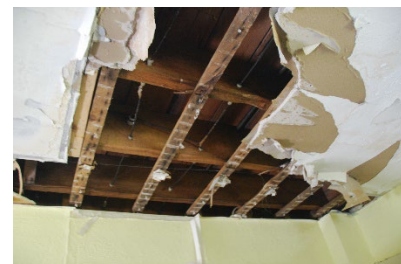
- C. Ceilings: Most of the ceilings on the second floor are in good condition. The kitchen needs significant repair and the ceiling in the front entry hall needs patching and repainting.

Kitchen Ceiling

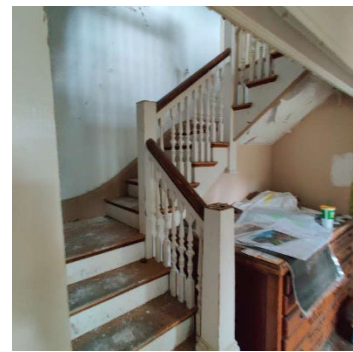
Stair: Missing Newel Post Caps

- E. Stairs: The main stair is in moderately good shape. The treads, risers are showing wear and the guard rails are too low as per code and newel post caps are missing, however that are stored on site and can be reinstalled. The stair to the basement also does not meet code.

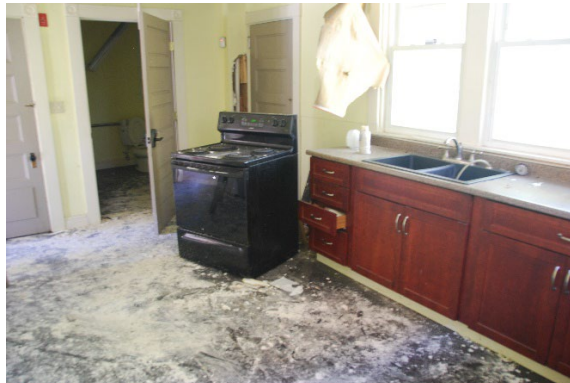
General view of the kitchen

F. Kitchen: The existing kitchen is in severe shape, although some of the cabinetry might be salvageable. The floor finishes must be replaced and parts of the gypsum ceiling has collapsed. The stove was disconnected, and therefore it was not checked to see if it could be reused and/or refurbished. There is no refrigerator.

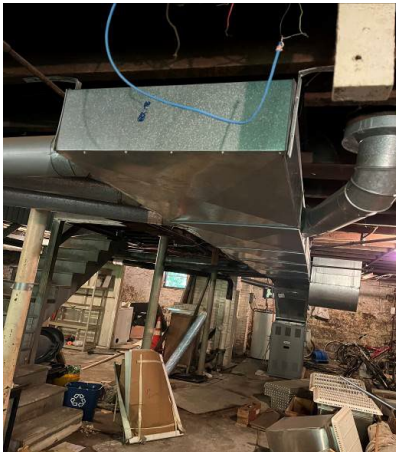
Uninsulated Ductwork

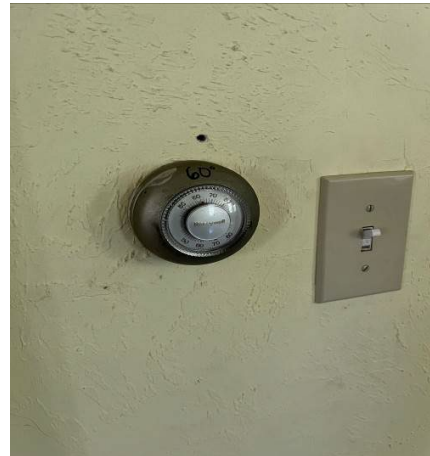
While the major components of the heating system were upgraded, the thermostat controlling the system is an antiquated mercury dial type, nonprogrammable thermostat. This thermostat should be removed and disposed of in a legal and safe manner and replaced with a programmable thermostat that better serves the building and occupants.

Mercury Thermostat

- 2) The existing mercury thermostat should be replaced with a 7-day programmable thermostat with remote monitoring.
- 3) Air conditioning would be recommended and depending on the building usage may be required. Since the existing heating system is only relies on fossil fuel, a heat pump system would be recommended. This would not require any additional equipment to a new air conditioning system and would reduce the oil dependency of the heating system.

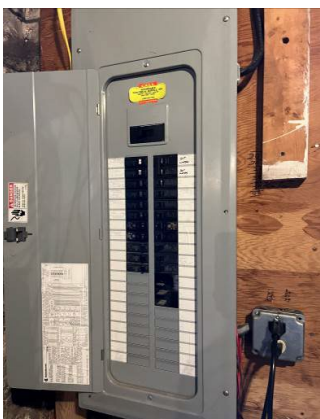
- A. Executive Summary: In general, the existing electrical infrastructure is in poor condition. Most of the electrical systems are in poor condition due to environmental conditions and no maintenance. Life safety systems such as fire alarm, emergency lighting, and exit signs are either non-existent or not code compliant.
- B. Electrical Distribution System: The building is serviced with a 200 Ampere main breaker, 120/240V, 1Ø, 3W, panelboard with 40 poles. The Load Center is located in the Basement. The utility meter is located outside. The service is coming in overhead from utility pole 1441/1. Distribution equipment is in poor condition.

Main Panel

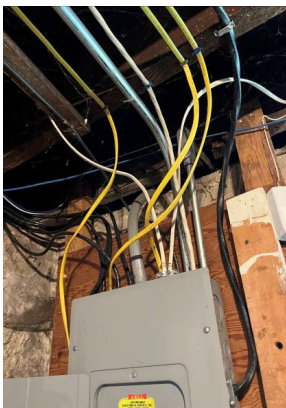
- G. Branch Circuitry: Branch circuits consists of Romex wiring and knob and tube. All knob and tube should be replaced. Branch circuitry is in poor condition. GFCI protection and arc fault protection is inadequate

Branch Circuits Romex

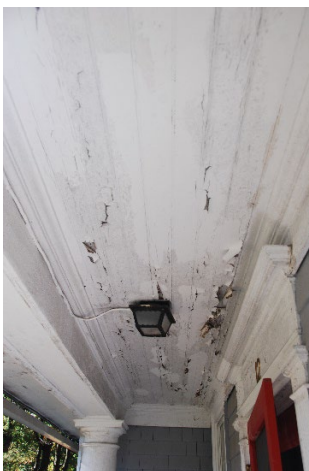
Peeling Paint ant entry soffit

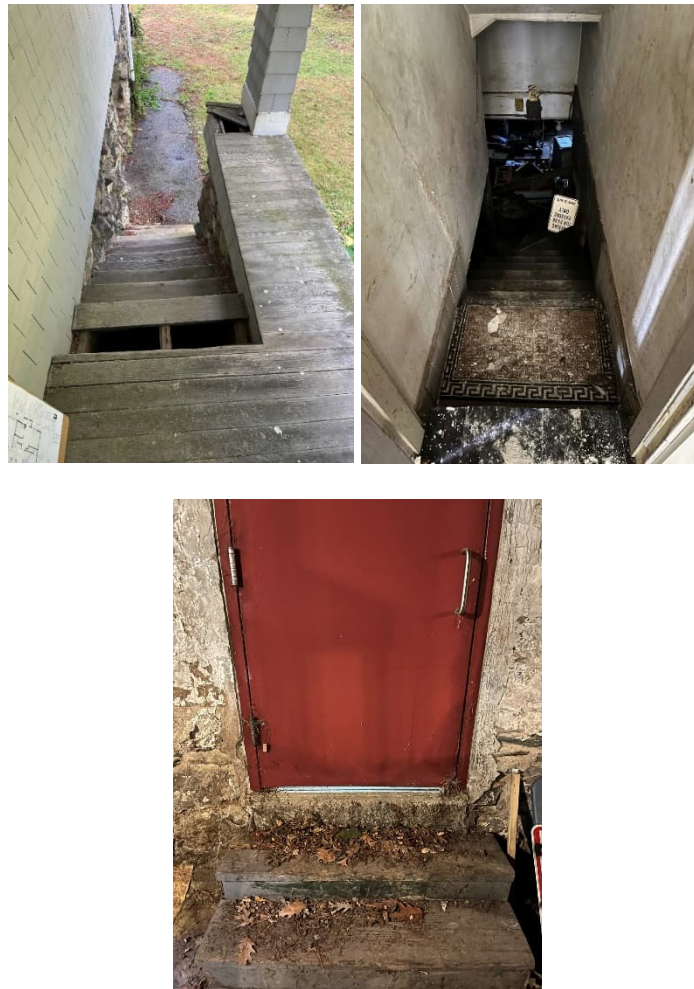
Handrails must be provided on at least one side of each stair. The rear stair, the stairs at the exterior basement door, and the top of the basement stair are not provided with handrails on either side (Figure 1). The lack of a handrails can be considered unsafe by the building official. Therefore, a handrail should be provided for these stairs as part of the proposed renovations.

*Figure 1: Lack of handrails at rear and basement stairs*

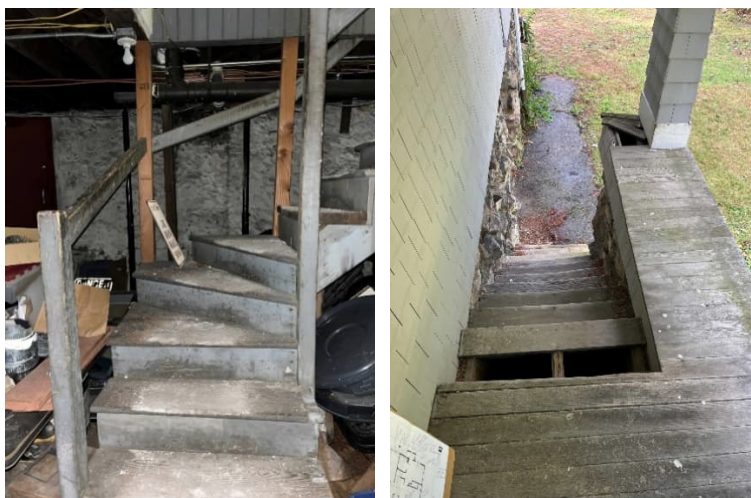
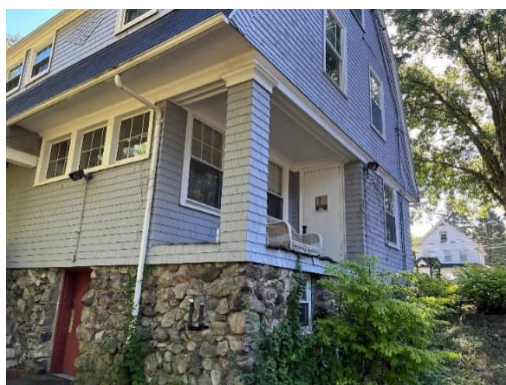
*Figure 2: Lack of guards at basement, rear stair, and exterior porch*

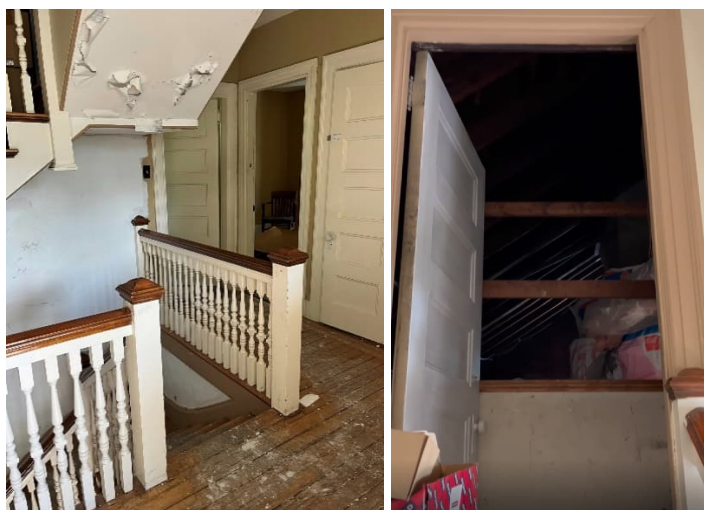
In addition, the guard on the second floor is only 33¾" inches high and the guard in the attic is only 34" high (Figure 3). The openings in the attic guard are also greater than 4" (approximately 14½"). New guards must be at least 36" above the floor and must not allow passage of a 4" sphere. The guards on the second floor and attic must be raised, and the openings in the attic guard must be reduced if they're altered or if the existing guards are deemed unsafe by the building official.

*Figure 3: Low guard on Level 2 and in the Attic*

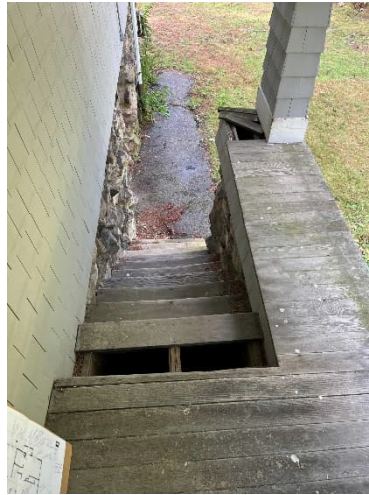
The rear stair is in disrepair due to missing treads and decking. Existing buildings, including means of egress must be maintained in safe, working condition. As is, the existing stairs are not safe for use. The missing treads and decking must be replaced.

*Figure 4: Missing treads and decking at rear stair*

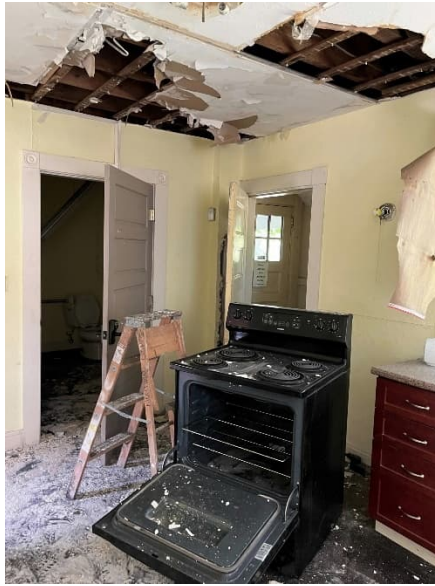
There are various floor/ceiling assemblies that are in disrepair (Figure 5). Floor assemblies must be provided with a membrane consisting of ½-inch gypsum wallboard, 5/8-inch wood structural panel, or equivalent membrane. The existing construction must be maintained in safe, working condition. The existing floor/ceiling membranes must be repaired and protected in accordance with these requirements.

*Figure 5: Floor/ceiling assemblies in disrepair*

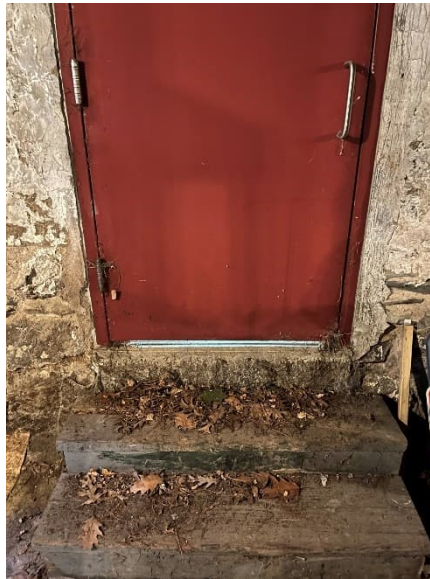
For new construction, landings are required on each side of exterior doors, except that a step of up to 7¾" is permitted on the exterior side of the door. The existing exterior door in the basement level has steps leading up to the door and there is no landing provided at the interior side of the door (Figure 6). A landing must be provided where the stairs are specifically altered, or where the condition is considered unsafe by the building official.

*Figure 6: Steps at basement exterior door*

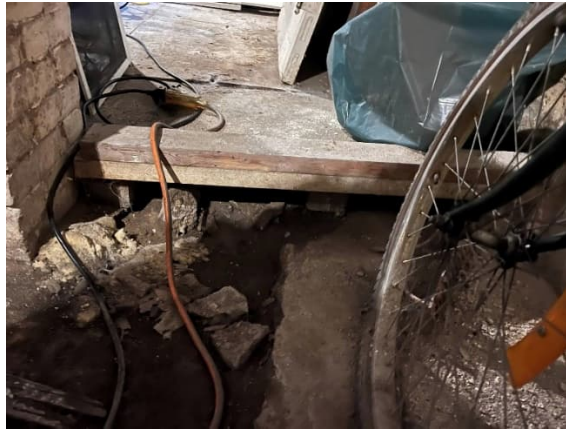
The basement level includes various elevation changes that range from 1½" to 8½" (Figure 7). The level changes present a tripping hazard and therefore can be considered an unsafe condition. As part of the alterations, a level walking surface should be provided.

*Figure 7: Non-level walking surface in basement*

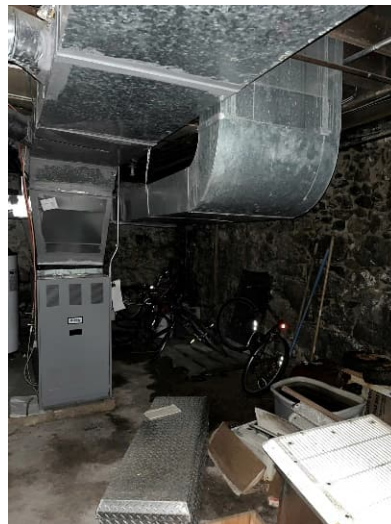
The existing headroom in non-habitable basements must not be reduced as part of the alterations. For new or altered areas, non-habitable basements must have a minimum ceiling height of 6'-8", with ducts permitted to project within 6'-4". There is an existing duct that reduces the available headroom to 63" (Figure 8). Where the duct is altered, the available headroom must comply with the requirements applicable to new construction to the greatest extent possible.

*Figure 8: Large duct that reduces basement headroom*

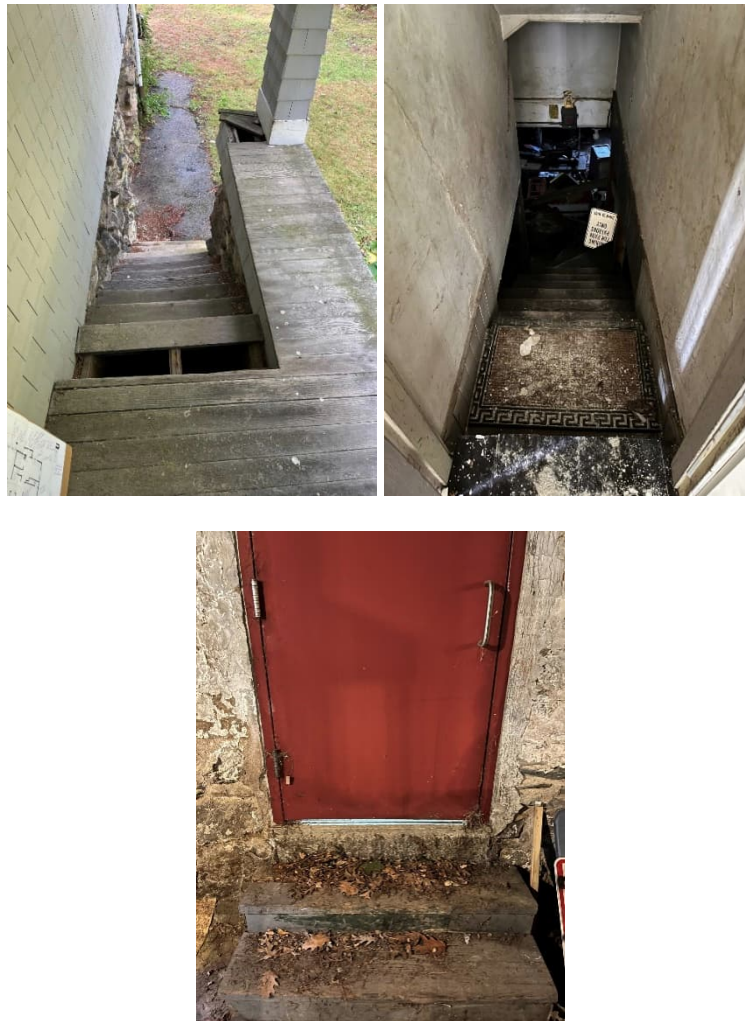
The handrails must comply with the requirements applicable to new construction, including number of handrails, height, continuity, and extensions where they are specifically altered, where an existing condition is deemed unsafe by the building official, or in areas open to the public, where the cost of work triggers the 30% threshold for full compliance with 521 CMR.

*Figure 1: Lack of handrails at rear and basement stairs*

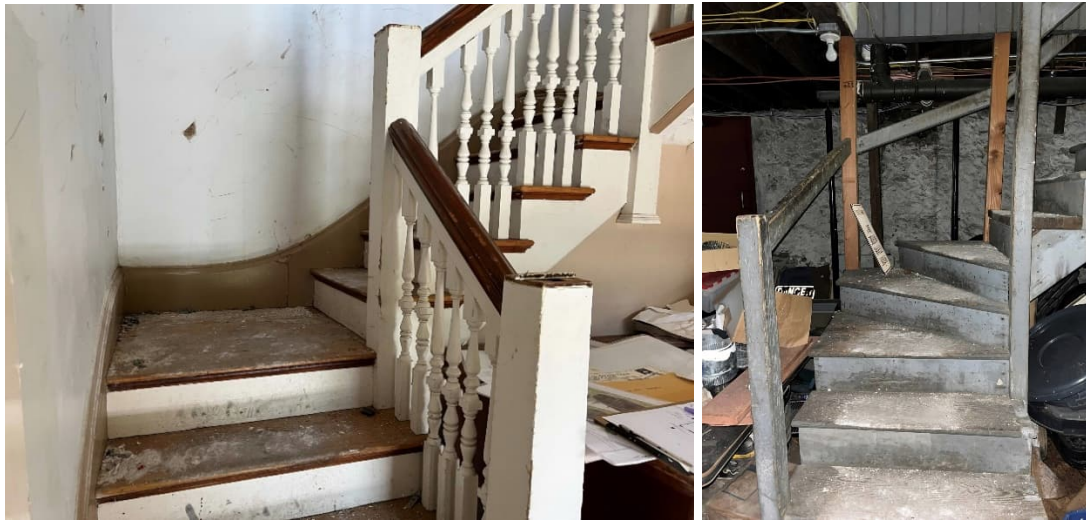
*Figure 2: Handrails interrupted by newel posts*

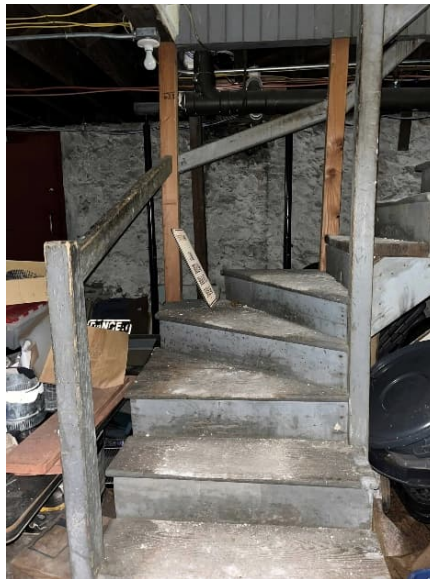
Winder treads are not permitted for use in stairs that serve as a means of egress, except within a dwelling unit. The basement stair currently includes winder treads (seen in Figure 5). The winder treads must be replaced with compliant treads if the basement stairs are altered or if the condition is considered unsafe by the building official.

Figure 5: Winder treads in basement

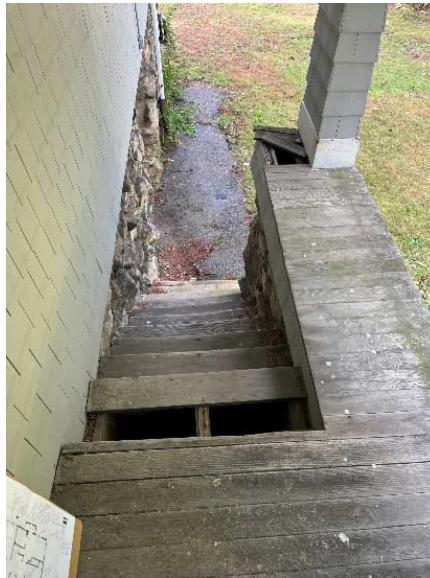
The rear stair is in disrepair due to missing treads and decking. Existing buildings, including means of egress must be maintained in safe, working condition. As is, the existing stairs are not safe for use. The missing treads and decking must be replaced.

Figure 6: Missing treads and decking at rear stair

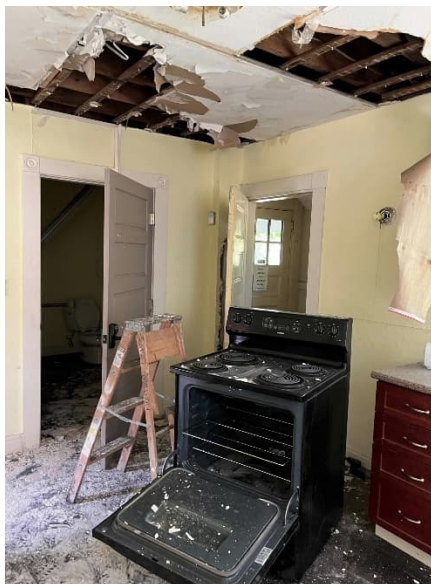
There are various floor/ceiling assemblies that are in disrepair (Figure 7). The existing construction must be maintained in safe, working condition. The existing floor/ceiling membranes must be repaired in accordance with these requirements.

Figure 7: Floor/ceiling assemblies in disrepair

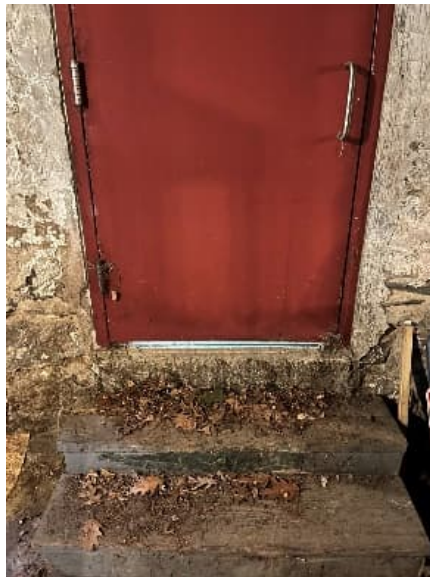
Landings at doors shall have a minimum length of 44 inches measured in the direction of travel and a width equal to the door or stair it serves, whichever is greater. The small stair leading to the door in the basement does not provide a landing with adequate length (as seen in Figure 8). The landing around the door must be made compliant with new construction if the door or landing is altered or deemed unsafe.

*Figure 8: Non-compliant landing on inside of door*

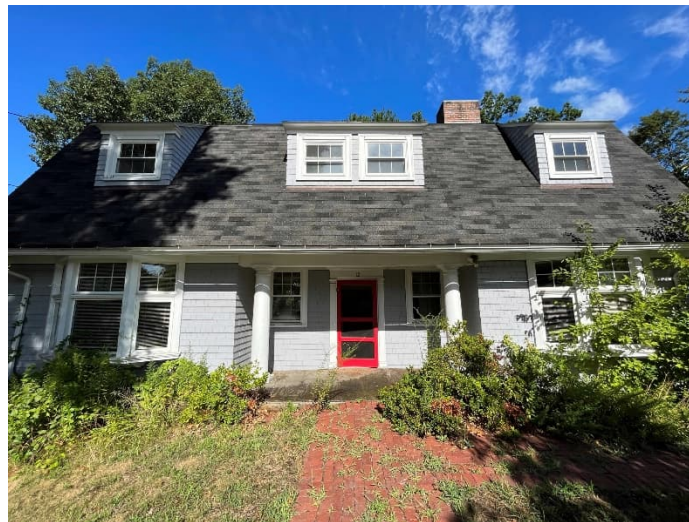
The existing path to the front door is uneven, overgrown, and in disrepair. If the building is open to the public, an accessible entrance must be provided where the cost of work exceeds \$100,000. Note that if the building is not open to the public, or the cost of work does not exceed \$100,000, the path to the front entrance must still be repaired in accordance with the maintenance provisions of 780 CMR 102.8.

*Figure 9: Existing front entrance*

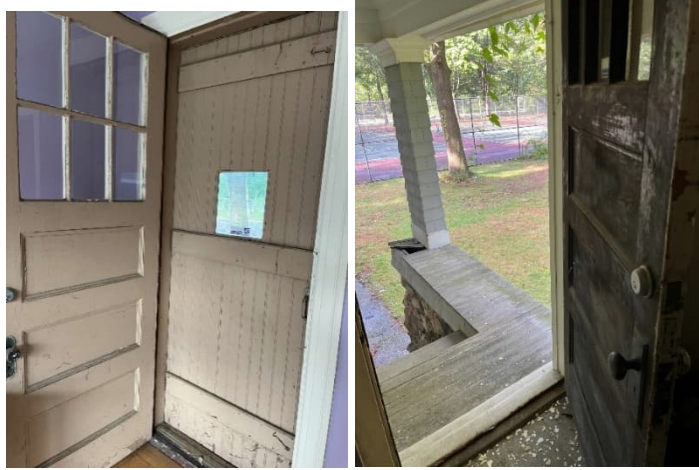
Various doors throughout the building include doorknobs (examples seen in Figure 10). Doorknobs are not accessible since they require tight grasping, pinching, or twisting of the wrist. Compliance can be achieved by replacing existing doorknobs with a lever-operated mechanism, push-type mechanism, or U-shaped mechanism doorknob. Doorknobs must be replaced with accessible hardware where they are specifically altered, or in areas open to the public where the 30% threshold for full compliance with 521 CMR is reached.

*Figure 10: Non-compliant doorknobs*

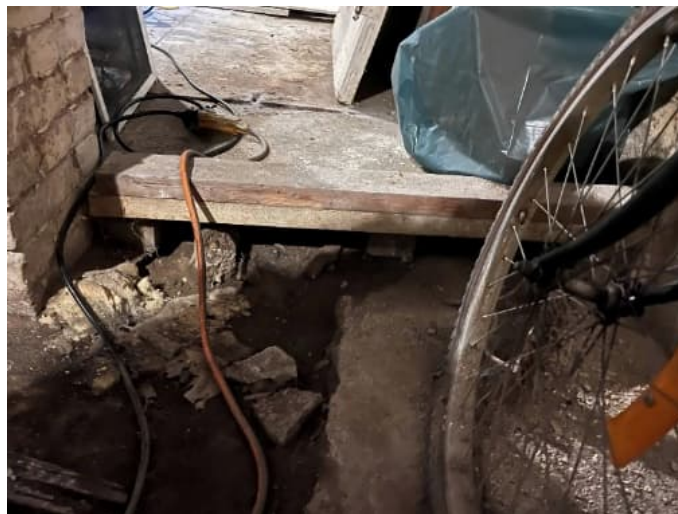
Where elevation changes of less than 12 inches exist in the means of egress, sloped surfaces shall be used. The basement includes various elevation changes less than 12" building (Figure 11) . The level changes present a tripping hazard and therefore can be considered an unsafe condition. As part of the alterations, a level walking surface should be provided.

Figure 11: Non-level walking surface in basement

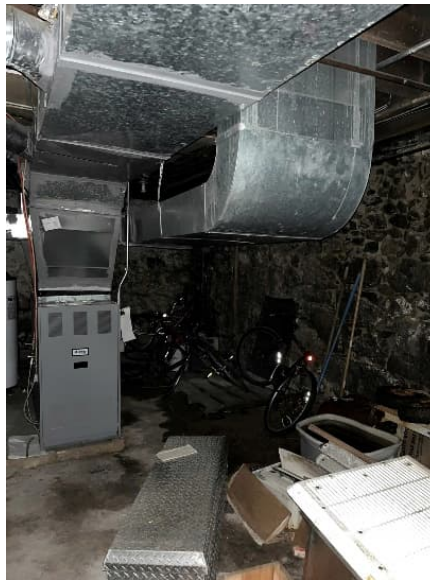
The required headroom clearance for storage rooms is 7' minimum. A large duct is located in the basement that reduces the headroom clearance to 63" (Figure 12). The headroom must comply with the requirements applicable to new construction where the ductwork is specifically altered or where the condition is deemed unsafe by the building official.

*Figure 12: Large duct that reduces basement headroom*
