# **2021 Triennial Inspection**

## **METROPOLITAN HIGHWAY SYSTEM**

### **REPORT OF CONDITIONS**

October 1, 2021

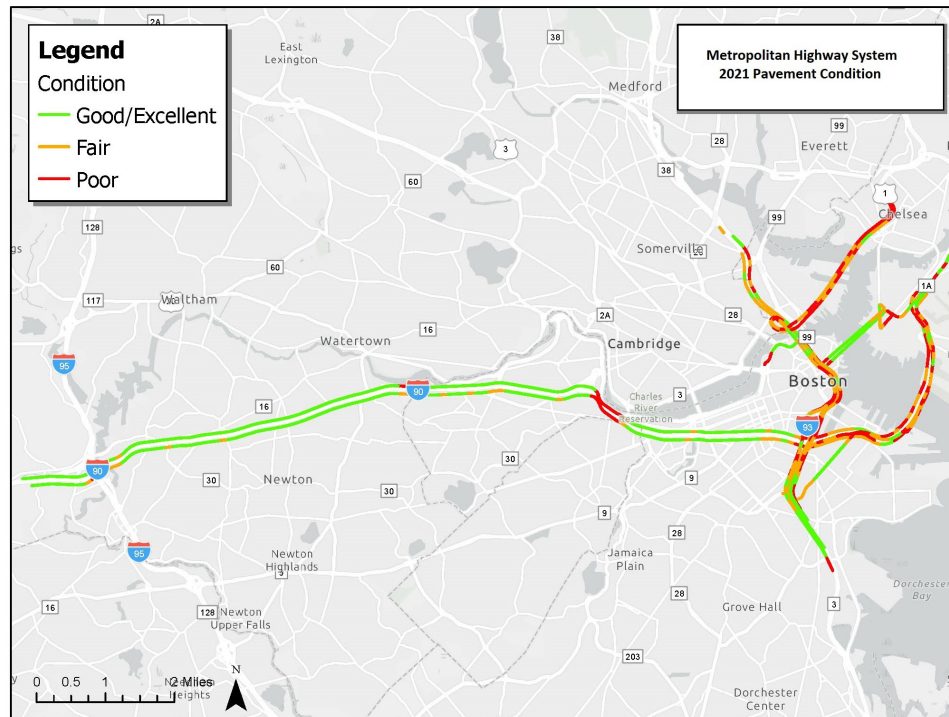
**Figure 9: MHS 2020 Pavement Condition Heat Map**

Each data point collected was assigned a “Heat” color and plotted along the MHS to generate a heat map. The heat map helps to identify stretches of pavement that are in Poor to Fair condition that might be suitable for rehabilitation/replacement.
