Office of the
Inspector General
Commonwealth of Massachusetts

A Big Dig Cost Recovery
Referral: Paving
Mismanagement by
Bechtel/Parsons
Brinckerhoff

January 2005

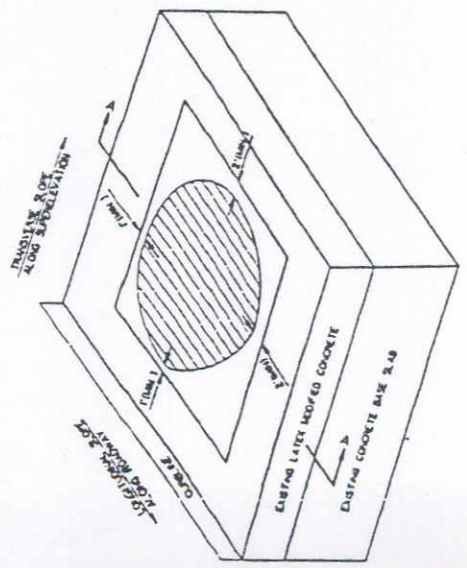
DETAIL 1
THREE DIMENSIONAL VIEW
OF A DELAMINATED AREA

THE EXTENT OF WORK ON RAMP E-T VIADUCT HAS BEEN REVISED TO FILL REMOVAL AND REPLACEMENT OF THE OVERLAY IN LEU OF PARTIAL REPAIR ONLY AT DELAMINATED AREAS. HOWEVER DETAIL 1 AND NOTES 1 & 3 ON THIS DRAWING REMAIN FOR INFORMATION PURPOSES.

3. DETAIL 1 ON THIS DRAWING IS FOR REMOVAL AND REPLACEMENT OF ONLY THE DELAMINATED AREAS ON RAMP E-T VIADUCT AS SHOWN ON DRAWING NO'S C-008, C-009 & C-010 AND SPEC SECTION 478.404. THE PAVEMENT ON RAMP E-T AND RAMP E-T BOAT SECTION SHALL BE REMOVED AND REPLACED IN ITS ENTIRETY AS SHOWN ON DRAWING NO'S C-012 & C-013 AND SPEC SECTION 487.403.

1. THE CONTRACTOR SHALL REMOVE DELAMINATED LATEX MODIFIED CONCRETE (LMC) AND REPLACE WITH NEW OVERLAY MATERIAL AT REPAIRED LOCATIONS FOLLOWING THE PROJECT SPECIFICATIONS AND STANDARD DRAWINGS ACCORDING TO THE FOLLOWING GUIDELINES:

- A. DETECT ALL THE UNBOUND/DELAMINATED LMC.
 - B. REMOVE ALL THE UNBOUND/DELAMINATED LMC IN ACCORDANCE WITH THESE CONTRACT DOCUMENTS. THE USE OF SAW CUT SHALL BE AT LEAST ONE FOOT ON THE UPHILL SIDE IN BOTH DIRECTIONS AND AT LEAST TWO FEET ON THE DOWNHILL SIDE IN BOTH DIRECTIONS OF THE DELAMINATED/PATCHED AREAS AS ILLUSTRATED IN DETAIL 1. THE DELAMINATED AREAS ADJACENT TO THE CURB/RE-UTILITY STRUCTURES SHALL BE REMOVED BY HAND. USE OF A MILLING MOWNE IS RECOMMENDED FOR LARGE AREAS.

- C. AFTER REMOVAL THE UNBOUND/DELAMINATED LMC, BLAST OR SCARIFY THE UNDERLYING BASE SLAB SURFACE TO REMOVE ALL LOOSE MATERIAL AND TO EXPOSE AT LEAST 3/4" COURSE AGGREGATE AS ILLUSTRATED IN DETAIL 2. IN THIS SHEET, CARE SHOULD BE TAKEN NOT TO EXPOSE REINFORCING STEEL.

- D. BLAST CLEAN ALL HORIZONTAL AREAS AND SOAK SURFACES TO RECEIVE NEW OVERLAY FOR AT LEAST 12 HOURS. CARE SHOULD BE EXERCISED TO ENSURE THAT HIGH POINTS OF THE AREA ARE SMOOTHED THE SAME AS THE REST OF THE AREA.

- E. APPLY BOARDING GROUT, AND PLACE OVERLAY. LET OVERLAY CURE.
2. FOR SAW CUT LONGITUDINAL CONSTRUCTION JOINT IN OVERLAY FOR TRAFFIC STAGING SEE STANDARD DRAWING NO. SD-C-304.
